Heritage Impact Statement

HERITAGE IMPACT STATEMENT

Planning Proposal - 169-173
Victoria Street & 92-98
Brougham Street

Prepared for
OAKSTAND
3 June 2020

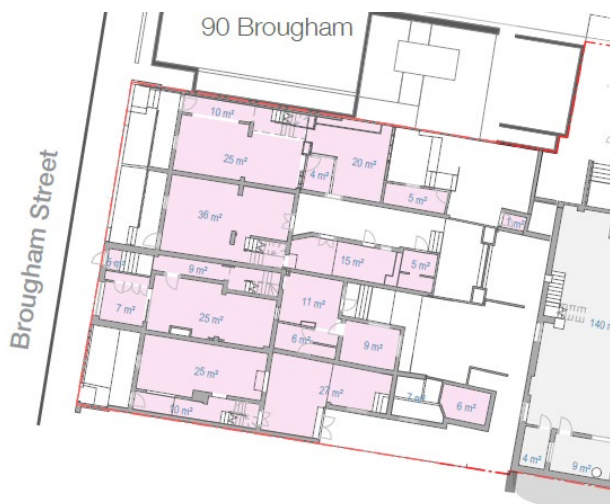
Figure 6 – Existing state of the Brougham Street terraces.

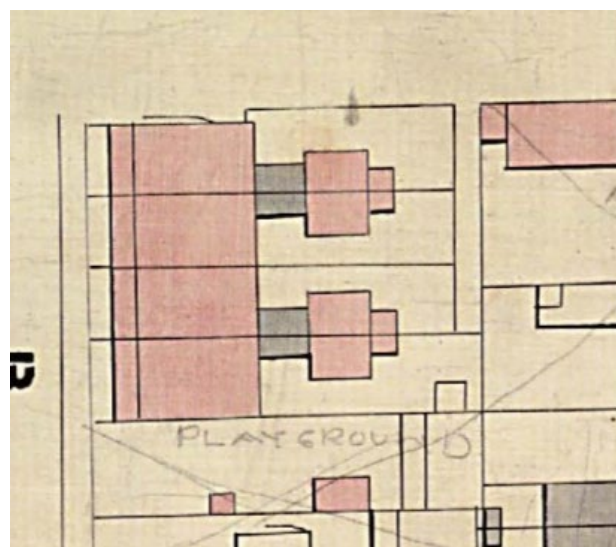
Figure 7 – 1855 state of the Brougham Street terraces (subject terrace outlined blue).

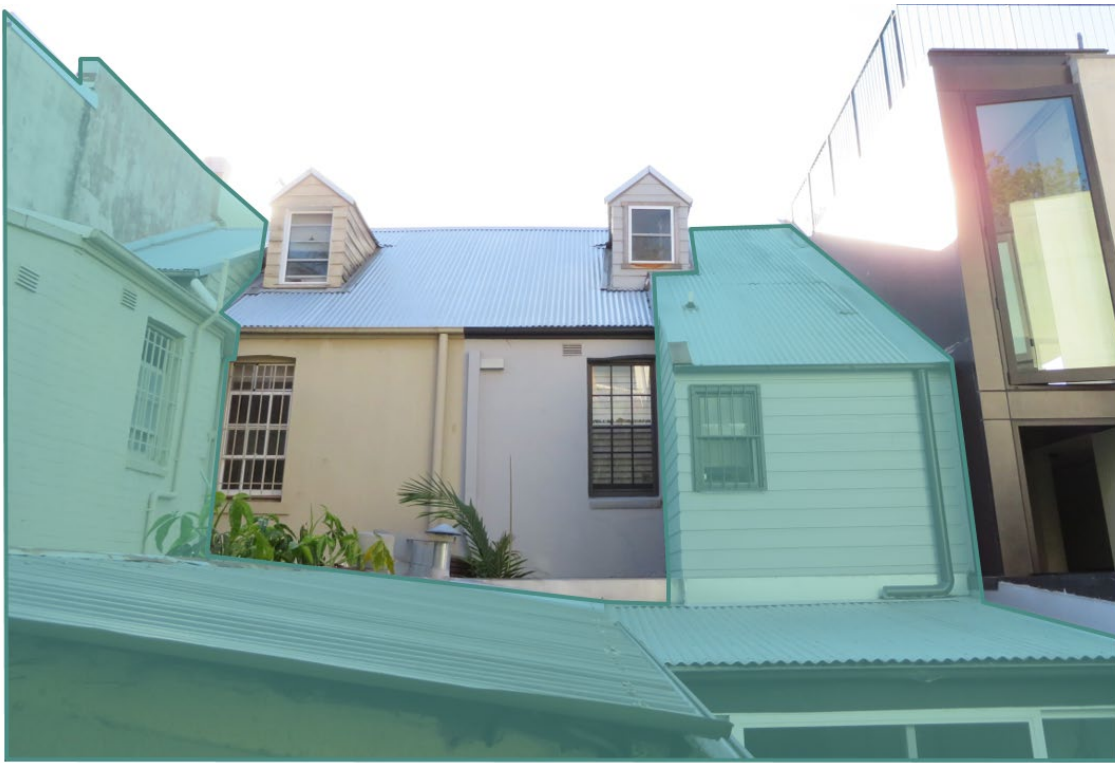
Figure 8 - Rear elevations of 92 – 94 Brougham Street showing later fabric shaded blue.

The rear walls of 96 and 98 indicate the original extents of the wings and retain an original chimney, however these forms are highly altered, extended and their roof sheeting has been replaced. The rear wings appear to have been removed entirely behind 92 and 94. The later rear wing associated with 94 Brougham notably now extends down the southern boundary of the property rather than the north.

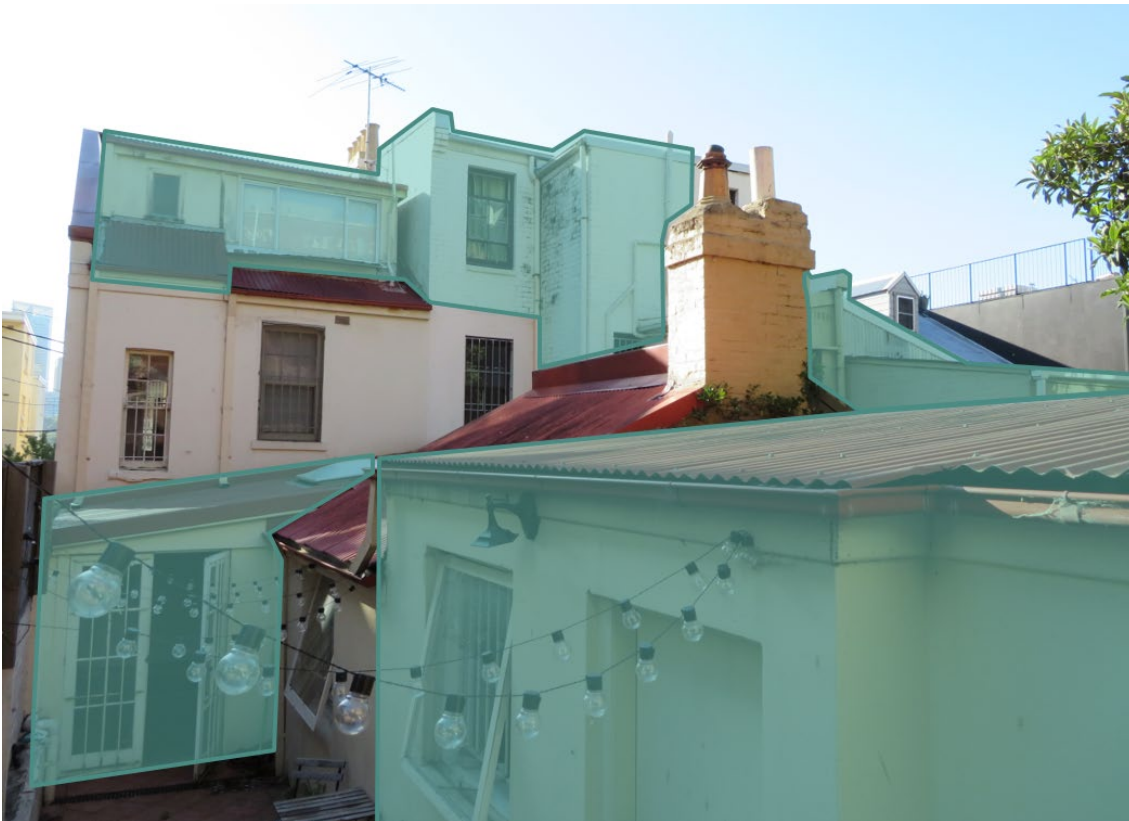
Figure 9 - Rear elevations of 96 – 98 Brougham Street showing later fabric shaded blue.

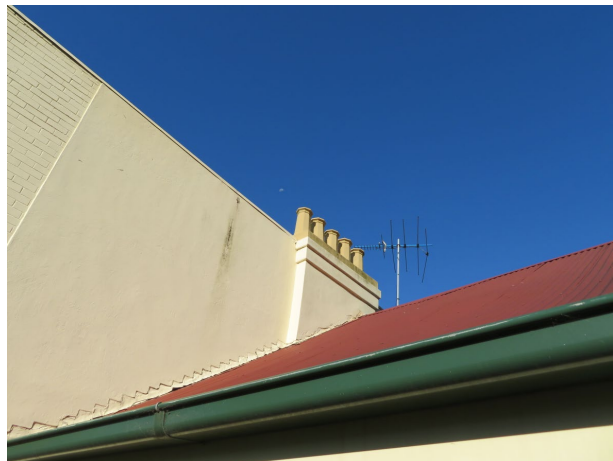
Figure 15 – Interaction between later fabric associated with 96 Brougham Street and original chimney.

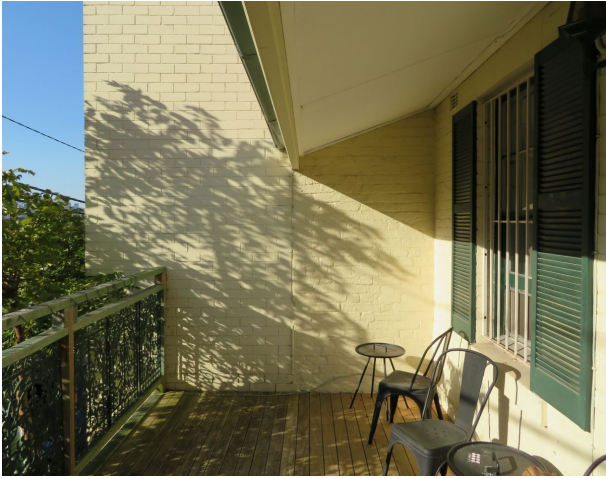
Figure 16 – View north to the later south façade of 96 Brougham Street. the original party wall is evident below the eaves line of 98 Brougham Street. Original joinery to the front of 98 Brougham.

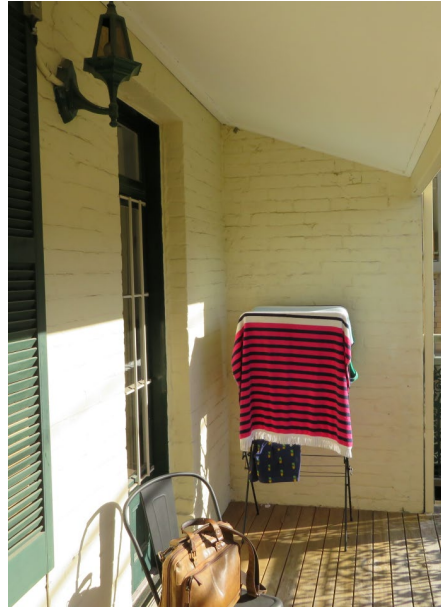
Figure 17 – View south across front veranda of 98 Brougham showing later floor and soffit finishes.

98 Brougham has an original fenestration configuration to the front façade. Some original window/door joinery remains to the first floor veranda. The veranda itself is of entirely later construction and now extends past the extent of the party wall and the original extents of the veranda. None of the iron lacework to the balustrades is original. The rear roof form of 98 Brougham Street has been altered to include a wide dormer window. The window on the first floor to the rear appear to be original however all other openings to the rear include later joinery. The front wall is not originally and none of the finishes or landscaping within the front setback are original.

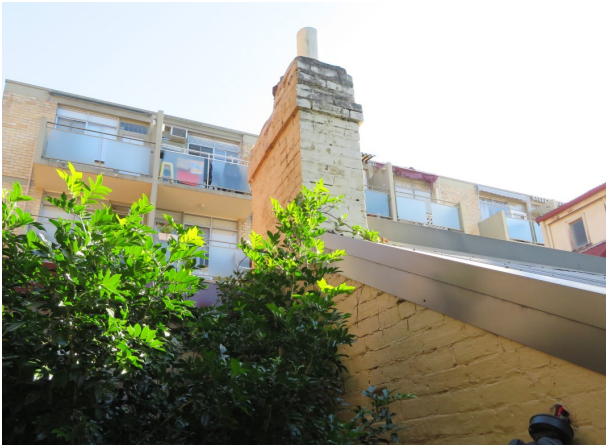
Figure 18 – Remnant wall of rear wings behind 96 and 98 Brougham Street.

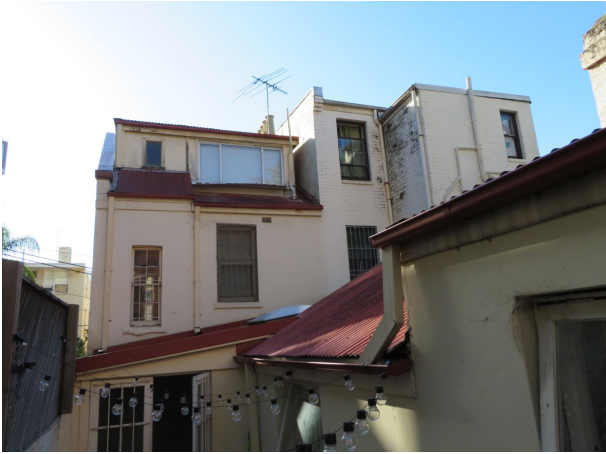
Figure 20 – Rear wall of 98 Brougham Street (96 Brougham to the right).

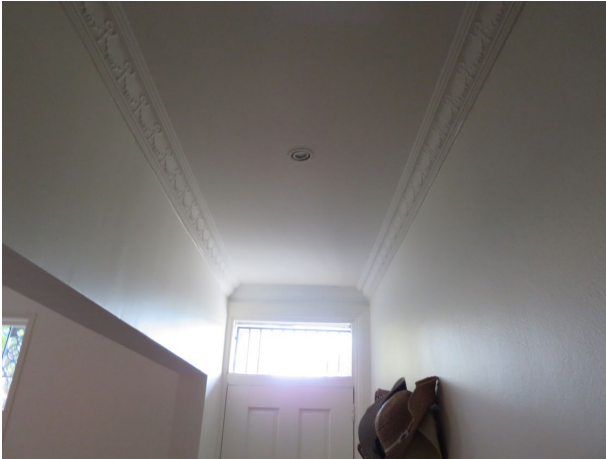
Figure 22 – Later ceiling to front hall of 92 Brougham Street.

In 1977 (refer 1486/77) alterations were made to the terraces at 92 – 94 Brougham Street to provide bathrooms to first floor and amend kitchens. 92 Brougham Street generally retains its original principal layout however has new finishes throughout and a later staircase to the front hall. Remnant of an original stair exists on the first floor. 94 Brougham Street does not retain its original stair. It appears to retain some skirtings however has no other characteristic features internally. 96 Brougham Street is highly altered to the rear however has original features to the principal rooms as shown below. This terrace retains its original stair. 98 Brougham Street has few original features within its principal form. Floor and wall finishes are later. Skirtings and cornices have been removed throughout however the front room on the first floor retain an original cornice. This terrace retains its original stair.

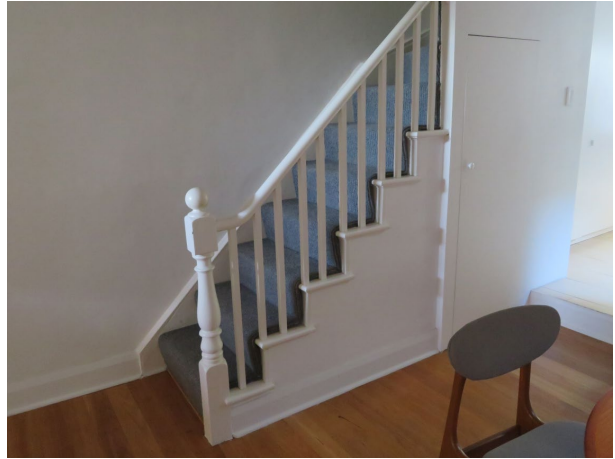
Figure 23 – Later staircase to front hall of 92 Brougham Street.

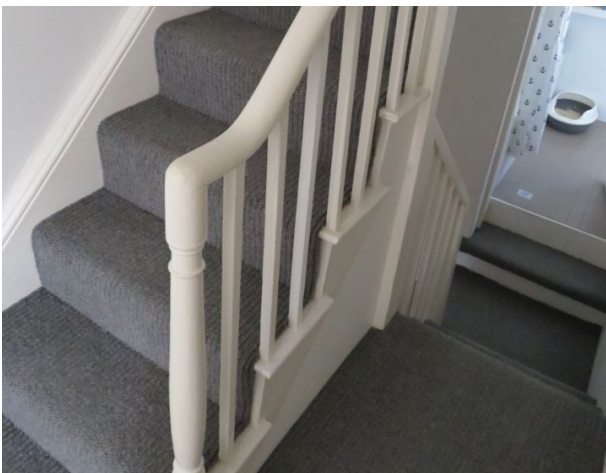
Figure 26 – Original stair between first floor and attic or 92 Brougham Street.

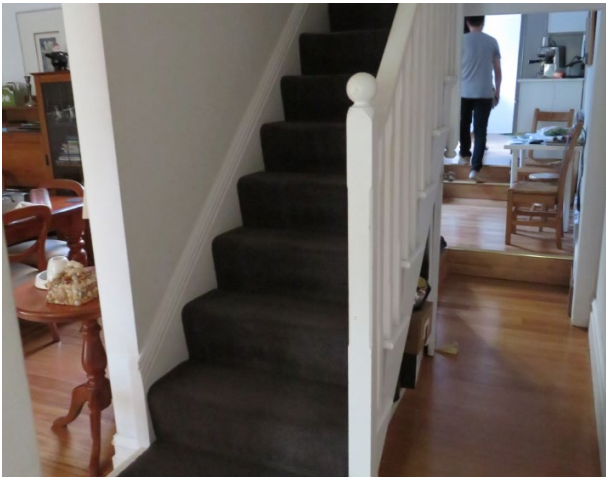
Figure 28 – Later stair to 94 Brougham Street.

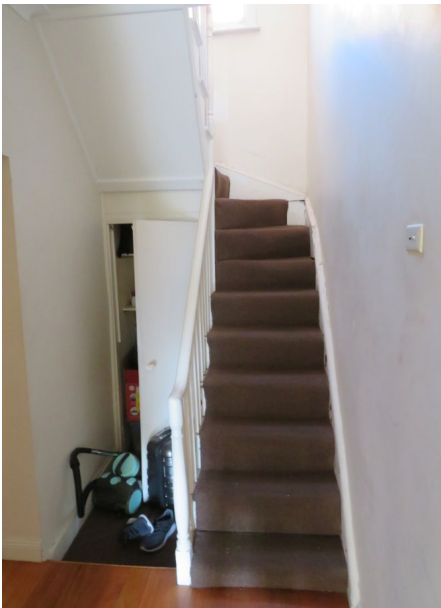
Figure 38 – Original stair to 98 Brougham Street.

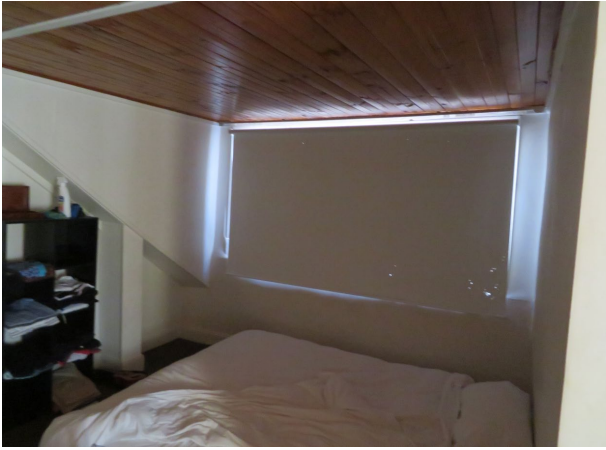
Figure 40 – Adapted roof space and later wide dormer to the rear of 98 Brougham.

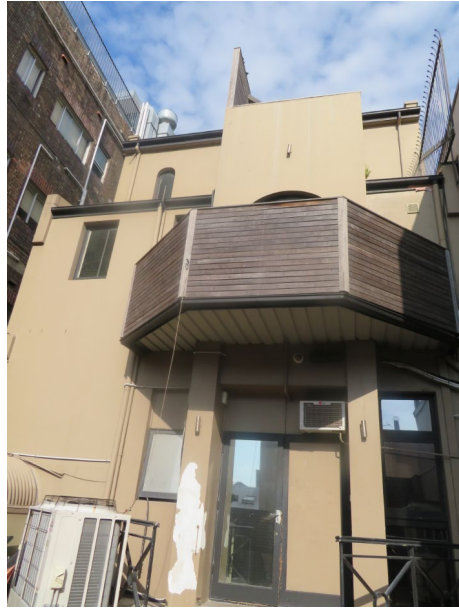
Figure 45 – View to highly altered rear elevation showing later veranda.

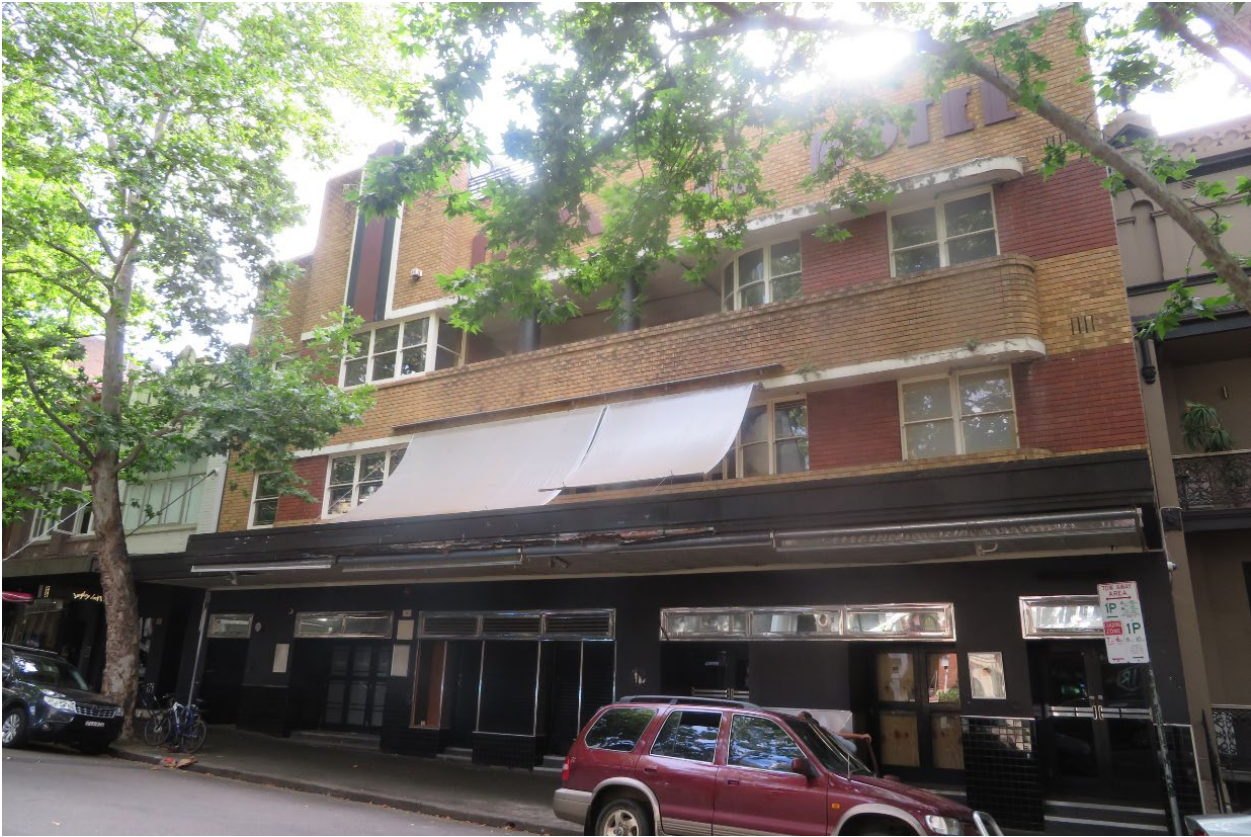
Figure 52 – The eastern façade of the Piccadilly Hotel.

from view from the brick balustrade and minor setback of the curve. This curved feature is also present at either ends of the balustrades and second floor detail. Two fabric awnings have been added above the first-floor balcony that extend down to the ground floor awning. The ground floor awning has corrugated metal cladding.

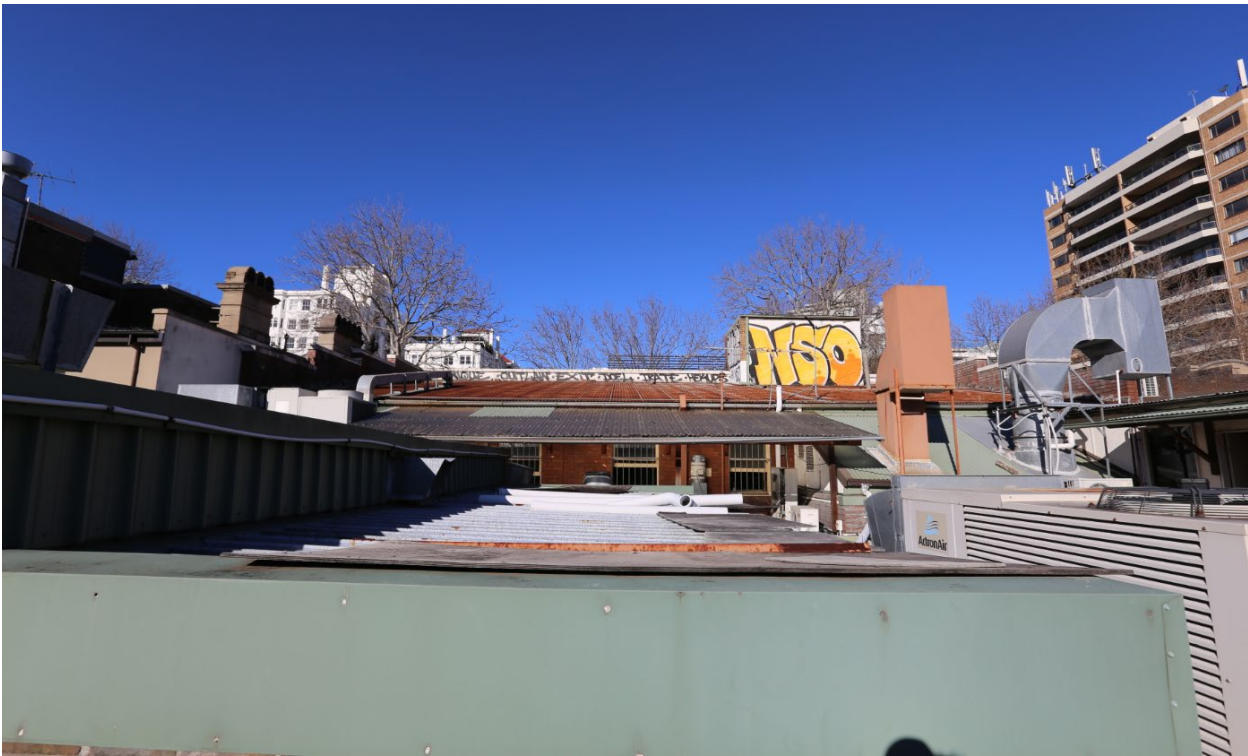
Figure 57 – View east over the open roof top toward the second floor.

From the open roof top, the extent of the parapet can also be seen with the tops of the parapet visible on the northern, southern and eastern walls of the building. The parapet on the southern and northern walls step with rendered concrete headers and exposed brick. The parapet would have originally hidden the roof form of the second floor from street level. However, this has been obscured now by recent additions to the neighbouring properties.

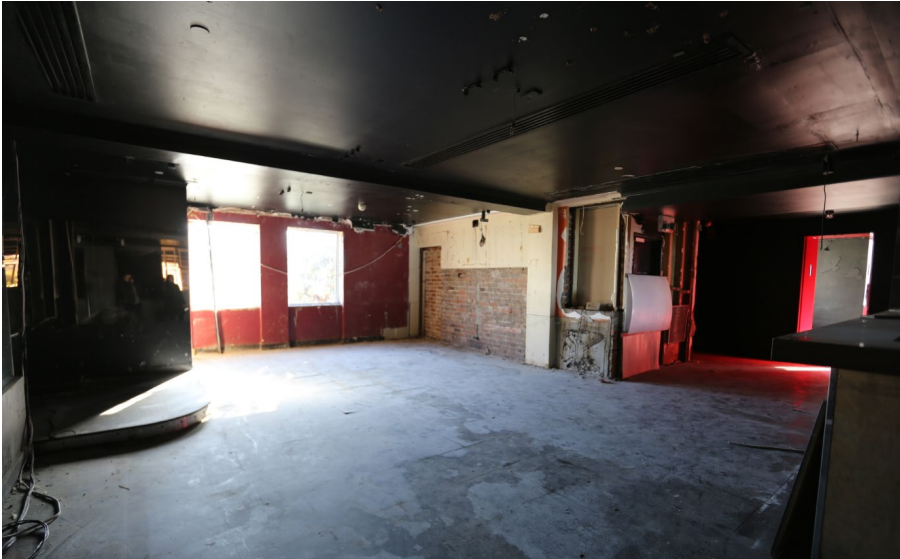
Figure 59 – View of the bar area, view north-west. The central bar is just visible in the right-hand corner of the image.

Some of the alterations to the floor include wall and floor finishes, bathroom, kitchen and bar fitout.

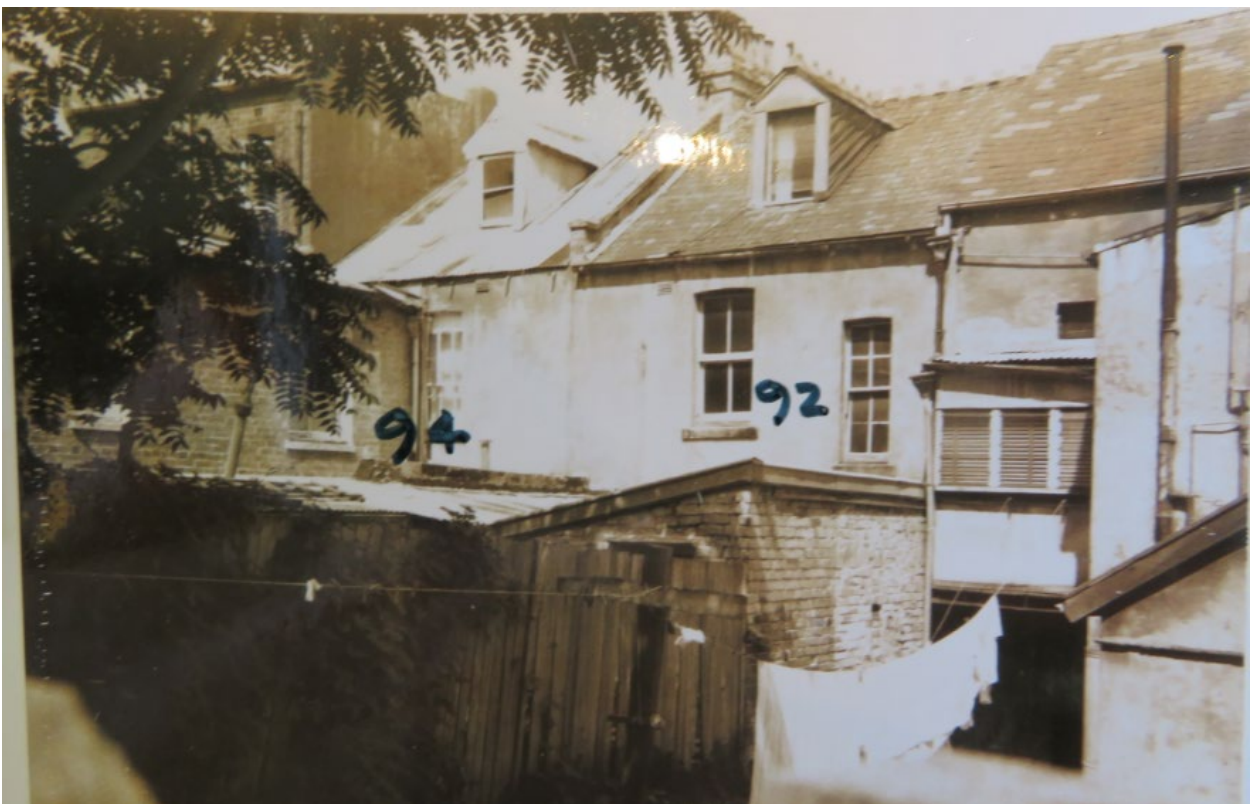
Figure 68 – View of rear of terraces in 1977

In 1977, under application no 1486/77 alterations were made to the terraces to provide bathrooms to first floor, amend kitchens, reopen the first-floor verandas by removing the existing windows, removal of the external chimneys, removal of the rear dormer windows, re-roofing in galvanised iron and provision of new timber framed dormers to the front. Images of No. 92-94 contained within the application show the terraces before the proposed works. The front verandas on the first floor that had been enclosed to create sun rooms off the front bedrooms (refer Figure 67). Photographs of the rear show that No. 94 also had a first-floor rear addition (refer Figure 68).

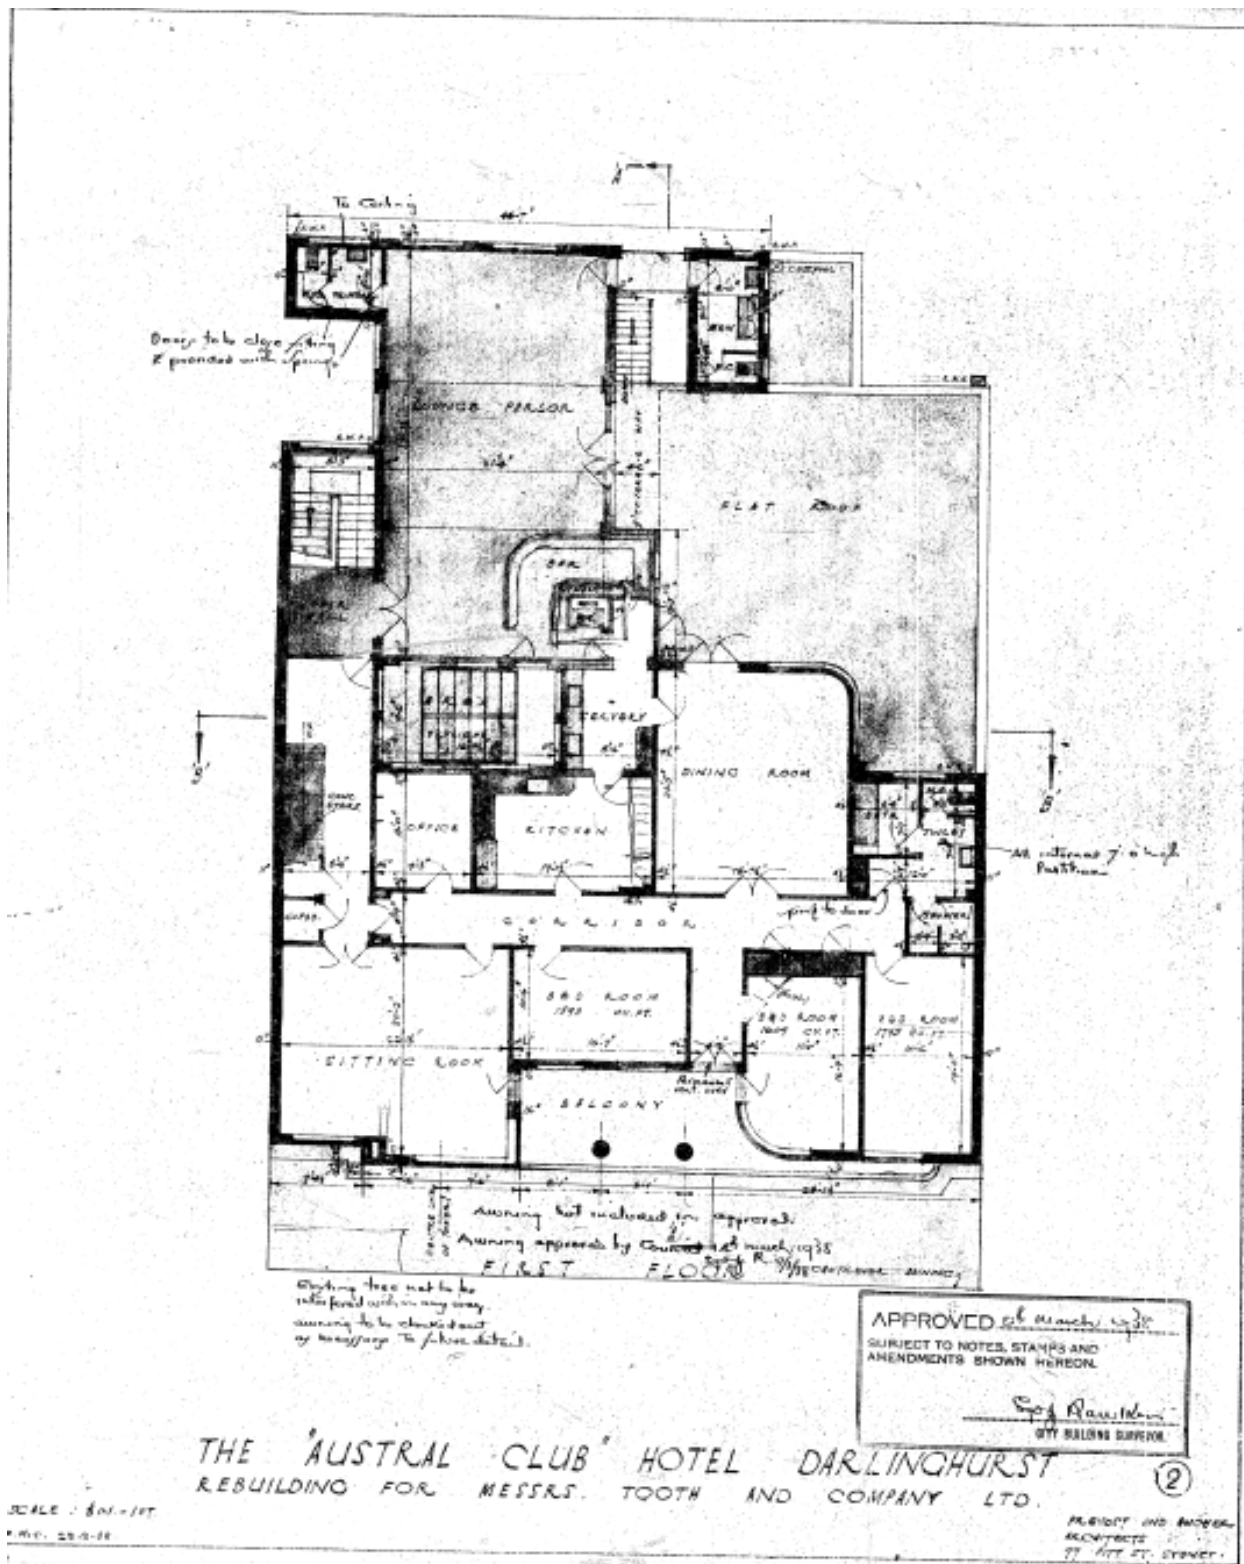
Figure 81 – Original first floor plan. Approved in 1938.

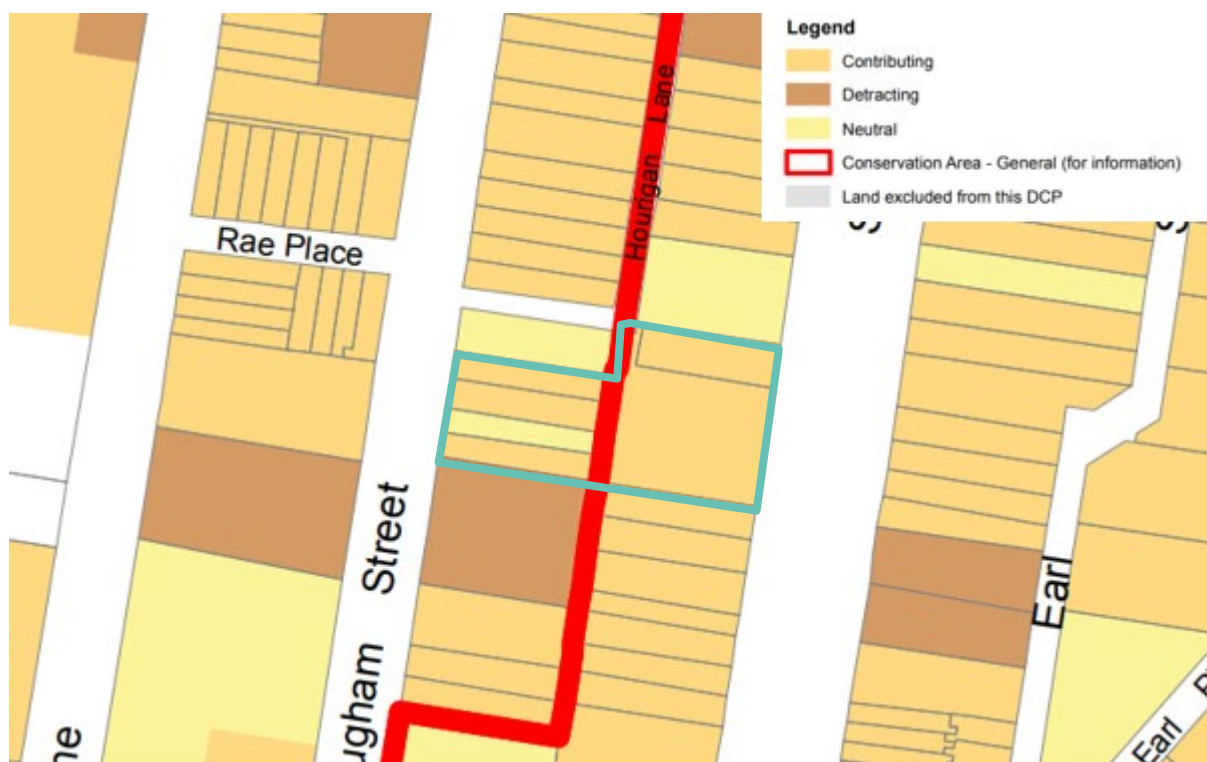
Figure 101 – Extract of Building Contributions map indicating contributing and neutral items within the subject site (outlined blue).
