**Remediation Action Plan  
757-763 George Street, Haymarket**

# Remediation Action Plan

757-763 GEORGE STREET, HAYMARKET  
NSW

EI Report No.: E22293 AB\_Rev2  
 Date: 7 September 2020

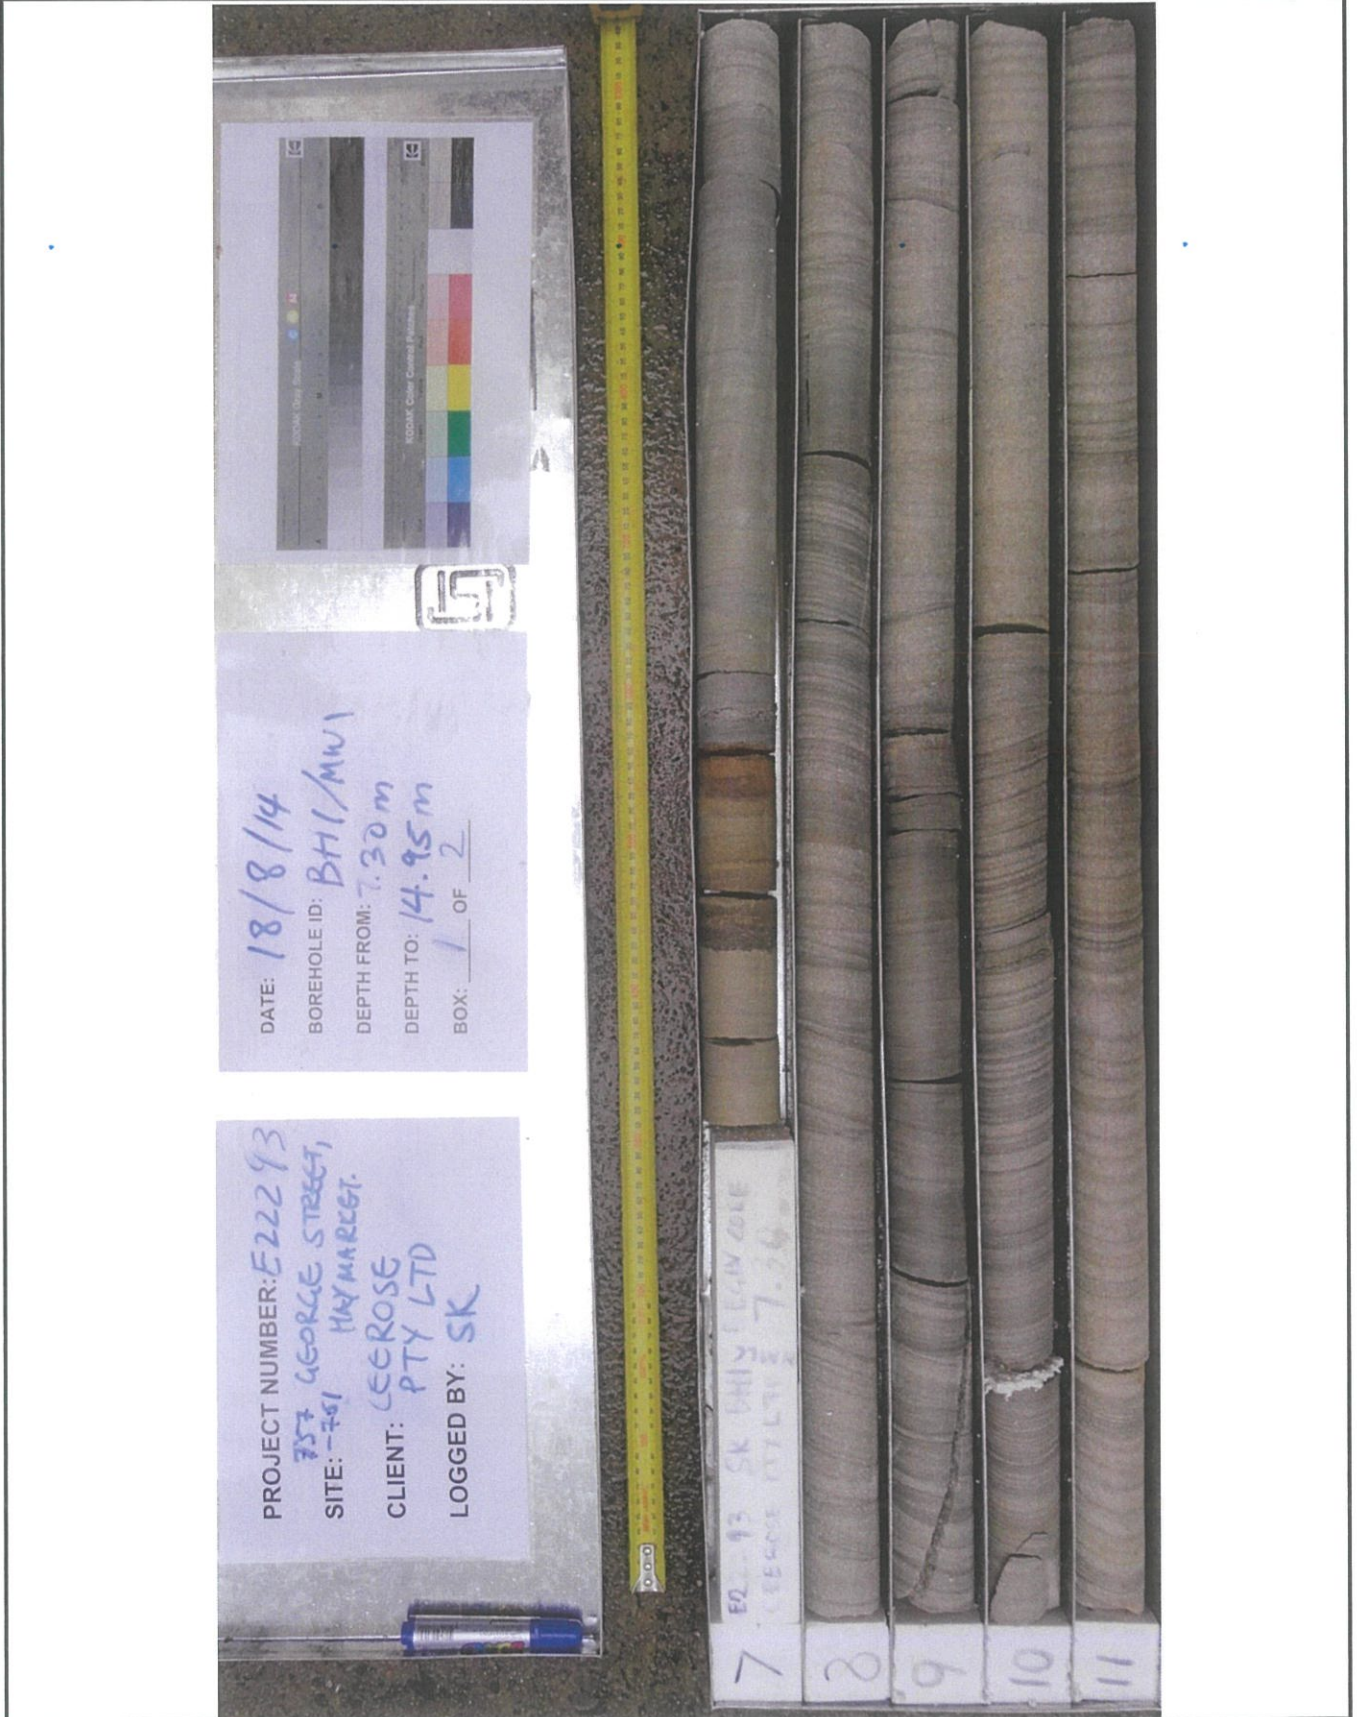
# REPORT OF BOREHOLE: BH1/MW1

EAST: 333917.396 m  
NORTH: 6249510.394 m MGA94 Zone 56  
INCLINATION: -90°  
BOX: 1 of 2  
HOLE DEPTH: 14.95 m

DEPTH RANGE: 7.30 m to 14.95 m  
DRILL RIG: MD 3000  
DRILLER: Traccess Pty Ltd  
LOGGED: SK DATE: 18/08/2014  
CHECKED: RP DATE: 03/10/2014

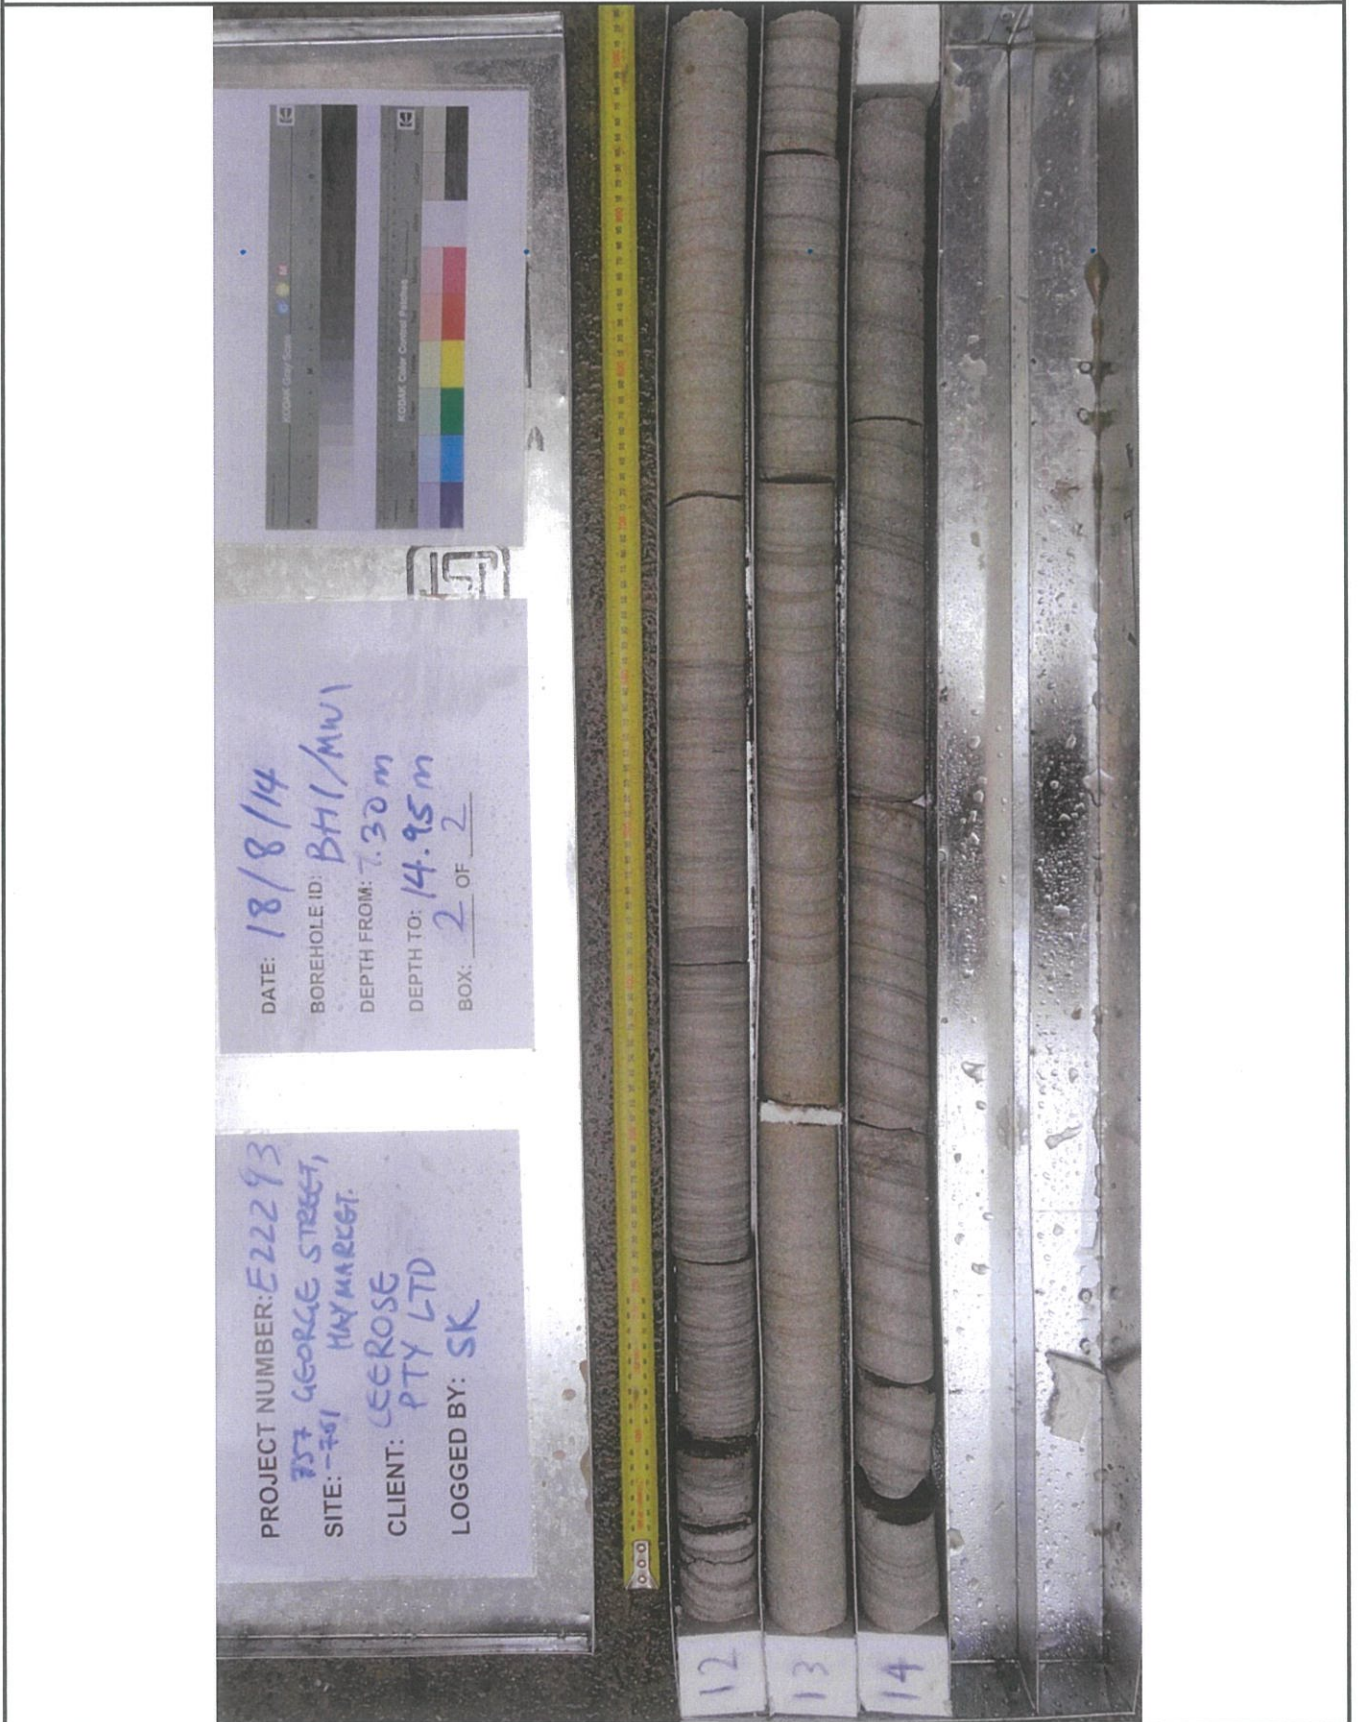
Project	Haymarket Geotechnical investigation	East	333905.9 m	Sheet	2 OF 3
Location	757-763 George St, Haymarket NSW	North	6249525.3 m MGA94 Zone 56	Date Started	18/8/14
Position	Refer to Figure 2	Contractor	Traccess Pty Ltd	Date Completed	18/8/14
Job No.	E22293	Drill Rig	MD 3000	Logged SK	Date: 18/8/14
Client	Ceeroose Pty Ltd	Inclination	-90°	Checked RP	Date: 3/10/14

Drilling					Field Material Description				Defect Information		
METHOD	WATER	TCR	RQD (SCR)	DEPTH (metres)	DEPTH RL	GRAPHIC LOG	ROCK / SOIL MATERIAL DESCRIPTION	WEATHERING	INFERRED STRENGTH Is(50) MPa	DEFECT DESCRIPTION & Additional Observations	AVERAGE DEFECT SPACING (mm)
								EL V L M H VH EH			10 30 100 300 1000 3000
				0							
				1							
				2							
				3							
				4							
				5							
				6							
				7
