**Preliminary Geotechnical Report  
757-763 George Street, Haymarket**

# Preliminary Geotechnical Investigation Report

757-763 George Street, Haymarket NSW

**Report No:** E22293 GA\_Rev3

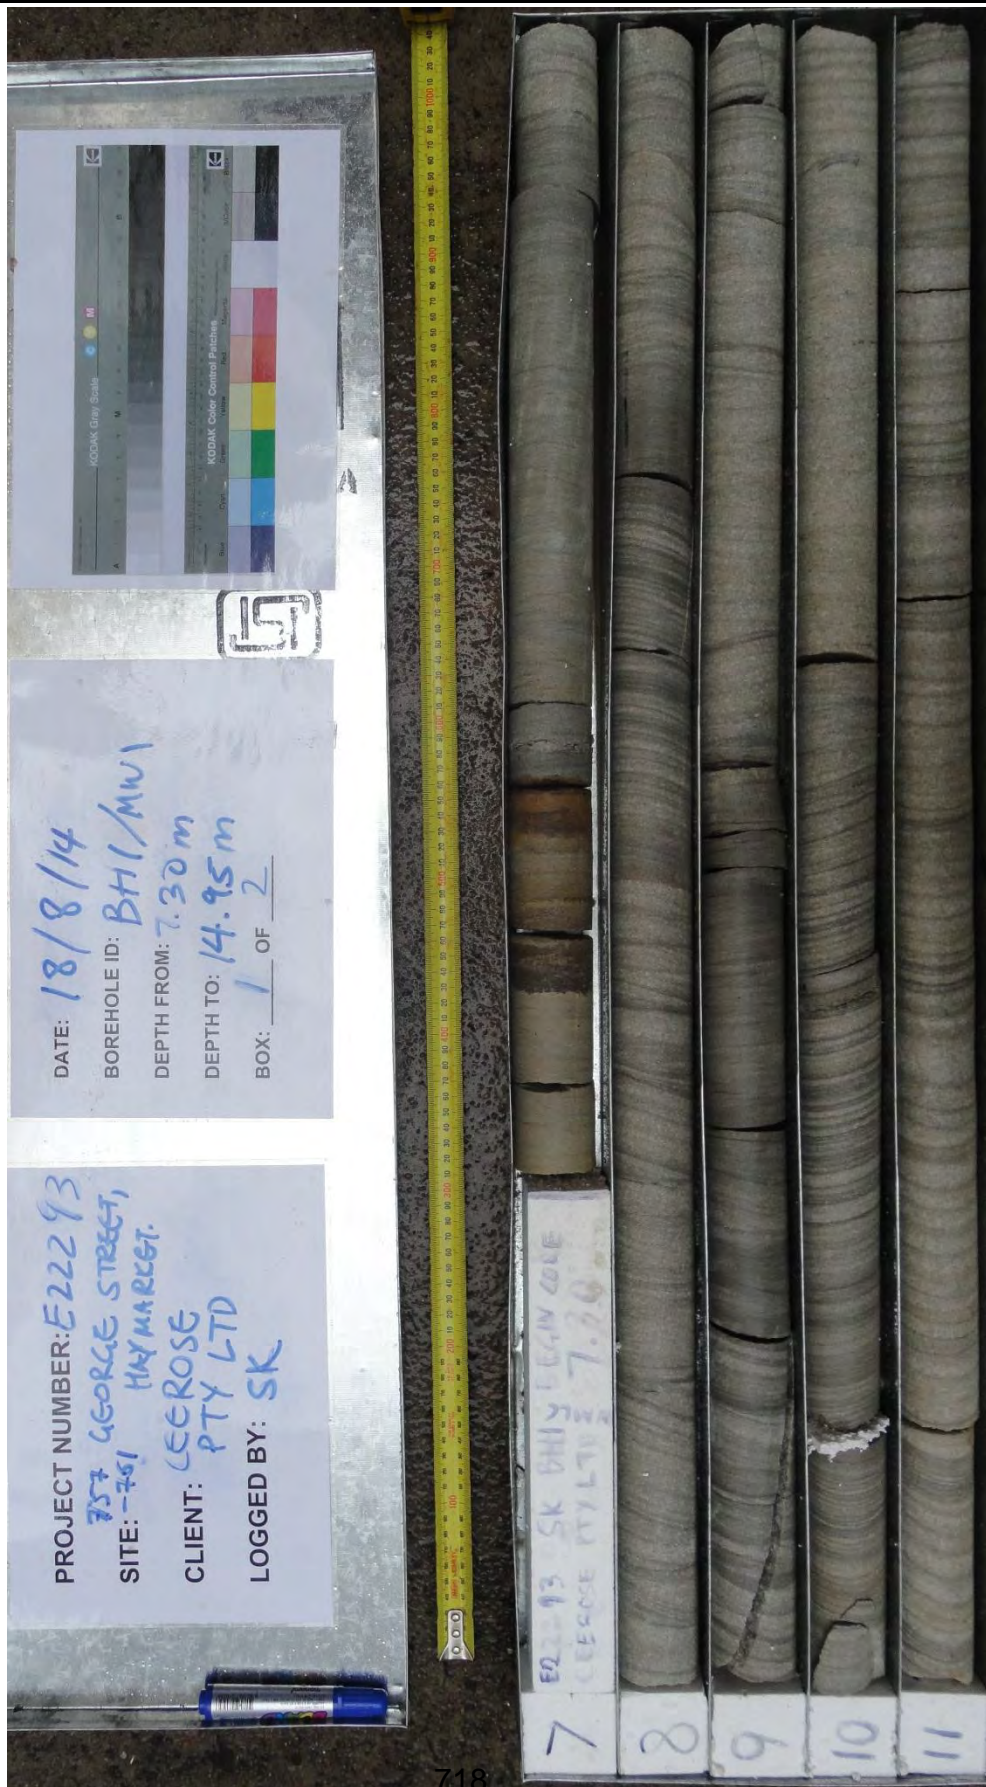
# REPORT OF BOREHOLE: BH1/MW1

EAST: 333917.396 m  
NORTH: 6249510.394 m MGA94 Zone 56  
INCLINATION: -90°  
BOX: 2 of 2  
HOLE DEPTH: 14.95 m

DEPTH RANGE: 7.30 m to 14.95 m  
DRILL RIG: MD 3000  
DRILLER: Traccess Pty Ltd  
LOGGED: SK DATE: 18/08/2014  
CHECKED: RP DATE: 03/10/2014

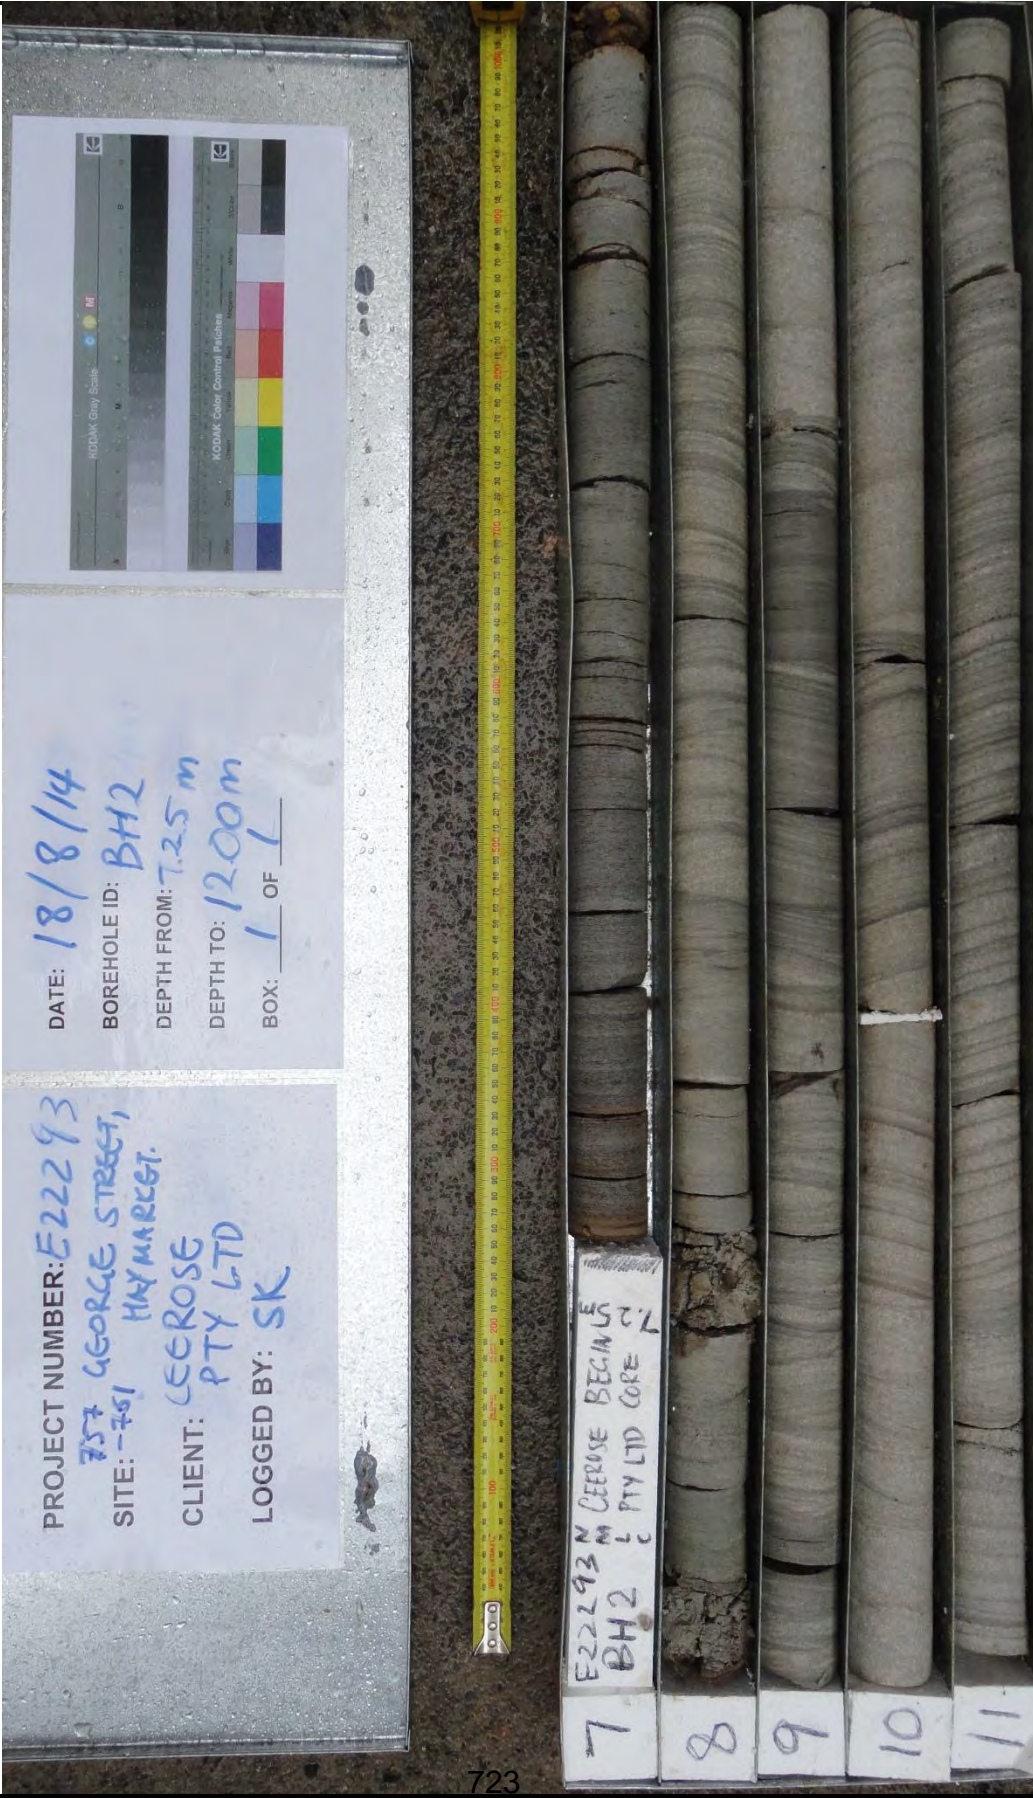
EAST: 333905.891 m  
NORTH: 6249525.260 m MGA94 Zone 56  
INCLINATION: -90°  
BOX: 1 of 1  
HOLE DEPTH: 12.00 m

DEPTH RANGE: 7.25 m to 12.00 m  
DRILL RIG: MD 3000  
DRILLER: Traccess Pty Ltd  
LOGGED: SK DATE: 18/08/2014  
CHECKED: RP DATE: 03/10/2014
