**Remediation Action Plan
757-763 George Street, Haymarket**

757-763 GEORGE STREET, HAYMARKET
NSW

EI Report No.: E22293 AB_Rev2
 Date: 7 September 2020

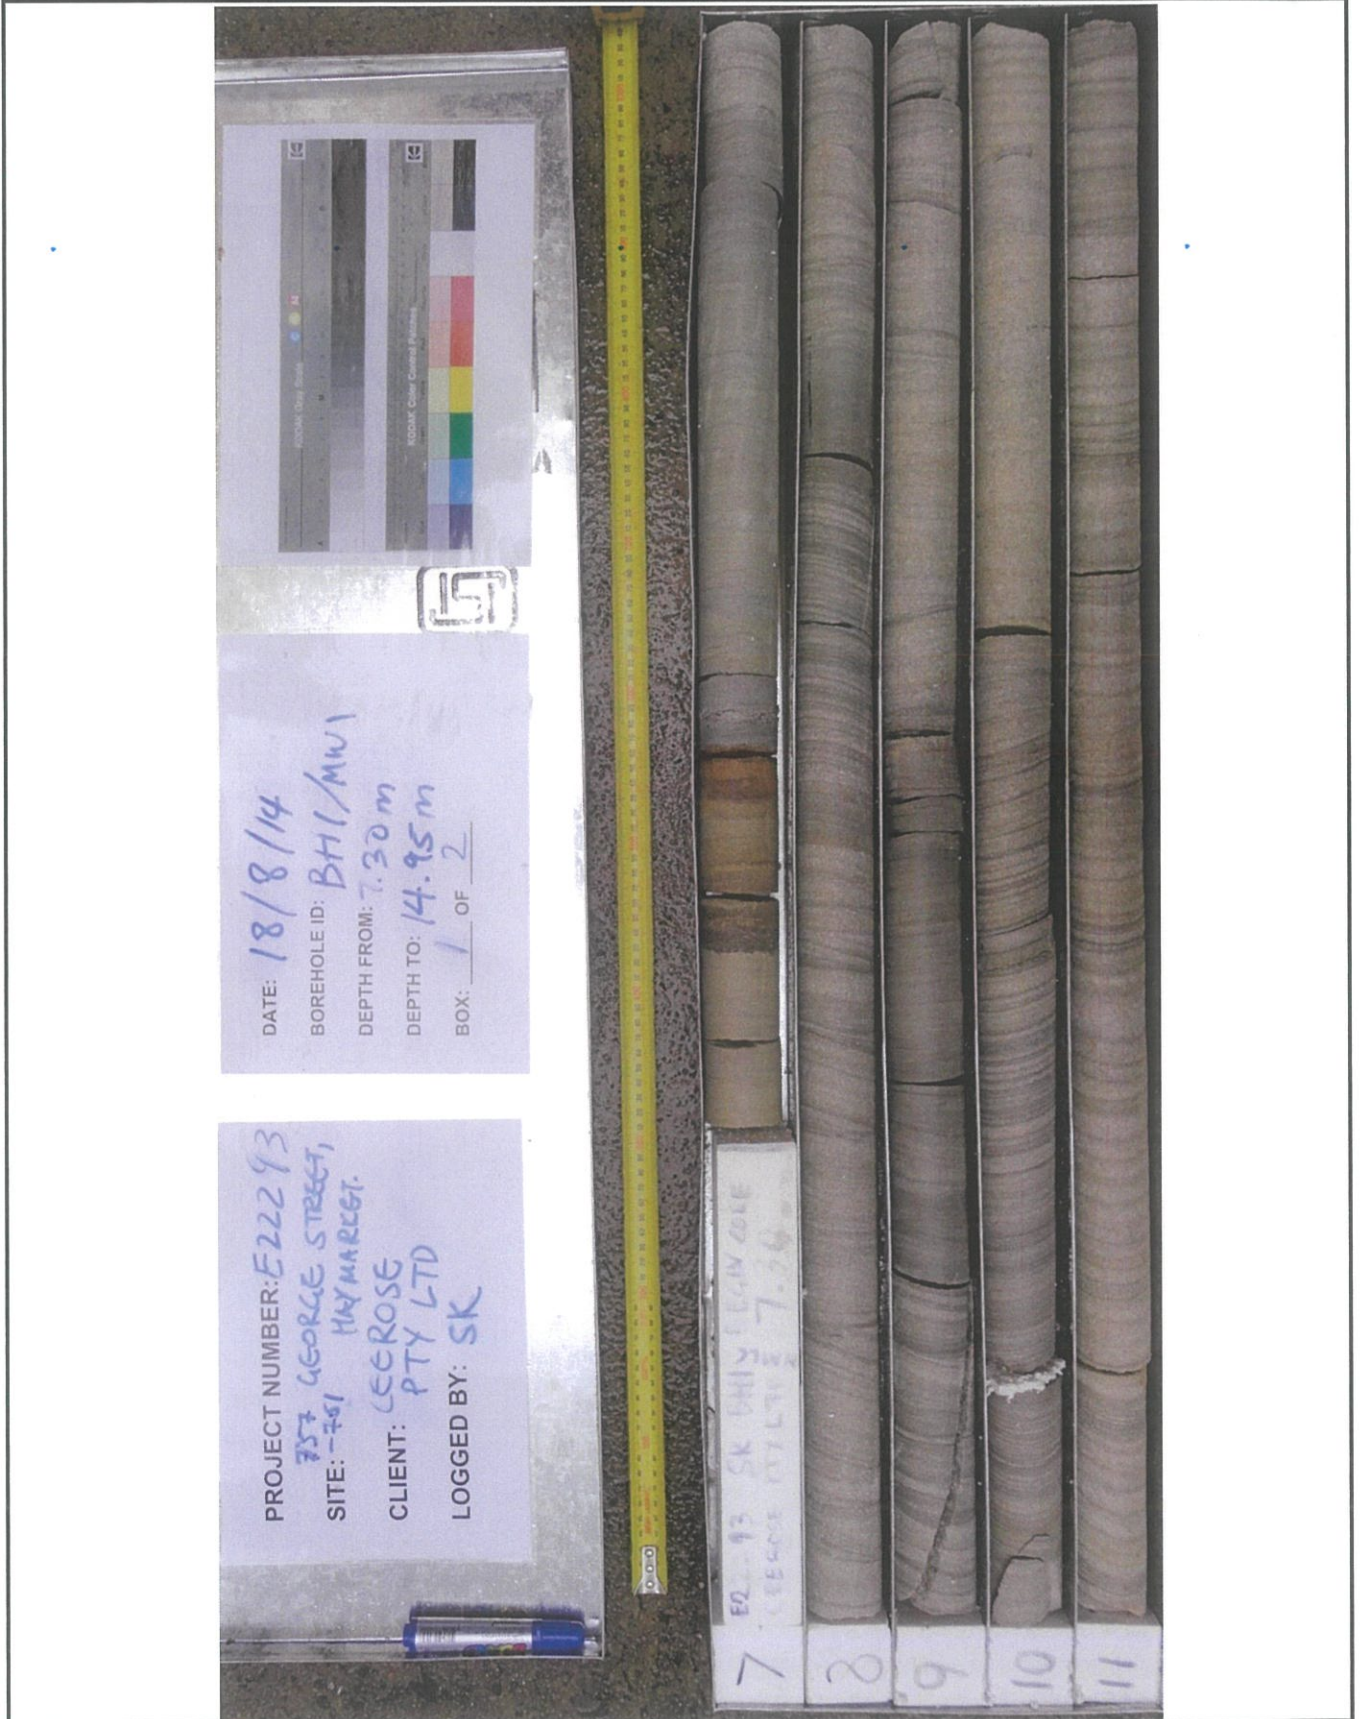
REPORT OF BOREHOLE: BH1/MW1

EAST: 333917.396 m
NORTH: 6249510.394 m MGA94 Zone 56
INCLINATION: -90°
BOX: 1 of 2
HOLE DEPTH: 14.95 m

DEPTH RANGE: 7.30 m to 14.95 m
DRILL RIG: MD 3000
DRILLER: Tracess Pty Ltd
LOGGED: SK DATE: 18/08/2014
CHECKED: RP DATE: 03/10/2014

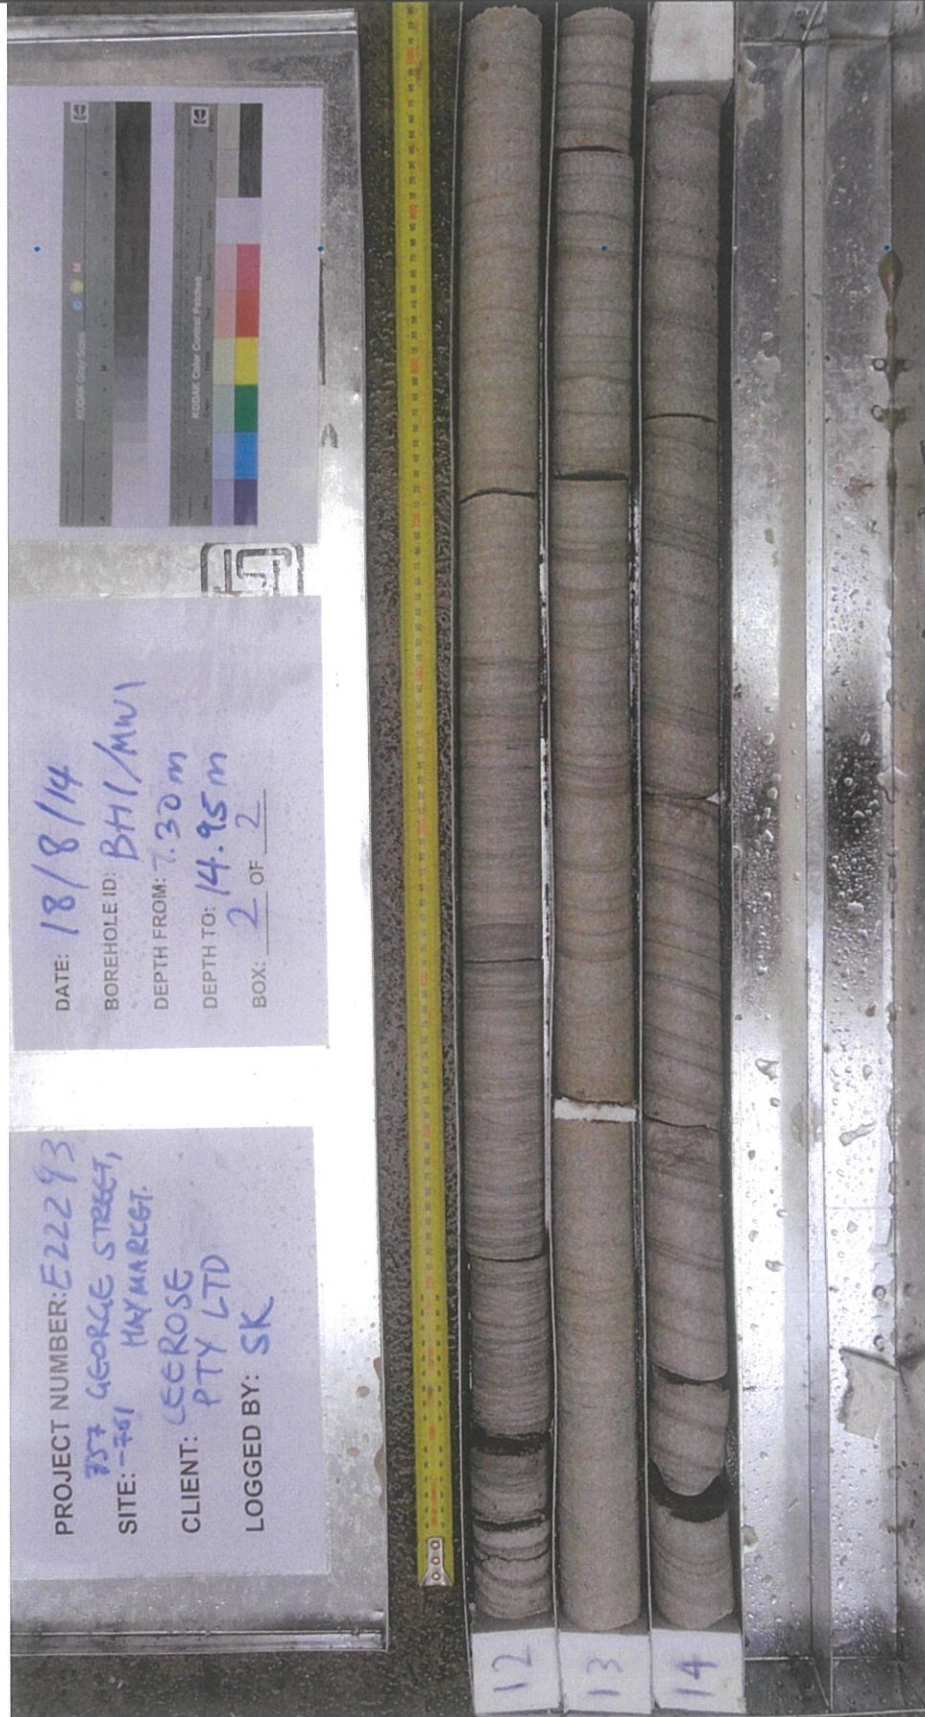
Project Haymarket Geotechnical investigation
Location 757-763 George St, Haymarket NSW
Position Refer to Figure 2
Job No. E22293
Client Ceerose Pty Ltd

East 333905.9 m
North 6249525.3 m MGA94 Zone 56
Contractor Traccess Pty Ltd
Drill Rig MD 3000
Inclination -90°
