**Remediation Action Plan
757-763 George Street, Haymarket**

757-763 GEORGE STREET, HAYMARKET
NSW

E22293 AB_Rev2
7 October 2020

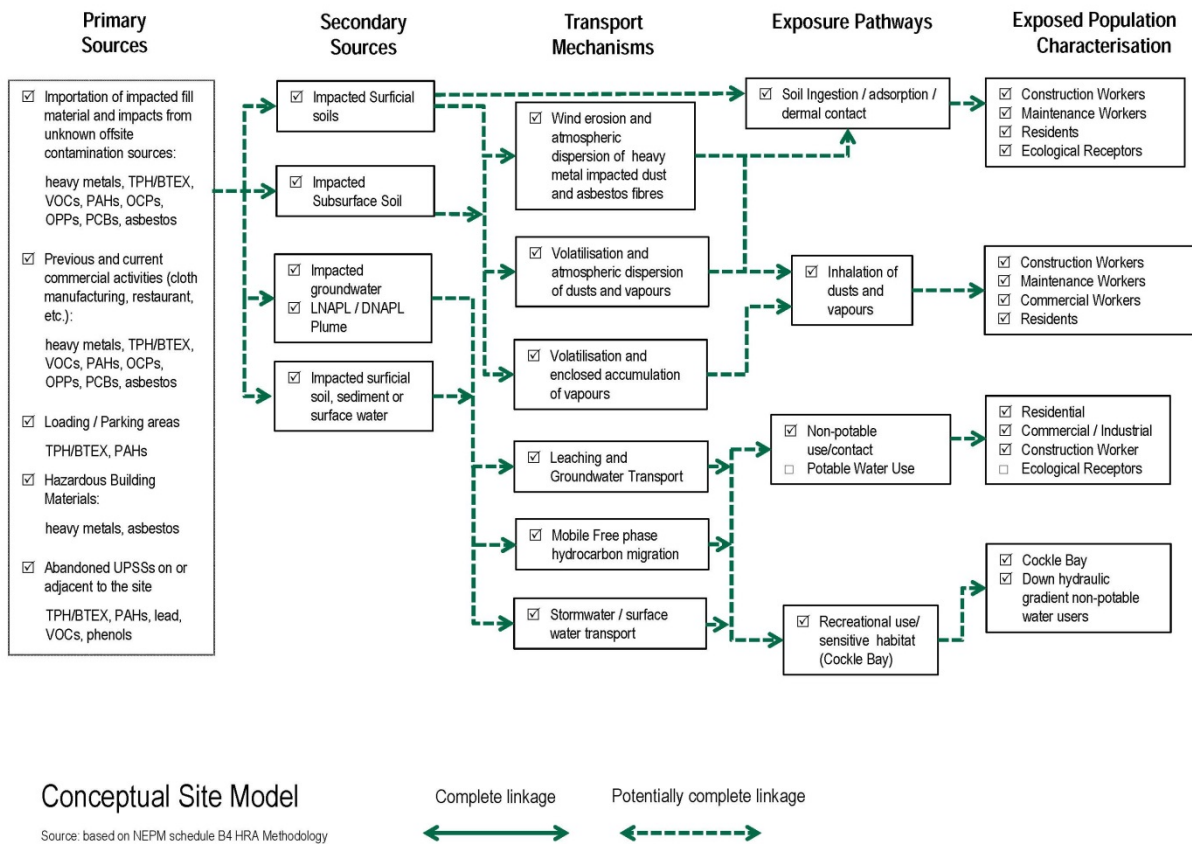
Drawing 1 Conceptual Site Model for 757-763 George Street, Haymarket NSW

On the basis of site history and review of the detailed assessment (EI, 2014), EI considers potential chemical hazards and onsite contamination sources to be as follows:

- Imported fill soils of unknown origin distributed across the site;
- Historical and current commercial activities on site;
- Demolition of previous site buildings;
- Weathering of painted structural surfaces (buildings), historically and currently;
- Hazardous materials, including identified asbestos and potential asbestos-containing materials (ACM) from building products;
- Abandoned underground petroleum storage systems (UPSS) on/adjacent to the site;
- Deeper, natural soils containing residual impacts, representing potential secondary sources of contamination;
- Potential presence of light and dense non aqueous phase liquids (LNAPL & DNAPL) that may spilled onto the ground surface and infiltrated the soil profile, or that may have leaked from the UPSS; and
- Impacts from unknown onsite/offsite contamination sources.

Based on the findings of the site history and contamination appraisal the chemicals of concern at the site are considered to be:

- Soil – heavy metals (HMs), total recoverable hydrocarbons (TRH), polycyclic aromatic hydrocarbons (PAH), the monocyclic aromatic hydrocarbon compounds benzene, toluene, ethyl benzene and xylenes (BTEX), volatile organic compounds (VOC), organochlorine and organophosphate pesticides (OCP/ OPP), polychlorinated biphenyls (PCB), phenols and asbestos.
- Groundwater – HMs, TPH, BTEX, PAH, VOC including chlorinated VOC (VOCC) such as trichloroethylene (TCE).

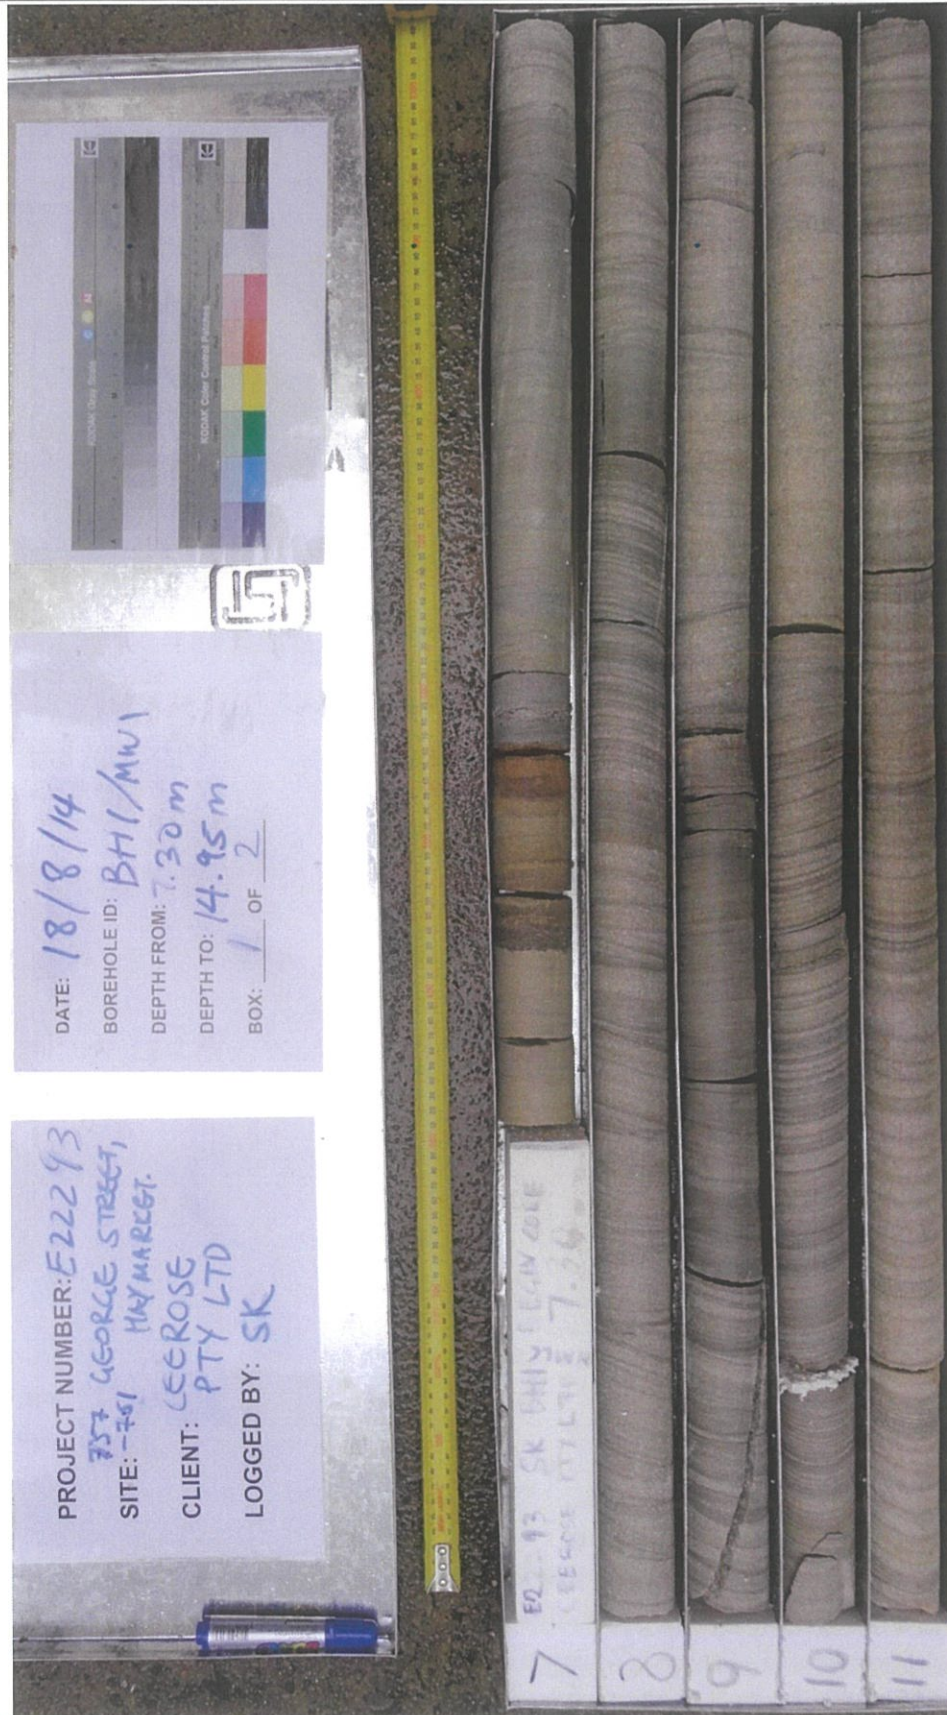
REPORT OF BOREHOLE: BH1/MW1

HOLE DEPTH: 14.95 m

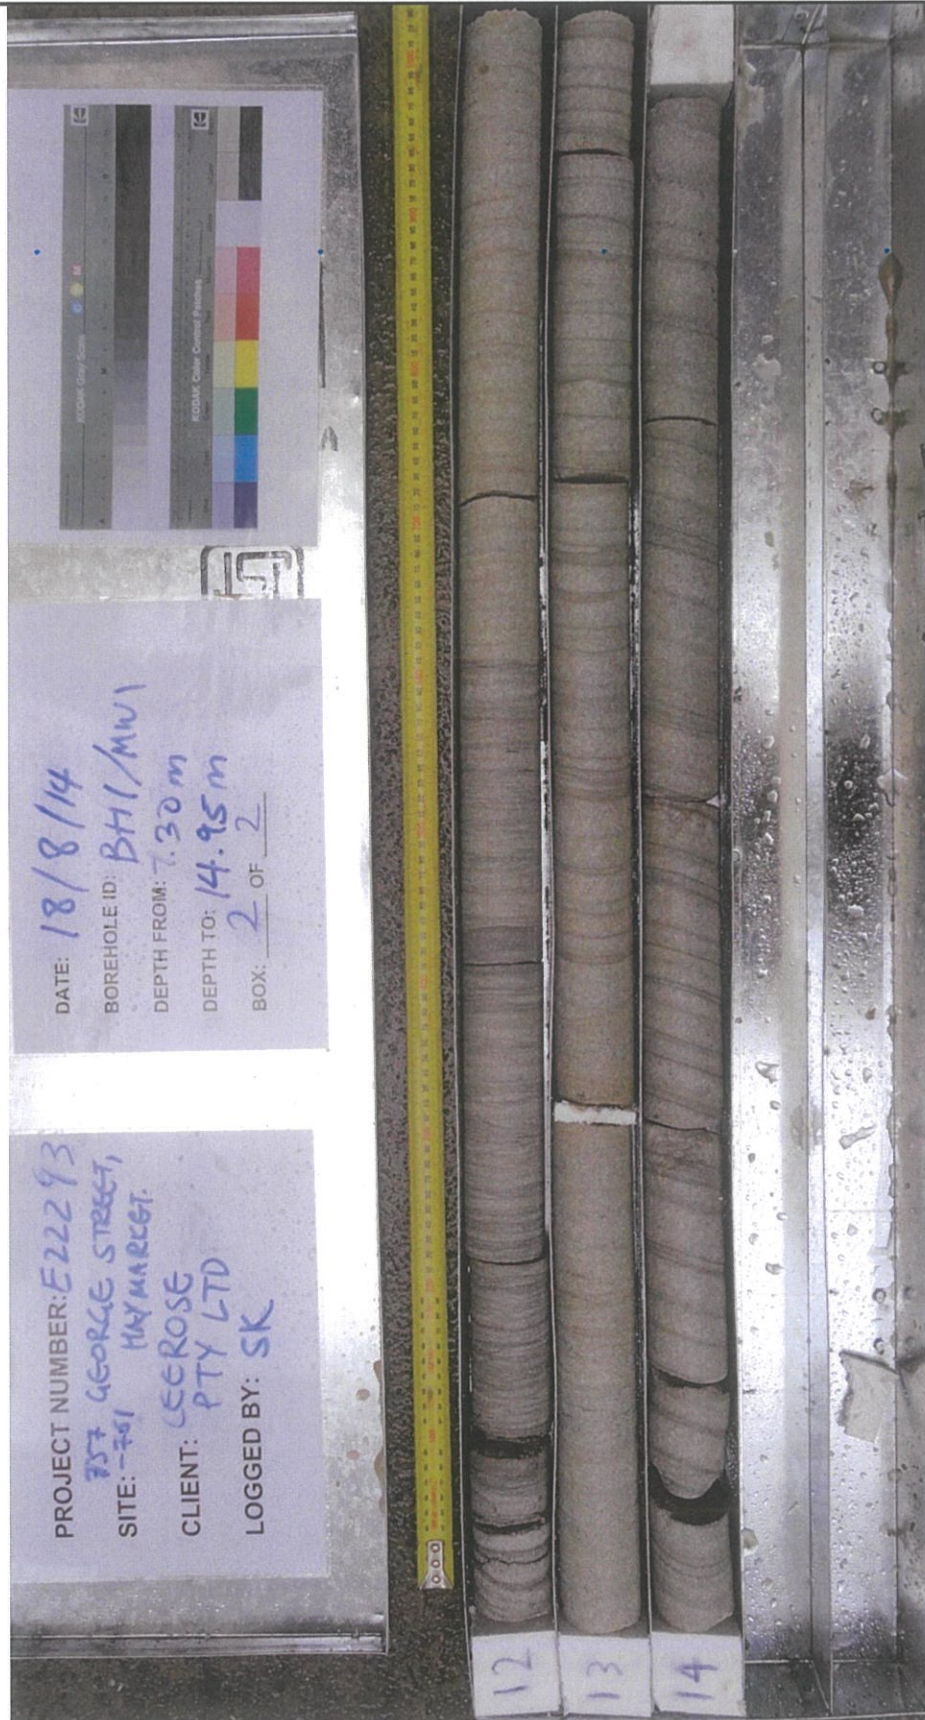
Project Haymarket Geotechnical investigation
 Location 757-763 George St, Haymarket NSW
 Position Refer to Figure 2
 Job No. E22293
 Client Ceerose Pty Ltd

East 333905.9 m
 North 6249525.3 m MGA94 Zone 56
 Contractor Traccess Pty Ltd
 Drill Rig MD 3000
 Inclination -90°
 Sheet 2 OF 3
 Date Started 18/8/14
 Date Completed 18/8/14
 Logged SK Date: 18/8/14
 Checked RP Date: 3/10/14
