Report on  
Geotechnical Investigation and Acid Sulphate Soil  
(ASS) Assessment

Proposed Woolworths Development  
923-935 Bourke Street, Waterloo

Prepared for  
Fabcot Pty Ltd

Project 86864.00  
October 2019

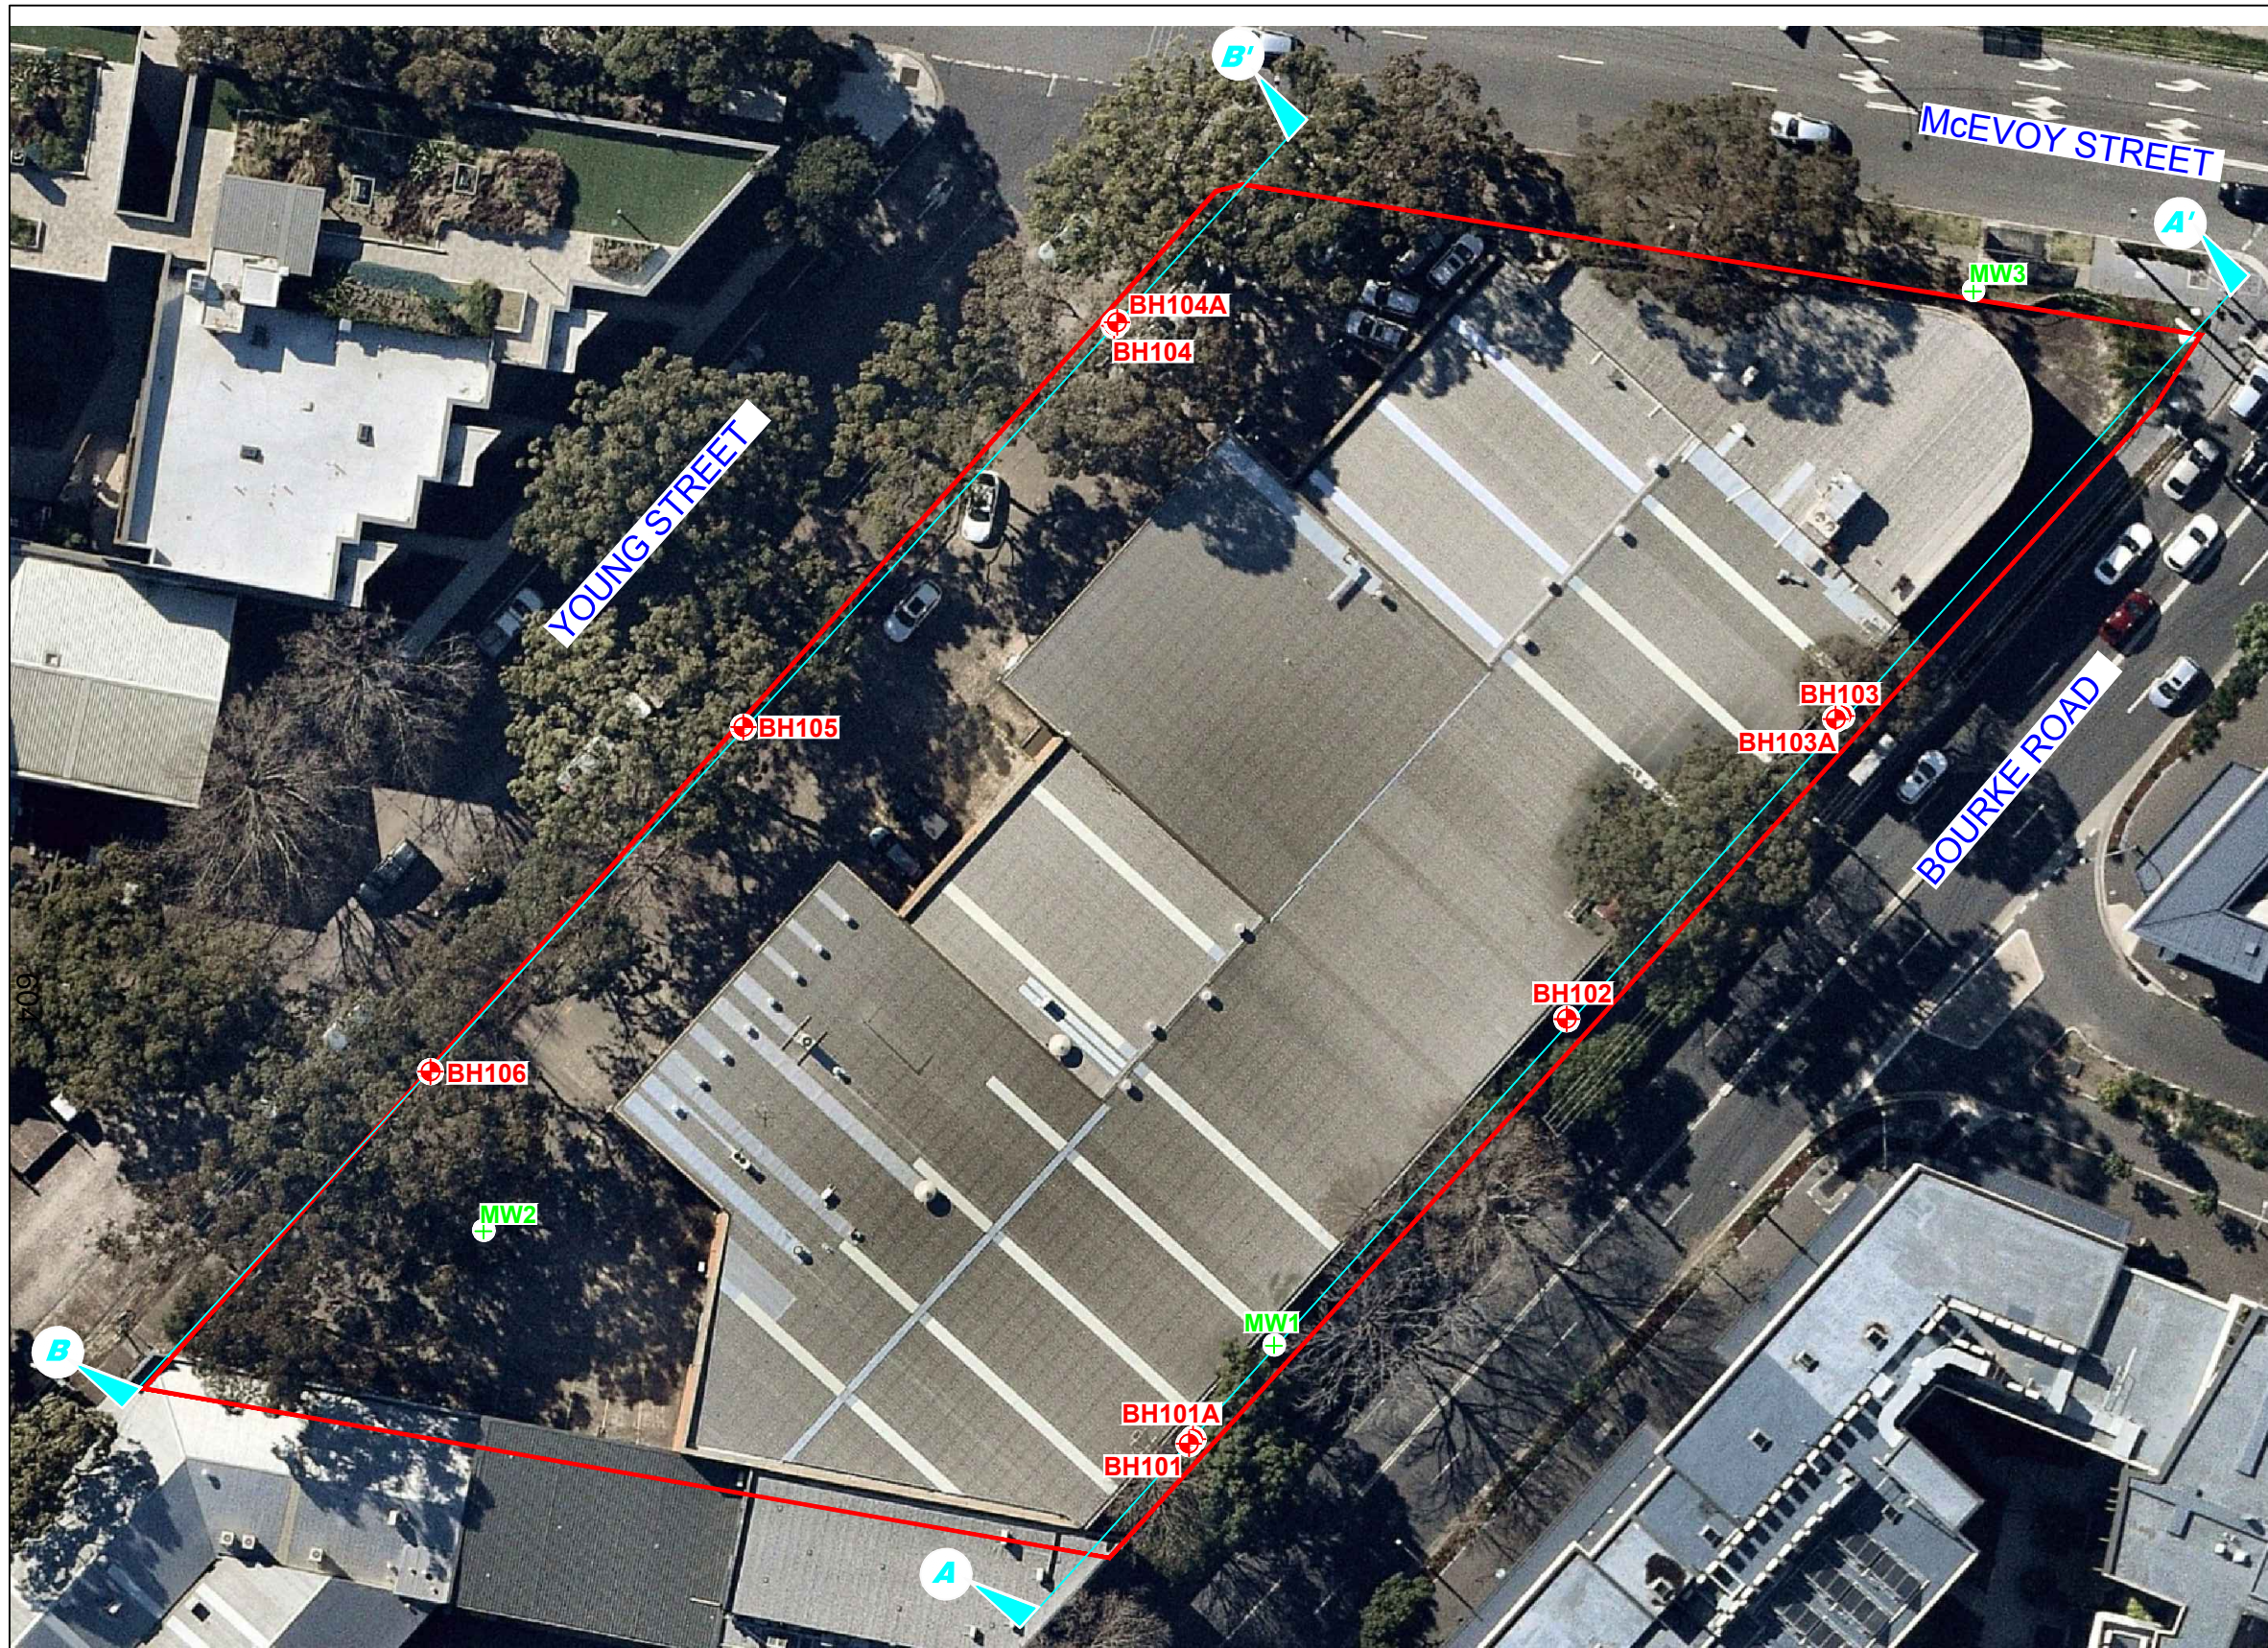
PROJECT No:	86864.00
DRAWING No:	1
REVISION:	0

The site comprises a parallelogram shaped area of about 5,200 m<sup>2</sup>, the general layout of which is shown on Drawing 1, Appendix B. At the time of DP's presence on site, single and two-storey commercial buildings with on-ground parking occupied the site. Currently the site is occupied by a crystal wholesaler, a textile wholesaler, a tyre shop, and various other retail / wholesale stores. Existing surface levels were observed be relatively flat across the site.

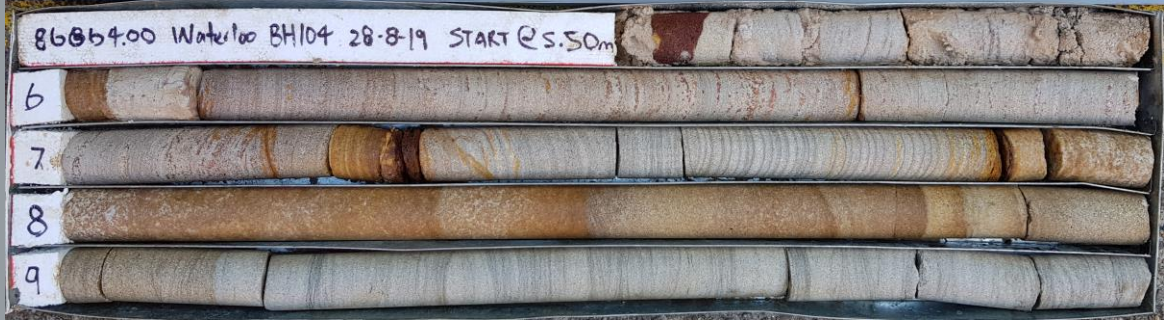
Project No: 86864.00  
BH ID: 104  
Depth: 5.50-10.00m  
Core Box No.: 1-2

5.50 - 10.00m

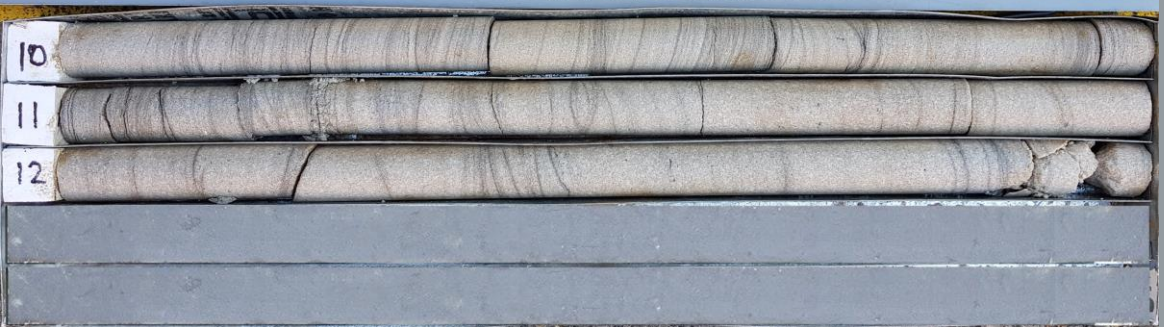
Project No: 86864.00  
BH ID: 104  
Depth: 10.00-13.00m  
Core Box No.: 2-2

10.00 - 13.00 m

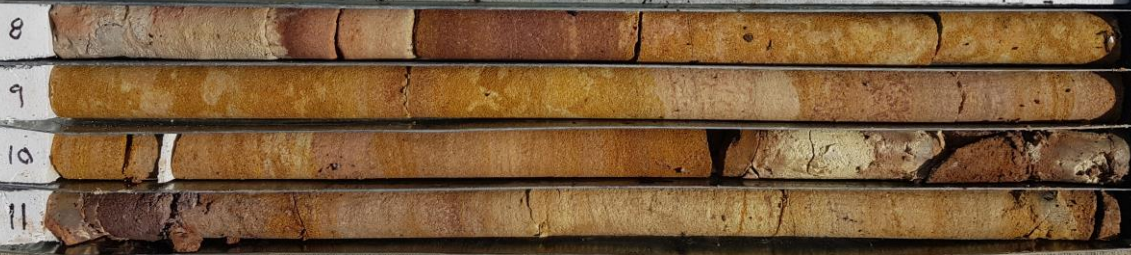
86864.00 Waterloo BH106 29-8-19 START @ 8.00m

8.00 - 12.00 m
