Report on
Acid Sulfate Soils Desktop Study Review and
Preliminary ASS Management Plan

Proposed Commercial Development
383 Kent Street, Sydney

Prepared for
Charter Hall Holdings Pty Ltd

Project 217267.02
December 2023

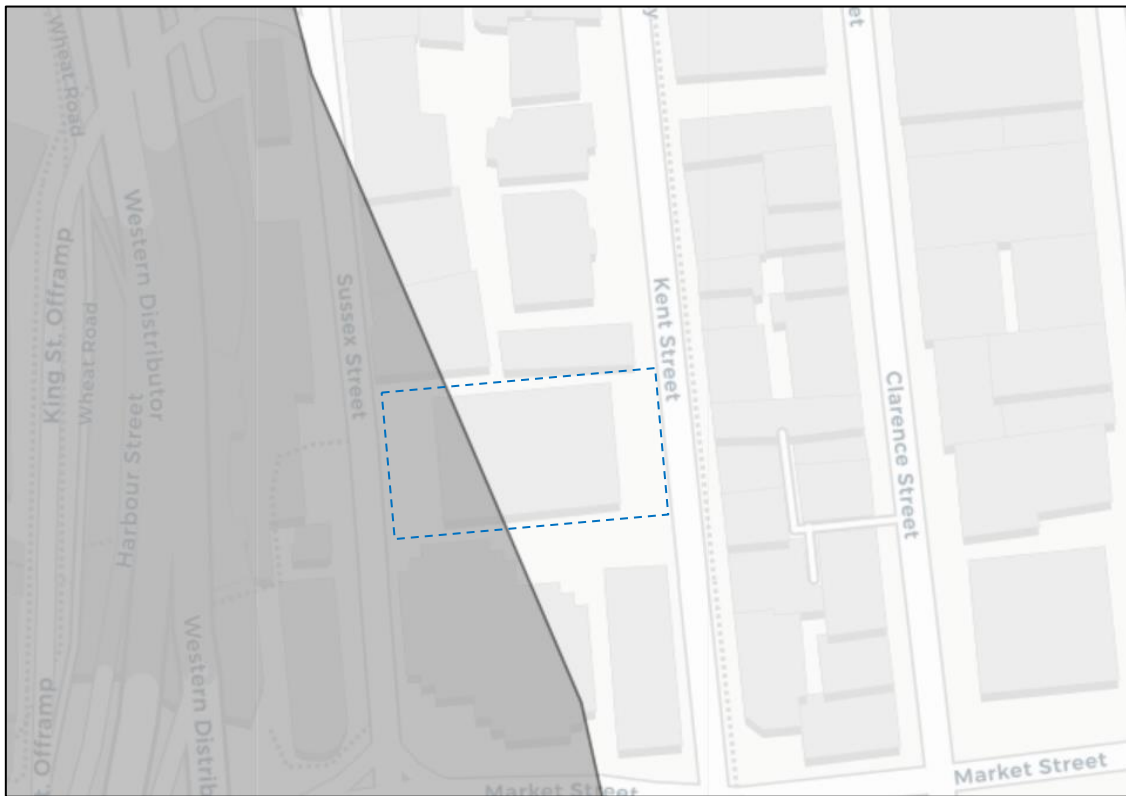
Figure 3: Extract of NSW Acid Sulfate Soil Risk Map 1998 (site locality shown as dashed line)

The NSW Department of Environment and Climate Change 1:25 000 ASS risk map (1998) is shown in Figure 3. The site locality is indicated in a blue dashed outline. Figure 3 shows that the western portion of is mapped as disturbed terrain, indicating that a soil investigation is needed to establish whether ASS exists at the site or not.
