Geotechnical Investigation Report

Project
242-258 Young Street, Waterloo NSW

Prepared for
Charvic Pty Ltd, &
International Screen Academy Property Pty Ltd

Report No
17185-GR-1-1

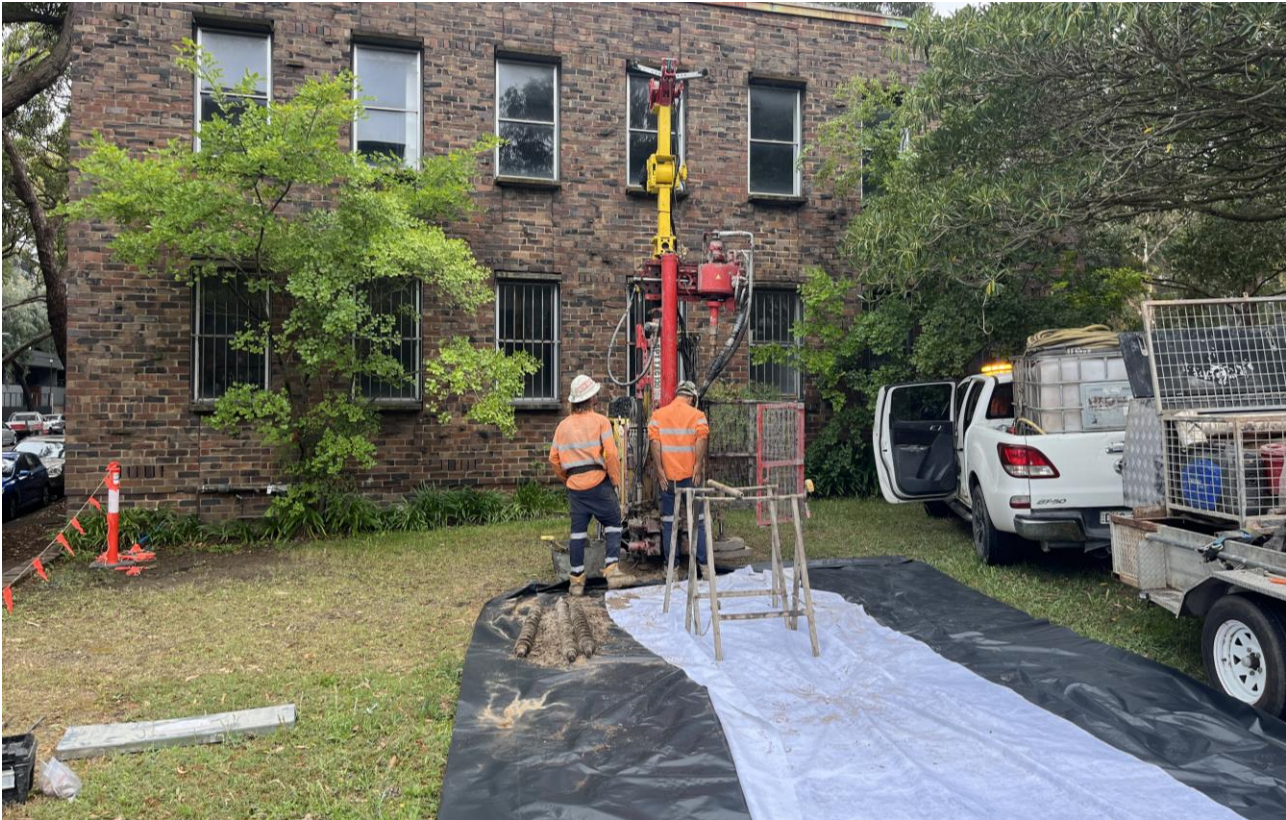
Figure 2-Photo of the drilling setup.

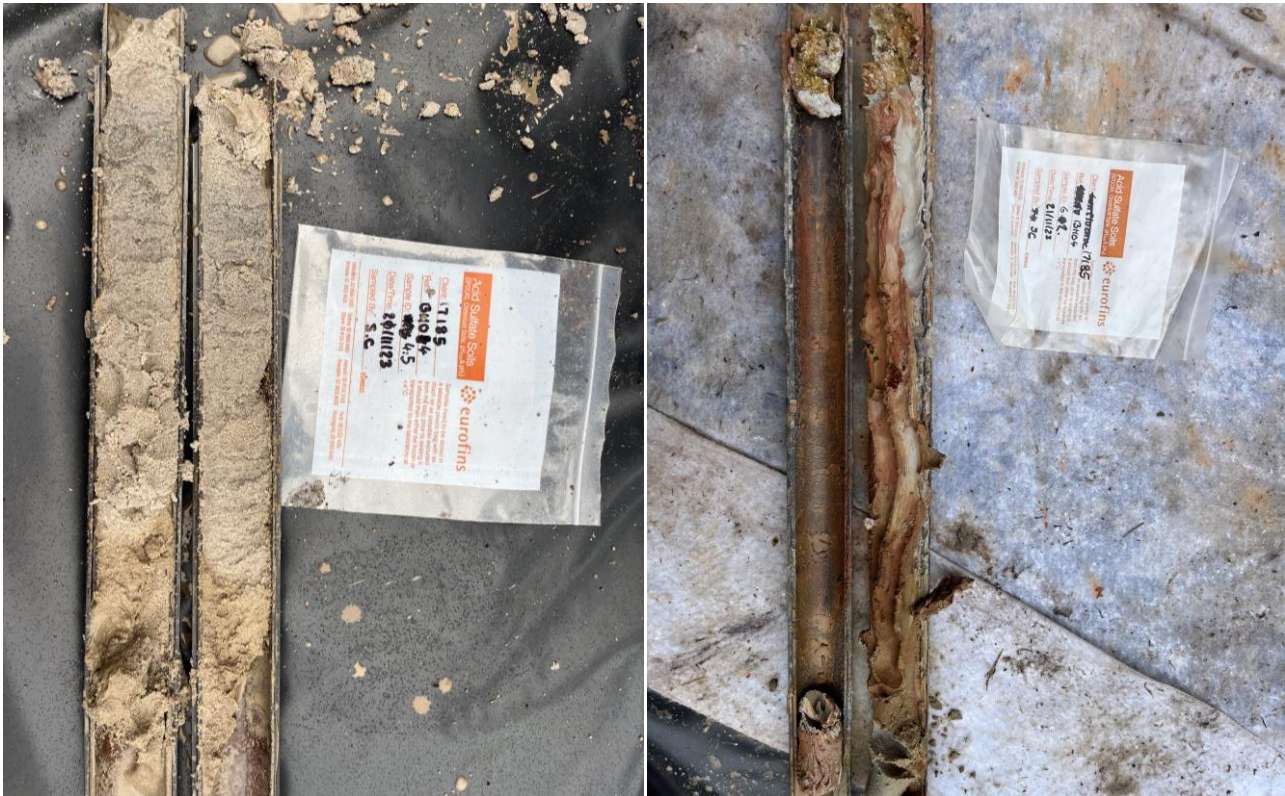
Figure 3-Photo of the marine sands (left) and clay (right) from BH04.

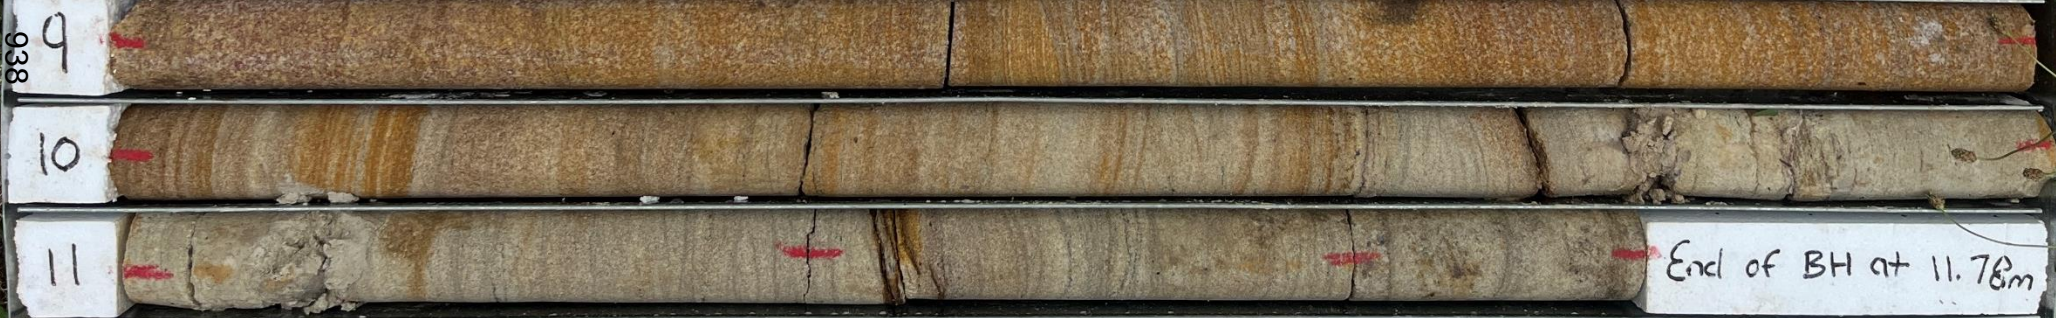
17185 BH02 Started Coring at 8.78m

BH02		Box 1/1		8.78-11.78m	
alliance	Client Name	Charvic Pty Ltd International Screen Academy Property Pty Ltd		Photo Date	20/11/23
	Project Name	Proposed Mixed Use Development		Report Number:	17185-GR-1-1
	Project Location	242-258 Young Street, Waterloo NSW

Method	Water	RL (m)	Depth (m)	Graphic Log	Material Description	Weathering	Estimated Strength		I _{s(50)} MPa	D- diam- etral A- axial	RQD %	Defect Spacing mm	Additional Data
							● Axial	○ Diametral					
NMLC		11.0	10.5		SANDSTONE, fine to medium grained, red brown, bedding fabric. (continued)	MW							10.0 - HB.
		10.5	11.0										
		10.0	11.5										10.73 - BP, 15°, PL, RO, VN.
		9.5											10.86-10.88 - EWS, PL, RO, clay. 10.88-10.9 - EWS, PL, RO, CT. 11.0 - HB. 11.04 - BP, 5°, PL, RO, VN. 11.07-11.12 - EWS, PL, RO, clay.
													11.35 - HB. 11.39 - BP, 15°, PL, RO, SN.
					Target depth. BH02 terminated at 11.78m								11.63 - DB.
													End of Borehole.

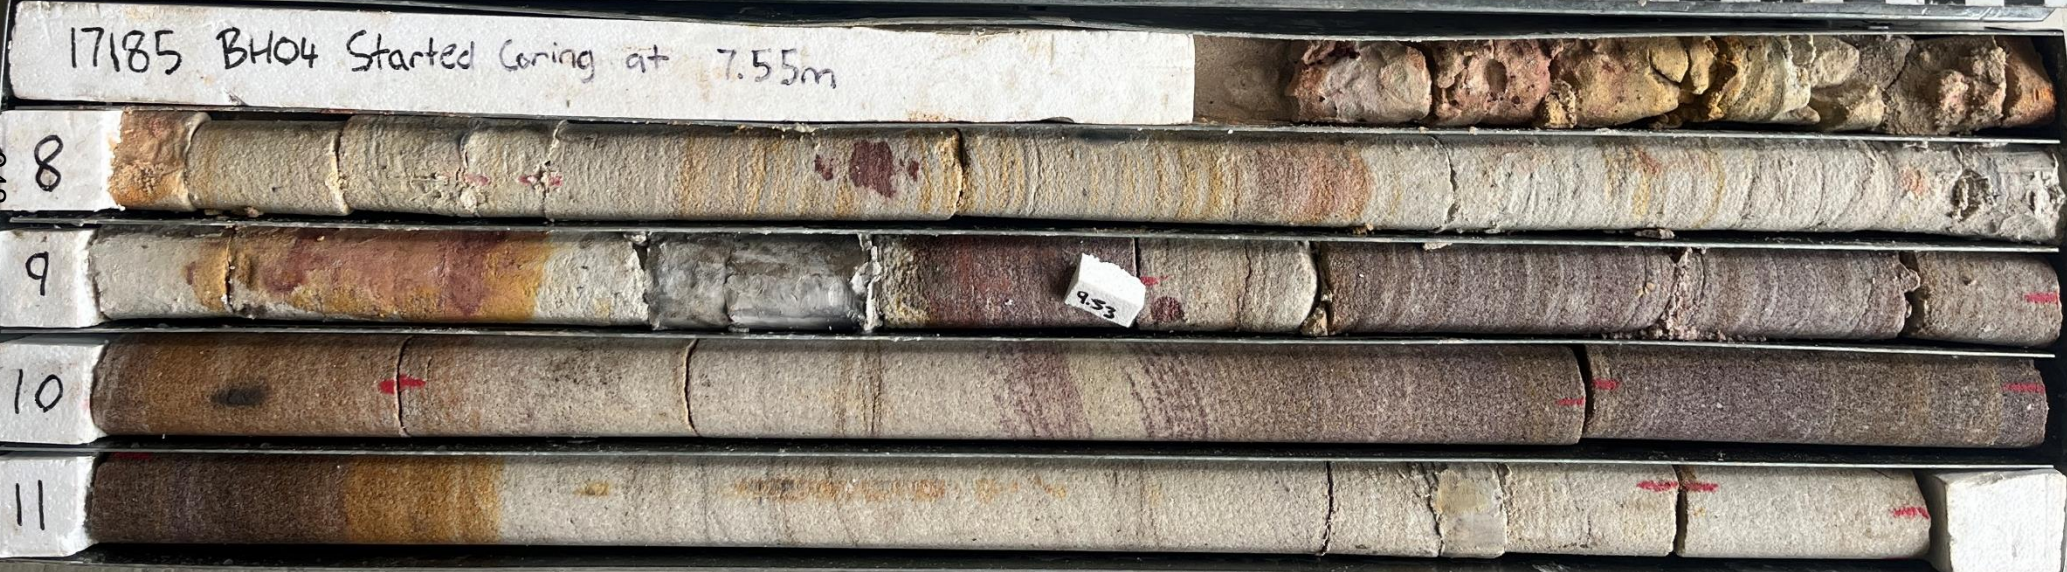
BOREHOLE # BH04	PROJECT # 17185	DEPTH 7.55 m TO 11.94 m
CLIENT	DATE 21/11/23	NOTES

BH04		Box 1/1	7.55-11.94m	
alliance	Client Name	Charvic Pty Ltd International Screen Academy Property Pty Ltd		Photo Date: 21/11/23
	Project Name	Proposed Mixed Use Development		Report Number: 17185-GR-1-1
	Project Location	242-258 Young Street, Waterloo NSW

Method	Water	RL (m)	Depth (m)	Graphic Log	Material Description	Weathering	Estimated Strength		I _{s(50)} MPa	Defect Spacing mm	Additional Data
							● Axial	○ Diametral			
NMLC		10.0			SANDSTONE, fine to medium grained, white, bedding fabric. (continued)	MW		D A	3.99 5.617		10.0 - HB.
		10.5									10.15 - HB.
		9.5									10.3 - BP.
		11.0									10.76 - HB.
		9.0									11.0 - HB.
		11.5									11.68-11.72 - EWS, PL, RO.
		8.5									11.81 - DB.
		12.0			BH04 terminated at 11.94m						End of Borehole.
		8.0									
		12.5									
		7.5									
		13.0									
		7.0									
		13.5									
		6.5									
		14.0									
		6.0									
		14.5									
		5.5									
		15.0
