Arboricultural Impact Assessment

242 – 258 Young Street Waterloo

**Prepared by Alex Austin
For
Sustainable Development Group Ltd
January 2024**

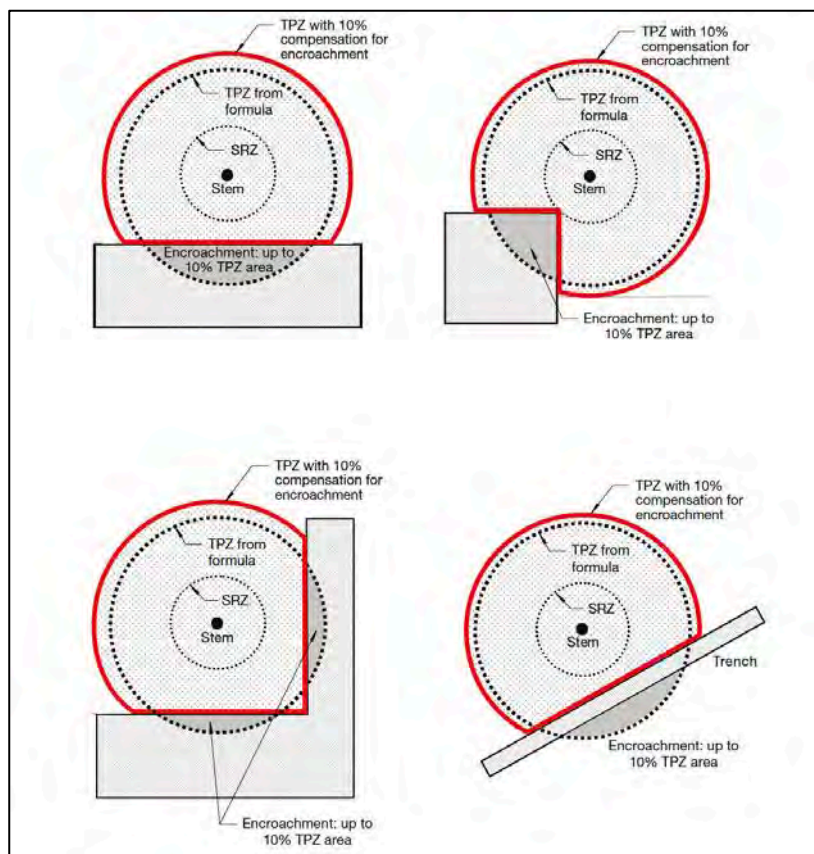
In line with section 3.3.2 of AS 4970:2009, a 10% incursion to a TPZ is considered a minor encroachment. Any more than 10% is considered a major incursion and special measures should be taken to minimise impact on the retained trees and the Arborist must demonstrate that the tree will remain viable post construction.

Figure 1: Example acceptable 10% minor encroachments. (Source: AS 4970:2007)

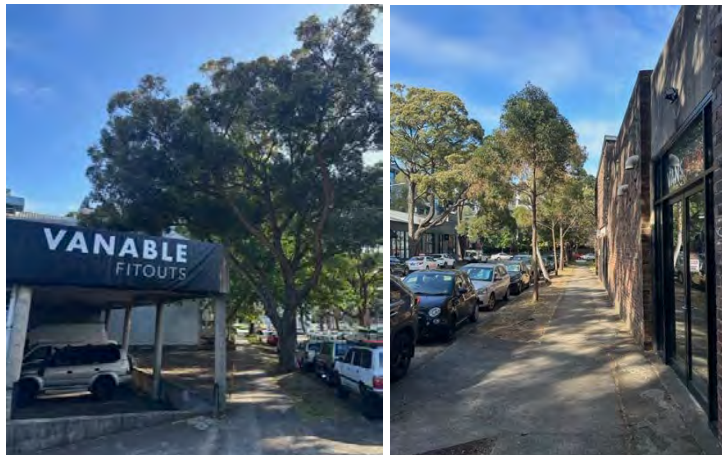
Figures 4 & 5: The typical appearance of the Young Street Frontage. (Source: Austin 2nd November 2023)

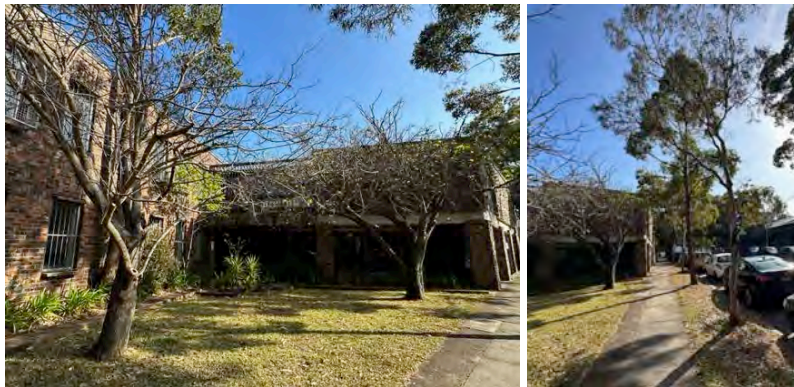
Figures 6 & 7: The typical appearance of the Young Street Frontage. (Source: Austin 2nd November 2023)

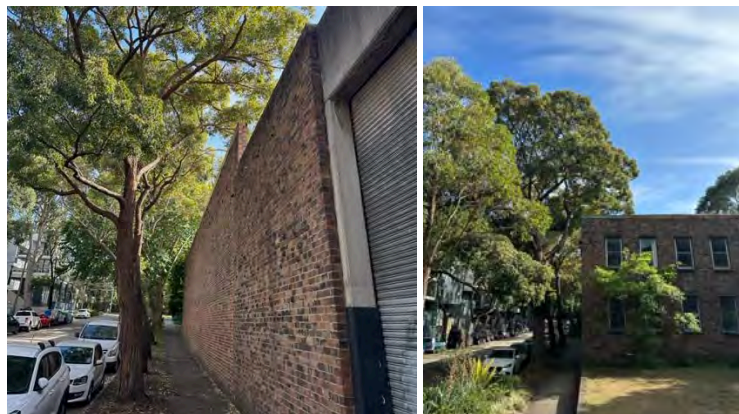
Figures 8 & 9: The typical appearance of the Hunter Street Frontage. (Source: Austin 2nd November 2023)

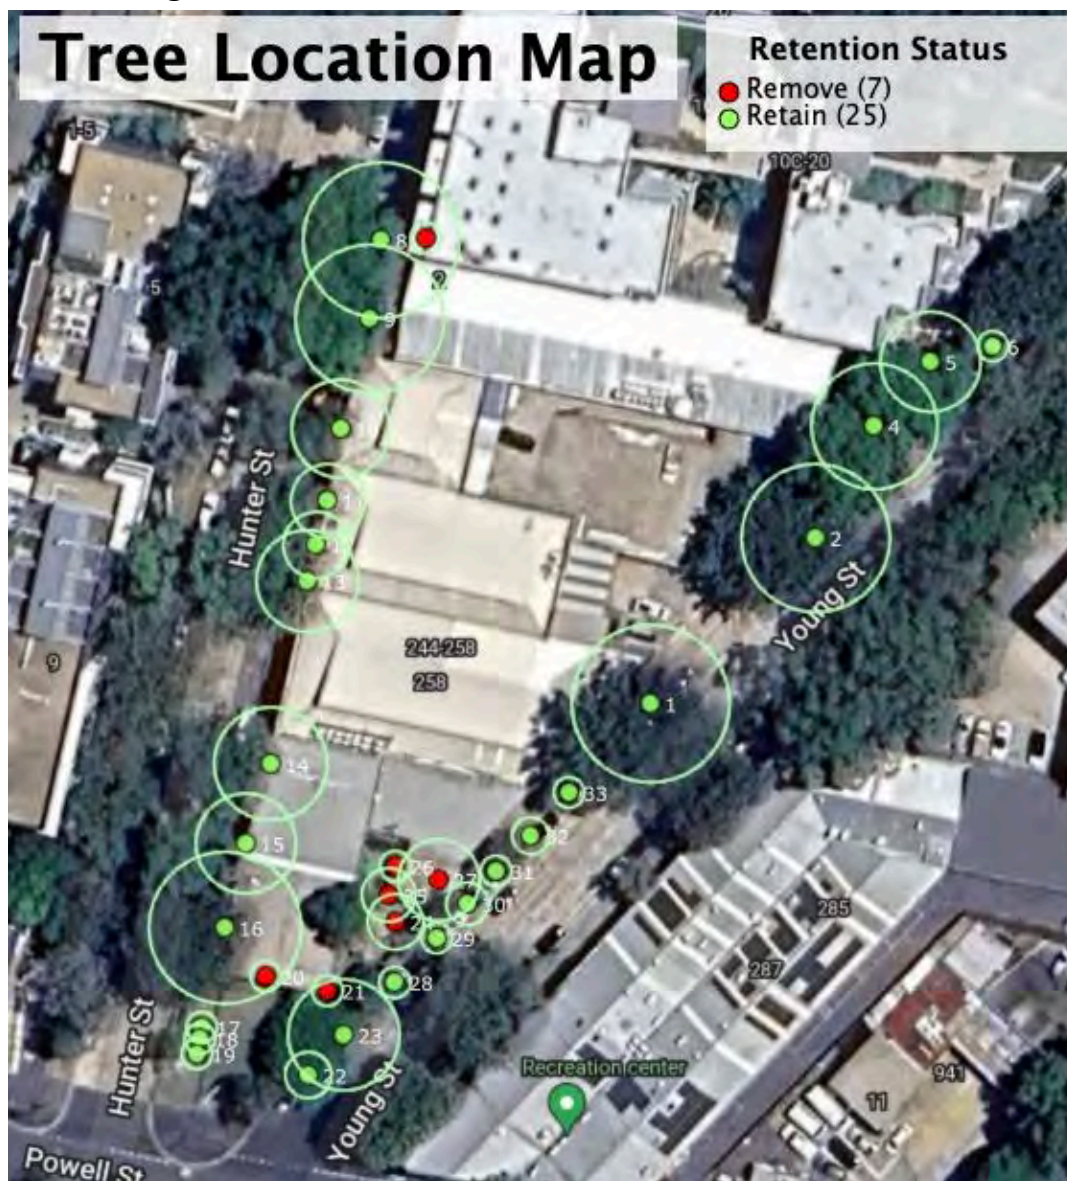
Figure 10: Aerial Image of the whole site showing tree locations. (Source: Arborsaw Tree Plotter 2022)

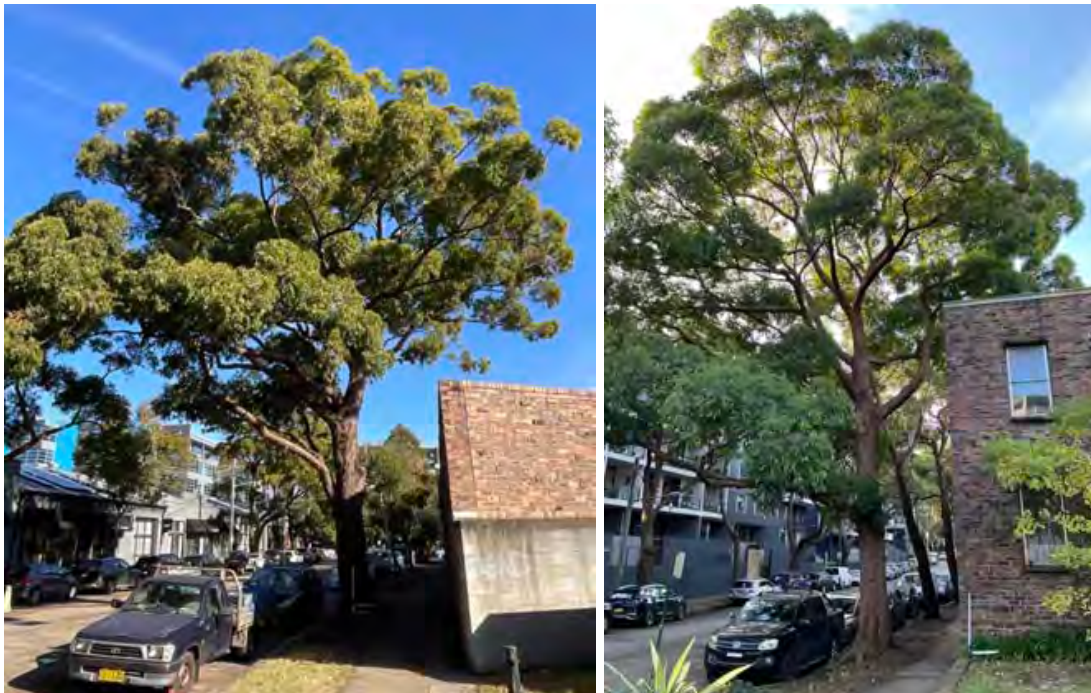
Trees 1, 2 & 16 *Eucalyptus microcorys* (Tallow Woods) are council trees with High retention value and with High landscape significance. The trees are in good condition and have long life expectancies of 40+ years. The trees have around 10 m TPZs and 3.2m SRZs. The trees have an estimated 7m site overhang at 10m height. Considerable efforts should be made to incorporate these trees within the project.

Figures 11 & 12: Tree 1 (Left) and Tree 16 (Right) in the landscape. (Source: Fisher 23rd June 2022).

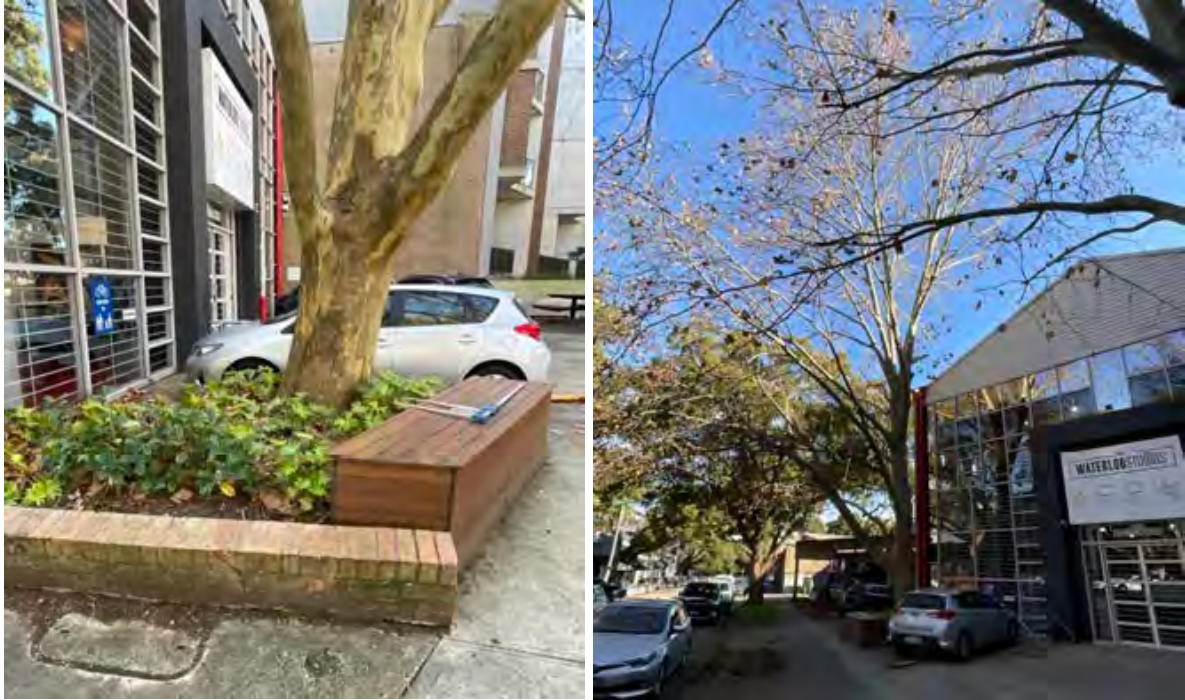
Trees 4 & 5 *Platanus x hybrida* (London Planes) are site trees on the Young Street frontage. The trees have High retention value and landscape significance. The trees are in good condition and have long life expectancies of 40+ years. The trees have large TPZ's. Considerable efforts should be made to incorporate these trees within the project

Figures 13 & 14: Tree 4's growing location (Left) and Tree 4 in the landscape. (Right). (Source: Fisher 23rd June 2022)

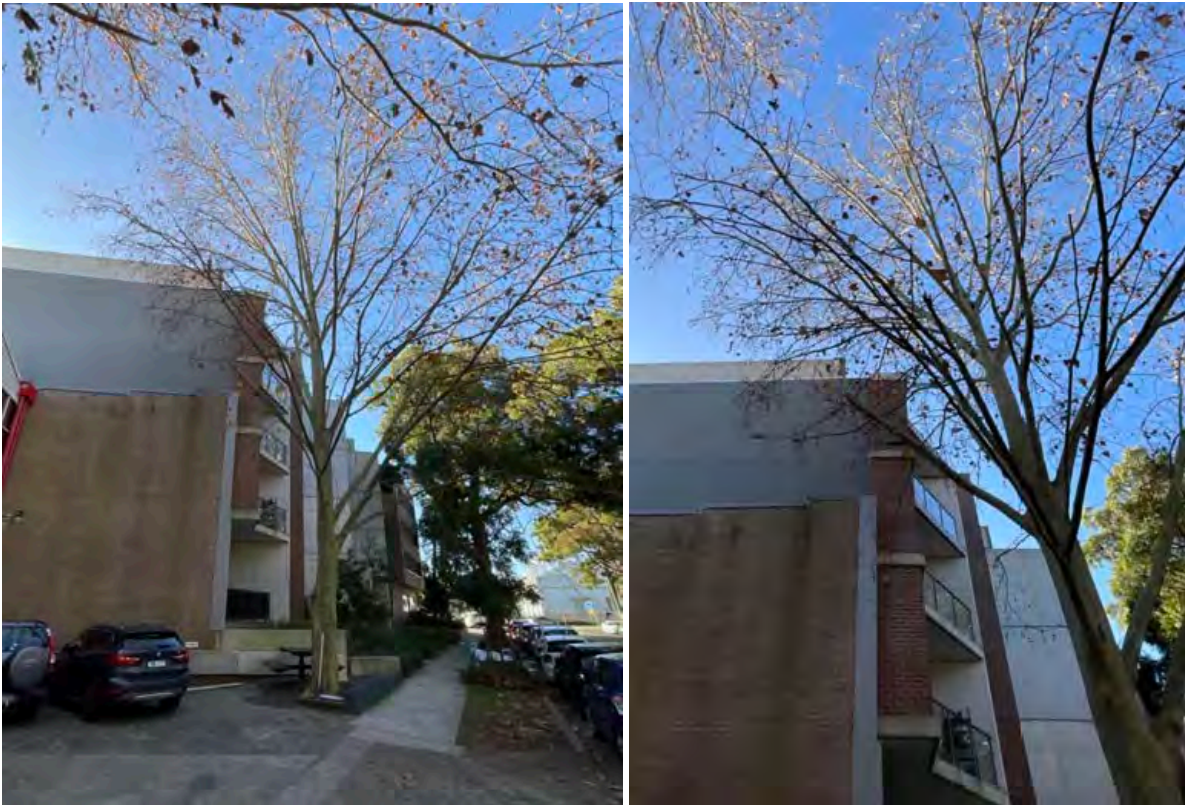
Figures 15 & 16: Tree 5 in the landscape (Left) and the upper crown proximity to the building can be observed. (Right). (Source: Fisher 23rd June 2022).

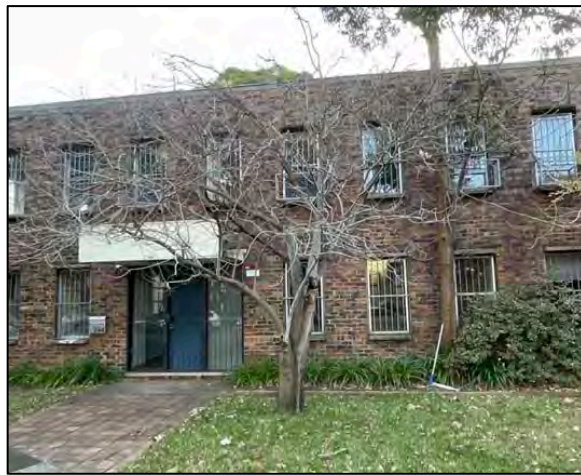
Tree 24 *Ulmus glabra* 'Lutescens' (Golden Scotch Elm) is site tree on the Young Street Frontage. Major Observations included; Cavity, Co-dominant stems, Deadwood > 30mm, Hanger(s) and Wound(s). The tree has a short life expectancy of 5-15 years and is recommended; for Remove deadwood > 30mm, Remove hanging limb(s).

Figure 24: Tree 24 in the landscape. (Source: Fisher 23rd June 2022)

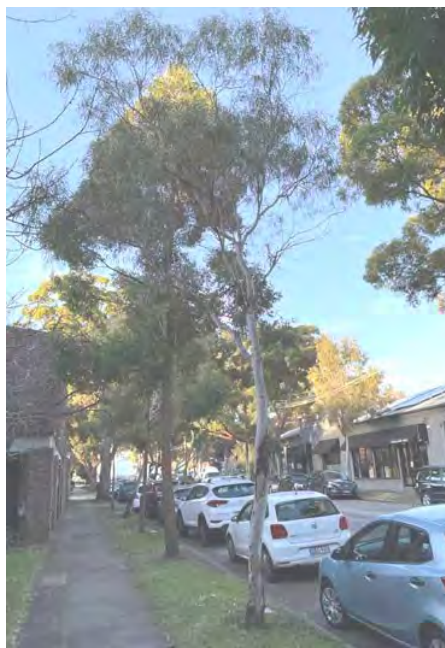
Tree 29 *Eucalyptus scoparia* (Wallangarra White Gum) is a council tree on the Young Street frontage. Major Observations included; Deadwood < 30mm, Dieback, Mechanical damage, Wound response growth, Wound(s). The tree has a short life expectancy of 5- 15 years.

Figure 25: Tree 29 in the landscape. (Source: Fisher 23rd June 2022)

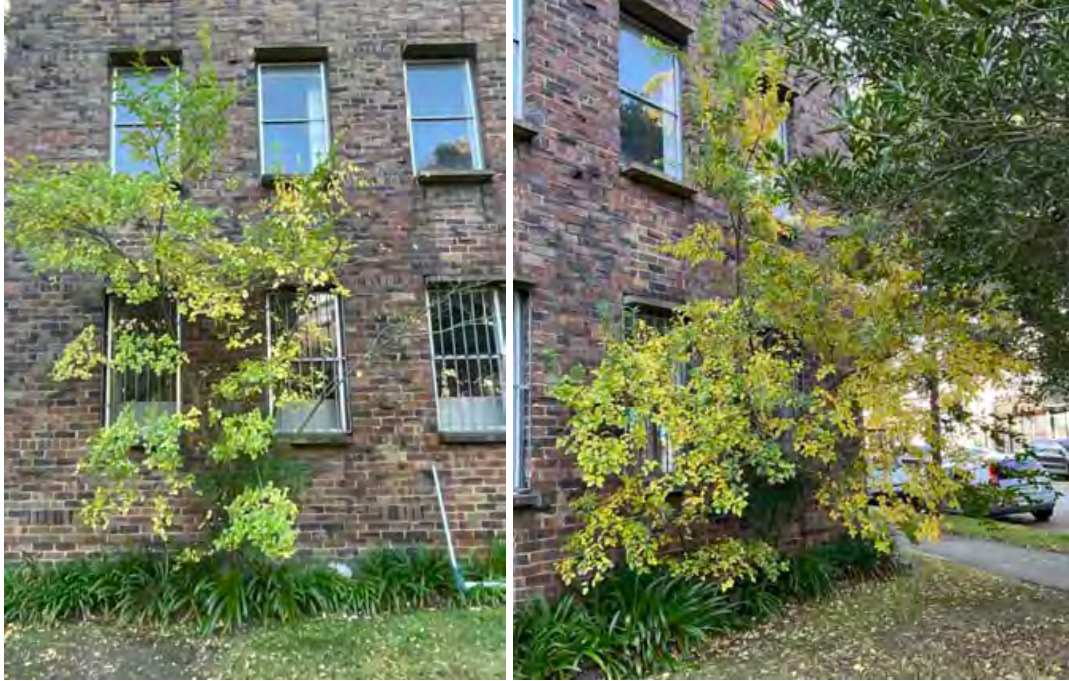
Figures 26 & 27: Tree 20 (Left) and Tree 21 (Right) self sown adjacent to the existing building. (Source: Fisher 23rd June 2022).

Seven (7) site trees numbered 7, 20, 21, 24, 25, 26 & 27 are proposed for removal and should be removed at the beginning of the project (STCA). The trees nominated for retention must not be damaged during the tree removal works.

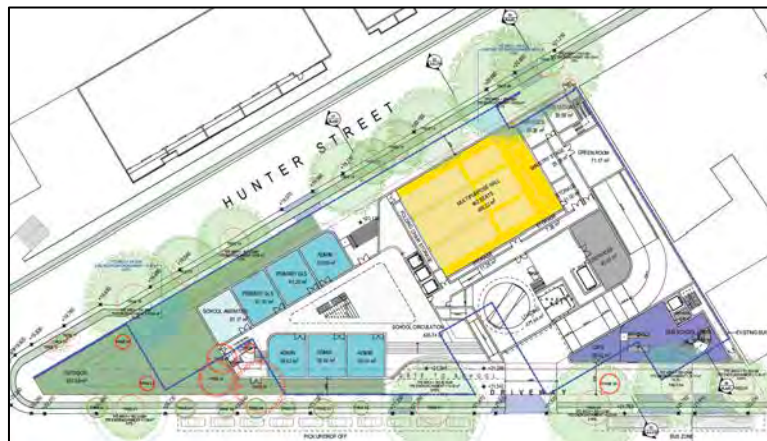
Figure 30: The proposed ground level development plan for the site. (Source Ground floor plan, from 20621 Presentation by SDG Dated 25.10.2023).

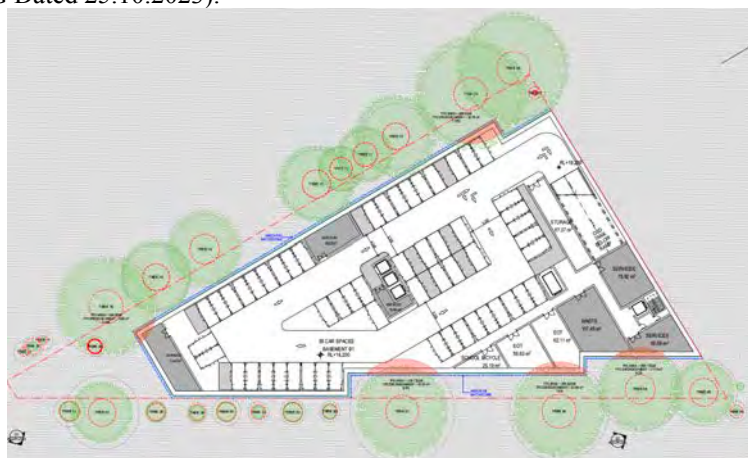
Figure 31: The proposed basement development plan for the site. (Source Basement plan, from 20621 Presentation by SDG Dated 25.10.2023).

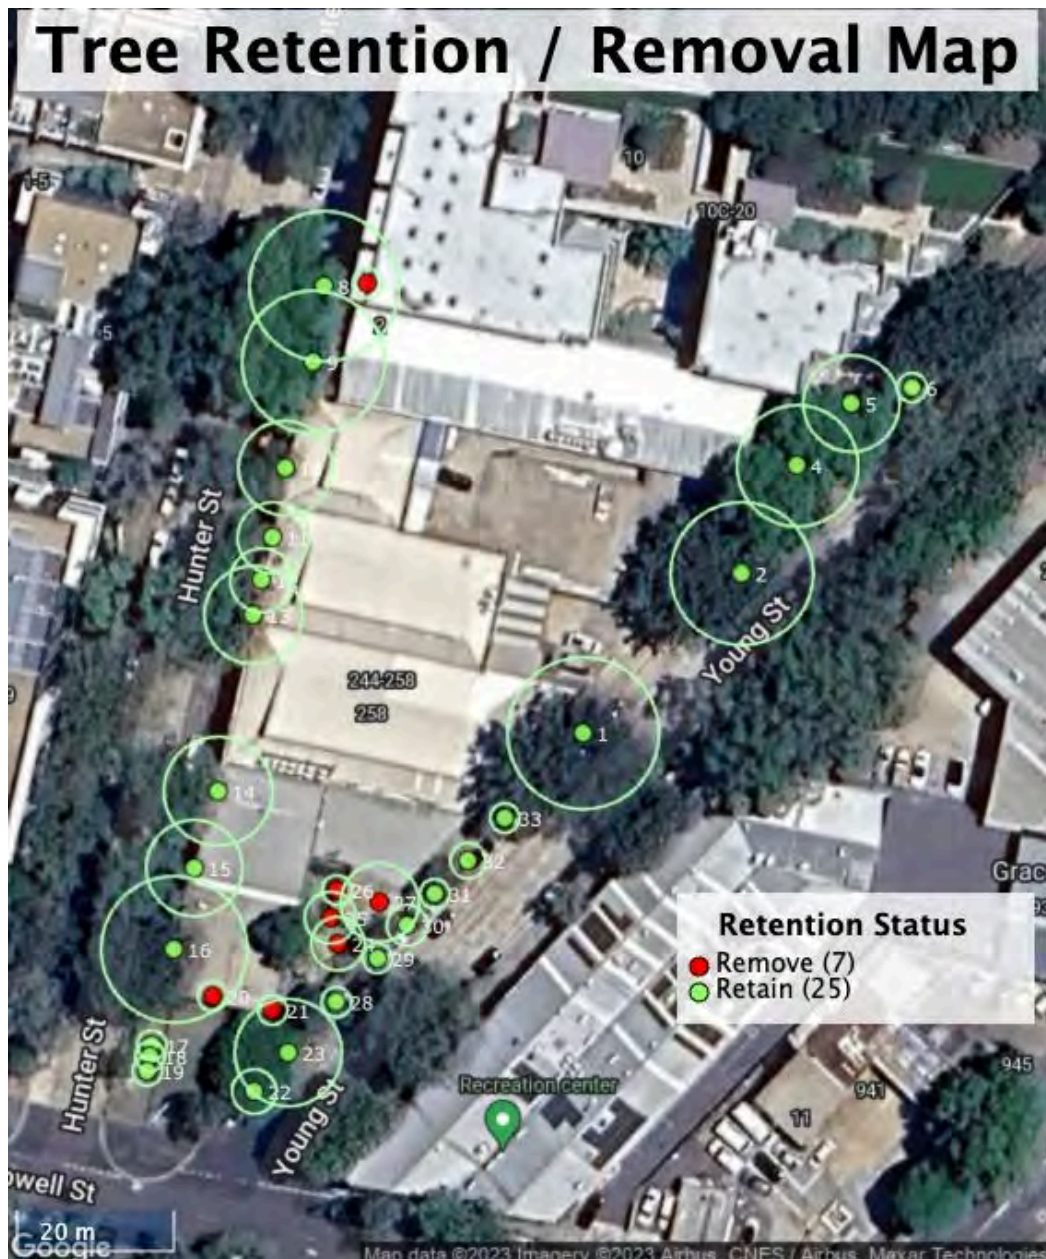
Figure 32: The proposed Tree retention and Removal Map (Source: Tree Plotter 2023).

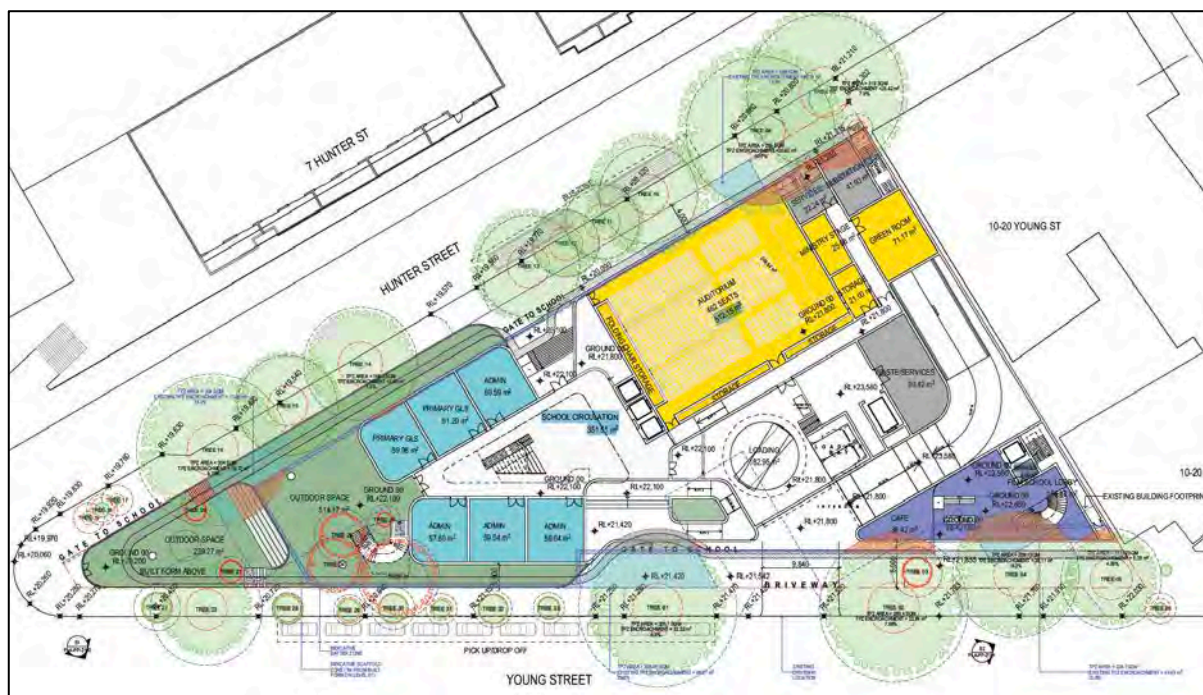
The existing building is a multistorey brick struck un a concrete slab and footing. The existing construction is expected to be restricting root growth and resulting in unfavourable growing conditions for tree growth. No evidence of building damage from roots penetrating beneath the building was observed.

Figure 33: The floor plan depicting the existing building in the blue hatched line with the proposed building TPZ encroachments shown in pink, batter in blue and scaffold from level 1 and above shown in hatch (Source: General Floor Plan, by Plus Architects, drawing number PLA-PP -1000 dated 21/12/2024). See appendix for larger plans.

Temporary scaffold 1m wide will be required to facilitate the building works. The scaffold must be placed on ground protection mats as to not damage roots or compact the ground.

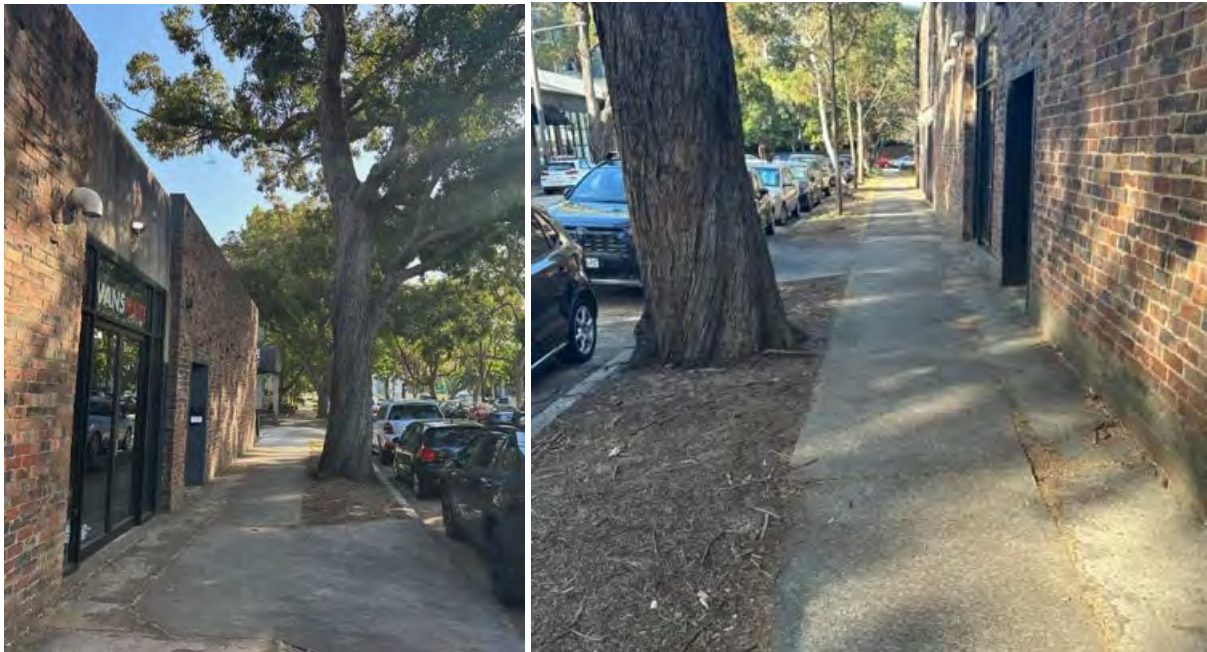
Figures 34 & 35: The proximity of Tree 1 to the existing building edge. (Source: Austin 2nd November 2023).

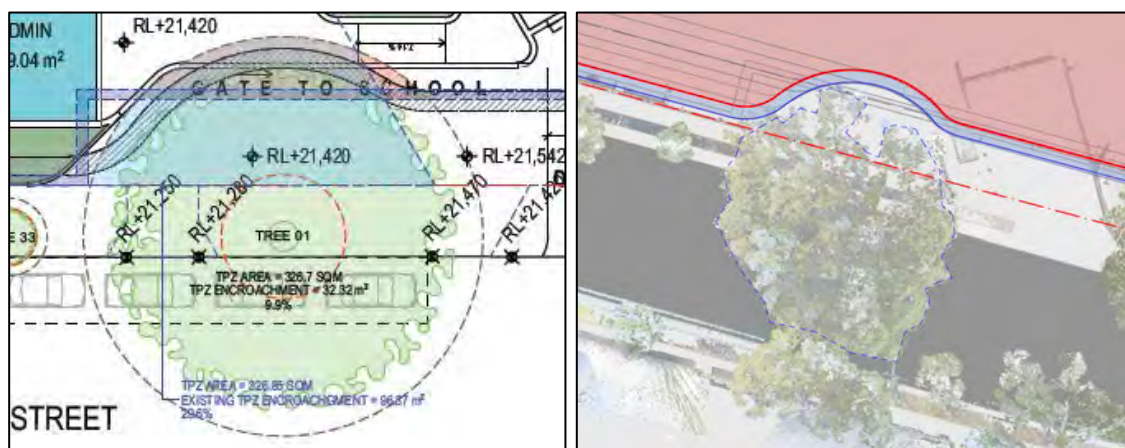
Figures 36 & 37: The ground floor plan depicting the existing building in the blue hatched line (partially hidden behind red hatch in this image) with the proposed building TPZ encroachments shown in pink, batter in blue and (Source: General Floor Plan, by Plus Architects, drawing number PLA-PP -1000 dated 15/12/2024). See appendix for larger plans & Tree Canopy Modelling by Plus Architects dated 1/08/2023)

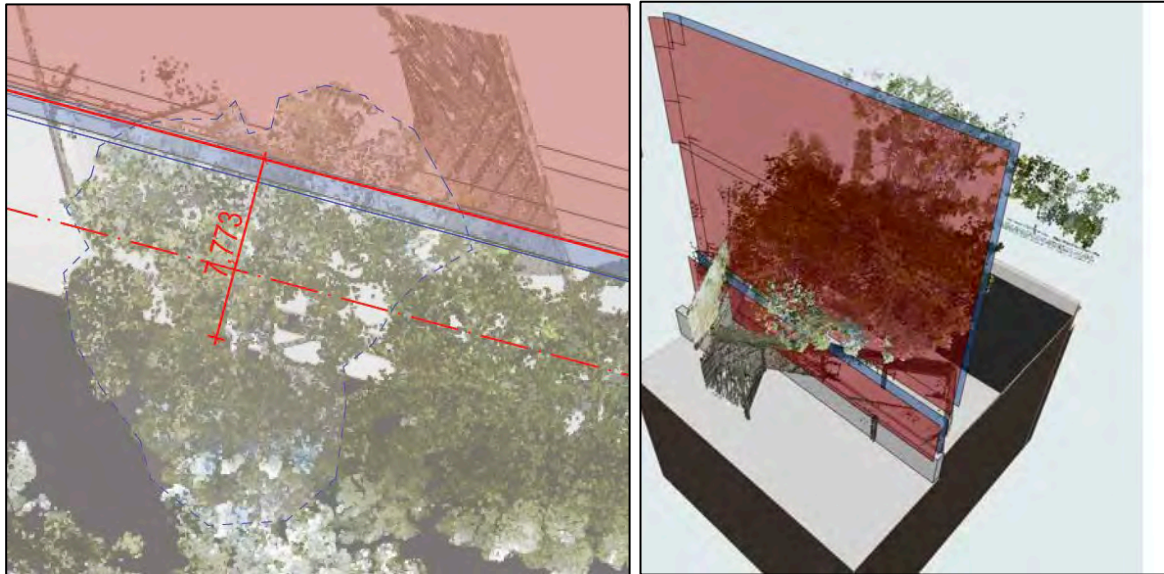
Figures 42 & 43: The Tree canopy impact of the proposed building in Pink and 1m wide scaffold in Blue. (Source: Tree Canopy Modelling by Plus Architects dated 1/08/2023)

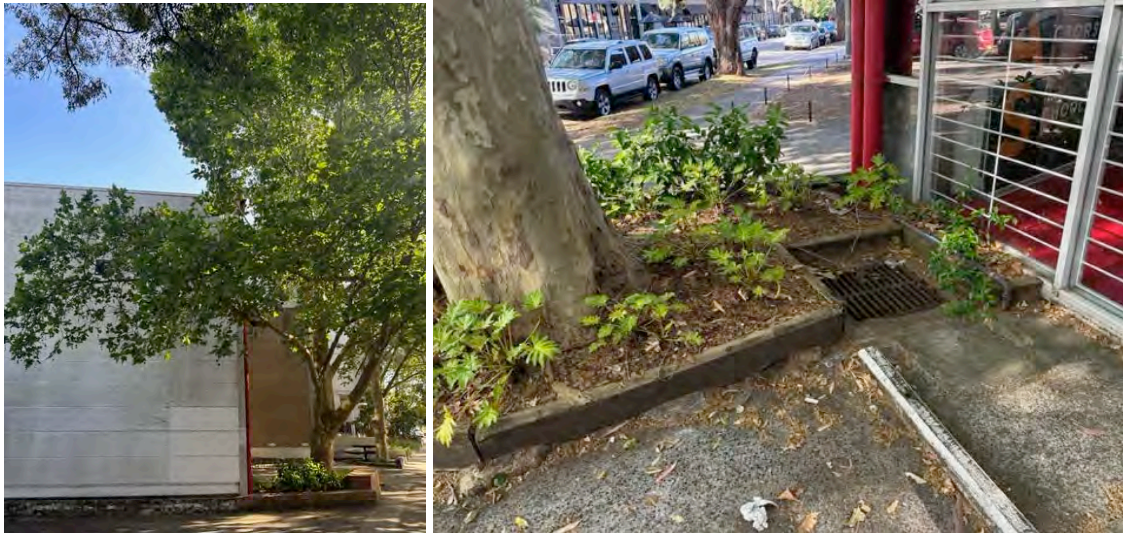
Figures 46 & 47: The proximity of Tree 4 to the existing building edge (Left) and the slab and drain between the trunk and the building(Right). (Source: Austin 2nd November 2023)

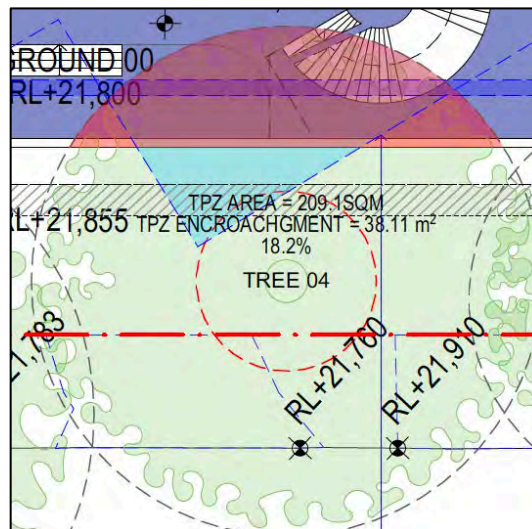
Figure 48: The floor plan depicting the existing building in the blue hatched line with the proposed building TPZ encroachments shown in pink, batter in blue and scaffold from level 1 and above shown in hatch (Source: General Floor Plan, by Plus Architects, drawing number PLA-PP -1000 dated 15/1/2024). See appendix for larger plans

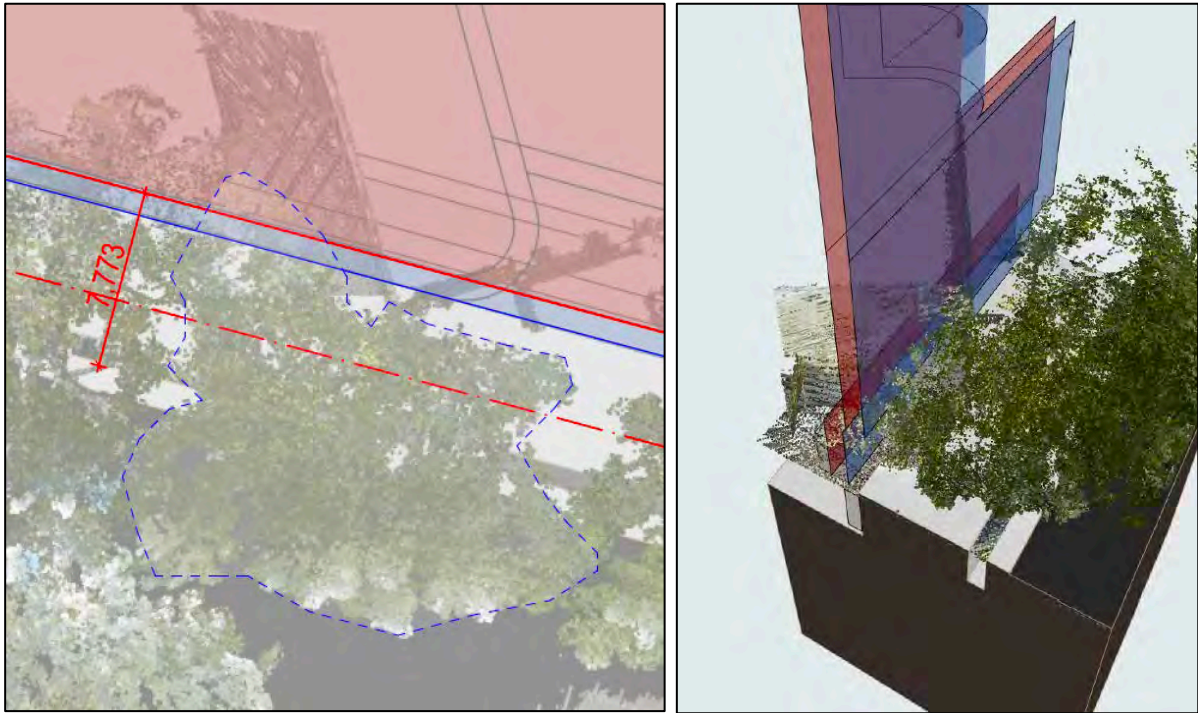
Figures 49 & 50: The 3d modelled Tree canopy impact of the proposed building in Pink and 1m wide scaffold in Blue. (Source: Tree Canopy Modelling by Plus Architects dated 1/08/2023)

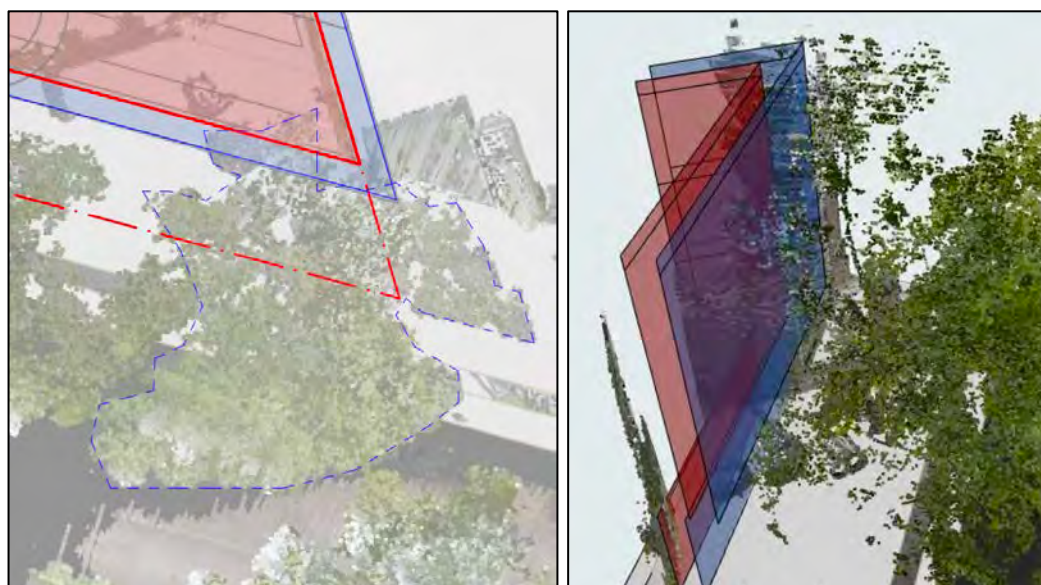
Figures 55 & 56: The Tree canopy impact of the proposed building in Pink and 1m wide scaffold in Blue. (Source: Tree Canopy Modelling by Plus Architects dated 1/08/2023)

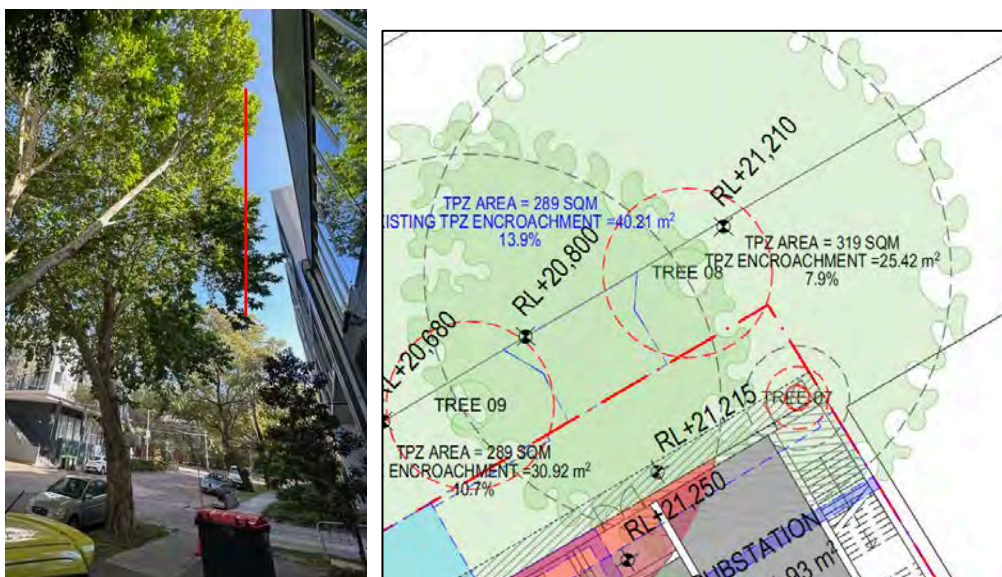
Figures 59 & 60: The proximity of Tree 8 to the existing building edge with an approximate pruning setback in red (Left - Source: Austin 2nd November 2023) and the floor plan depicting the existing building in the blue hatched line with the proposed building TPZ encroachments shown in pink, batter in blue and scaffold from level 1 and above shown in hatch (Source: General Floor Plan, by Plus Architects, drawing number PLA-PP - 1000 dated 15/1/2024). See appendix for larger plans.

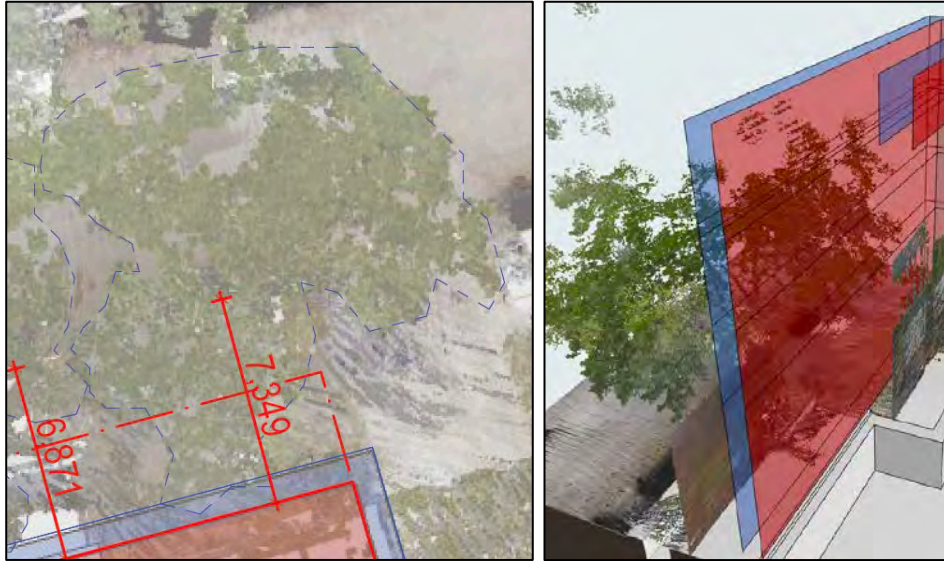
Figures 61 & 62: The Tree canopy impact of the proposed building in Pink and 1m wide scaffold in Blue. (Source: Tree Canopy Modelling by Plus Architects dated 1/08/2023)

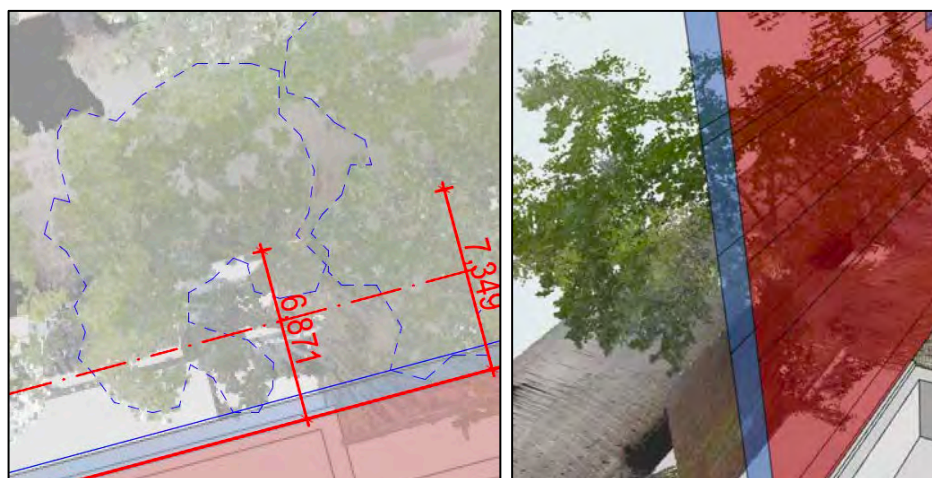
Figures 66 & 67: The Tree canopy impact of the proposed building in Pink and 1m wide scaffold in Blue. (Source: Tree Canopy Modelling by Plus Architects dated 1/08/2023)

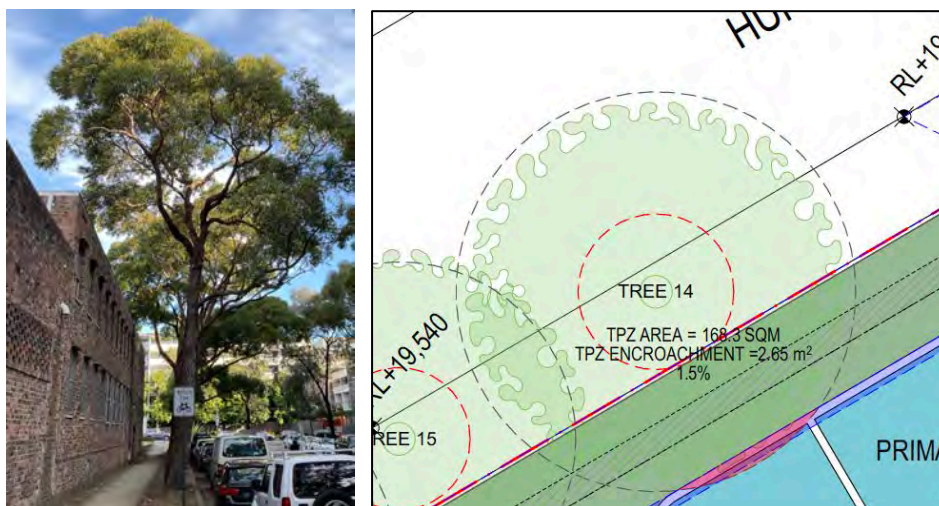
Figures 74 & 75: The proximity of Tree 14 to the existing building edge (Left - Source: Austin 2nd November 2023) and the floor plan depicting the existing building in the blue hatched line with the proposed building TPZ encroachments shown in pink, batter in blue and scaffold from level 1 and above shown in hatch (Source: General Floor Plan, by Plus Architects, drawing number PLA-PP -1000 dated 15/1/2024) See appendix for larger plans.

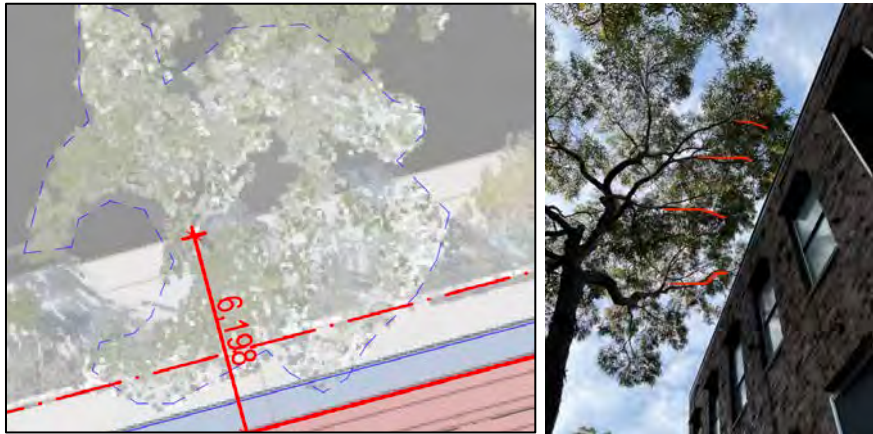
Figures 76 & 77: The Tree canopy impact of the proposed building in Pink and 1m wide scaffold in Blue. (Left) (Source: Tree Canopy Modelling by Plus Architects dated 1/08/2023) and The proposed pruning requirements to accommodate the proposed building façade next to Tree 14. (Source: Austin 2nd November 2023).

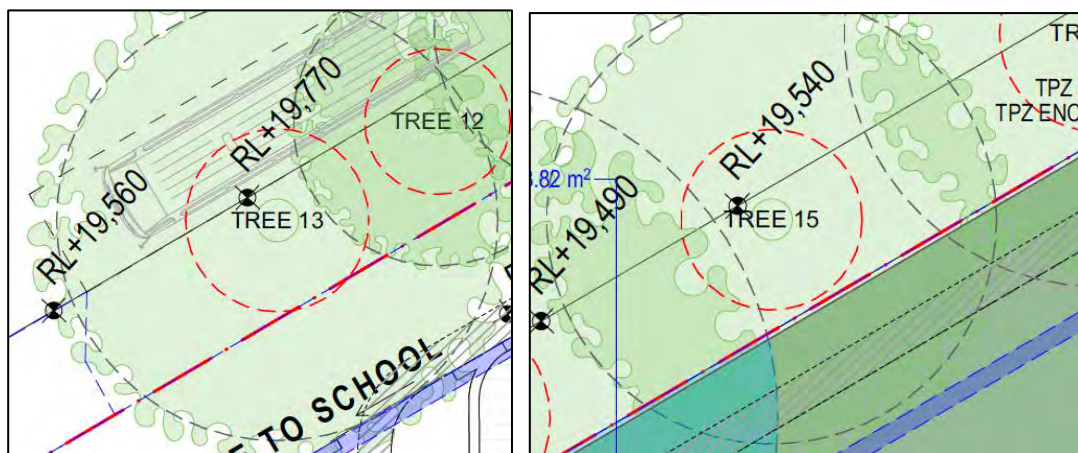
Figures 78 & 79: The floor plan depicting the existing building in the blue hatched line with the proposed building TPZ encroachments shown in pink, batter in blue and scaffold from level 1 and above shown in hatch to Tree 13 (Left) and Tree 15 (Right). (Source: General Floor Plan, by Plus Architects, drawing number PLA-PP -1000 dated 15/1/2024) See appendix for larger plans

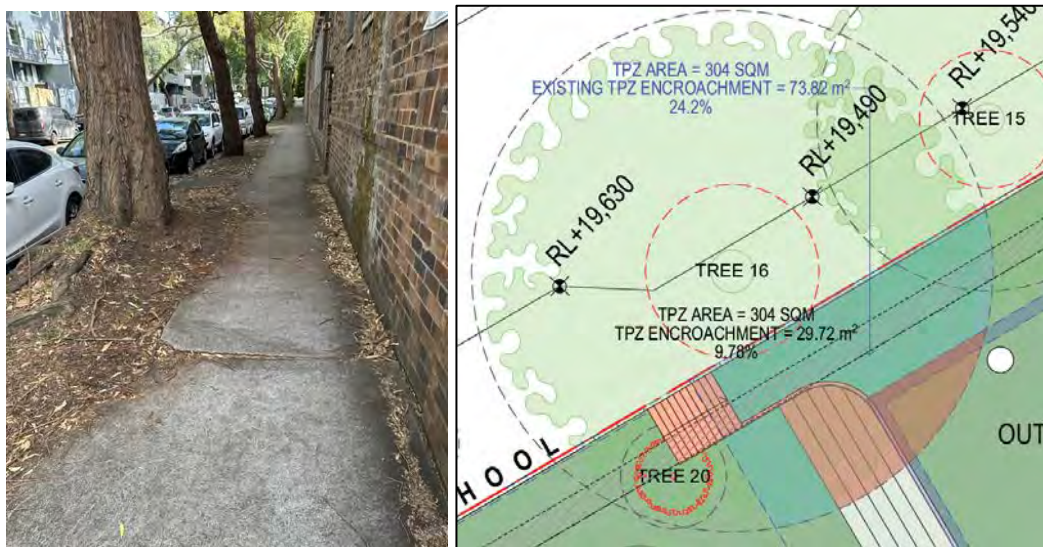
Figures 80 & 81: The proximity of Tree 16 to the existing building edge depicting the lifted paving (Left - Source: Austin 2nd November 2023) and the floor plan depicting the existing building in the blue hatched line with the proposed building TPZ encroachments shown in pink, batter in blue and scaffold from level 1 and above shown in hatch (Source: General Floor Plan, by Plus Architects, drawing number PLA-PP -1000 dated 15/1/2024). See appendix for larger plans.

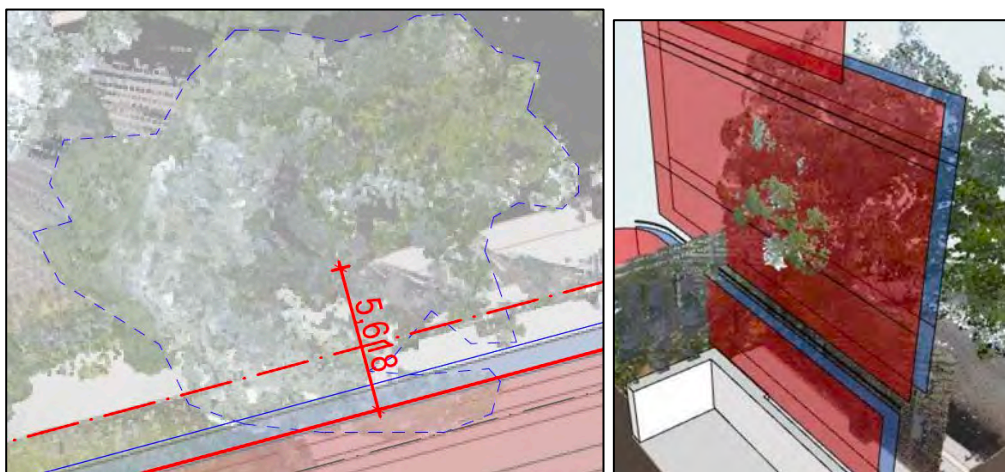
Figures 82 & 83: The Tree canopy impact of the proposed building in Pink and 1m wide scaffold in Blue. (Source: Tree Canopy Modelling by Plus Architects dated 1/08/2023)

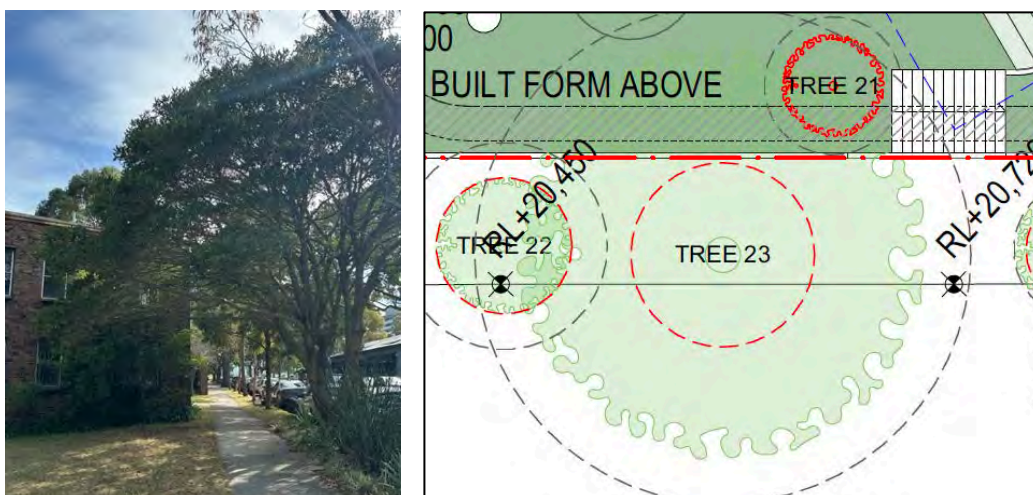
Figures 86 & 87: The proximity of Tree 23 to the existing building edge depicting the lifted paving (Left - Source: Austin 2nd November 2023) and the floor plan depicting the existing building in the blue hatched line scaffold from level 1 and above shown in hatch (Source: General Floor Plan, by Plus Architects, drawing number PLA-PP -1000 dated 15/1/2024). See appendix for larger plans

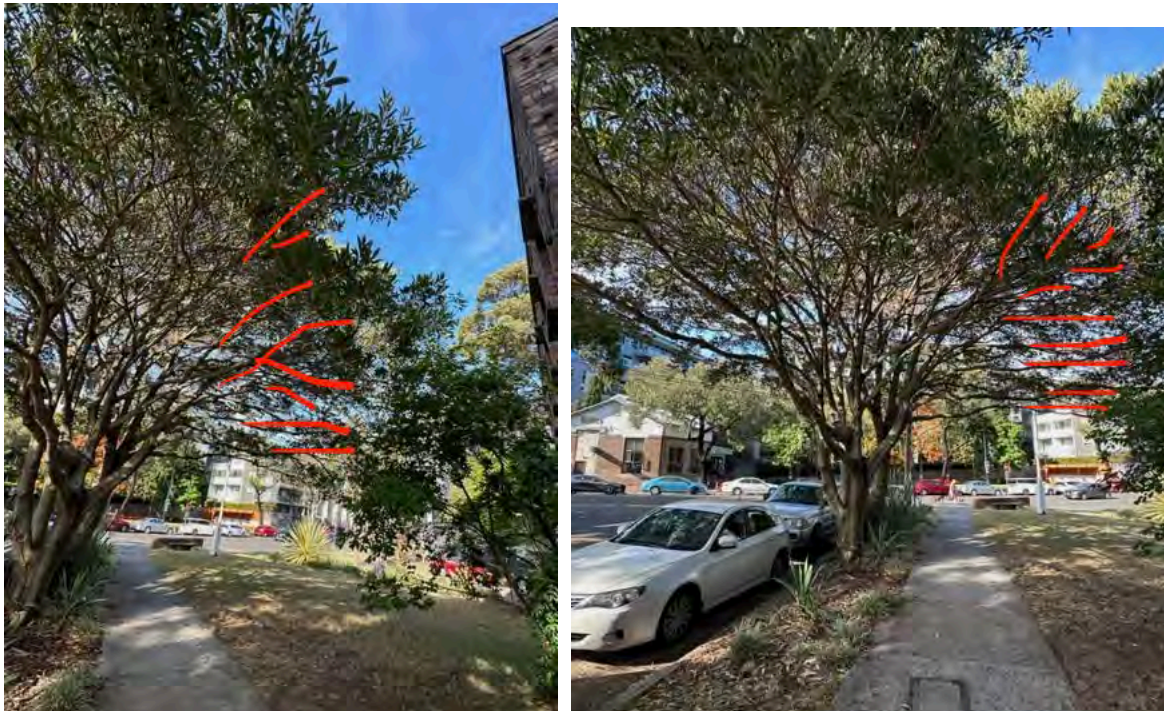
Figures 90 & 91: The proposed pruning requirements to accommodate the proposed building façade next to Tree 16. (Source: Austin 2nd November 2023).

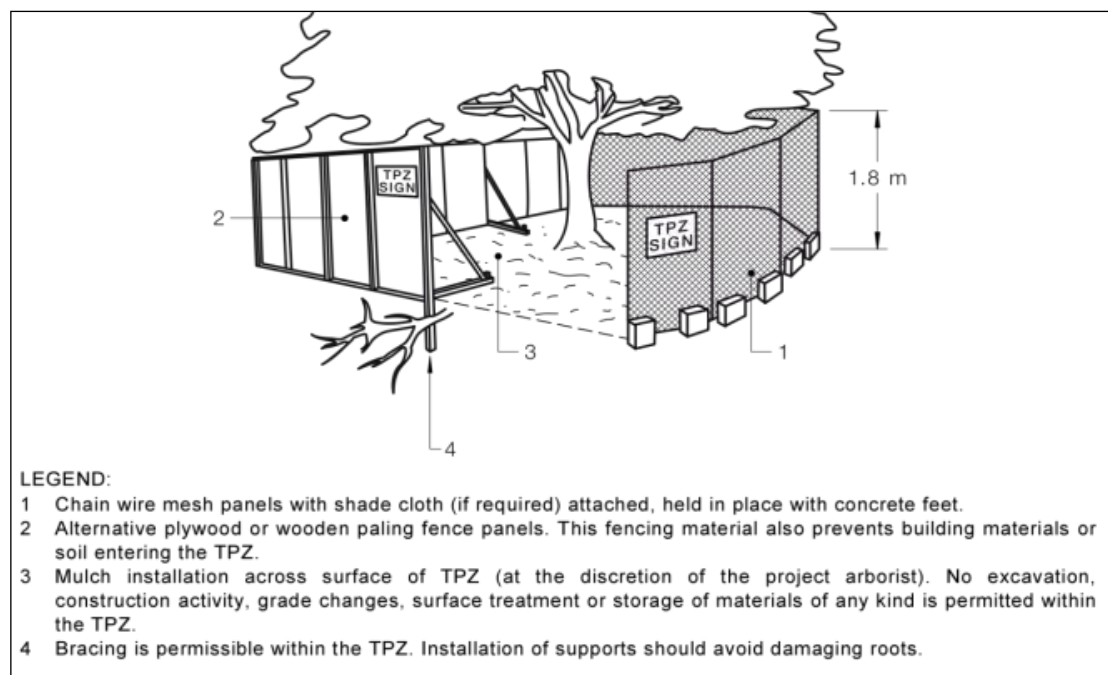
Figure 92: TPZ fencing specification. (Source: AS 4970:2007).
