Arboricultural Impact Assessment

242 – 258 Young Street Waterloo

**Prepared by Alex Austin
For
Sustainable Development Group Ltd
January 2024**

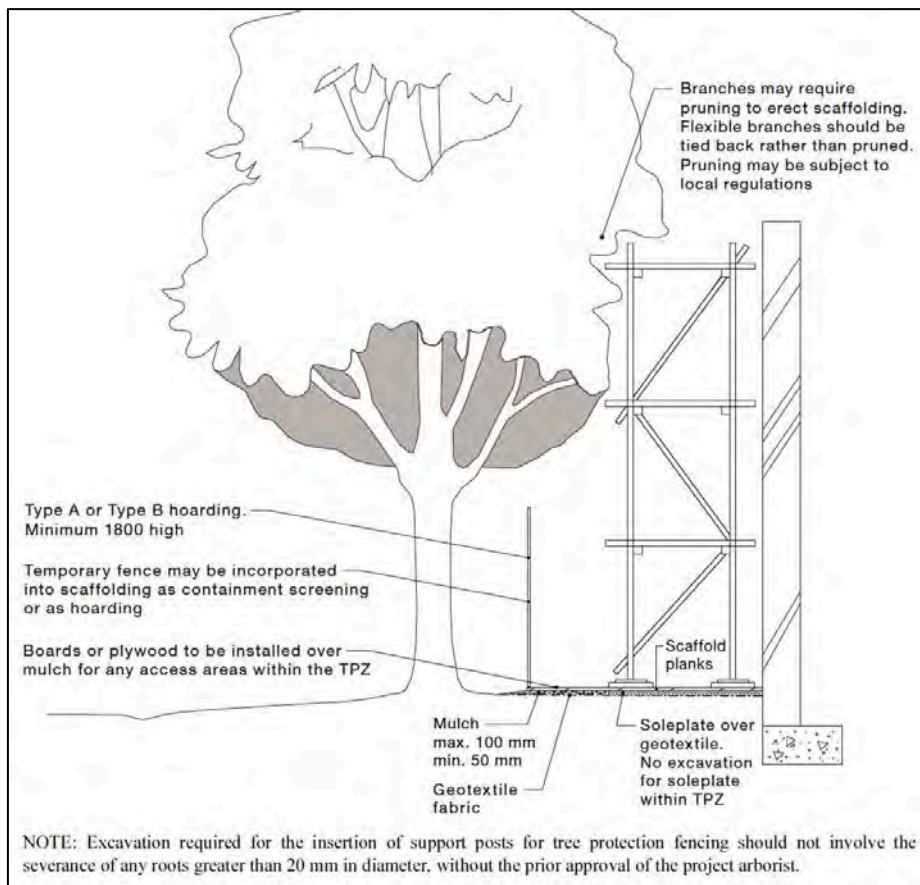
Figure 94: Scaffold within the TPZ specification. (Source: AS 4970:2007)

Temporary scaffold 1m wide will be required to facilitate the building works. The scaffold must be placed on ground protection mats as to not damage roots or compact the ground. Scaffold construction will be combined with canopy pruning and trunk/branch wrapping.

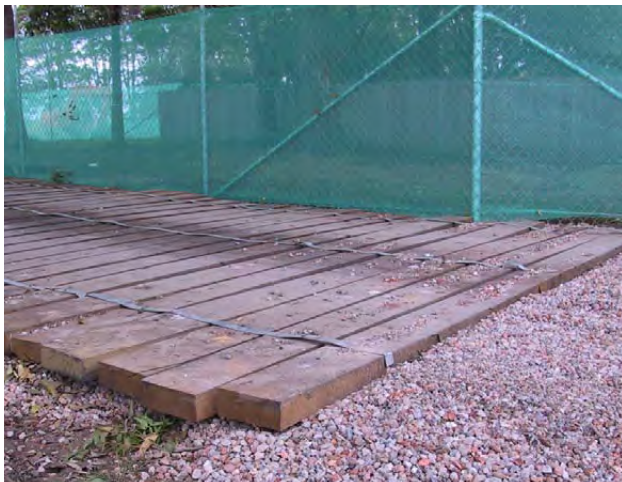
Figure 90- Where access is required through an identified tree protection zone the ground surface shall be protected through appropriate boarding and mulch or gravel placed above the existing ground surface to protect the roots and limit soil compaction. (Photo: Arterra)

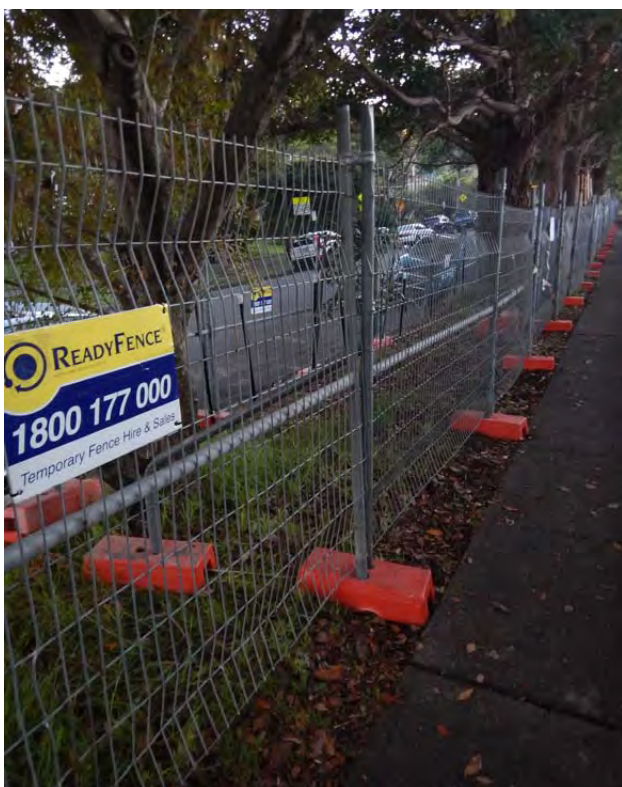
Figure 91- Groups of street trees within a grass strip may also require tree protection fencing installed to protect the trees and the ground surface around them. (Photo: Arterra)

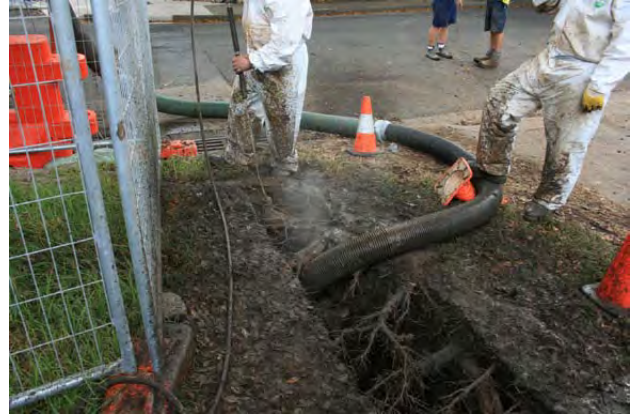
Figure 95- Hand excavation or other non-destructive methods such as water jetting and vacuum extraction to excavate around tree roots. (Photo: Arterra)

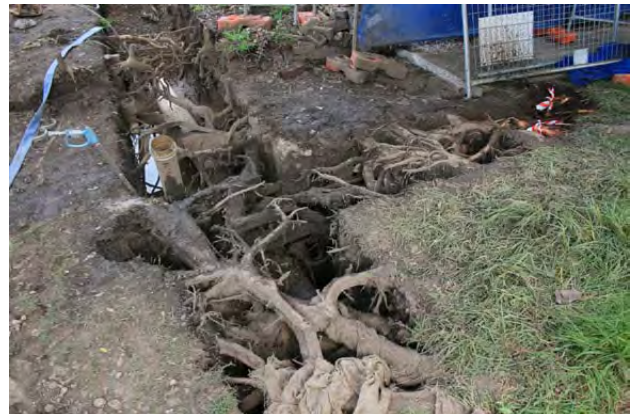
Figure 96- Non-destructive excavation methods can allow services to be installed across verges without the need to sever important and structural tree roots. (Photo: Arterra)
