Geotechnical Investigation Report

Project
242-258 Young Street, Waterloo NSW

Prepared for
Charvic Pty Ltd, &
International Screen Academy Property Pty Ltd

Report No
17185-GR-1-1

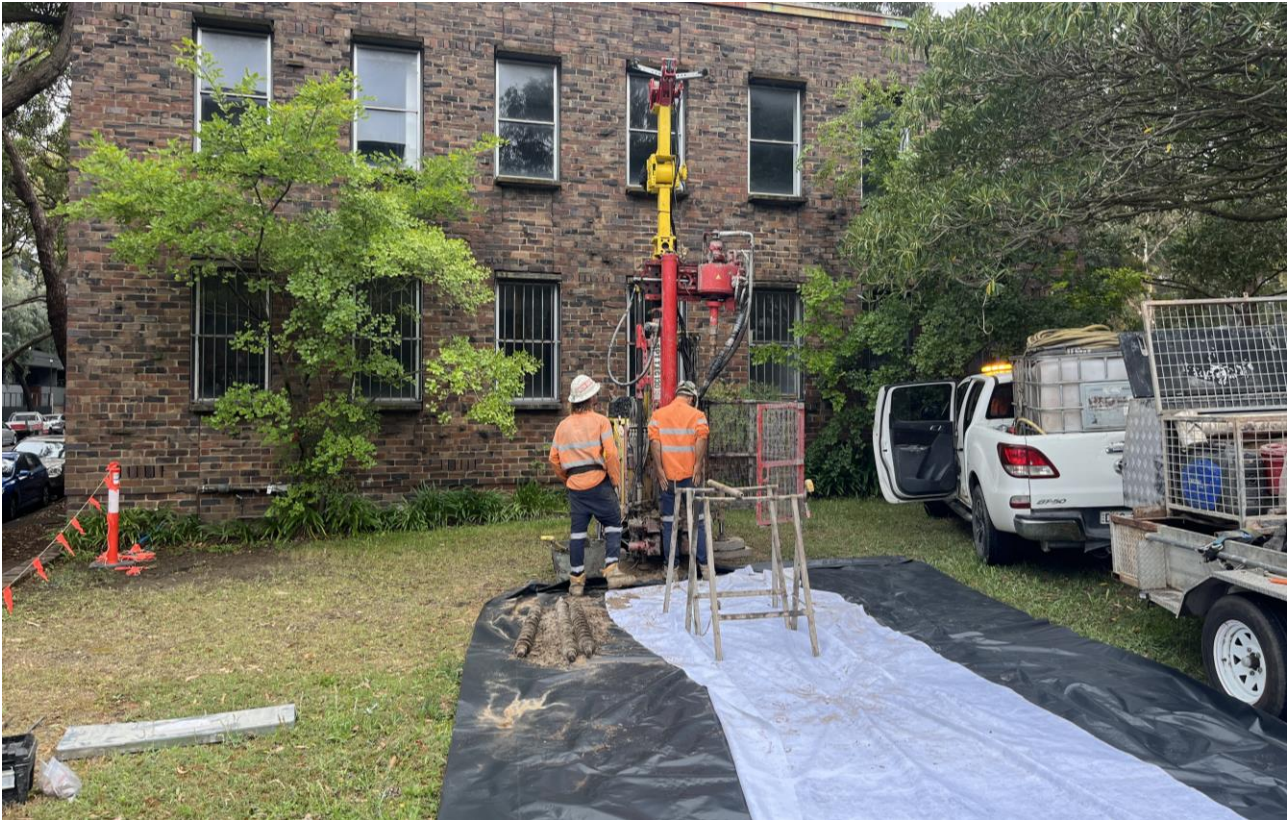
Figure 2-Photo of the drilling setup.

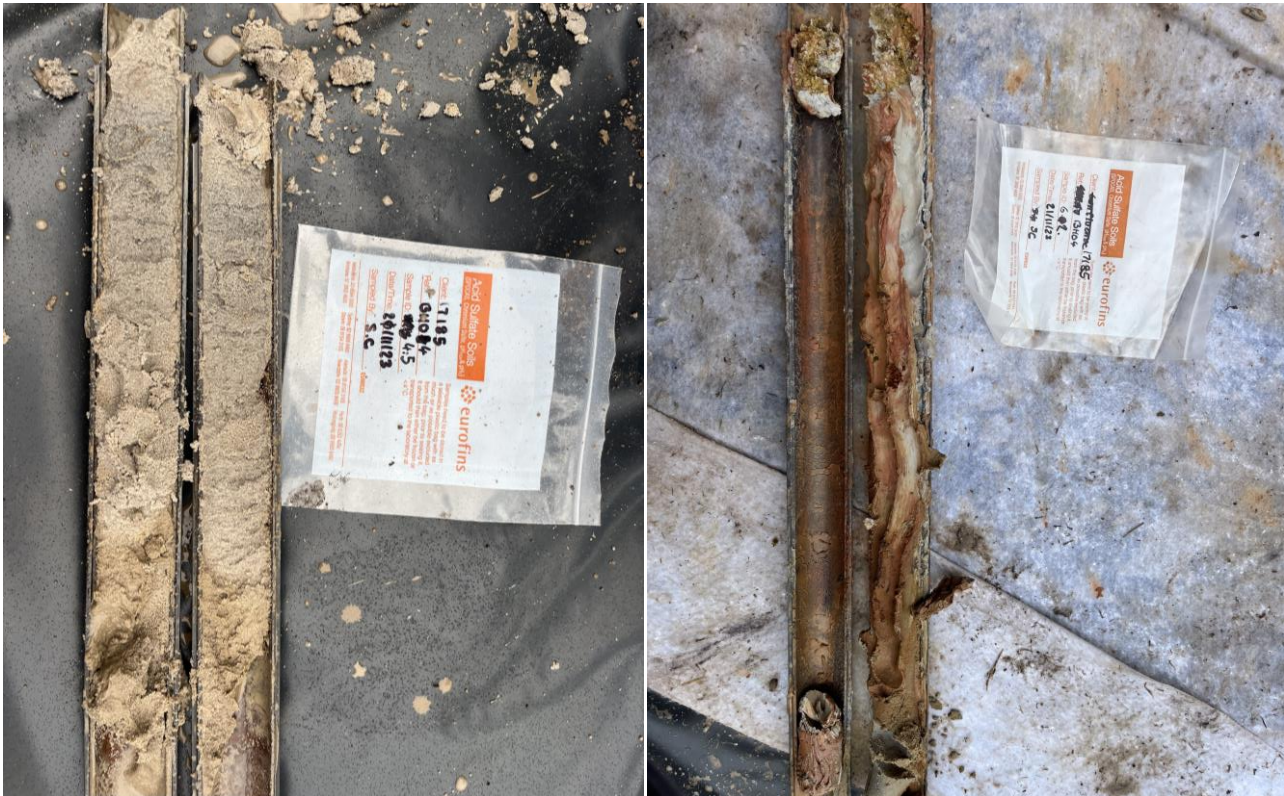
Figure 3-Photo of the marine sands (left) and clay (right) from BH04.

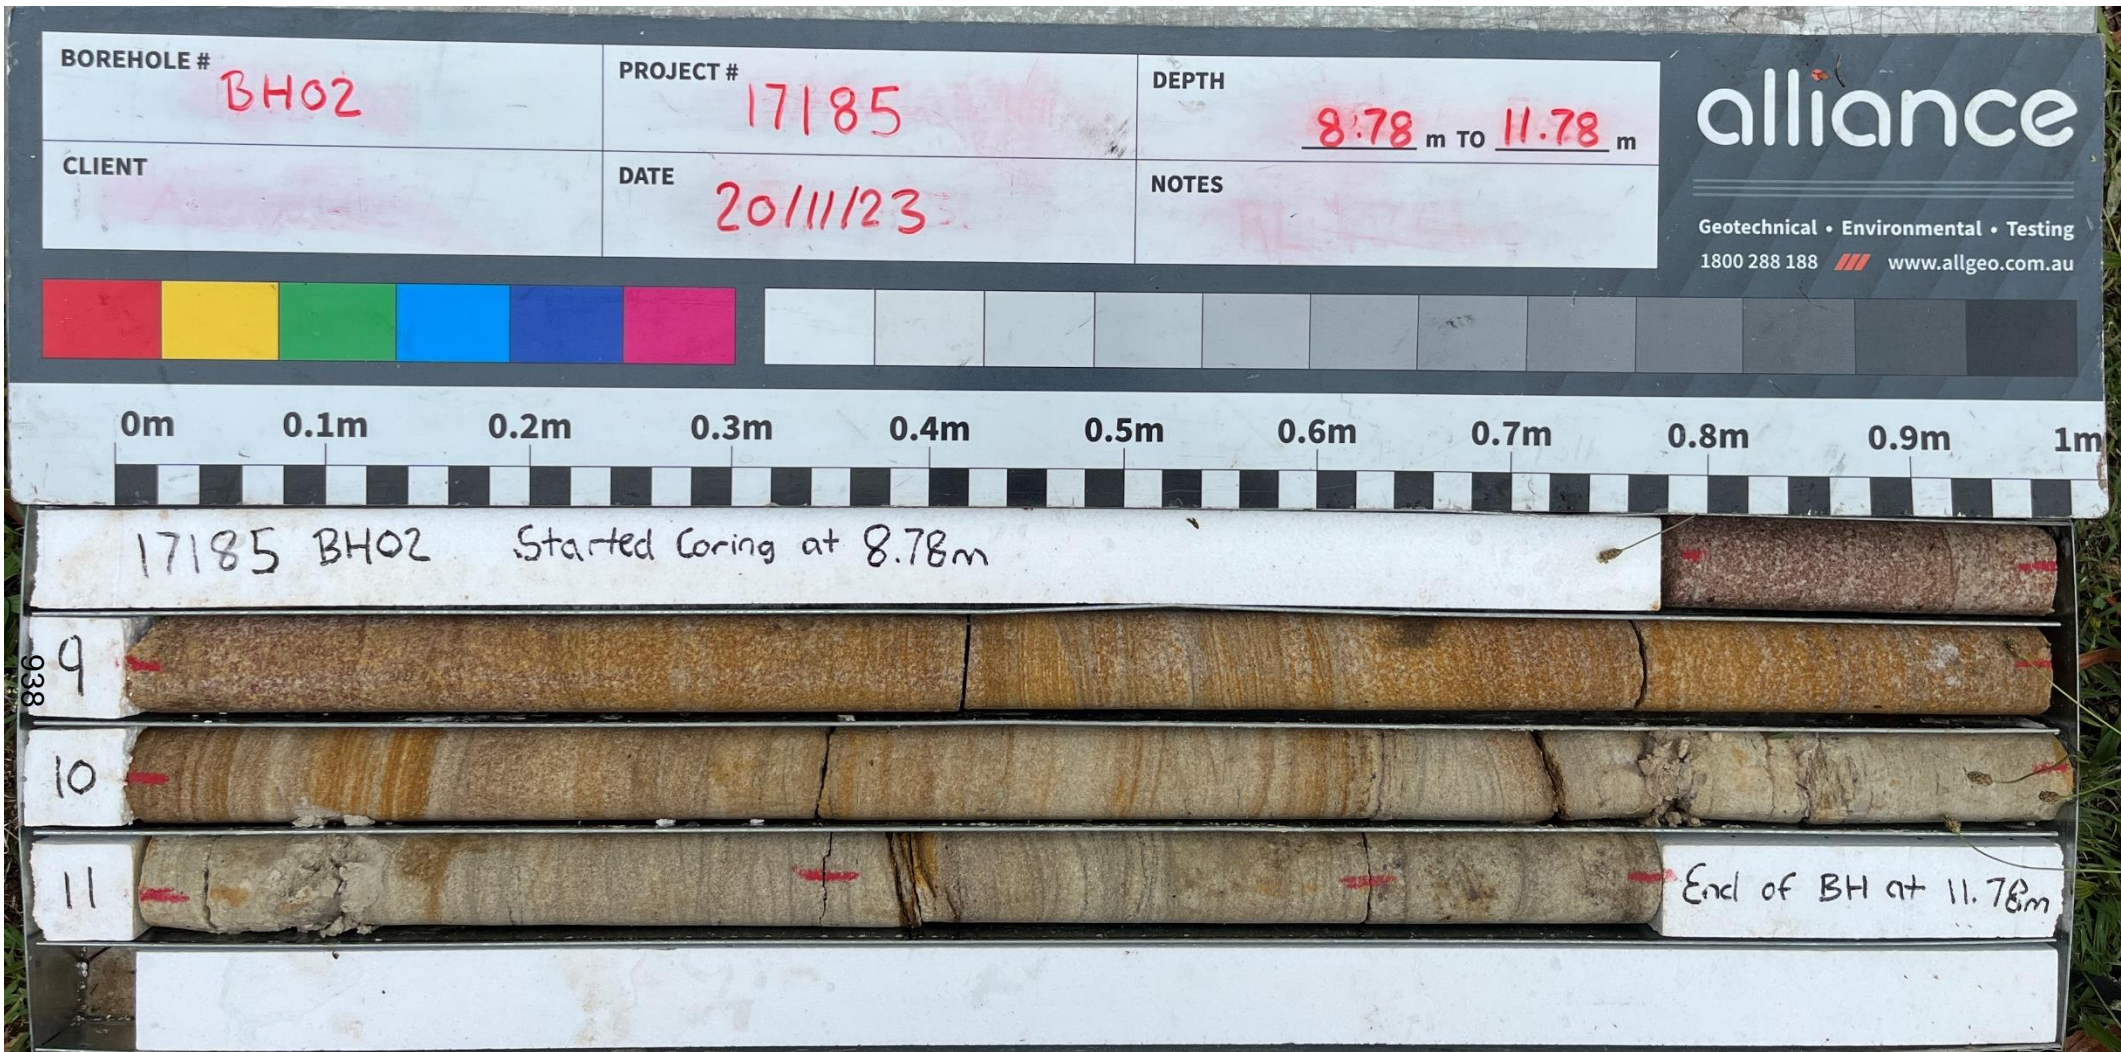
BH02		Box 1/1		8.78-11.78m

Method	Water	RL (m)	Depth (m)	Graphic Log	Material Description	Weathering	Estimated Strength		I _{s(50)} MPa	D- diam- etral A- axial	RQD %	Defect Spacing mm	Additional Data
							● Axial	○ Diametral					
NMLC		11.0	10.5		SANDSTONE, fine to medium grained, red brown, bedding fabric. (continued)	MW							10.0 - HB.
		10.5	11.0										
		10.0	11.5										10.73 - BP, 15°, PL, RO, VN.
		9.5											10.86-10.88 - EWS, PL, RO, clay. 10.88-10.9 - EWS, PL, RO, CT. 11.0 - HB. 11.04 - BP, 5°, PL, RO, VN. 11.07-11.12 - EWS, PL, RO, clay.
													11.35 - HB. 11.39 - BP, 15°, PL, RO, SN.
					Target depth. BH02 terminated at 11.78m								11.63 - DB.
													End of Borehole.

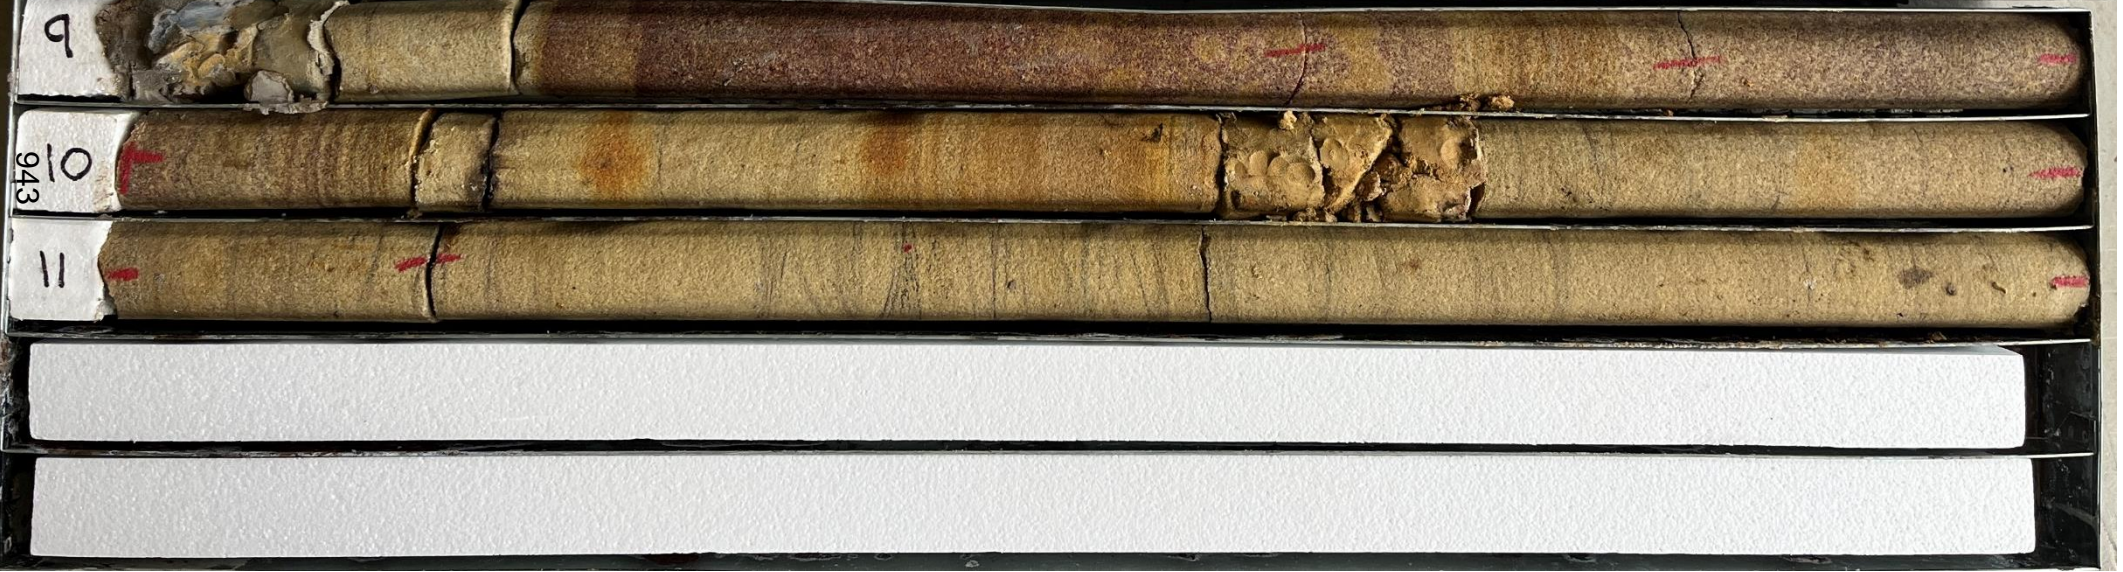
BH03		Box 1/1		9.0-12.0m	
alliance	Client Name	Charvic Pty Ltd International Screen Academy Property Pty Ltd		Photo Date:	23/11/23
	Project Name	Proposed Mixed Use Development		Report Number:	17185-GR-1-1
	Project Location	242-258 Young Street, Waterloo NSW

Method	Water	RL (m)	Depth (m)	Graphic Log	Material Description	Weathering	Estimated Strength		I _{s(50)} MPa	RQD %	Defect Spacing mm	Additional Data
							● Axial	○ Diametral				
NMLC		11.0	10.5		SANDSTONE, fine to medium grained, orange brown and pale grey, bedding fabric. (continued)	MW	●	○	D A 1.361.822	91		10.0 - HB.
		10.5	11.0				10.15 - BP, 5°, PL, RO, SN.					
		10.0	11.5									10.19 - BP, 55°, PL, RO, SN.
		9.5	12.0									10.56-10.69 - EWS, PL, RO.
												11.0 - HB.
												11.16 - DB.
												11.55 - BP, 5°, PL, RO, CN.
					BH03 terminated at 12m							End of Borehole.
		9.0	12.5									
		8.5	13.0									
		8.0	13.5									
		7.5	14.0									
		7.0	14.5									
		6.5	15.0
