# **Attachment A**

**Location Plan and Site Photos**

# Regent Street Reserve, Paddington

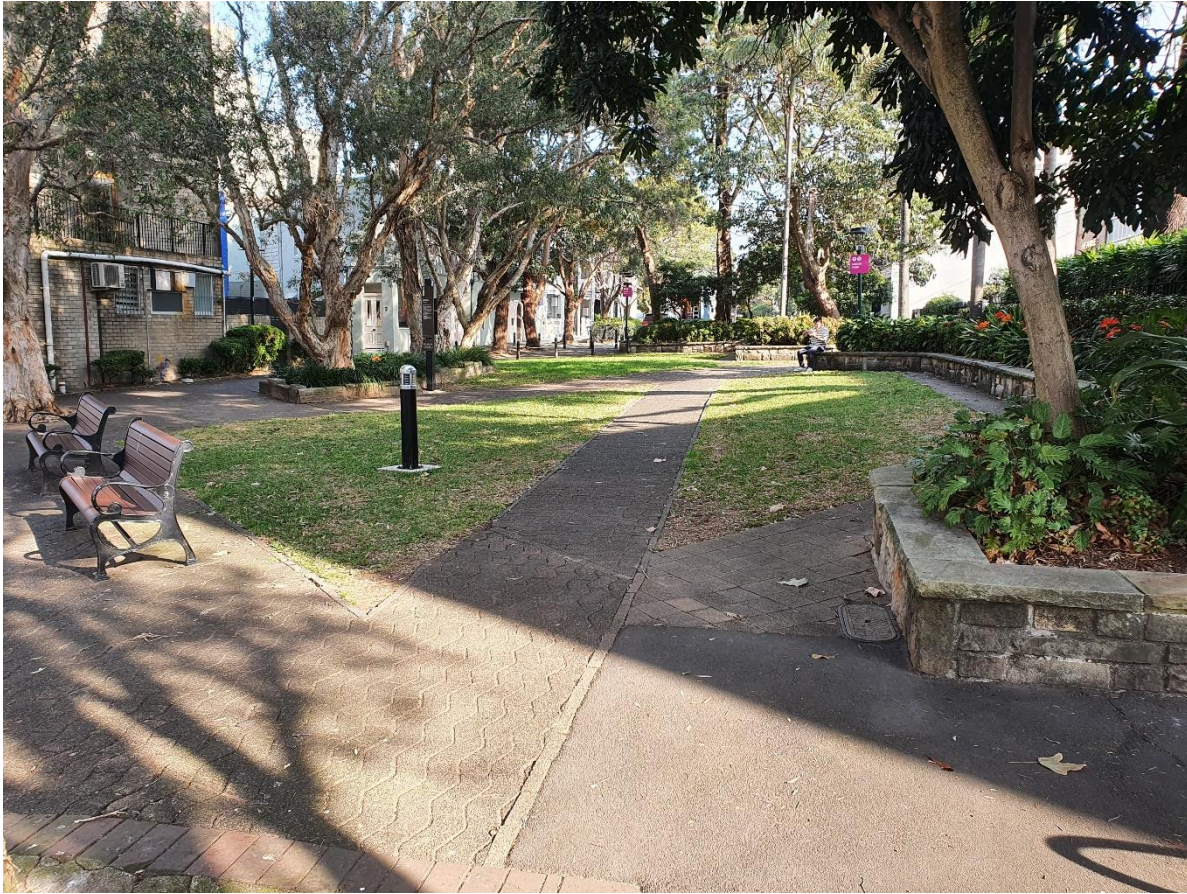
Existing reserve looking south towards the rear of the site. The paving is at the end of its lifecycle. The turf is worn on the corners due to pedestrian movements. Sandstone planter bed retaining wall needs some maintenance to extend life. Mature trees fill the site and provide ample shade to the space.

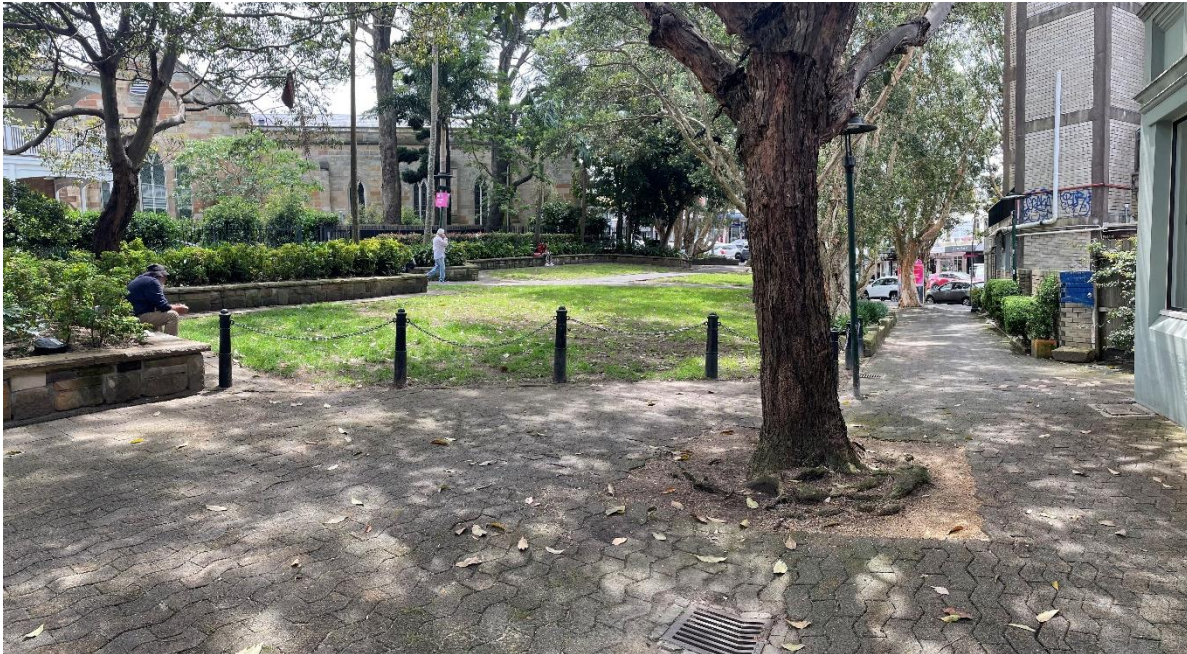
Looking north towards Oxford Street from Regent Street. Uneven paving caused by the trees. Bollards stopping unwanted movement on to grass. End of life lighting and stormwater visible.
