# View Loss Assessment

Submitted to City of Sydney in response to RFI dated 31 July 2024

St Vincent's College, 1 Challis Avenue, Potts Point  
The Trustees of the Sisters of Charity of Australia

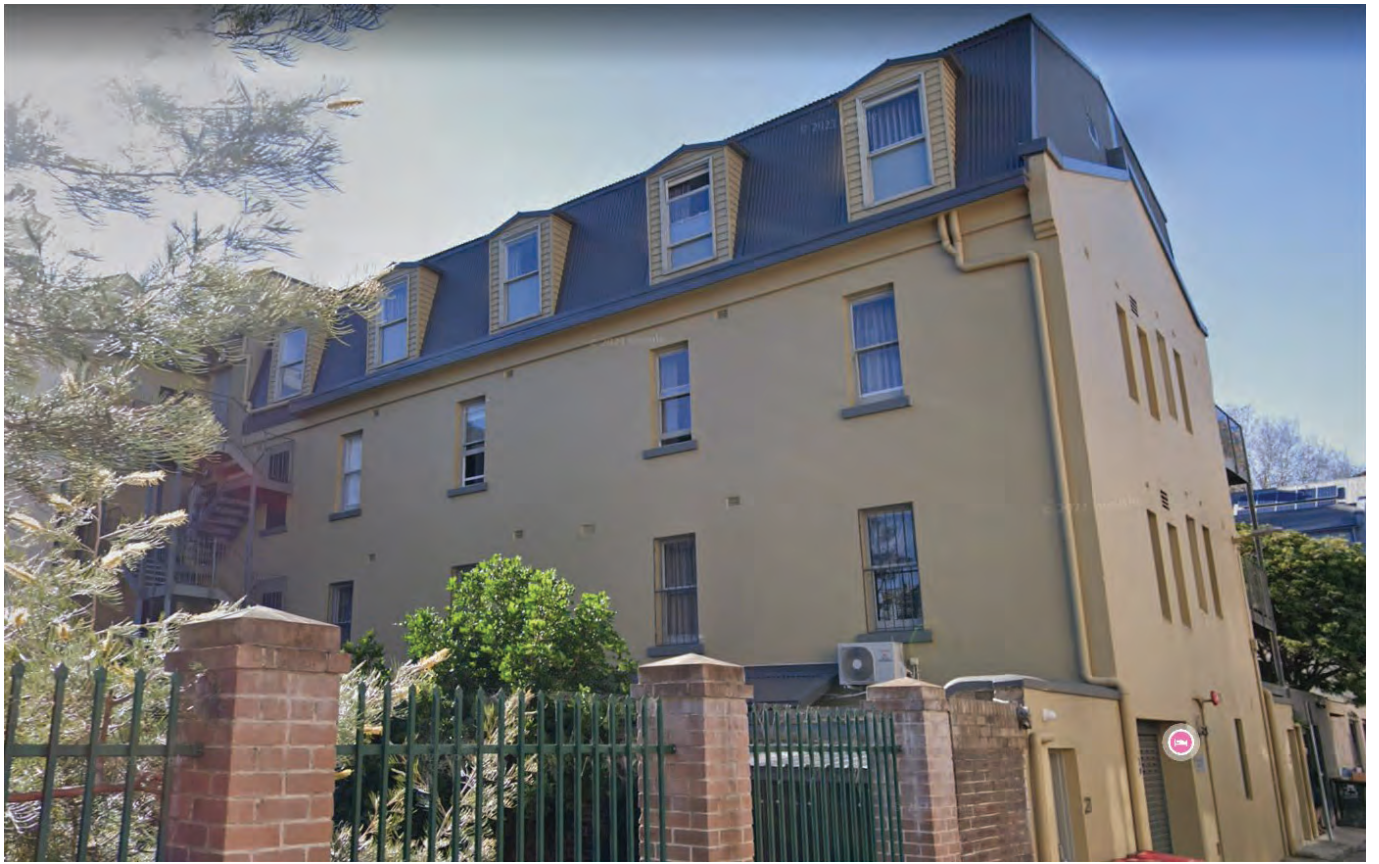
**Figure 2** Hotel Challis western façade overlooking the site

The site has an approximate area of 1.4 hectares and is irregular in shape. This site is bound by Challis Avenue to the north and Victoria Street to the west. North of Challis Avenue is a mix of residential flat buildings and terrace housing. Adjoining the site to the east is the Hotel Challis. This hotel has rooms that overlook the site's eastern boundary (refer **Figure 2**). Rockwall Lane bounds a portion of the site's boundary, with the rear of terrace housing opposite to and overlooking the site (refer **Figure 3**). This lane is elevated above the natural grade of the school grounds.

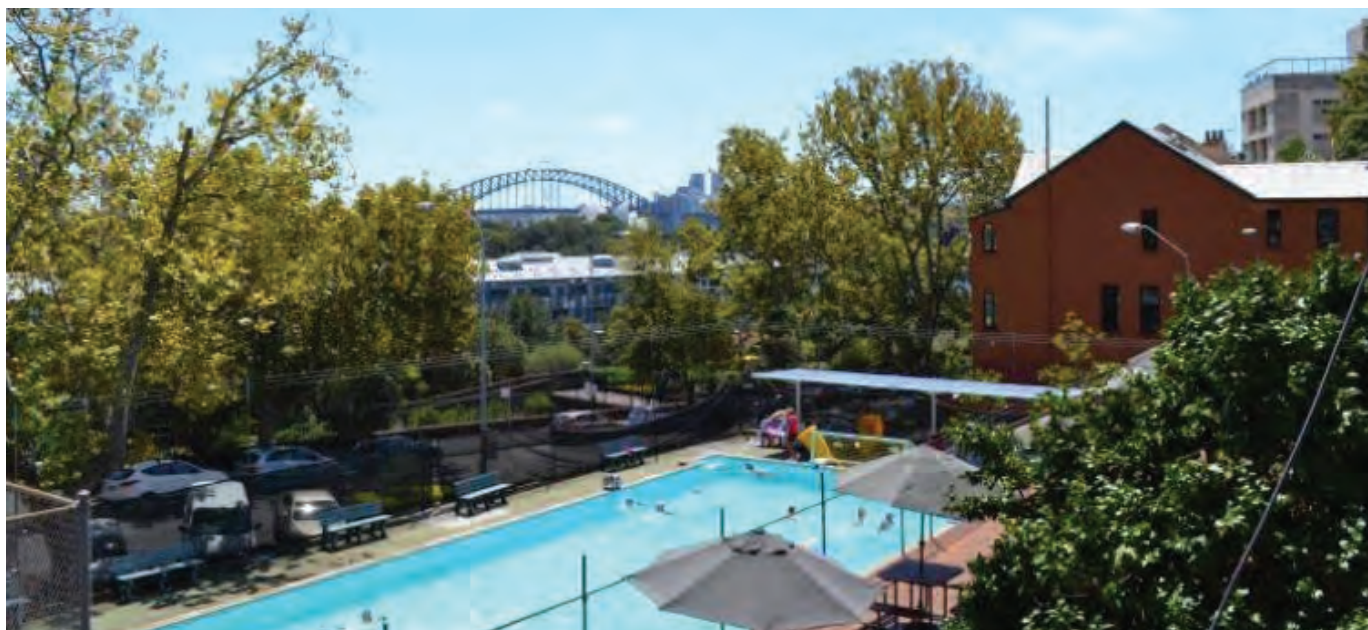
**Figure 4** The existing open space comprising a swimming pool at the corner of Challis Avenue and Victoria Street

The northern portion of the site, which is of particular focus in this VLA, comprises at present a swimming pool and mixed sporting courts elevated above the adjacent street level (refer **Figure 4**). The focus area also includes open space immediately adjacent Rockwall Lane, and the Garcia Building fronting Challis Avenue. The 'Carmelita' (Garcia) building is listed as an item of local heritage significance. Further, the site is located within the Potts Point Heritage Conservation Area (HCA).

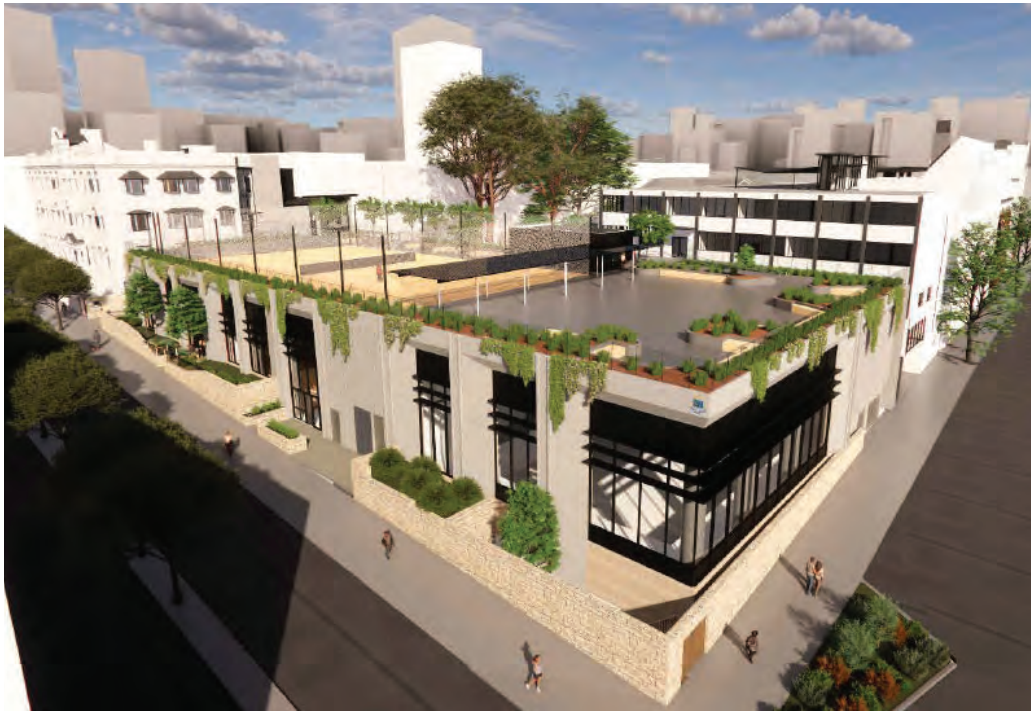
**Figure 5** Perspective of the proposed development from the corner of Challis Avenue and Elizabeth Street

The application seeks approval for the construction of a partially sunken multi-purpose building at the corner of Challis Avenue and Victoria Street, accommodating a sports hall and indoor water polo facility. The building includes a new entry to the school from Challis Avenue. The rooftop of this building comprises a sport court with mesh fencing and open space partially covered by an awning. The proposal also includes the Bethania Building, a part two, part three storey building with general and music learning facilities to the rear of the Garcia building and adjacent Rockwall Lane. This building is connected to the Garcia Building, providing accessible access to each floor. A perspective of the proposed development is provided at **Figure 5**.

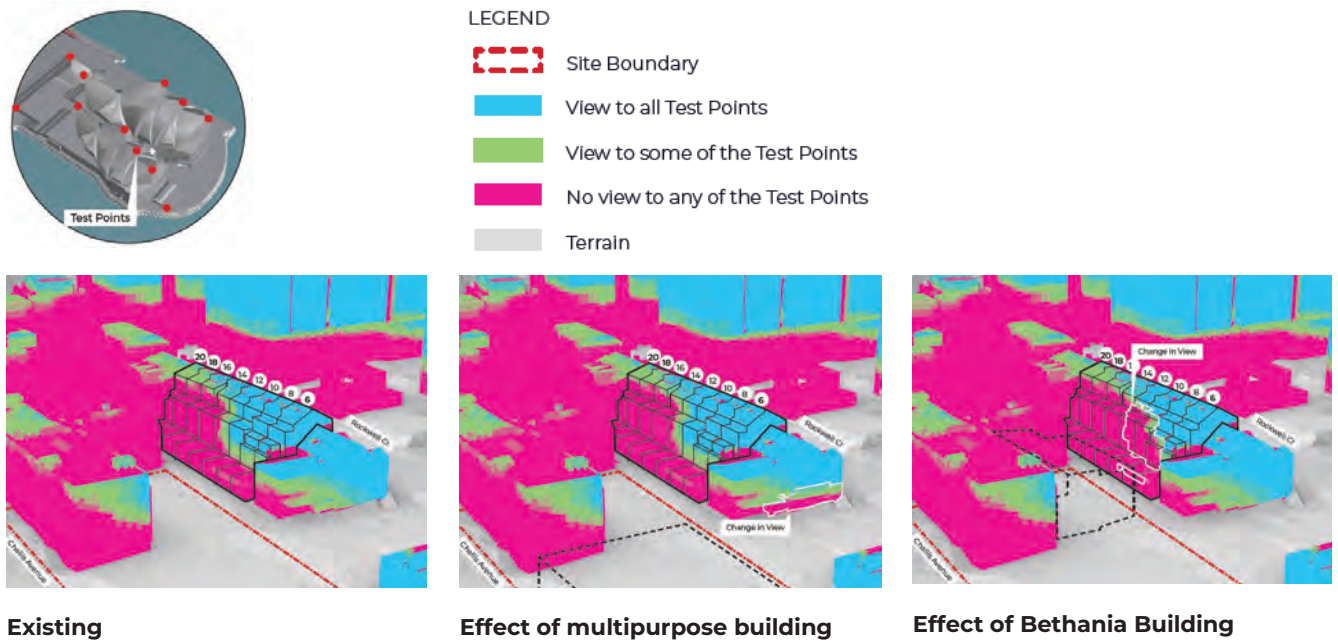
Figure 7 Viewing heatmap analysis illustrating exposure to Sydney Opera House views

The following viewing heatmap analysis identifies the extent of façade of adjacent properties that are exposed to views of the items listed above. The heatmap image on the left identifies the present exposure. The heatmap in the centre identifies the extent of exposure when the proposed multipurpose volume is positioned on the site. The heatmap on the right identifies the extent of exposure when the proposed Bethania Building is positioned on the site. It is noted that the heatmap analysis is undertaken prior to development of photomontages to the standard of the LEC principle. The purpose of these images is to develop a preliminary understanding of view loss (scoping study) in order to identify the properties that will be further assessed in this VLA. The images are therefore not to be considered as a fully accurate representation of view loss and serve as a guide only.

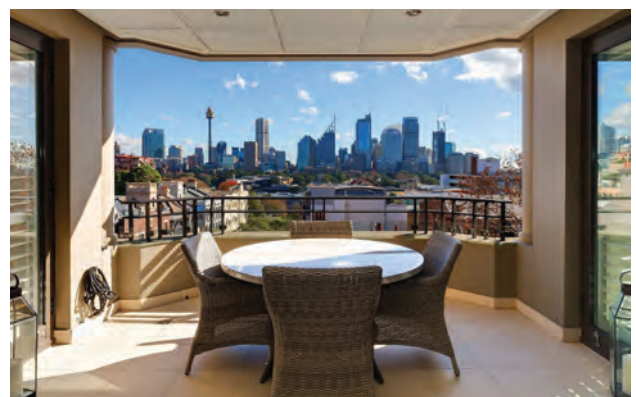
Indicative view from apartment 602

- **14 Macleay Street, Elizabeth Bay, “Pomeroy”.** This multi-residential property is positioned at the junction of Challis Avenue and Macleay Street, with viewing down Challis Avenue towards Woolloomooloo Bay and the city skyline beyond. Preliminary analysis found that the proposed form obscured built mass and a minor portion of water and wharf viewing. The viewing loss is greatly mitigated by the property’s elevated position at the top of Challis Street.

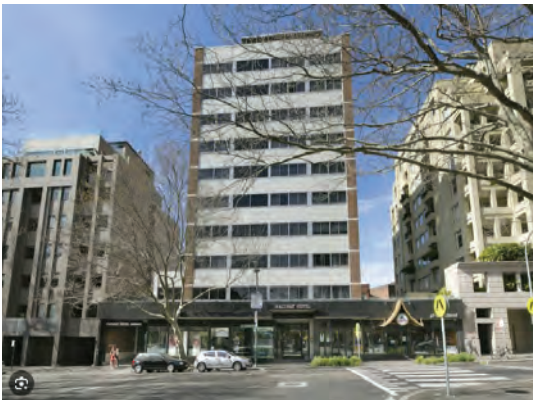
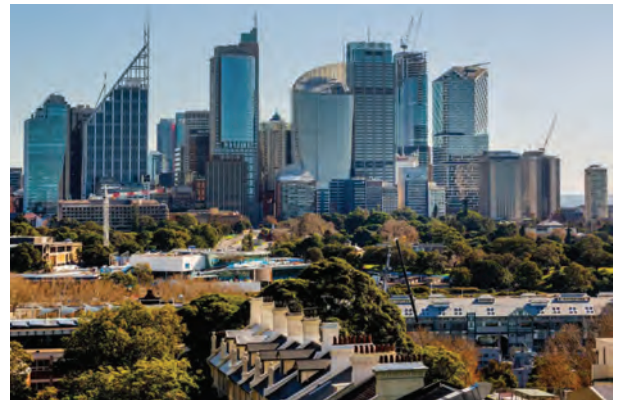
- 28 Macleay Street, Elizabeth Bay, “The Macleay”.** This property comprises serviced apartments and is positioned at the junction of Rockwall Crescent and Macleay Street, with viewing down Rockwall Crescent towards Woolloomooloo Bay and the city skyline beyond. As for the property above, preliminary analysis found that the proposed form obscured built mass and a minor portion of water and wharf viewing. The viewing loss is greatly mitigated by the property’s elevated position at the top of Rockwall Crescent.

Indicative view from apartment 811

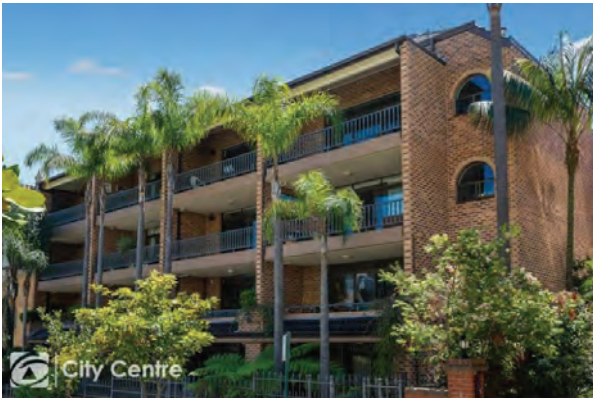
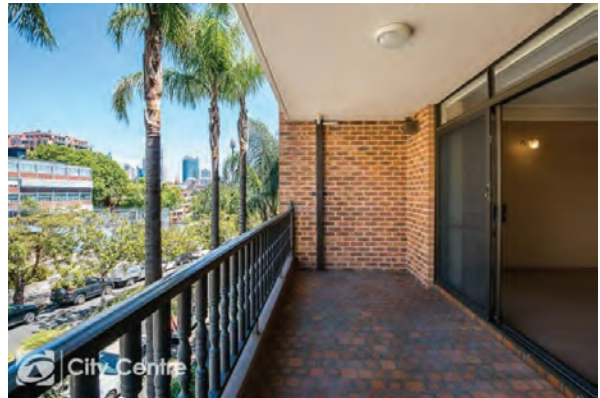
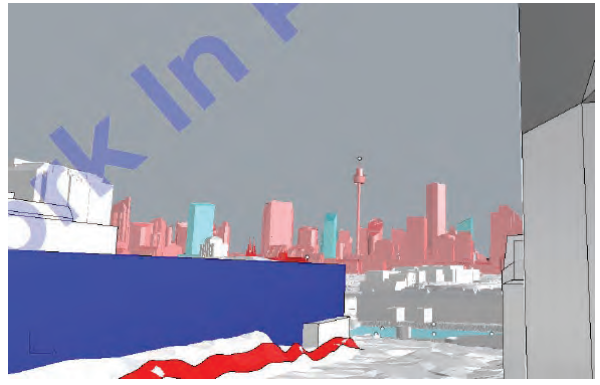
**Figure 14** Images and preliminary analysis of 28 Macleay Street, Elizabeth Bay

- 6 Challis Avenue, Potts Point.** This multi-residential property is positioned opposite the proposed development, with viewing of the southern end of Woolloomooloo Bay and the city skyline. Preliminary analysis found that the proposed form primarily obscured viewing of the 5 storey St Vincent's College building to the immediate south of the proposed development. Only a minor portion of distant viewing was estimated to be occluded.

View with indicative proposed envelope

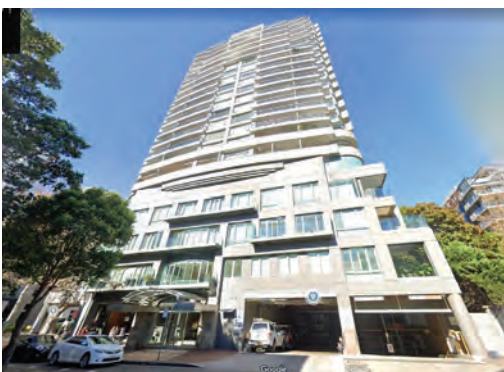
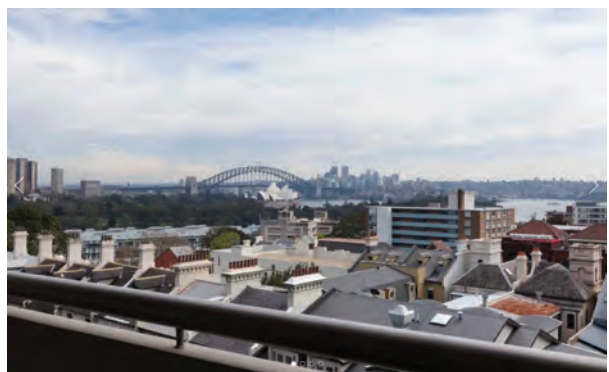
- 7 Rockwall Crescent, Potts Point, "Rockwall Apartments".** This residential tower has panoramic distant viewing, particularly at its upper levels. Preliminary analysis of the lower levels found that the proposed form obscured built mass and a minor portion of water and wharf viewing. However, the proposed development is largely occluded by the existing terraces adjacent the site on Rockwall Crescent, and thus these terraces provide an existing limitation to viewing.

Indicative view from apartment 503

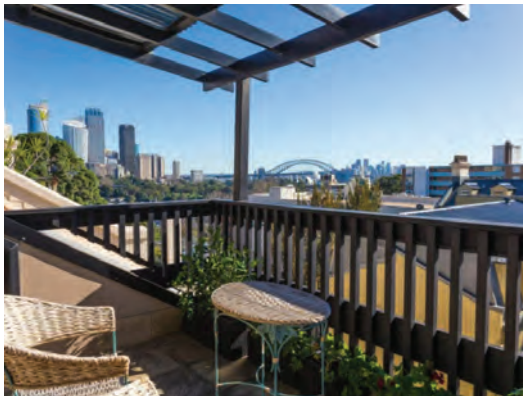
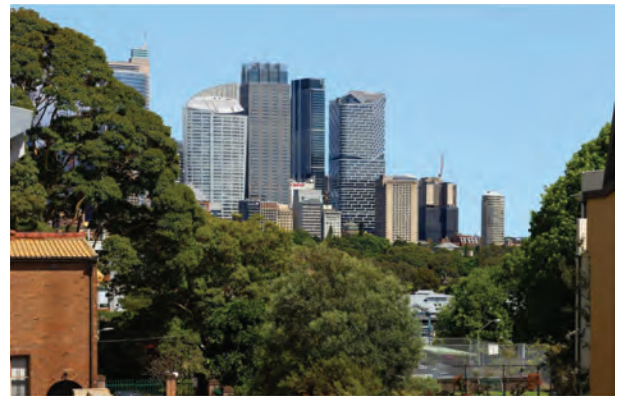
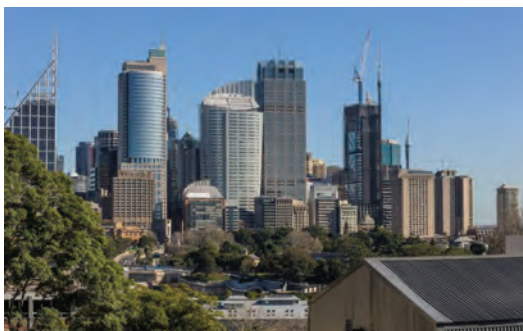
**Figure 16** Existing views from 18 to 22 Rockwall Crescent, Potts Point

- Properties from 18 to 22 Rockwall Crescent.** The remaining properties with rear boundary to Rockwall Lane (east of those that have been selected for assessment) experience distant viewing across the subject site at their upper floors. Travelling east along Rockwall Lane, distant viewing of properties is increasingly occluded by the Hotel Challis mass. Viewing from the top floor is not anticipated to be obstructed by the proposed development, which is at a lower elevation (this inference was subsequently supported by the detailed analysis of the 10-16 Rockwall Crescent property following in this report). View loss to lower floors (where views currently exist) is considered to be either commensurate to or qualitatively less significant than that of 10-16 Rockwall Crescent, and therefore analysis of 10-16 Rockwall Crescent is considered sufficient to derive an adequate assessment of view loss resulting from the proposed development. It is also noted that the further east the property, the higher the elevation when compared to the St Vincent's College grounds.

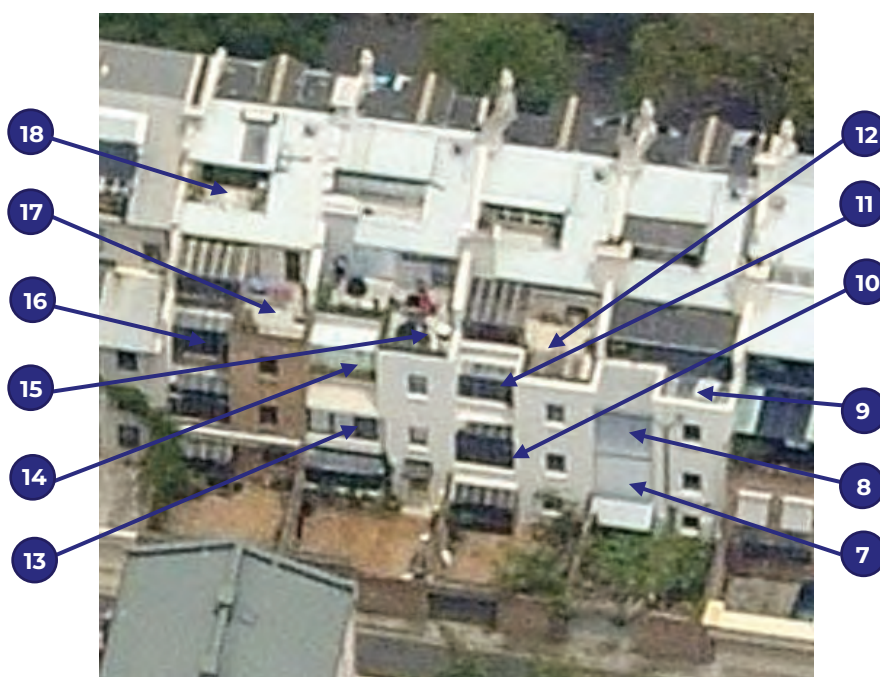
**Figure 18 Viewpoint locations from apartments at 6-8 Rockwall Crescent**

View	Address	Position
CAM07	Unit 1, 10 Rockwall Crescent Potts Point	Upper ground, study
CAM08	Unit 2, 10 Rockwall Crescent Potts Point	Level 1, Dining room
CAM09	Unit 2, 10 Rockwall Crescent Potts Point	Level 2, balcony
CAM10	Unit 1, 12 Rockwall Crescent Potts Point	Upper ground, study
CAM11	Unit 2, 12 Rockwall Crescent Potts Point	Level 1, Lounge
CAM12	Unit 2, 12 Rockwall Crescent Potts Point	Level 2, balcony
CAM13	Unit 1, 14 Rockwall Crescent Potts Point	Upper ground, study
CAM14	Unit 2, 14 Rockwall Crescent Potts Point	Level 1, lounge
CAM15	Unit 2, 14 Rockwall Crescent Potts Point	Level 2, balcony
CAM16	16 Rockwall Crescent Potts Point	Level 1, dining
CAM17	16 Rockwall Crescent Potts Point	Level 2 balcony
CAM18	16 Rockwall Crescent Potts Point	Level 3 balcony

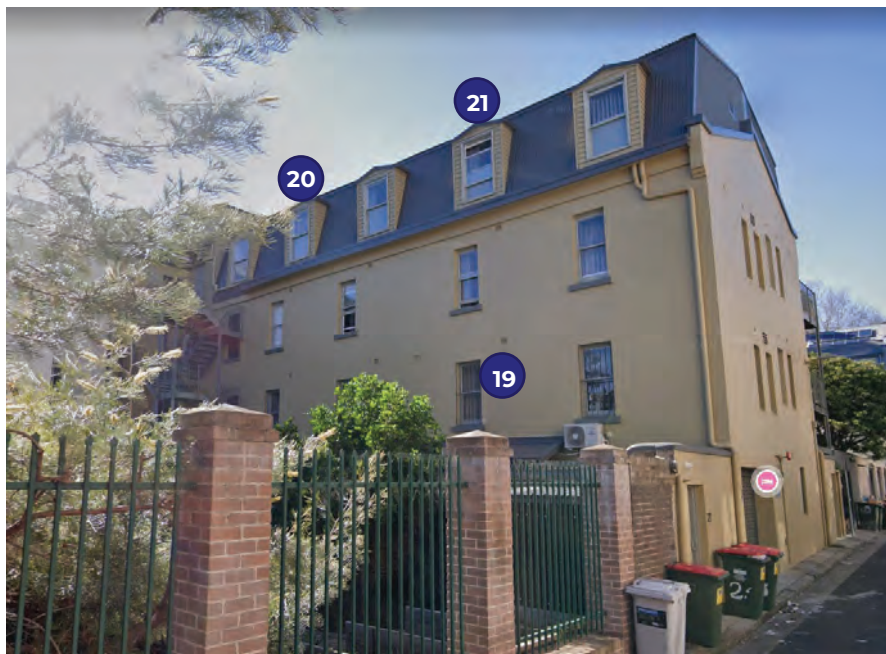
**Figure 19 Viewpoint locations from apartments at 21-23 Challis Avenue**

The Hotel Challis at 21-23 Challis Avenue is a boutique hotel contained within 2 three storey Victorian terraces. A wing of hotel rooms extends to meet the rear boundary at Rockwall Lane. The property comprises approximately 53 rooms. The rear wing’s western façade overlooks the St Vincent’s College open space, the subject site of the proposed development. This wing contains hotel rooms at the second, third and fourth storeys. The rooms at the top floor are contained within an attic and have dormer type windows. Three rooms were selected for assessment, which are considered to be representative of the viewing experienced by western facing rooms. Two rooms were selected at the top floor, as this elevated level has the most distant viewing. These viewpoints are identified in **Table 4** and illustrated at **Figure 19** below.

View	Address	Position
CAM19	Room 214, 21-23 Challis Avenue Potts Point	Level 1 - south end of west facade
CAM20	Room 408, 21-23 Challis Avenue Potts Point	Level 3 - north end of west facade
CAM21	Room 412, 21-23 Challis Avenue Potts Point	Level 3 - south end of west facade

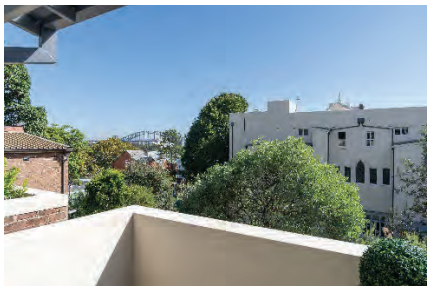
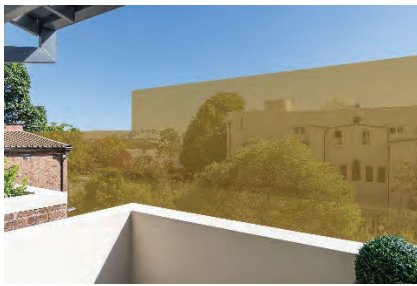
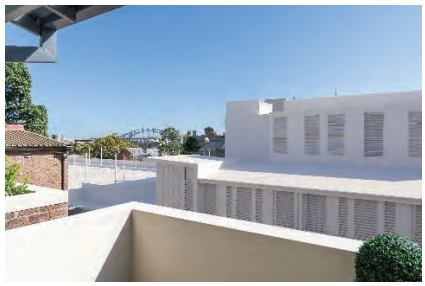
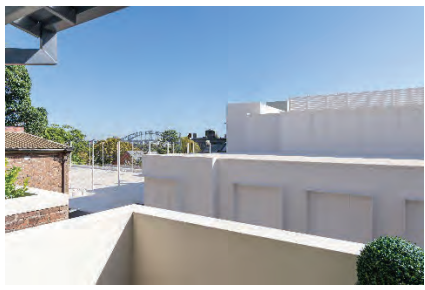
**Table 6** CAM02: Unit 3, 8 Rockwall Crescent Potts Point - Level 1, terrace off kitchen

Existing view	Compliant LEP/DCP envelope	Proposed development (as revised)

<p data-bbox="1023 1503 1479 1547">Originally lodged photomontage</p>

Qualitatively, the severity of the extent of loss with respect to distant viewing (that may or may not include iconic views) is considered in **Table 11** below. It is noted that all views, with the exception of the Level 1 views, are from bedrooms. The Level 1 views are from kitchens. Tenacity identifies that rooms (such as kitchens) where residents are likely to spend more time are of greater significance when considering view loss. It is noted, however, that the Level 2 bedrooms are connected to a balcony, which (given the viewing experienced from the balcony) is considered to be a significant casual recreation space for residents.

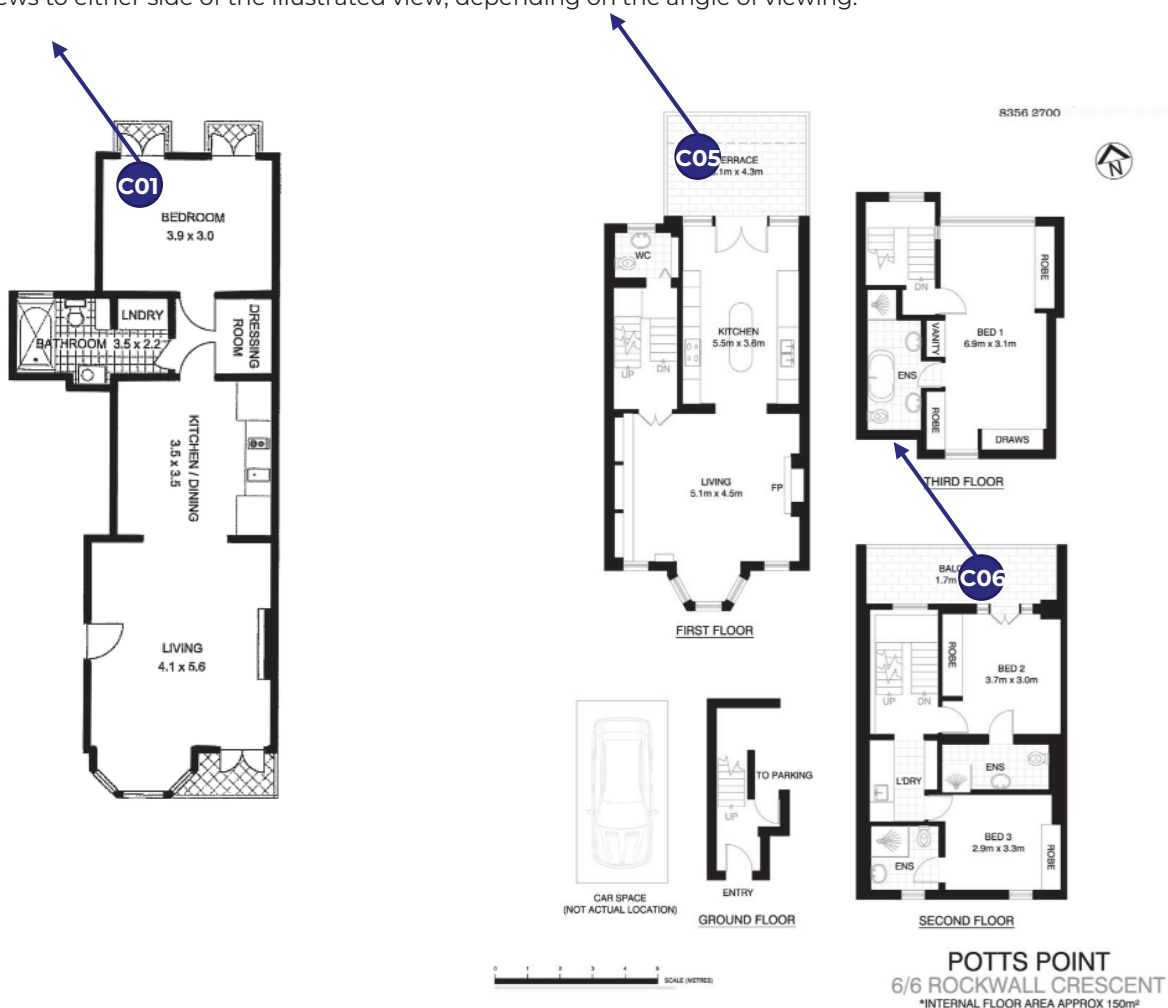
Figure 20 Floor plan of 2/8 Rockwall Crescent

The views are obtained from a standing position in front of windows (where there is no connecting balcony) or on balconies looking over the balustrade. Information relating to the type of room adjoining the window or balcony has been provided by the photographer engaged by Virtual Ideas. Further, where available, floor plans from real estate websites provide additional understanding of the subject/adjacent rooms (refer **Figure 20** and **Figure 21**). All views are across the rear boundary of the property, adjacent Rockwall Lane.

It is noted that the views illustrated do not represent the full extent of viewing possible from the balcony or window of the affected units, but rather the view in the direction of the distant view corridor to the northwest. The resident also experiences views to either side of the illustrated view, depending on the angle of viewing.

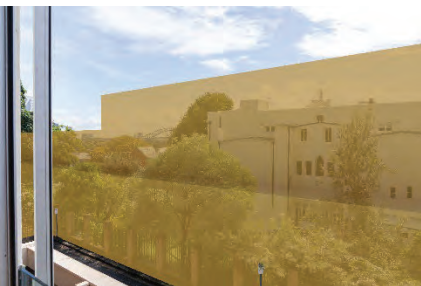
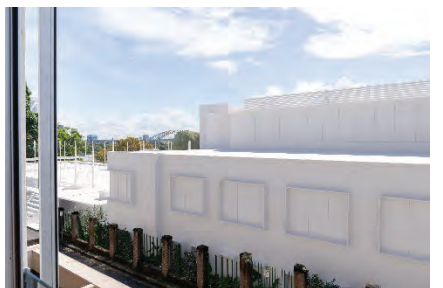
**Table 13** CAM08: Unit 2, 10 Rockwall Crescent Potts Point - Level 1, Dining room

Existing view	Compliant LEP/DCP envelope	Proposed development (as revised)

Originally lodged photomontage

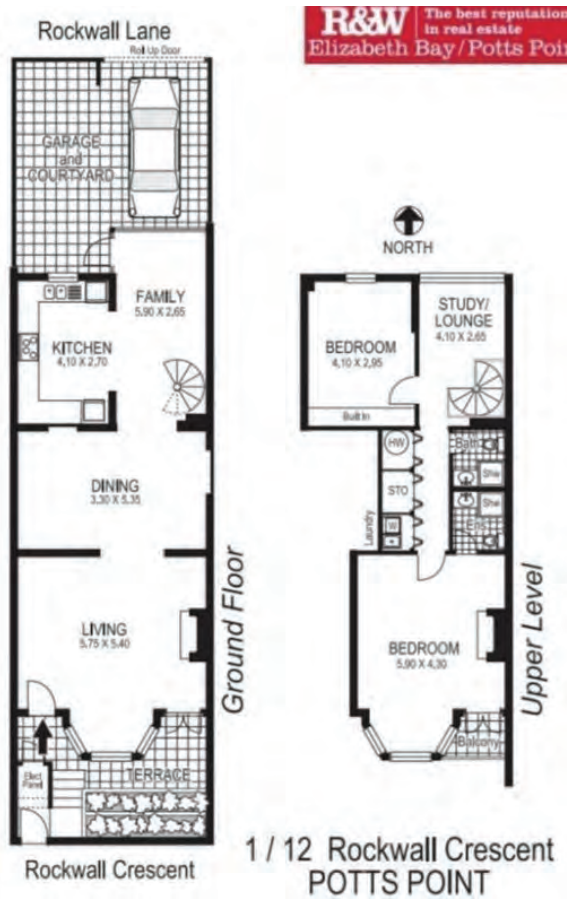
Figure 22 Floor plan of 1/12 Rockwall Crescent  
Source: Realestate.com

The views are obtained from a standing position in front of windows (where there is no connecting balcony) or on balconies looking over the balustrade. Information relating to the type of room adjoining the window or balcony has been provided by the photographer engaged by Virtual Ideas. Further, where available, floor plans from real estate websites provide additional understanding of the subject/adjacent rooms (refer **Figure 22** and **Figure 23**). All views are across the rear boundary of the property, adjacent Rockwall Lane.

It is noted that the views illustrated do not represent the full extent of viewing possible from the balcony or window of the affected units, but rather the view in the direction of the distant view corridor to the northwest (where this is achieved). The resident also experiences views to either side of the illustrated view, depending on the angle of viewing.

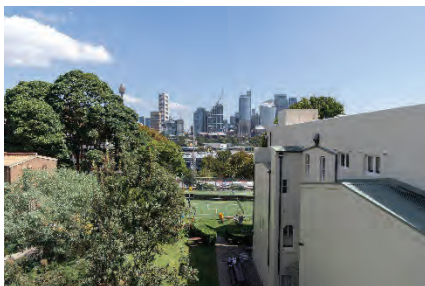
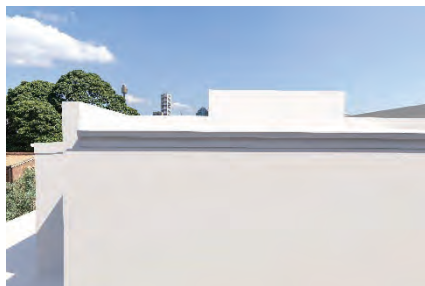
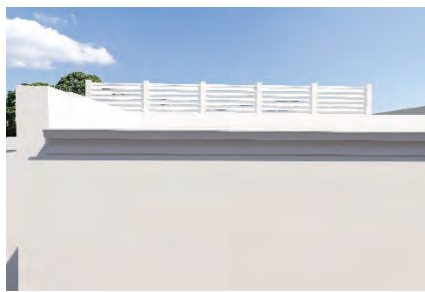
**Table 26** CAM20: Room 408, 21-23 Challis Avenue Potts Point - Level 3 - north end of west facade

Existing view	Compliant LEP/DCP envelope	Proposed development (as revised)

<p data-bbox="1034 1393 1460 1431">Originally lodged photomontage</p>

Rooms 408 and 412 experience distant viewing framed by built form on either side of the College grounds. The distant viewing includes a portion of Woolloomooloo Wharf and the Sydney CBD skyline. Sydney Tower is also visible (where not partially occluded by vegetation). These views are assessed as having a high value. It is noted however that views from the Hotel Challis rooms does not include viewing of the Opera House or Harbour Bridge.

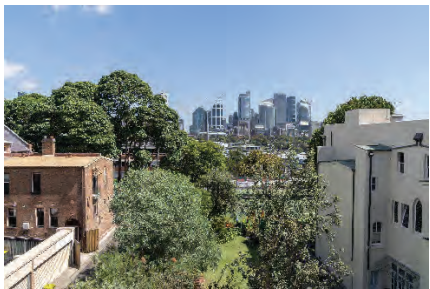
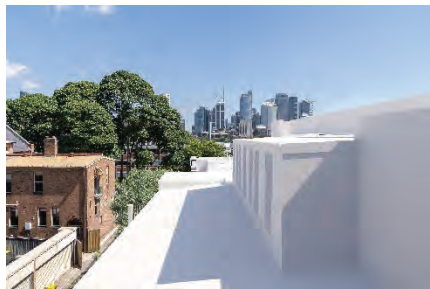
**Table 27** CAM21: Room 412, 21-23 Challis Avenue Potts Point - Level 3 - south end of west facade

Existing view	Compliant LEP/DCP envelope	Proposed development (as revised)

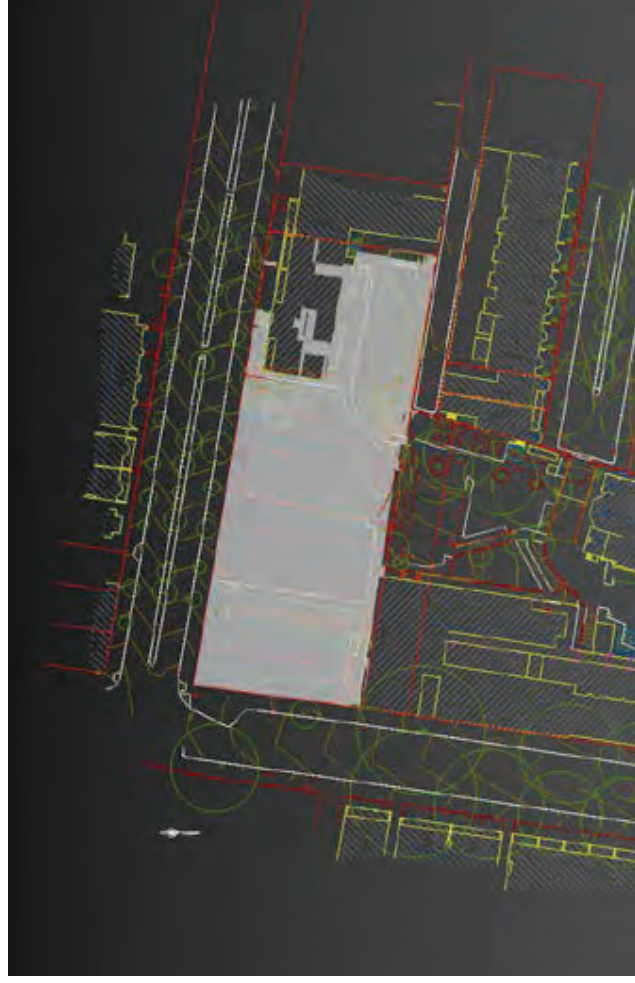
Image showing survey drawing supplied by Project Surveyors at MGA 56 GDA2020 and 3D model of the proposed building (white) supplied by Leaf Architecture aligned to the site boundary

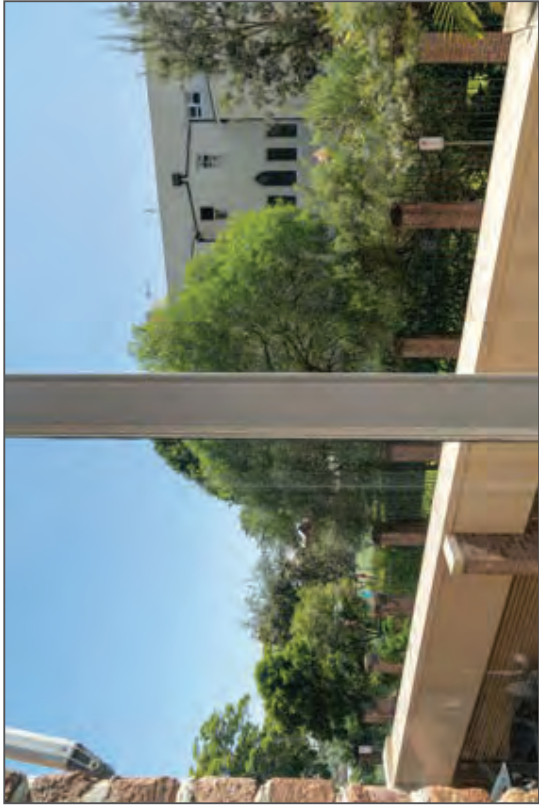
## 5.1 VIEWPOINT POSITION 01 - Unit 2, 6 Rockwall Crescent, Upper Ground Bedroom

PHOTOGRAPH OF CURRENT CONDITION

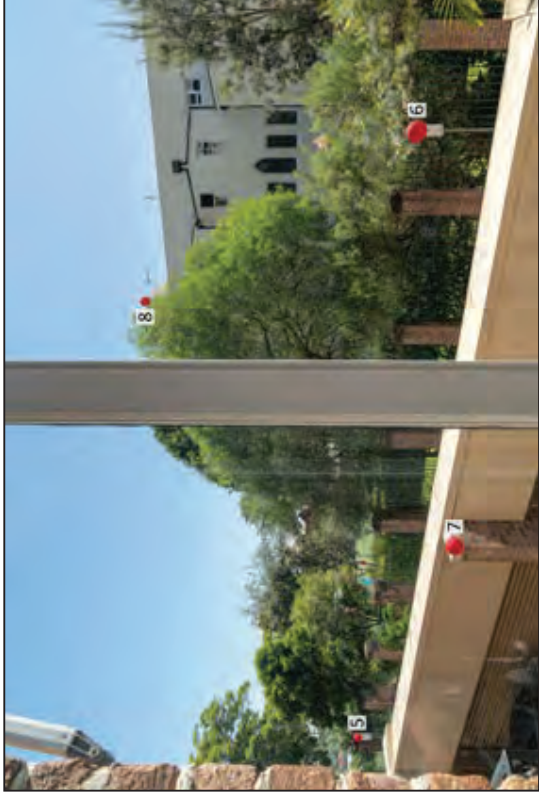
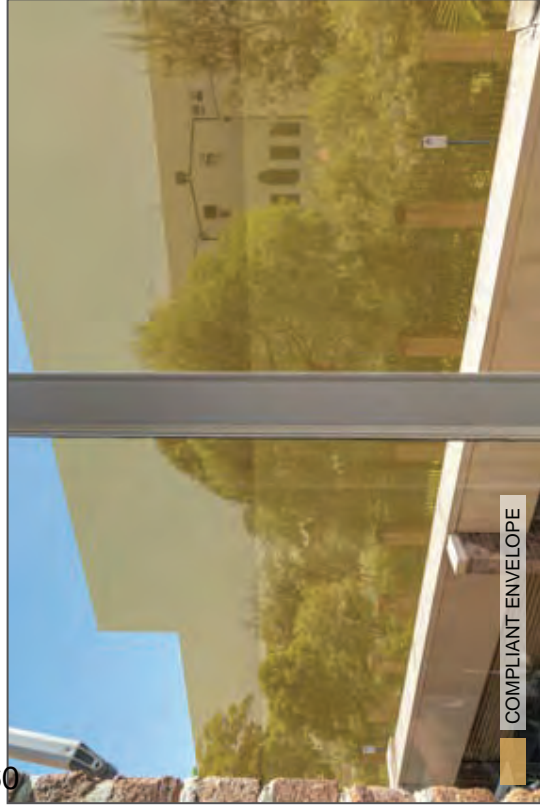
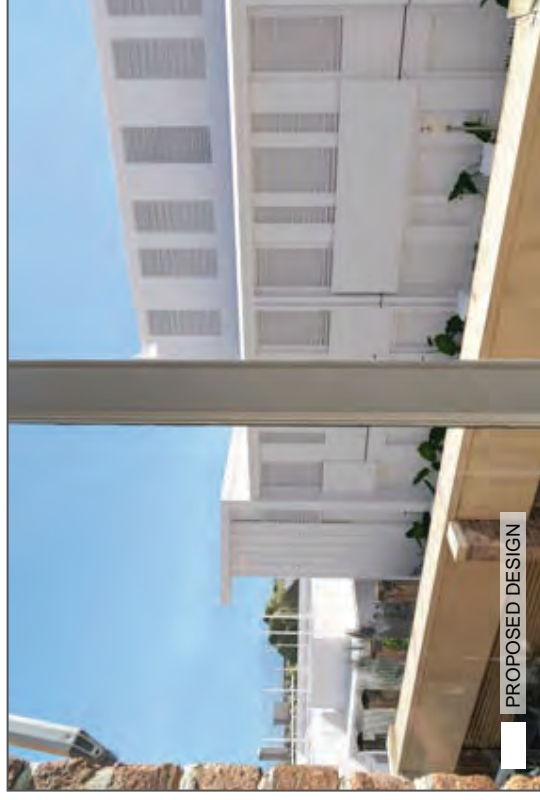
Photo Date:	16 March 2023
Camera Used:	Sony ILCE-7C
Camera Lens:	FE 24-70mm F2.8 GM
Focal length in 35mm Film:	24mm

PHOTOMONTAGE OF COMPLIANT BUILDING ENVELOPE

PHOTOMONTAGE OF PROPOSED BUILDING DESIGN

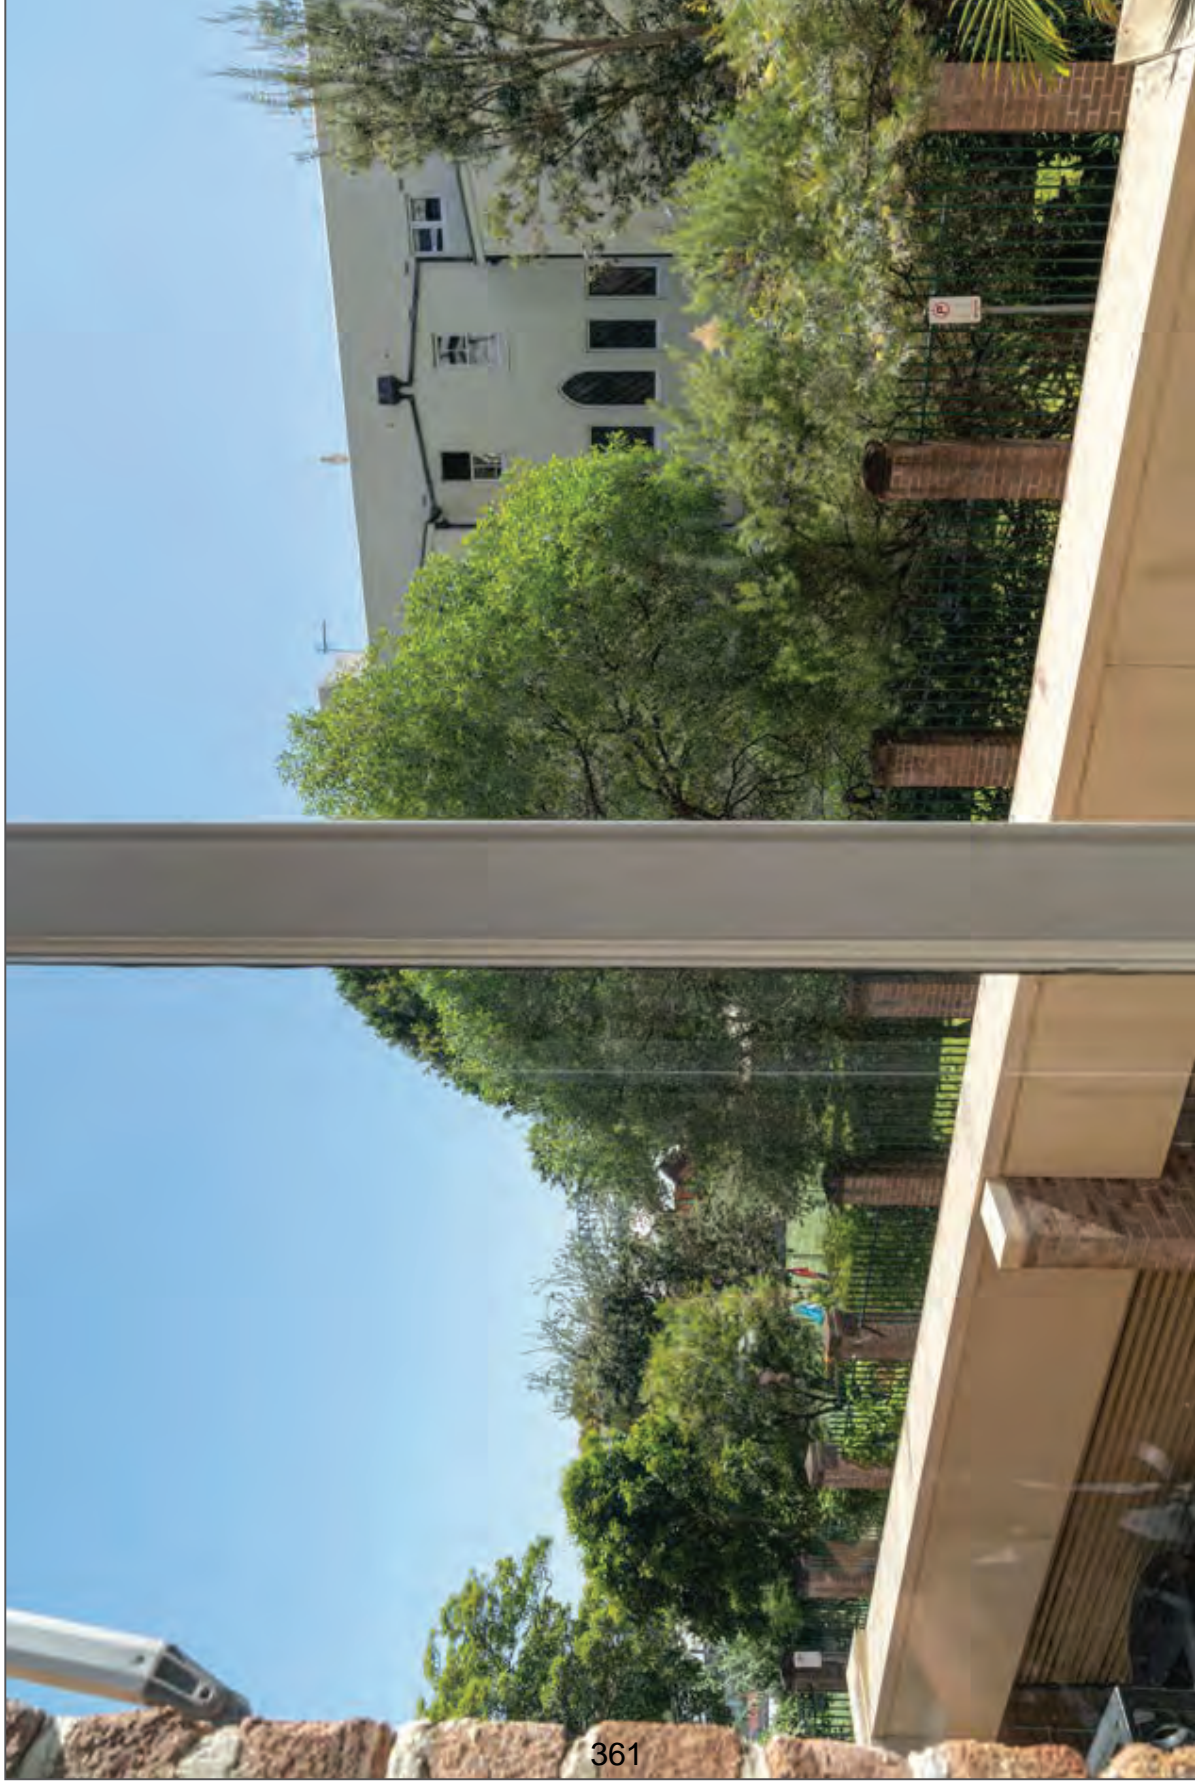
## 5.2 VIEWPOINT POSITION 01 - Unit 2, 6 Rockwall Crescent, Upper Ground Bedroom

PHOTOGRAPH OF CURRENT CONDITION

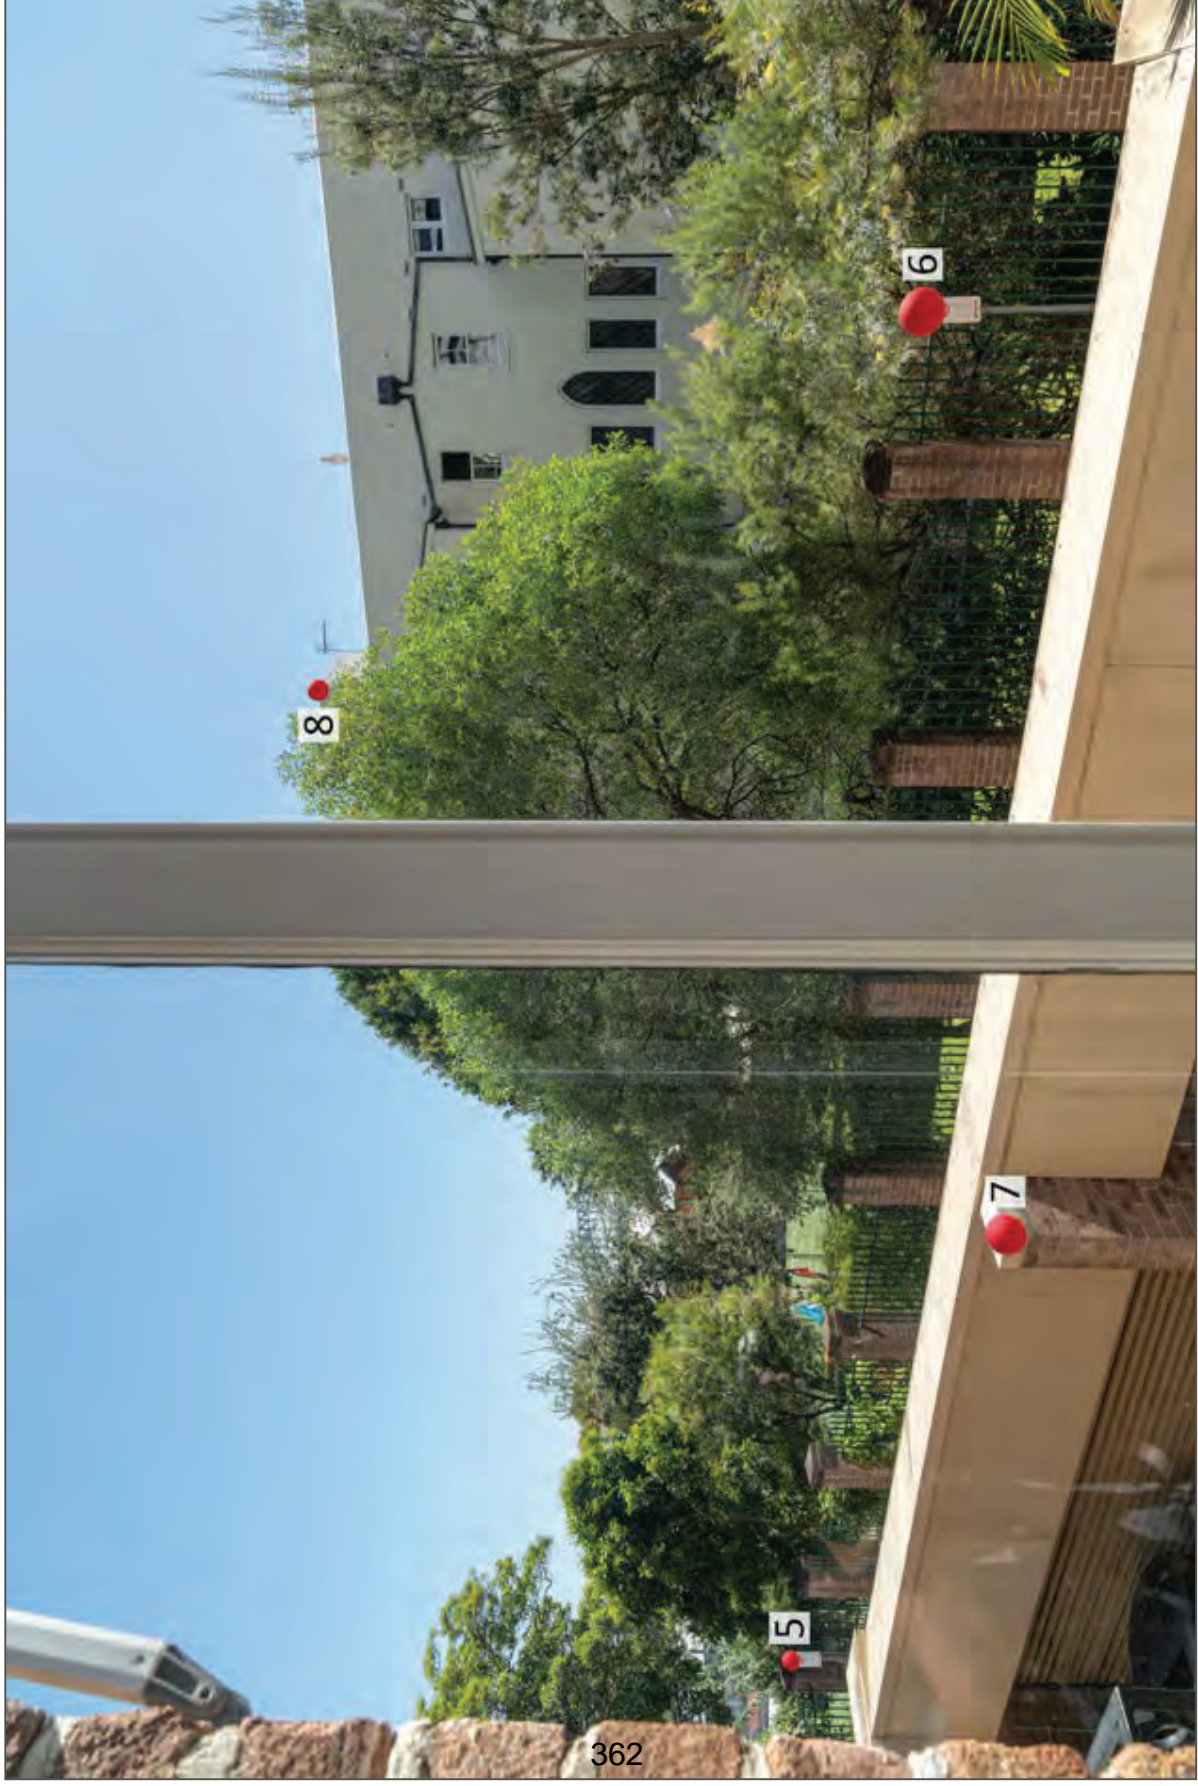
### 5.3 VIEWPOINT POSITION 01 - Unit 2, 6 Rockwall Crescent, Upper Ground Bedroom

OVERLAY OF SURVEY POINTS USED FOR 3D CAMERA ALIGNMENT

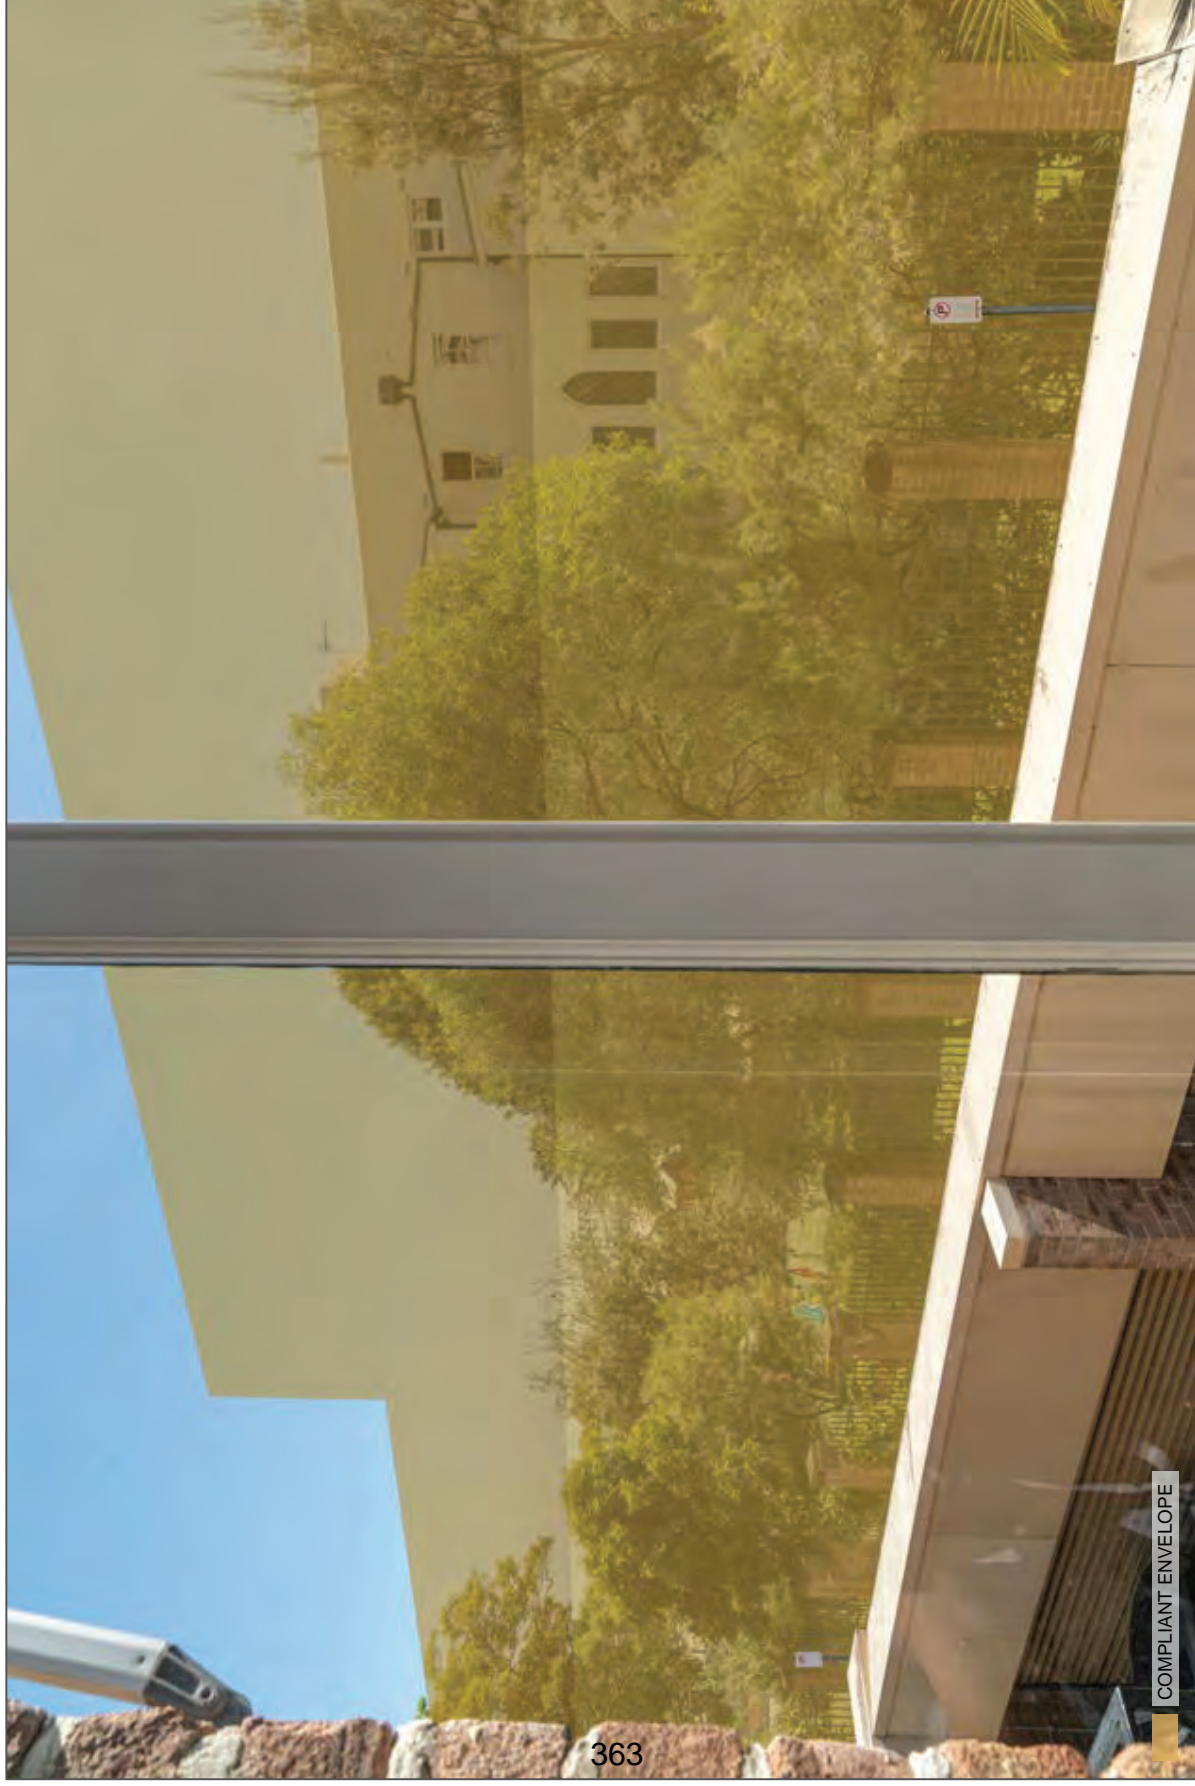
#### 5.4 VIEWPOINT POSITION 01 - Unit 2, 6 Rockwall Crescent, Upper Ground Bedroom

PHOTOMONTAGE OF COMPLIANT BUILDING ENVELOPE
