# View Loss Assessment

Submitted to City of Sydney in response to RFI dated 31 July 2024

St Vincent's College, 1 Challis Avenue, Potts Point  
The Trustees of the Sisters of Charity of Australia

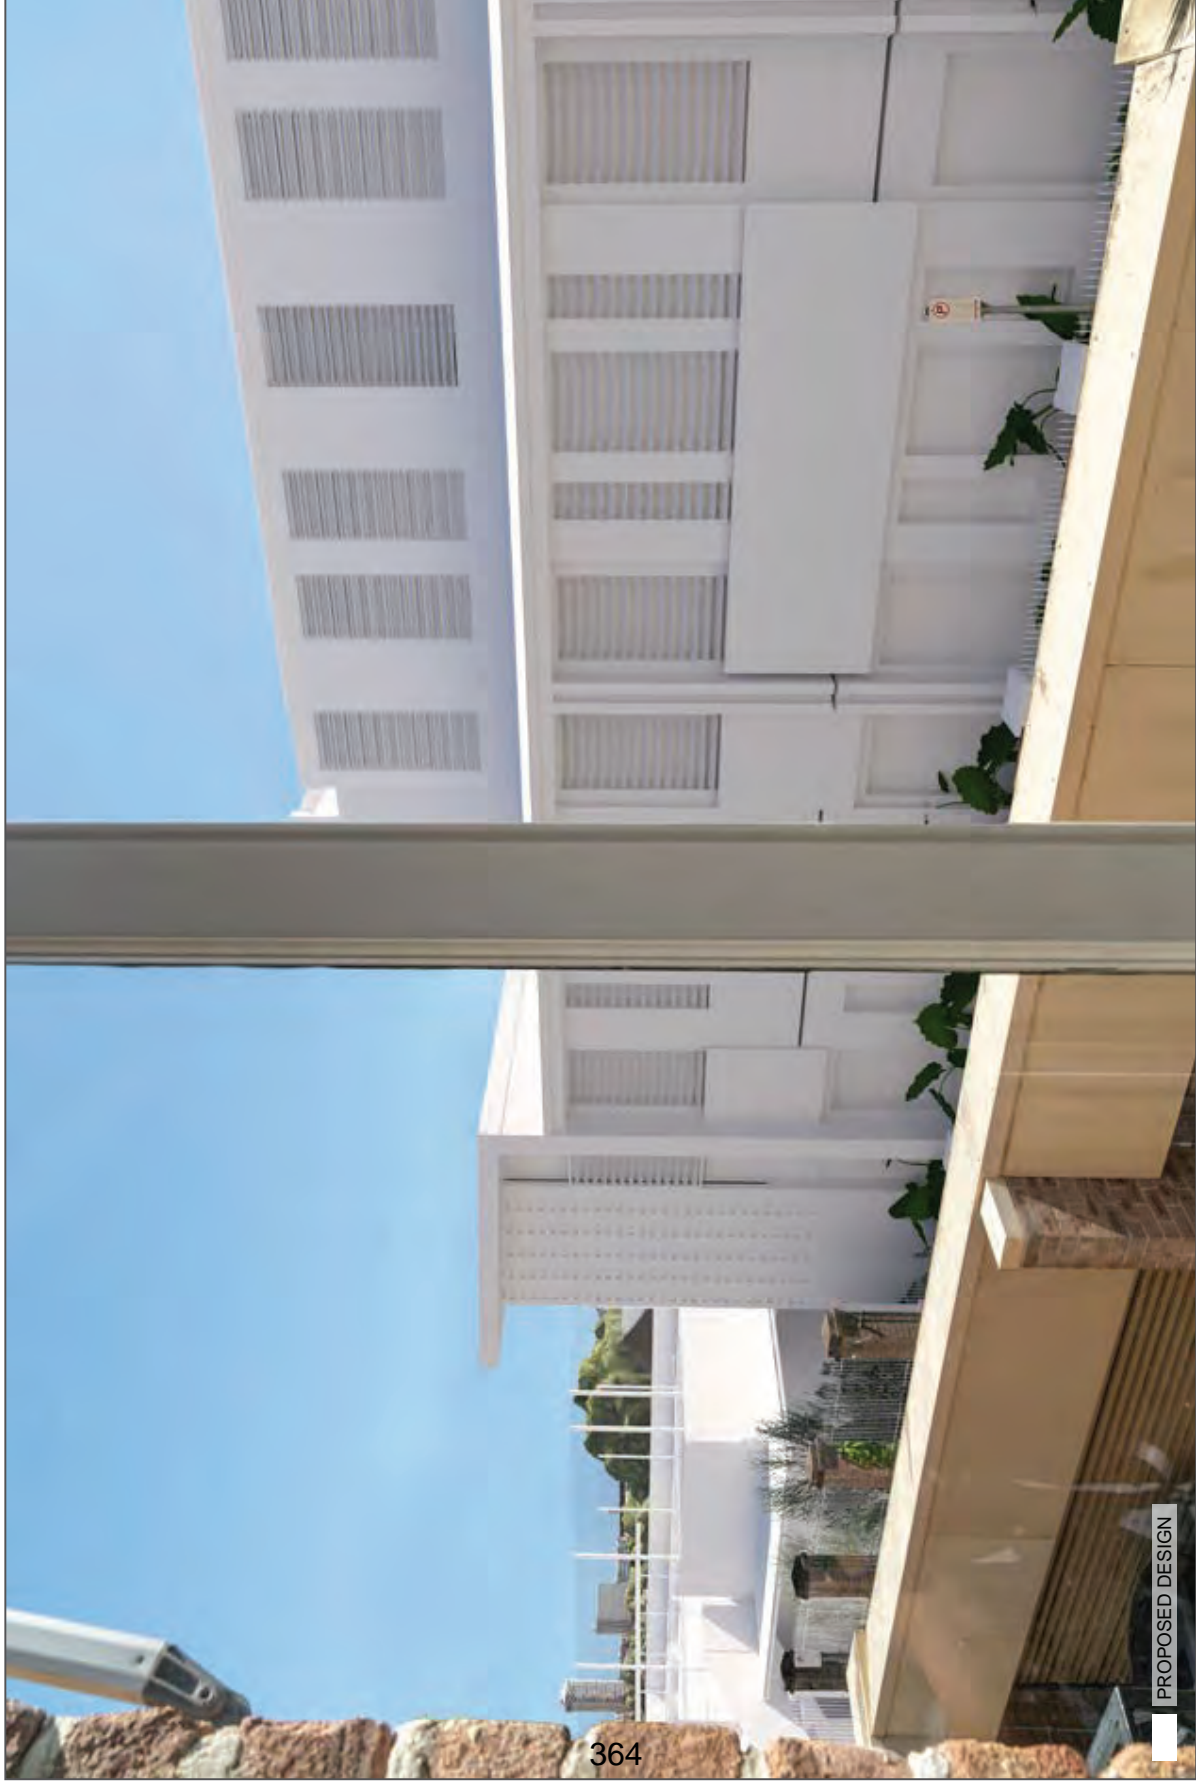
## 5.5 VIEWPOINT POSITION 01 - Unit 2, 6 Rockwall Crescent, Upper Ground Bedroom

PHOTOMONTAGE OF PROPOSED BUILDING DESIGN

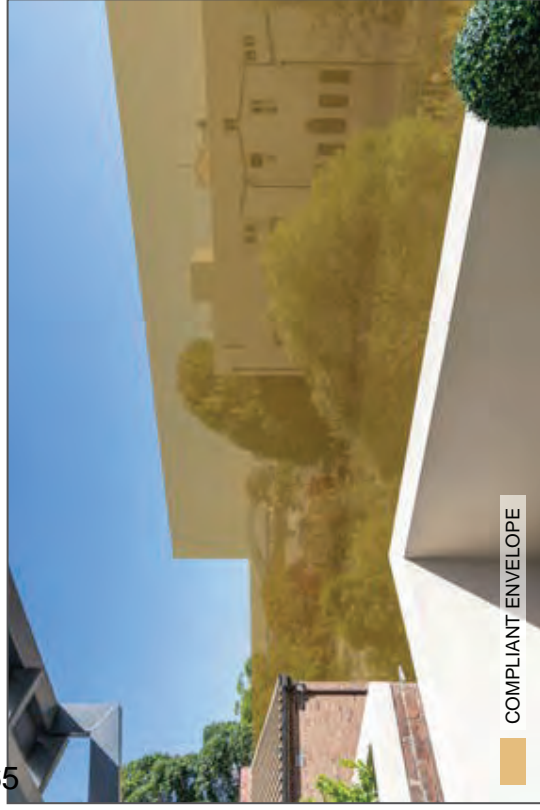
PHOTOMONTAGE OF COMPLIANT BUILDING ENVELOPE

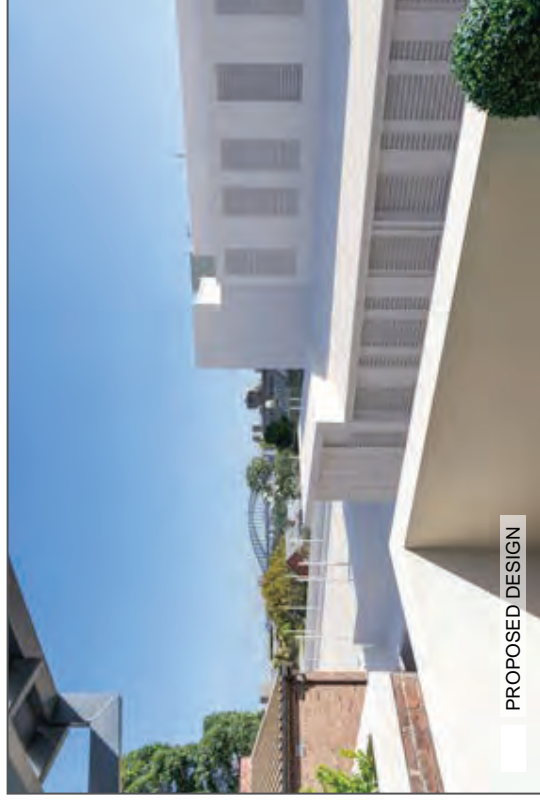
PHOTOMONTAGE OF PROPOSED BUILDING DESIGN

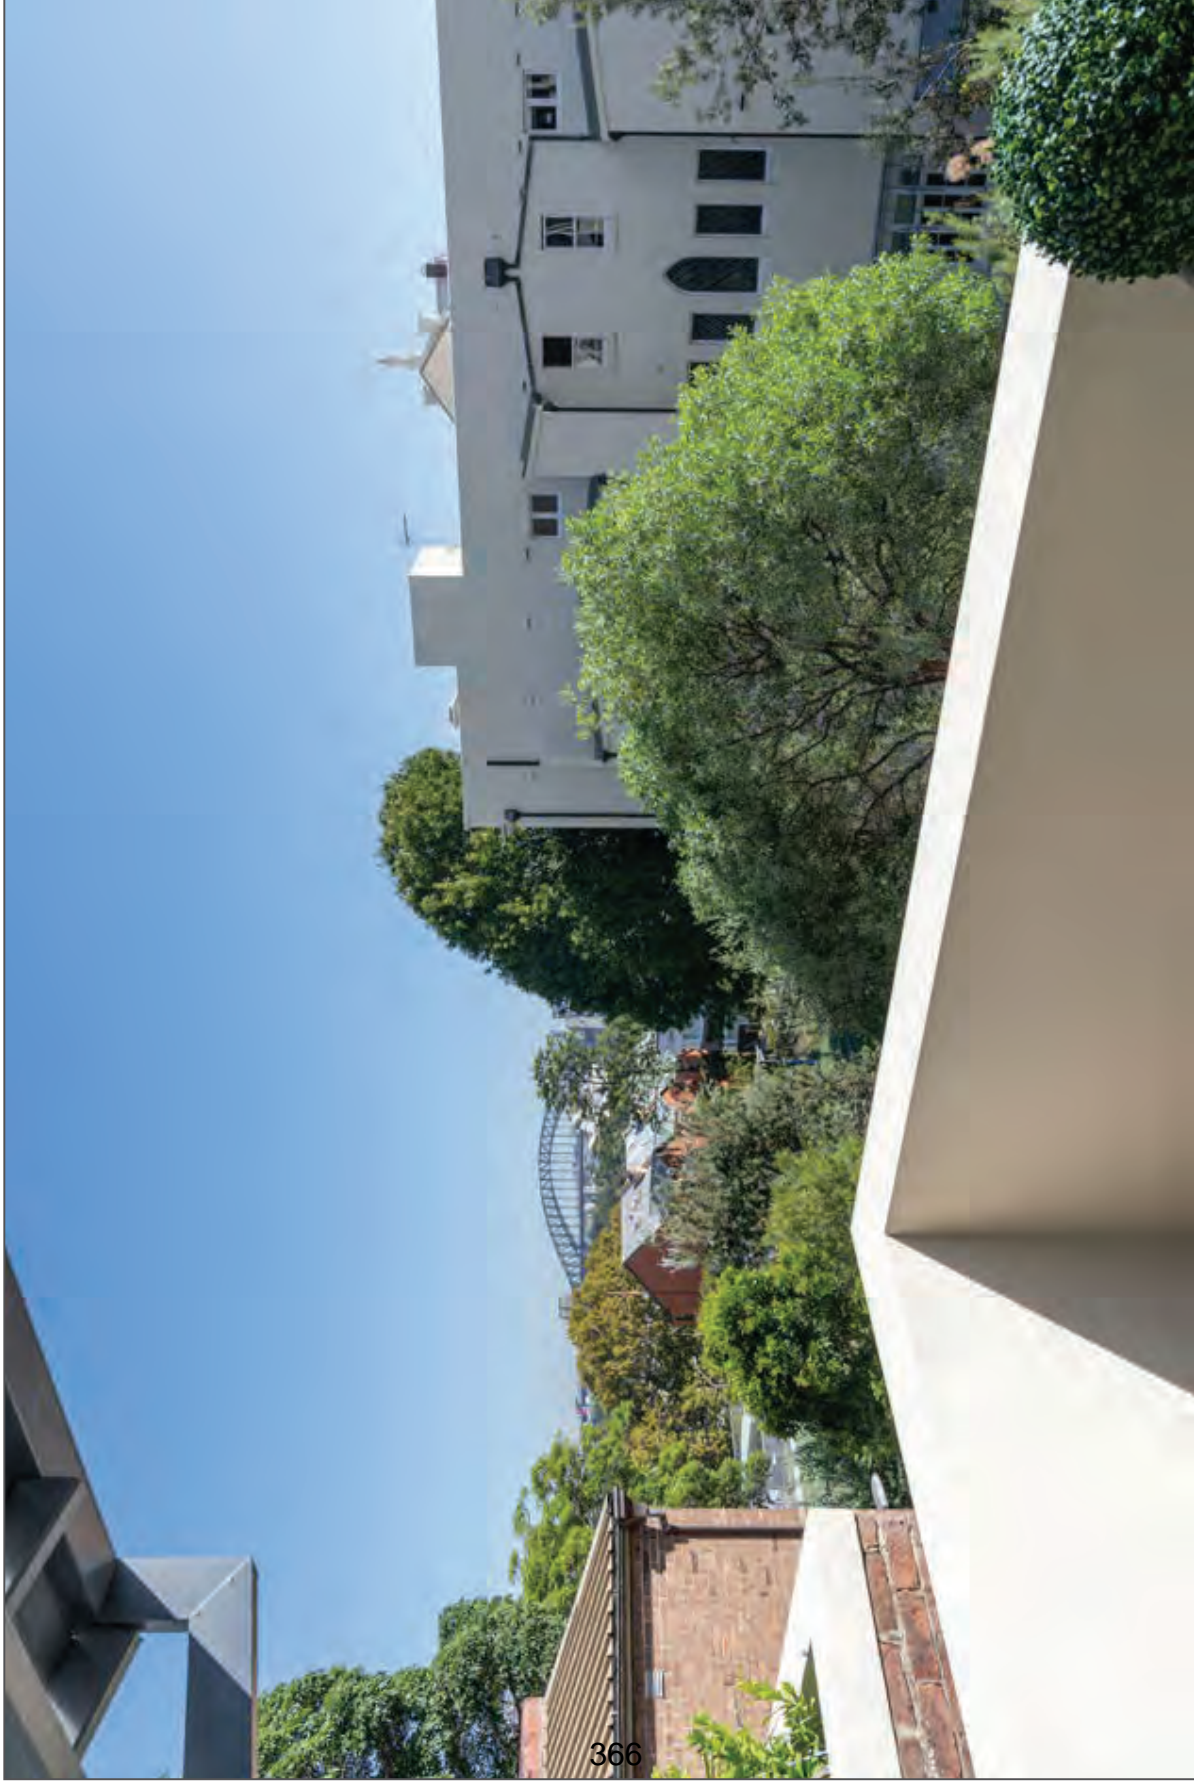
**6.2 VIEWPOINT POSITION 02 - Unit 3, 6 Rockwall Crescent, Level 1 Terrace**

**PHOTOGRAPH OF CURRENT CONDITION**

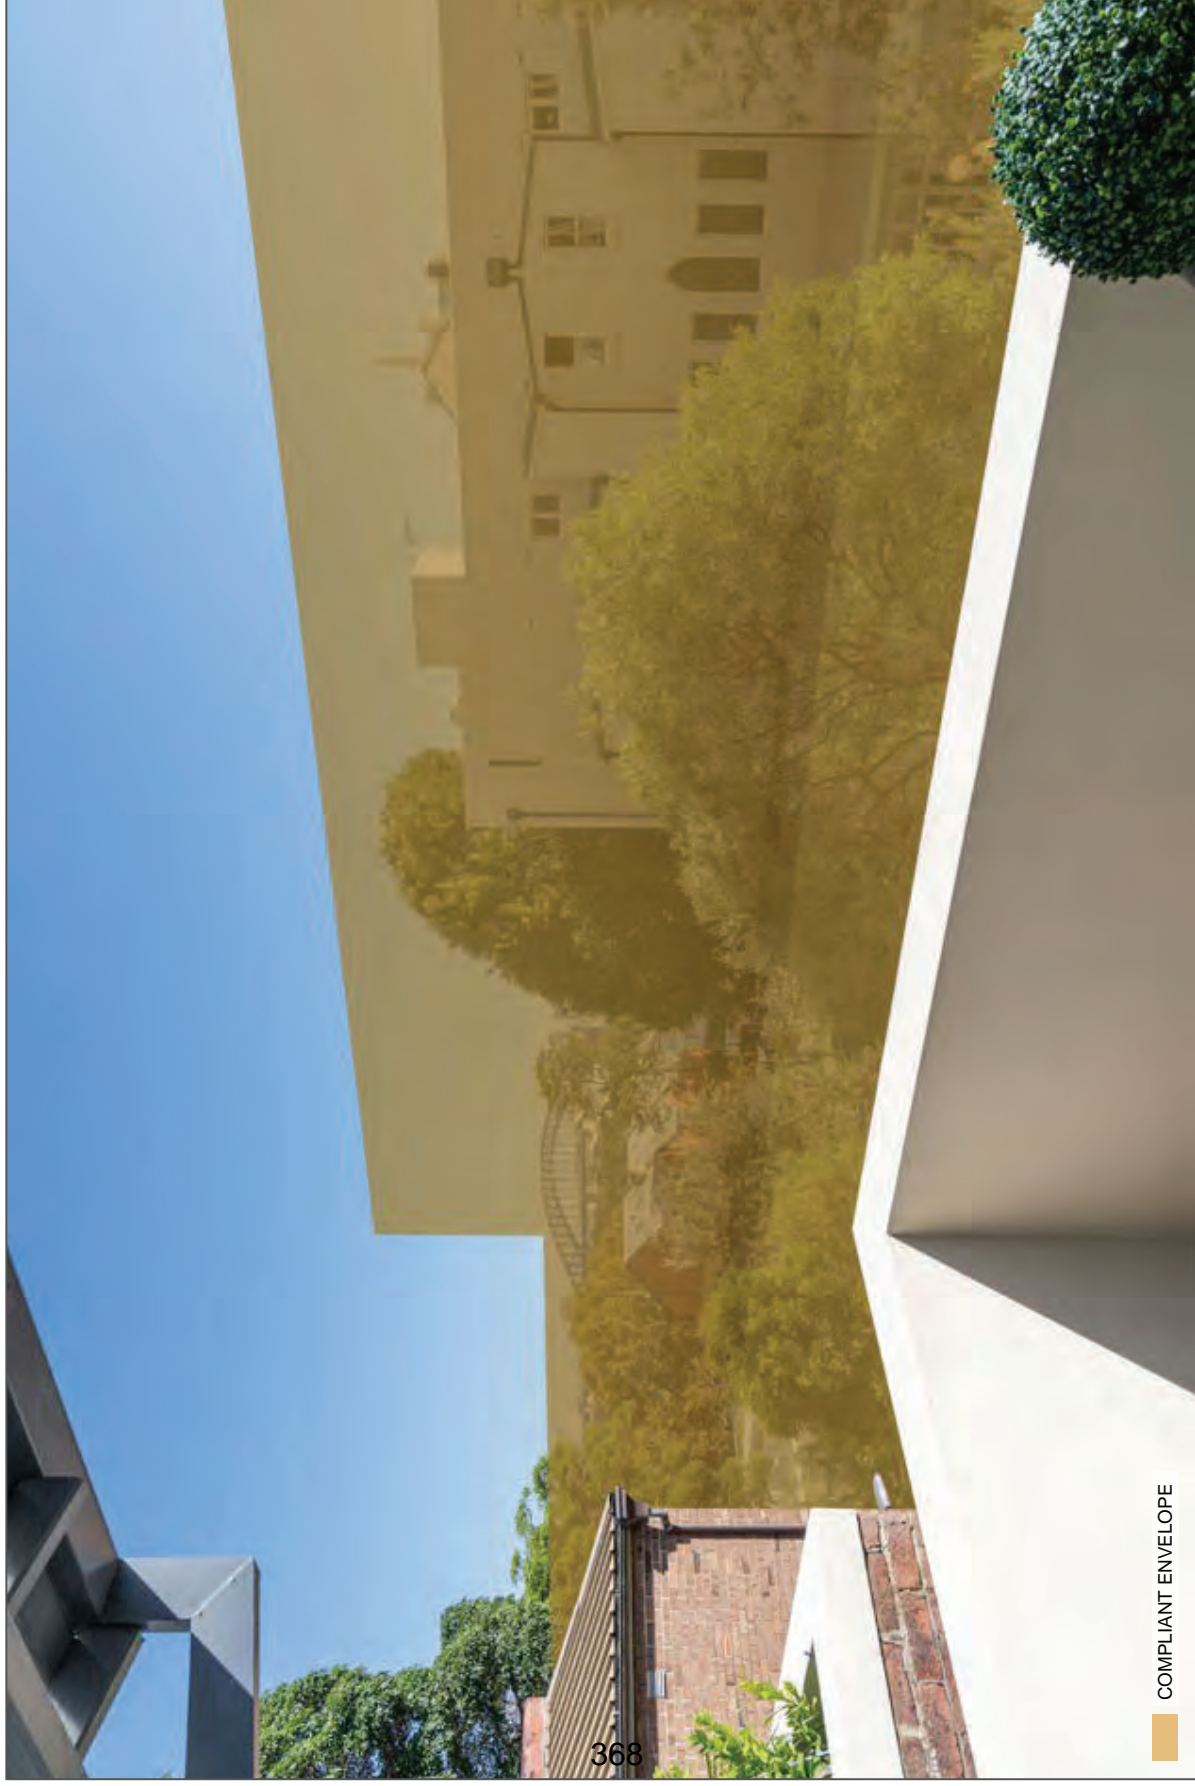
## 6.4 VIEWPOINT POSITION 02 - Unit 3, 6 Rockwall Crescent, Level 1 Terrace

PHOTOMONTAGE OF COMPLIANT BUILDING ENVELOPE

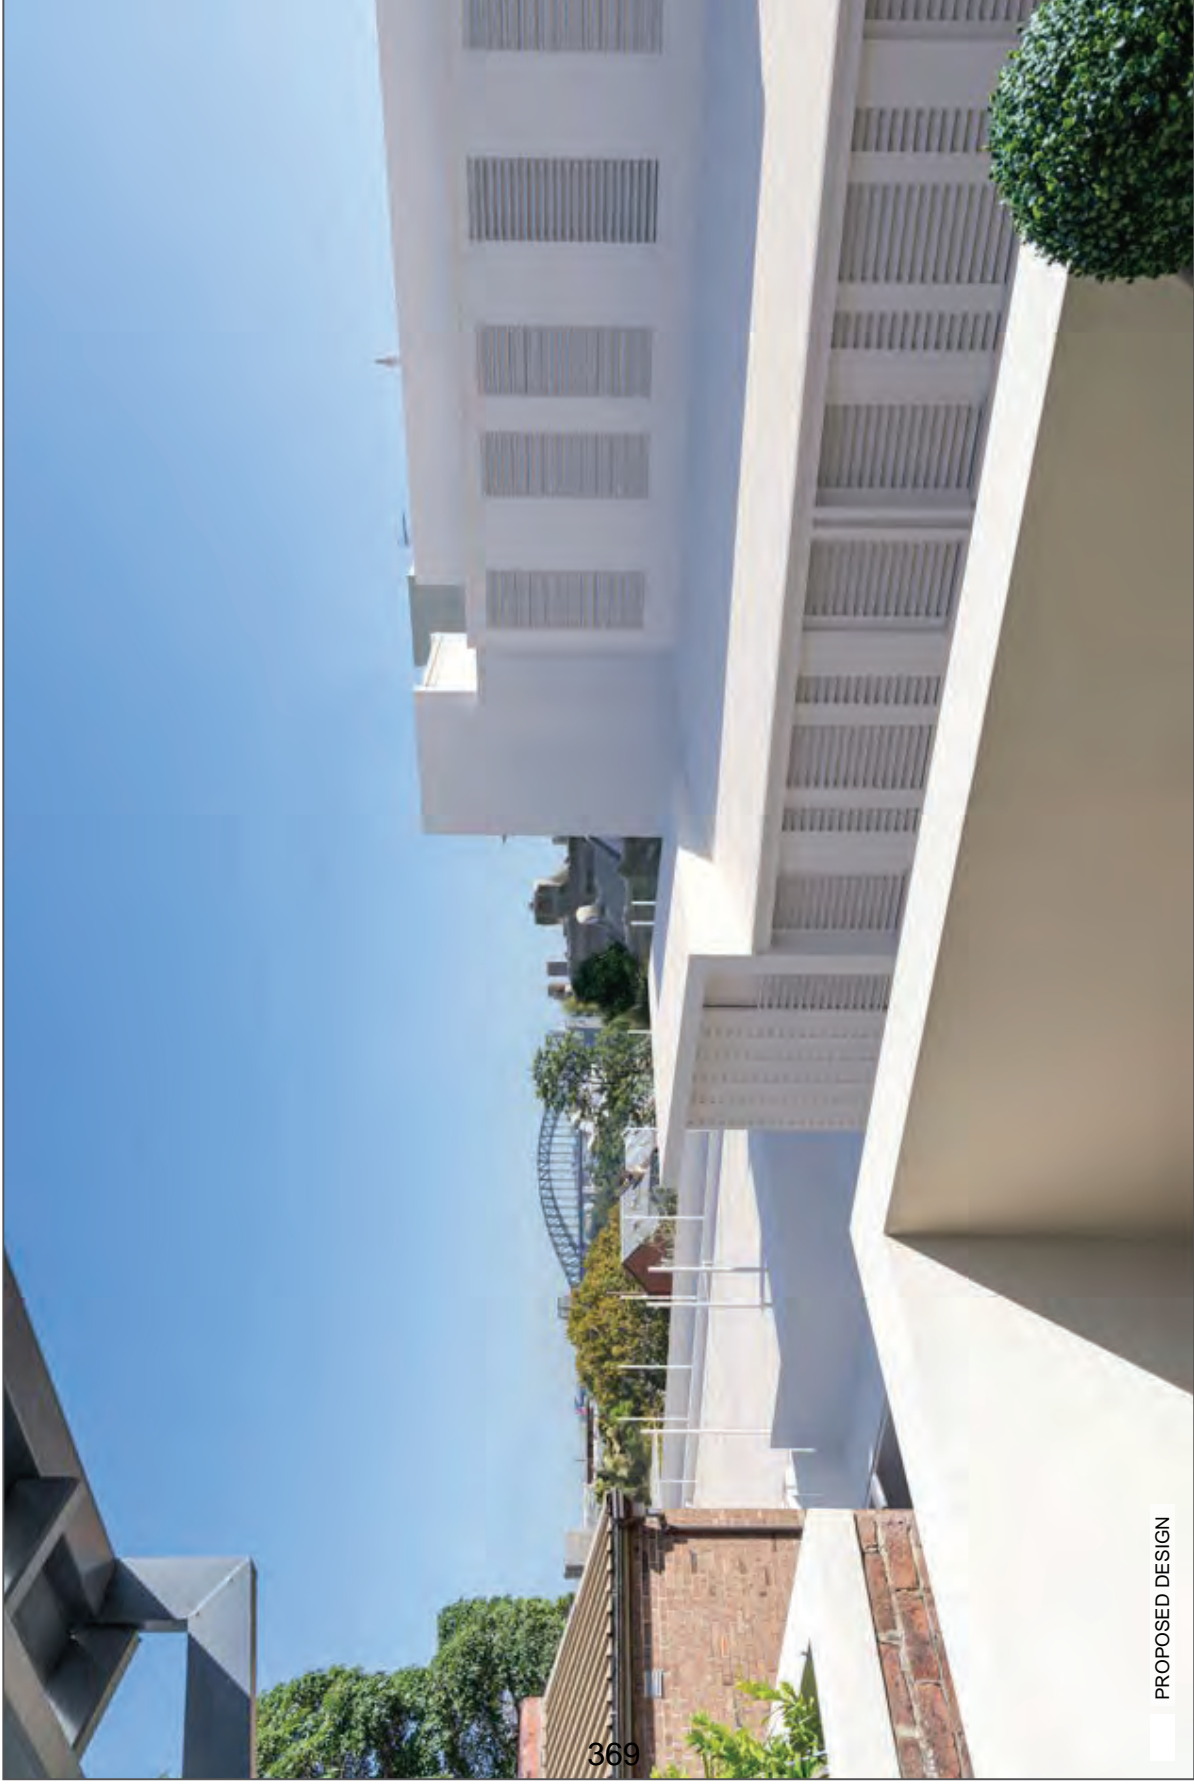
## 6.5 VIEWPOINT POSITION 02 - Unit 3, 6 Rockwall Crescent, Level 1 Terrace

PHOTOMONTAGE OF PROPOSED BUILDING DESIGN

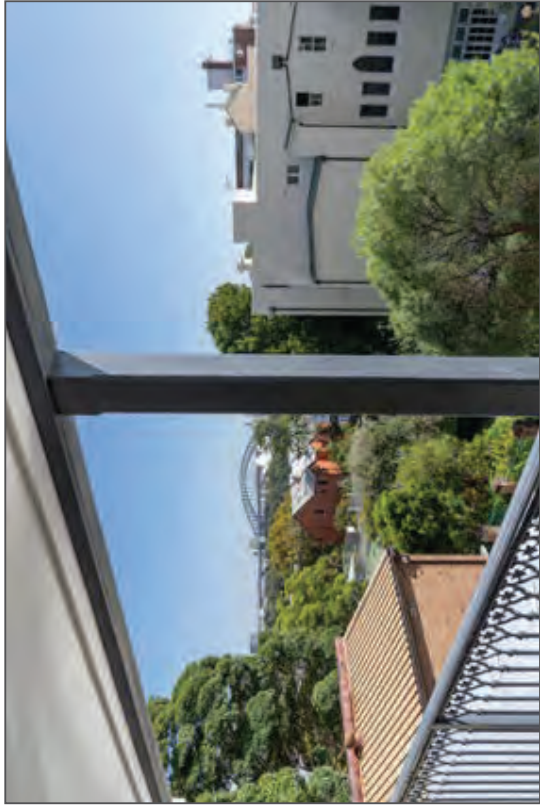
## 7.1 VIEWPOINT POSITION 03 - Unit 3, 6 Rockwall Crescent, Level 2 Balcony

PHOTOGRAPH OF CURRENT CONDITION

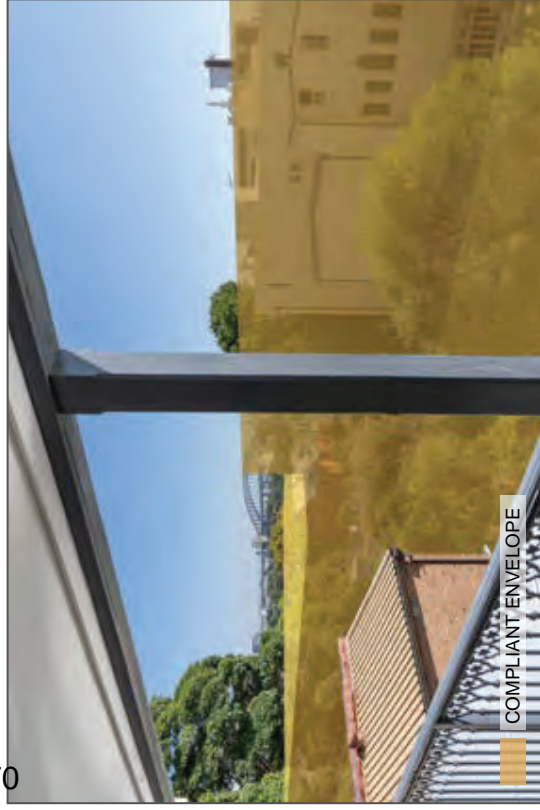
PHOTOMONTAGE OF COMPLIANT BUILDING ENVELOPE

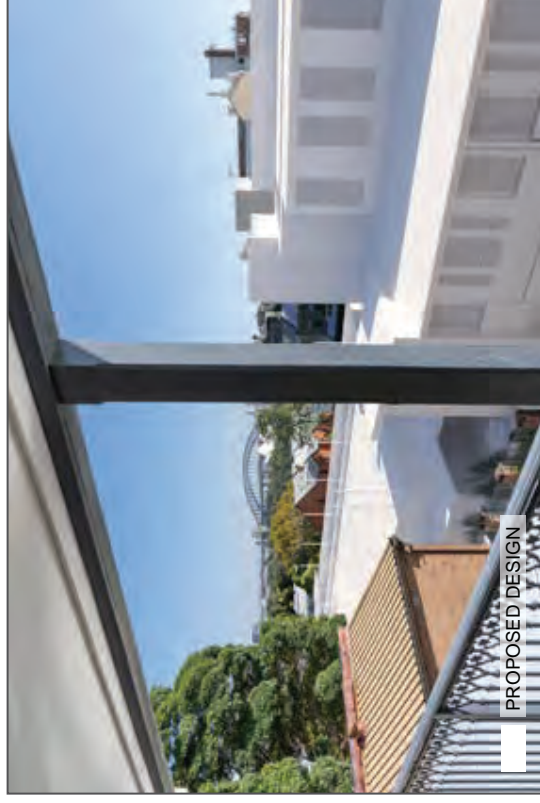
PHOTOMONTAGE OF PROPOSED BUILDING DESIGN

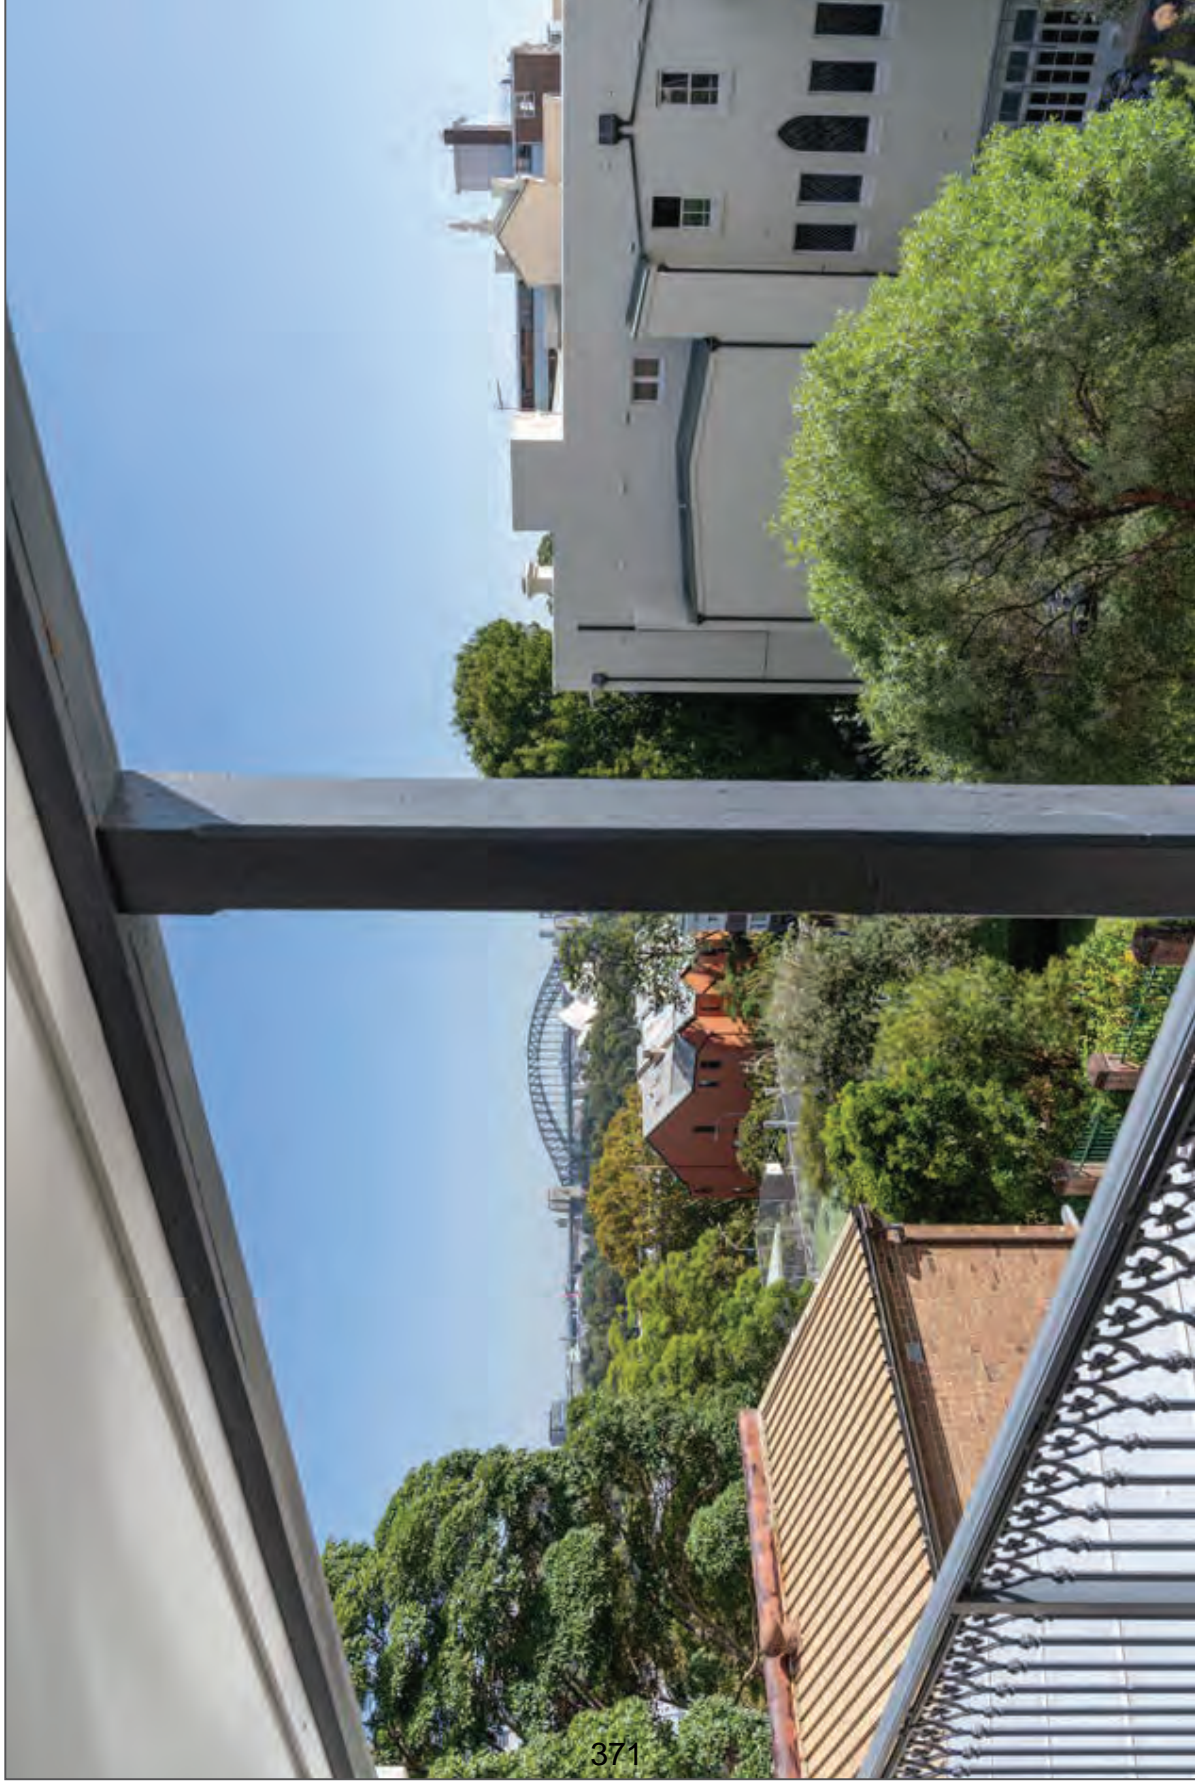
**7.2 VIEWPOINT POSITION 03 - Unit 3, 6 Rockwall Crescent, Level 2 Balcony**

**PHOTOGRAPH OF CURRENT CONDITION**

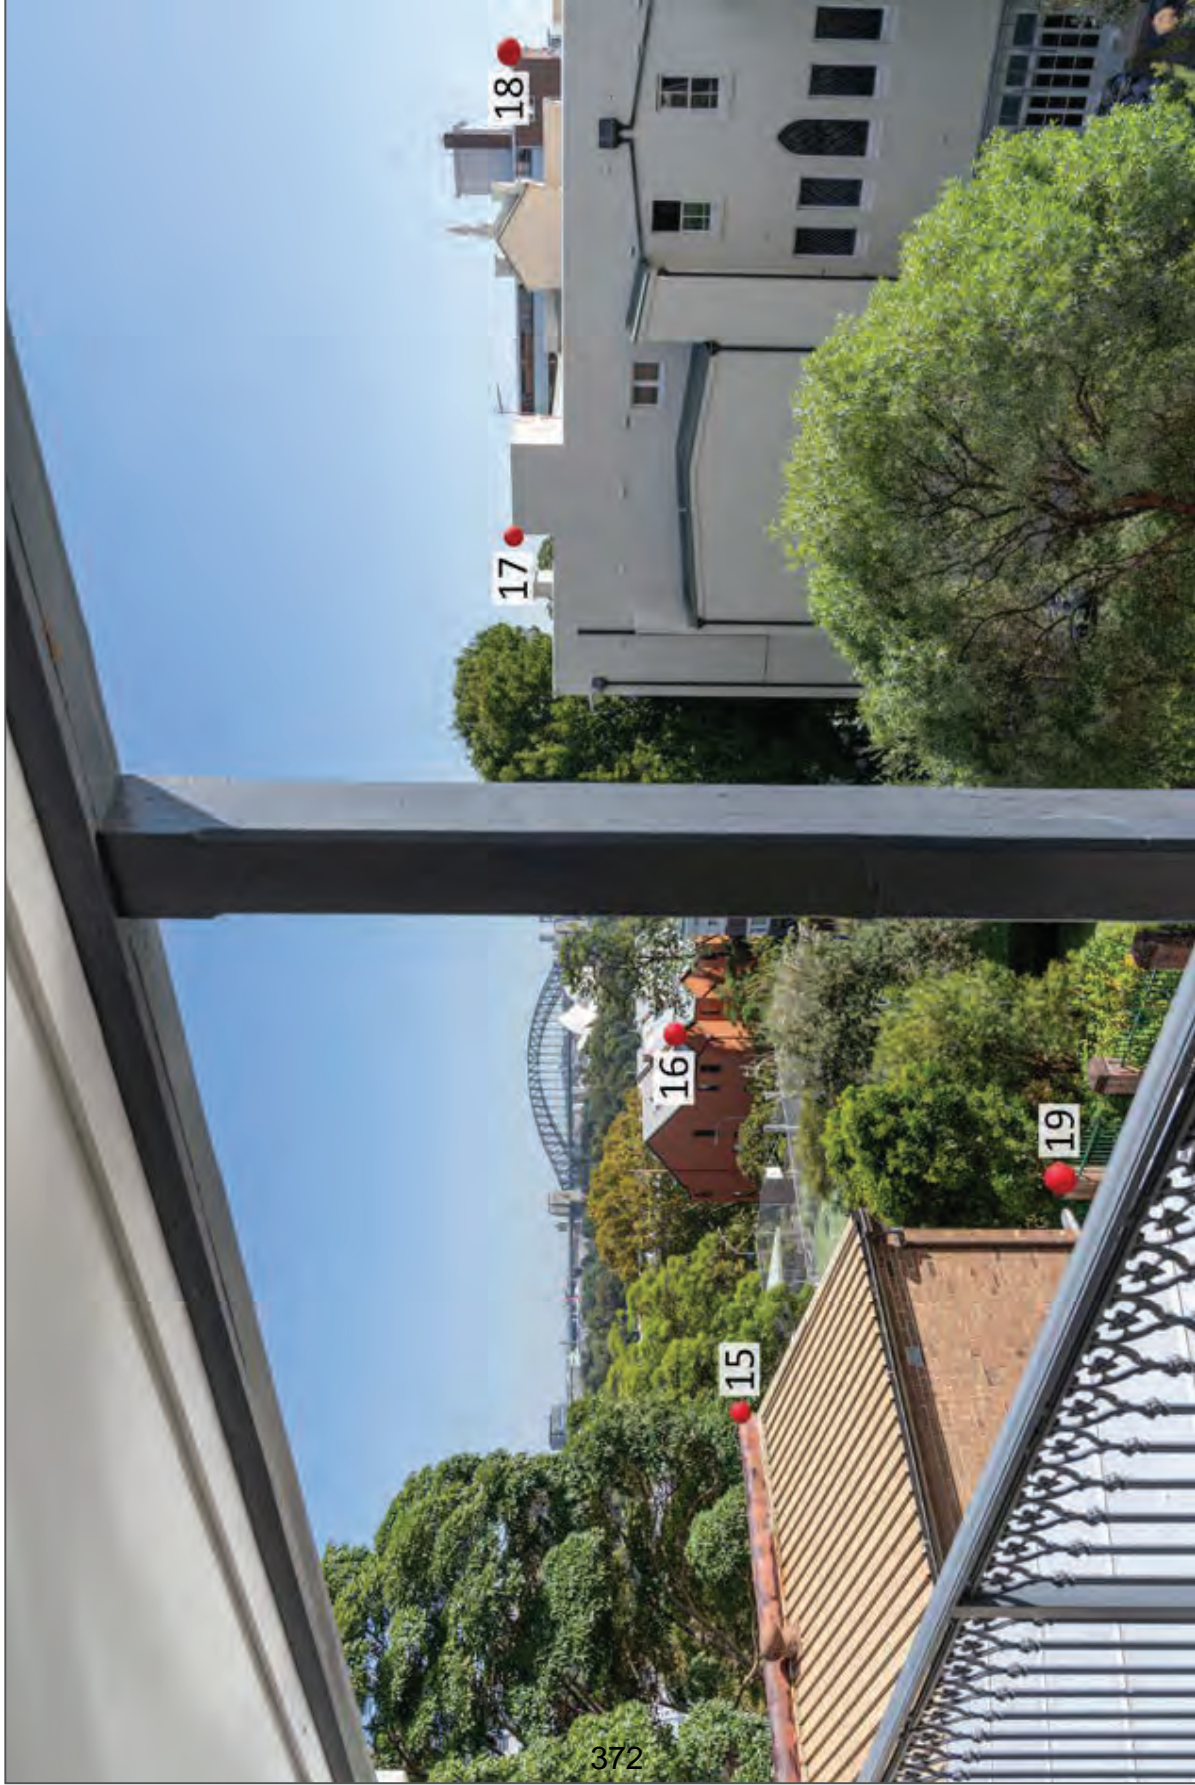
### 7.3 VIEWPOINT POSITION 03 - Unit 3, 6 Rockwall Crescent, Level 2 Balcony

OVERLAY OF SURVEY POINTS USED FOR 3D CAMERA ALIGNMENT

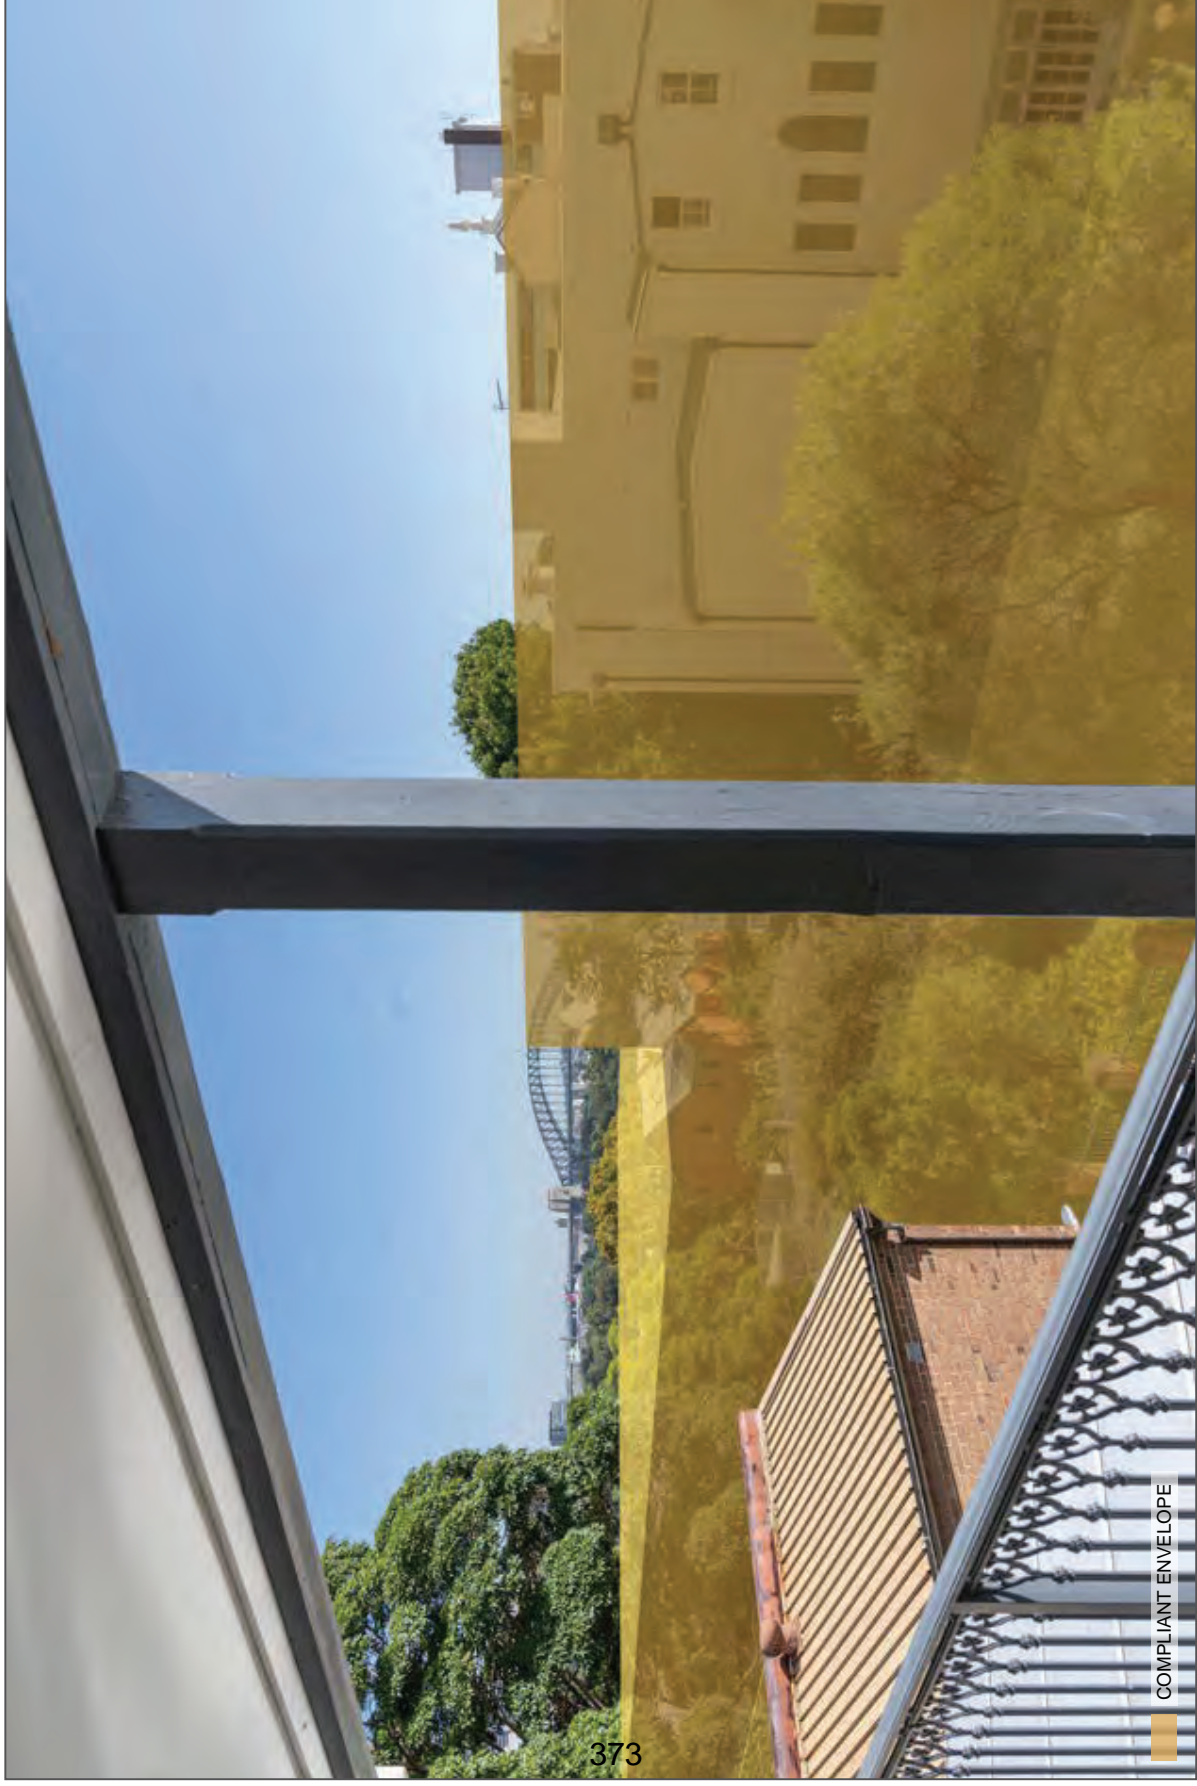
### 7.4 VIEWPOINT POSITION 03 - Unit 3, 6 Rockwall Crescent, Level 2 Balcony

PHOTOMONTAGE OF COMPLIANT BUILDING ENVELOPE

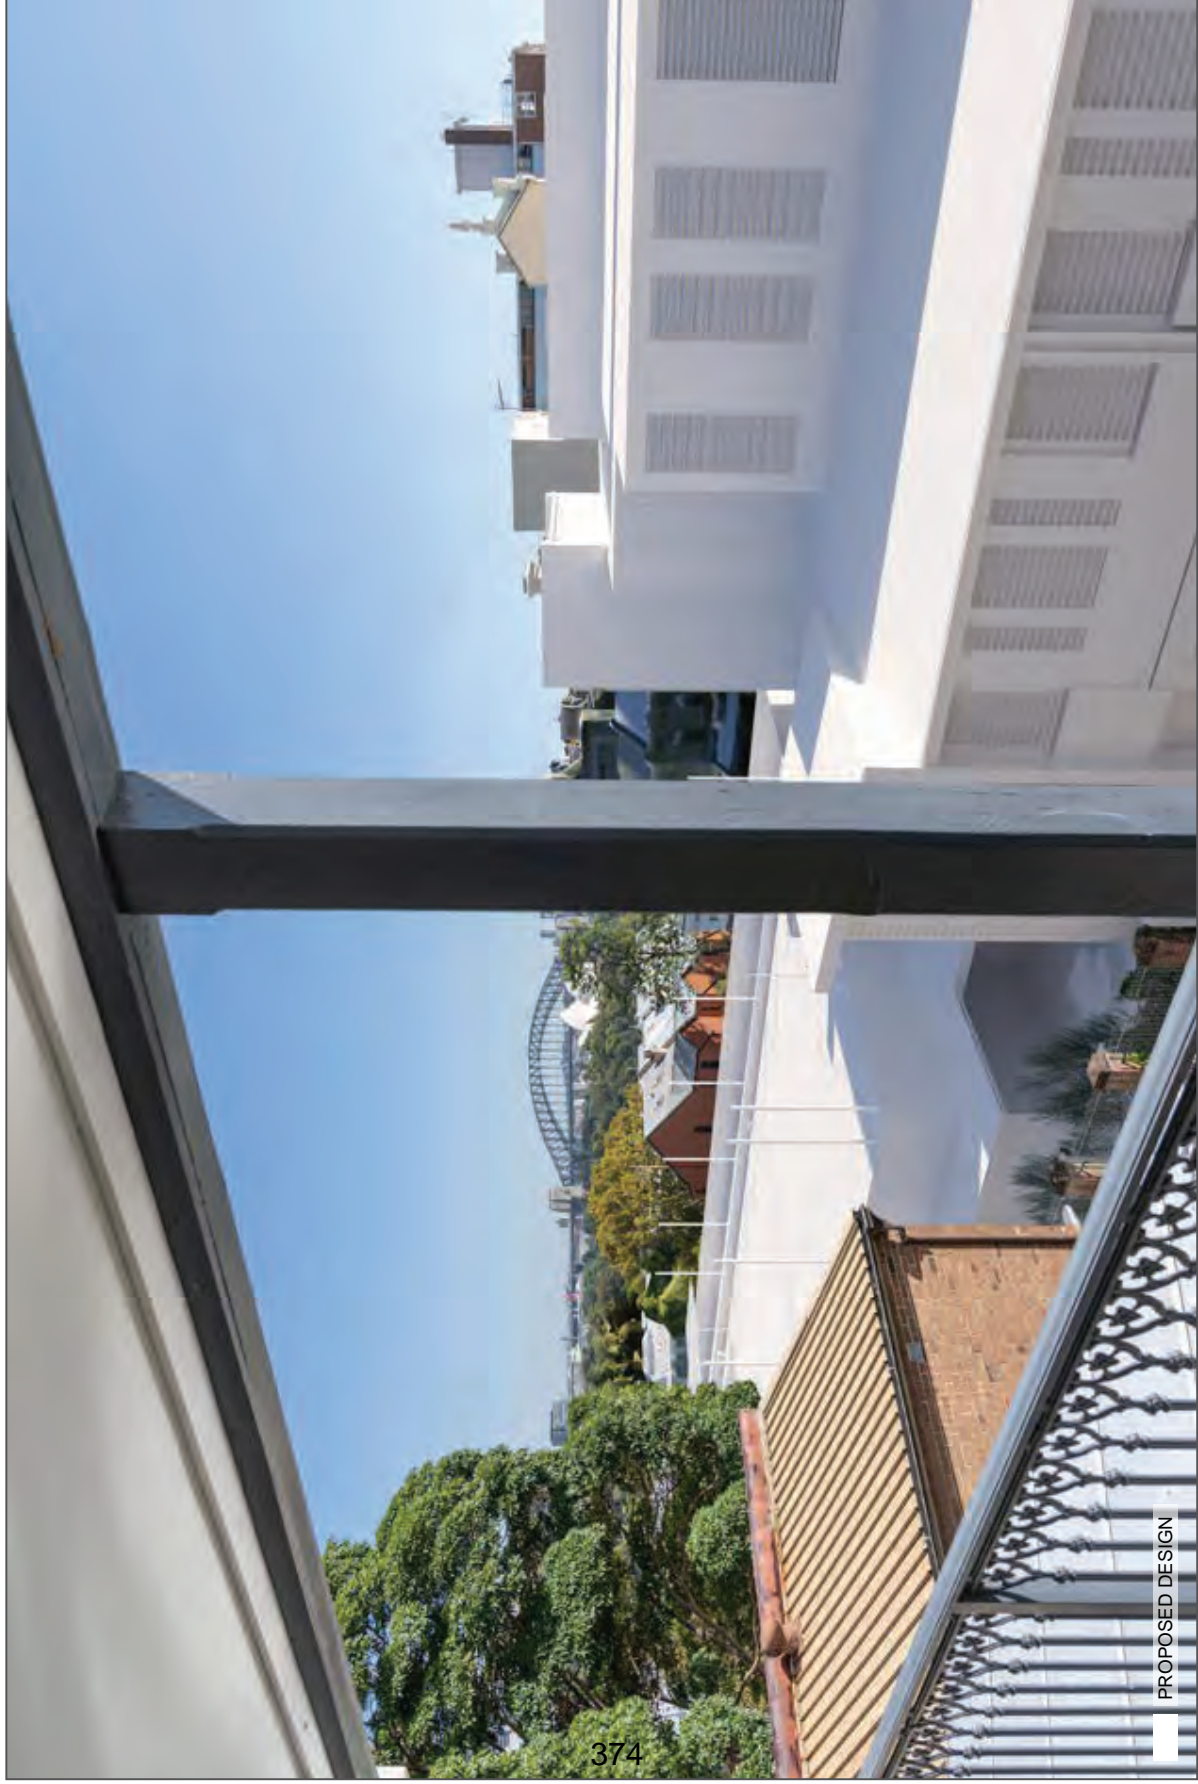
### 7.5 VIEWPOINT POSITION 03 - Unit 3, 6 Rockwall Crescent, Level 2 Balcony

PHOTOMONTAGE OF PROPOSED BUILDING DESIGN

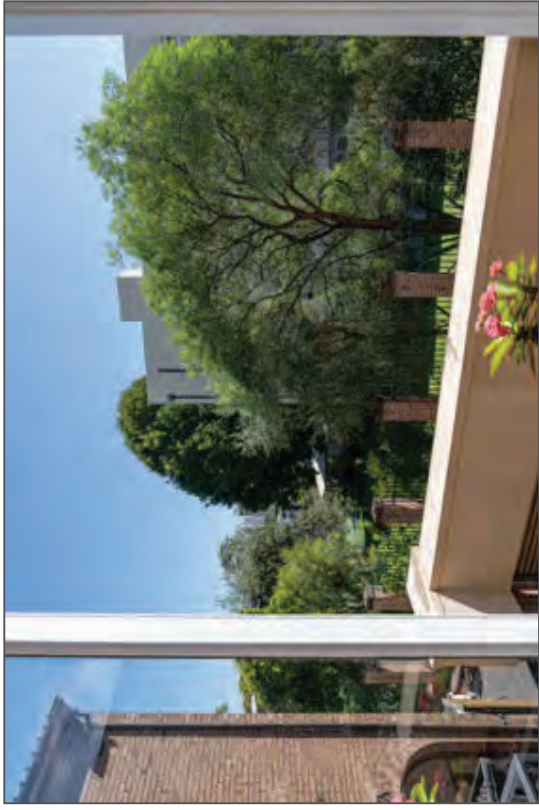
## 8.1 VIEWPOINT POSITION 04 - Unit 5, 6 Rockwall Crescent, Upper Ground Bedroom

PHOTOGRAPH OF CURRENT CONDITION

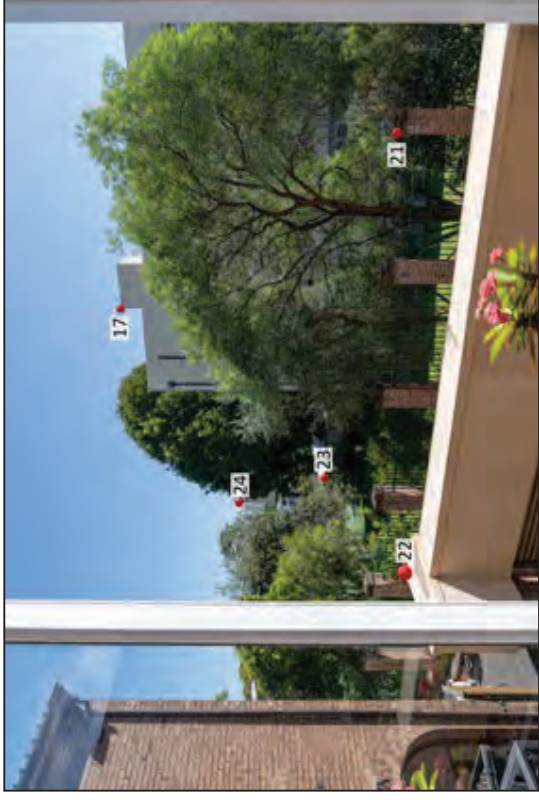
SURVEY POINTS USED FOR 3D CAMERA ALIGNMENT

Photo Date:	16 March 2023
Camera Used:	Sony ILCE-7C
Camera Lens:	FE 24-70mm F2.8 GM
Focal length in 35mm Film:	24mm

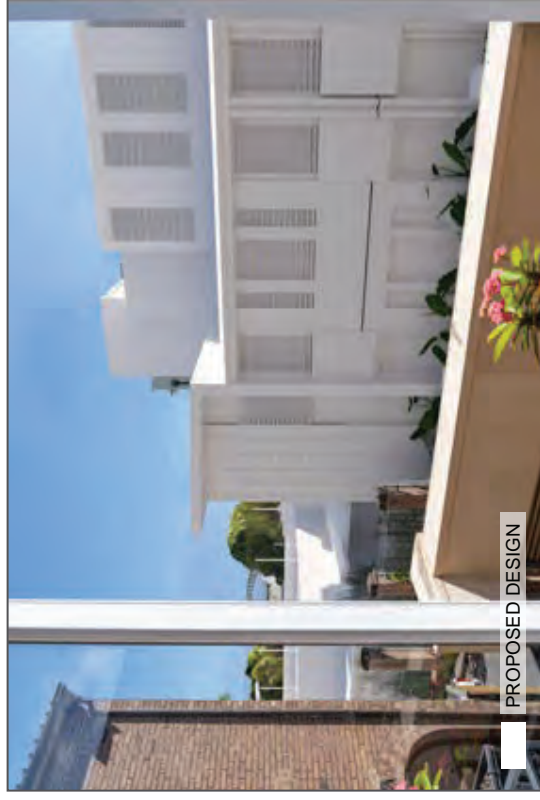
PHOTOMONTAGE OF PROPOSED BUILDING DESIGN

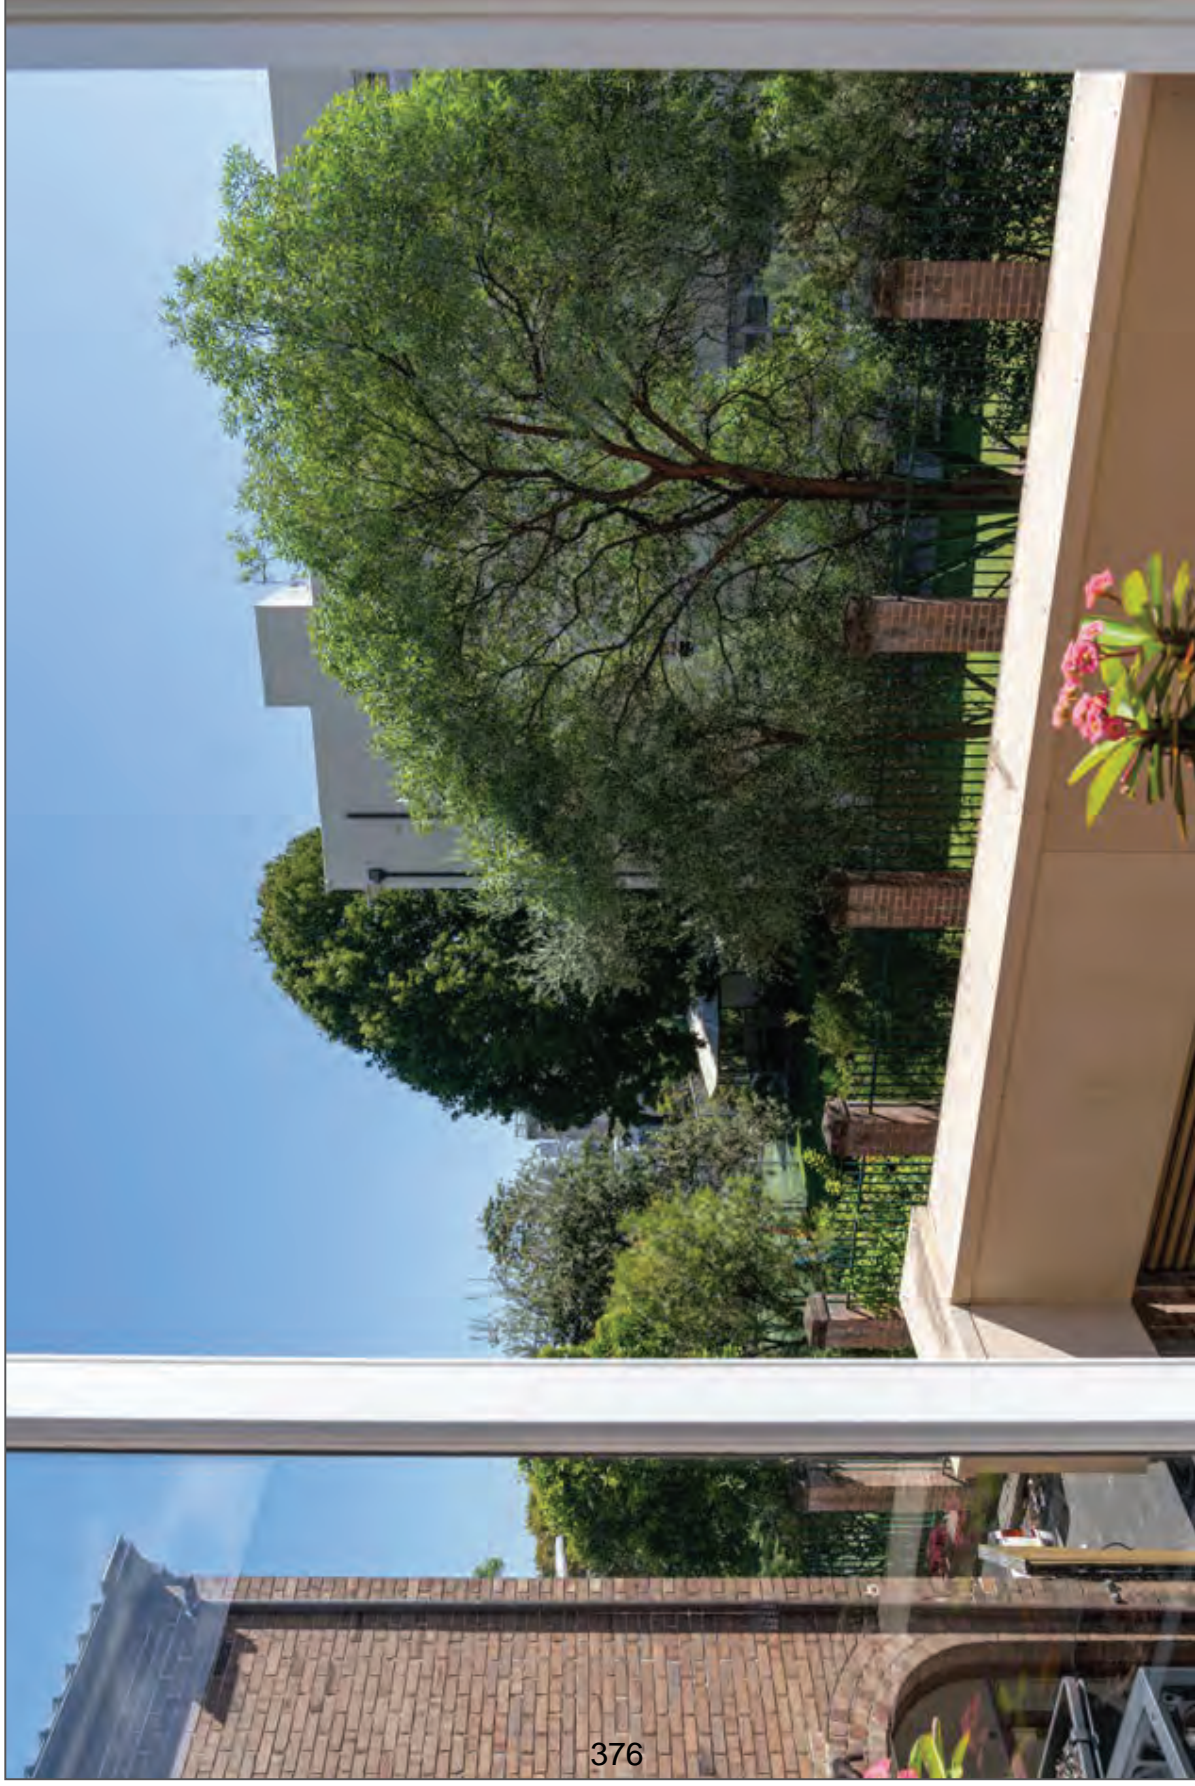
## 8.2 VIEWPOINT POSITION 04 - Unit 5, 6 Rockwall Crescent, Upper Ground Bedroom

PHOTOGRAPH OF CURRENT CONDITION
