# View Loss Assessment

Submitted to City of Sydney in response to RFI dated 31 July 2024

St Vincent's College, 1 Challis Avenue, Potts Point  
The Trustees of the Sisters of Charity of Australia

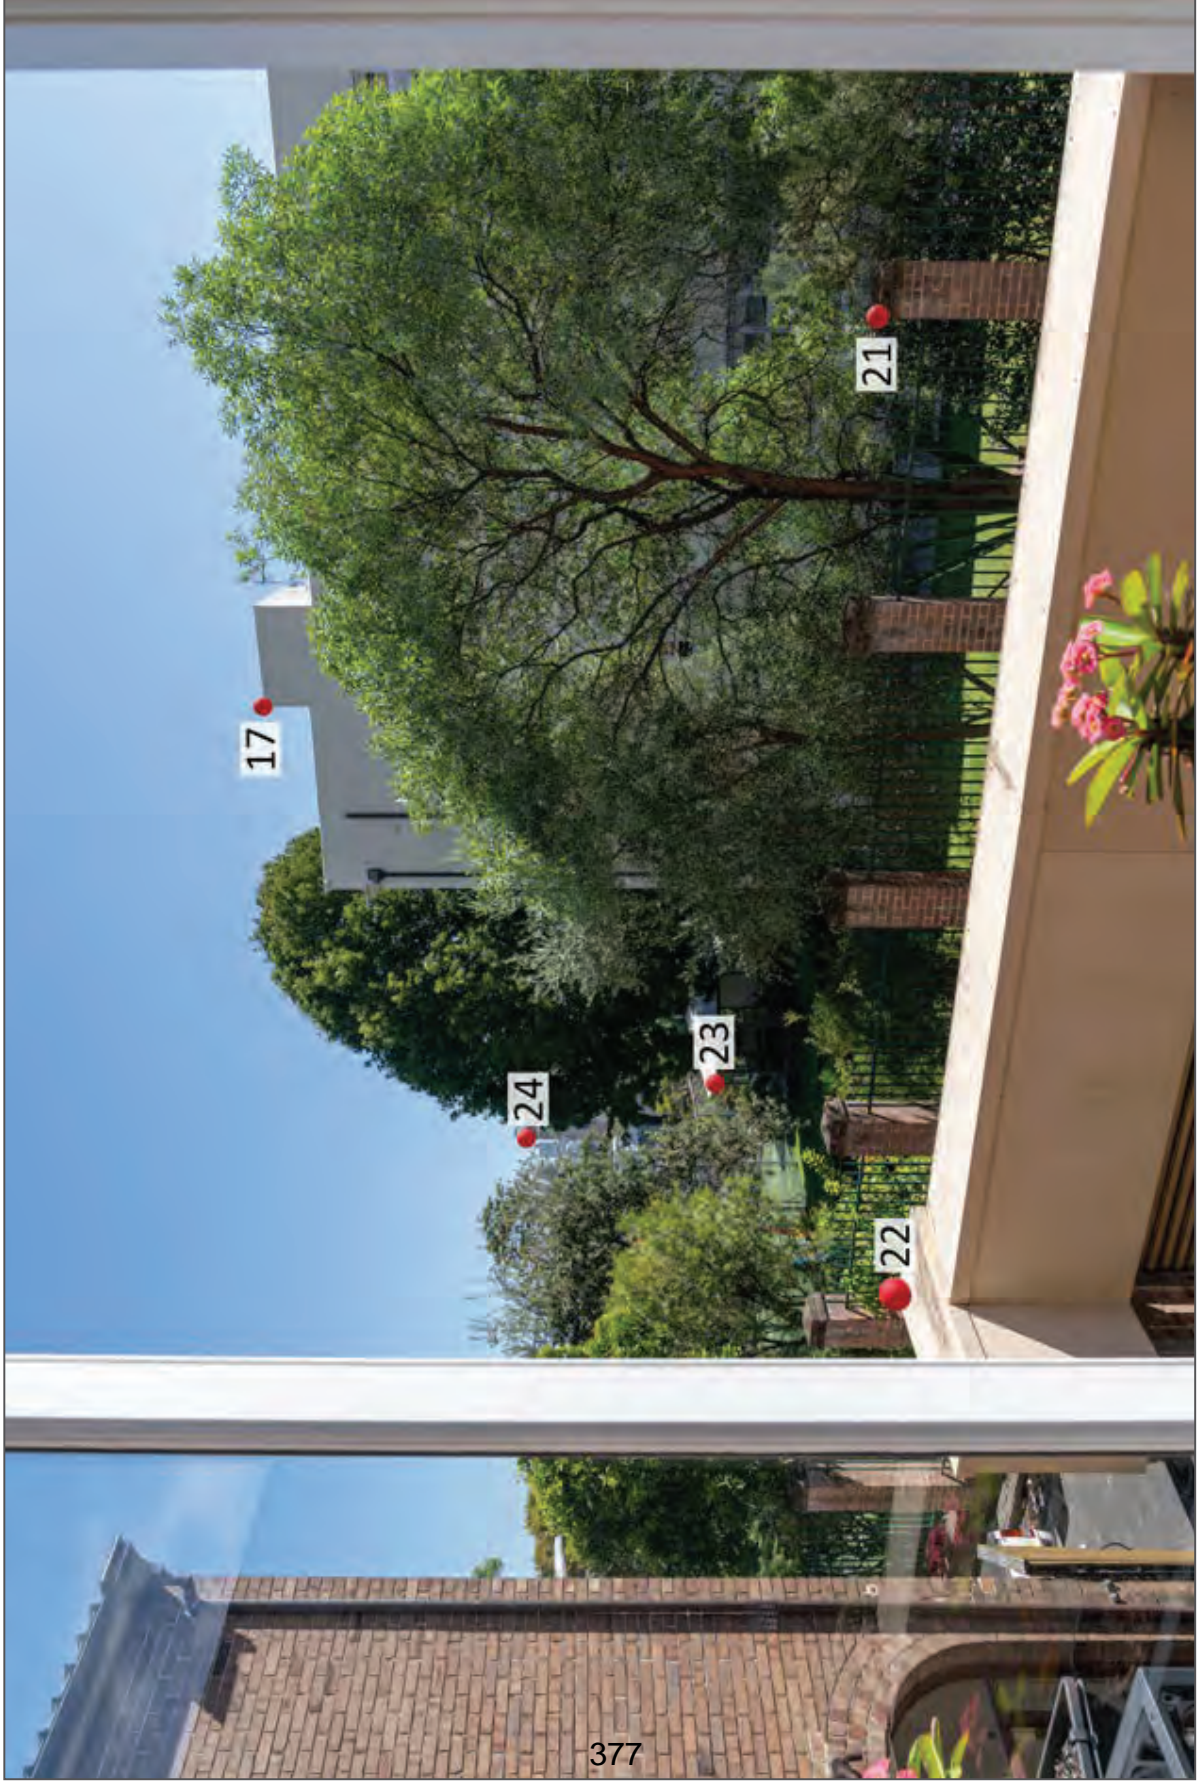
### 8.3 VIEWPOINT POSITION 04 - Unit 5, 6 Rockwall Crescent, Upper Ground Bedroom

OVERLAY OF SURVEY POINTS USED FOR 3D CAMERA ALIGNMENT

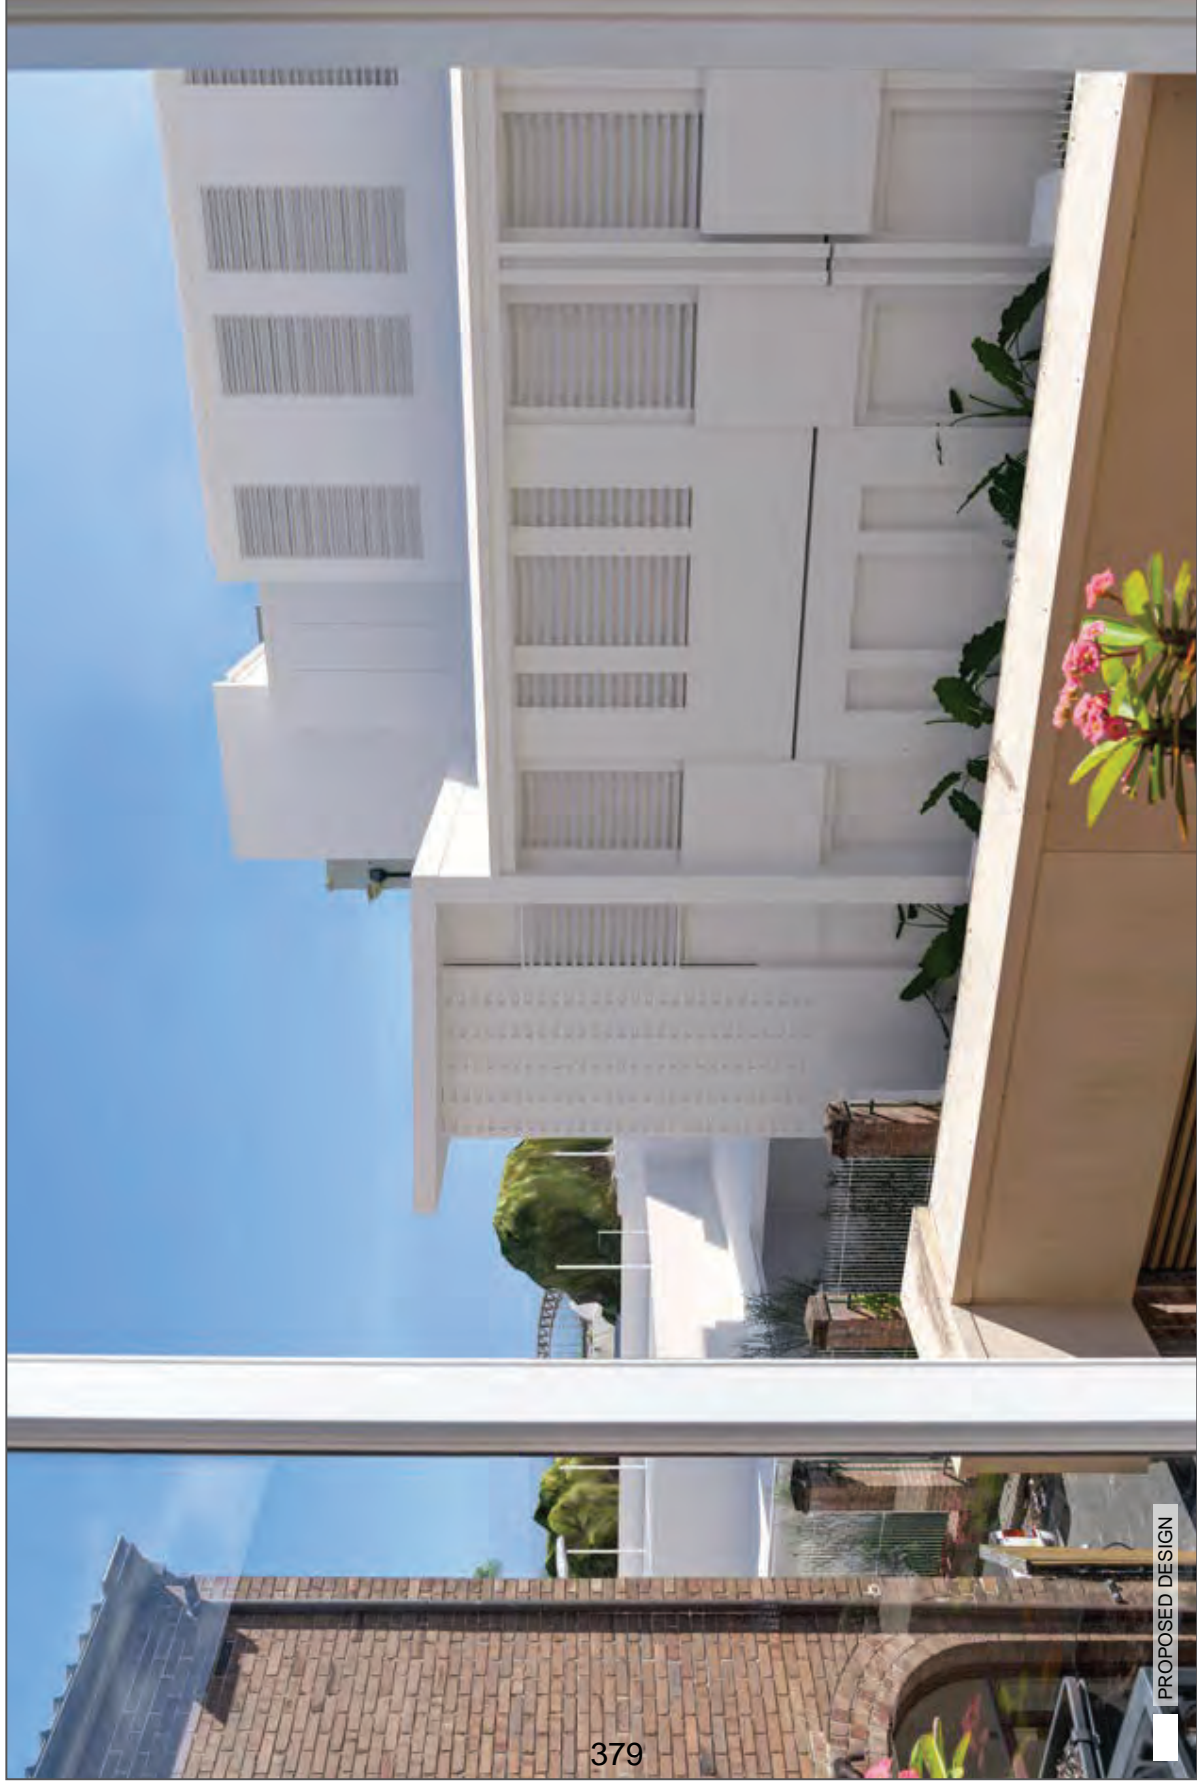
## 8.5 VIEWPOINT POSITION 04 - Unit 5, 6 Rockwall Crescent, Upper Ground Bedroom

PHOTOMONTAGE OF PROPOSED BUILDING DESIGN

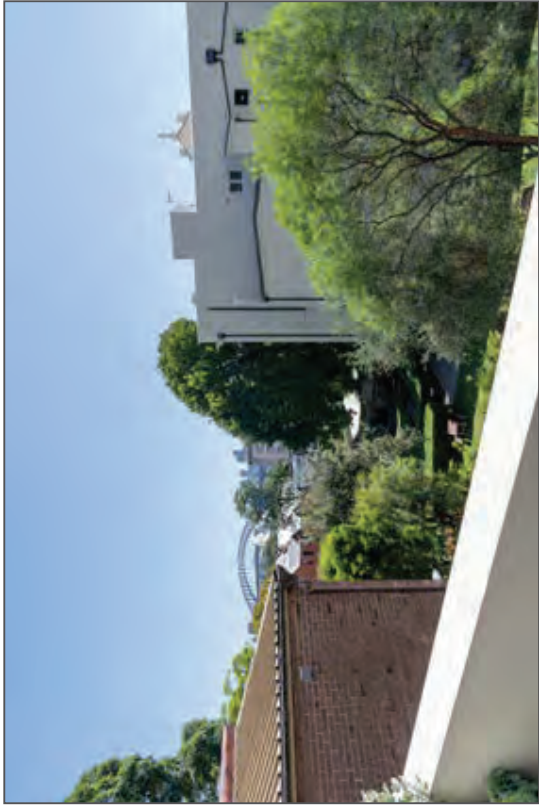
## 9.1 VIEWPOINT POSITION 05 - Unit 6, 6 Rockwall Crescent, Level 1 Terrace

PHOTOGRAPH OF CURRENT CONDITION

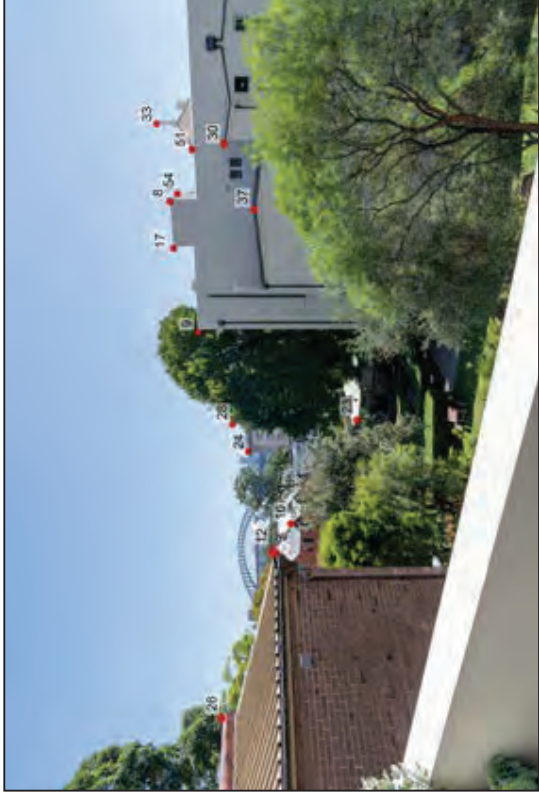
SURVEY POINTS USED FOR 3D CAMERA ALIGNMENT

Photo Date:	16 March 2023
Camera Used:	Sony ILCE-7C
Camera Lens:	FE 24-70mm F2.8 GM
Focal length in 35mm Film:	24mm

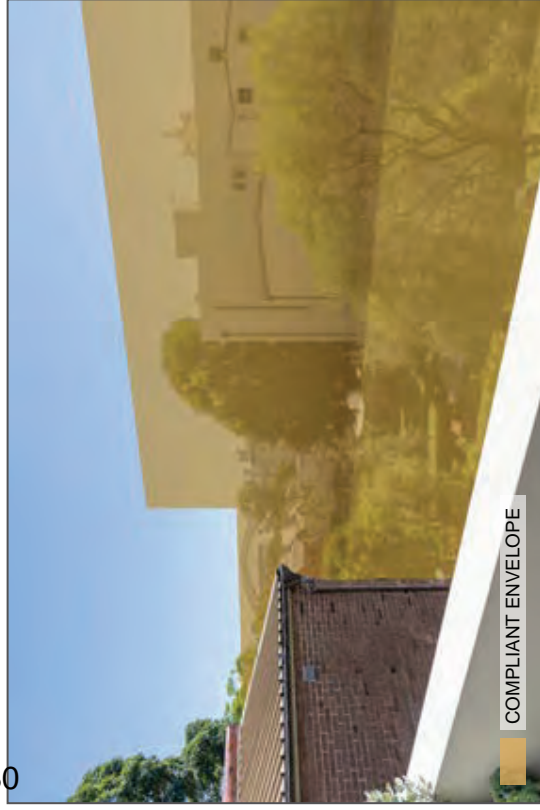
PHOTOMONTAGE OF COMPLIANT BUILDING ENVELOPE

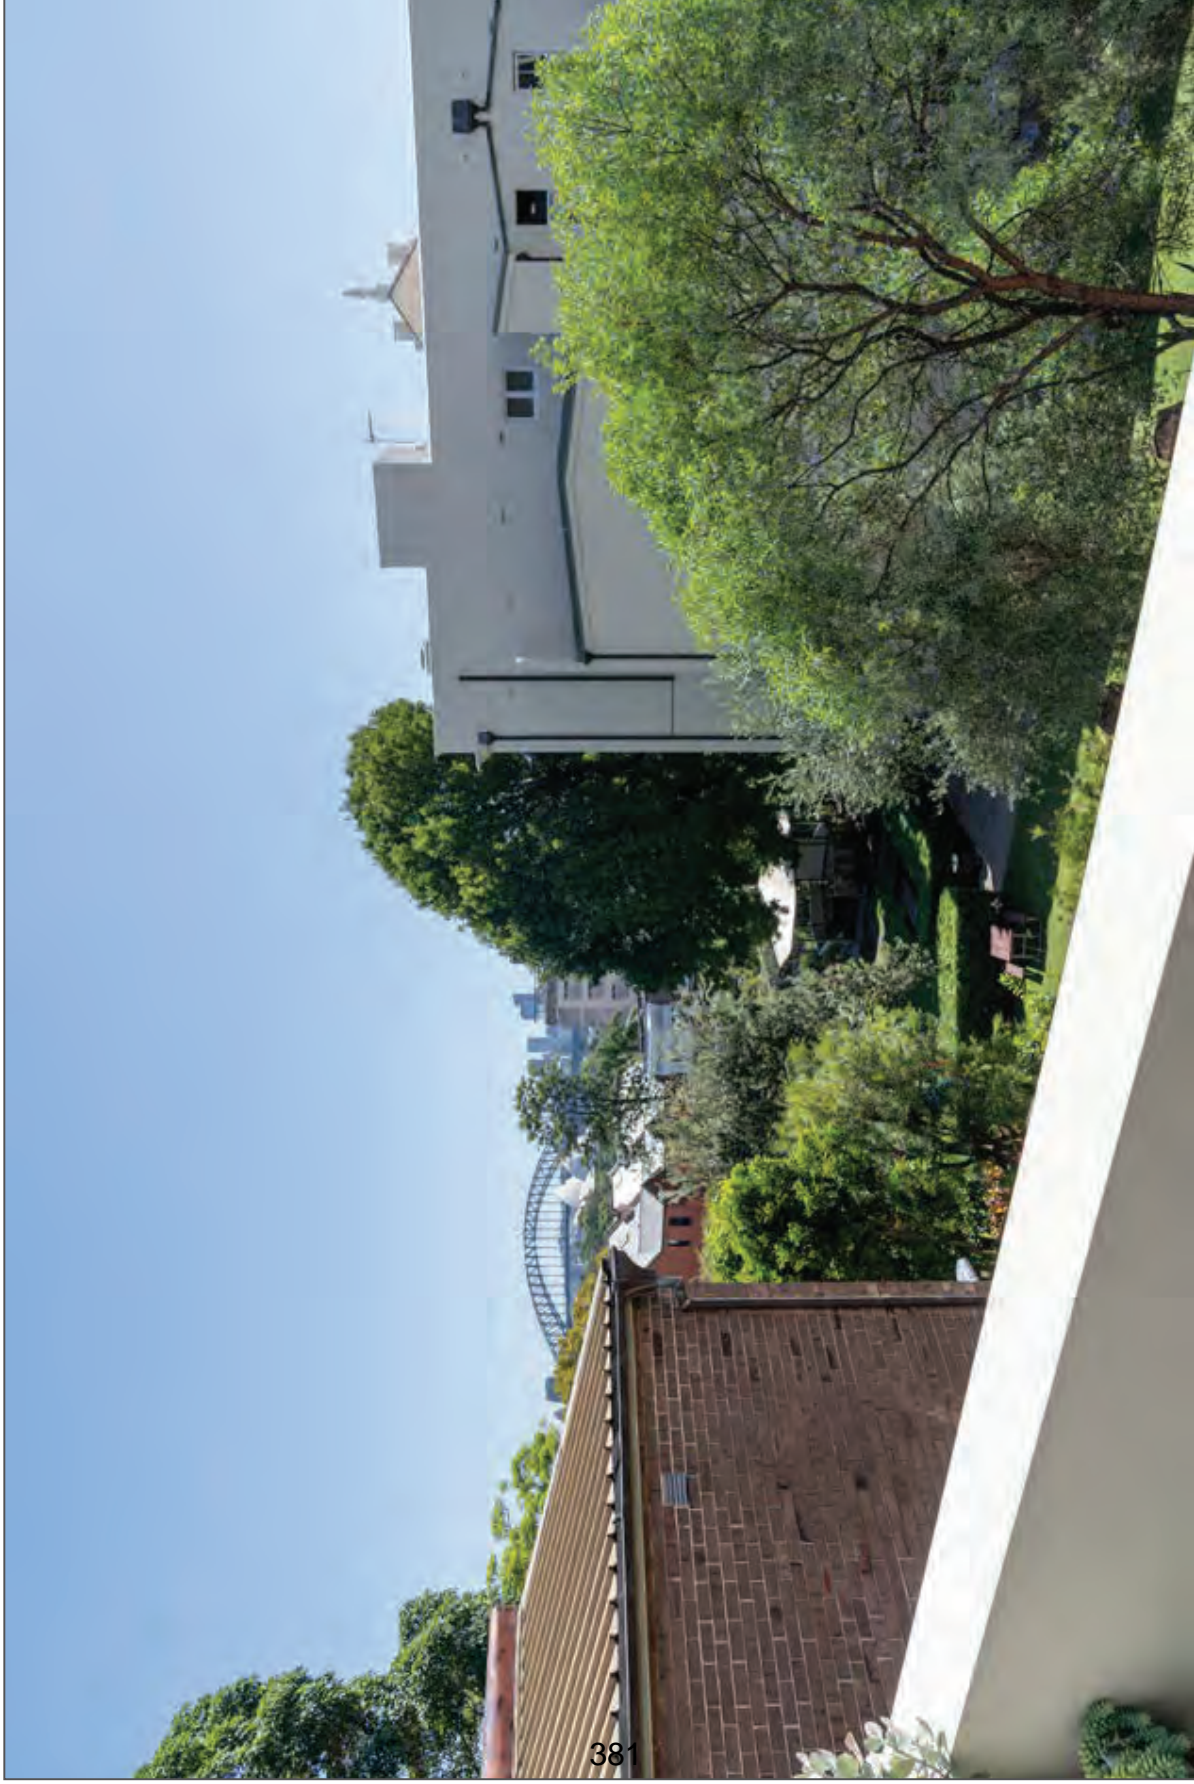
**9.2 VIEWPOINT POSITION 05 - Unit 6, 6 Rockwall Crescent, Level 1 Terrace**

**PHOTOGRAPH OF CURRENT CONDITION**

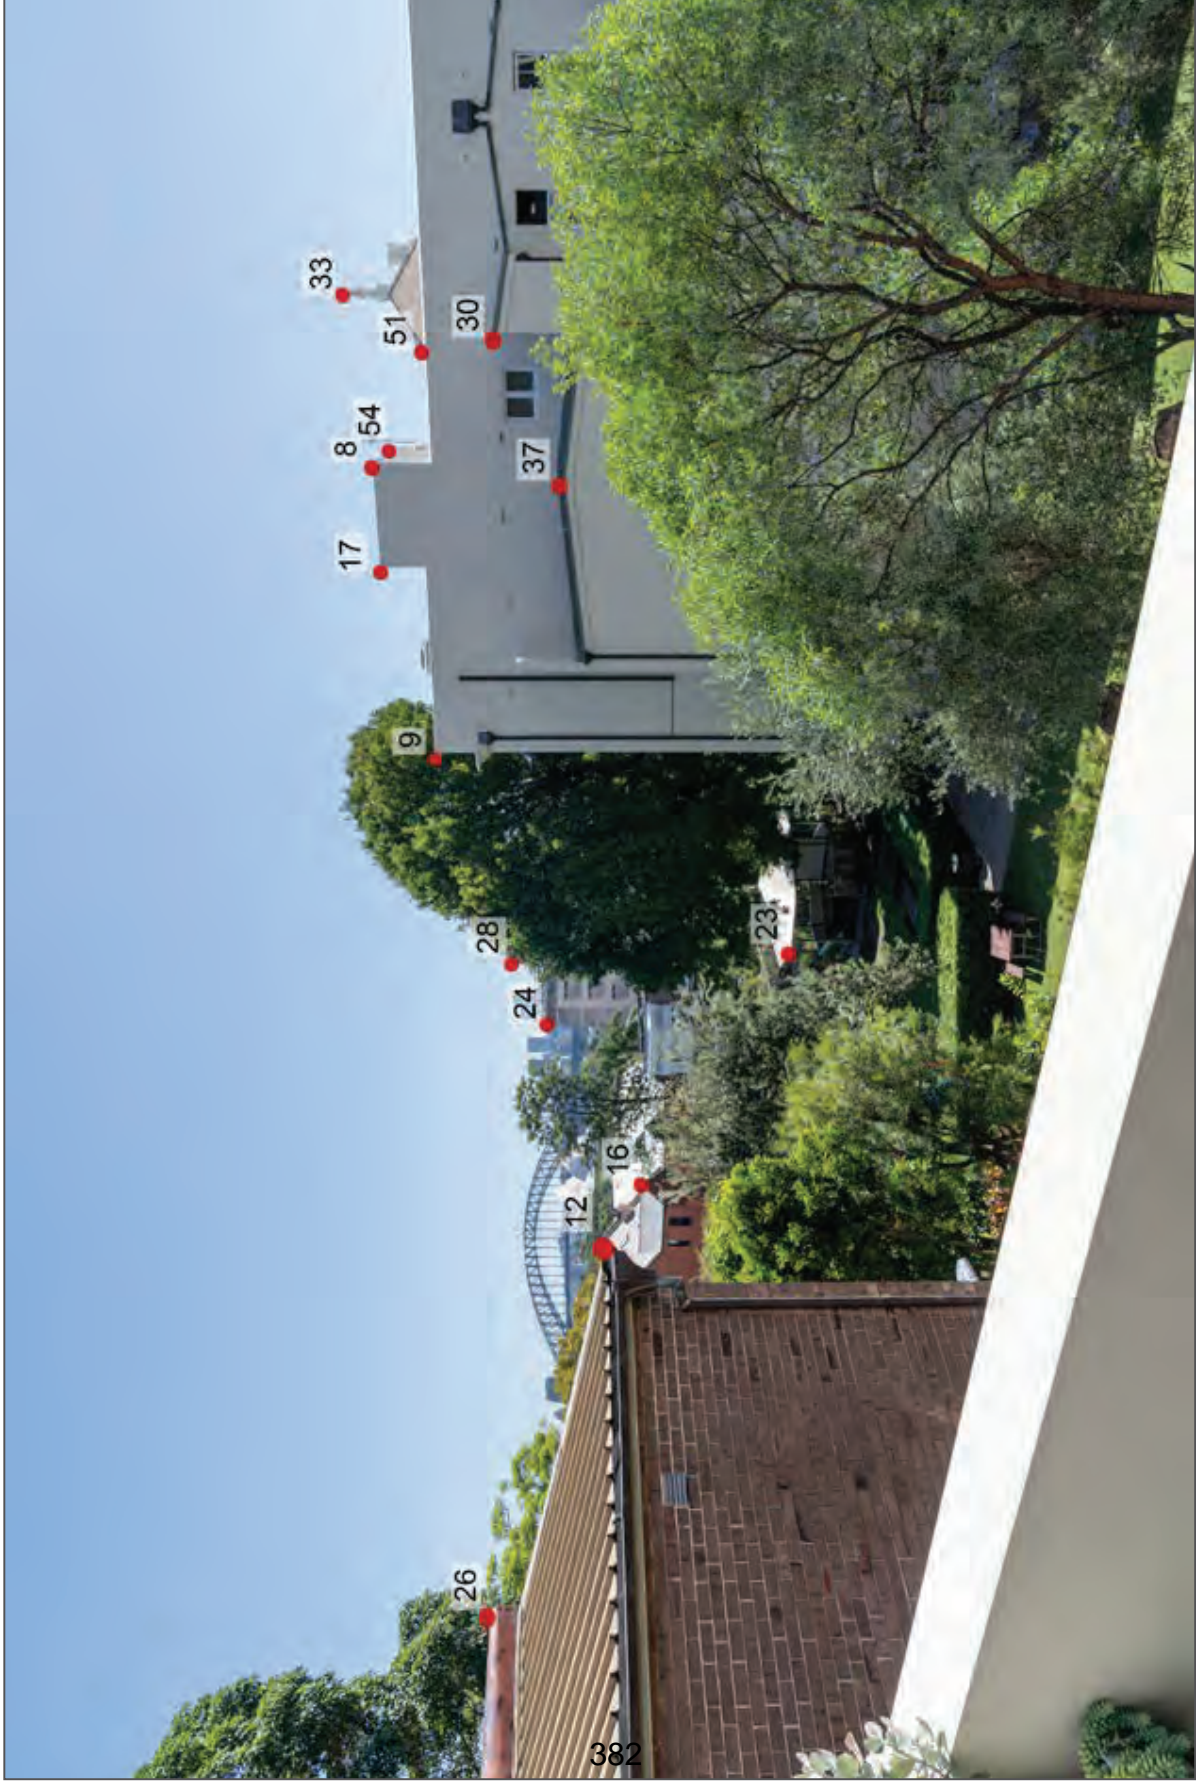
### 9.3 VIEWPOINT POSITION 05 - Unit 6, 6 Rockwall Crescent, Level 1 Terrace

OVERLAY OF SURVEY POINTS USED FOR 3D CAMERA ALIGNMENT

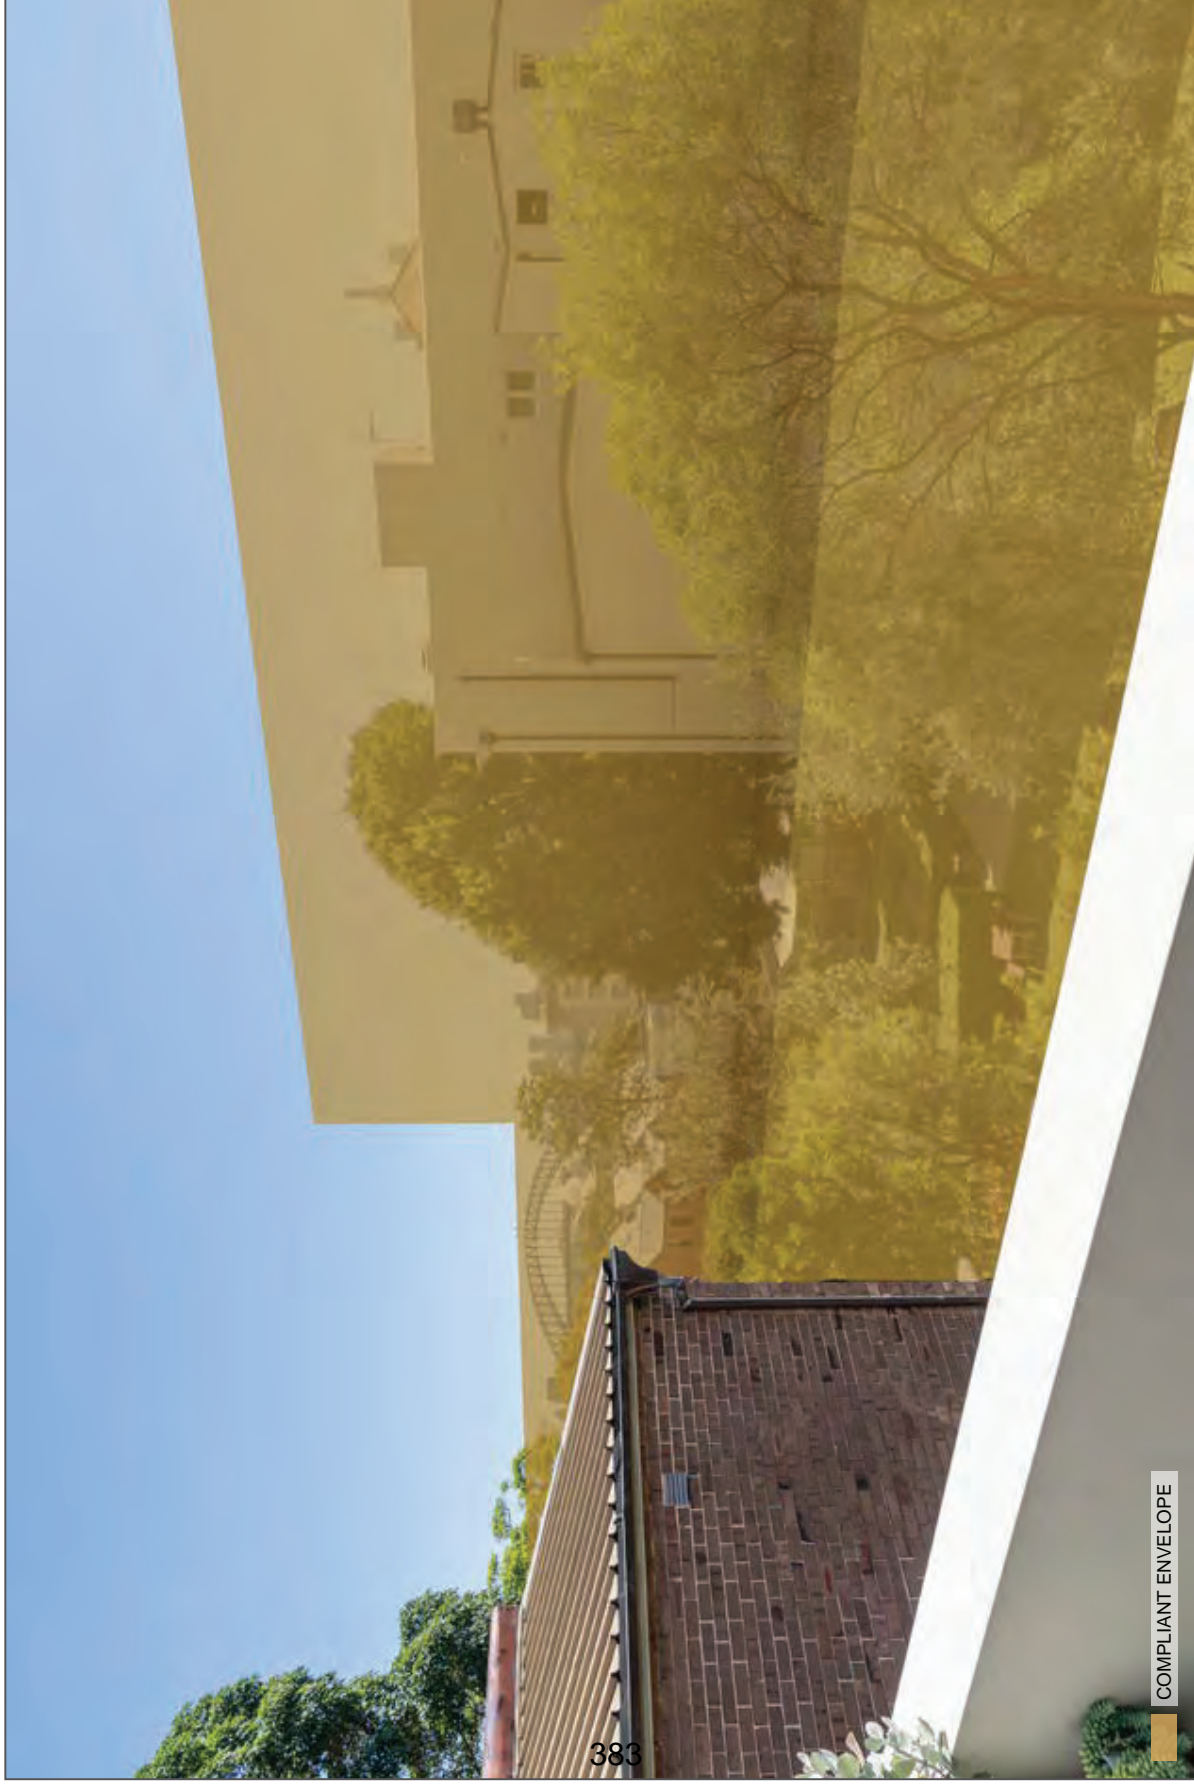
## 9.4 VIEWPOINT POSITION 05 - Unit 6, 6 Rockwall Crescent, Level 1 Terrace

PHOTOMONTAGE OF COMPLIANT BUILDING ENVELOPE

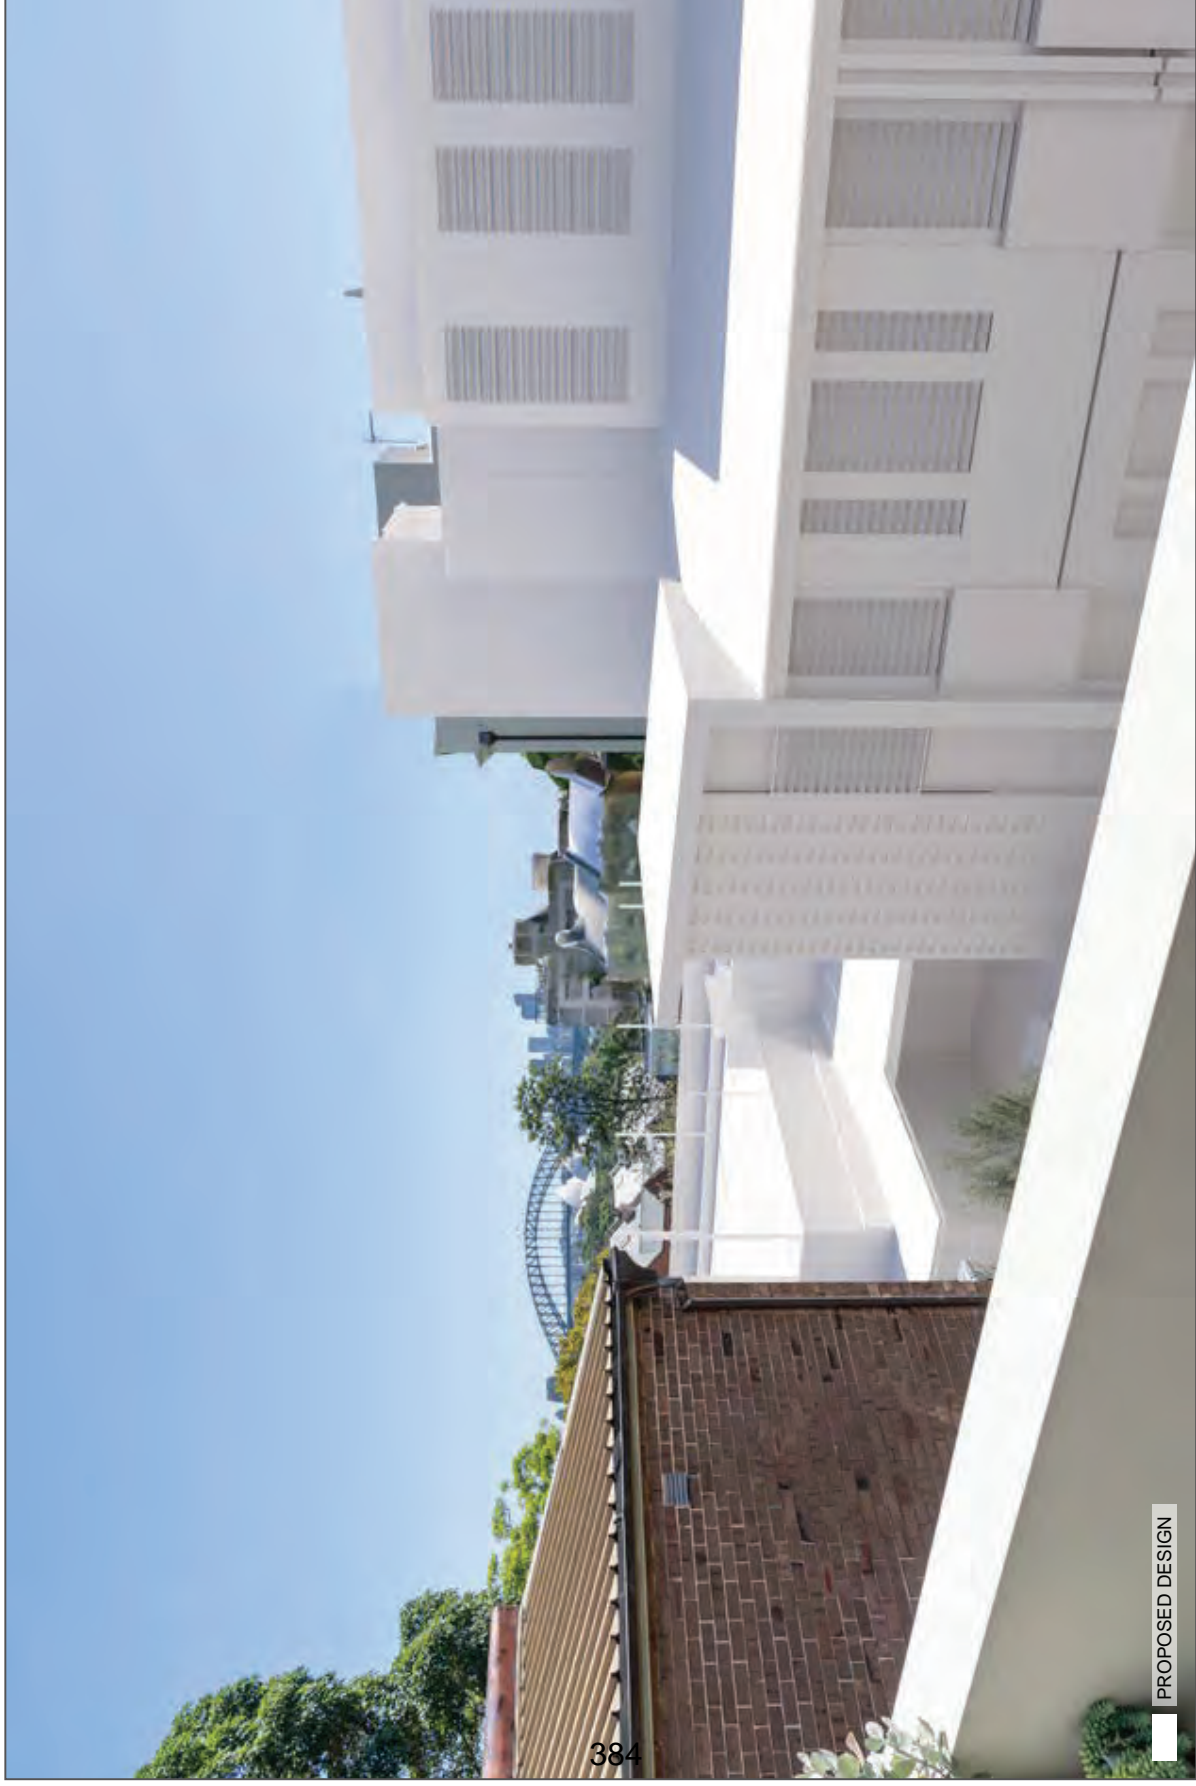
## 9.5 VIEWPOINT POSITION 05 - Unit 6, 6 Rockwall Crescent, Level 1 Terrace

PHOTOMONTAGE OF PROPOSED BUILDING DESIGN

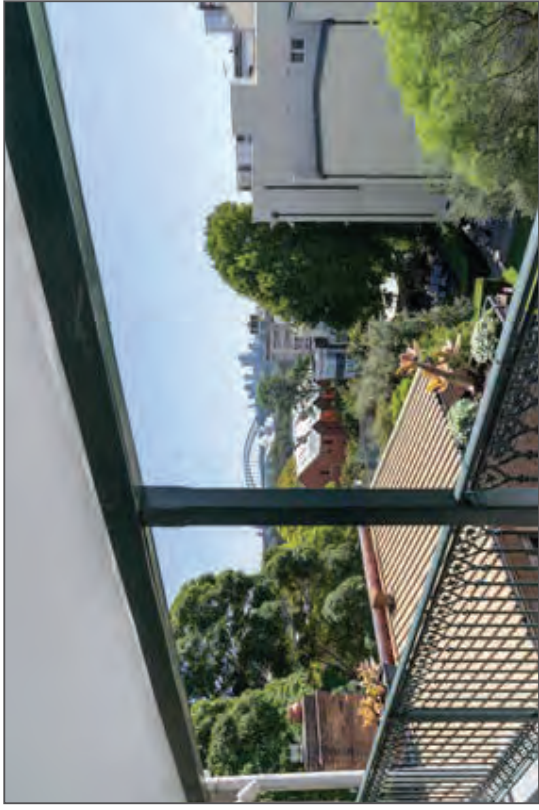
## 10.1 VIEWPOINT POSITION 06 - Unit 6, 6 Rockwall Crescent, Level 2 Balcony

PHOTOGRAPH OF CURRENT CONDITION

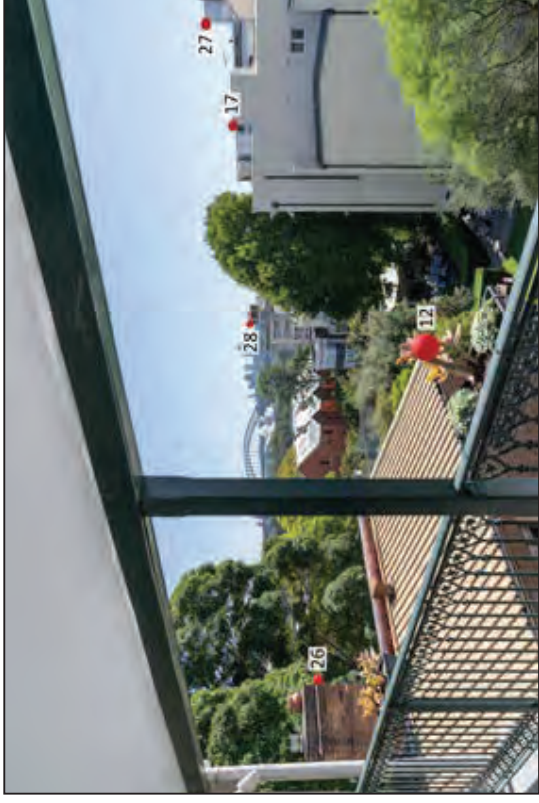
SURVEY POINTS USED FOR 3D CAMERA ALIGNMENT

Photo Date:	16 March 2023
Camera Used:	Sony ILCE-7C
Camera Lens:	FE 24-70mm F2.8 GM
Focal length in 35mm Film:	24mm

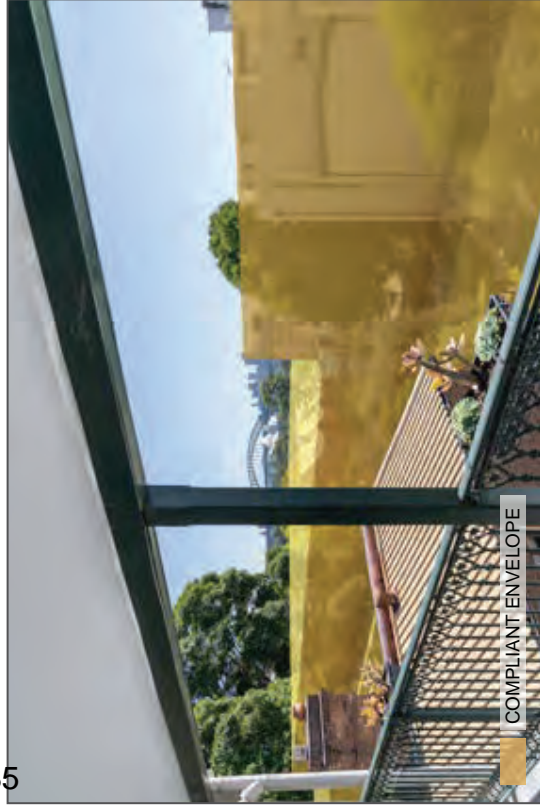
PHOTOMONTAGE OF COMPLIANT BUILDING ENVELOPE

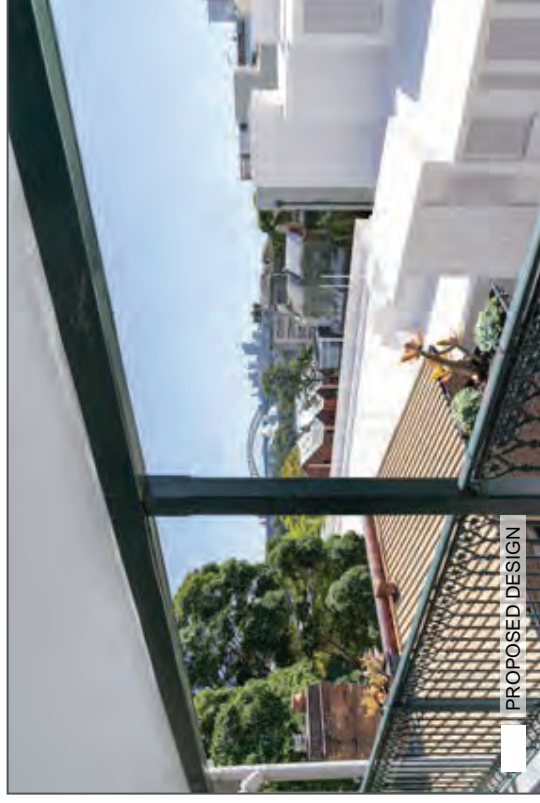
PHOTOMONTAGE OF PROPOSED BUILDING DESIGN

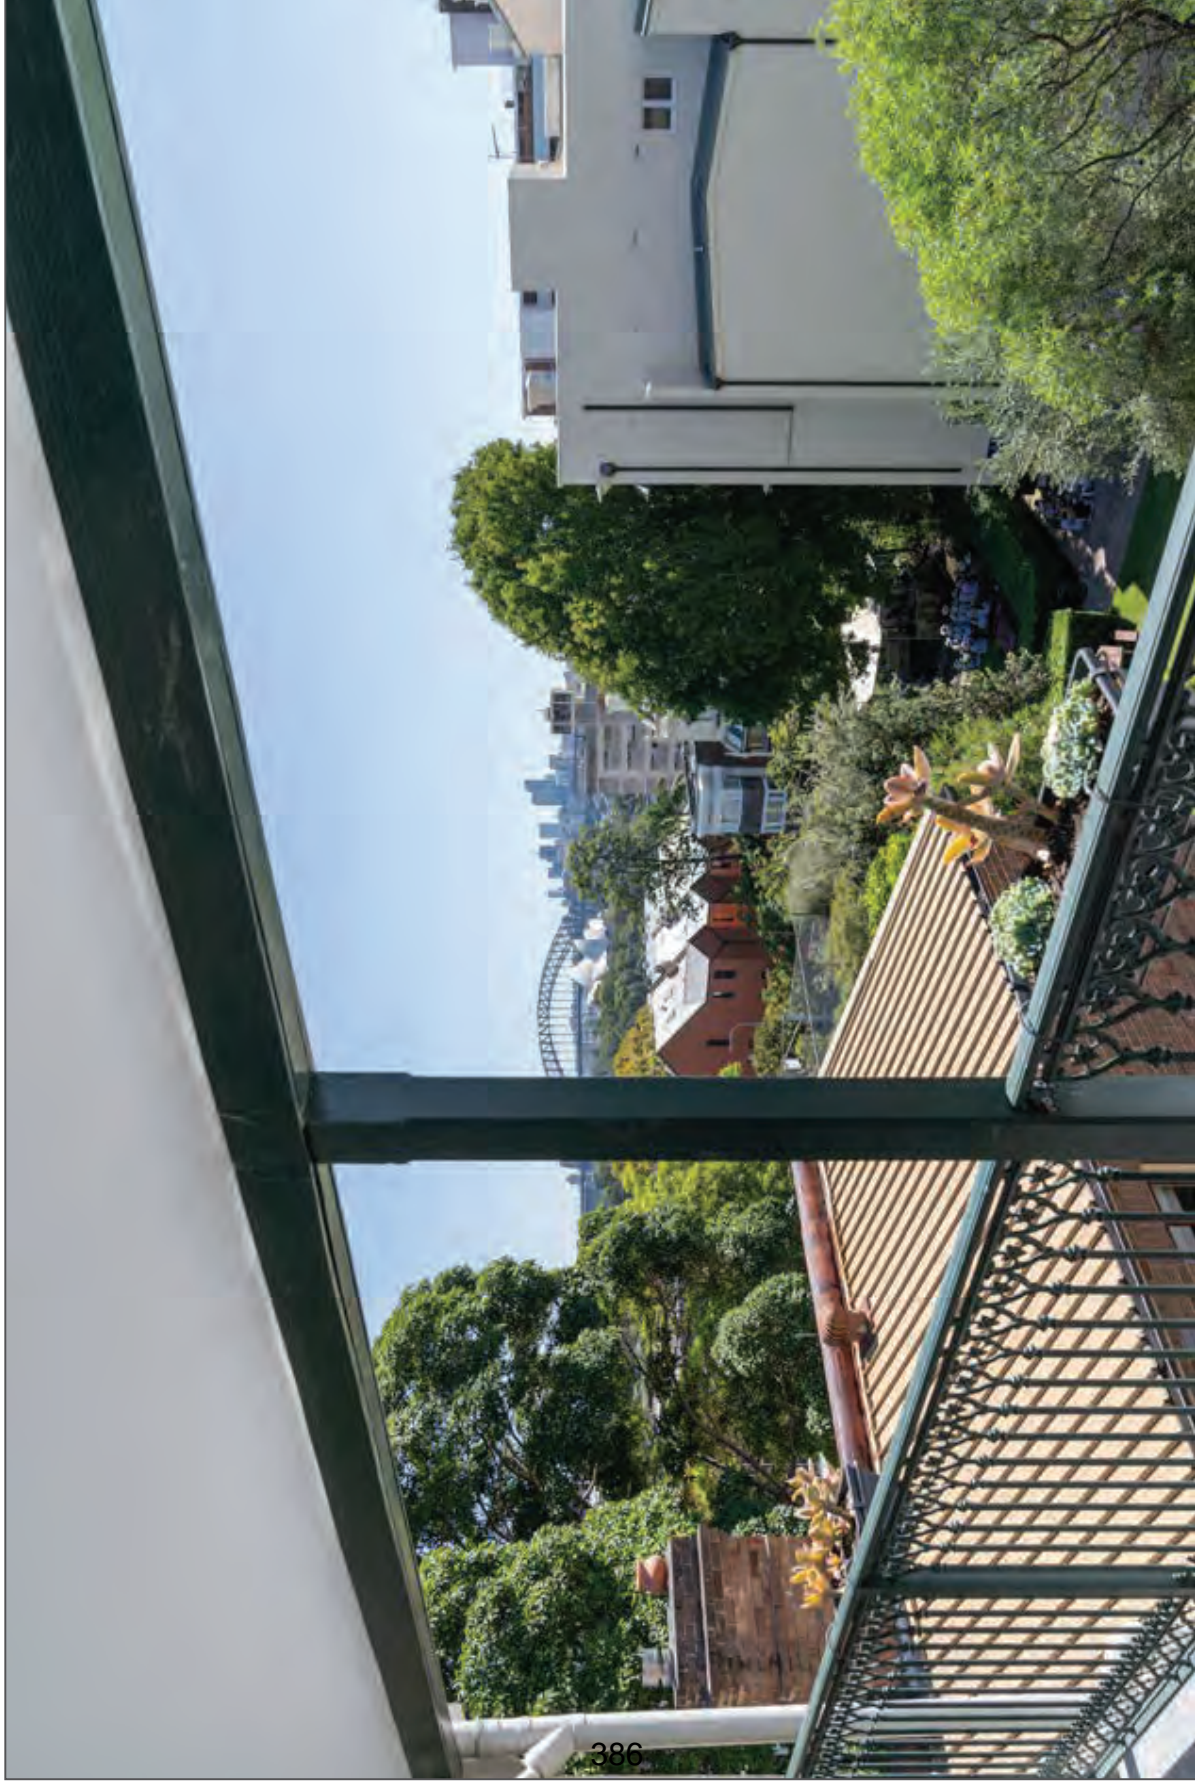
## 10.2 VIEWPOINT POSITION 06 - Unit 6, 6 Rockwall Crescent, Level 2 Balcony

PHOTOGRAPH OF CURRENT CONDITION

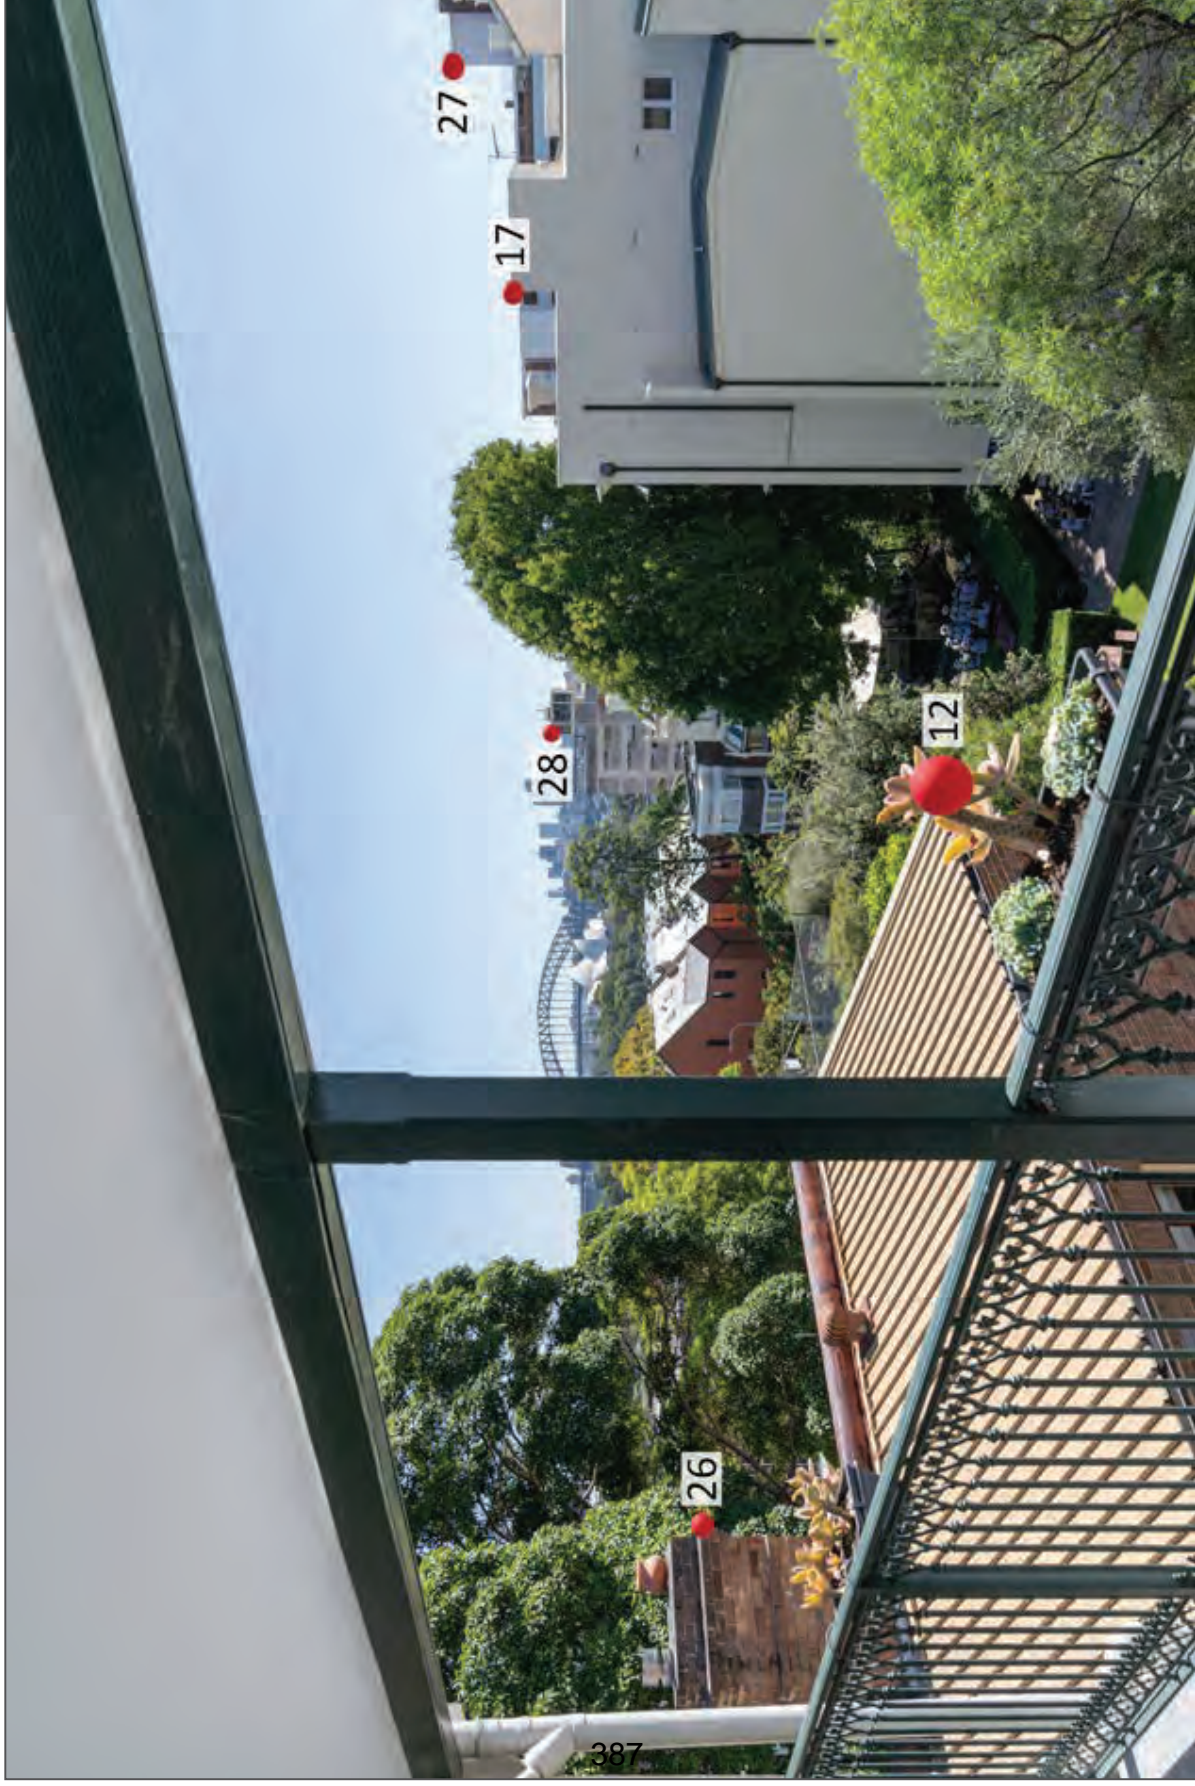
### 10.3 VIEWPOINT POSITION 06 - Unit 6, 6 Rockwall Crescent, Level 2 Balcony

OVERLAY OF SURVEY POINTS USED FOR 3D CAMERA ALIGNMENT

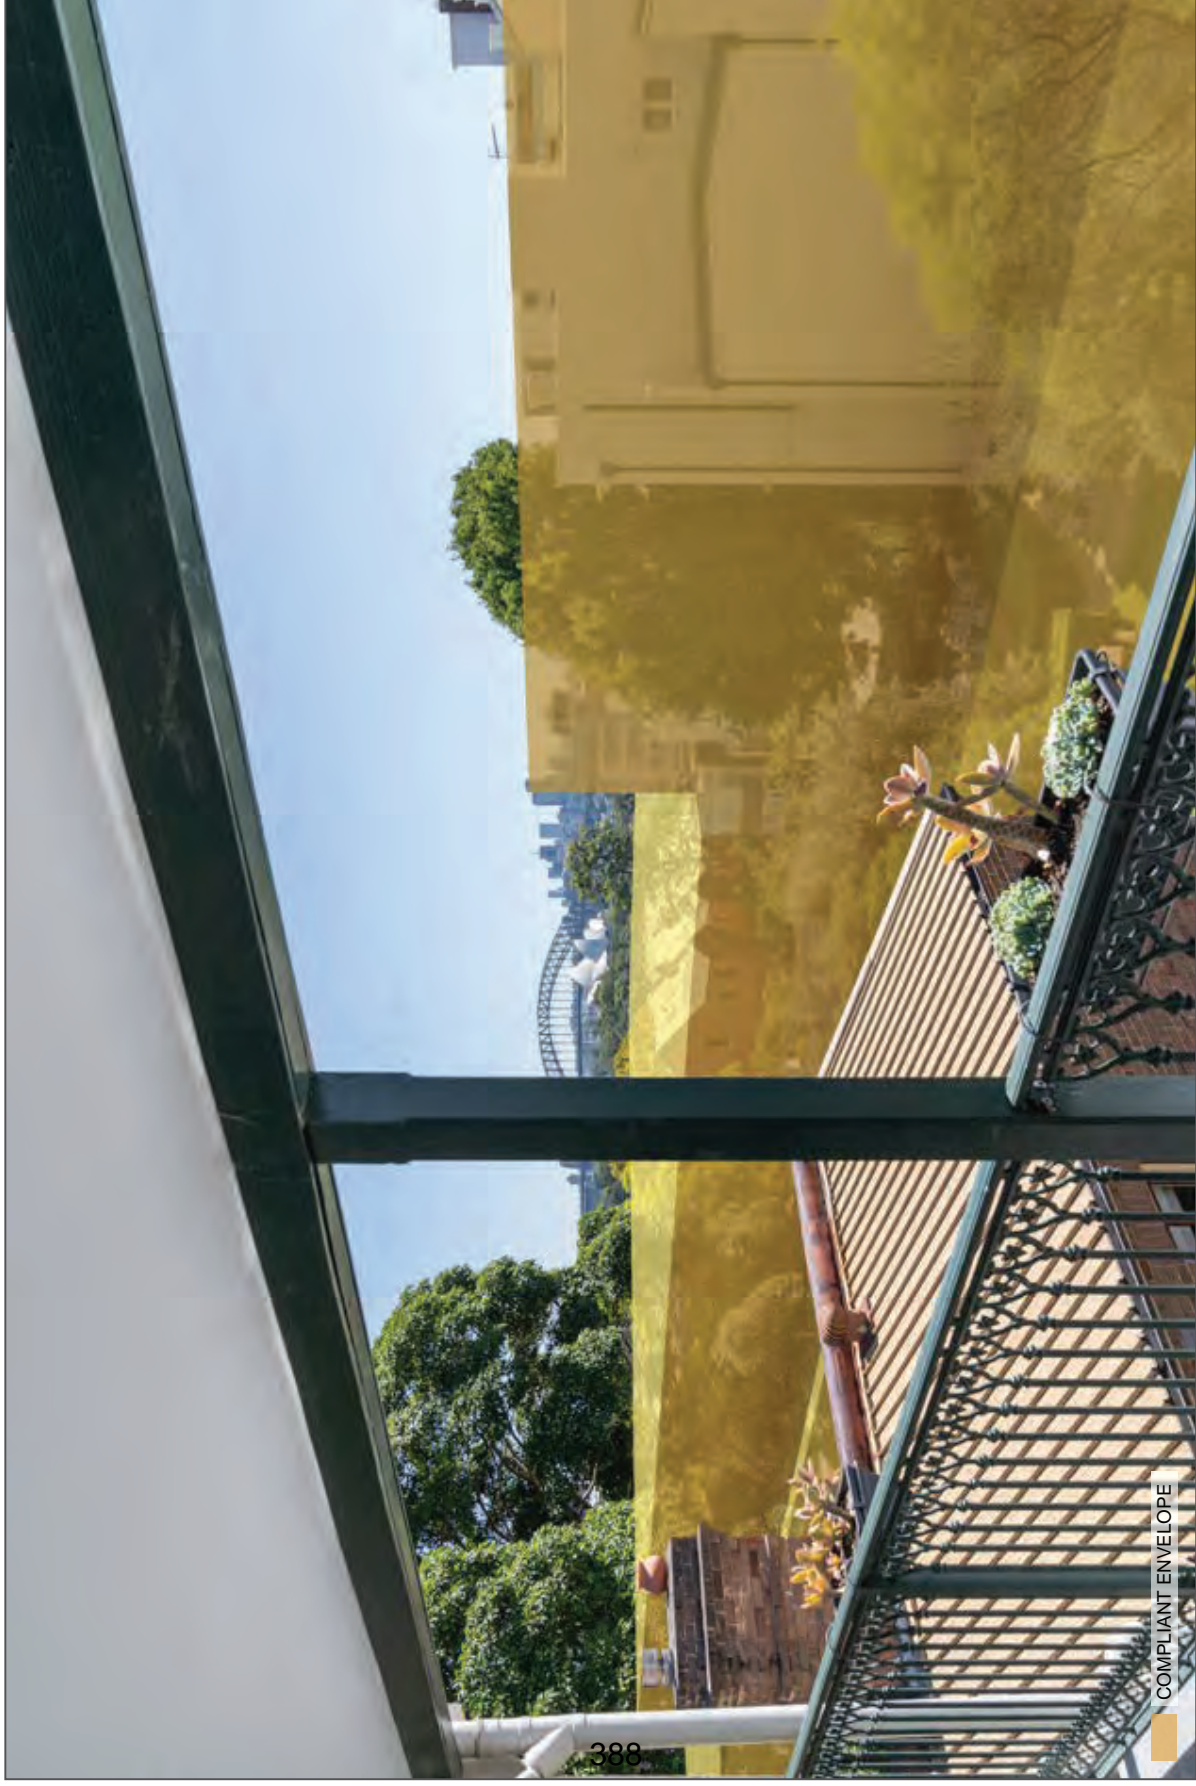
#### 10.4 VIEWPOINT POSITION 06 - Unit 6, 6 Rockwall Crescent, Level 2 Balcony

PHOTOMONTAGE OF COMPLIANT BUILDING ENVELOPE
