# View Loss Assessment

Submitted to City of Sydney in response to RFI dated 31 July 2024

St Vincent's College, 1 Challis Avenue, Potts Point  
The Trustees of the Sisters of Charity of Australia

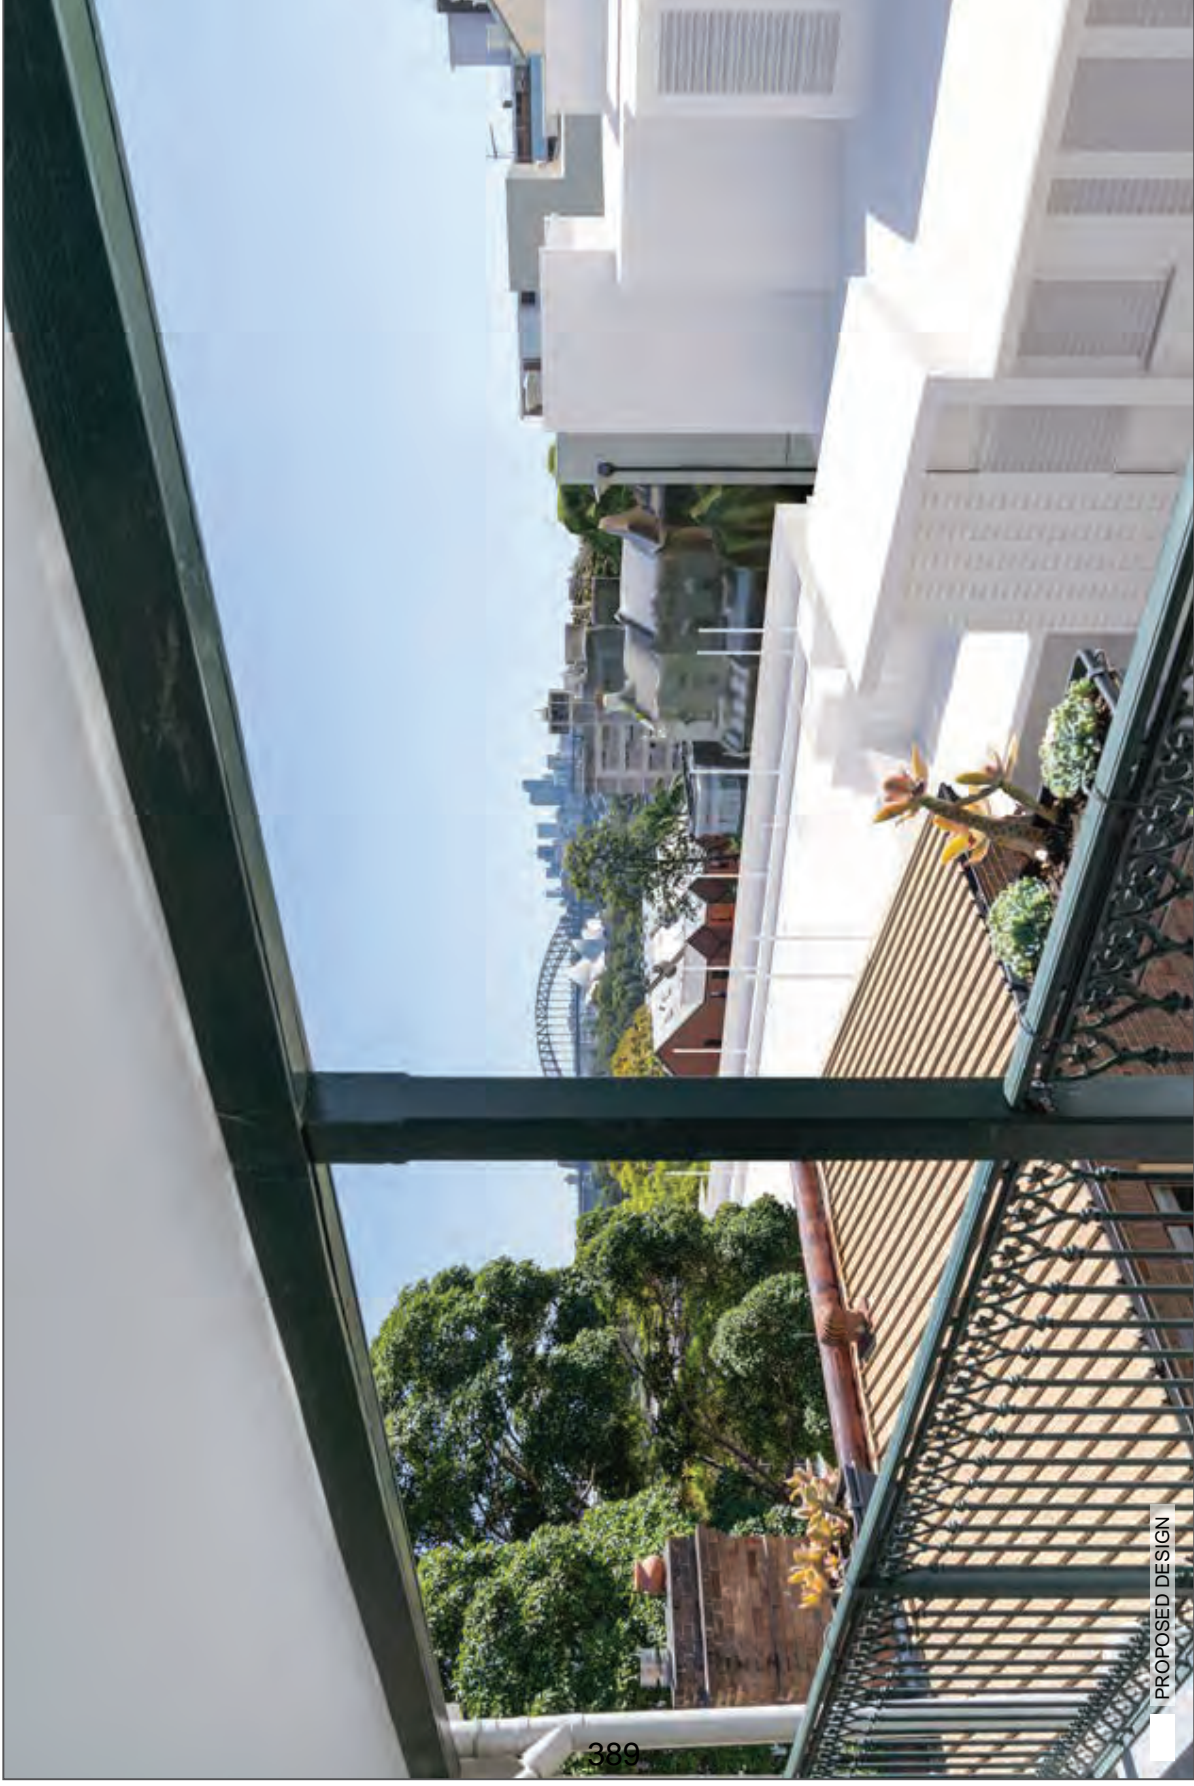
## 10.5 VIEWPOINT POSITION 06 - Unit 6, 6 Rockwall Crescent, Level 2 Balcony

PHOTOMONTAGE OF PROPOSED BUILDING DESIGN

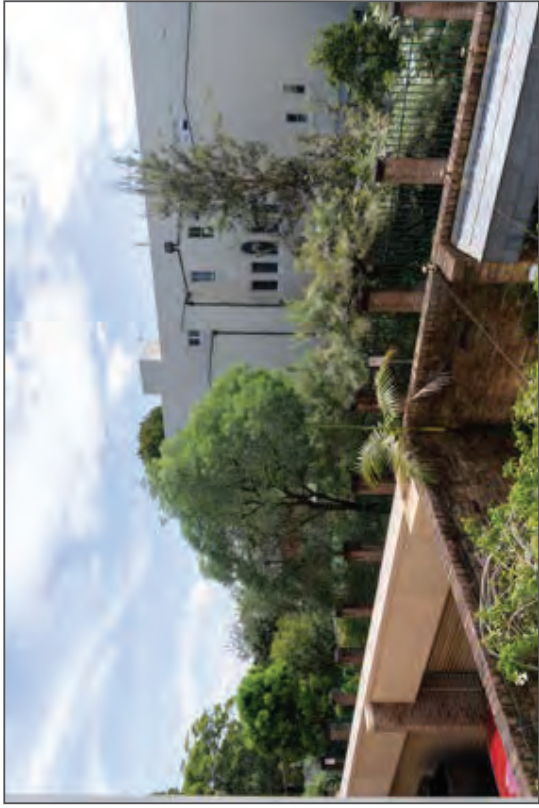
## 11.1 VIEWPOINT POSITION 07 - Unit 1, 10 Rockwall Crescent, Upper Ground Study

PHOTOGRAPH OF CURRENT CONDITION

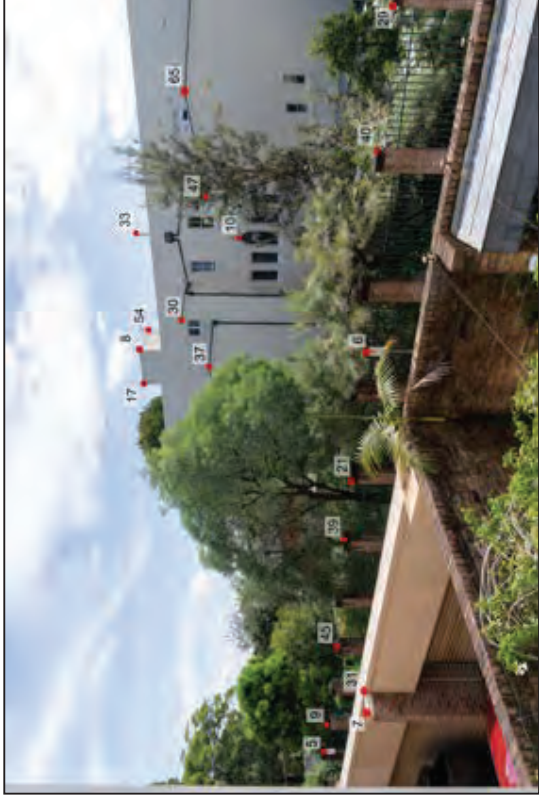
SURVEY POINTS USED FOR 3D CAMERA ALIGNMENT

Photo Date:	3 April 2023
Camera Used:	Sony ILCE-7C
Camera Lens:	FE 24-70mm F2.8 GM
Focal length in 35mm Film:	24mm

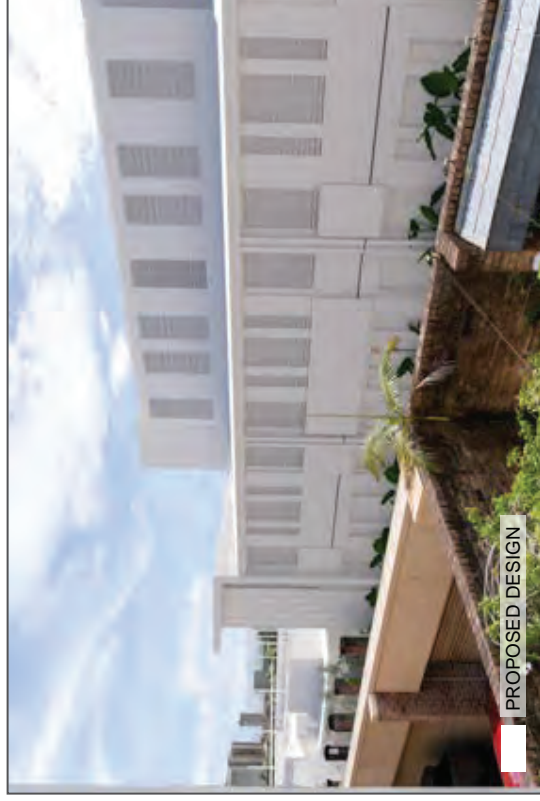
PHOTOMONTAGE OF PROPOSED BUILDING DESIGN

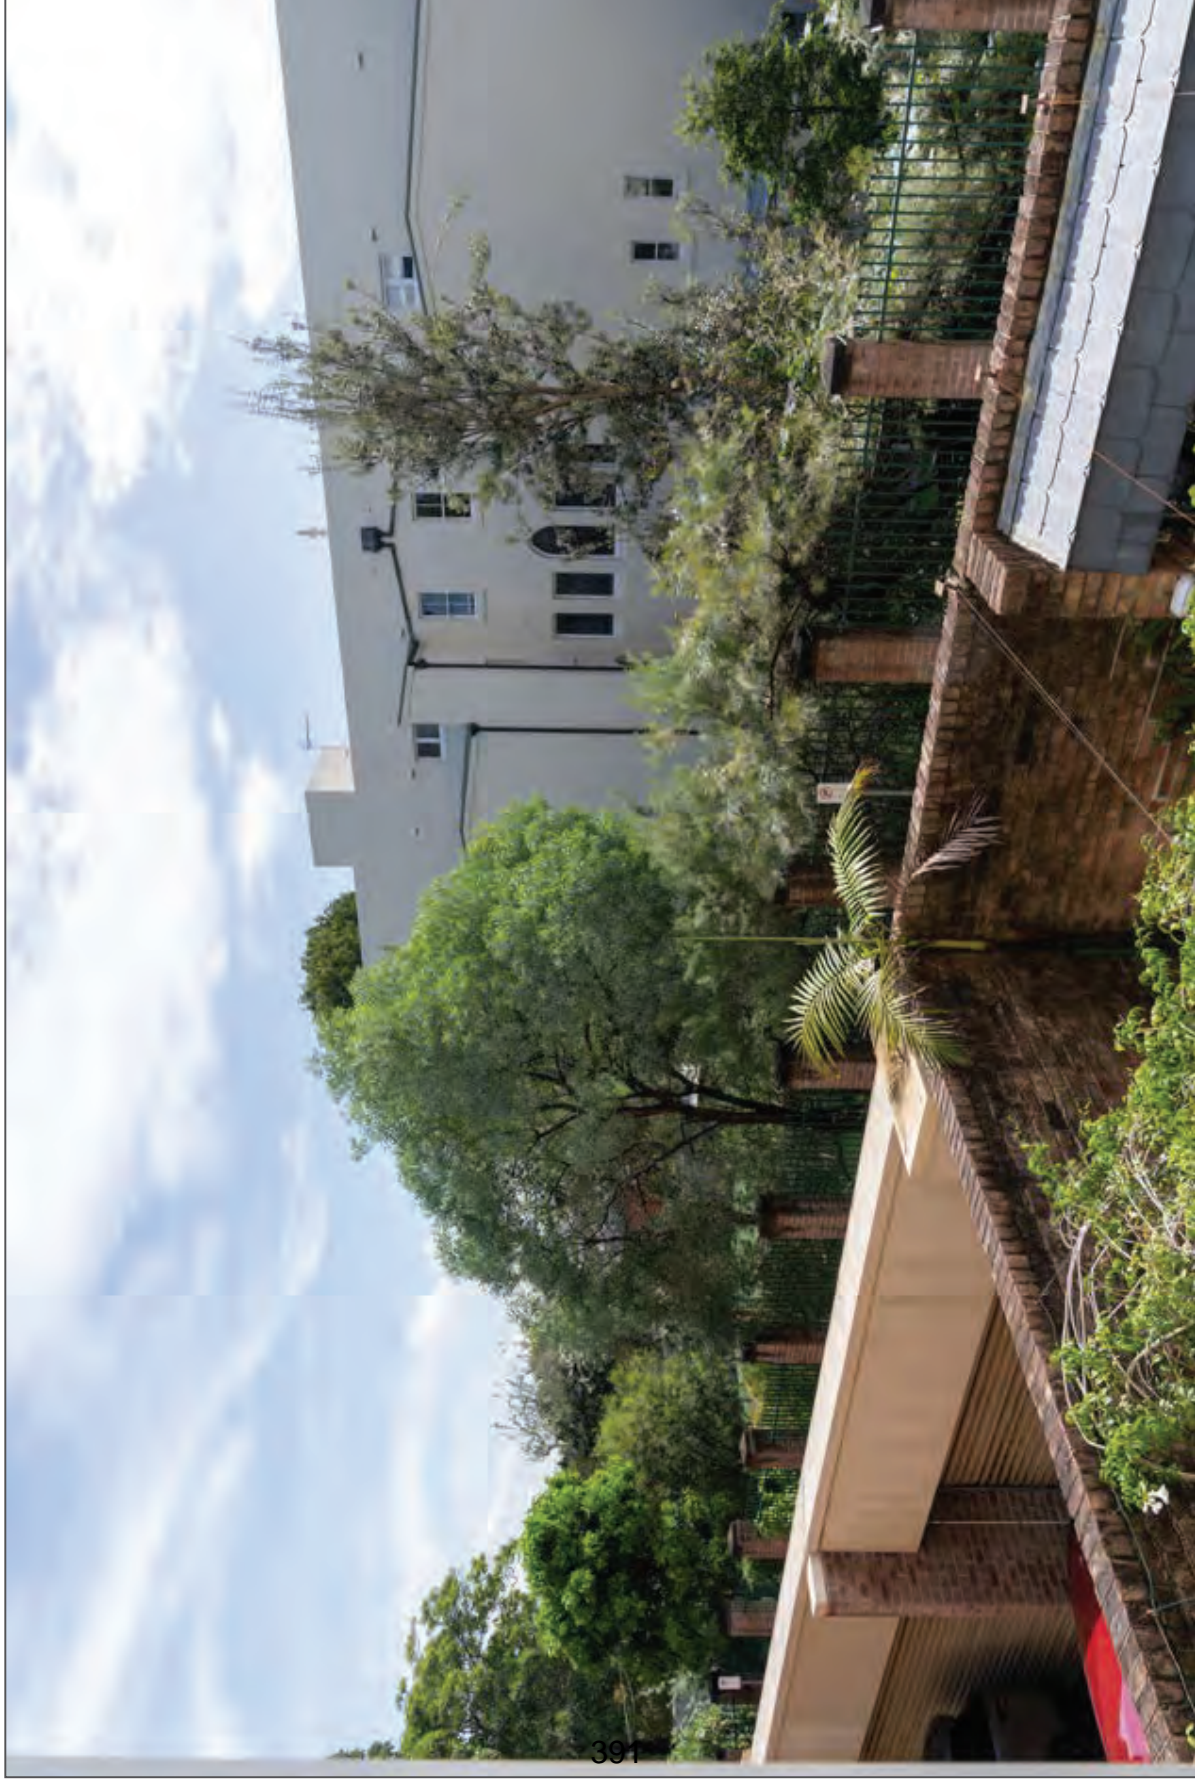
## 11.2 VIEWPOINT POSITION 07 - Unit 1, 10 Rockwall Crescent, Upper Ground Study

PHOTOGRAPH OF CURRENT CONDITION

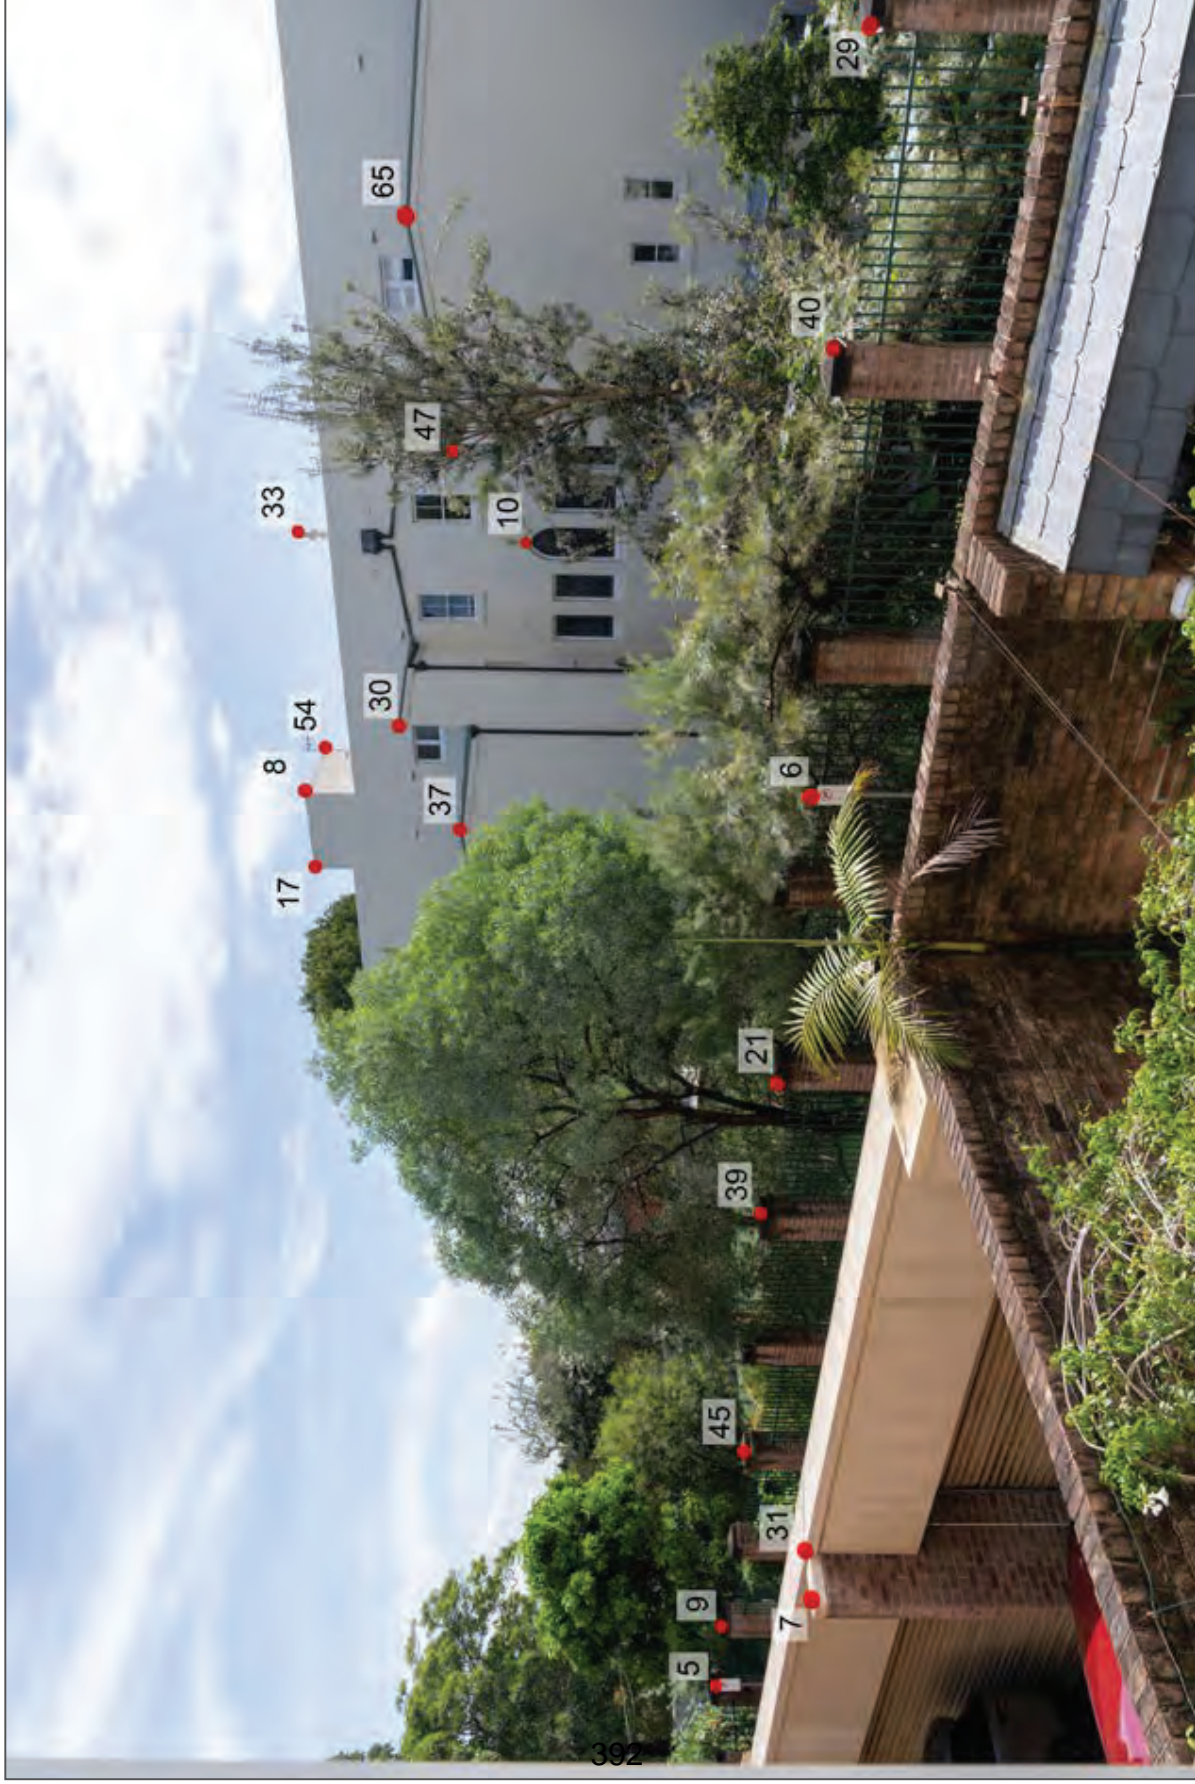
### 11.3 VIEWPOINT POSITION 07 - Unit 1, 10 Rockwall Crescent, Upper Ground Study

OVERLAY OF SURVEY POINTS USED FOR 3D CAMERA ALIGNMENT

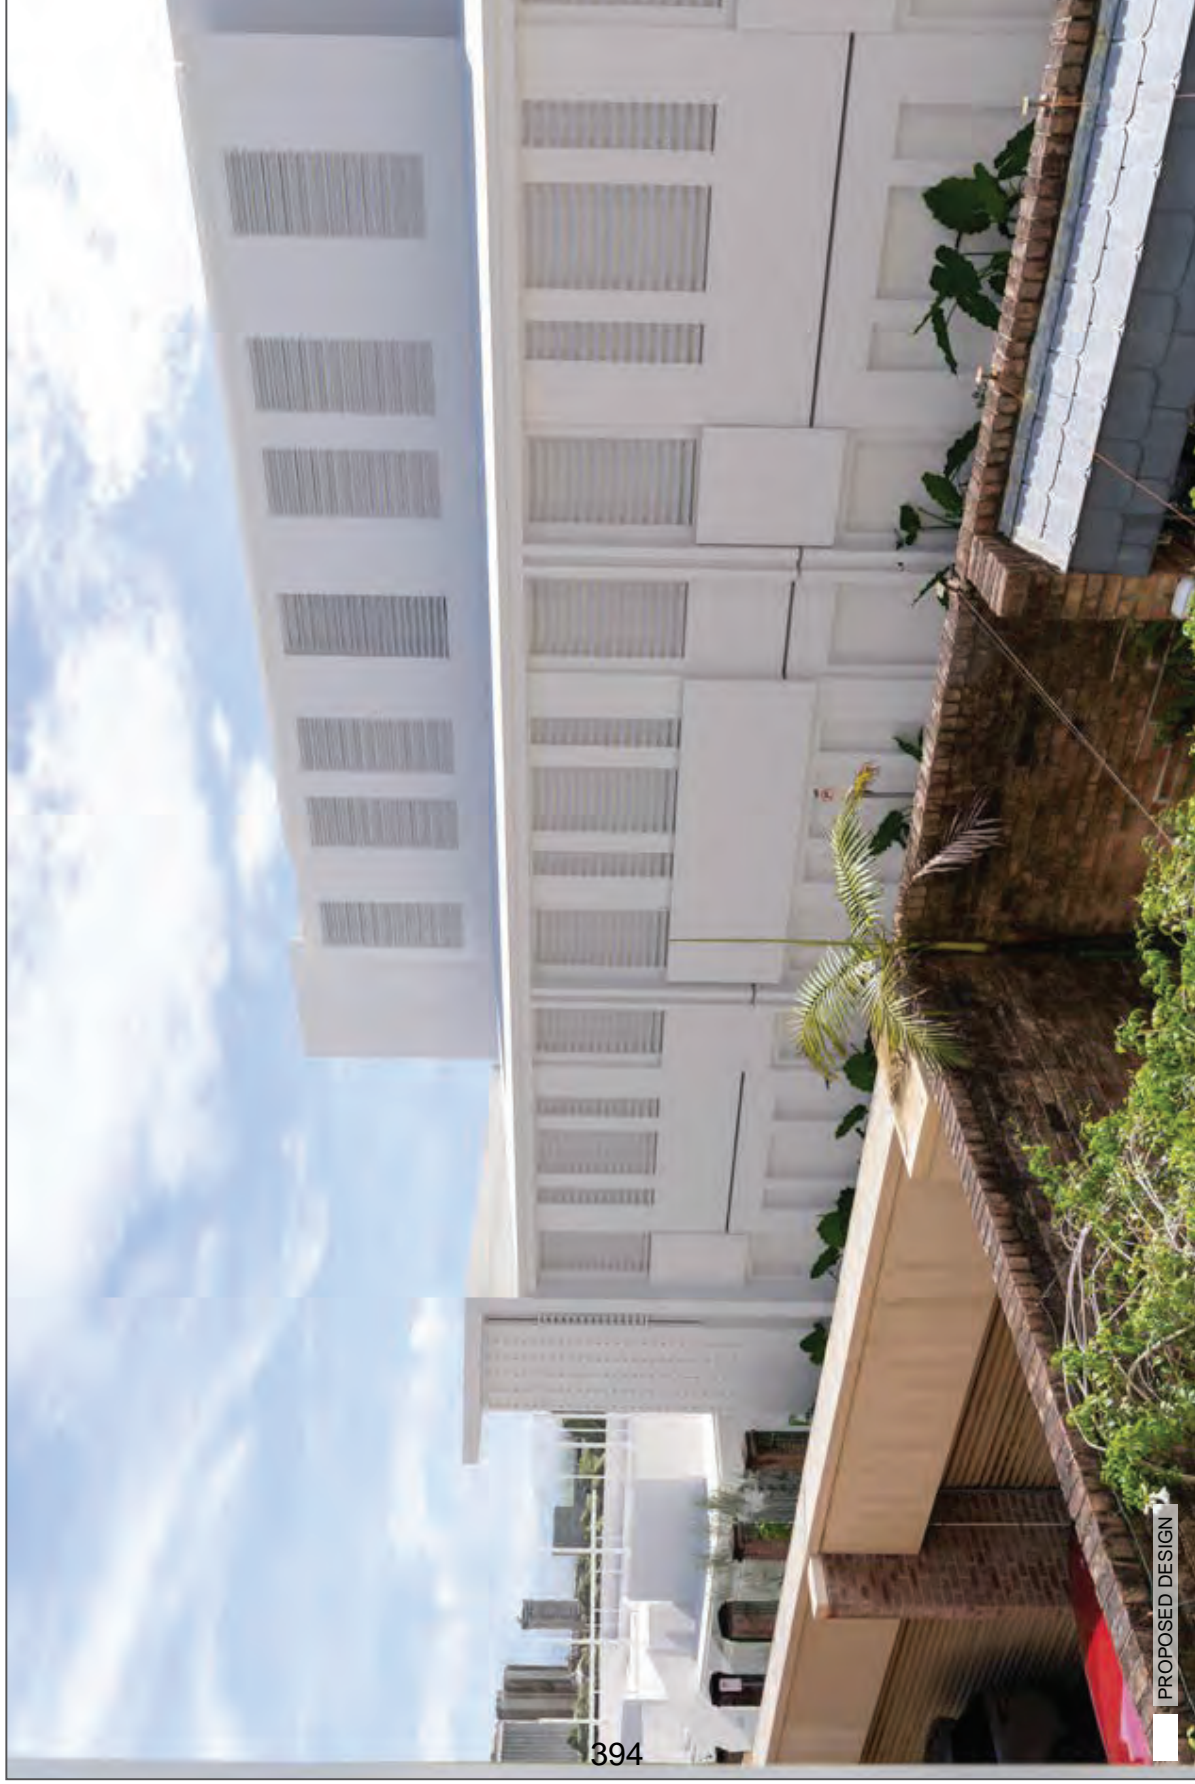
## 11.5 VIEWPOINT POSITION 07 - Unit 1, 10 Rockwall Crescent, Upper Ground Study

PHOTOMONTAGE OF PROPOSED BUILDING DESIGN

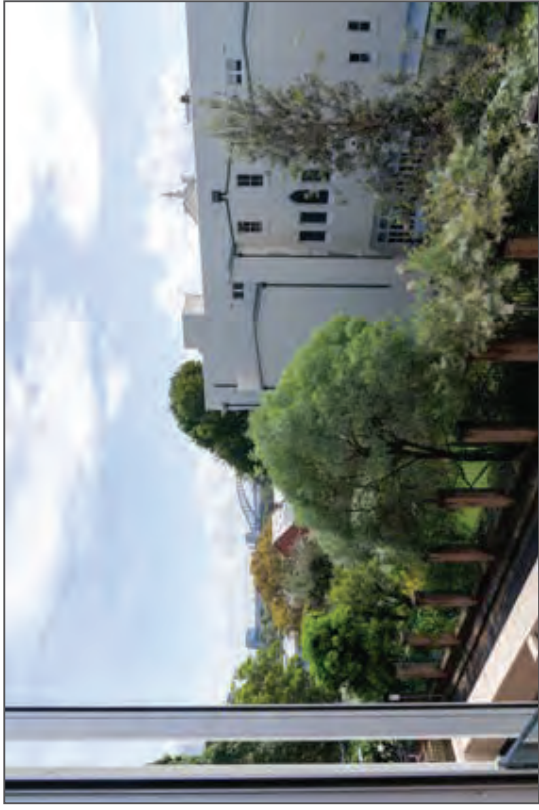
## 12.1 VIEWPOINT POSITION 08 - Unit 2, 10 Rockwall Crescent, Level 1 Dining Room

PHOTOGRAPH OF CURRENT CONDITION

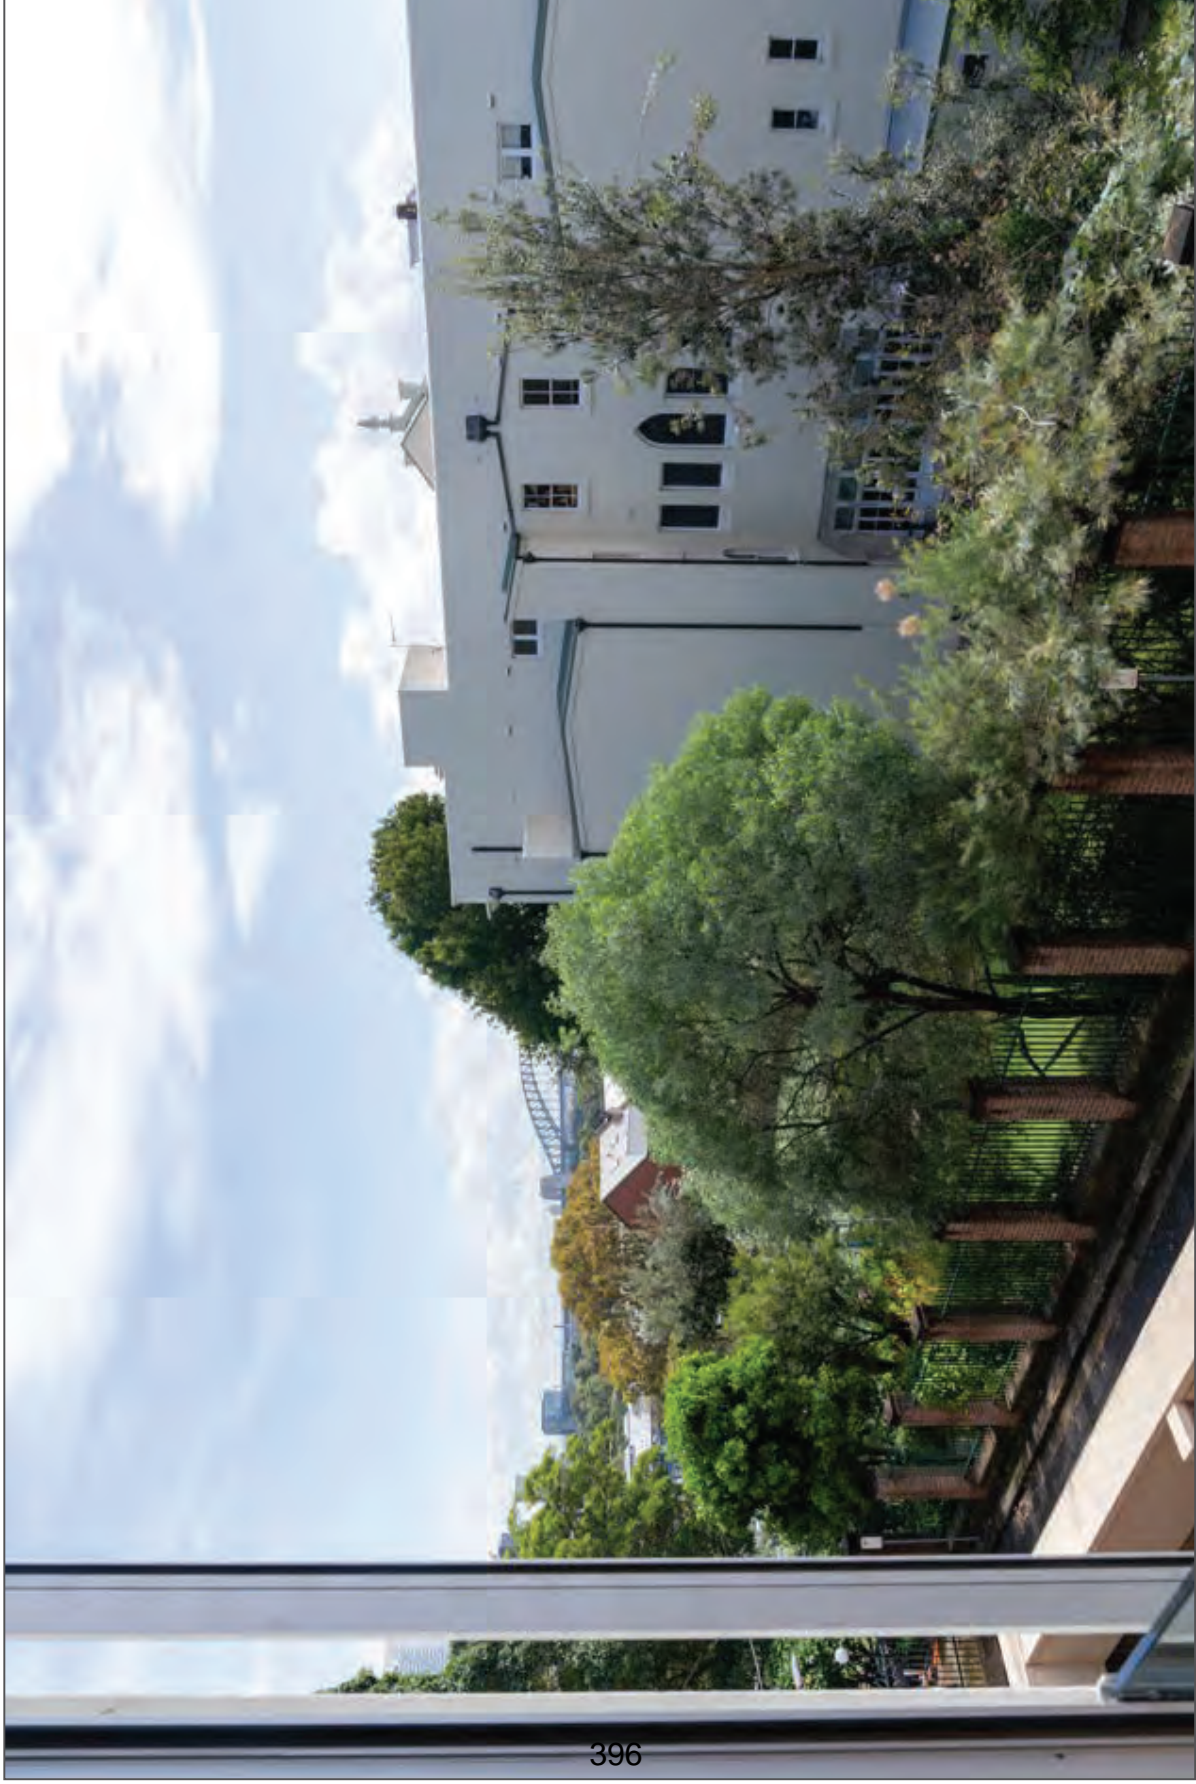
**12.2 VIEWPOINT POSITION 08 - Unit 2, 10 Rockwall Crescent, Level 1 Dining Room**

**PHOTOGRAPH OF CURRENT CONDITION**

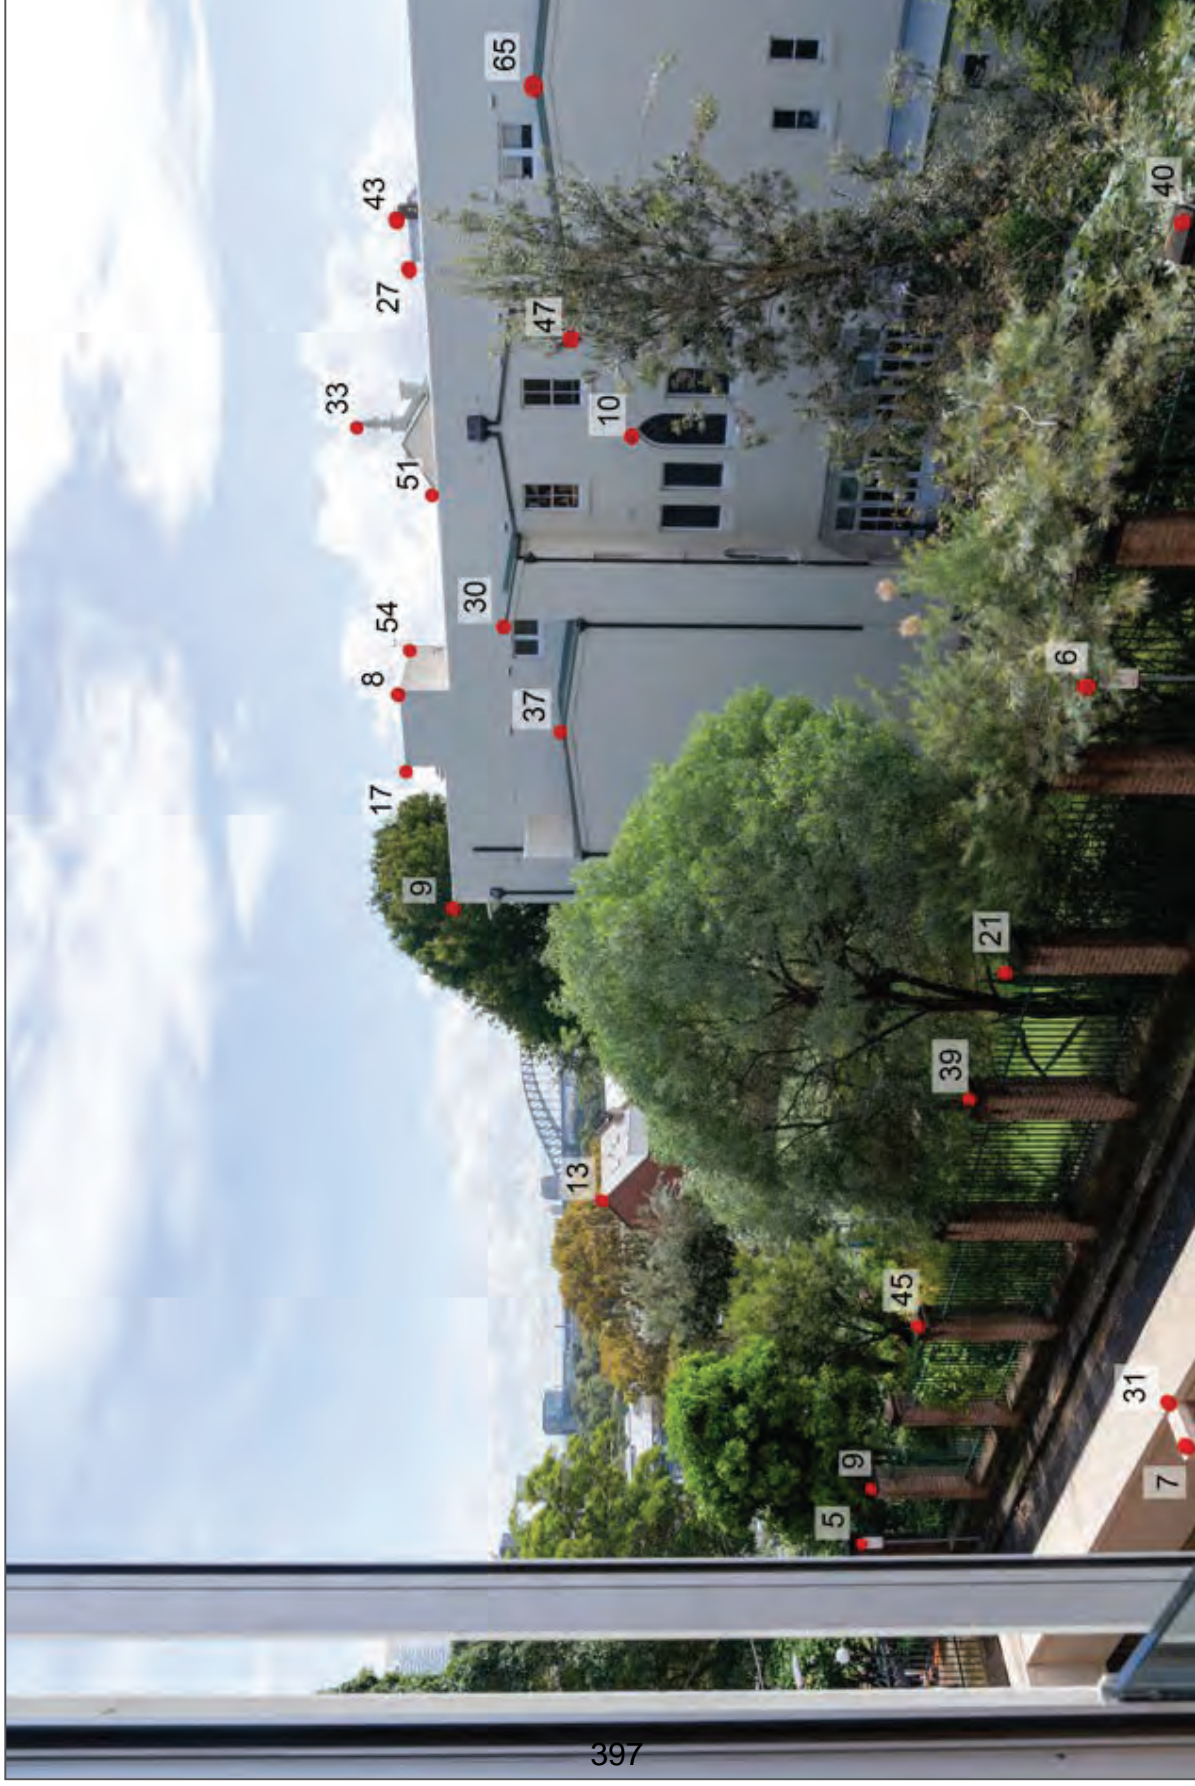
### 12.3 VIEWPOINT POSITION 08 - Unit 2, 10 Rockwall Crescent, Level 1 Dining Room

OVERLAY OF SURVEY POINTS USED FOR 3D CAMERA ALIGNMENT

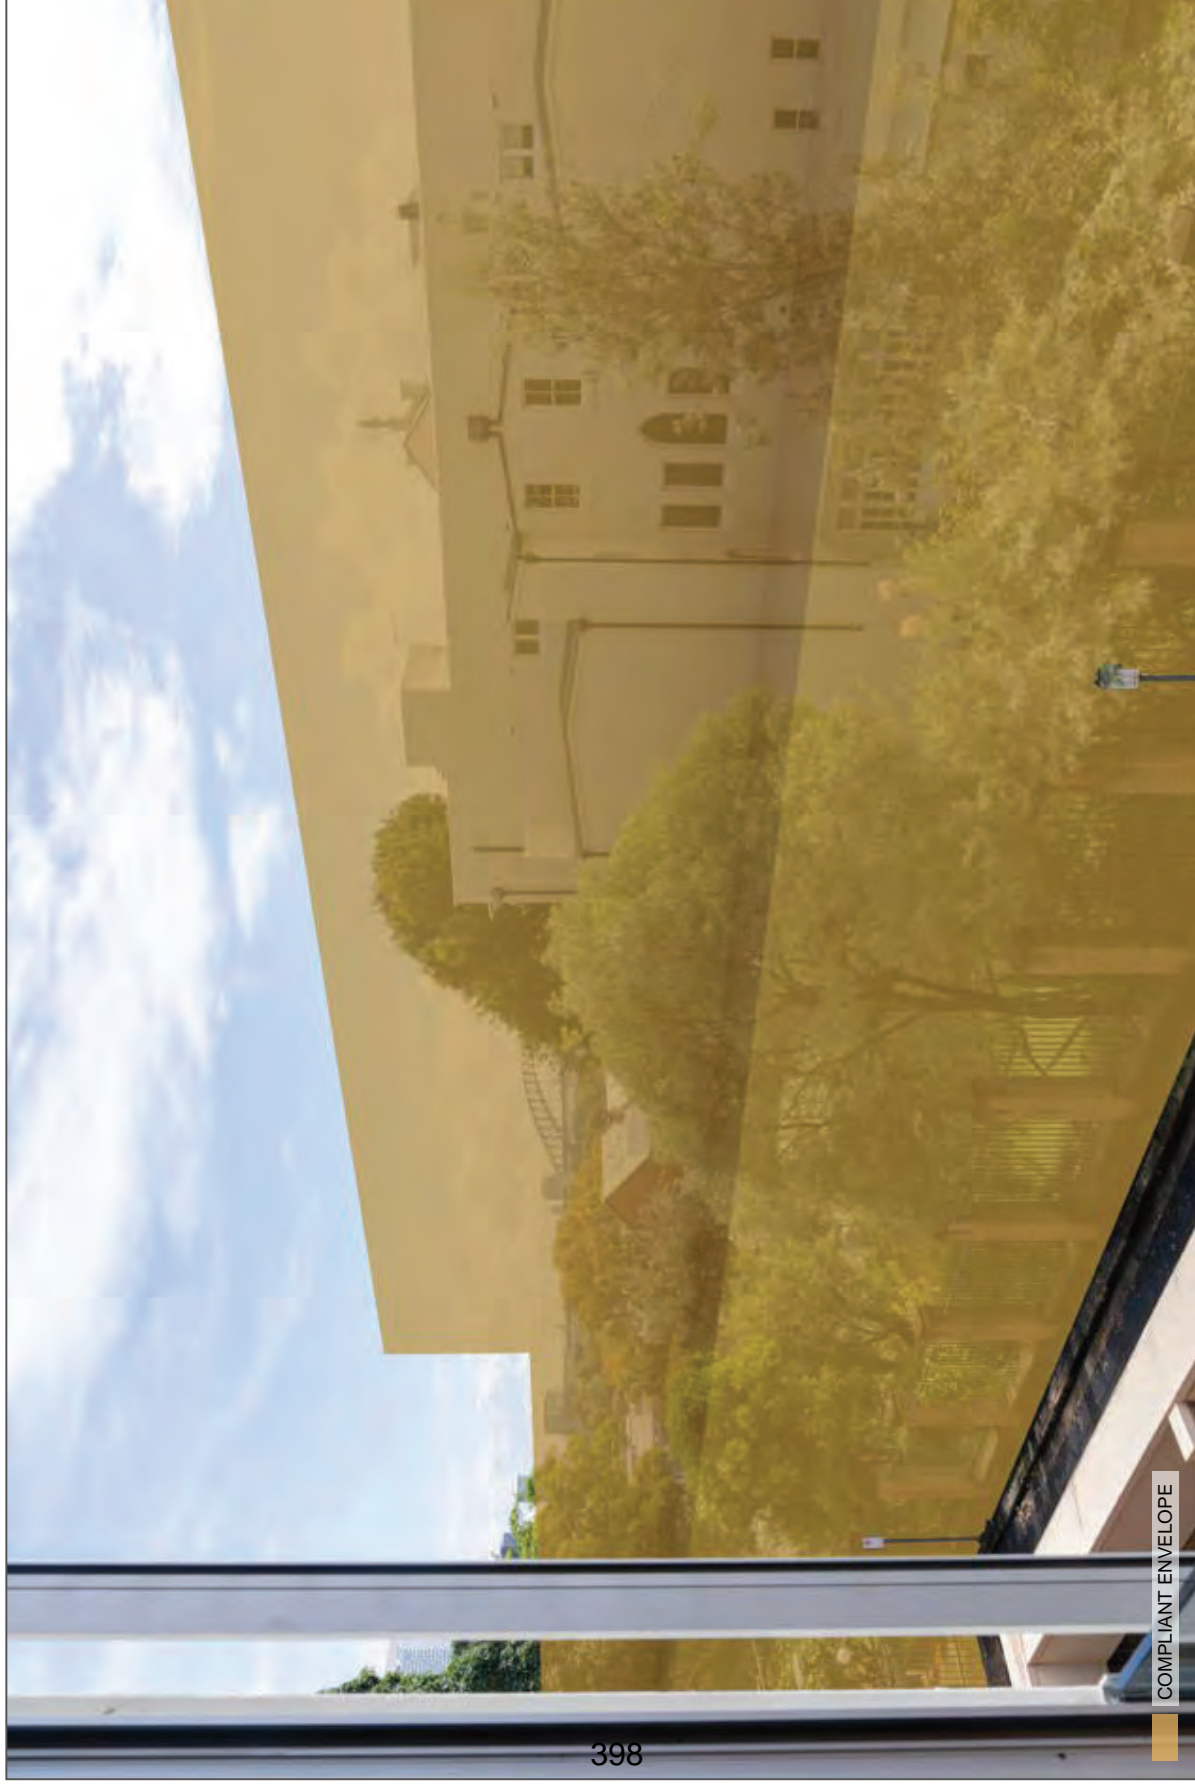
## 12.4 VIEWPOINT POSITION 08 - Unit 2, 10 Rockwall Crescent, Level 1 Dining Room

PHOTOMONTAGE OF COMPLIANT BUILDING ENVELOPE

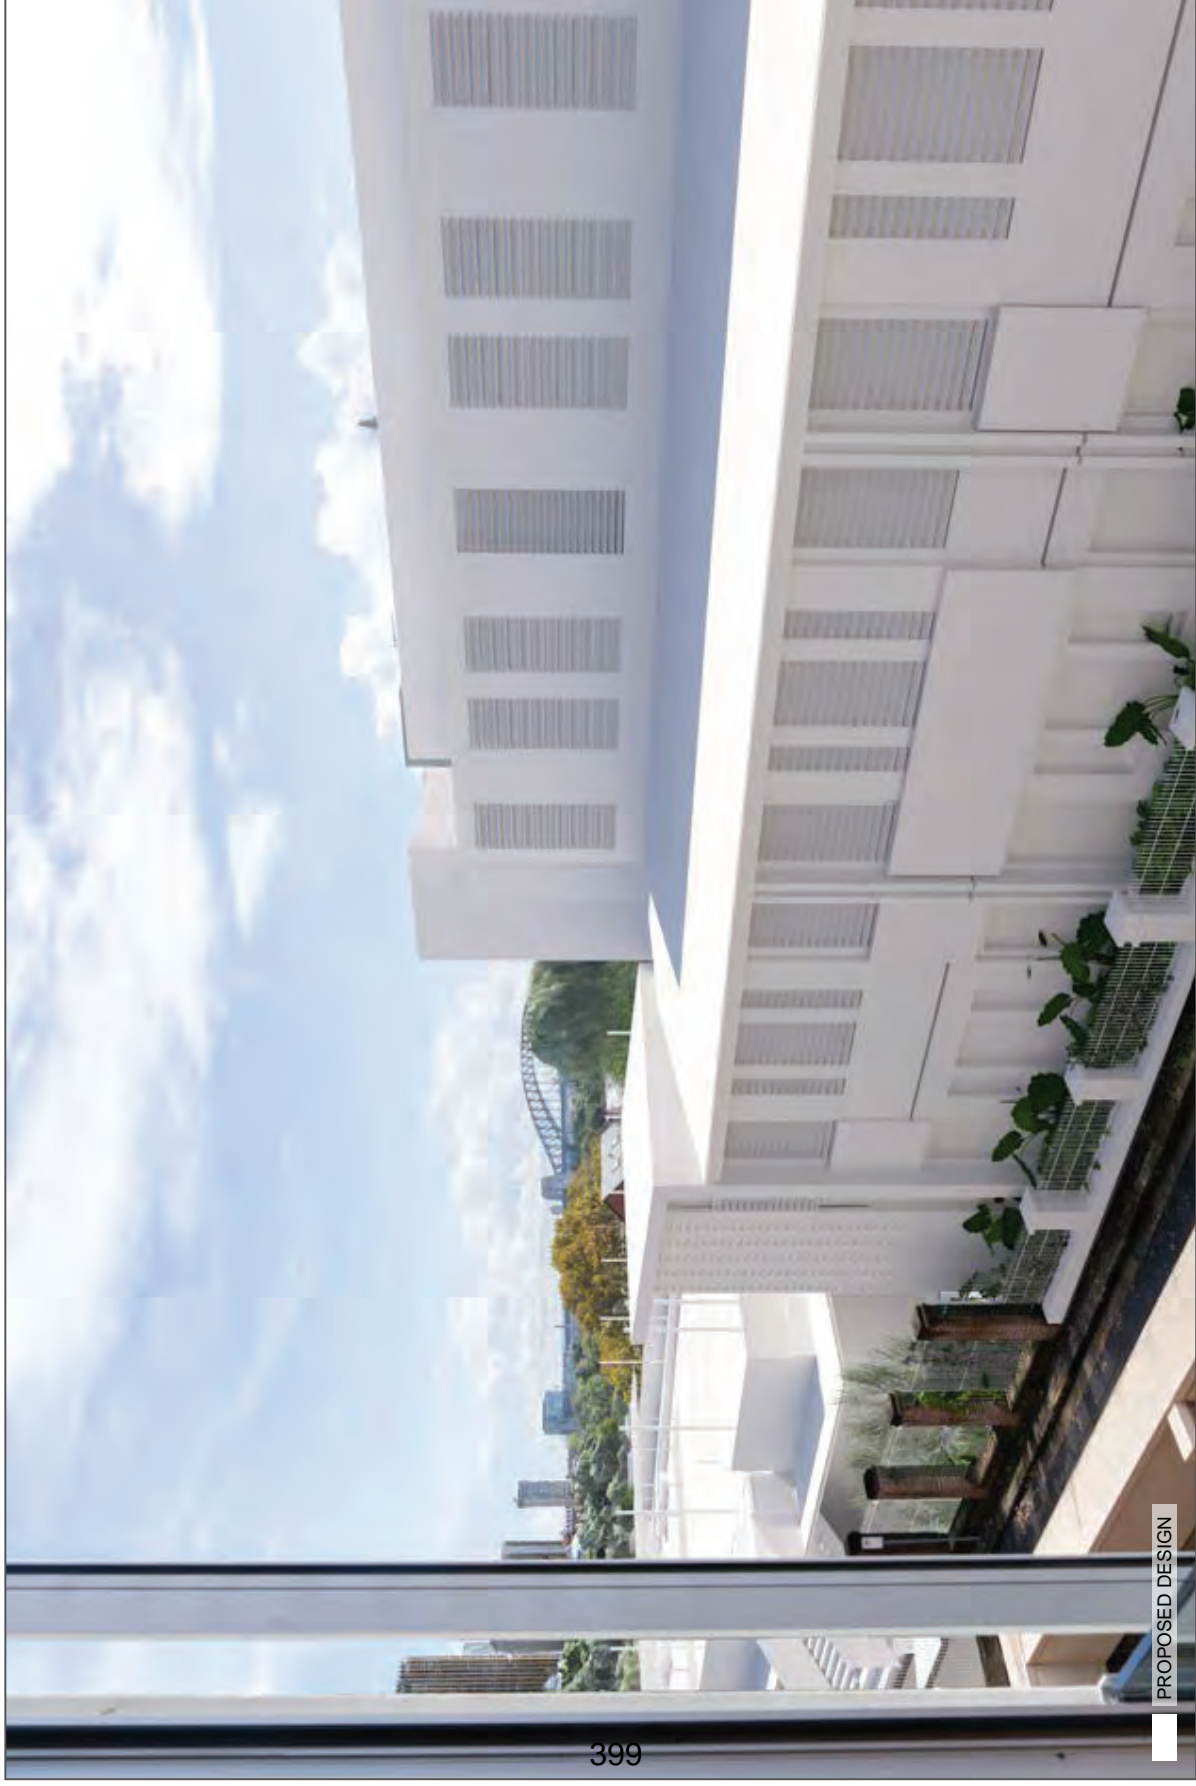
## 12.5 VIEWPOINT POSITION 08 - Unit 2, 10 Rockwall Crescent, Level 1 Dining Room

PHOTOMONTAGE OF PROPOSED BUILDING DESIGN

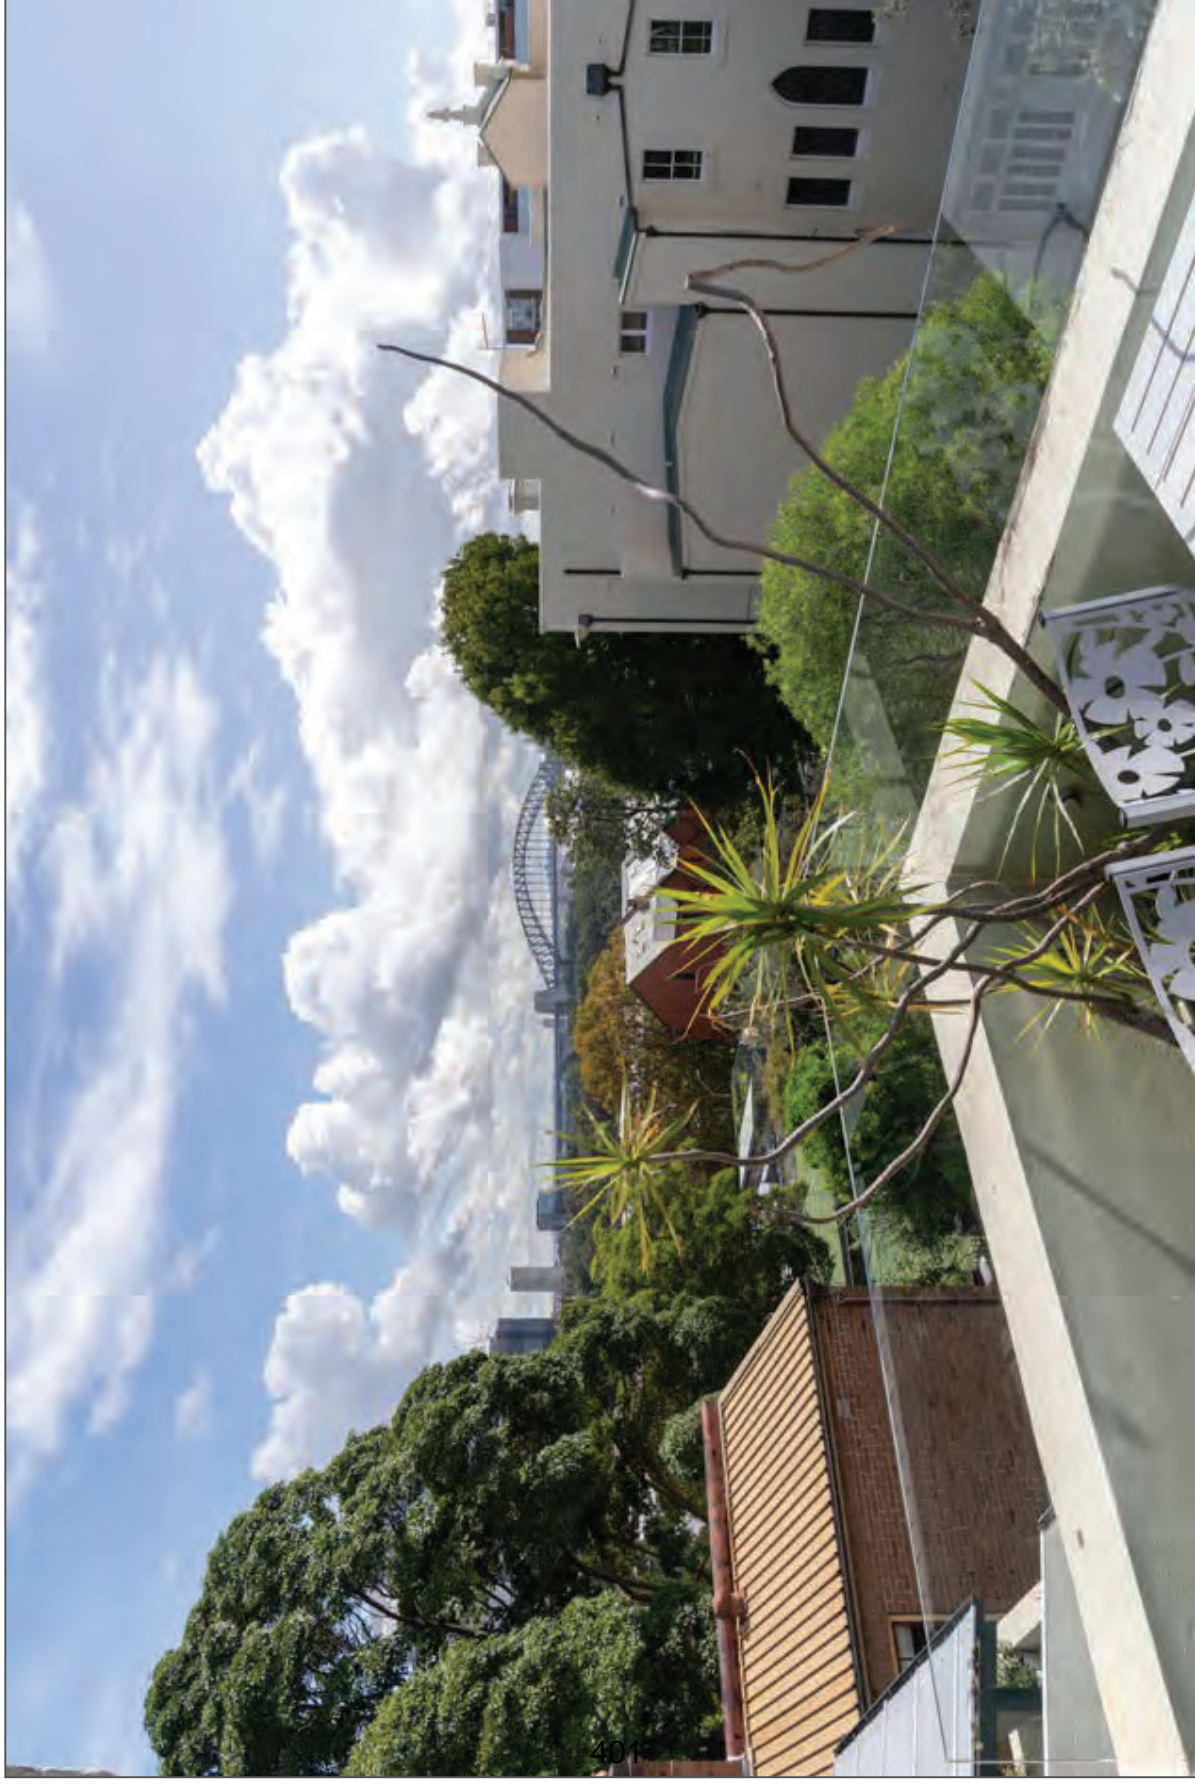
### 13.2 VIEWPOINT POSITION 09 - Unit 2, 10 Rockwall Crescent, Level 2 Balcony

PHOTOGRAPH OF CURRENT CONDITION
