# View Loss Assessment

Submitted to City of Sydney in response to RFI dated 31 July 2024

St Vincent's College, 1 Challis Avenue, Potts Point  
The Trustees of the Sisters of Charity of Australia

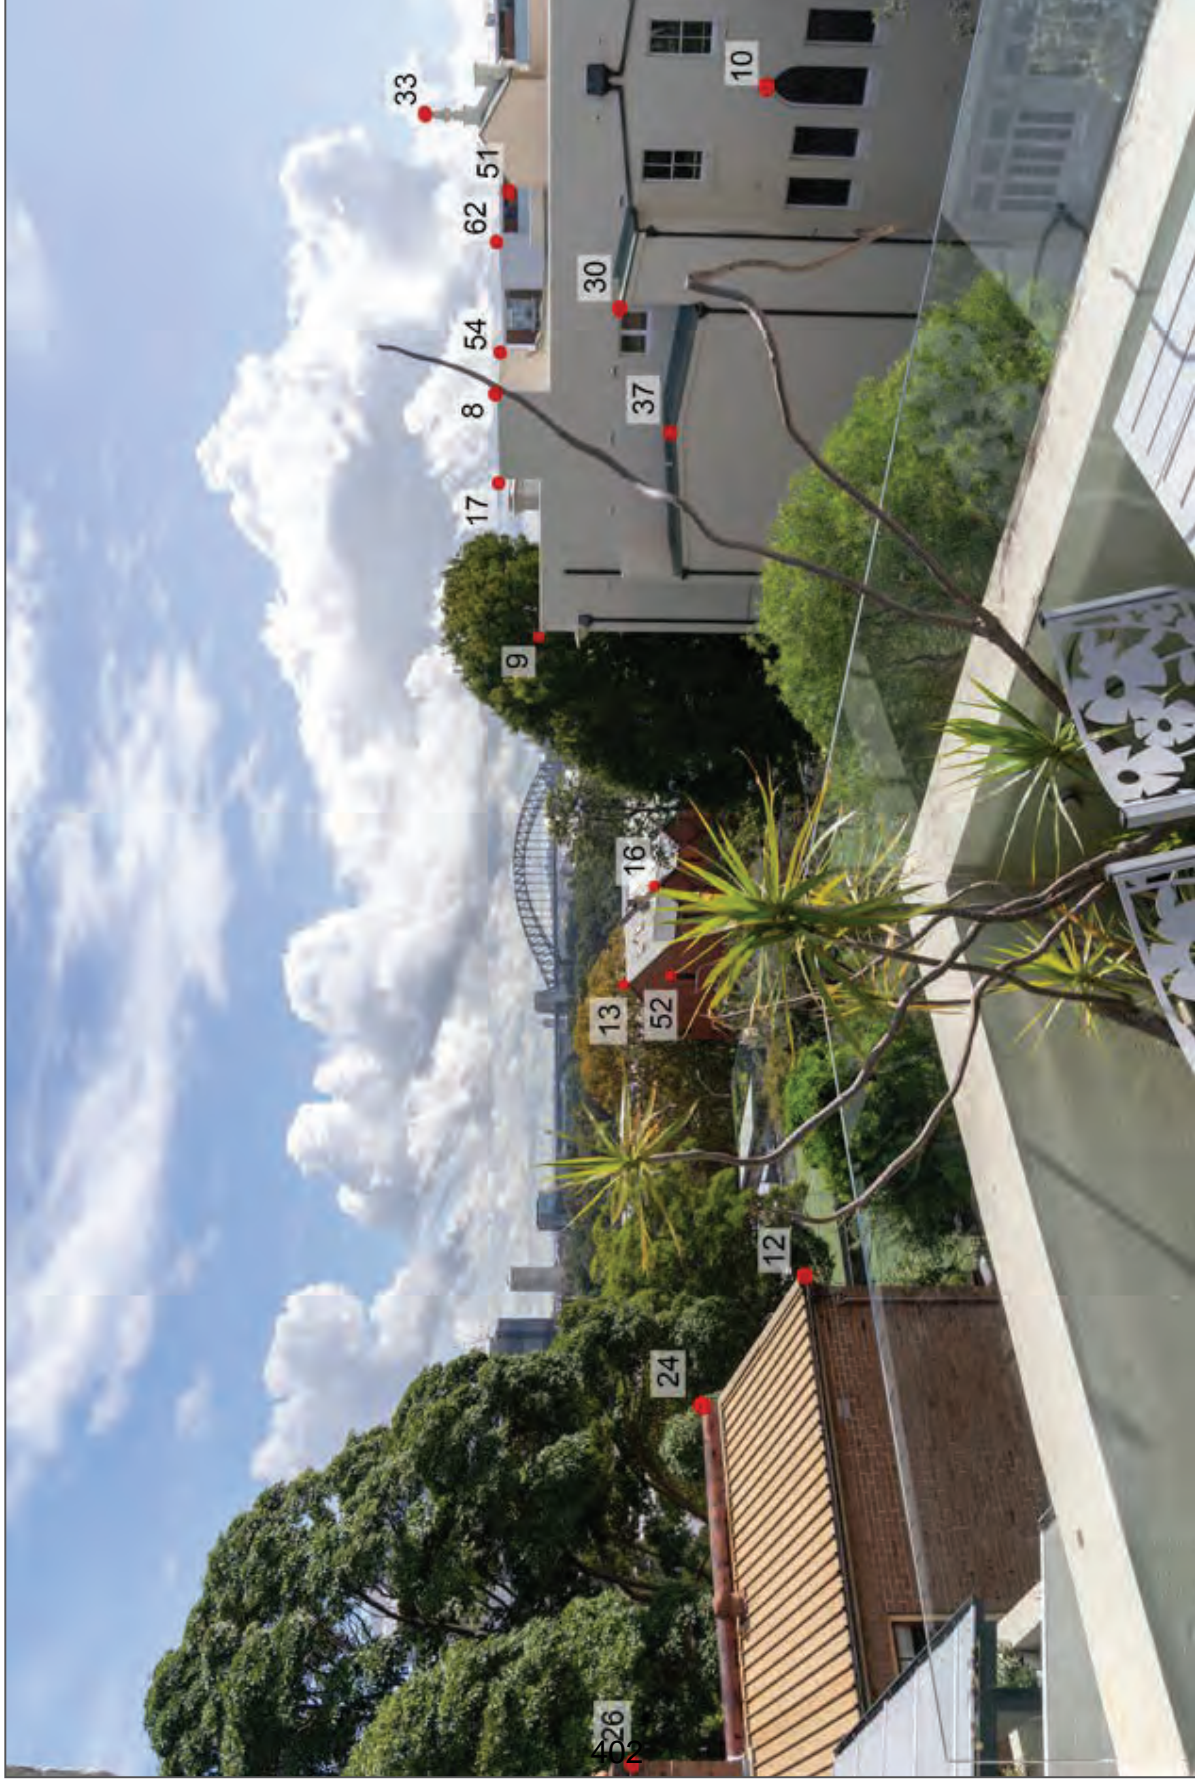
### 13.3 VIEWPOINT POSITION 09 - Unit 2, 10 Rockwall Crescent, Level 2 Balcony

OVERLAY OF SURVEY POINTS USED FOR 3D CAMERA ALIGNMENT

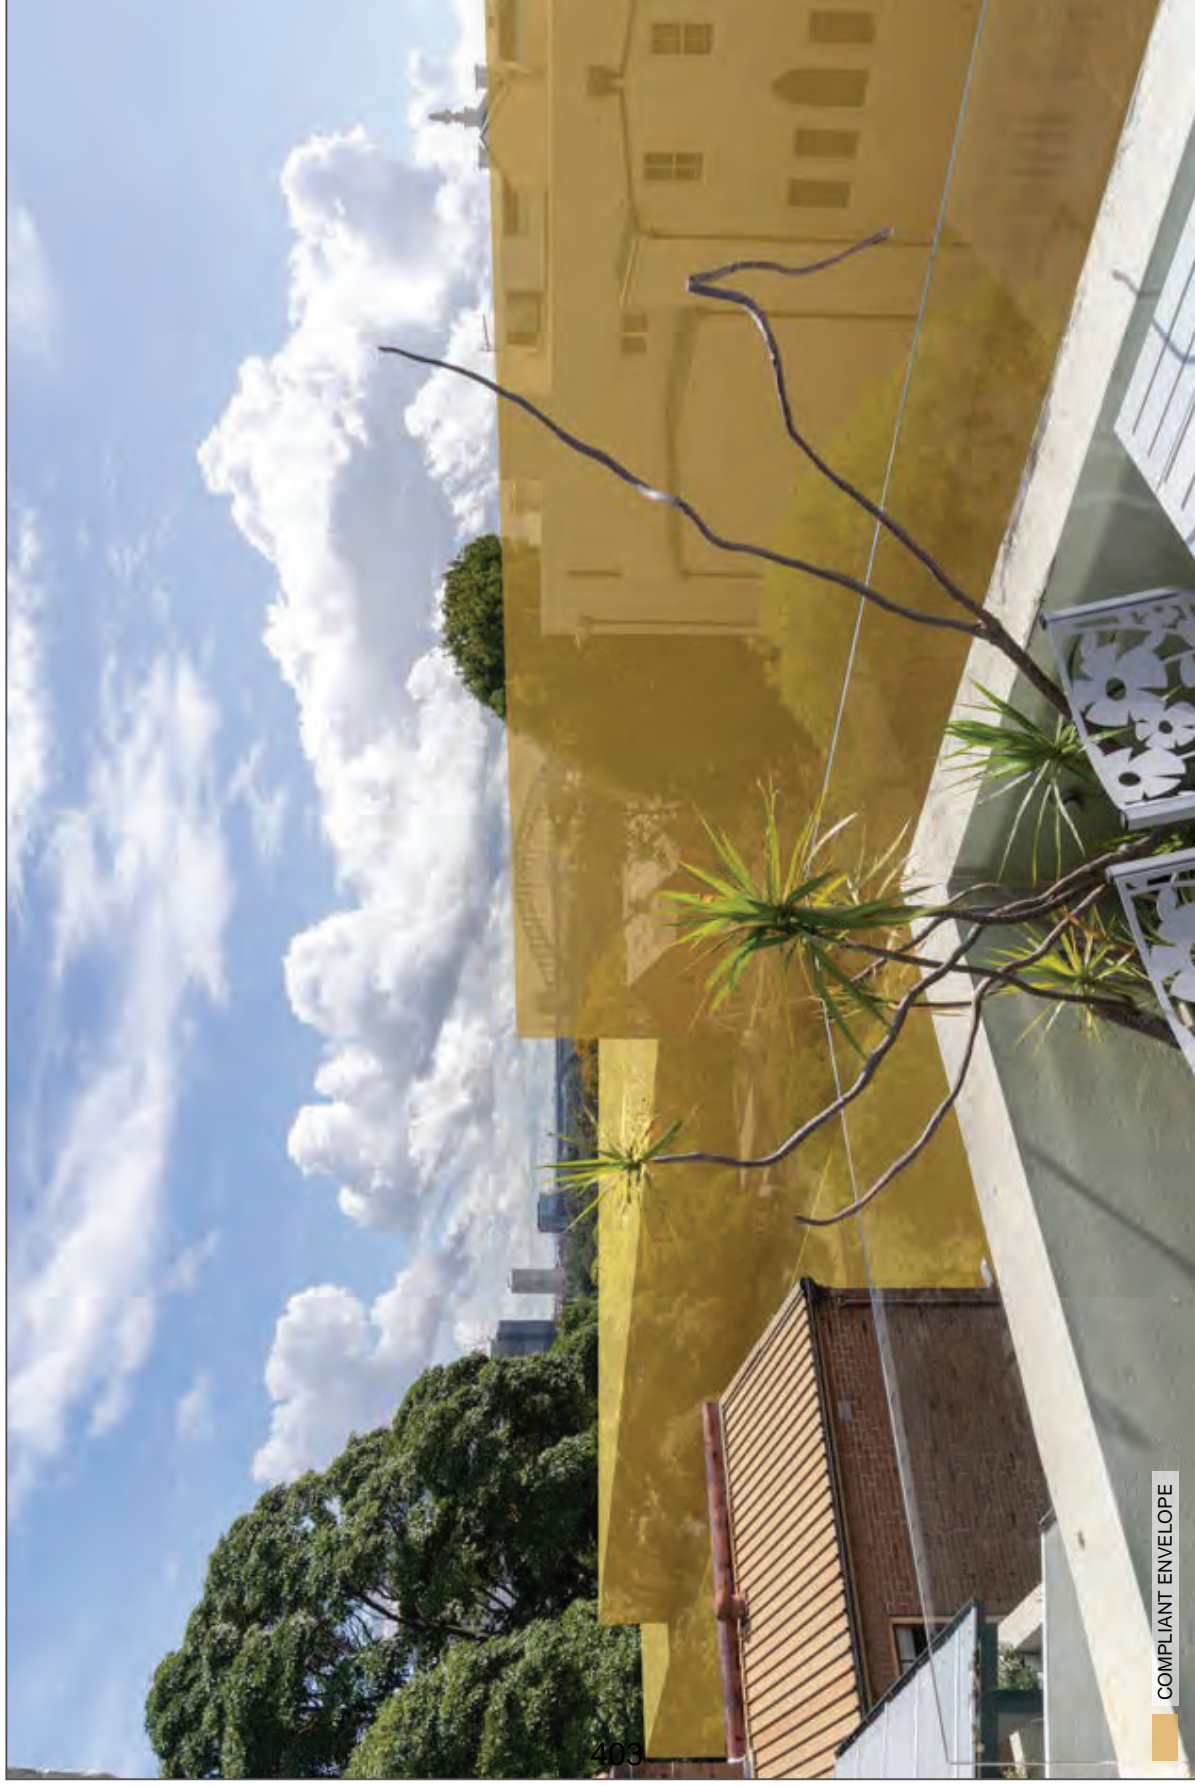
### 13.4 VIEWPOINT POSITION 09 - Unit 2, 10 Rockwall Crescent, Level 2 Balcony

PHOTOMONTAGE OF COMPLIANT BUILDING ENVELOPE

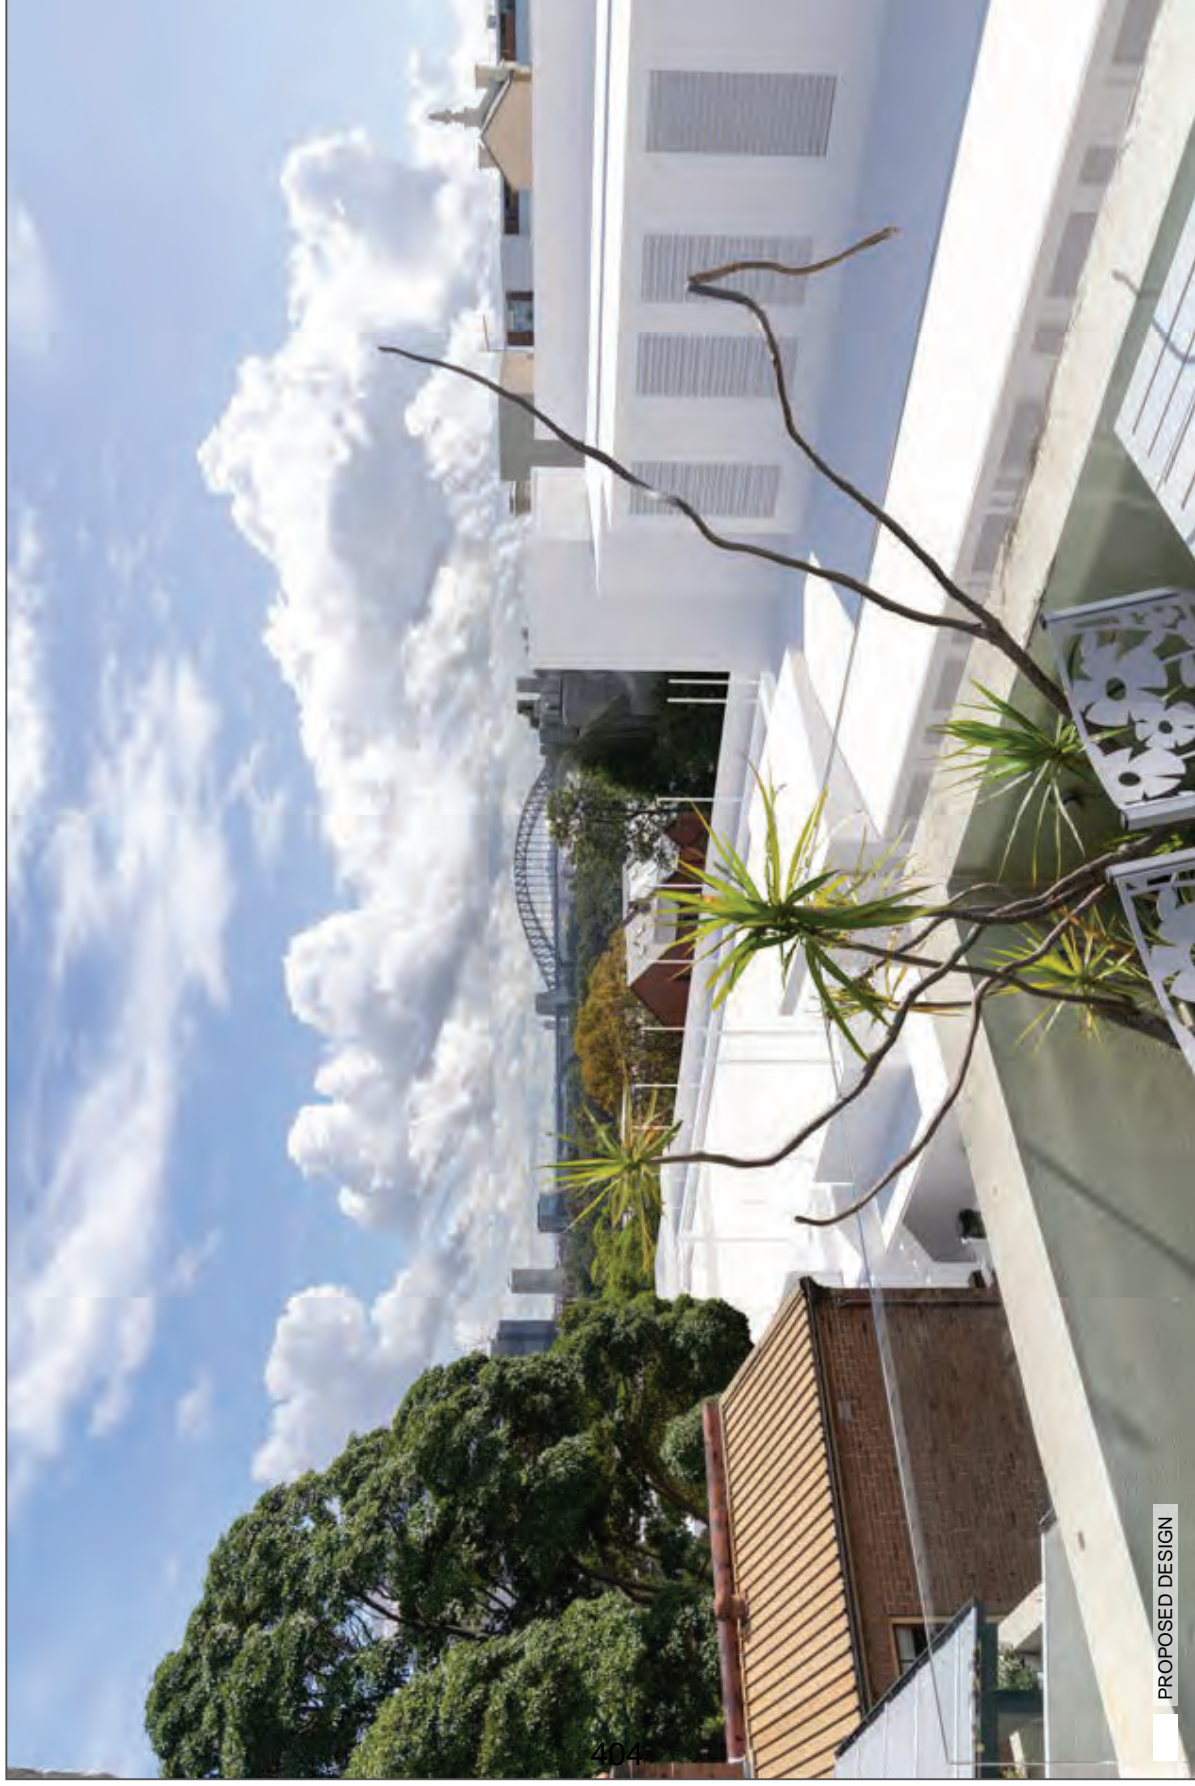
### 13.5 VIEWPOINT POSITION 09 - Unit 2, 10 Rockwall Crescent, Level 2 Balcony

PHOTOMONTAGE OF PROPOSED BUILDING DESIGN

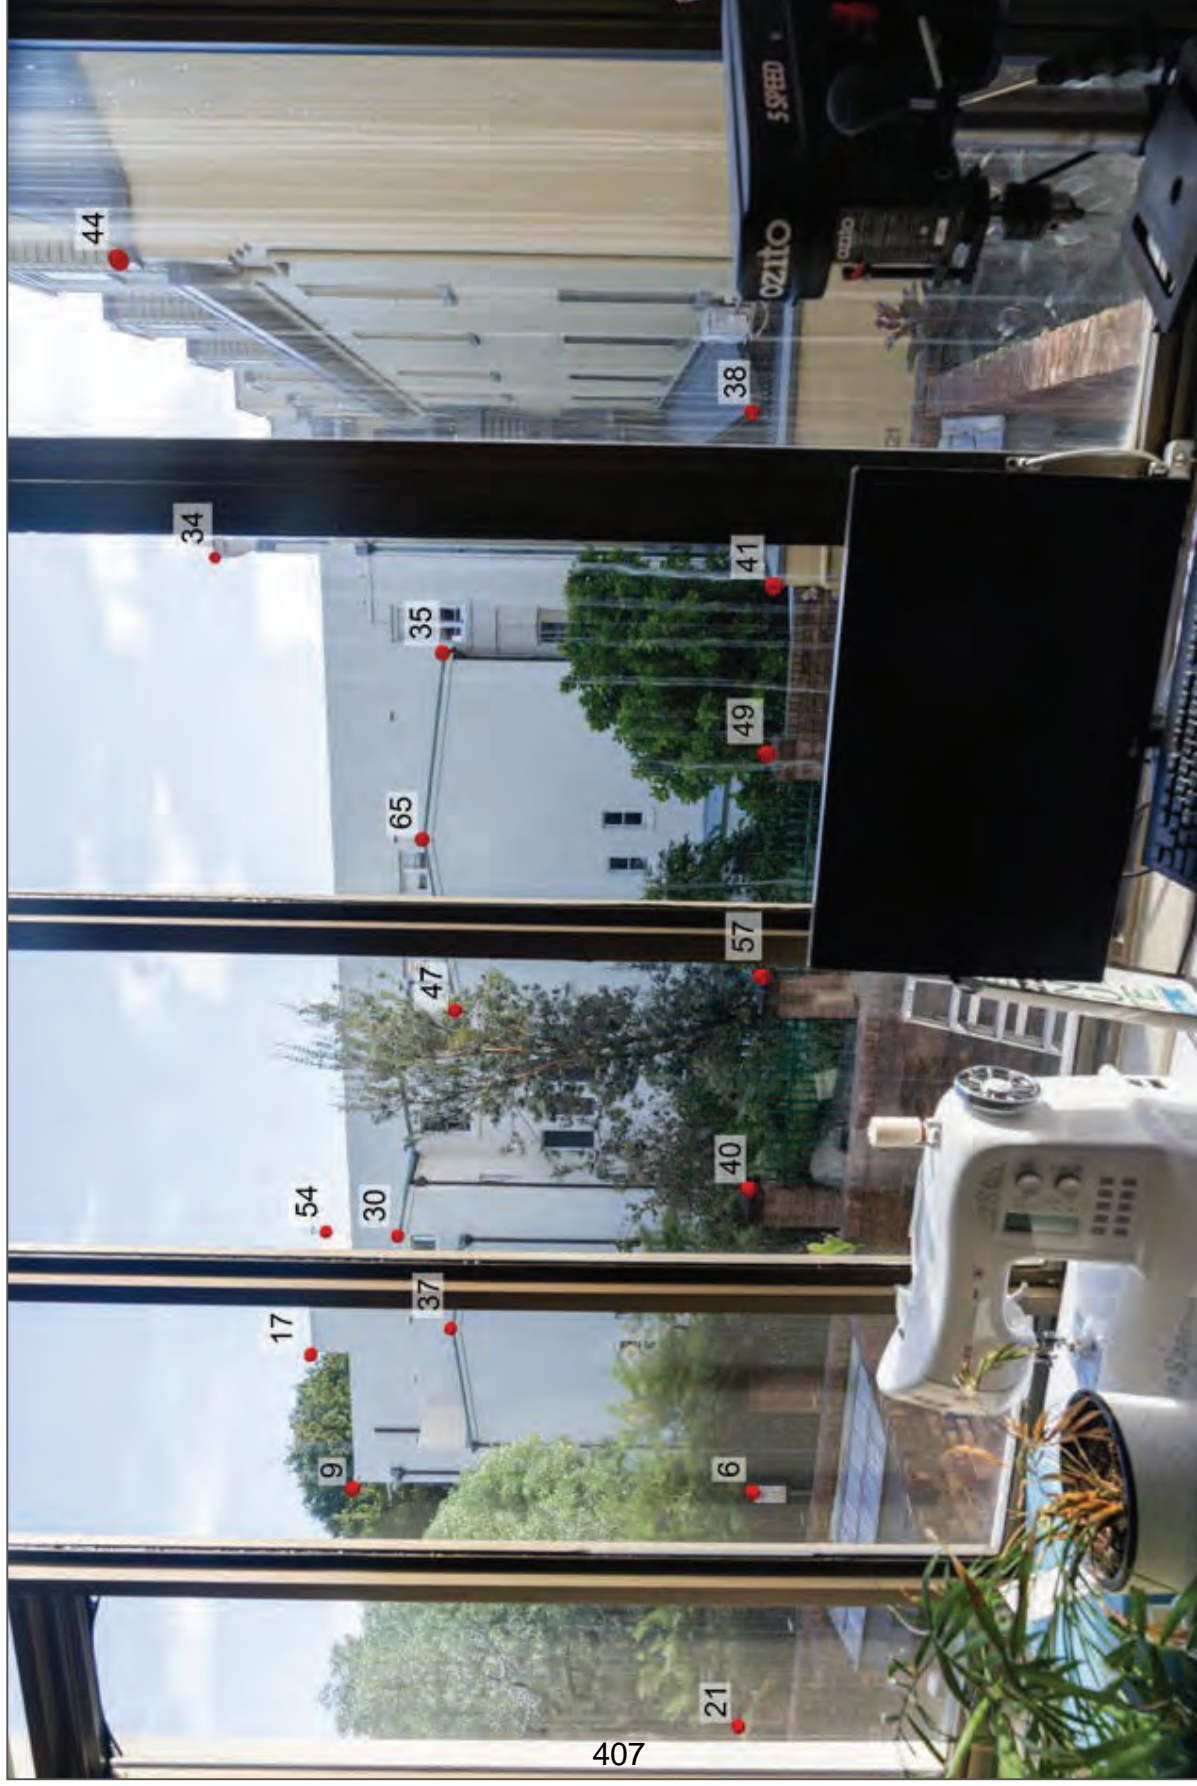
### 14.3 VIEWPOINT POSITION 10 - Unit 1, 12 Rockwall Crescent, Upper Ground Study

OVERLAY OF SURVEY POINTS USED FOR 3D CAMERA ALIGNMENT

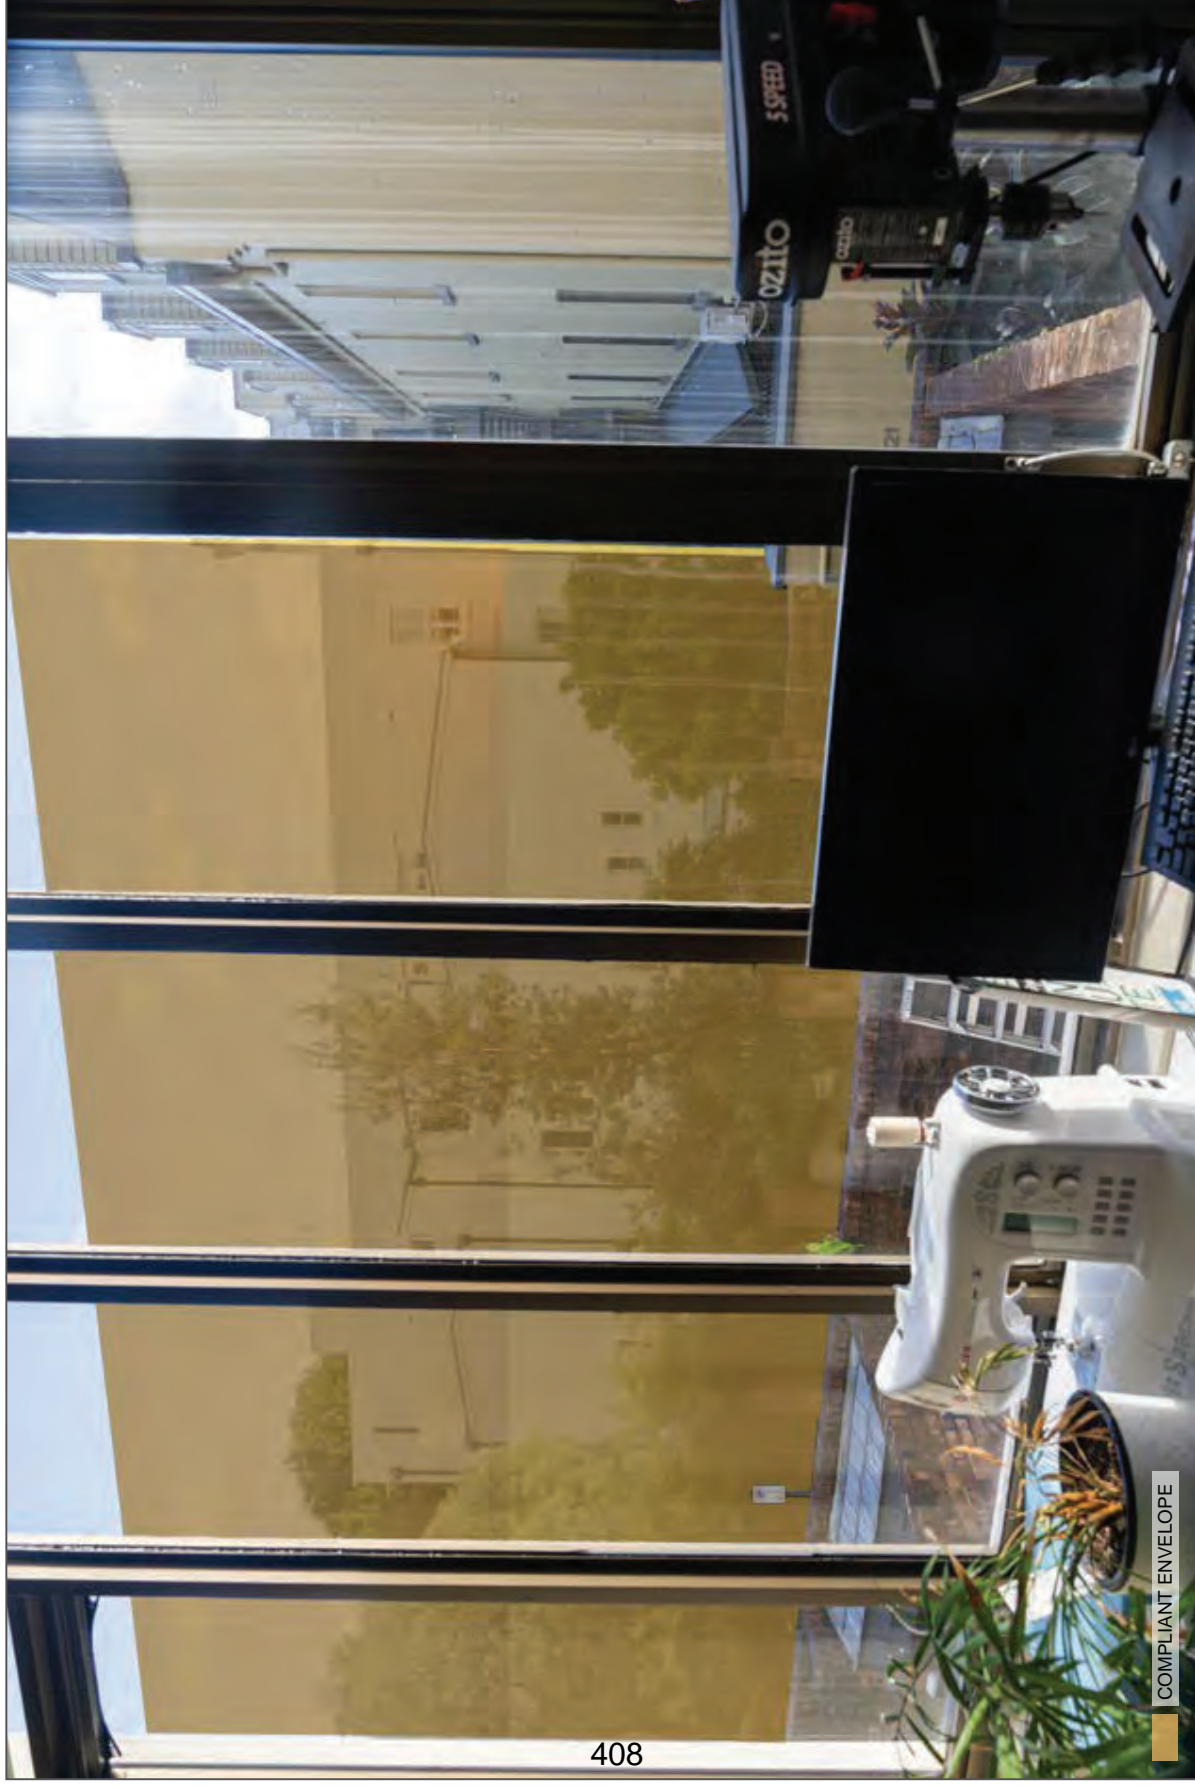
#### 14.4 VIEWPOINT POSITION 10 - Unit 1, 12 Rockwall Crescent, Upper Ground Study

PHOTOMONTAGE OF COMPLIANT BUILDING ENVELOPE

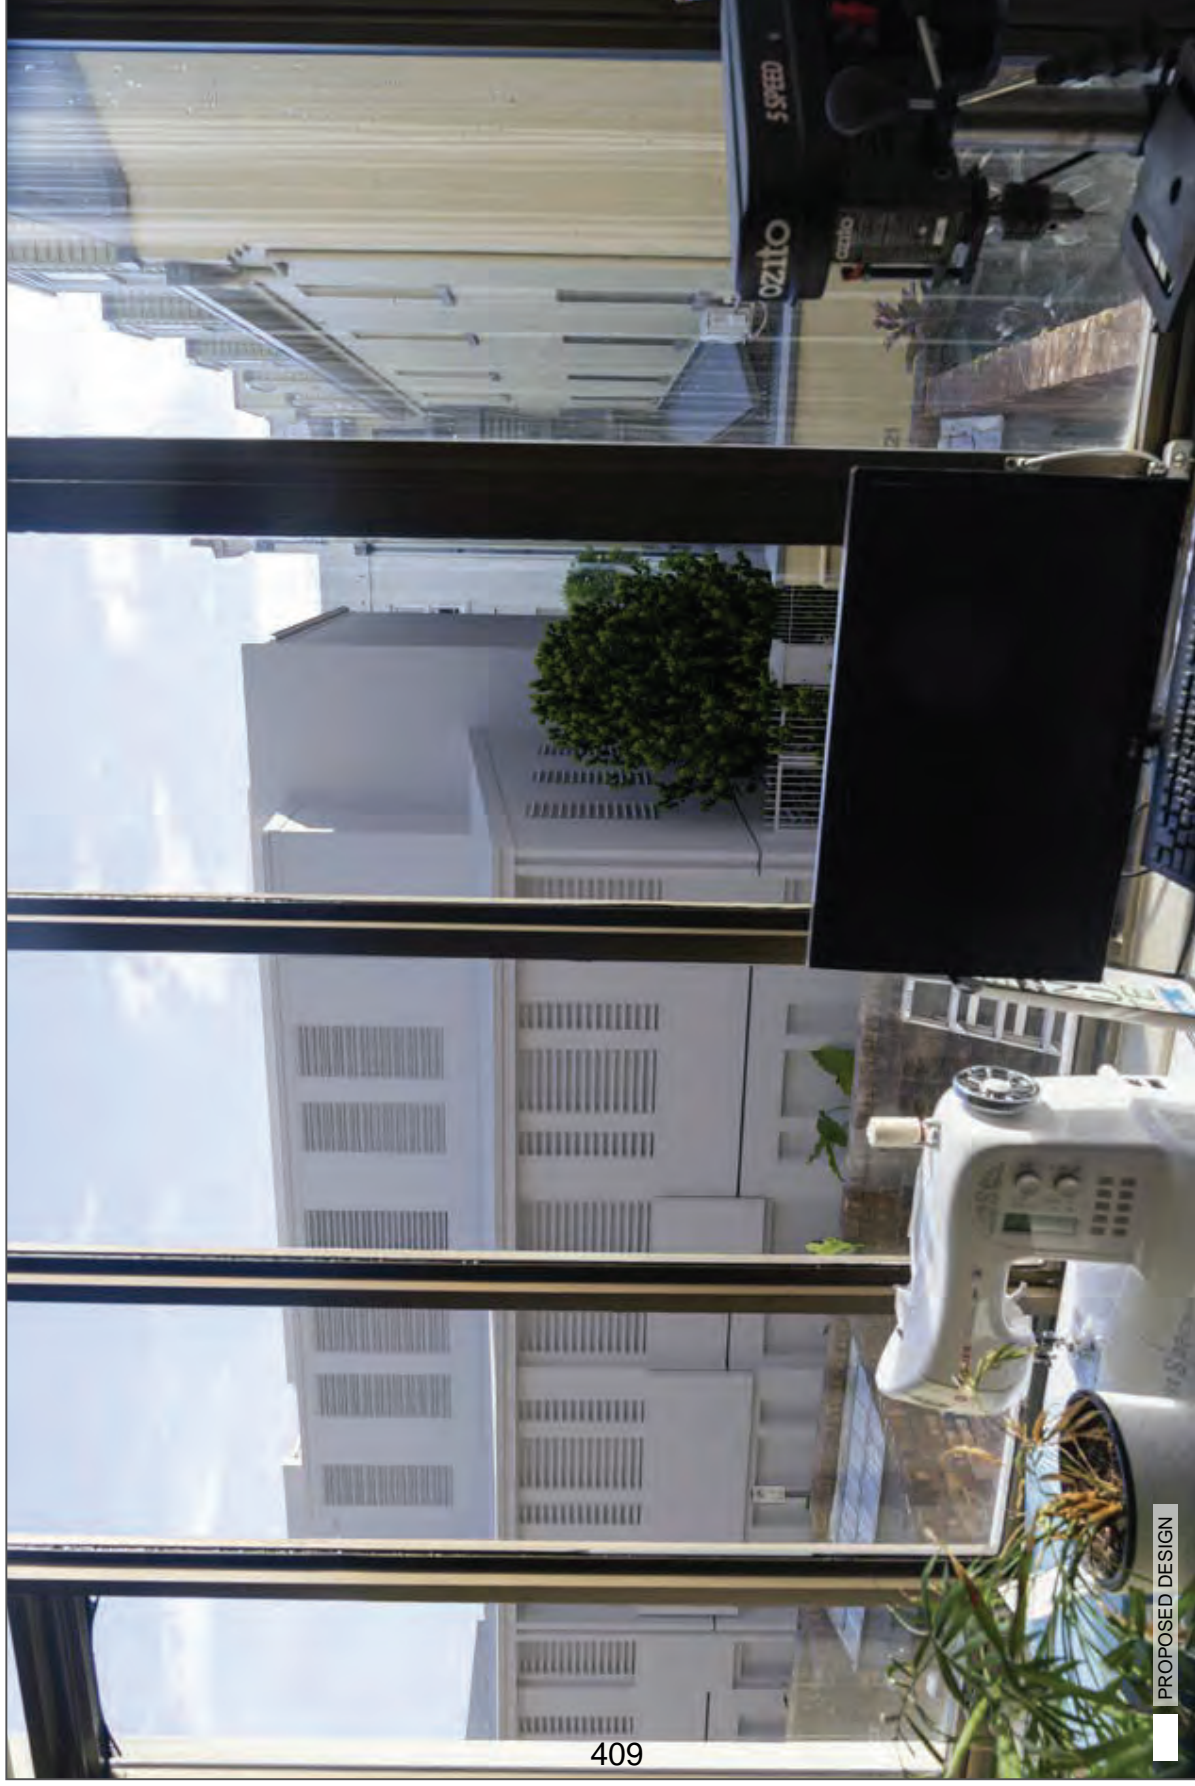
### 14.5 VIEWPOINT POSITION 10 - Unit 1, 12 Rockwall Crescent, Upper Ground Study

PHOTOMONTAGE OF PROPOSED BUILDING DESIGN

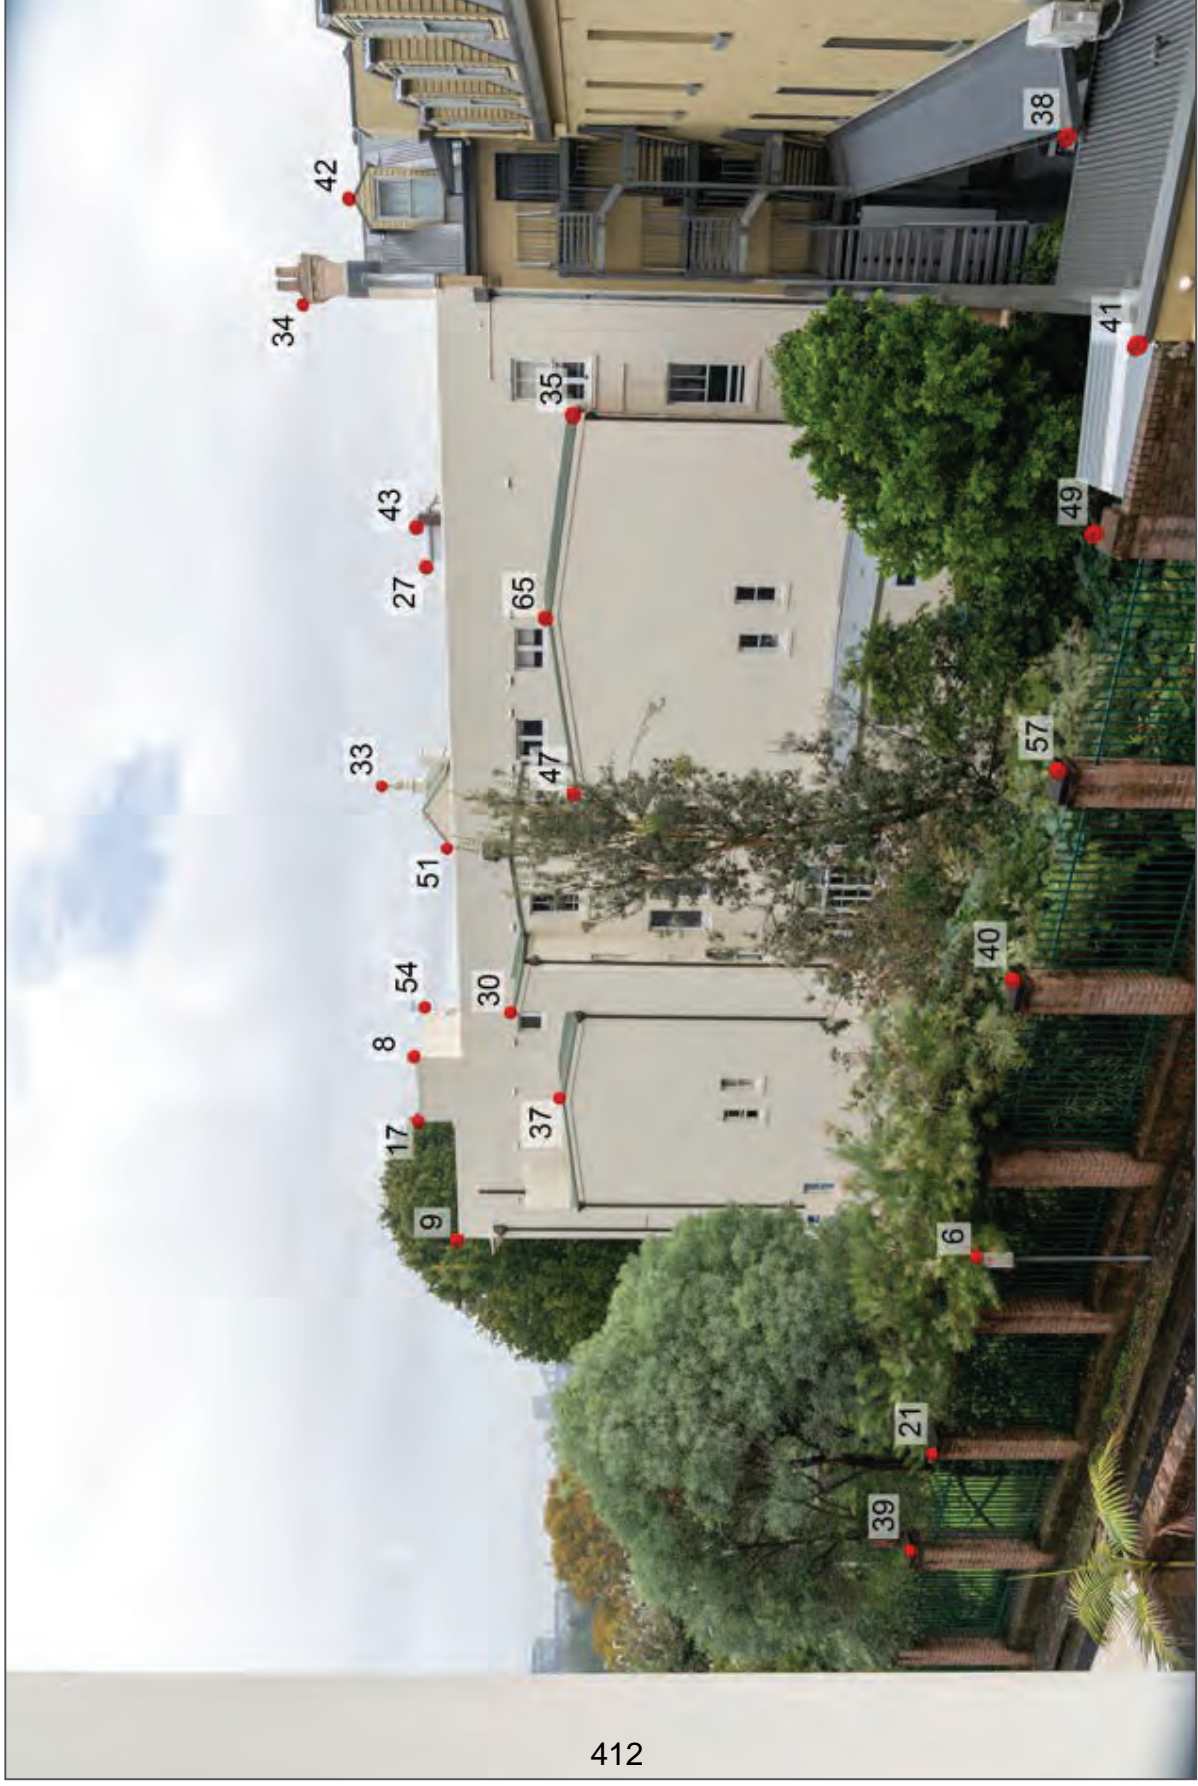
### 15.3 VIEWPOINT POSITION 11 - Unit 2, 12 Rockwall Crescent, Level 1 Lounge

OVERLAY OF SURVEY POINTS USED FOR 3D CAMERA ALIGNMENT

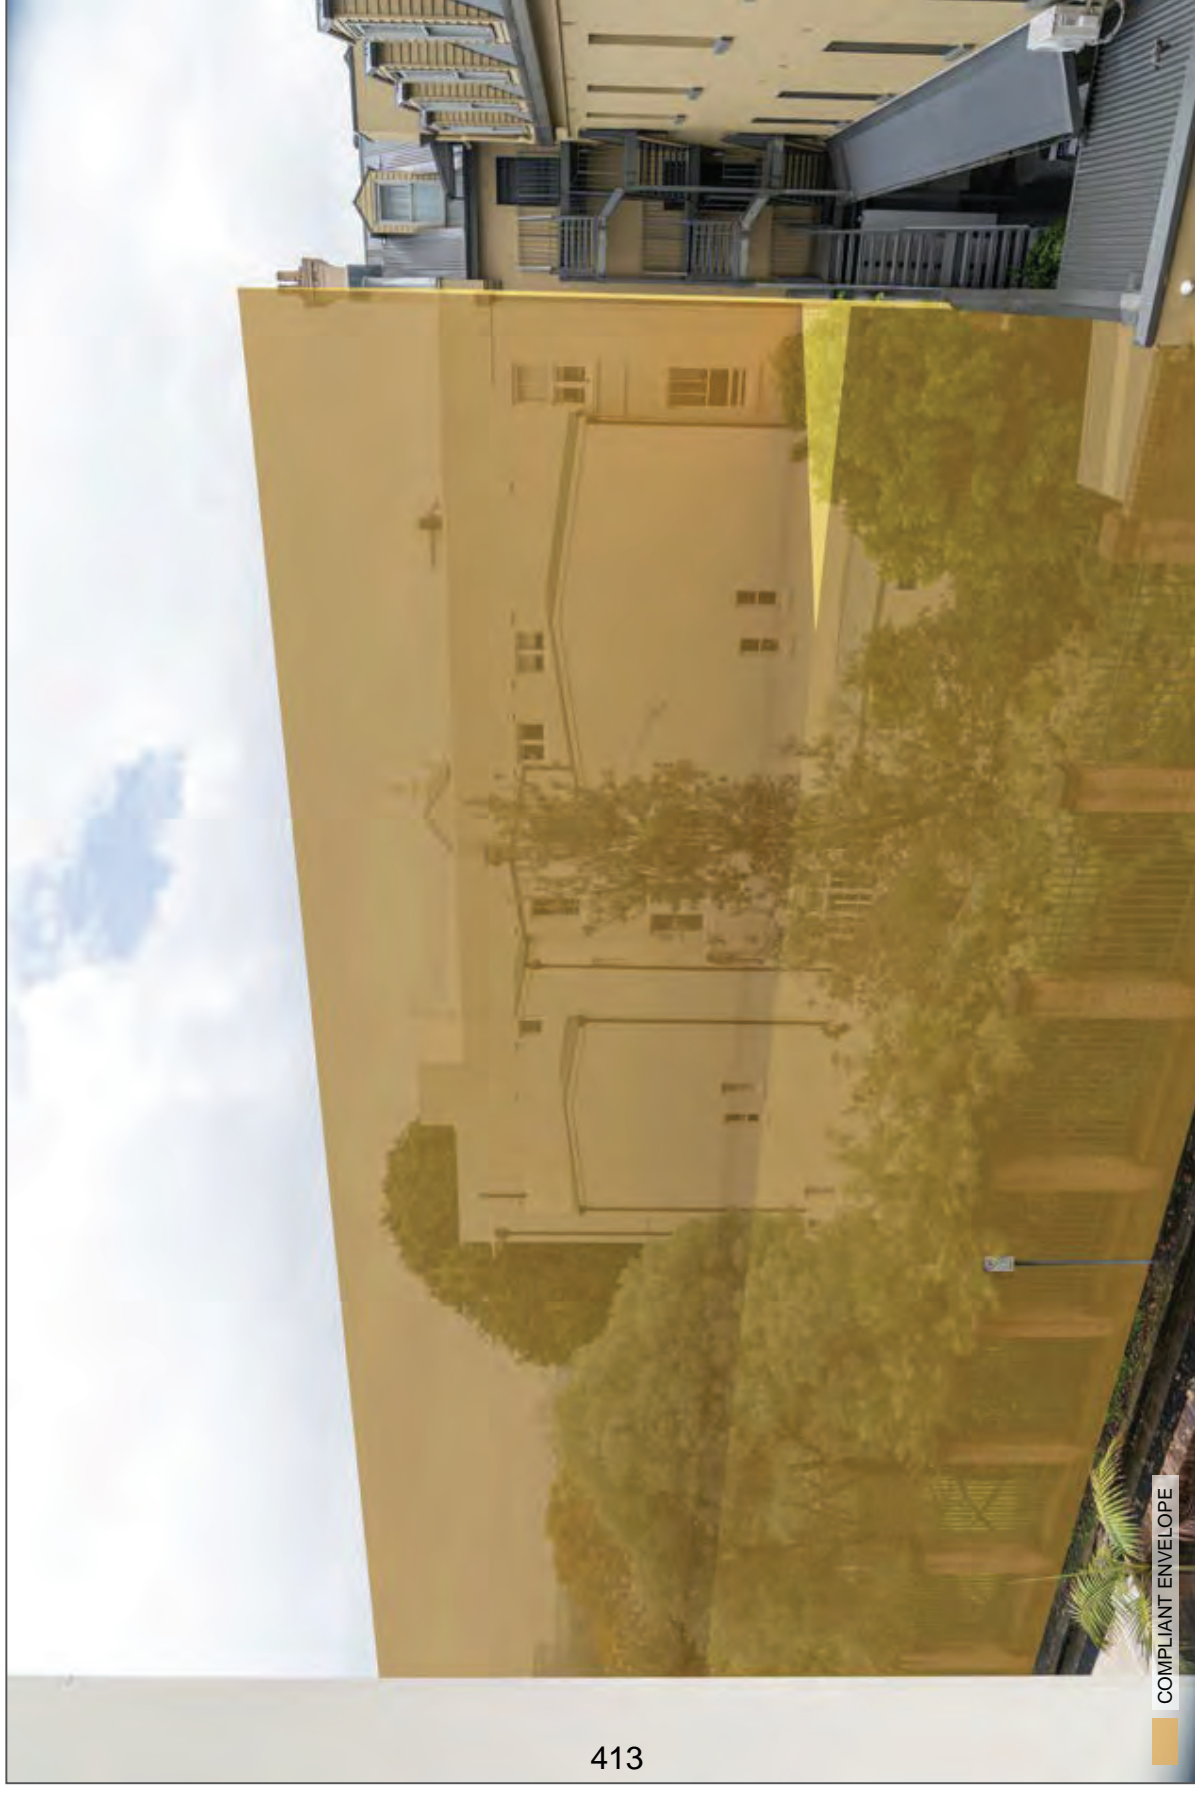
### 15.4 VIEWPOINT POSITION 11 - Unit 2, 12 Rockwall Crescent, Level 1 Lounge

PHOTOMONTAGE OF COMPLIANT BUILDING ENVELOPE

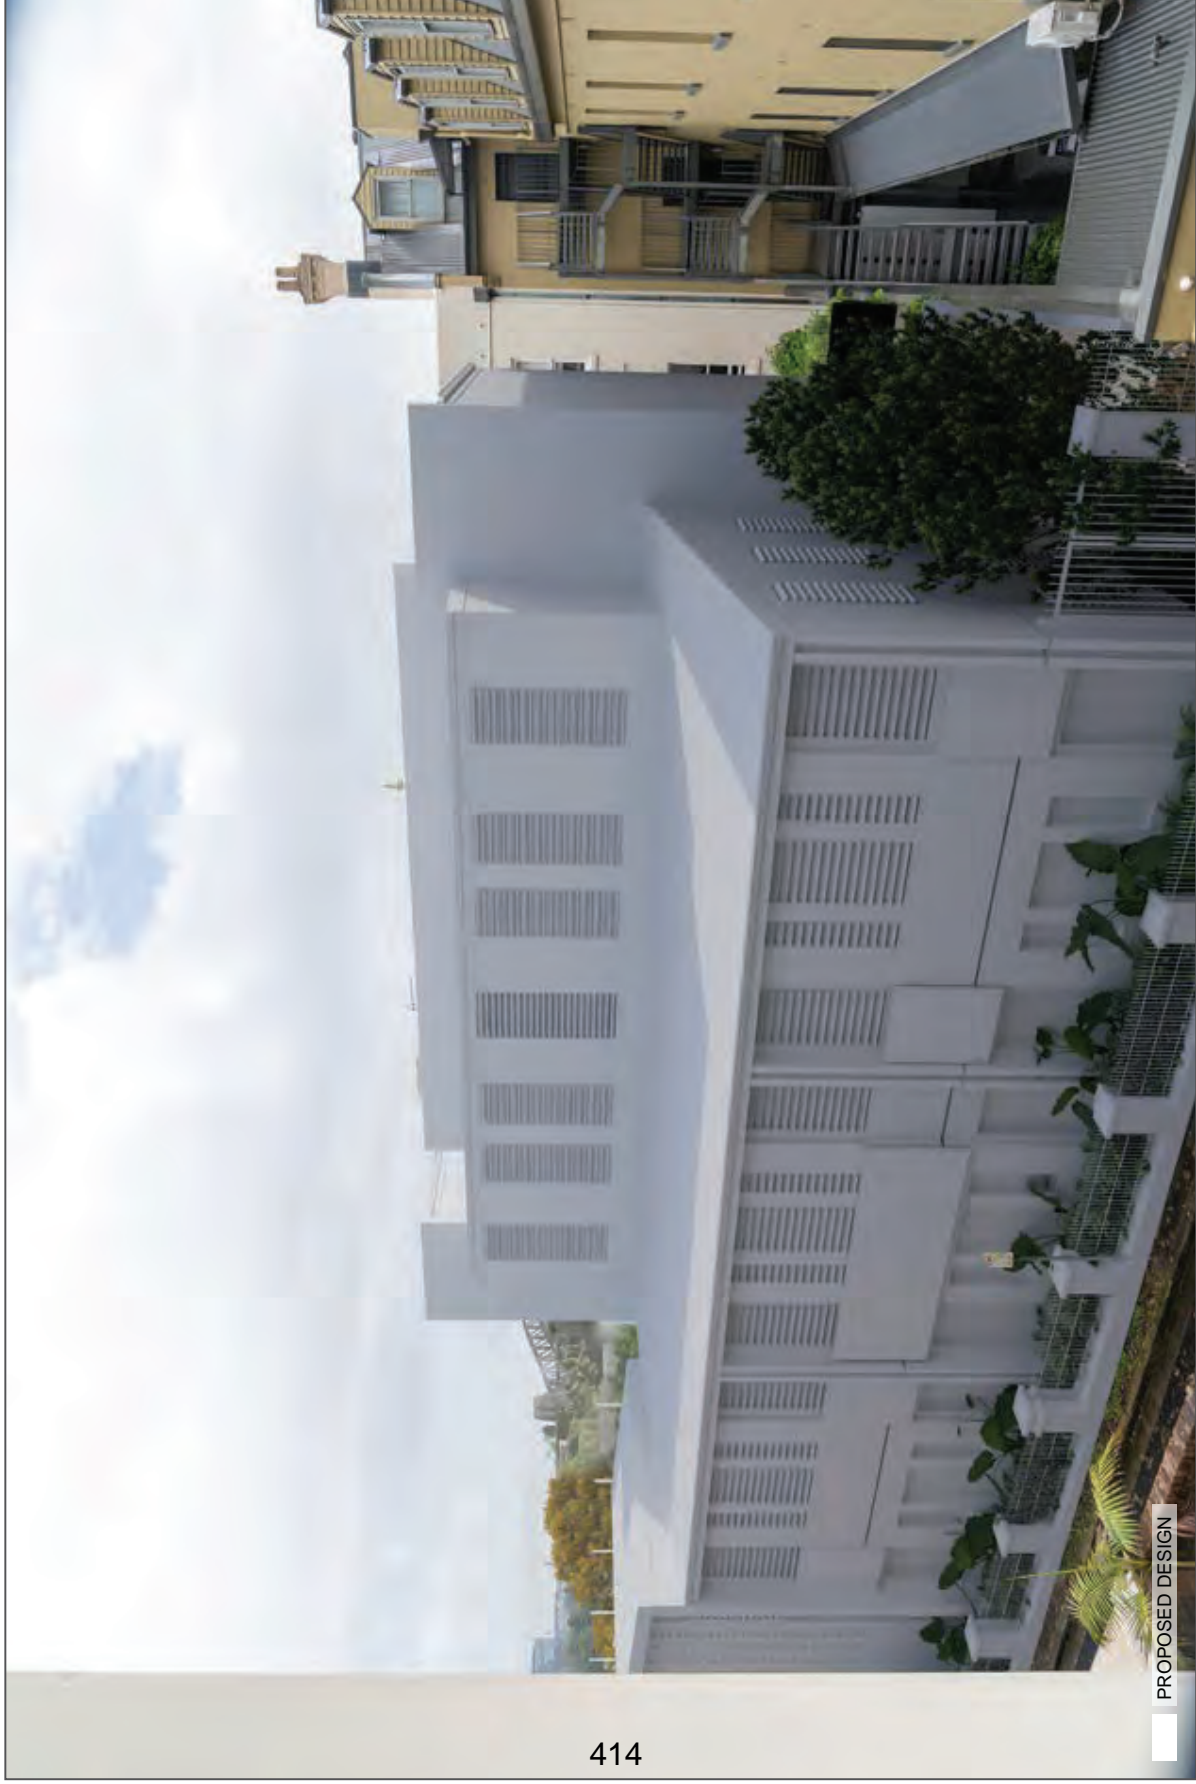
### 15.5 VIEWPOINT POSITION 11 - Unit 2, 12 Rockwall Crescent, Level 1 Lounge

PHOTOMONTAGE OF PROPOSED BUILDING DESIGN

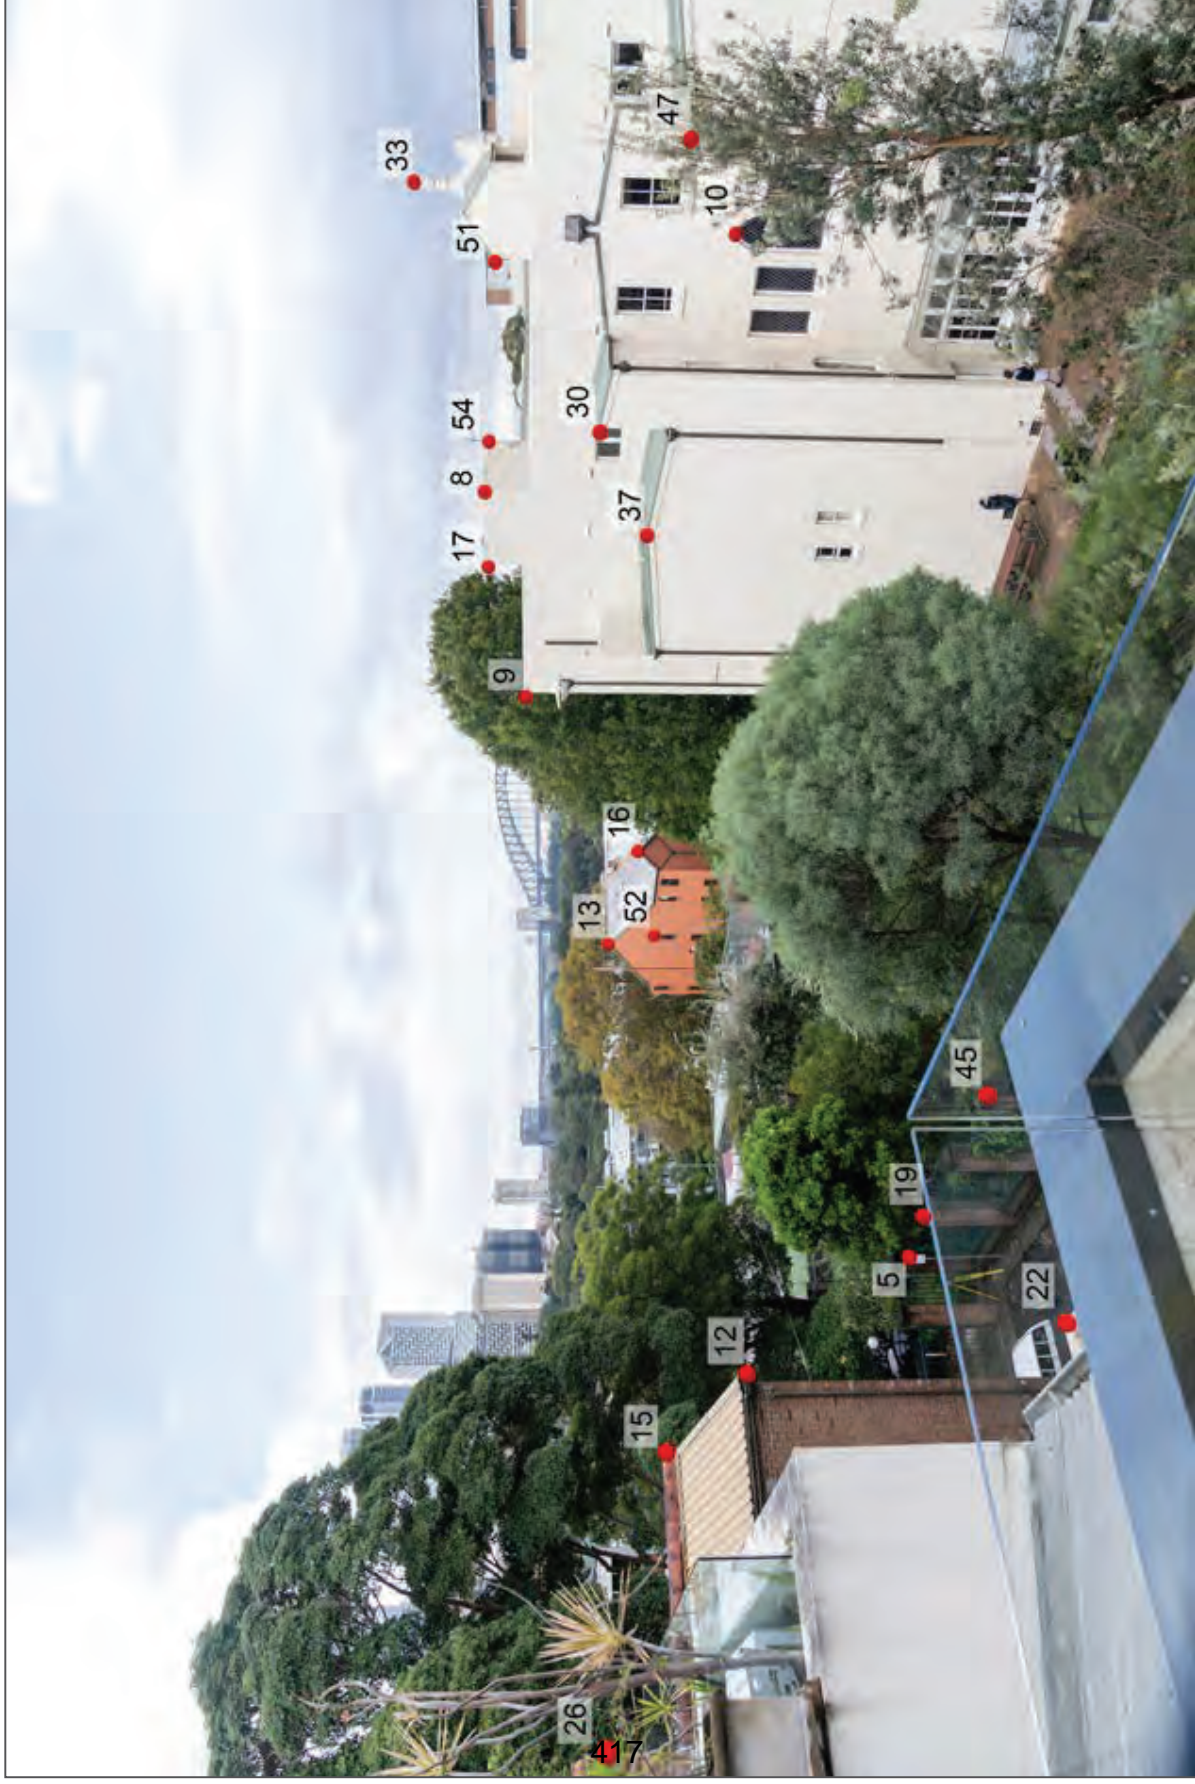
### 16.3 VIEWPOINT POSITION 12 - Unit 2, 12 Rockwall Crescent, Level 2 Balcony

OVERLAY OF SURVEY POINTS USED FOR 3D CAMERA ALIGNMENT
