# View Loss Assessment

Submitted to City of Sydney in response to RFI dated 31 July 2024

St Vincent's College, 1 Challis Avenue, Potts Point  
The Trustees of the Sisters of Charity of Australia

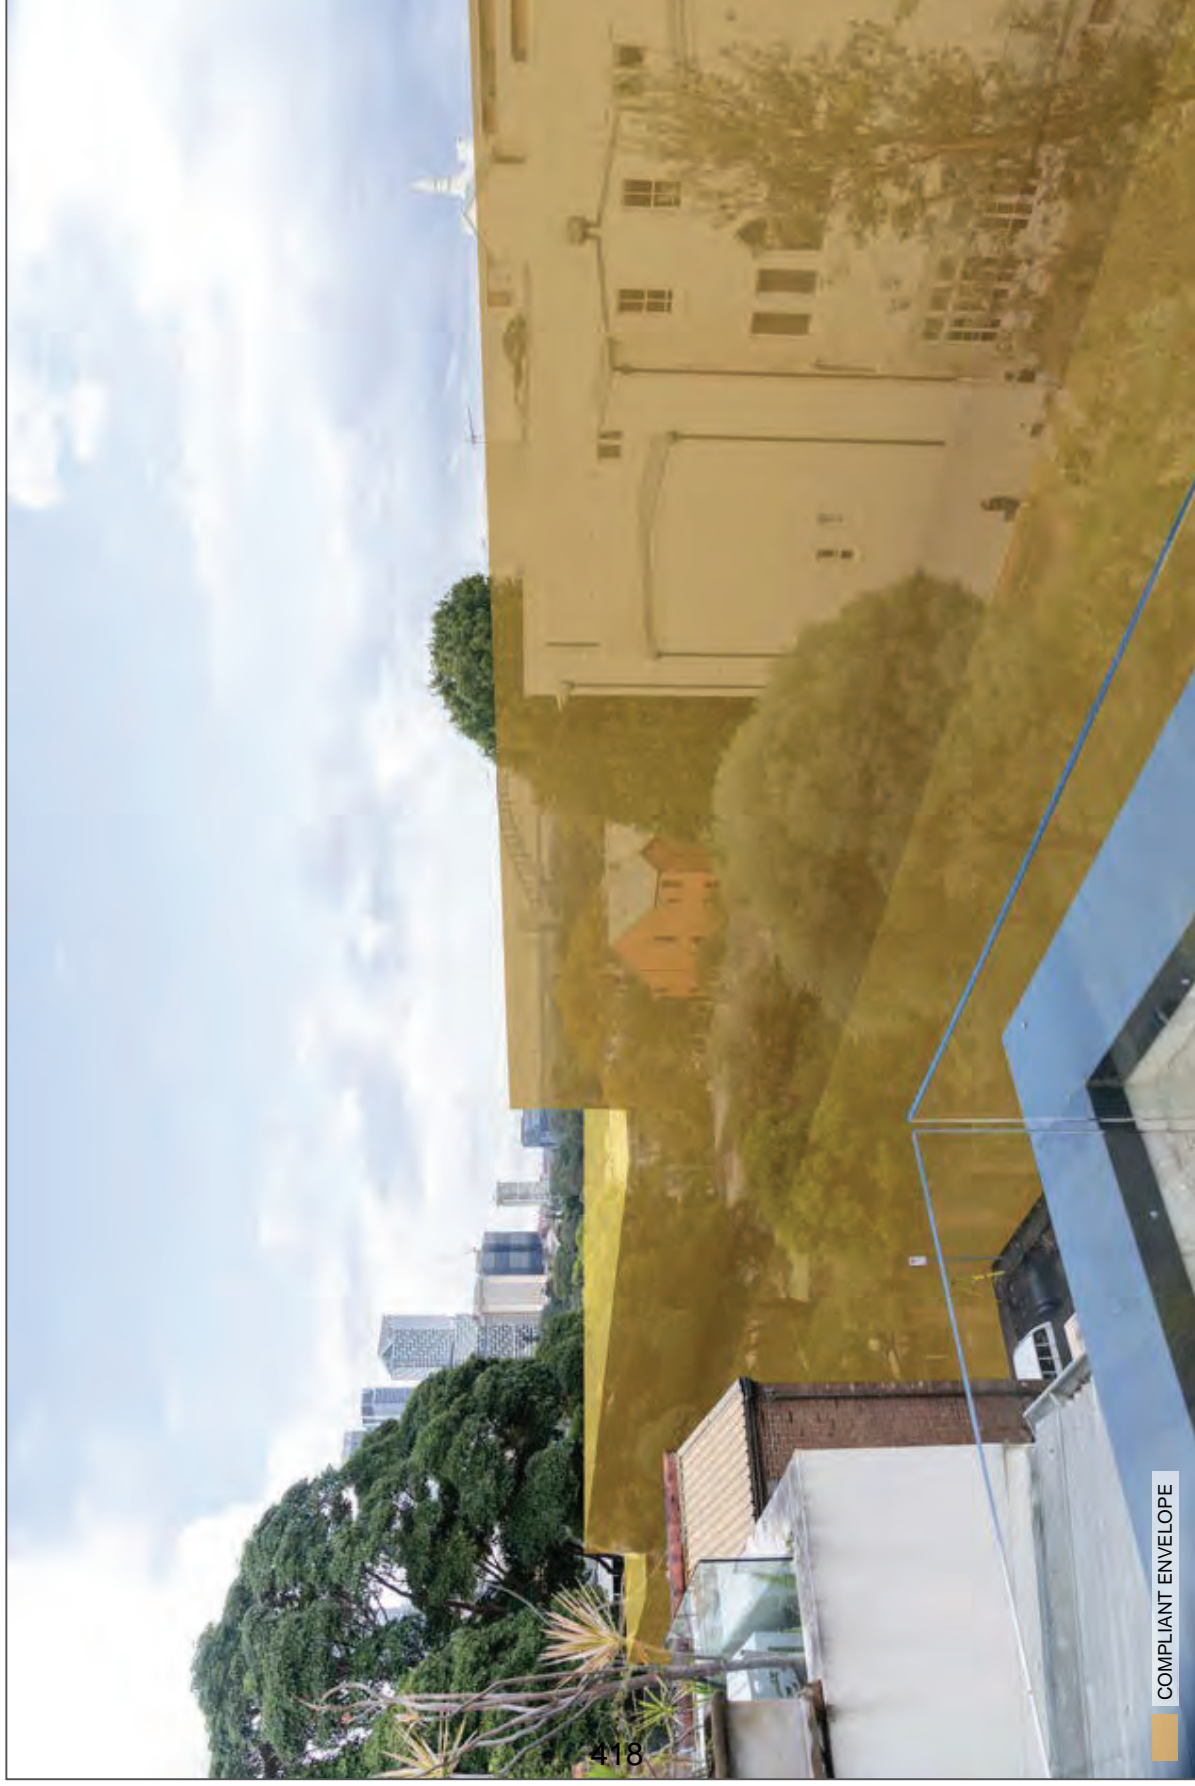
## 16.4 VIEWPOINT POSITION 12 - Unit 2, 12 Rockwall Crescent, Level 2 Balcony

PHOTOMONTAGE OF COMPLIANT BUILDING ENVELOPE

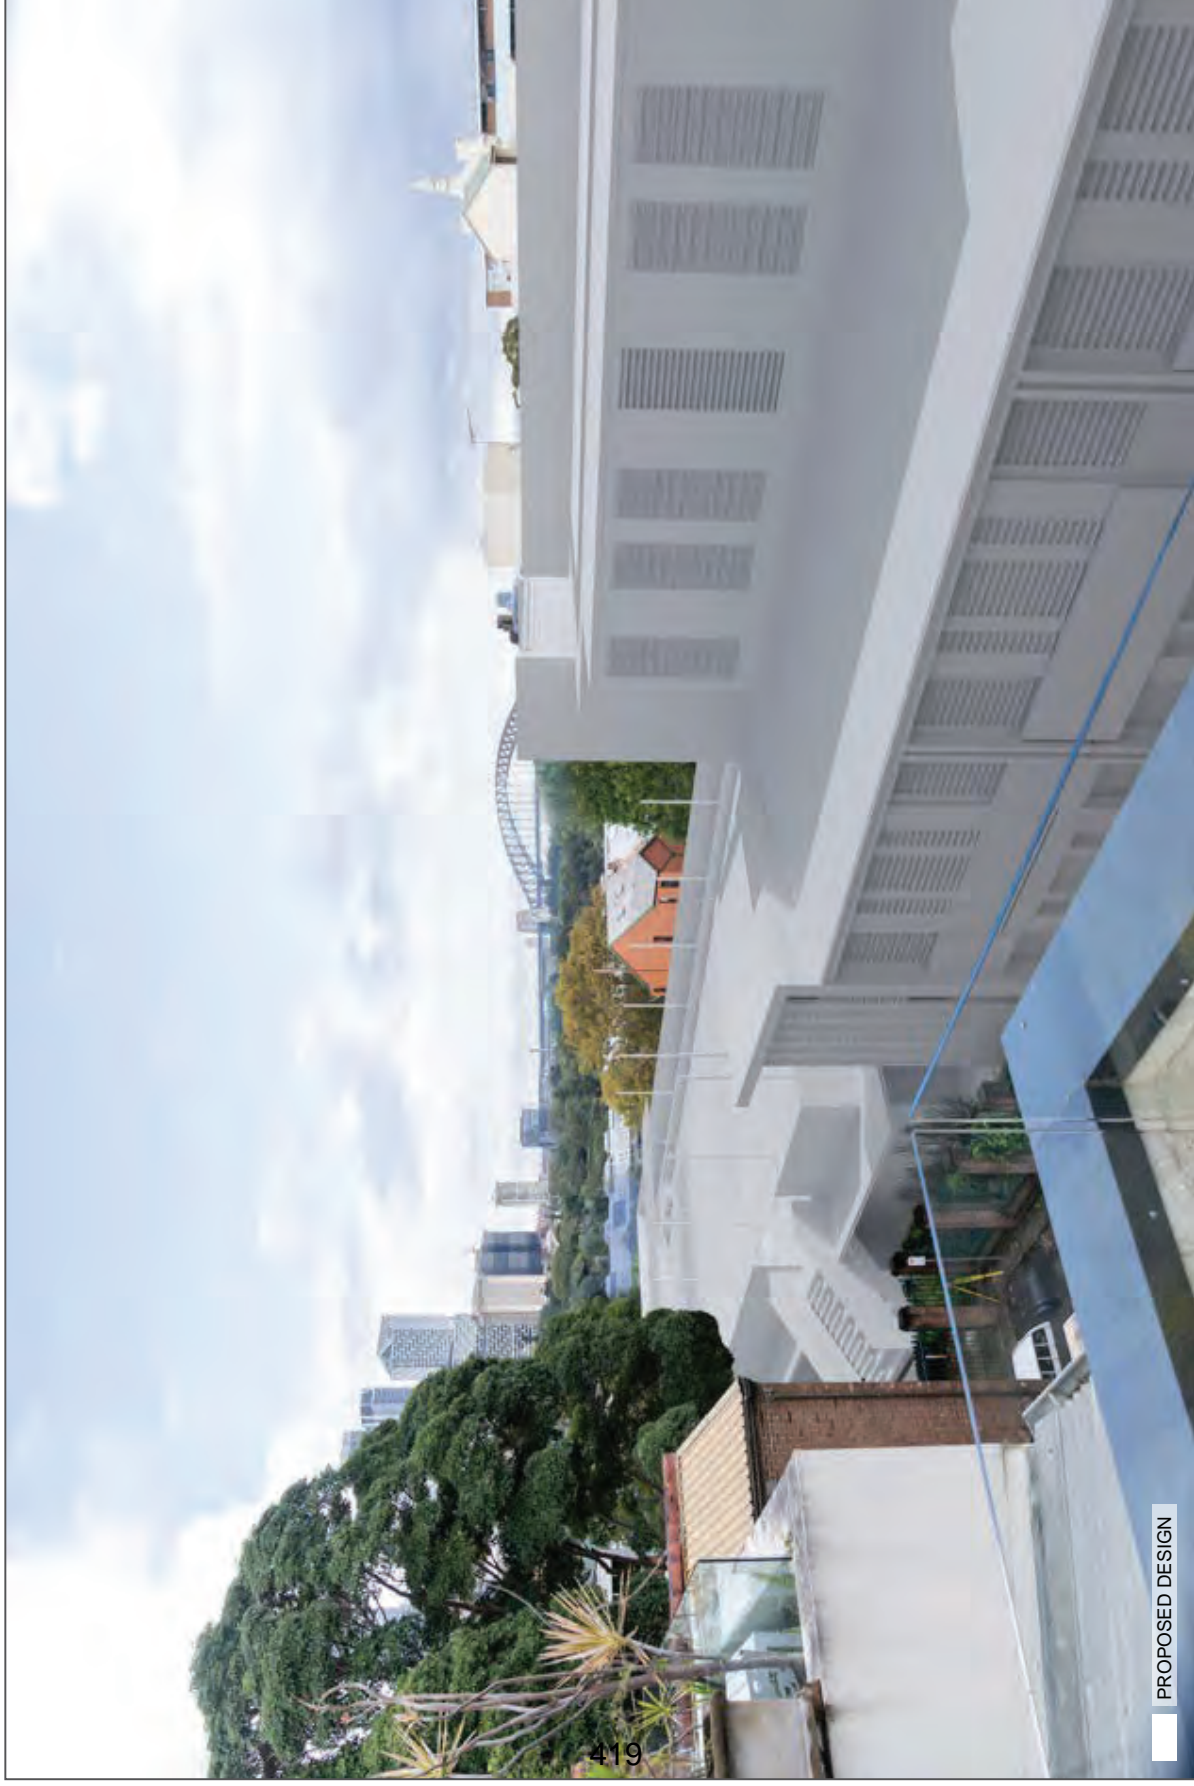
## 16.5 VIEWPOINT POSITION 12 - Unit 2, 12 Rockwall Crescent, Level 2 Balcony

PHOTOMONTAGE OF PROPOSED BUILDING DESIGN

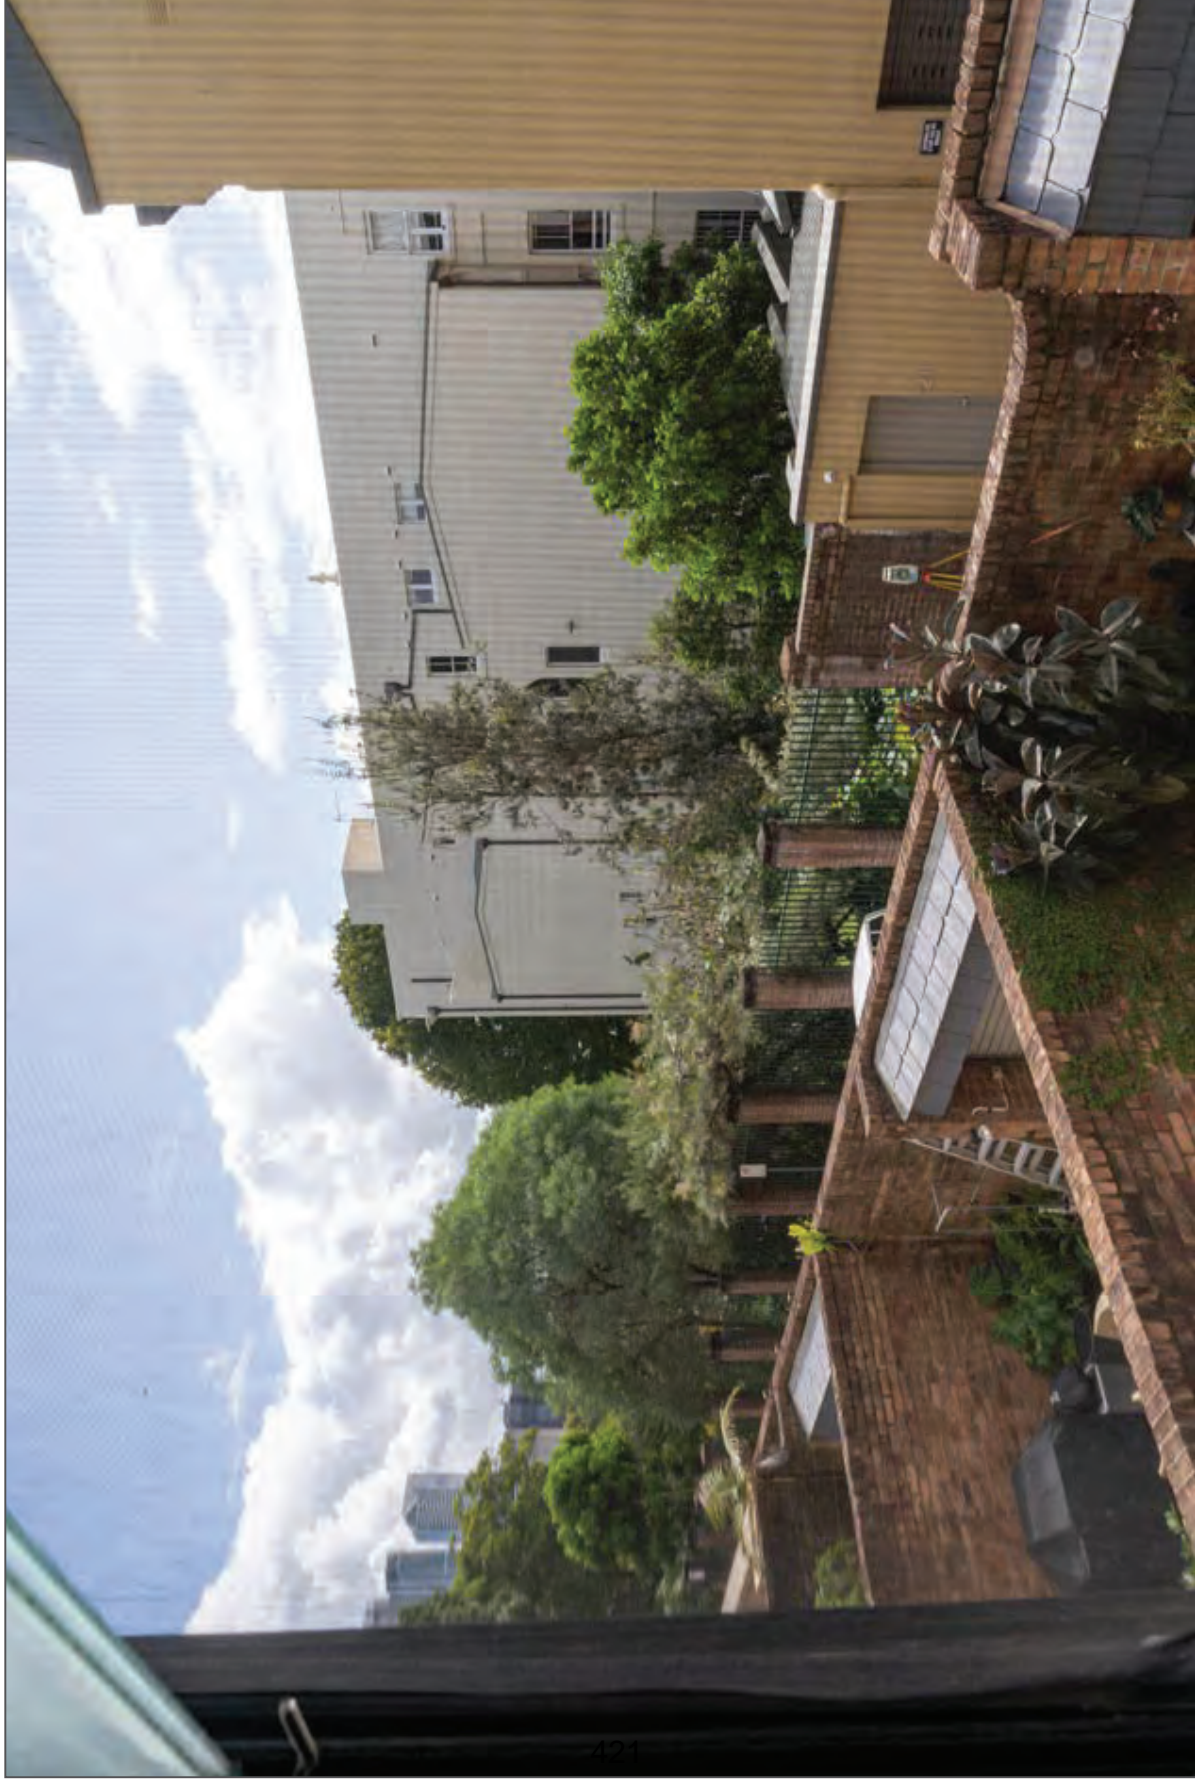
## 17.2 VIEWPOINT POSITION 13 - Unit 1, 14 Rockwall Crescent, Upper Ground Study

PHOTOGRAPH OF CURRENT CONDITION

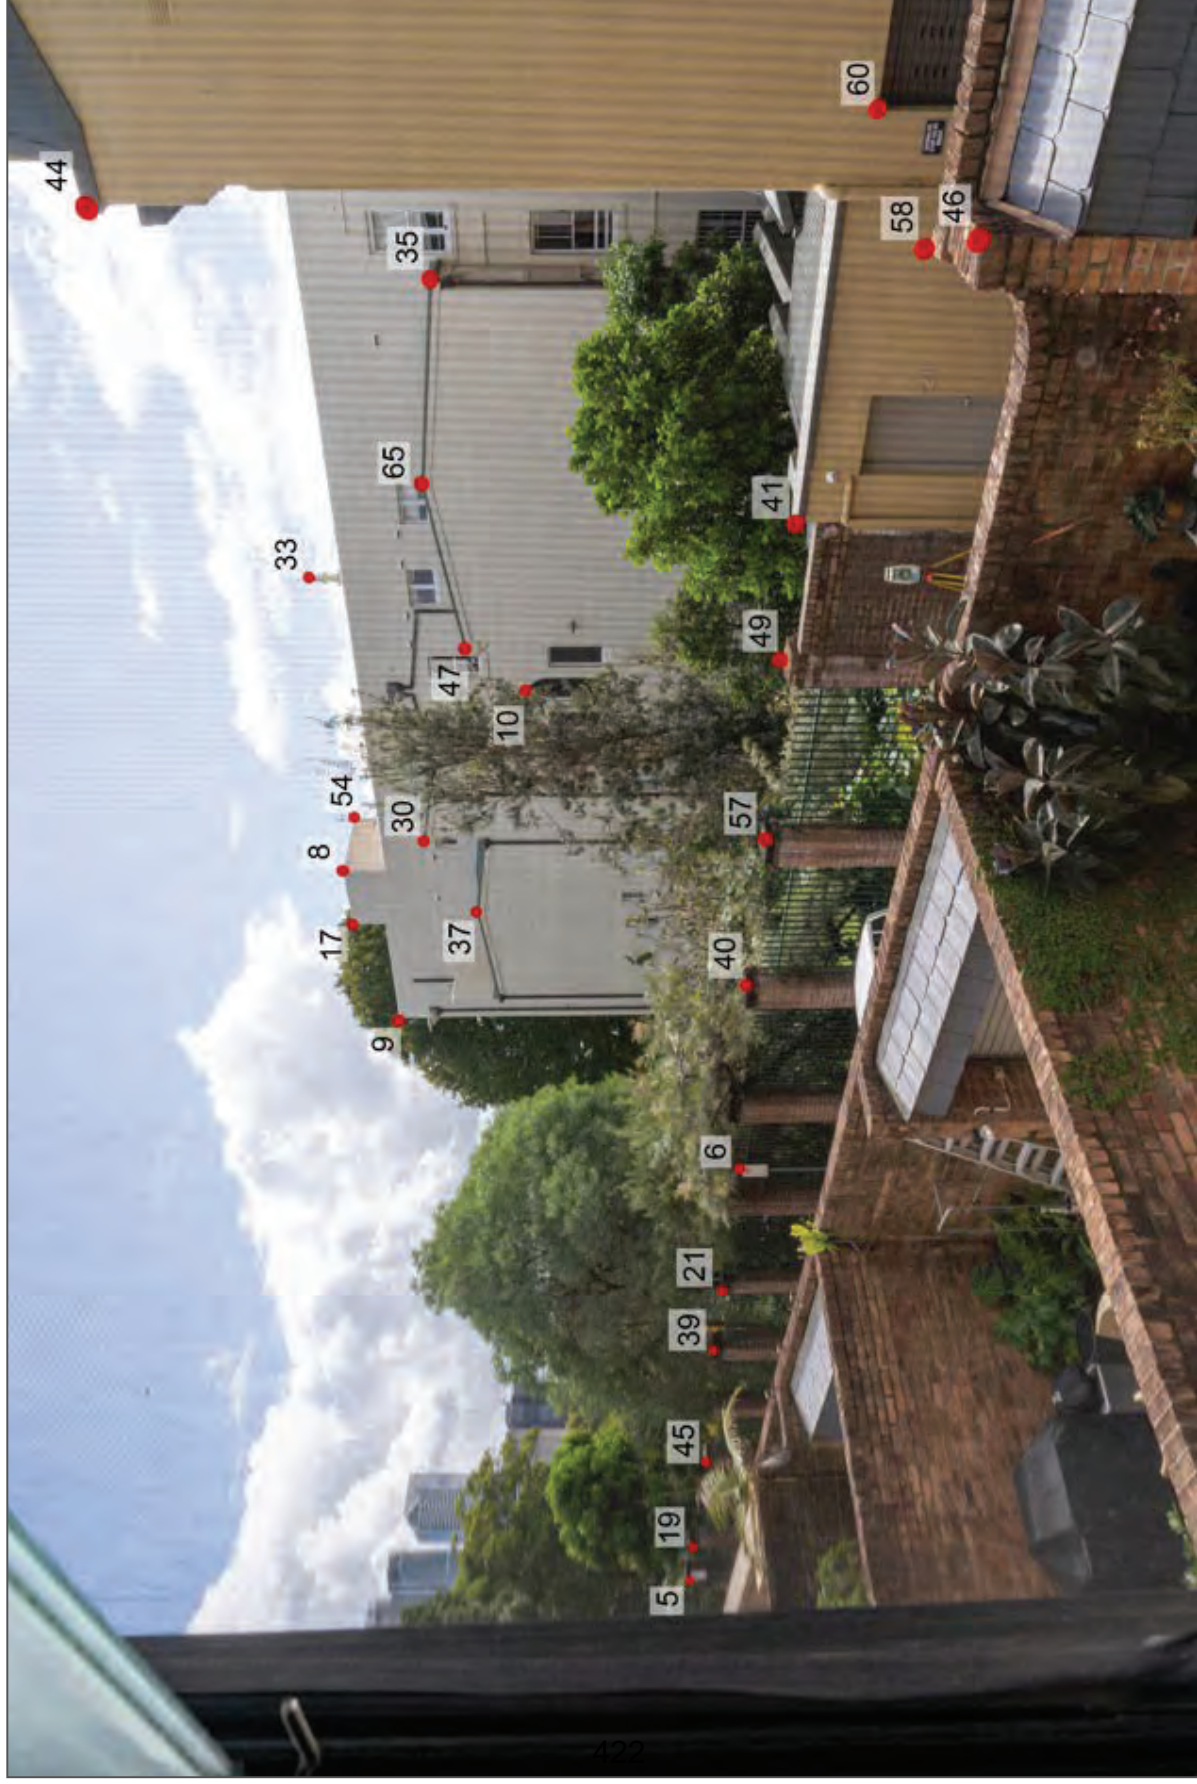
### 17.3 VIEWPOINT POSITION 13 - Unit 1, 14 Rockwall Crescent, Upper Ground Study

OVERLAY OF SURVEY POINTS USED FOR 3D CAMERA ALIGNMENT

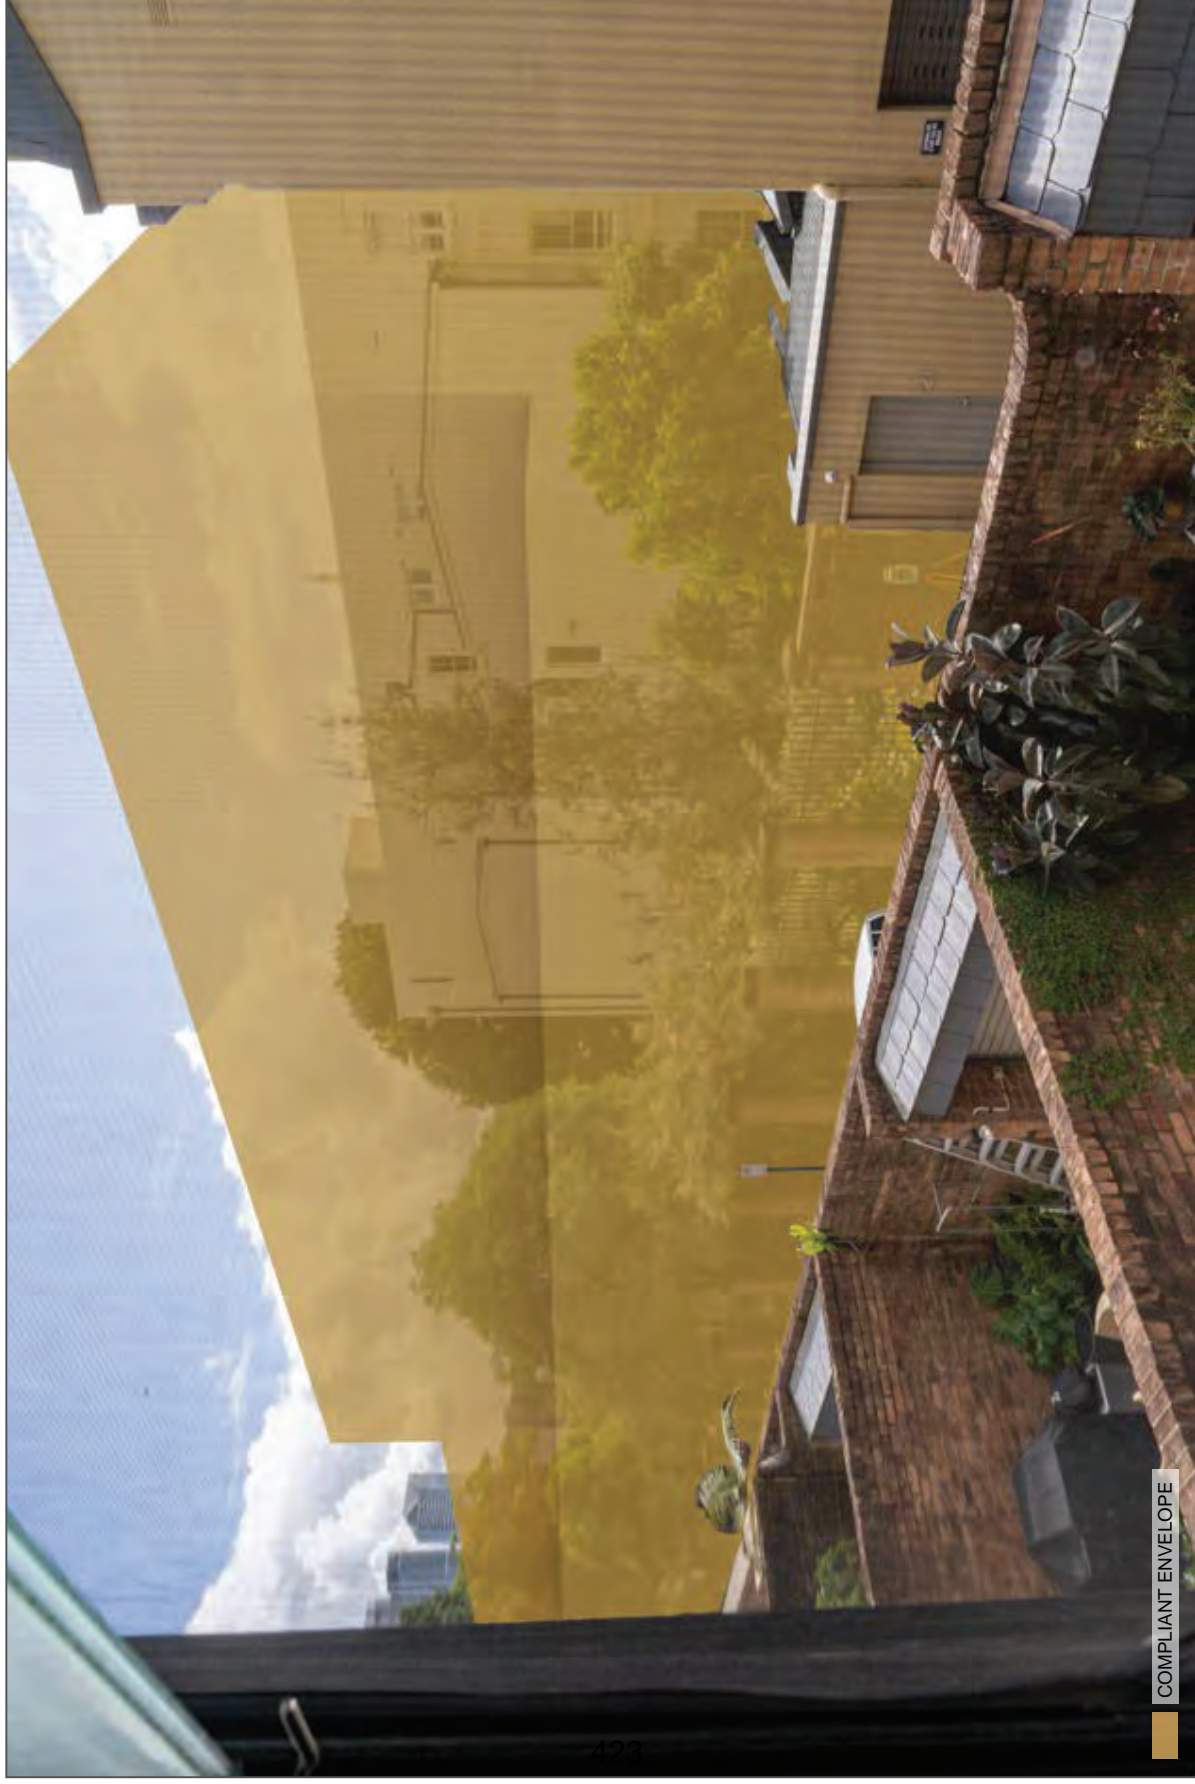
### 17.4 VIEWPOINT POSITION 13 - Unit 1, 14 Rockwall Crescent, Upper Ground Study

PHOTOMONTAGE OF COMPLIANT BUILDING ENVELOPE

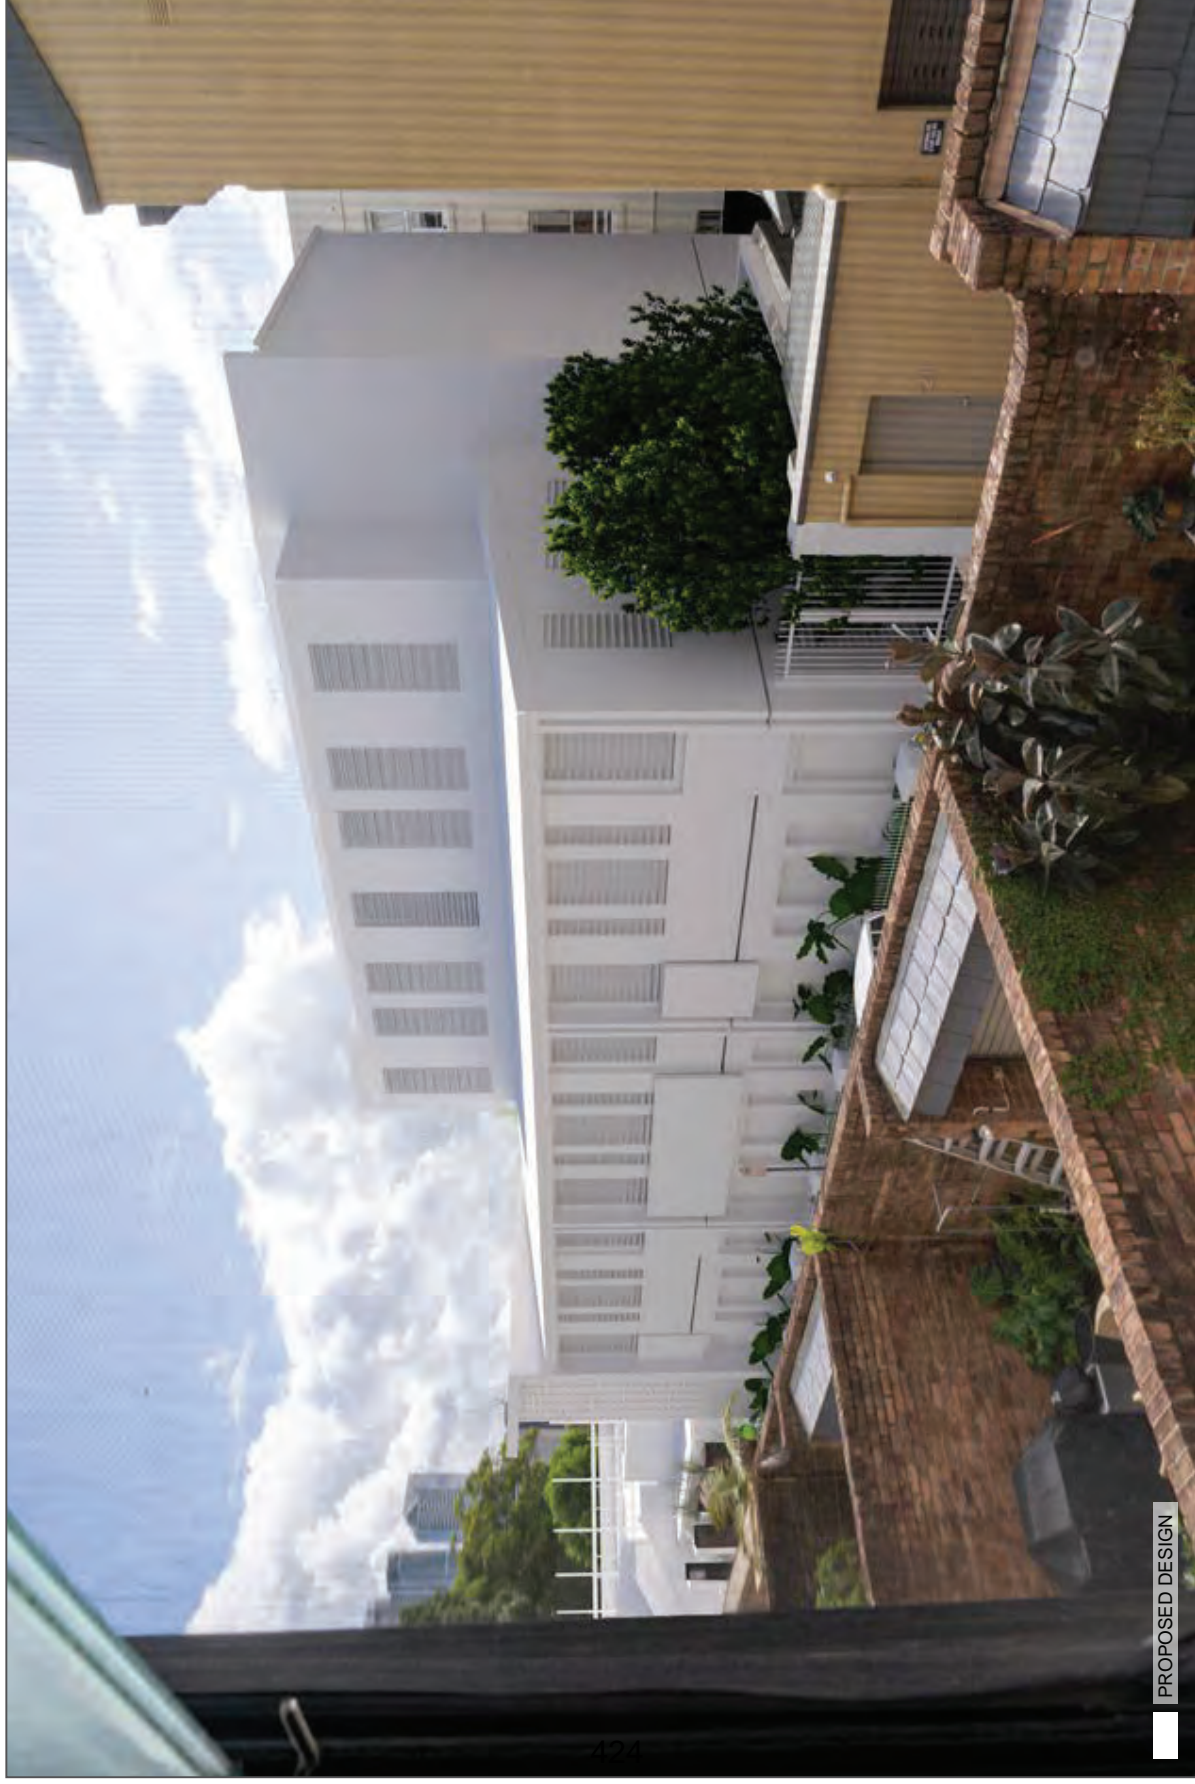
## 17.5 VIEWPOINT POSITION 13 - Unit 1, 14 Rockwall Crescent, Upper Ground Study

PHOTOMONTAGE OF PROPOSED BUILDING DESIGN

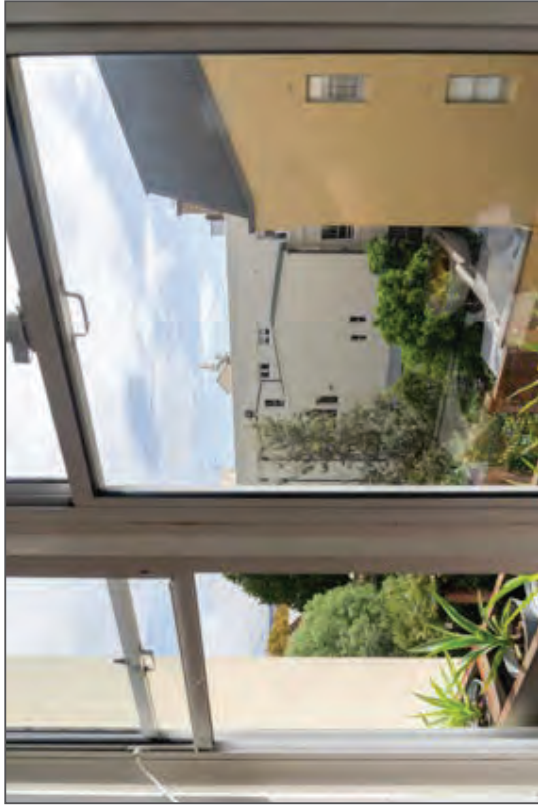
## 18.1 VIEWPOINT POSITION 14 - Unit 2, 14 Rockwall Crescent, Level 1 Lounge

PHOTOGRAPH OF CURRENT CONDITION

Photo Date:	3 April 2023
Camera Used:	Sony ILCE-7C
Camera Lens:	FE 24-70mm F2.8 GM
Focal length in 35mm Film:	24mm

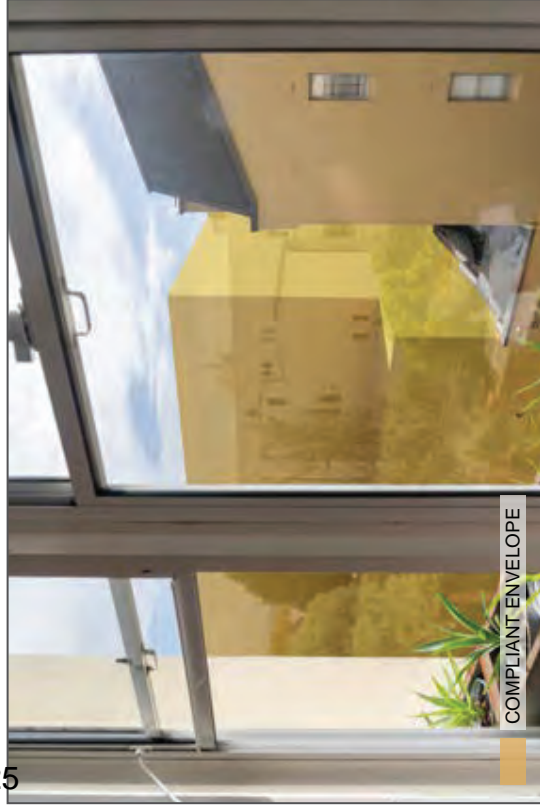
PHOTOMONTAGE OF COMPLIANT BUILDING ENVELOPE

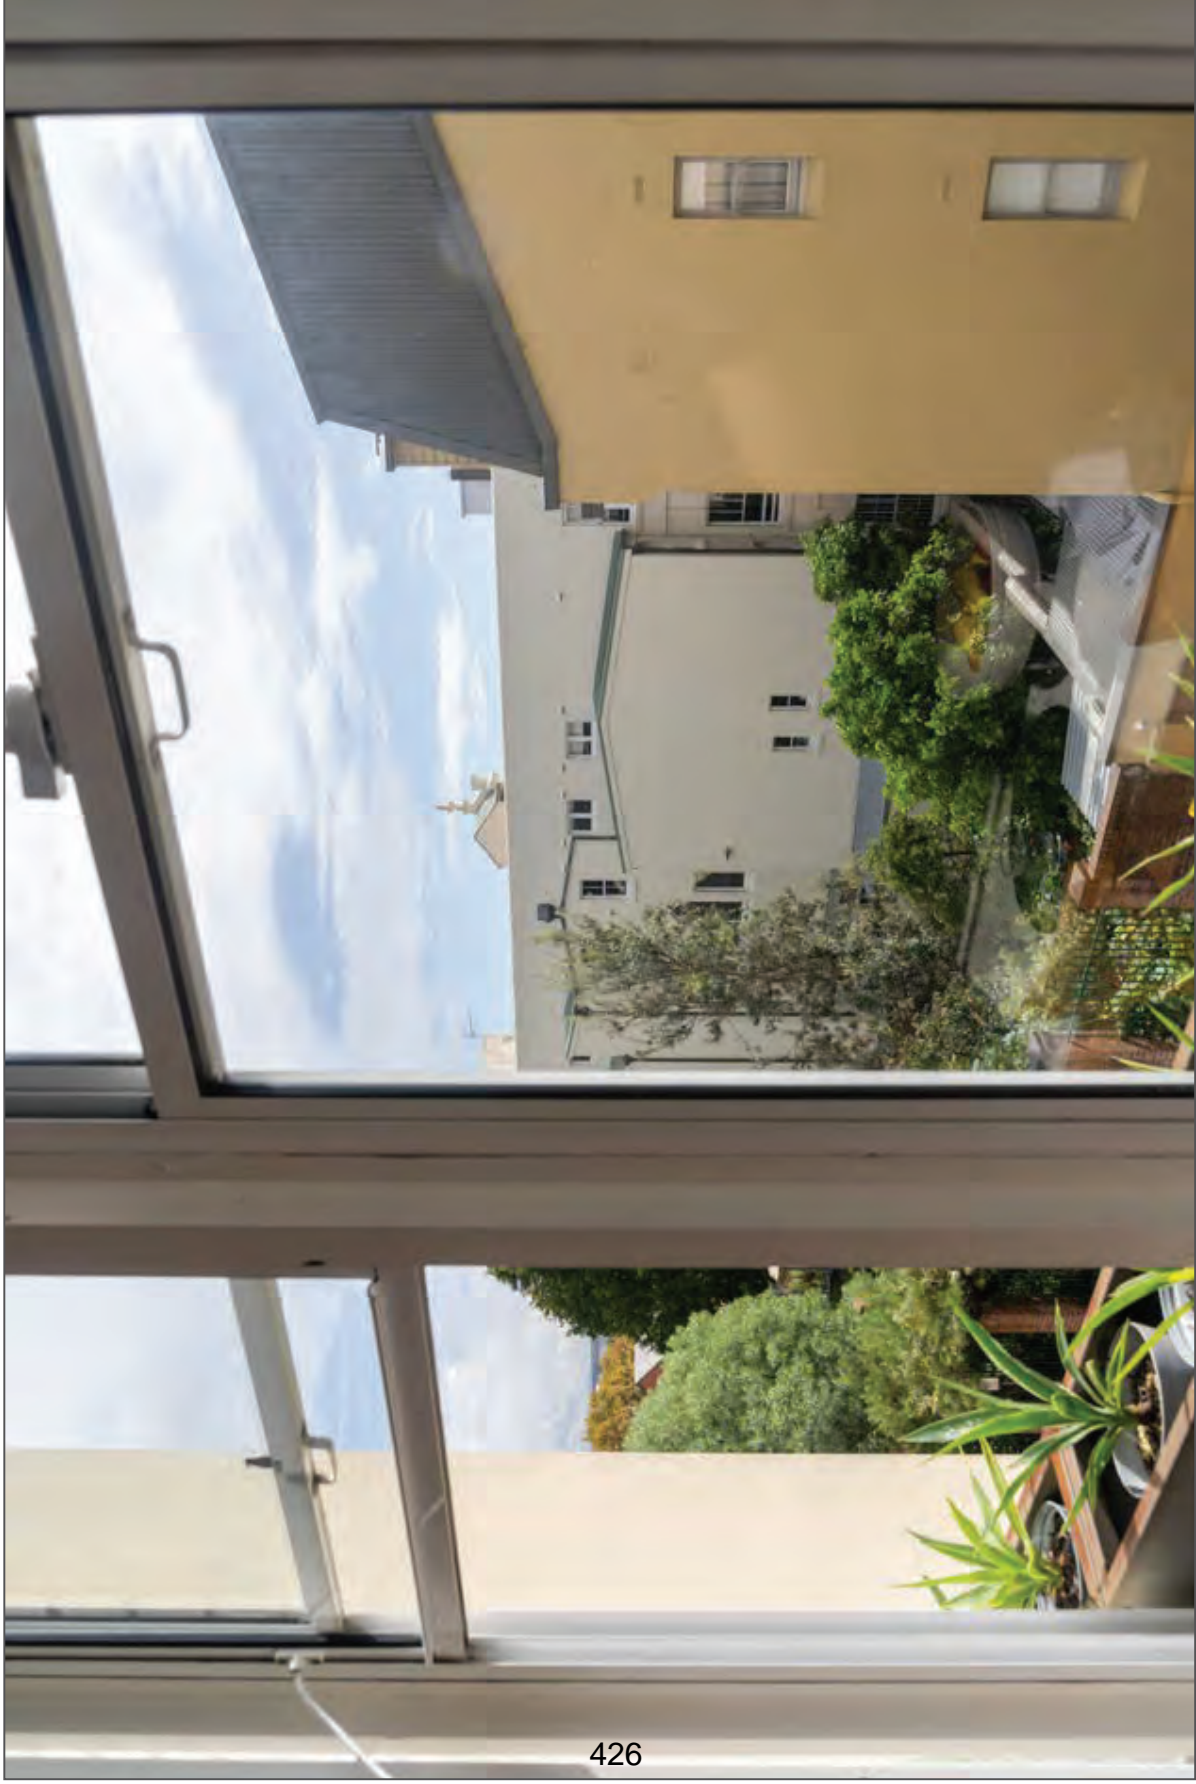
**18.2 VIEWPOINT POSITION 14 - Unit 2, 14 Rockwall Crescent, Level 1 Lounge**

**PHOTOGRAPH OF CURRENT CONDITION**

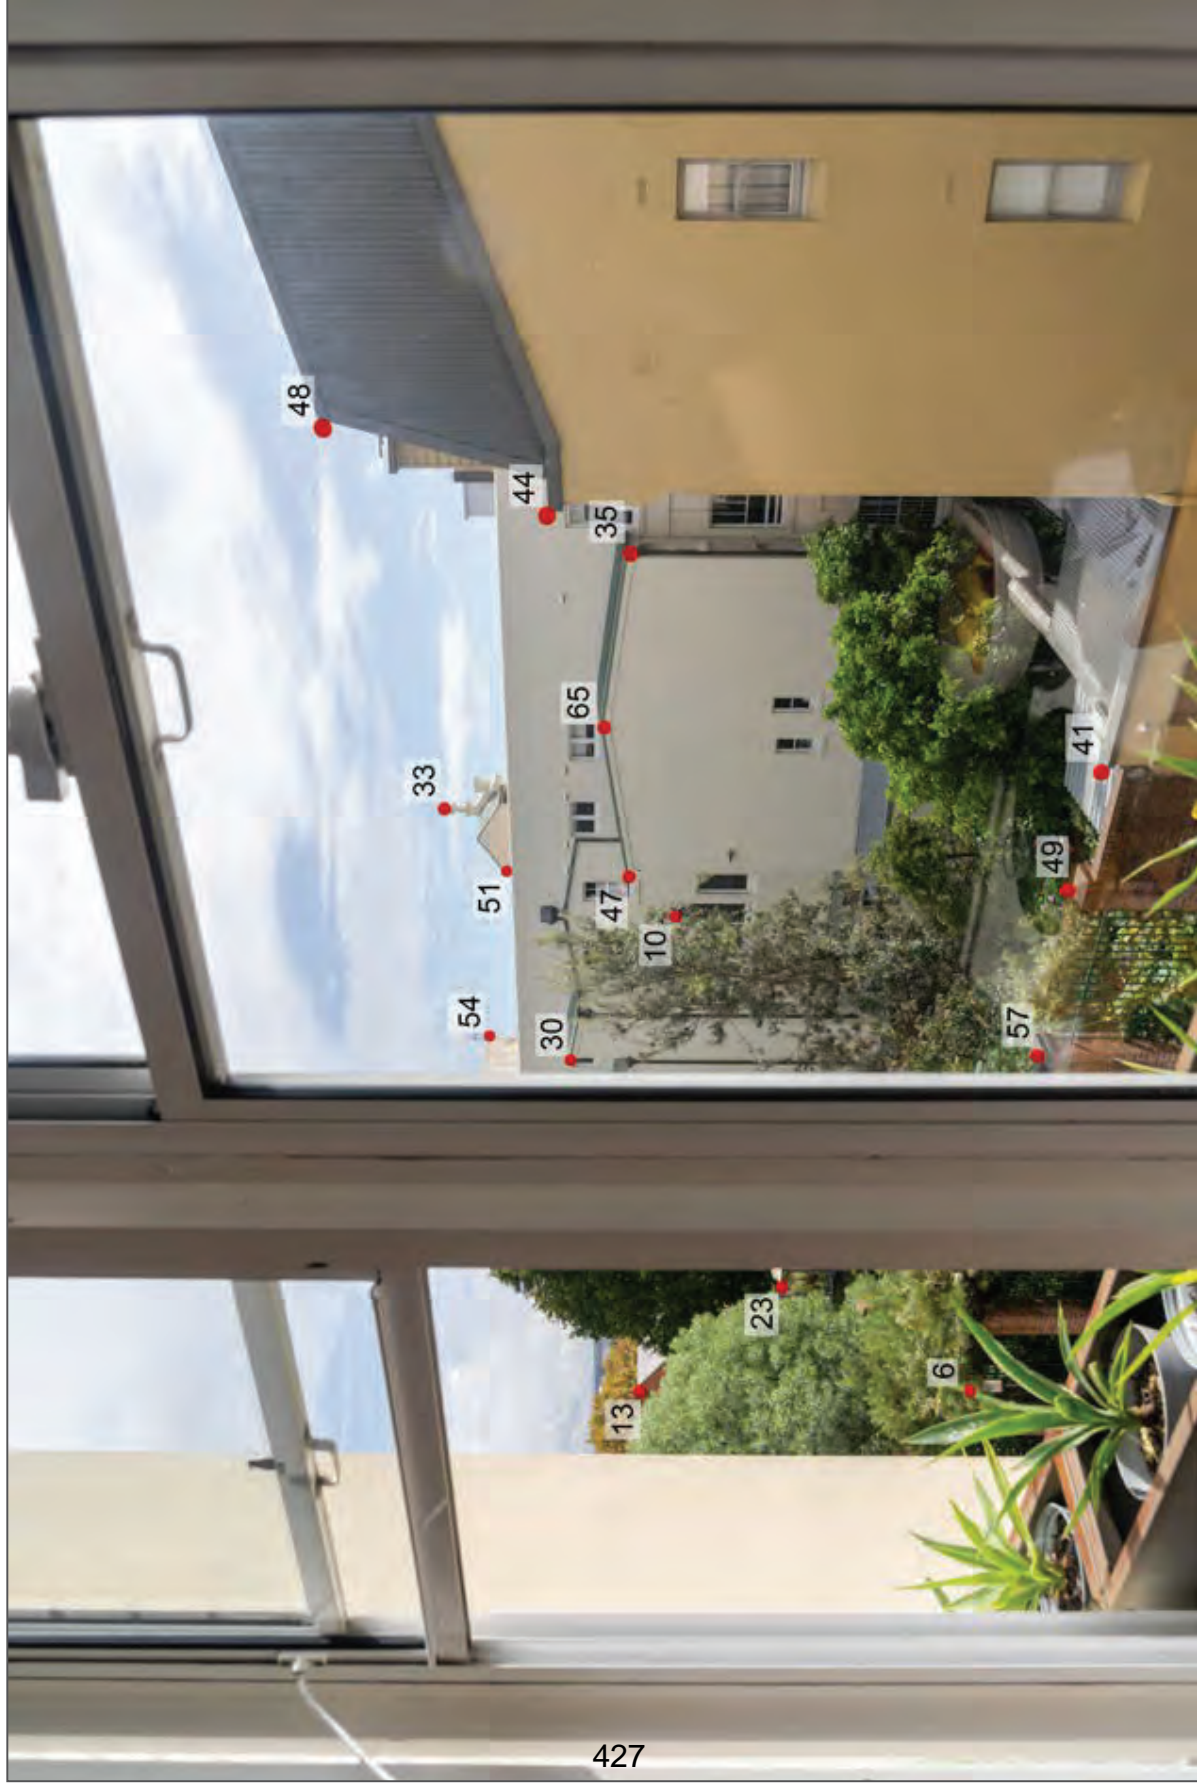
### 18.3 VIEWPOINT POSITION 14 - Unit 2, 14 Rockwall Crescent, Level 1 Lounge

OVERLAY OF SURVEY POINTS USED FOR 3D CAMERA ALIGNMENT

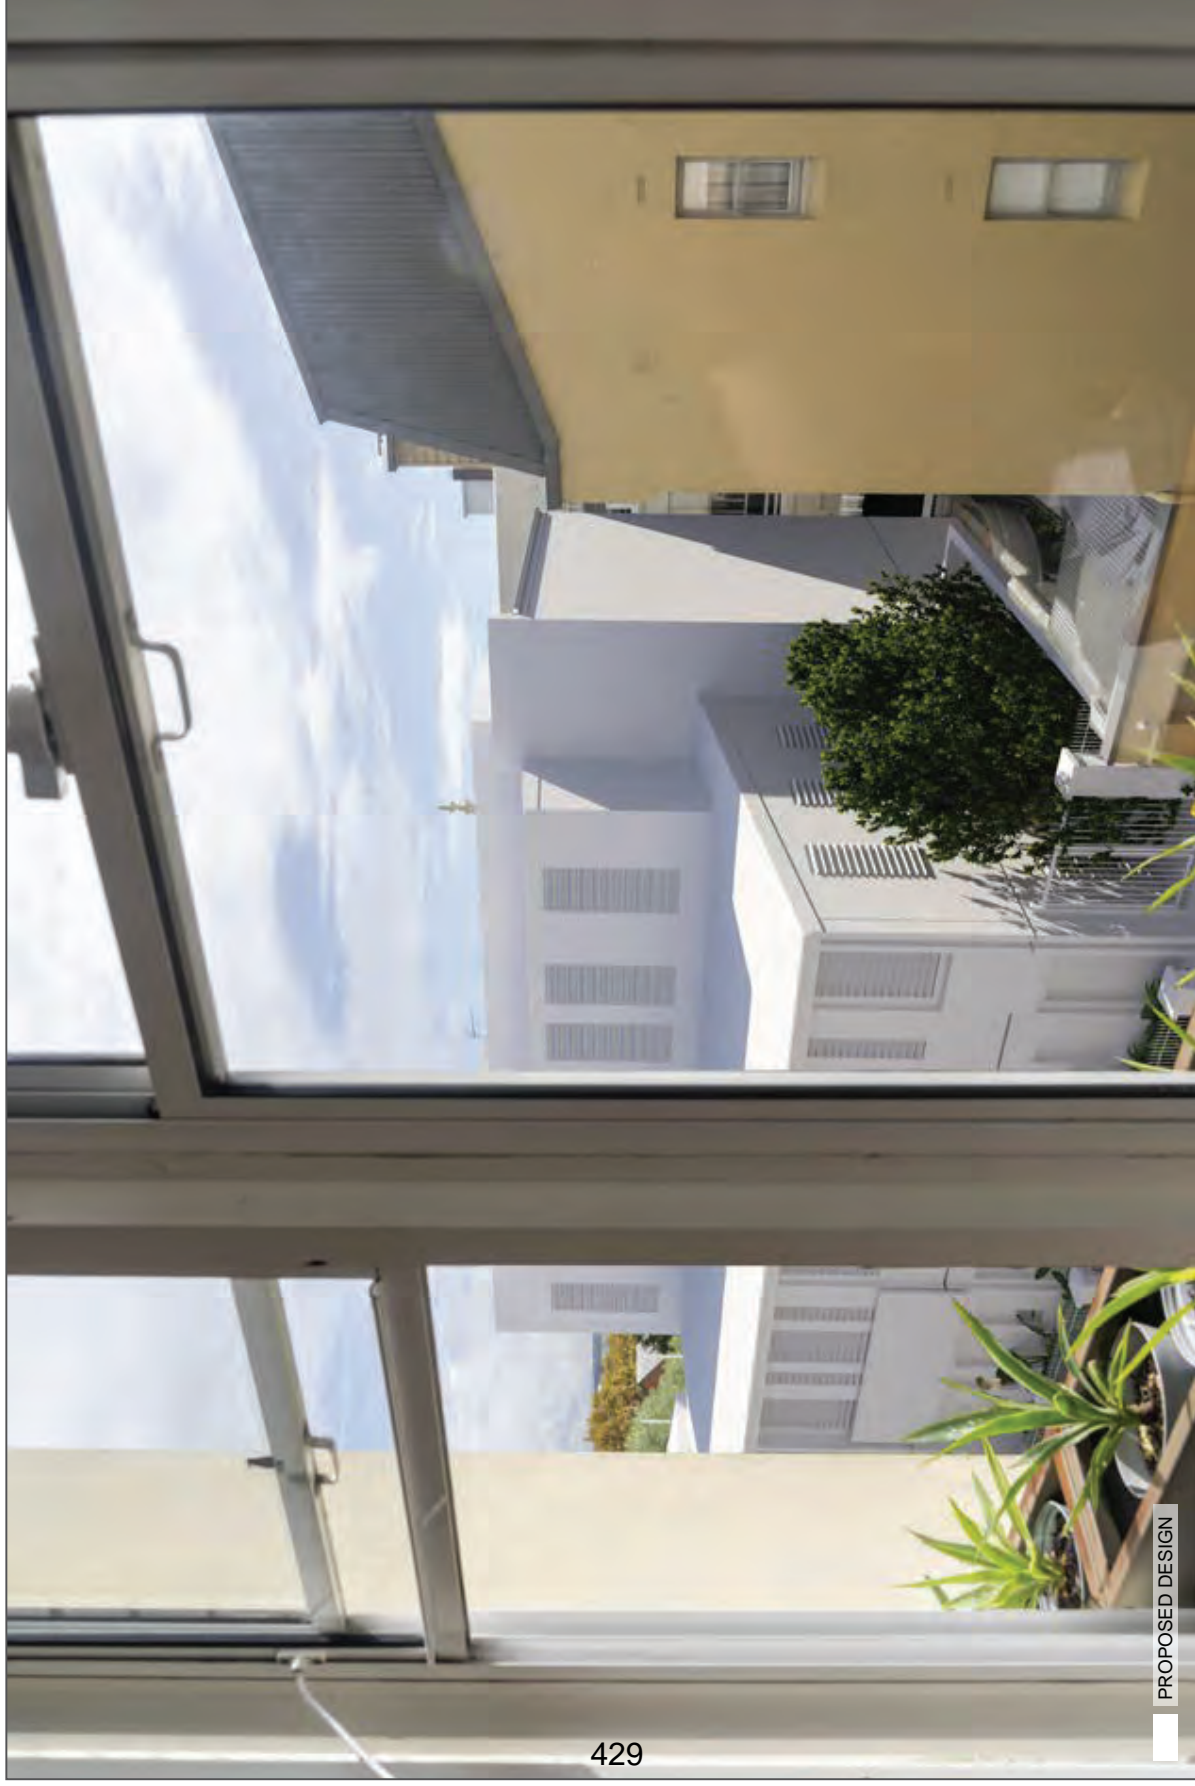
### 18.5 VIEWPOINT POSITION 14 - Unit 2, 14 Rockwall Crescent, Level 1 Lounge

PHOTOMONTAGE OF PROPOSED BUILDING DESIGN

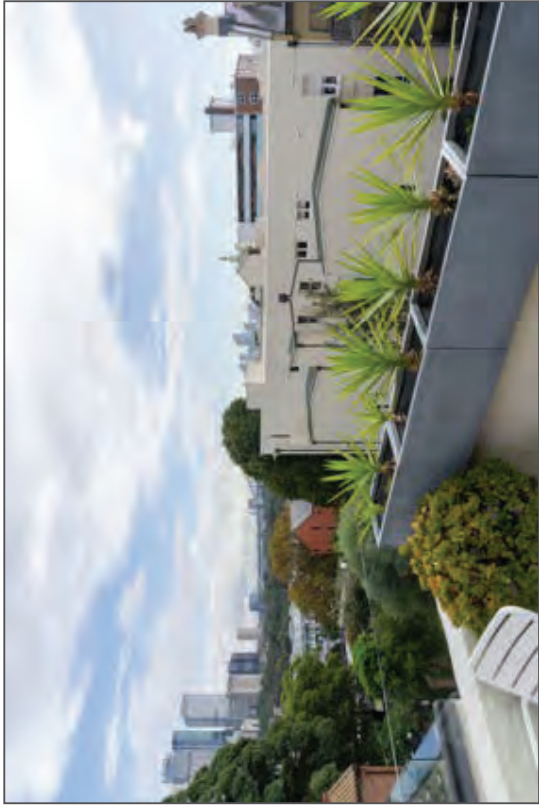
## 19.1 VIEWPOINT POSITION 15 - Unit 2, 14 Rockwall Crescent, Level 2 Balcony

PHOTOGRAPH OF CURRENT CONDITION

Photo Date:	3 April 2023
Camera Used:	Sony ILCE-7C
Camera Lens:	FE 24-70mm F2.8 GM
Focal length in 35mm Film:	24mm

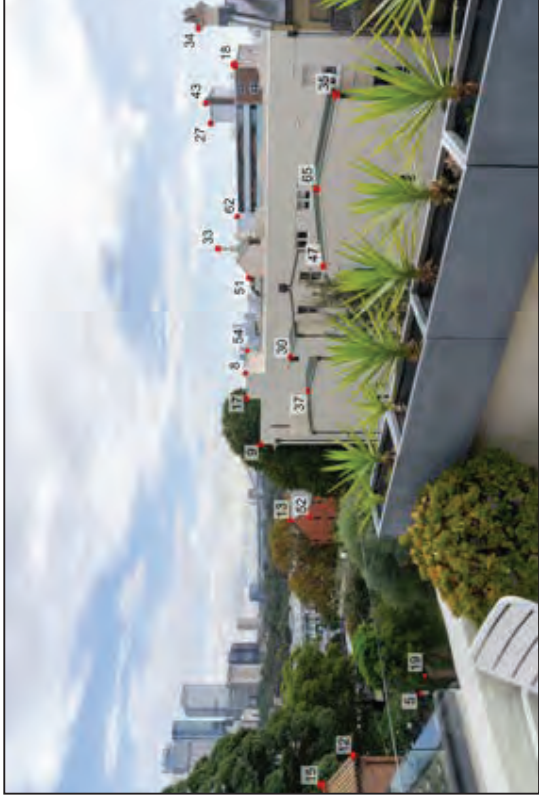
SURVEY POINTS USED FOR 3D CAMERA ALIGNMENT

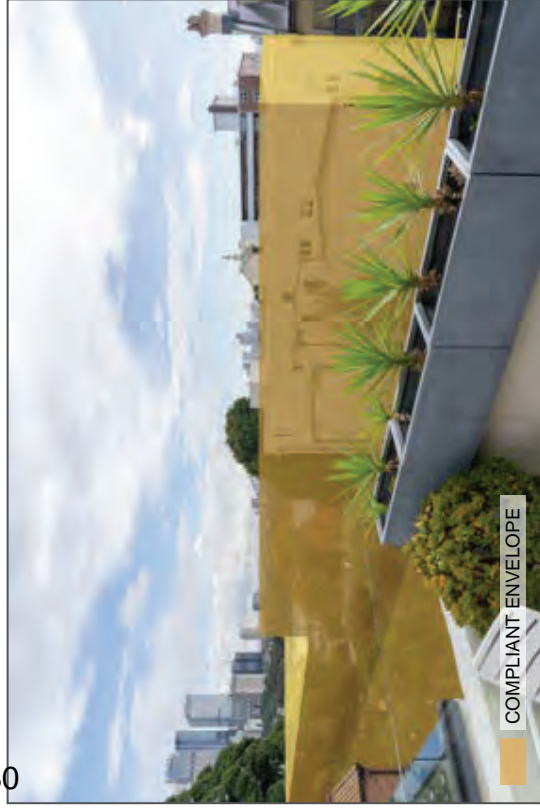
PHOTOMONTAGE OF COMPLIANT BUILDING ENVELOPE

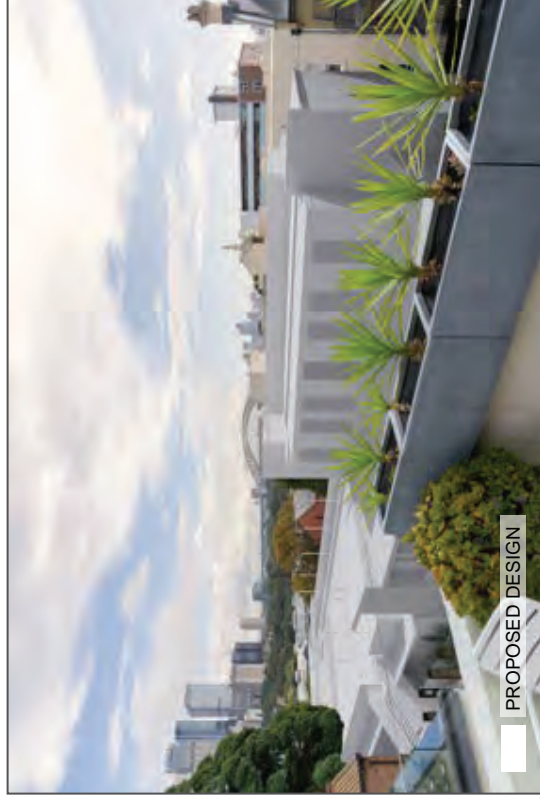
PHOTOMONTAGE OF PROPOSED BUILDING DESIGN
