# View Loss Assessment

Submitted to City of Sydney in response to RFI dated 31 July 2024

St Vincent's College, 1 Challis Avenue, Potts Point  
The Trustees of the Sisters of Charity of Australia

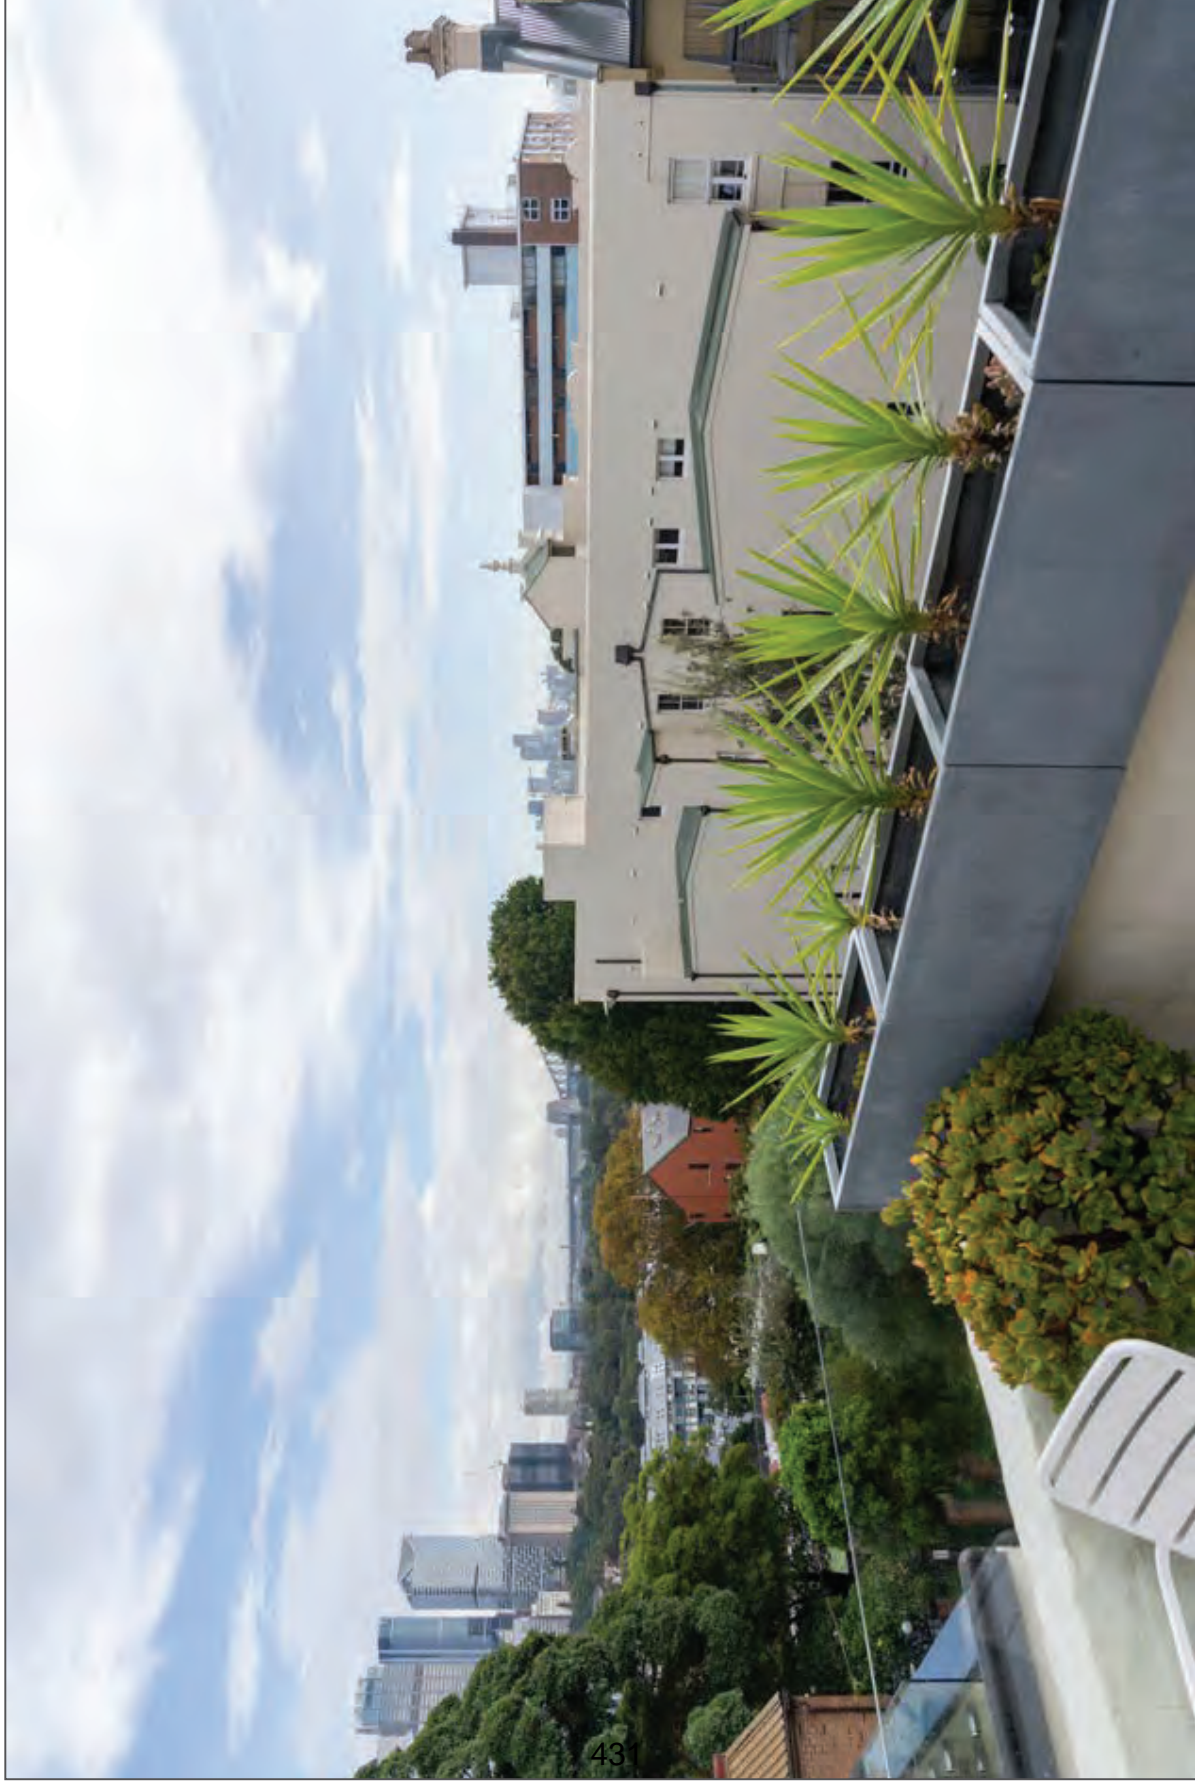
## 19.2 VIEWPOINT POSITION 15 - Unit 2, 14 Rockwall Crescent, Level 2 Balcony

PHOTOGRAPH OF CURRENT CONDITION

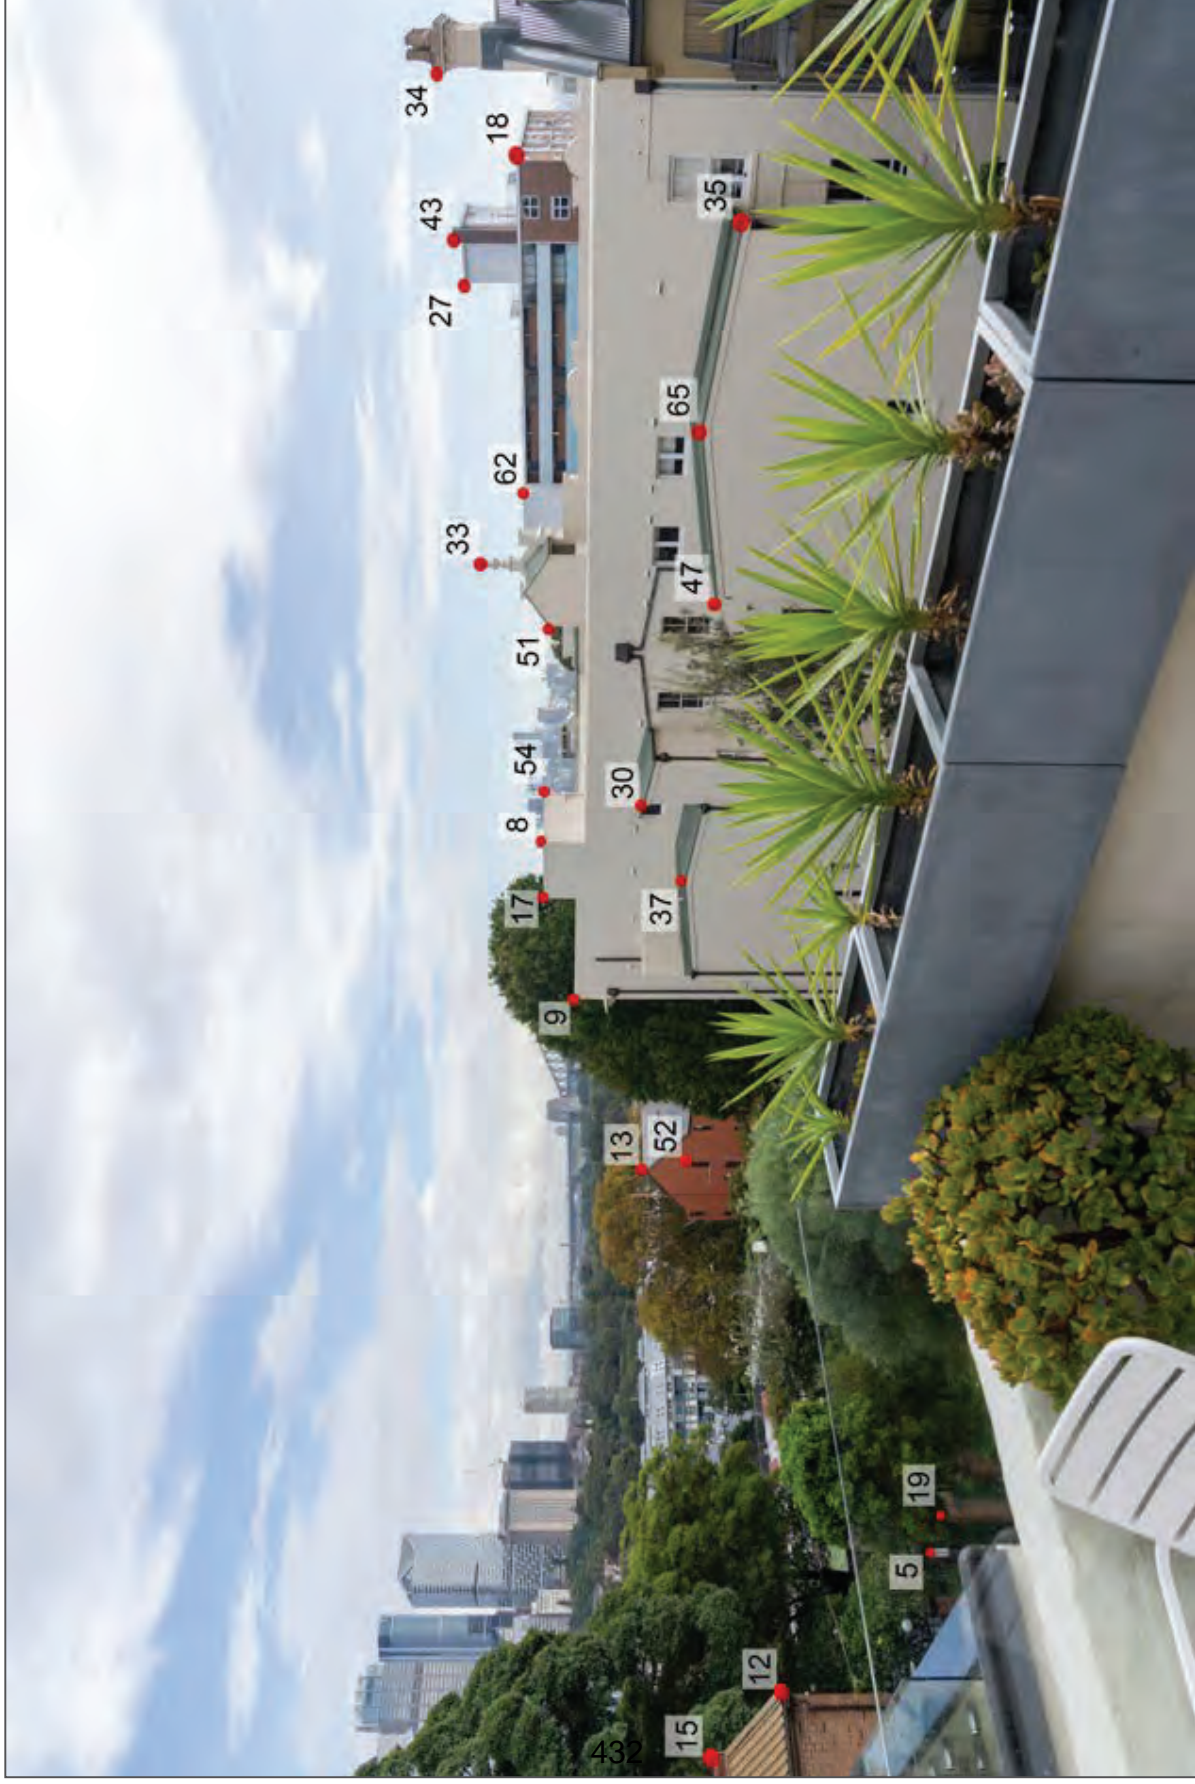
### 19.3 VIEWPOINT POSITION 15 - Unit 2, 14 Rockwall Crescent, Level 2 Balcony

OVERLAY OF SURVEY POINTS USED FOR 3D CAMERA ALIGNMENT

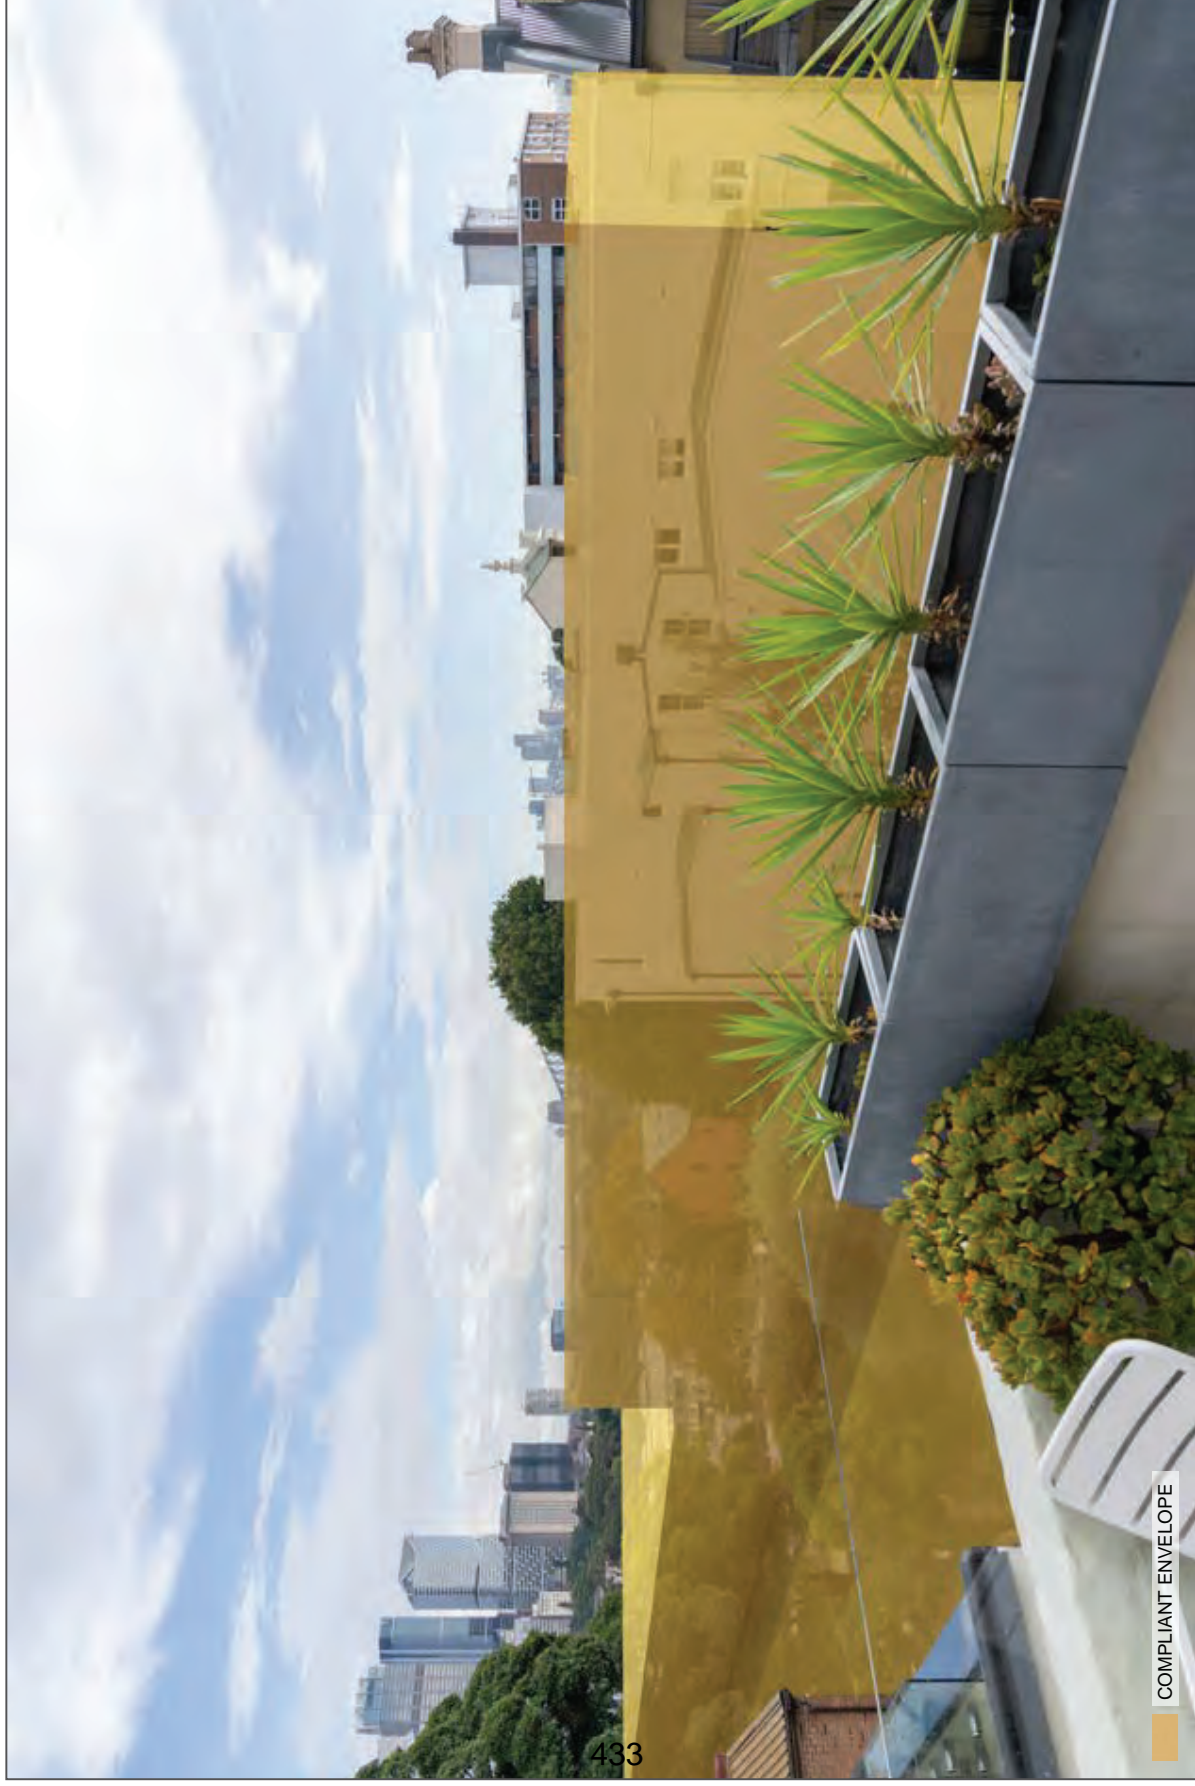
## 19.4 VIEWPOINT POSITION 15 - Unit 2, 14 Rockwall Crescent, Level 2 Balcony

PHOTOMONTAGE OF COMPLIANT BUILDING ENVELOPE

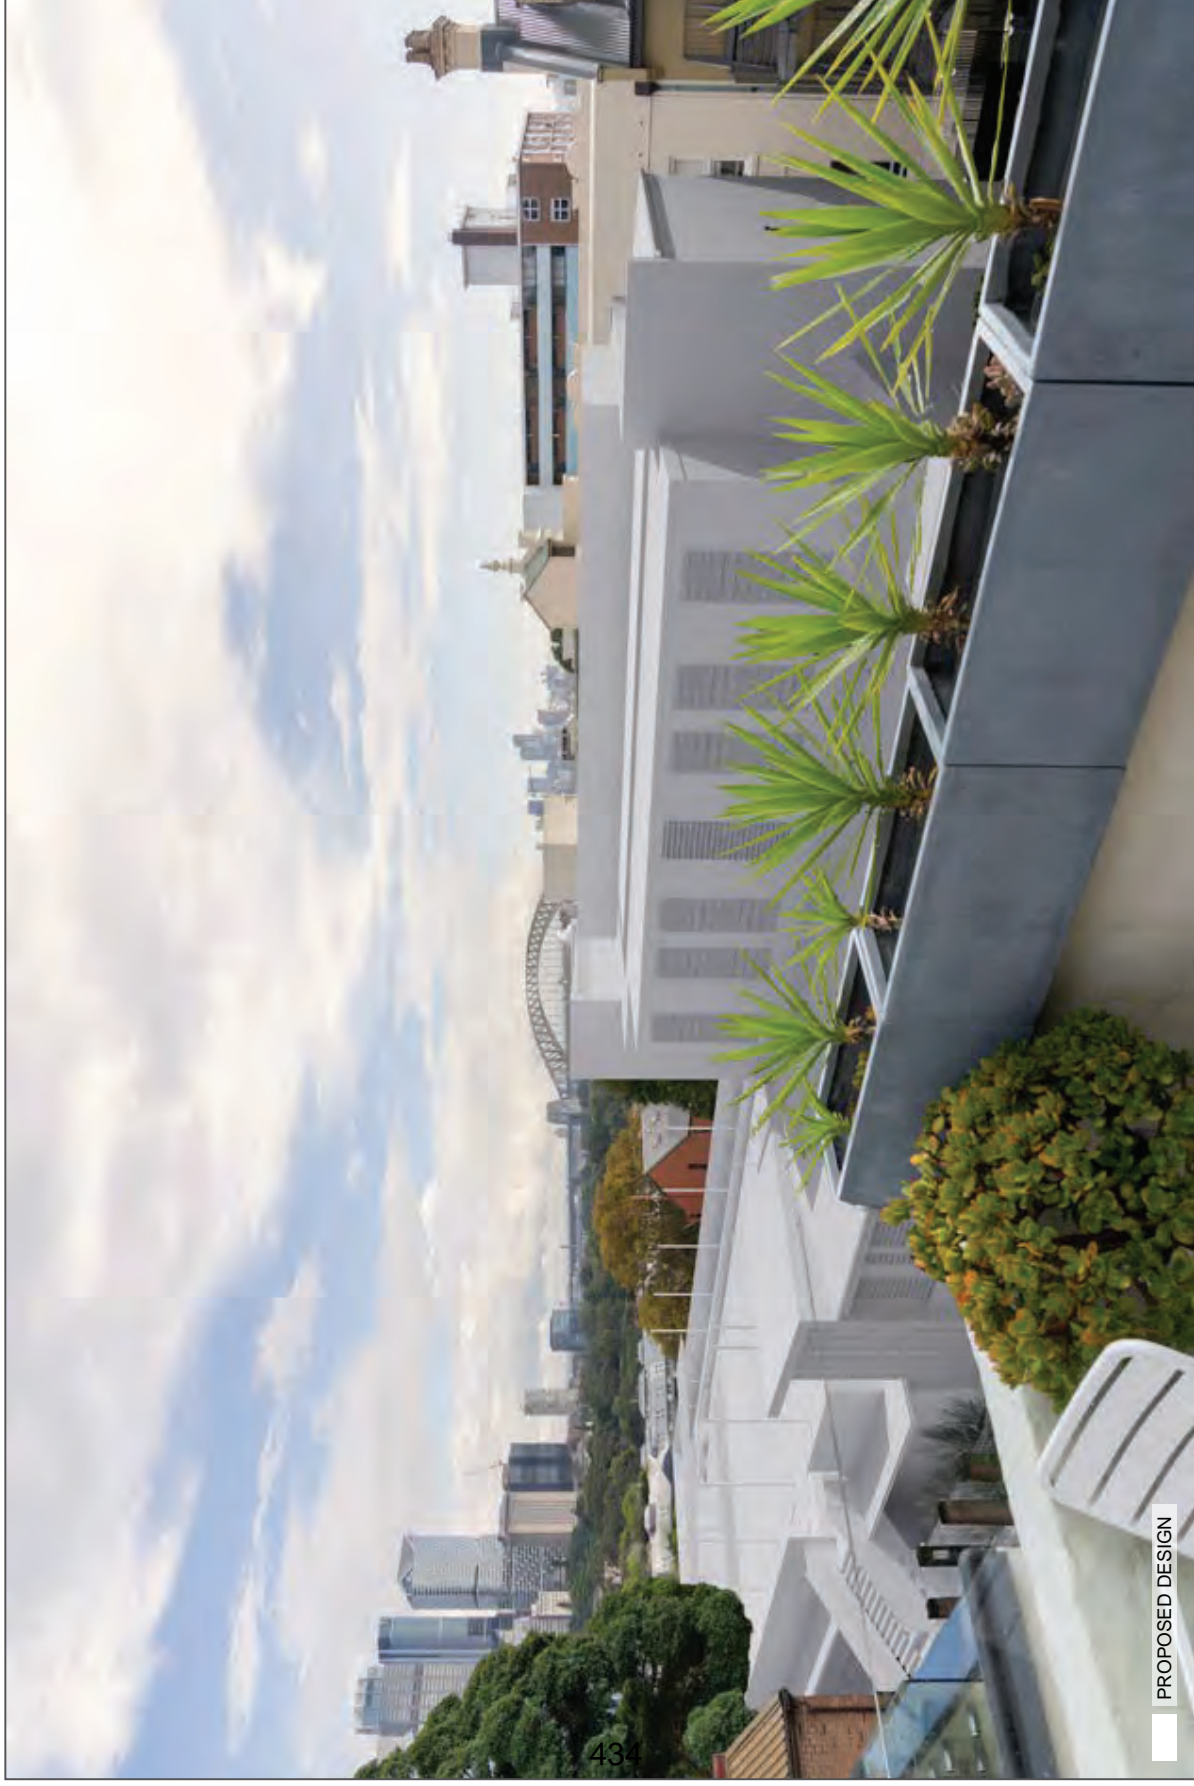
## 19.5 VIEWPOINT POSITION 15 - Unit 2, 14 Rockwall Crescent, Level 2 Balcony

PHOTOMONTAGE OF PROPOSED BUILDING DESIGN

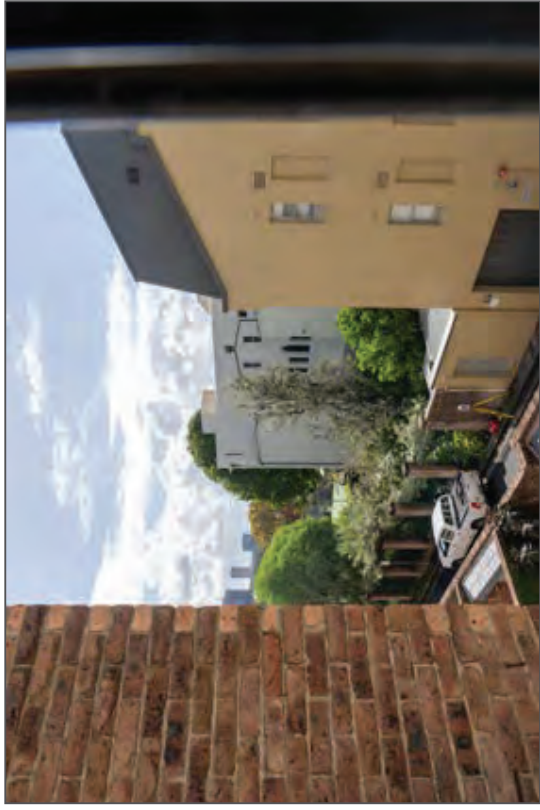
## 20.1 VIEWPOINT POSITION 16 - 16 Rockwall Crescent, Level 1 Dining

PHOTOGRAPH OF CURRENT CONDITION

Photo Date:	3 April 2023
Camera Used:	Sony ILCE-7C
Camera Lens:	FE 24-70mm F2.8 GM
Focal length in 35mm Film:	24mm

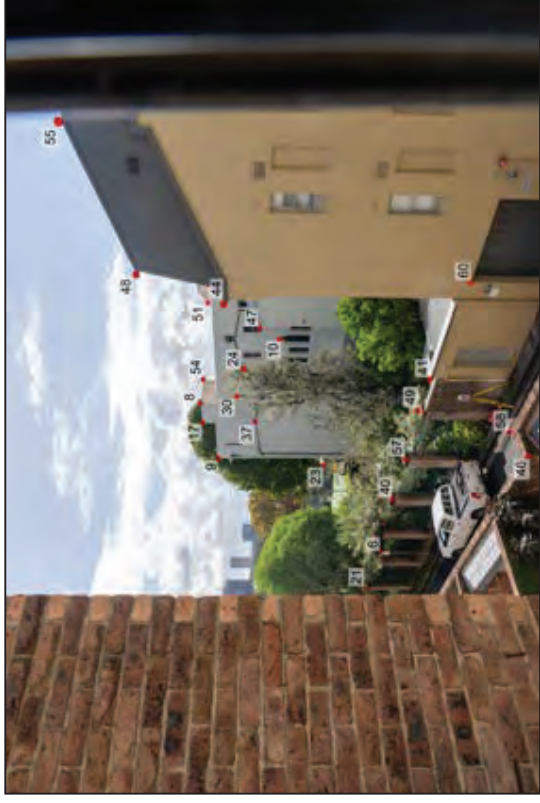
SURVEY POINTS USED FOR 3D CAMERA ALIGNMENT

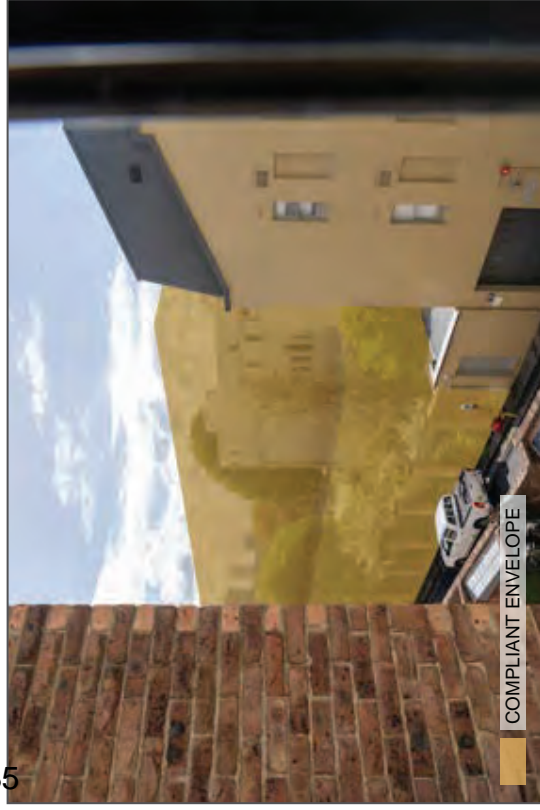
PHOTOMONTAGE OF COMPLIANT BUILDING ENVELOPE

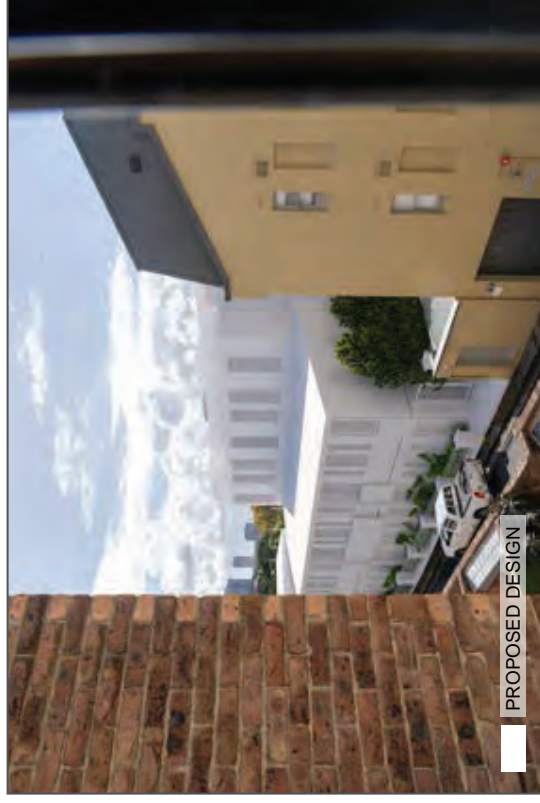
PHOTOMONTAGE OF PROPOSED BUILDING DESIGN

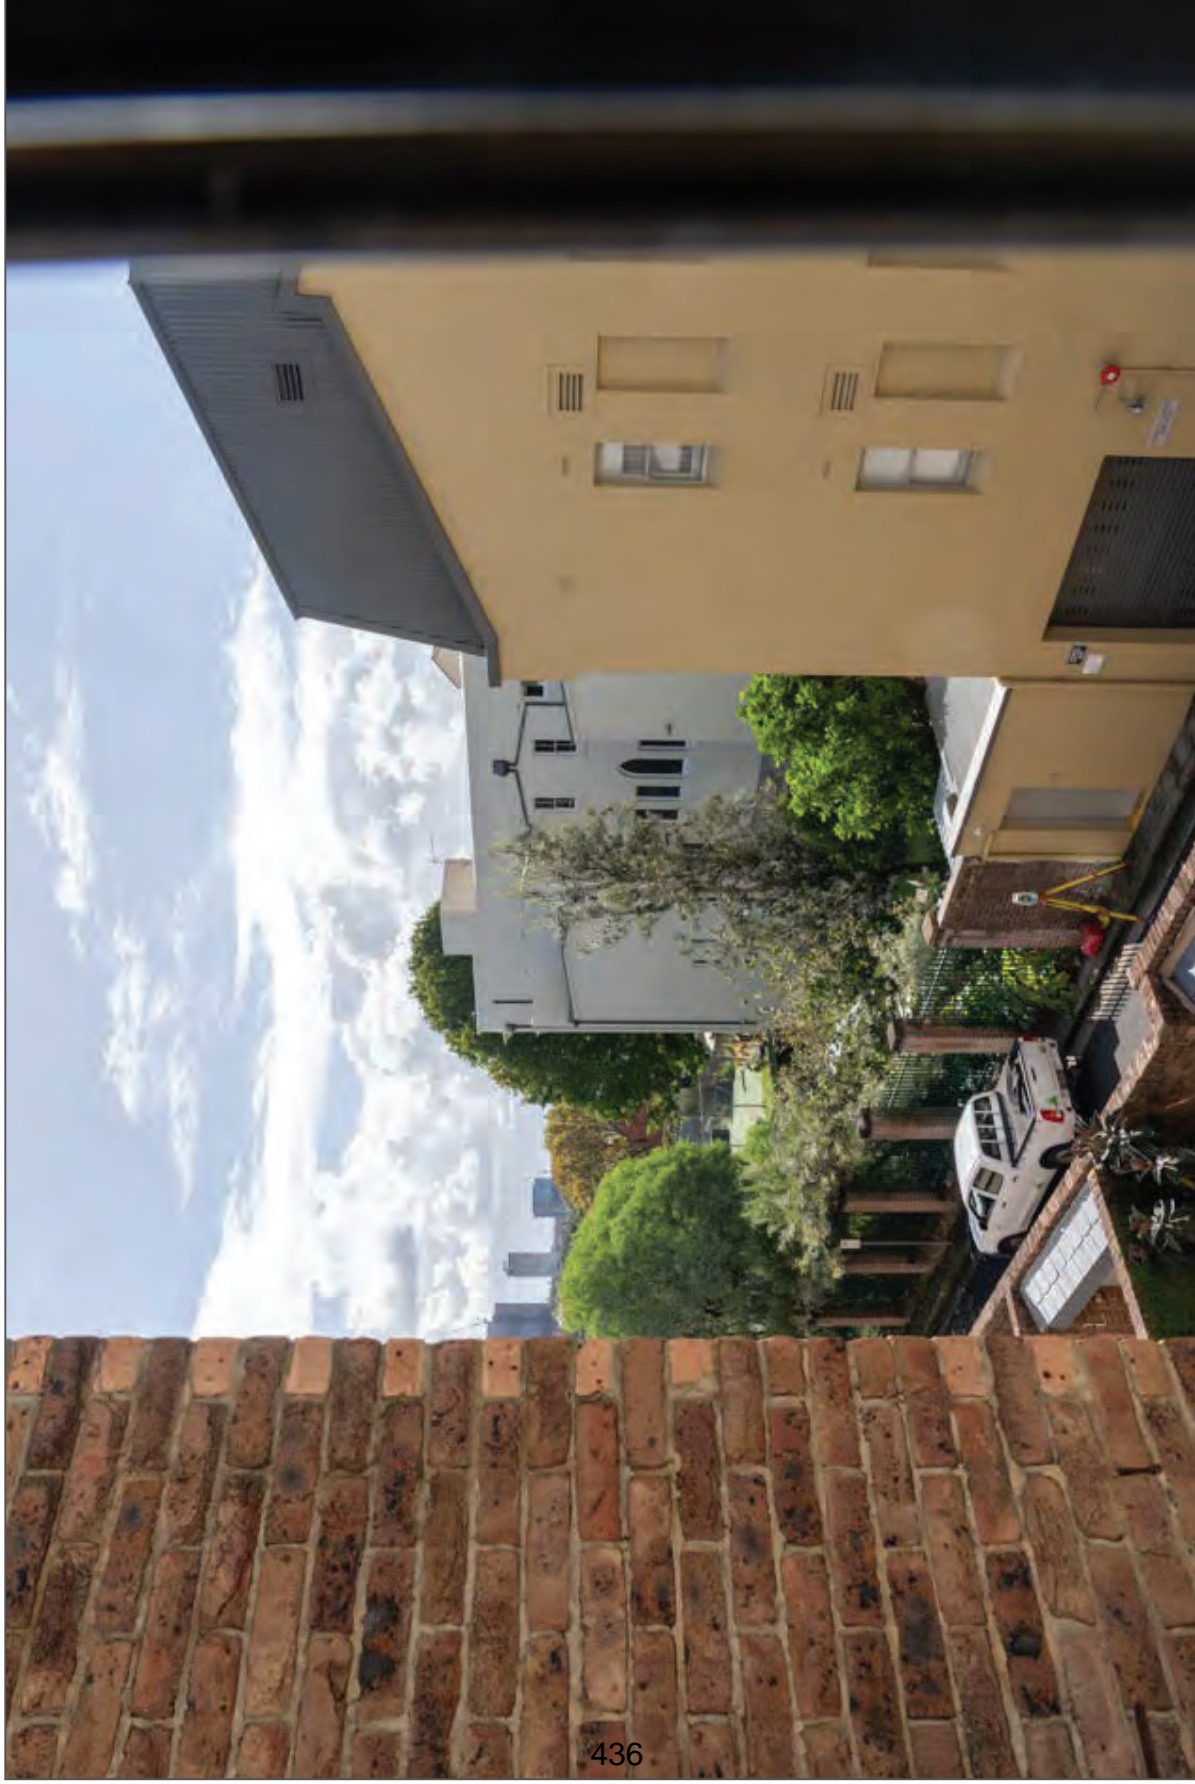
## 20.2 VIEWPOINT POSITION 16 - 16 Rockwall Crescent, Level 1 Dining

PHOTOGRAPH OF CURRENT CONDITION

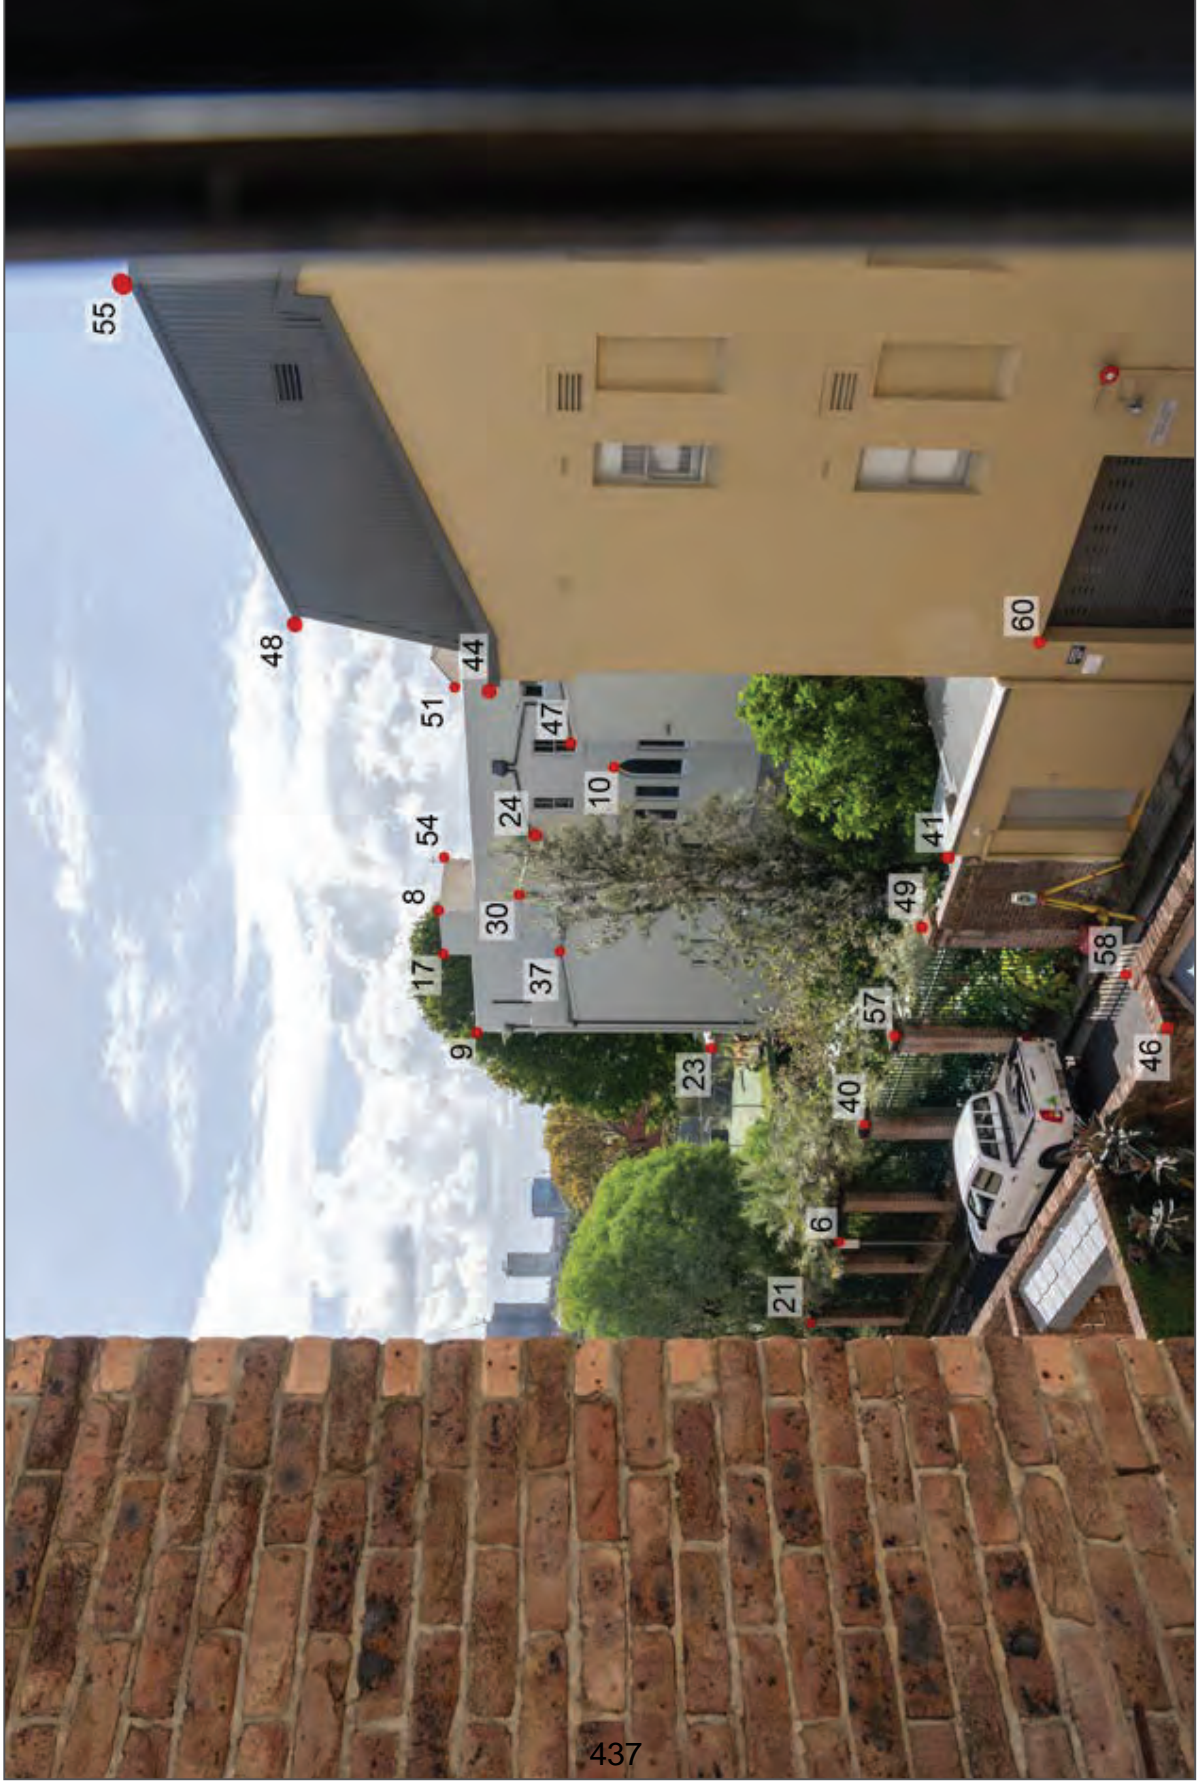
### 20.3 VIEWPOINT POSITION 16 - 16 Rockwall Crescent, Level 1 Dining

OVERLAY OF SURVEY POINTS USED FOR 3D CAMERA ALIGNMENT

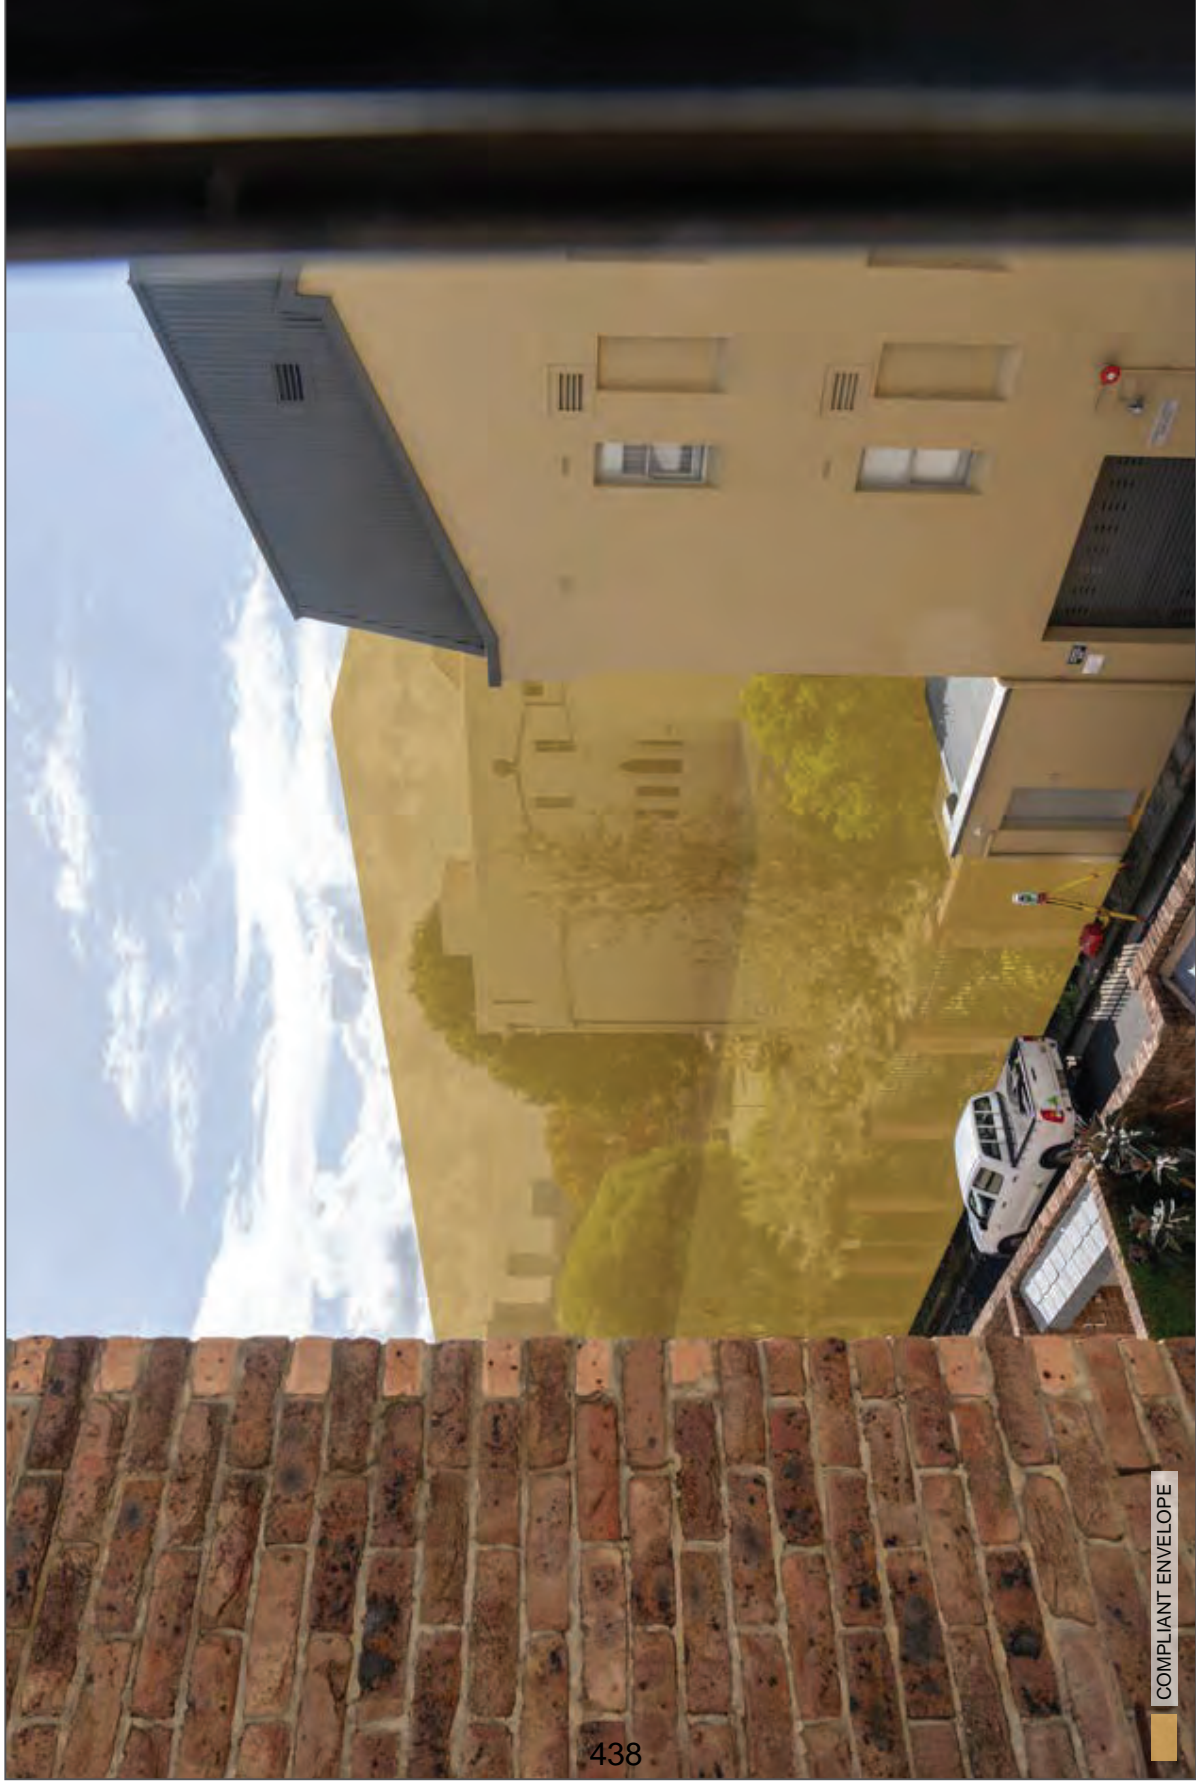
## 20.4 VIEWPOINT POSITION 16 - 16 Rockwall Crescent, Level 1 Dining

PHOTOMONTAGE OF COMPLIANT BUILDING ENVELOPE

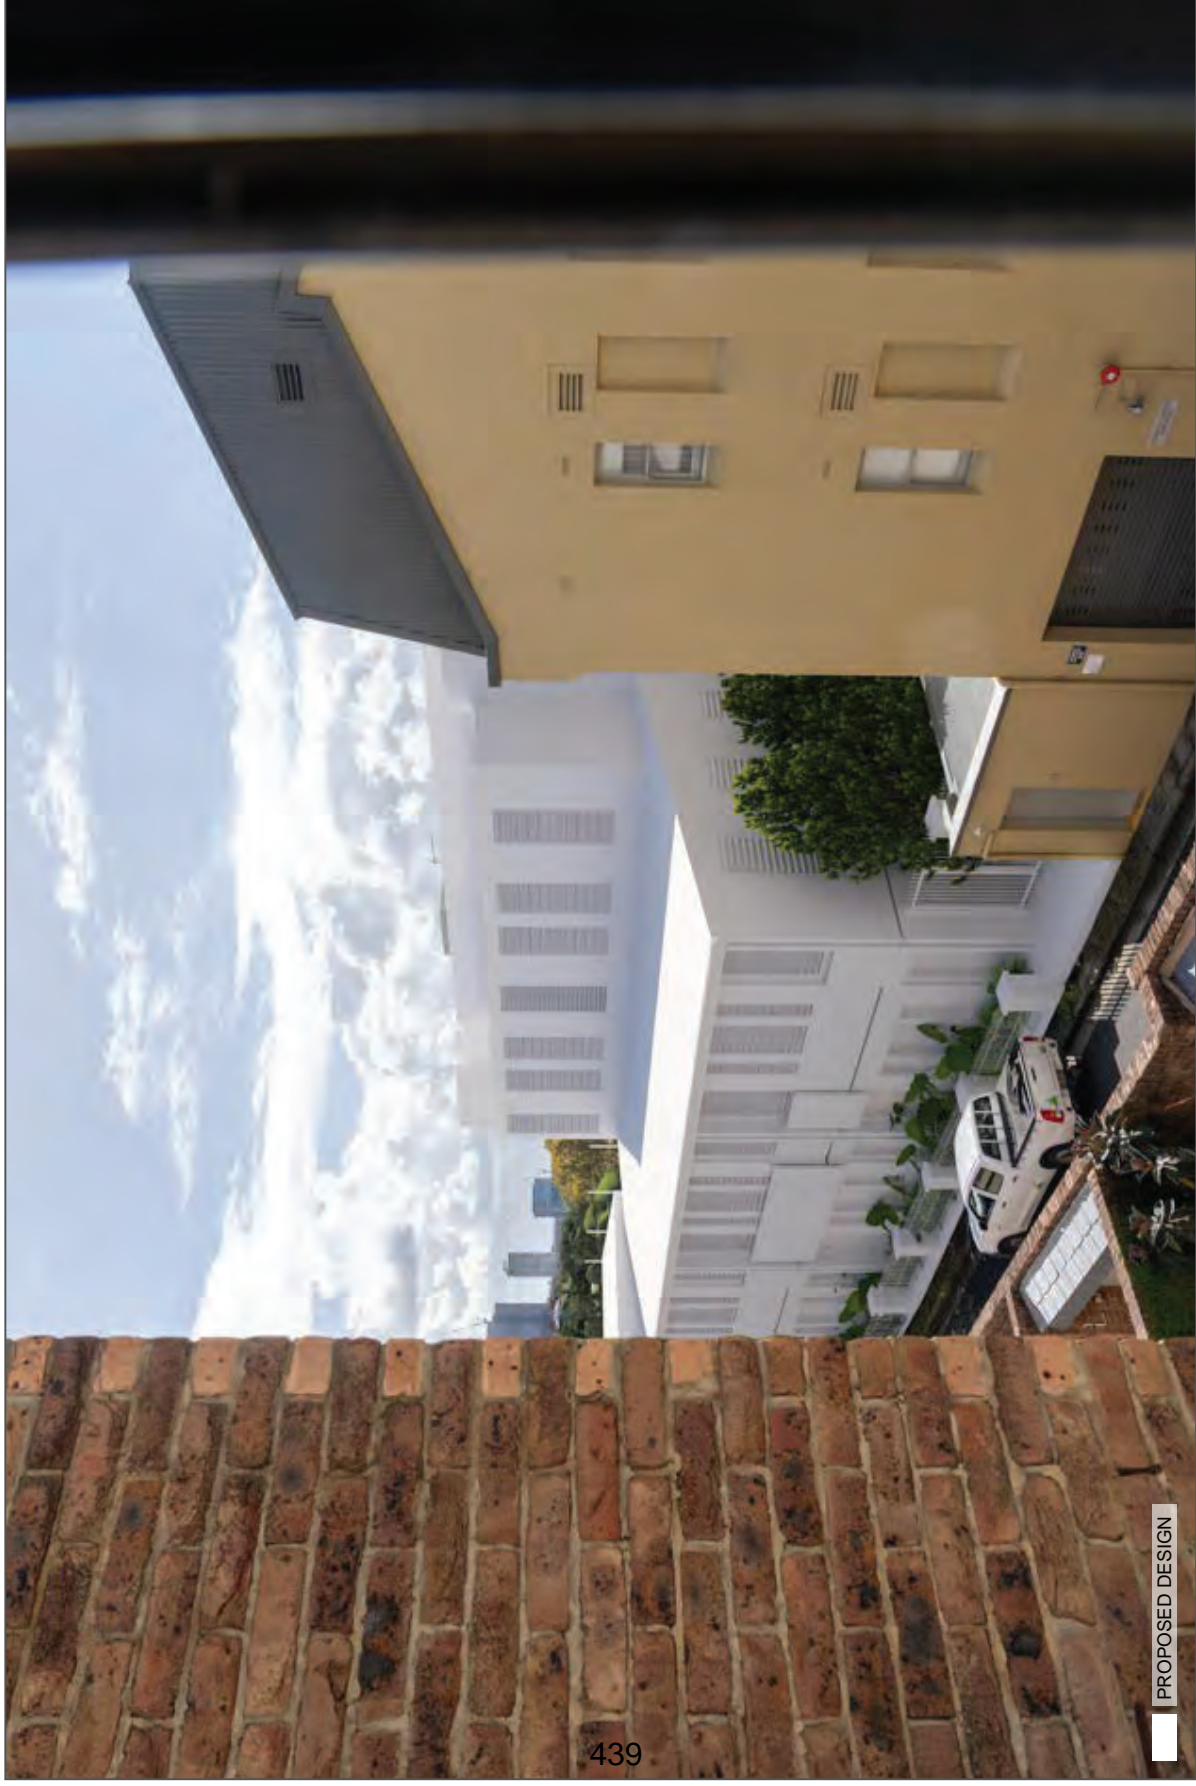
## 20.5 VIEWPOINT POSITION 16 - 16 Rockwall Crescent, Level 1 Dining

PHOTOMONTAGE OF PROPOSED BUILDING DESIGN

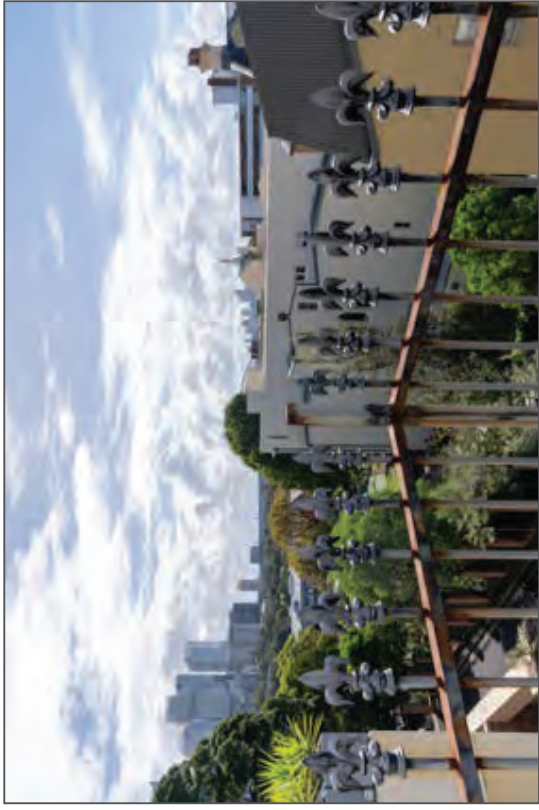
## 21.1 VIEWPOINT POSITION 17 - 16 Rockwall Crescent, Level 2 Balcony

PHOTOGRAPH OF CURRENT CONDITION

Photo Date:	3 April 2023
Camera Used:	Sony ILCE-7C
Camera Lens:	FE 24-70mm F2.8 GM
Focal length in 35mm Film:	24mm

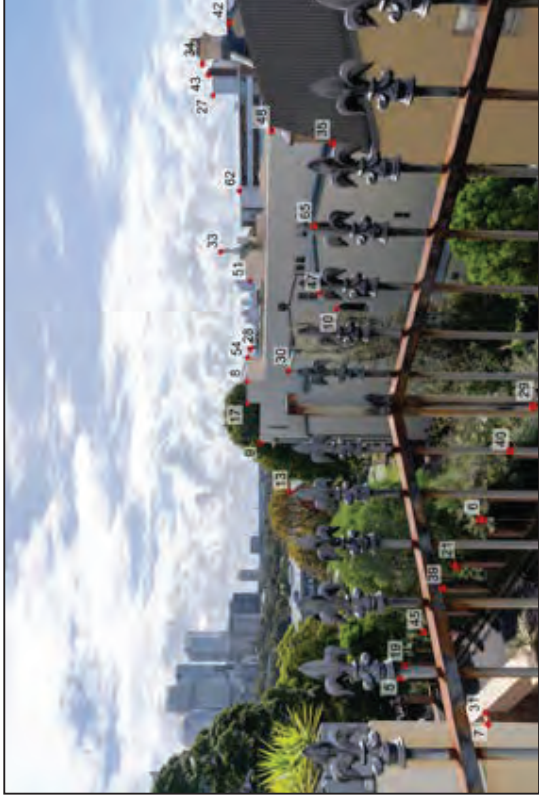
SURVEY POINTS USED FOR 3D CAMERA ALIGNMENT

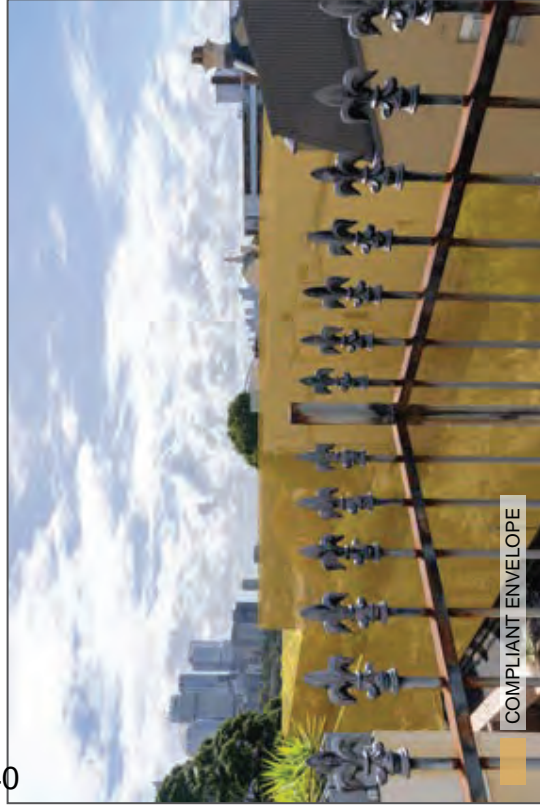
PHOTOMONTAGE OF COMPLIANT BUILDING ENVELOPE

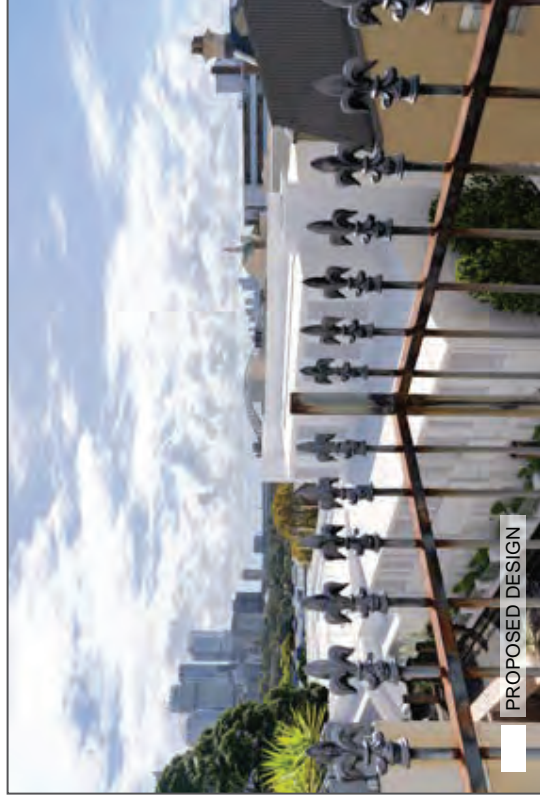
PHOTOMONTAGE OF PROPOSED BUILDING DESIGN

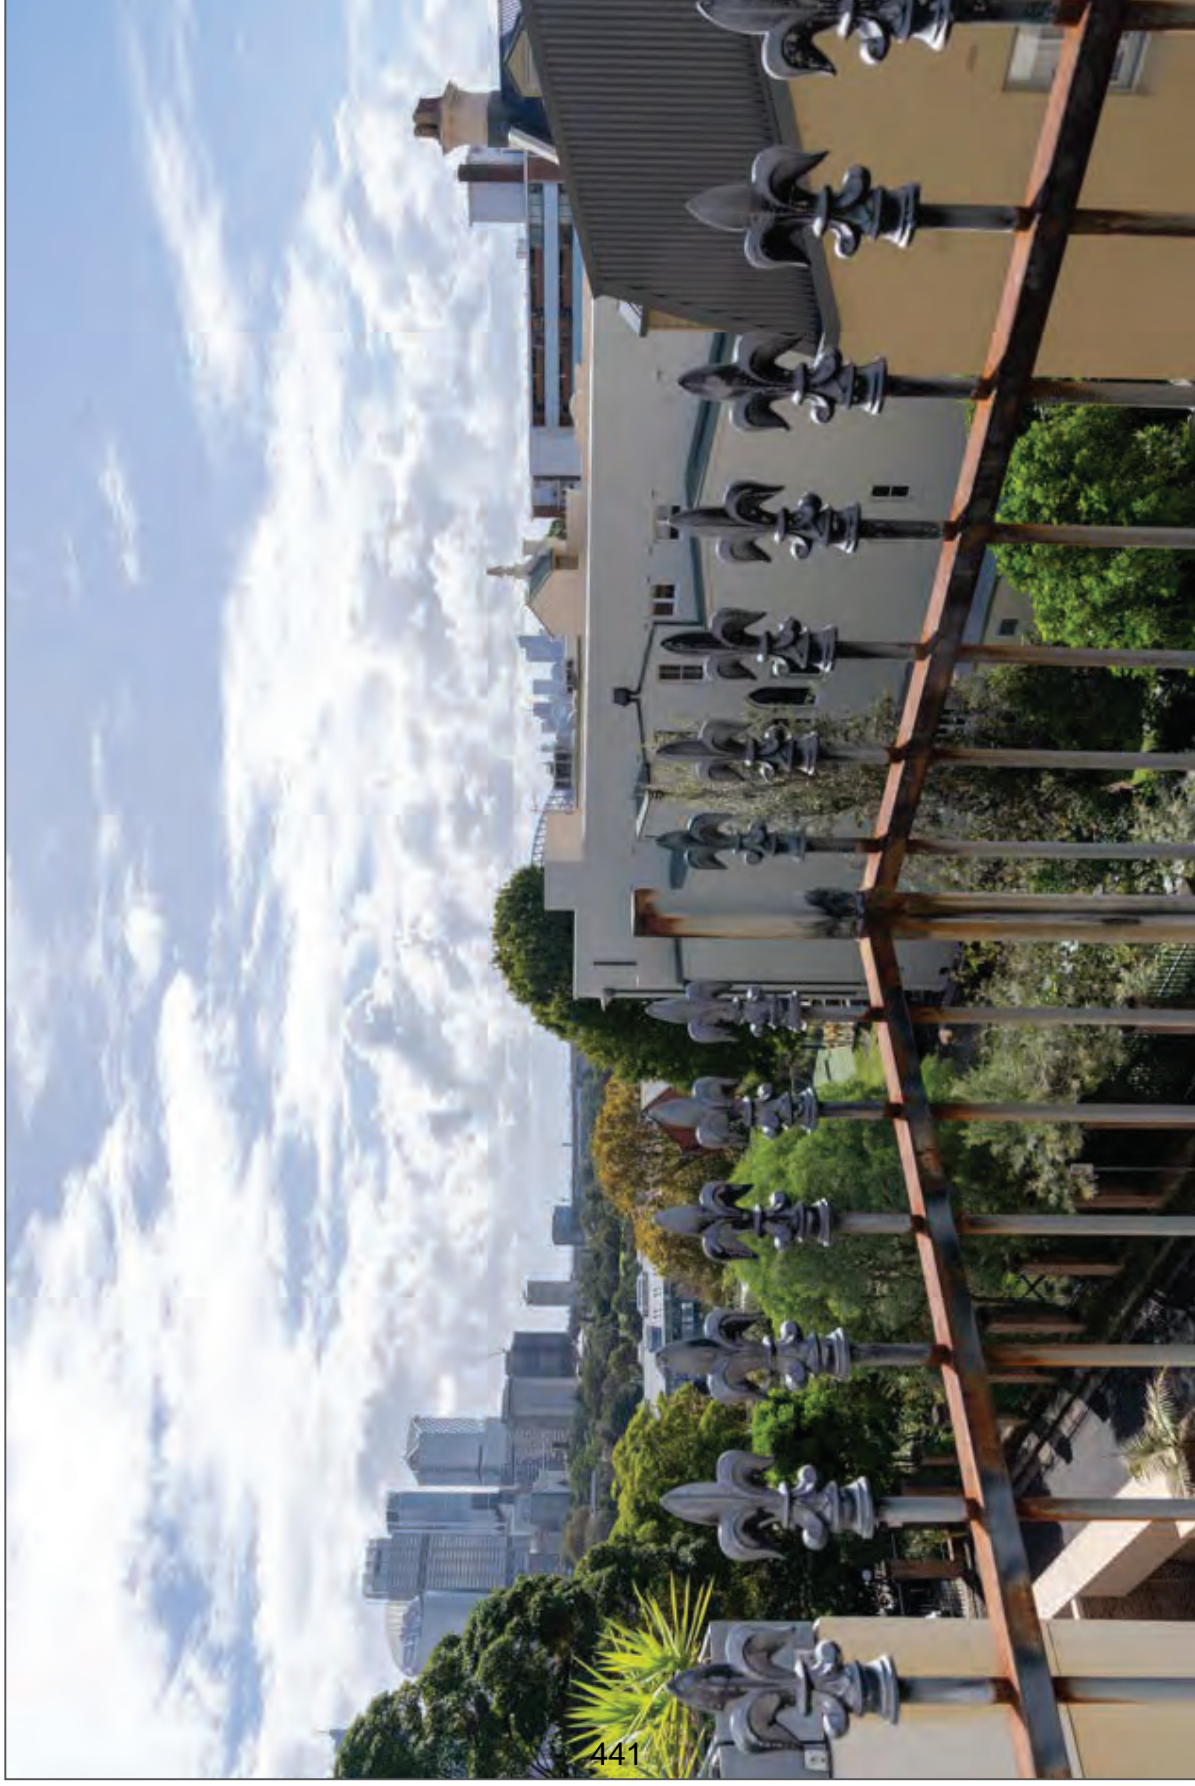
## 21.2 VIEWPOINT POSITION 17 - 16 Rockwall Crescent, Level 2 Balcony

PHOTOGRAPH OF CURRENT CONDITION
