# View Loss Assessment

Submitted to City of Sydney in response to RFI dated 31 July 2024

St Vincent's College, 1 Challis Avenue, Potts Point  
The Trustees of the Sisters of Charity of Australia

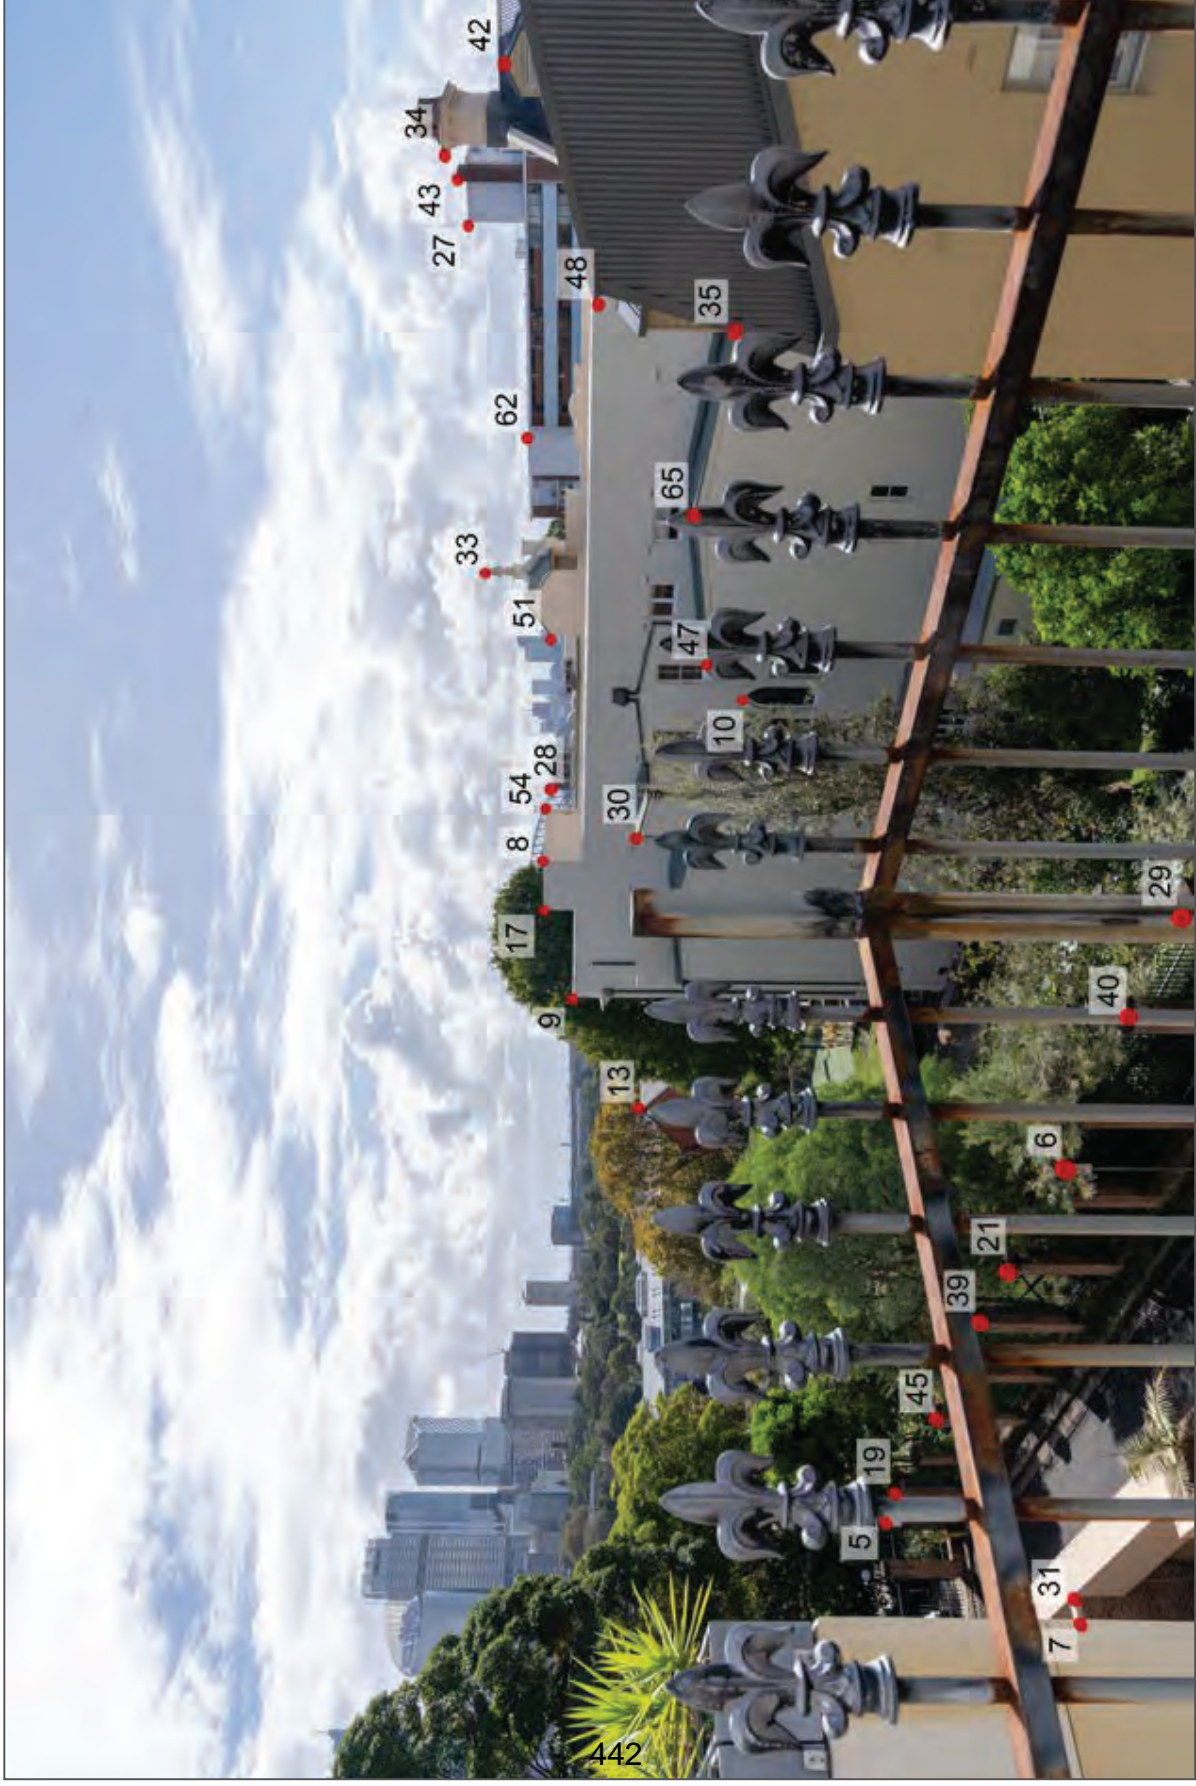
### 21.3 VIEWPOINT POSITION 17 - 16 Rockwall Crescent, Level 2 Balcony

OVERLAY OF SURVEY POINTS USED FOR 3D CAMERA ALIGNMENT

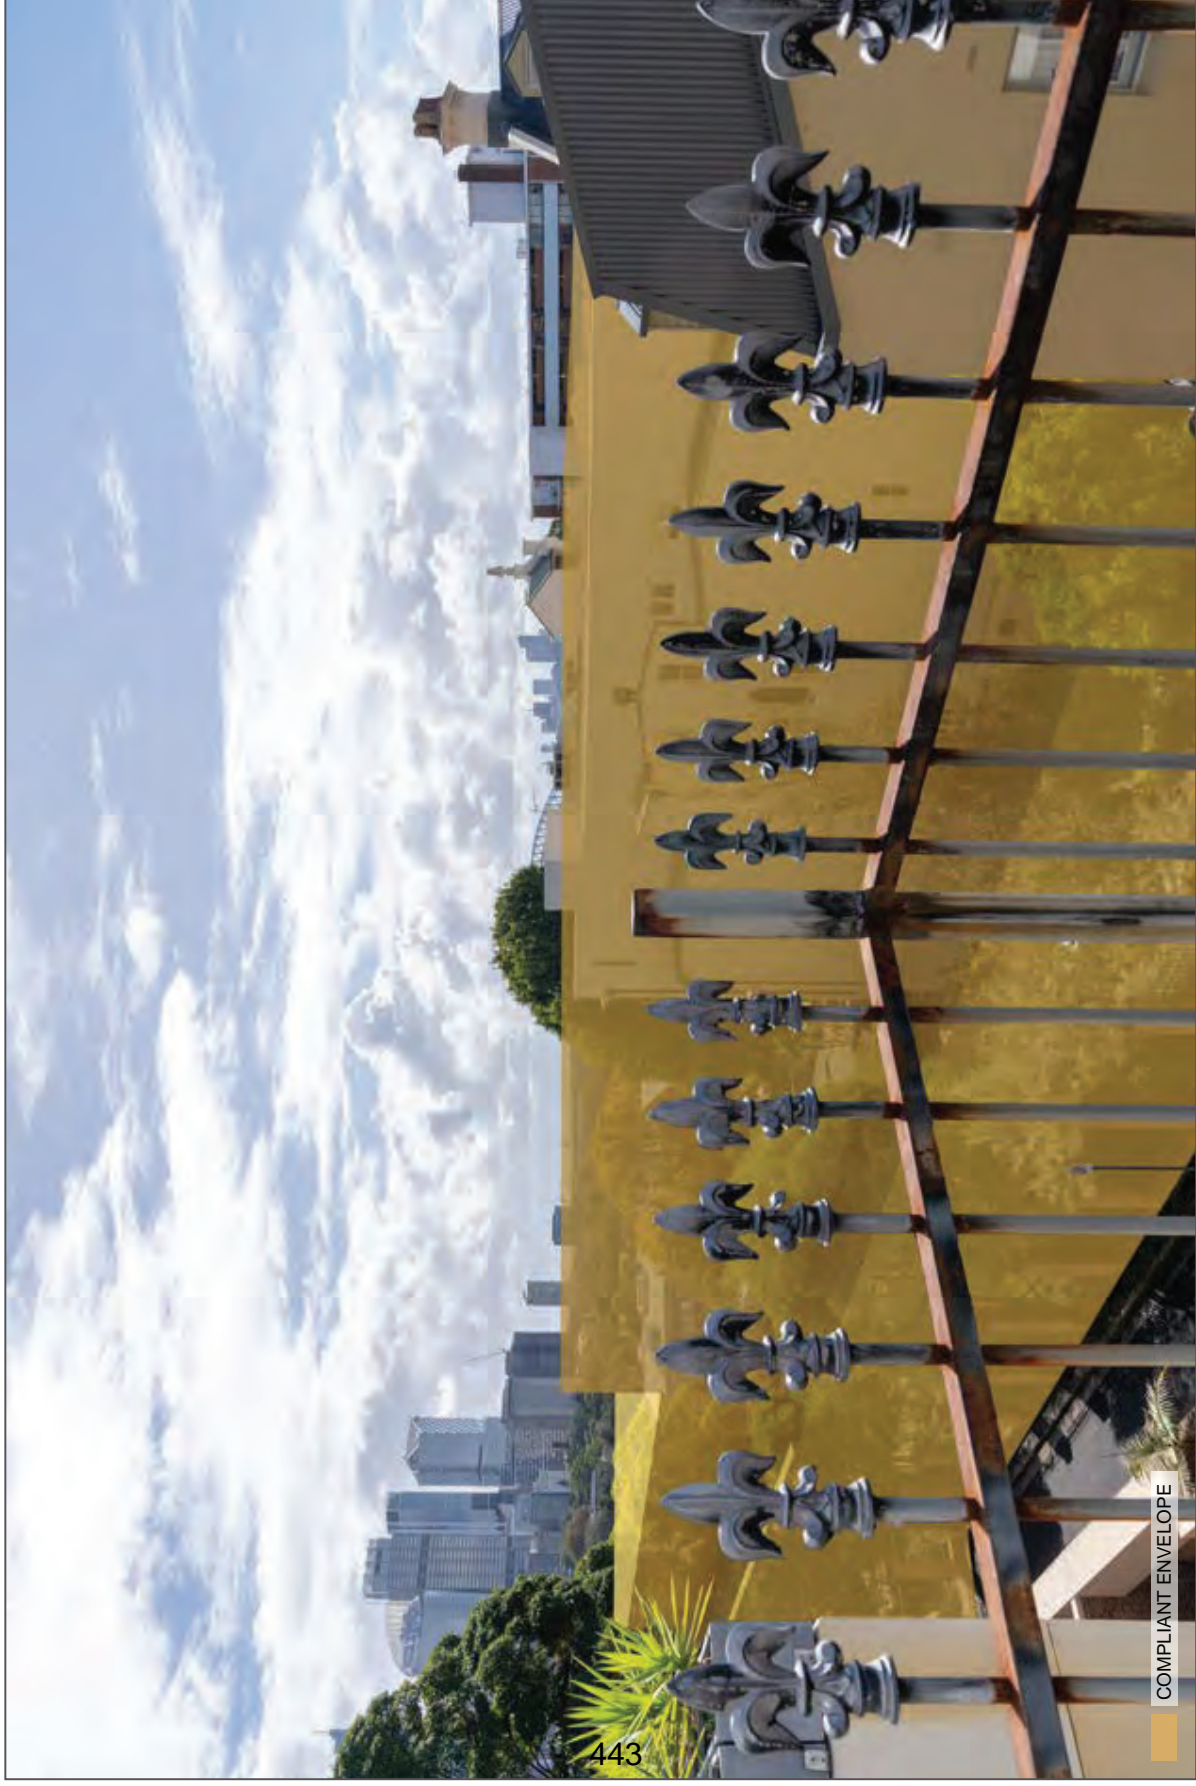
## 21.4 VIEWPOINT POSITION 17 - 16 Rockwall Crescent, Level 2 Balcony

PHOTOMONTAGE OF COMPLIANT BUILDING ENVELOPE

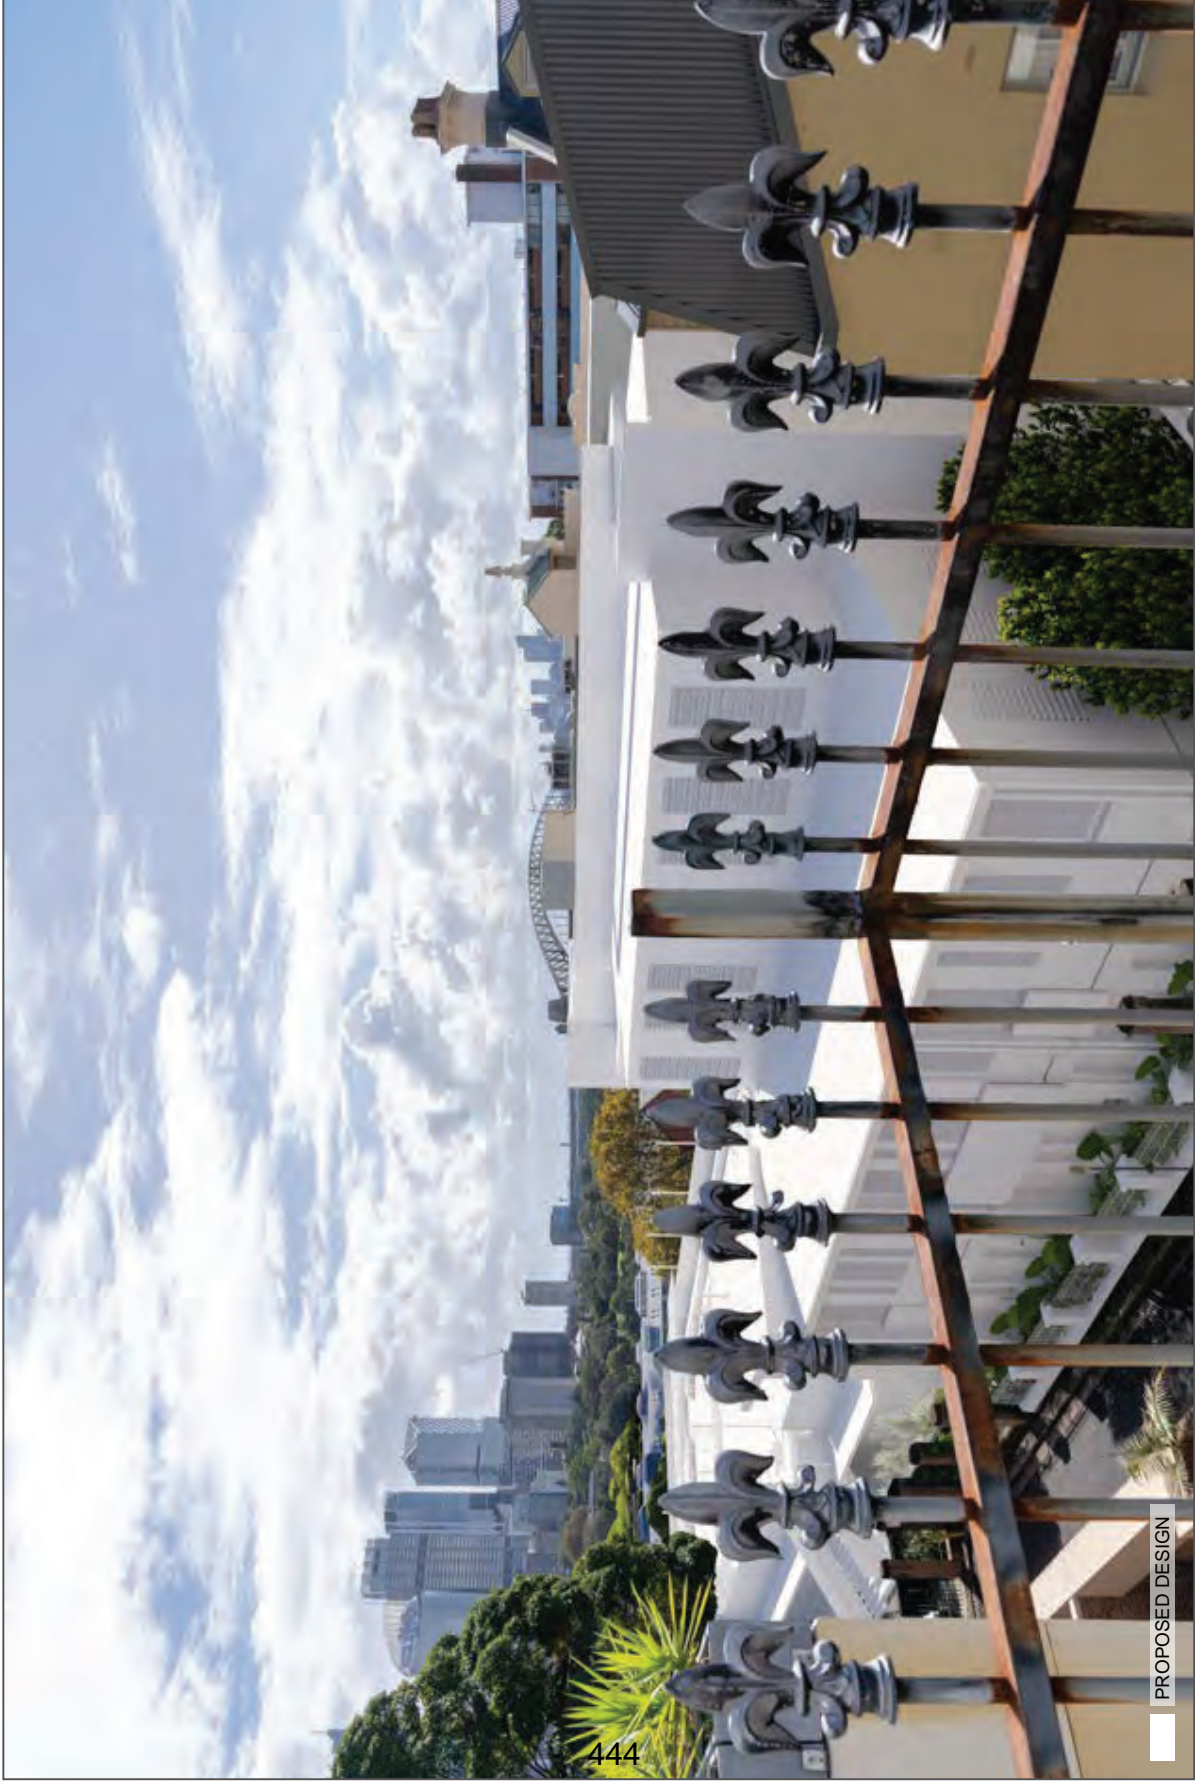
## 21.5 VIEWPOINT POSITION 17 - 16 Rockwall Crescent, Level 2 Balcony

PHOTOMONTAGE OF PROPOSED BUILDING DESIGN

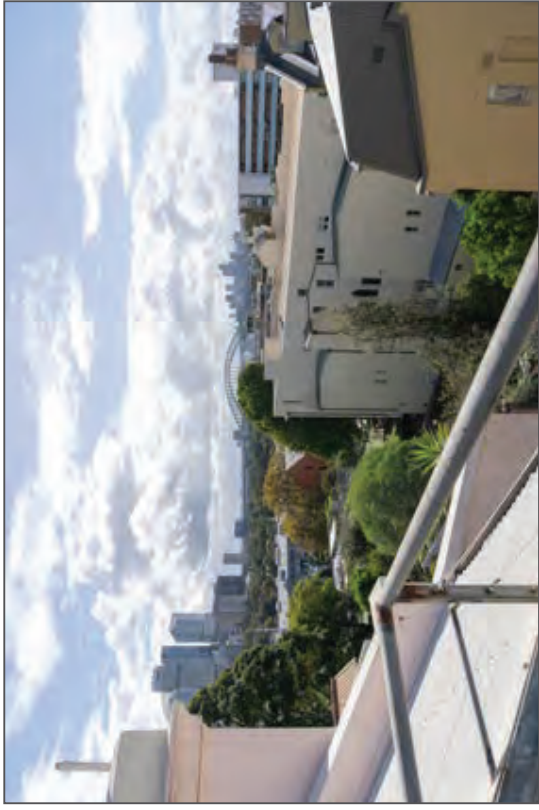
## 22.1 VIEWPOINT POSITION 18 - 16 Rockwall Crescent, Level 3 Balcony

PHOTOGRAPH OF CURRENT CONDITION

Photo Date:	3 April 2023
Camera Used:	Sony ILCE-7C
Camera Lens:	FE 24-70mm F2.8 GM
Focal length in 35mm Film:	24mm

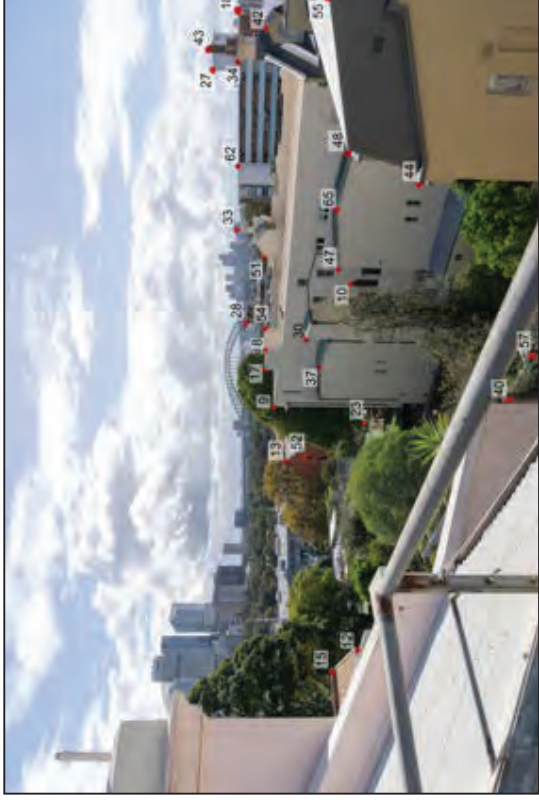
SURVEY POINTS USED FOR 3D CAMERA ALIGNMENT

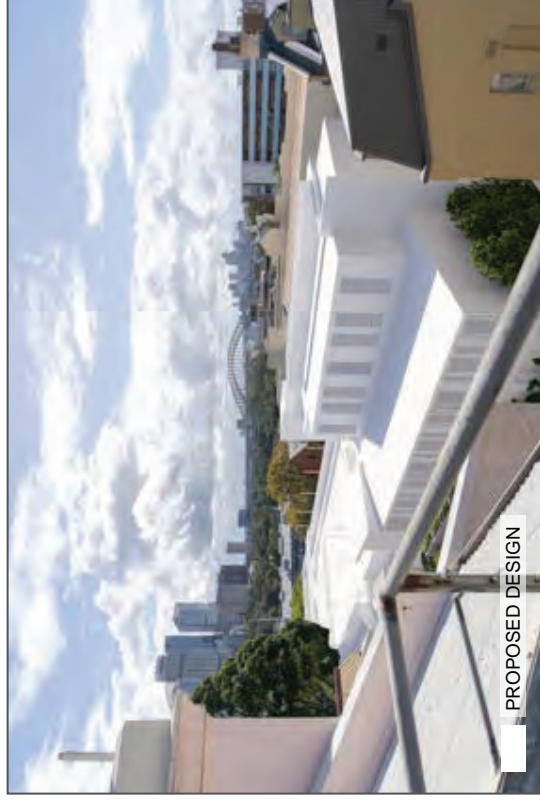
PHOTOMONTAGE OF PROPOSED BUILDING DESIGN

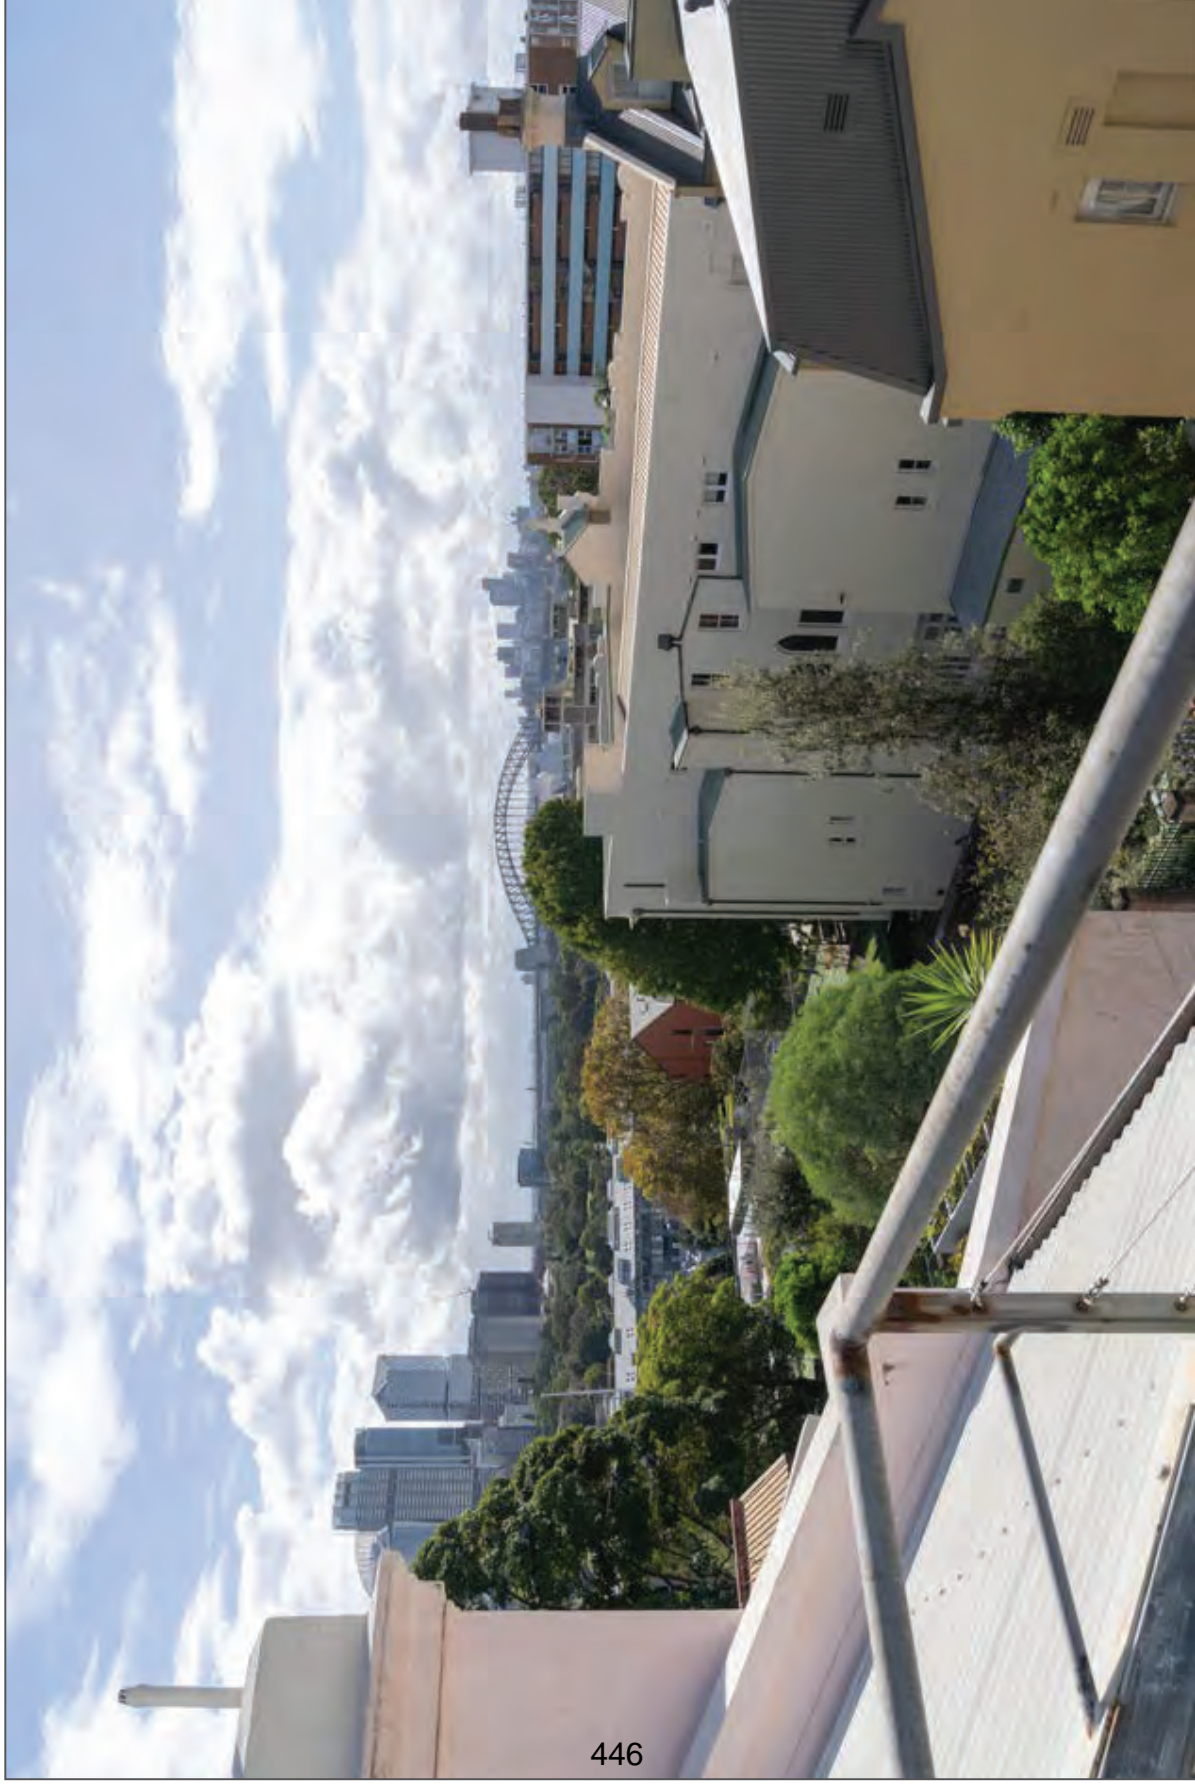
## 22.2 VIEWPOINT POSITION 18 - 16 Rockwall Crescent, Level 3 Balcony

PHOTOGRAPH OF CURRENT CONDITION

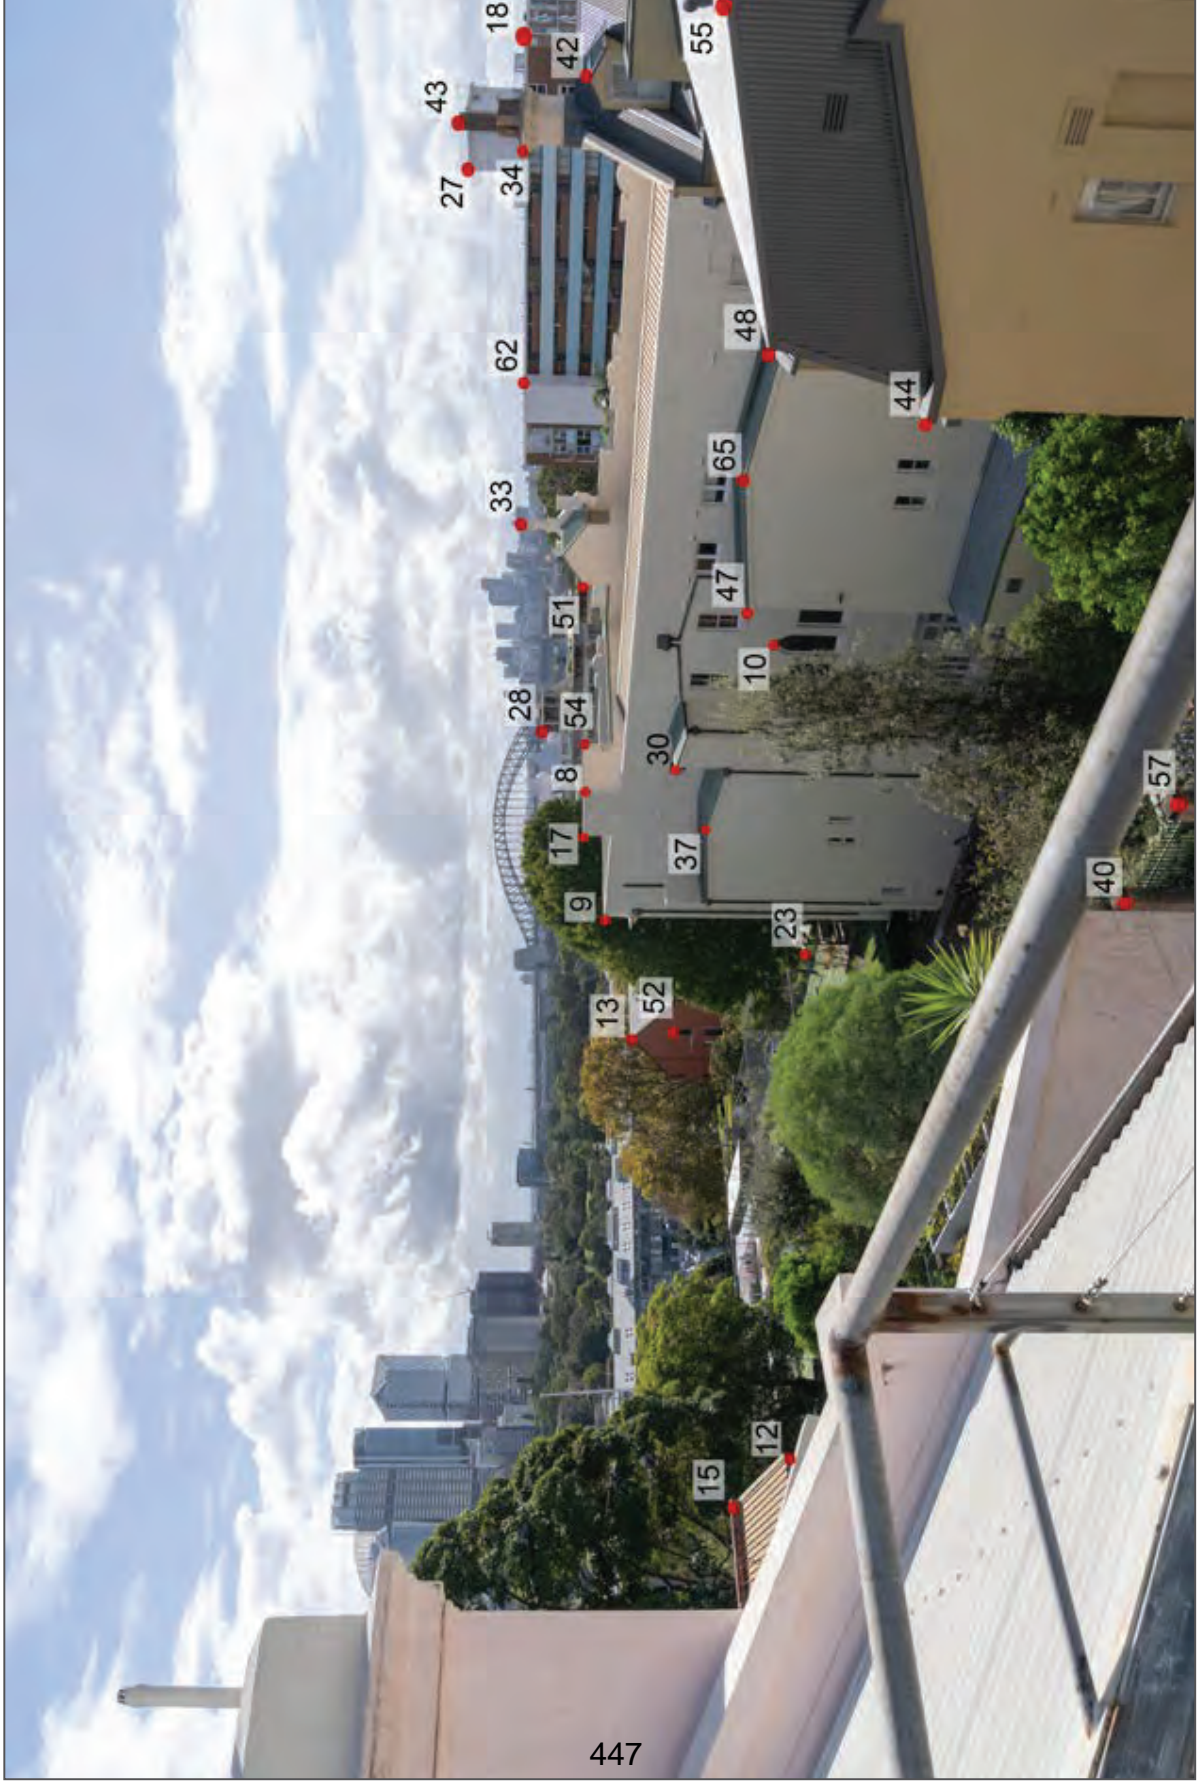
### 22.3 VIEWPOINT POSITION 18 - 16 Rockwall Crescent, Level 3 Balcony

OVERLAY OF SURVEY POINTS USED FOR 3D CAMERA ALIGNMENT

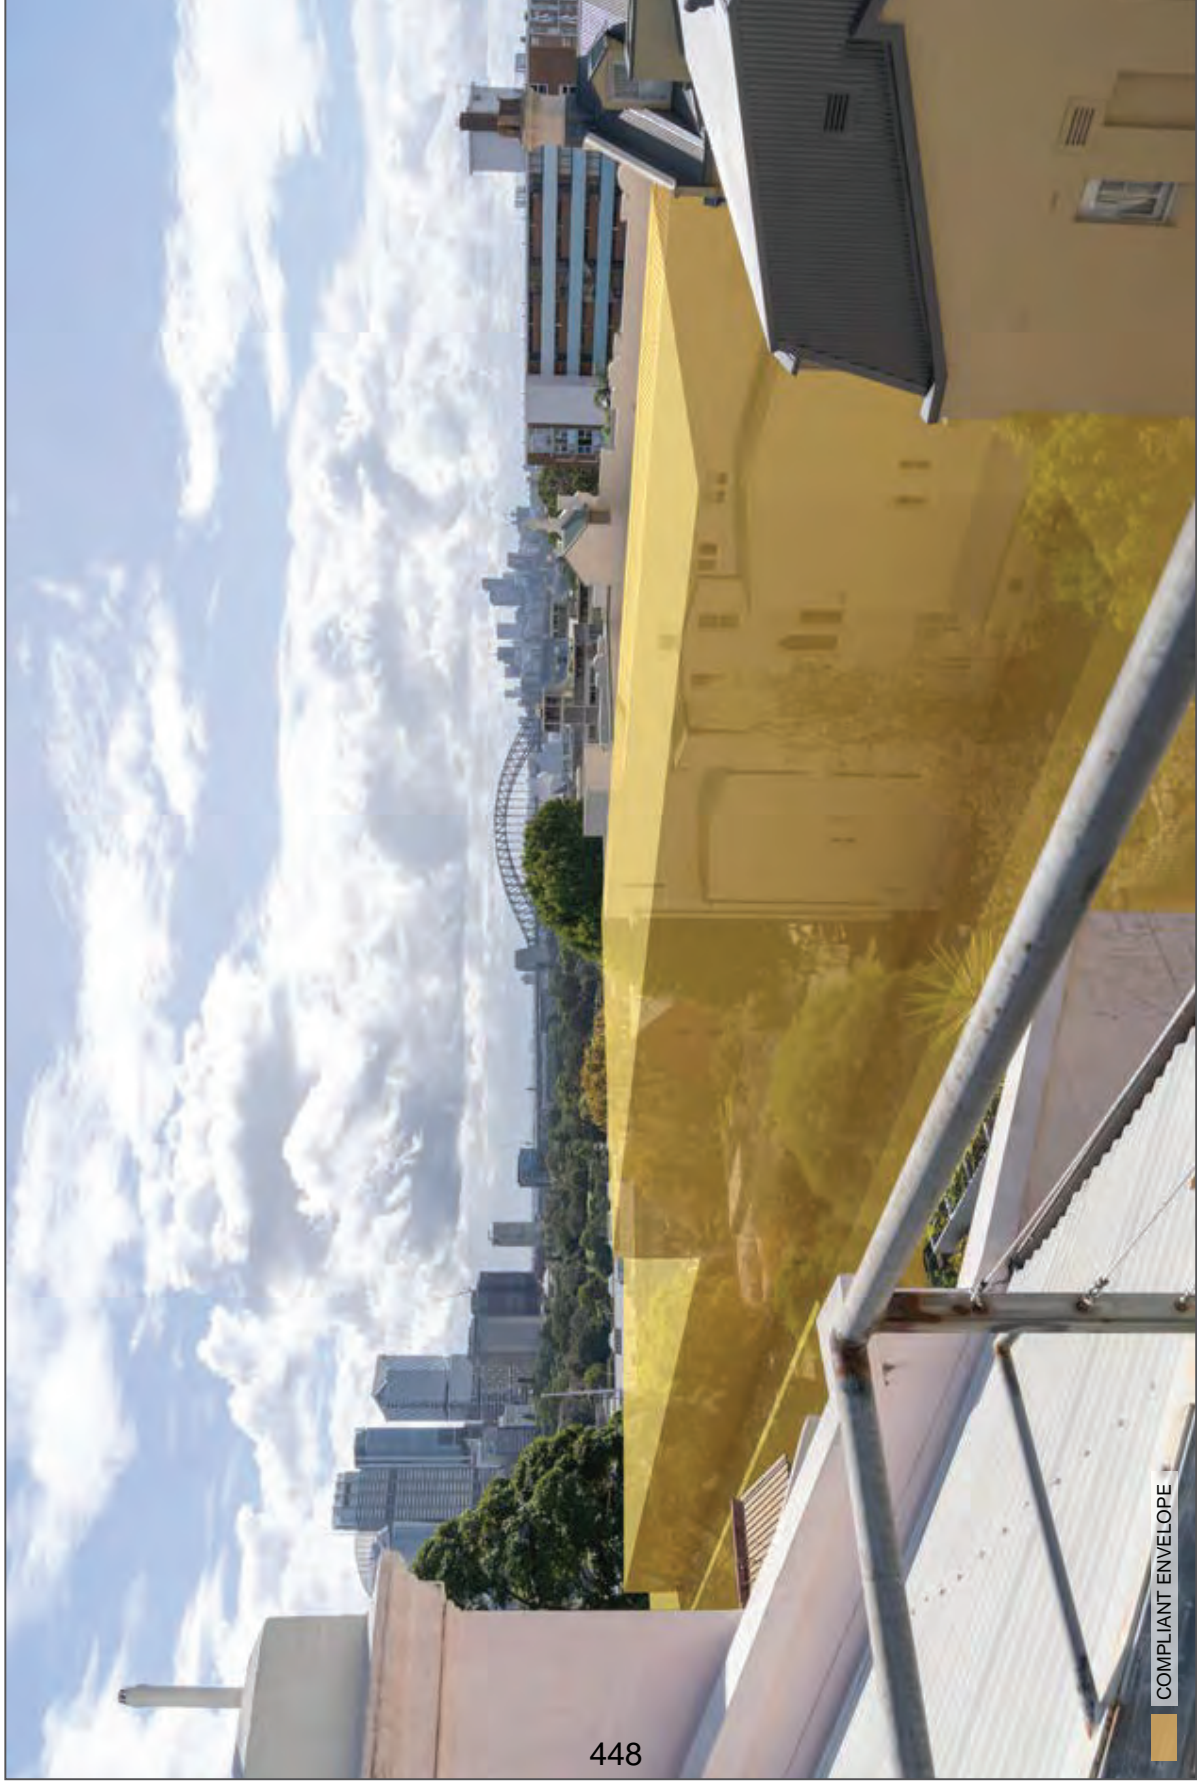
## 22.4 VIEWPOINT POSITION 18 - 16 Rockwall Crescent, Level 3 Balcony

PHOTOMONTAGE OF COMPLIANT BUILDING ENVELOPE

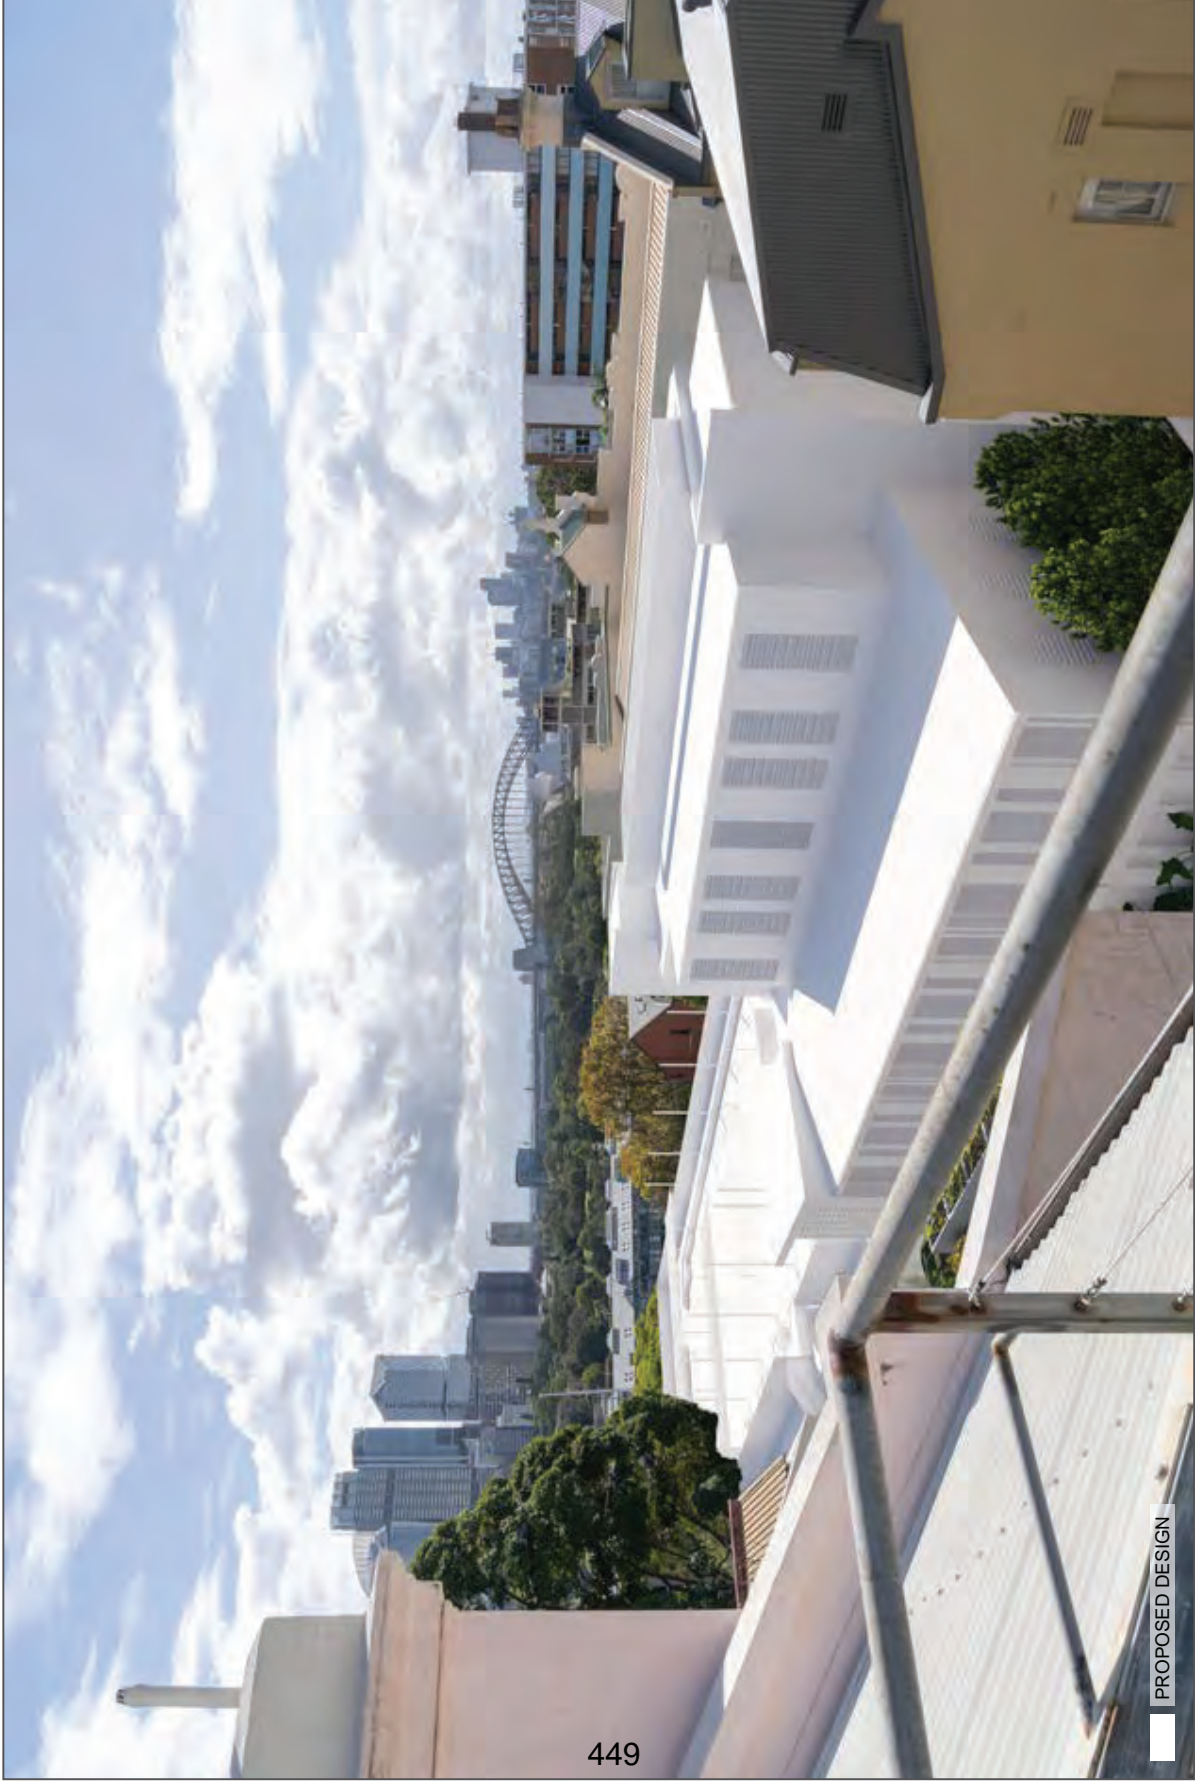
## 22.5 VIEWPOINT POSITION 18 - 16 Rockwall Crescent, Level 3 Balcony

PHOTOMONTAGE OF PROPOSED BUILDING DESIGN

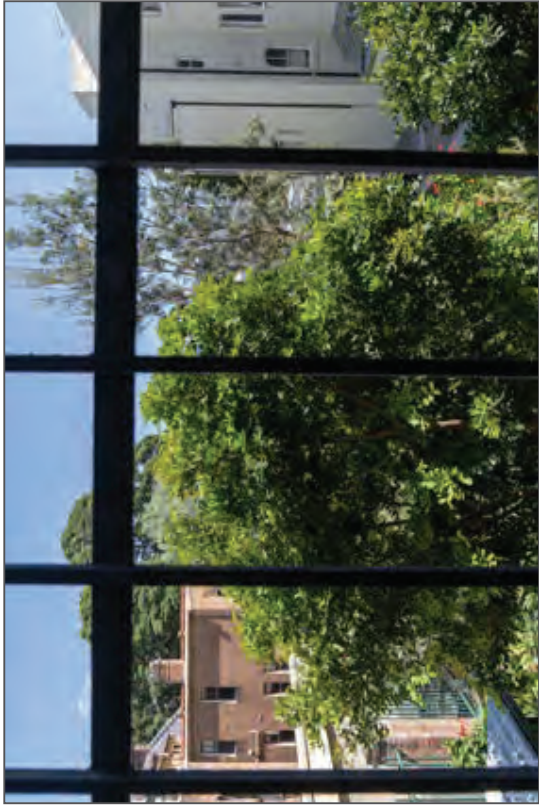
### 23.1 VIEWPOINT POSITION 19 - Hotel Challis, 21-23 Challis Avenue, Room 214

PHOTOGRAPH OF CURRENT CONDITION

Photo Date:	15 March 2023
Camera Used:	Sony ILCE-7C
Camera Lens:	FE 24-70mm F2.8 GM
Focal length in 35mm Film:	24mm

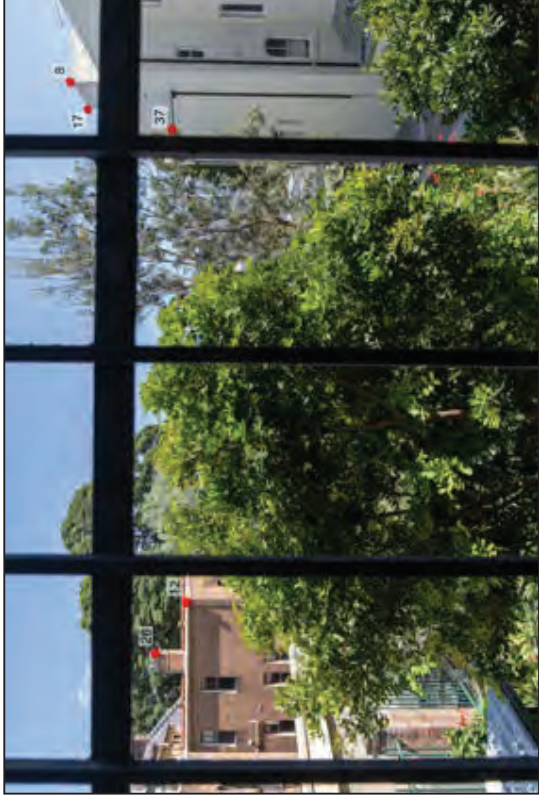
SURVEY POINTS USED FOR 3D CAMERA ALIGNMENT

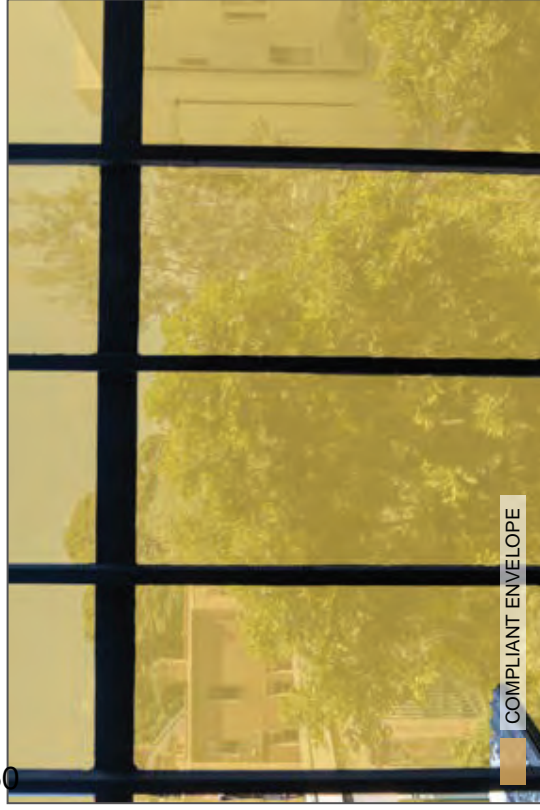
PHOTOMONTAGE OF COMPLIANT BUILDING ENVELOPE

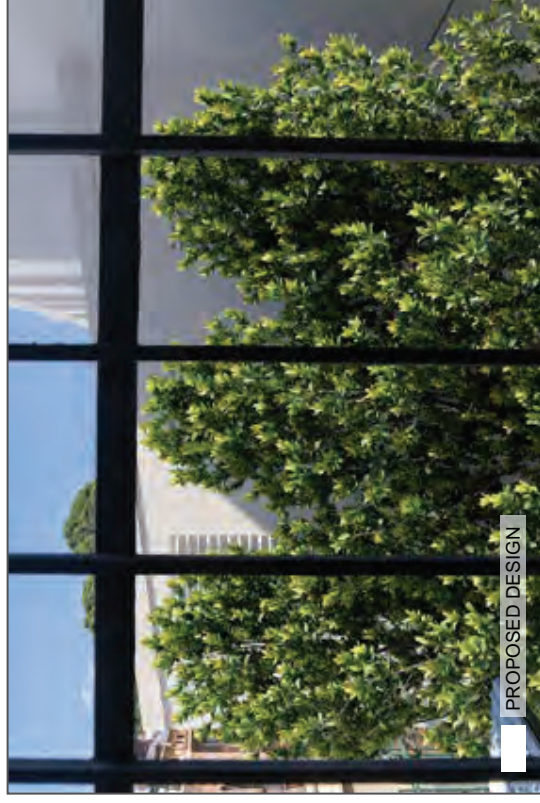
PHOTOMONTAGE OF PROPOSED BUILDING DESIGN

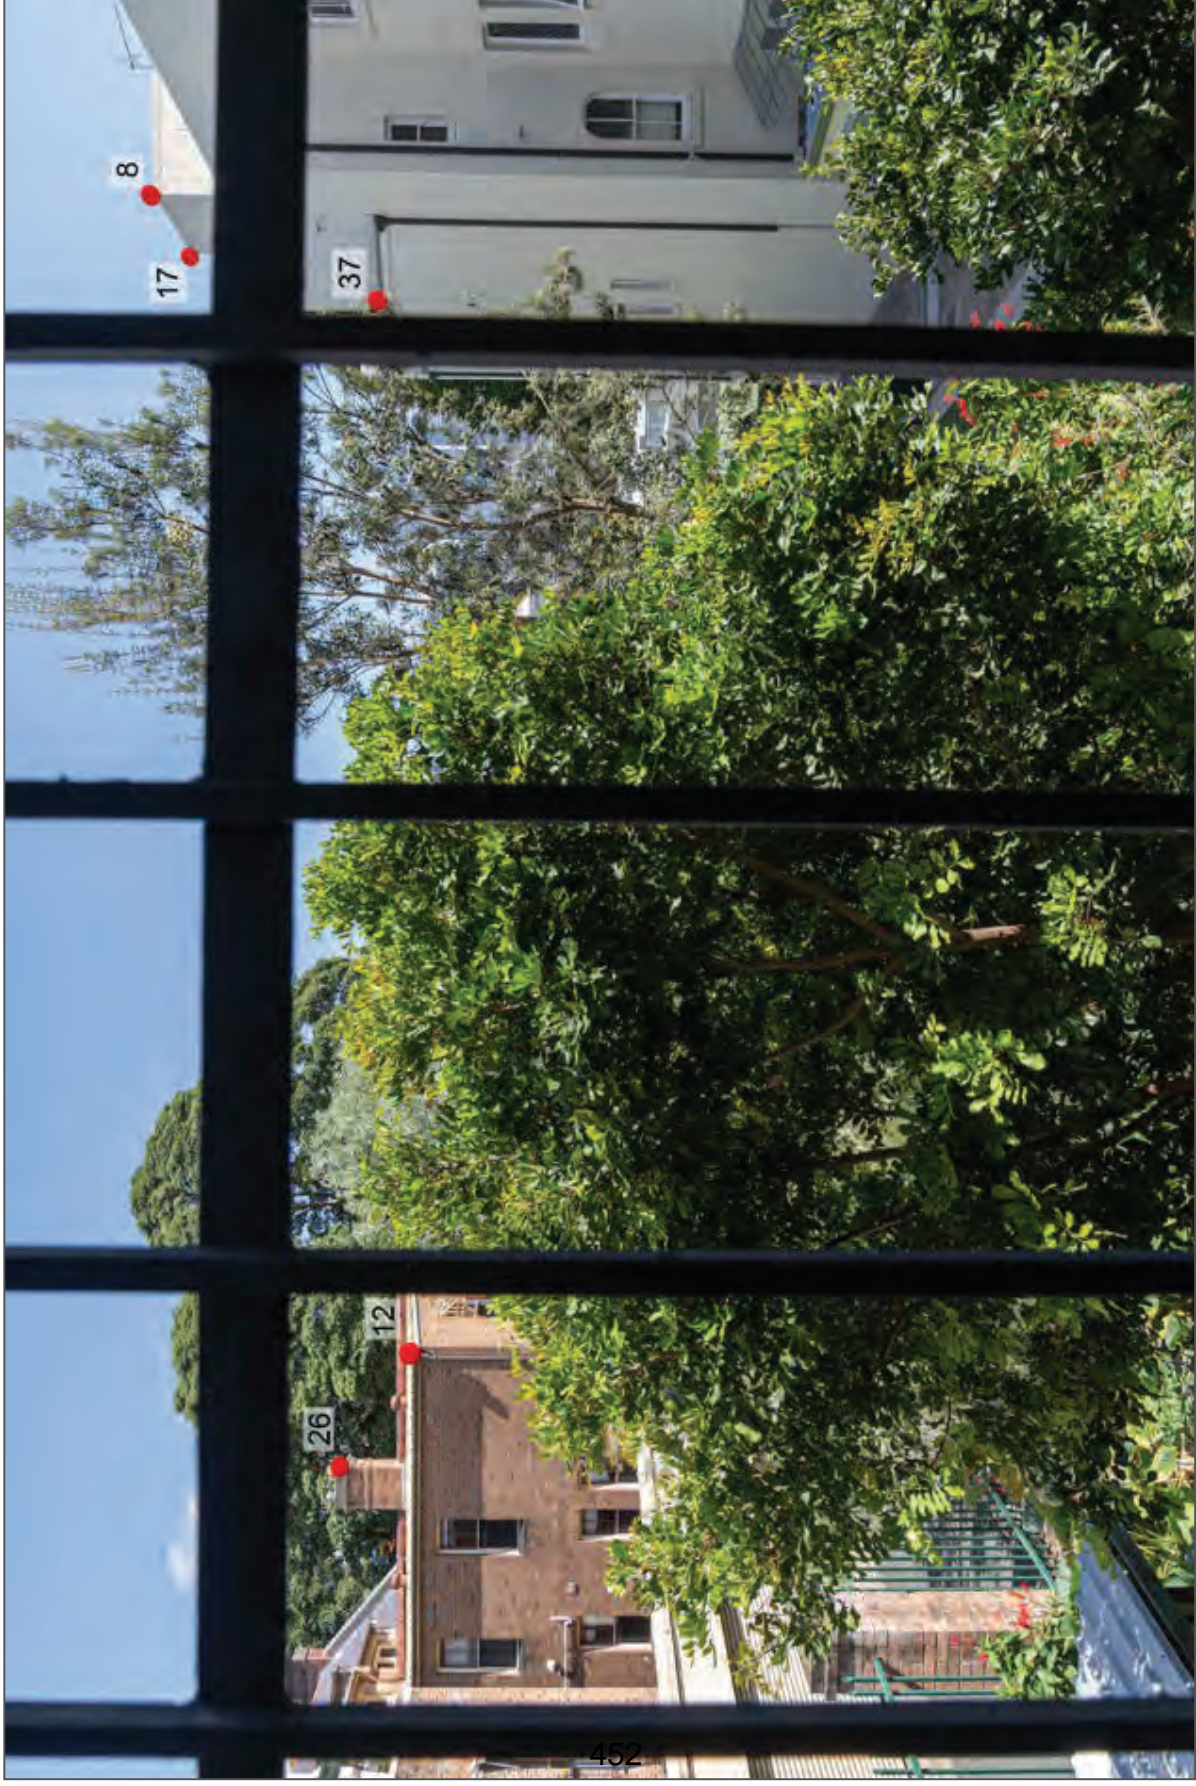
### 23.3 VIEWPOINT POSITION 19 - Hotel Challis, 21-23 Challis Avenue, Room 214

OVERLAY OF SURVEY POINTS USED FOR 3D CAMERA ALIGNMENT

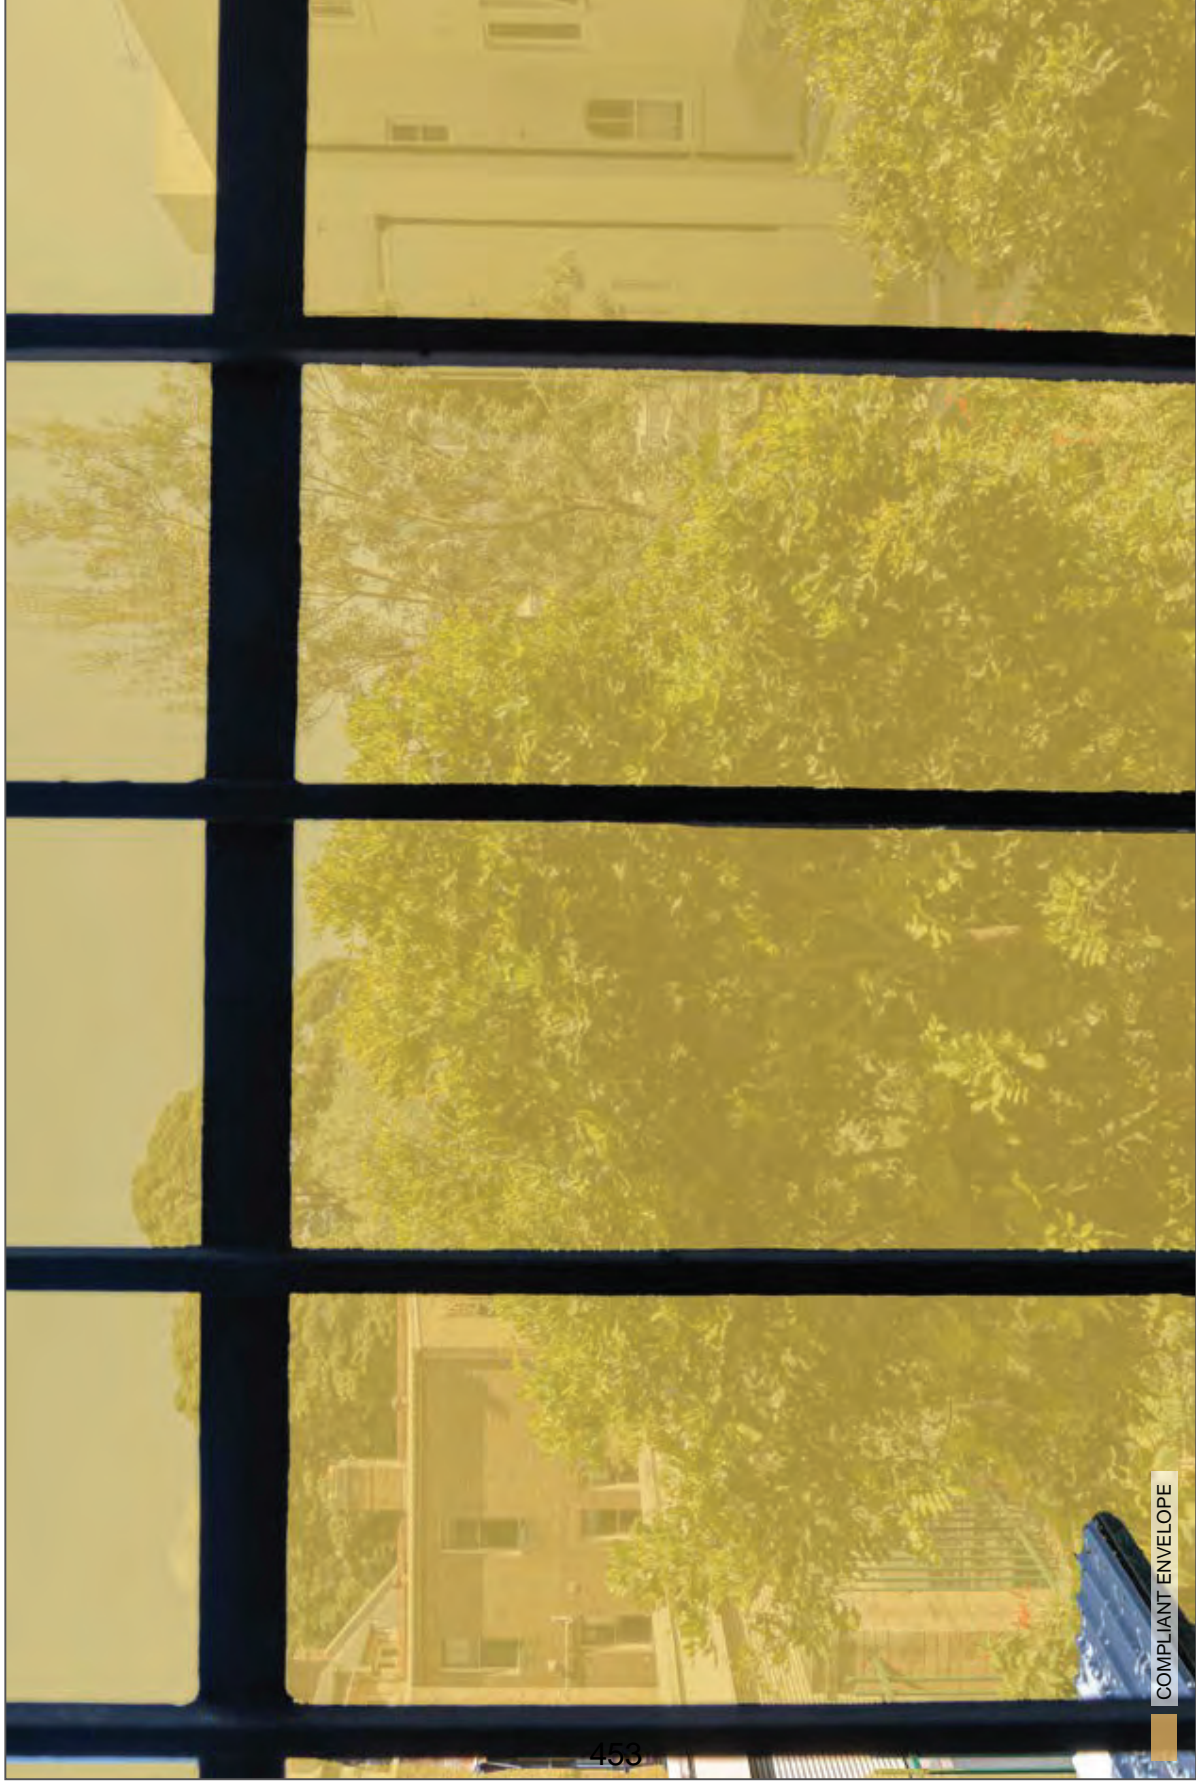
### 23.4 VIEWPOINT POSITION 19 - Hotel Challis, 21-23 Challis Avenue, Room 214

PHOTOMONTAGE OF COMPLIANT BUILDING ENVELOPE
