# View Loss Assessment

Submitted to City of Sydney in response to RFI dated 31 July 2024

St Vincent's College, 1 Challis Avenue, Potts Point  
The Trustees of the Sisters of Charity of Australia

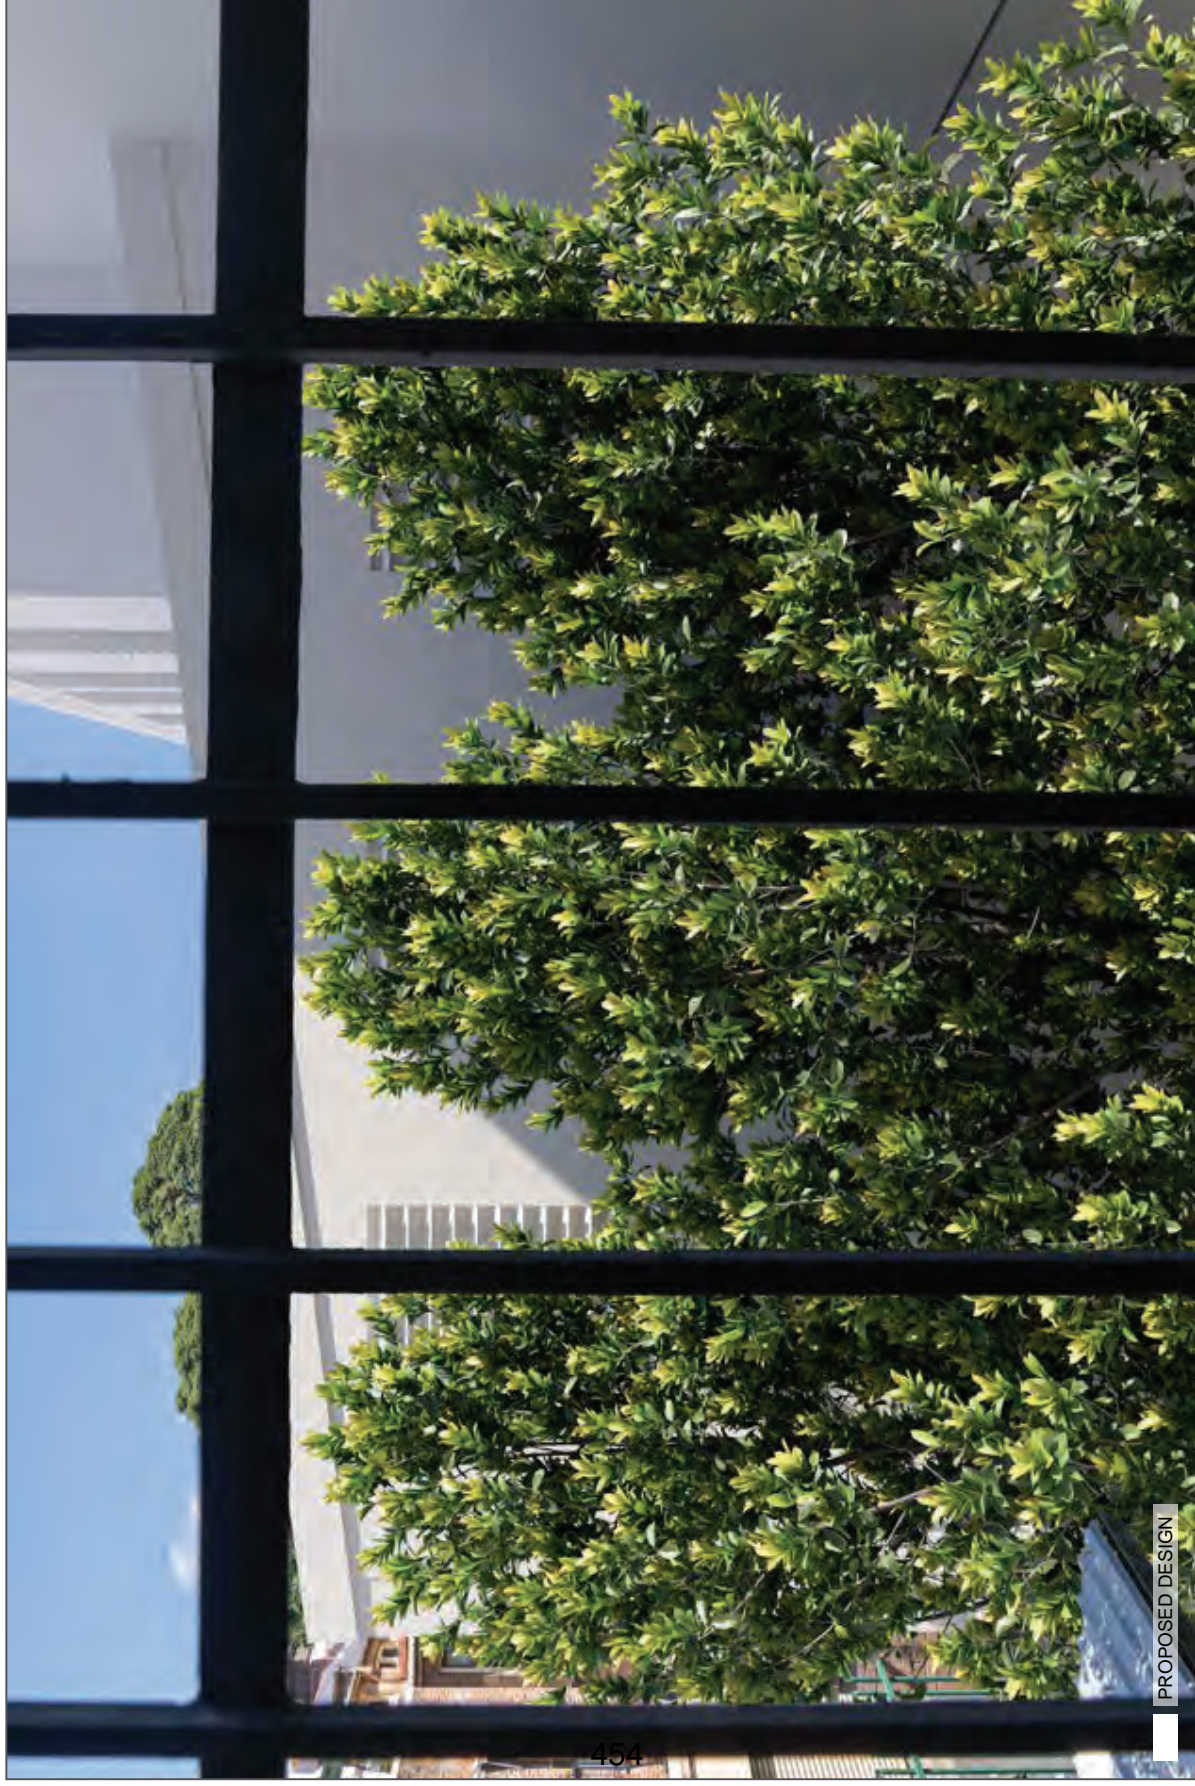
### 23.5 VIEWPOINT POSITION 19 - Hotel Challis, 21-23 Challis Avenue, Room 214

PHOTOMONTAGE OF PROPOSED BUILDING DESIGN

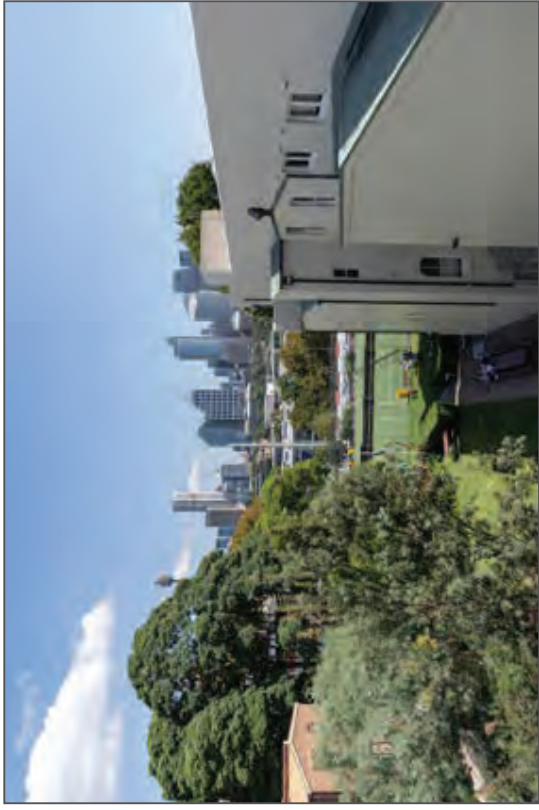
## 24.1 VIEWPOINT POSITION 20 - Hotel Challis, 21-23 Challis Avenue, Room 408

PHOTOGRAPH OF CURRENT CONDITION

Photo Date:	15 March 2023
Camera Used:	Sony ILCE-7C
Camera Lens:	FE 24-70mm F2.8 GM
Focal length in 35mm Film:	24mm

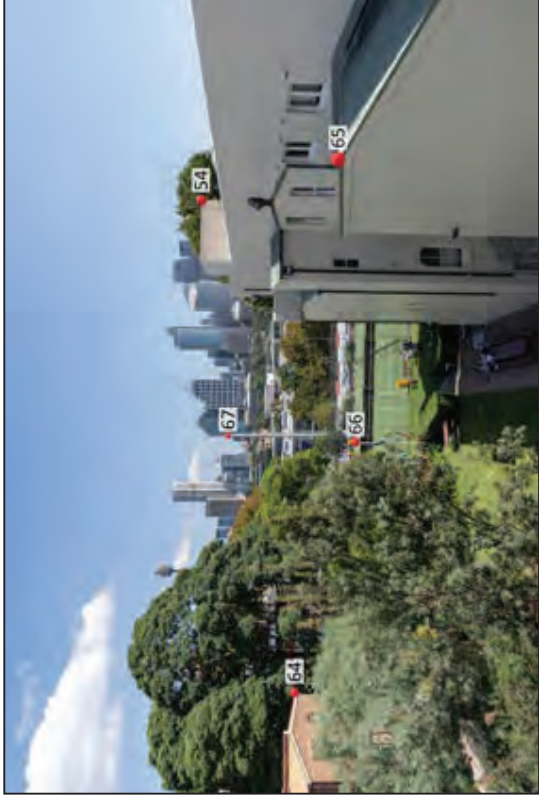
SURVEY POINTS USED FOR 3D CAMERA ALIGNMENT

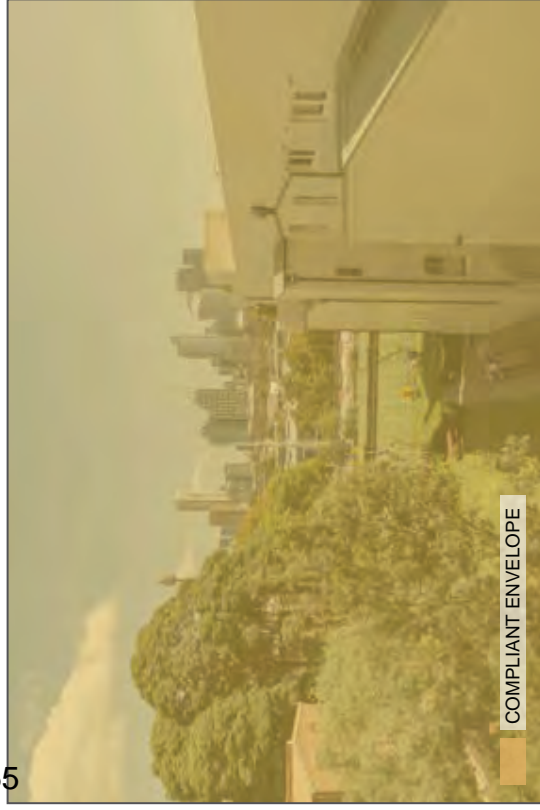
PHOTOMONTAGE OF COMPLIANT BUILDING ENVELOPE

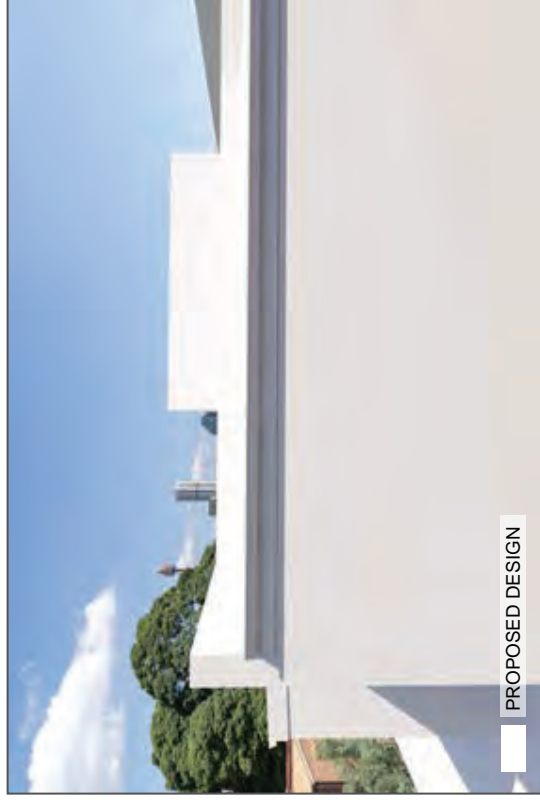
PHOTOMONTAGE OF PROPOSED BUILDING DESIGN

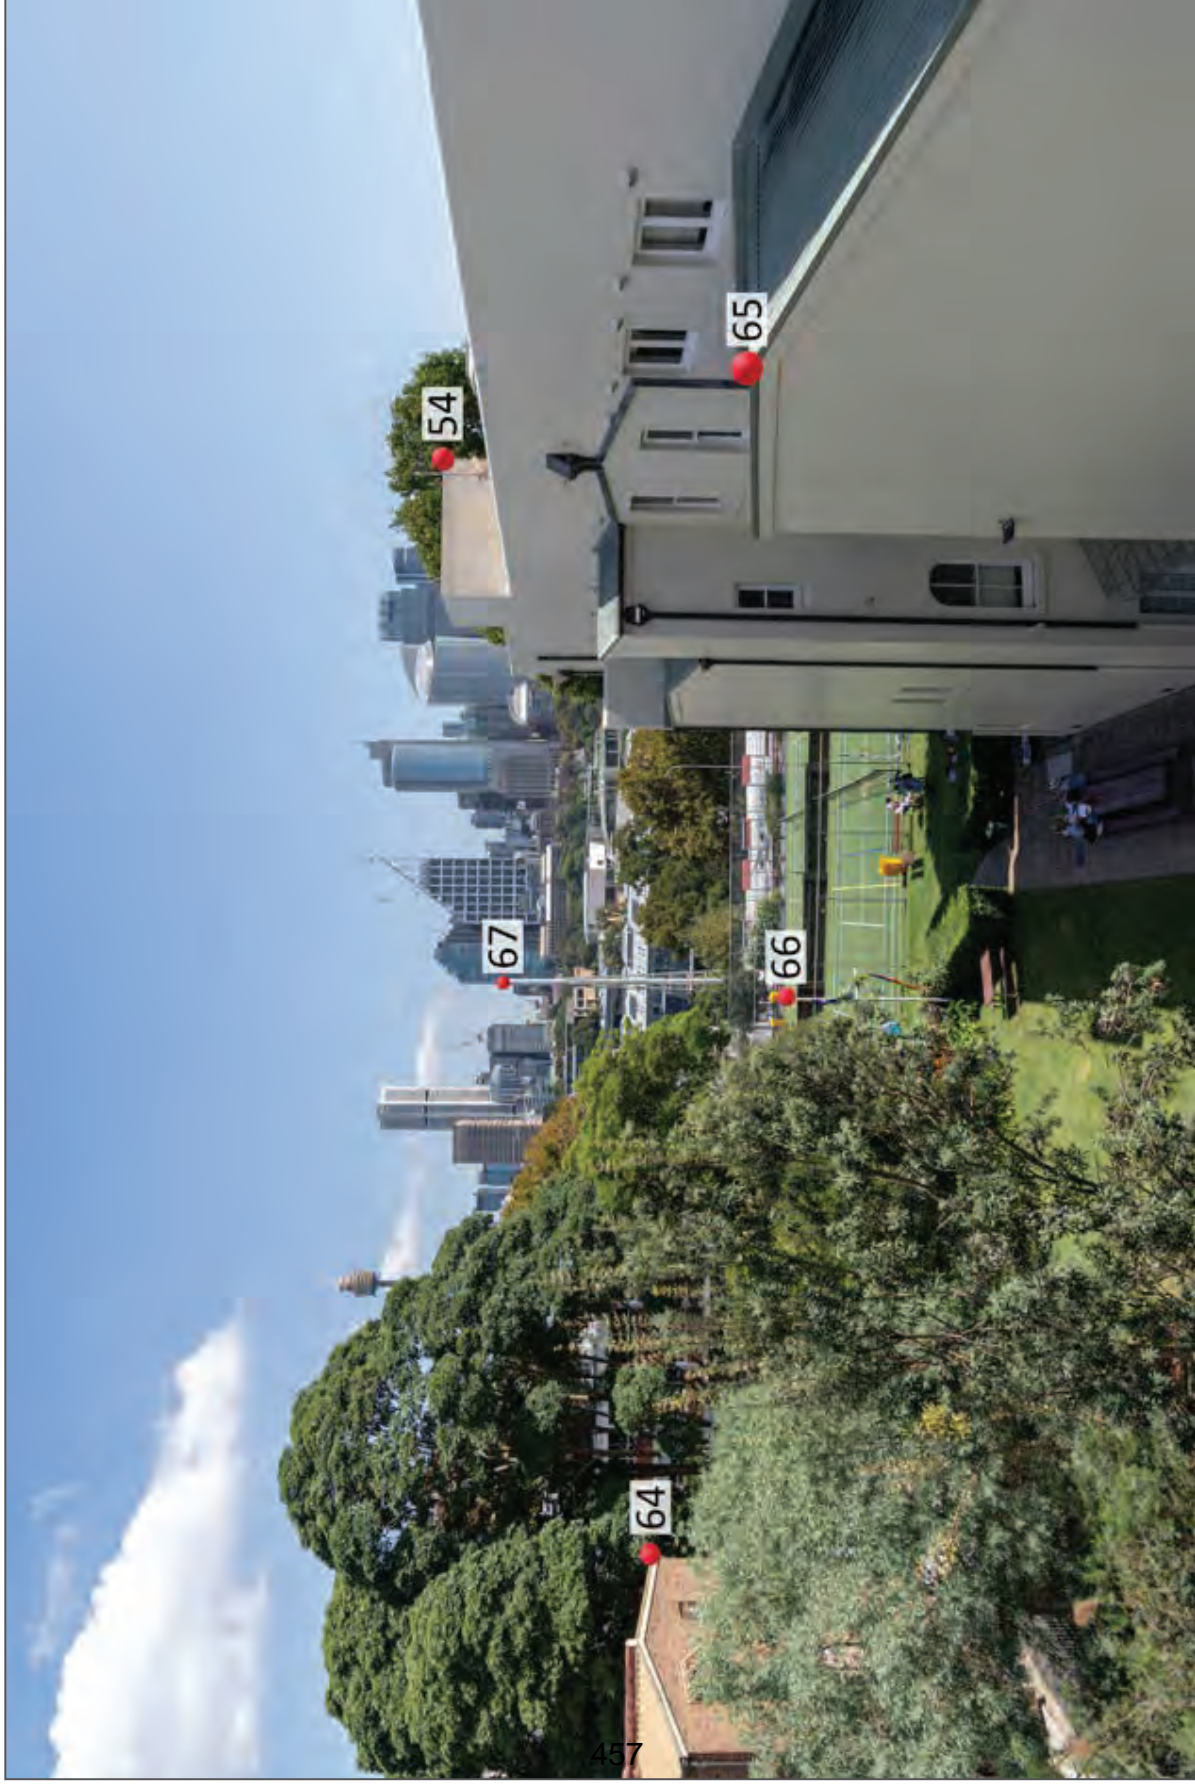
### 24.3 VIEWPOINT POSITION 20 - Hotel Challis, 21-23 Challis Avenue, Room 408

OVERLAY OF SURVEY POINTS USED FOR 3D CAMERA ALIGNMENT

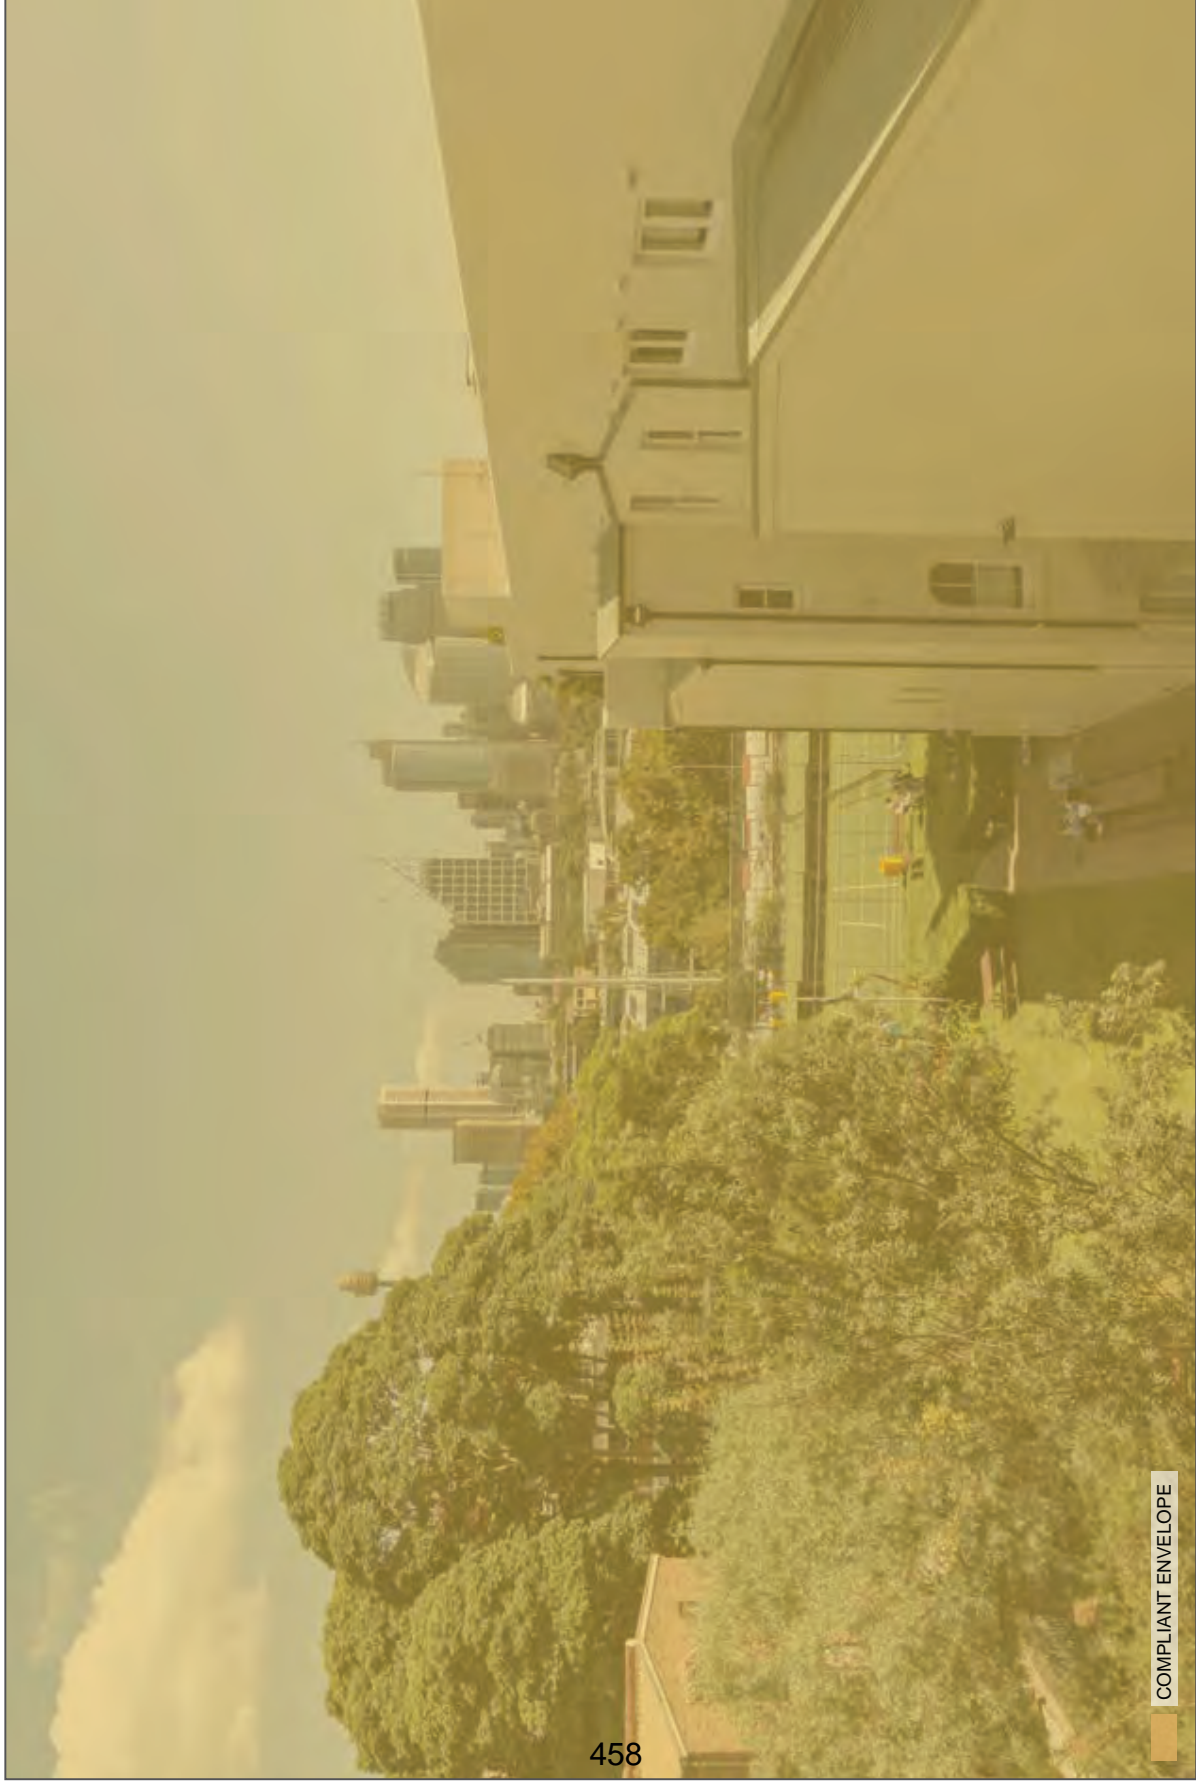
## 24.4 VIEWPOINT POSITION 20 - Hotel Challis, 21-23 Challis Avenue, Room 408

PHOTOMONTAGE OF COMPLIANT BUILDING ENVELOPE

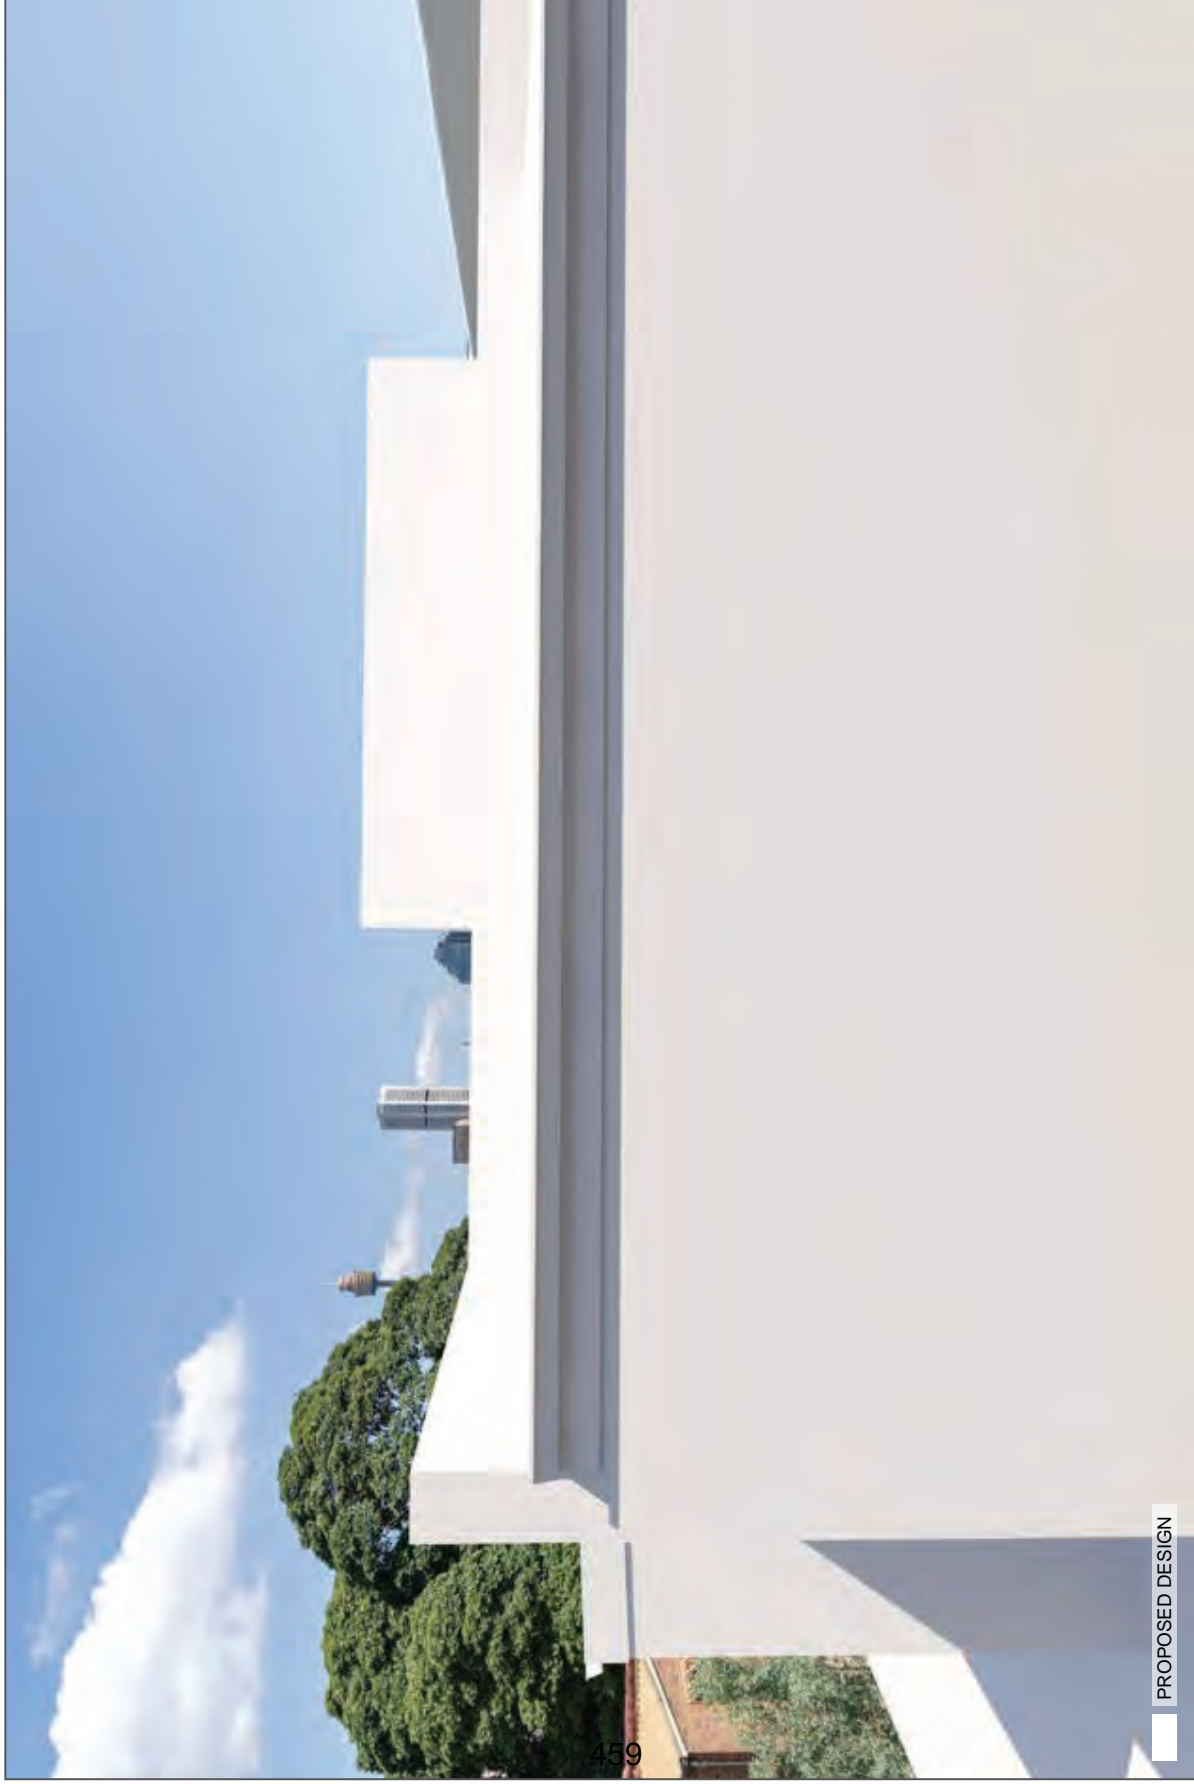
## 24.5 VIEWPOINT POSITION 20 - Hotel Challis, 21-23 Challis Avenue, Room 408

PHOTOMONTAGE OF PROPOSED BUILDING DESIGN

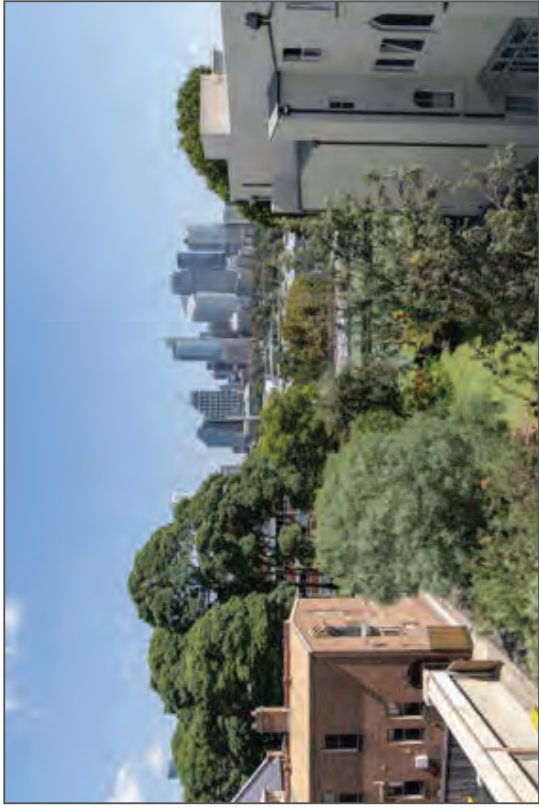
## 25.1 VIEWPOINT POSITION 21 - Hotel Challis, 21-23 Challis Avenue, Room 412

PHOTOGRAPH OF CURRENT CONDITION

Photo Date:	15 March 2023
Camera Used:	Sony ILCE-7C
Camera Lens:	FE 24-70mm F2.8 GM
Focal length in 35mm Film:	24mm

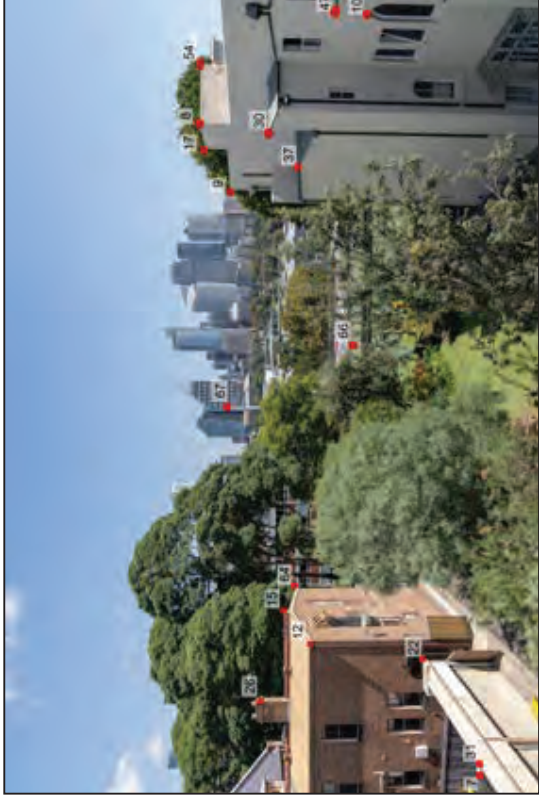
SURVEY POINTS USED FOR 3D CAMERA ALIGNMENT

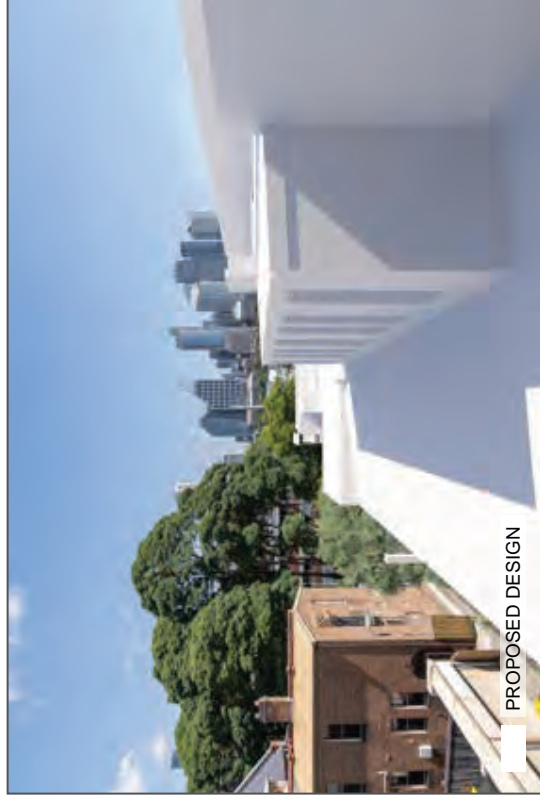
PHOTOMONTAGE OF PROPOSED BUILDING DESIGN

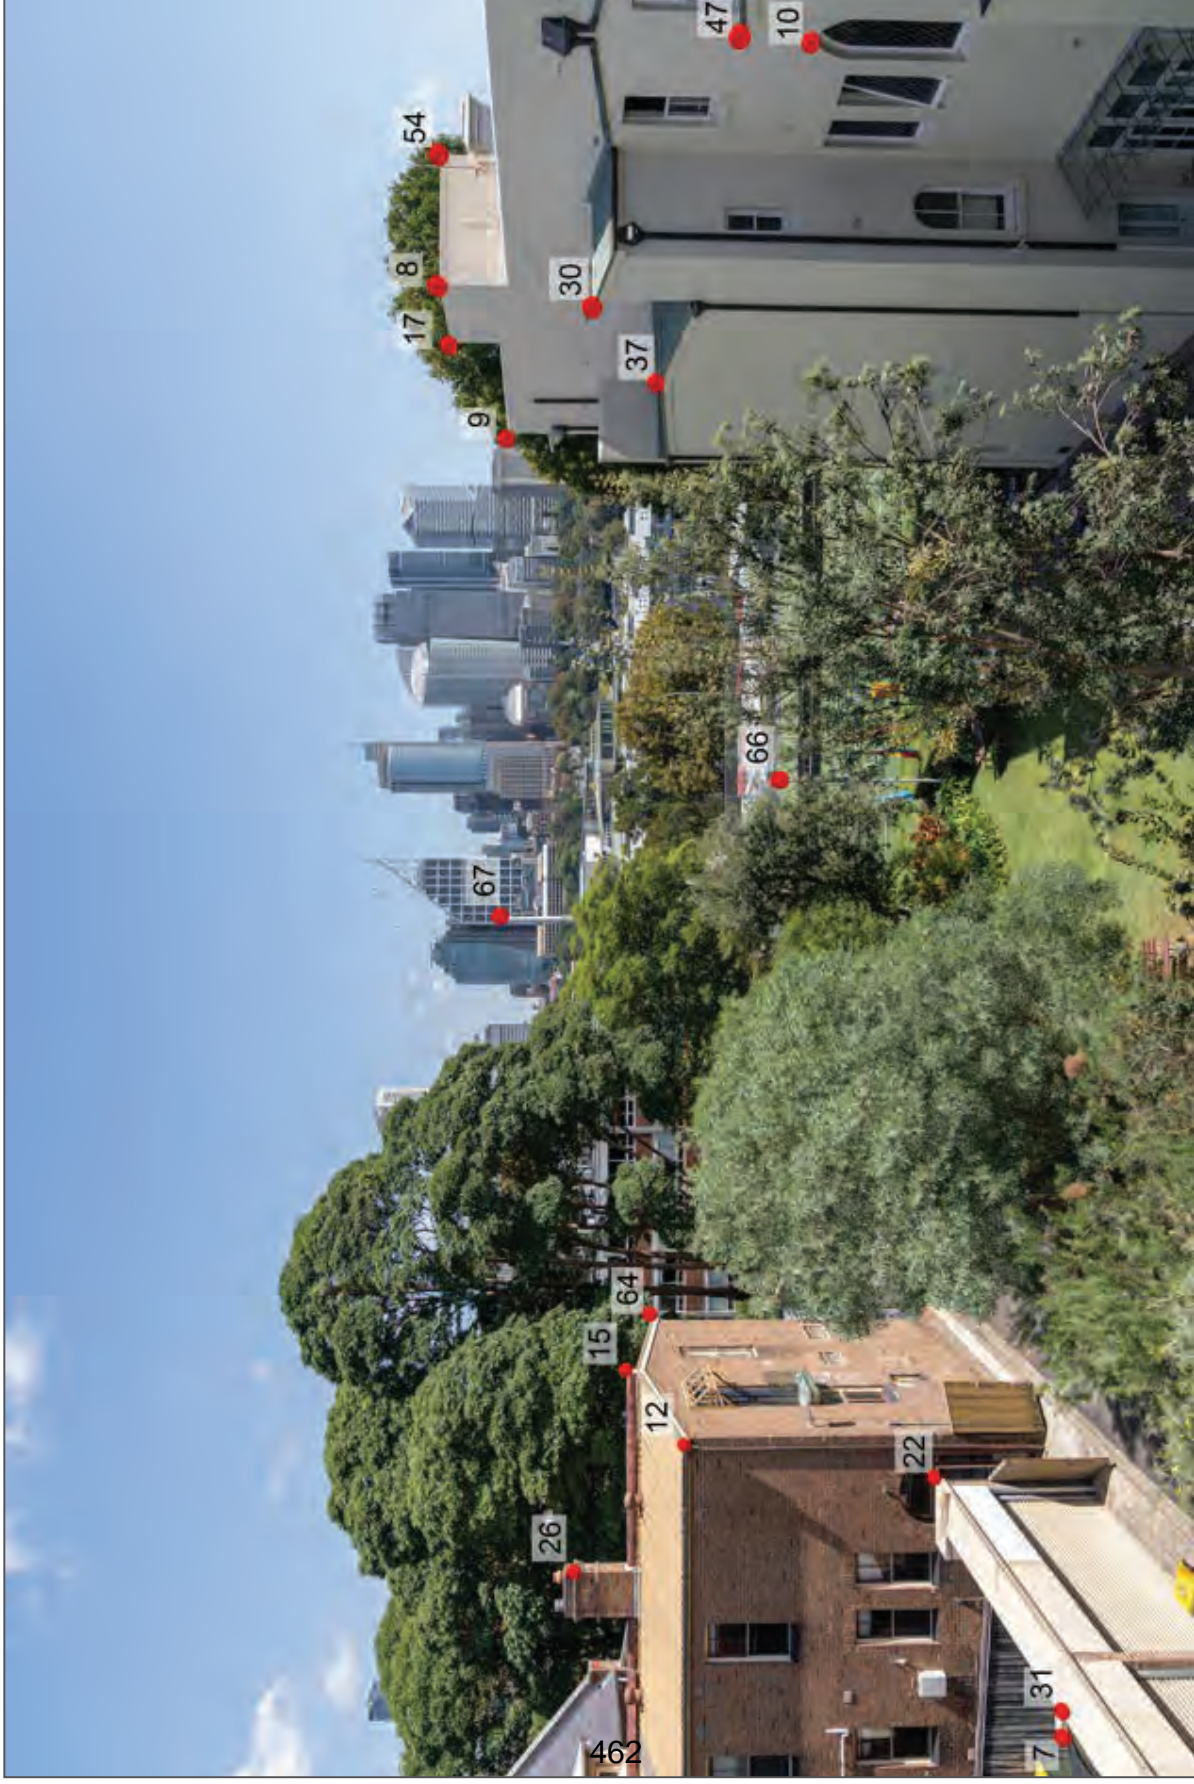
### 25.3 VIEWPOINT POSITION 21 - Hotel Challis, 21-23 Challis Avenue, Room 412

OVERLAY OF SURVEY POINTS USED FOR 3D CAMERA ALIGNMENT

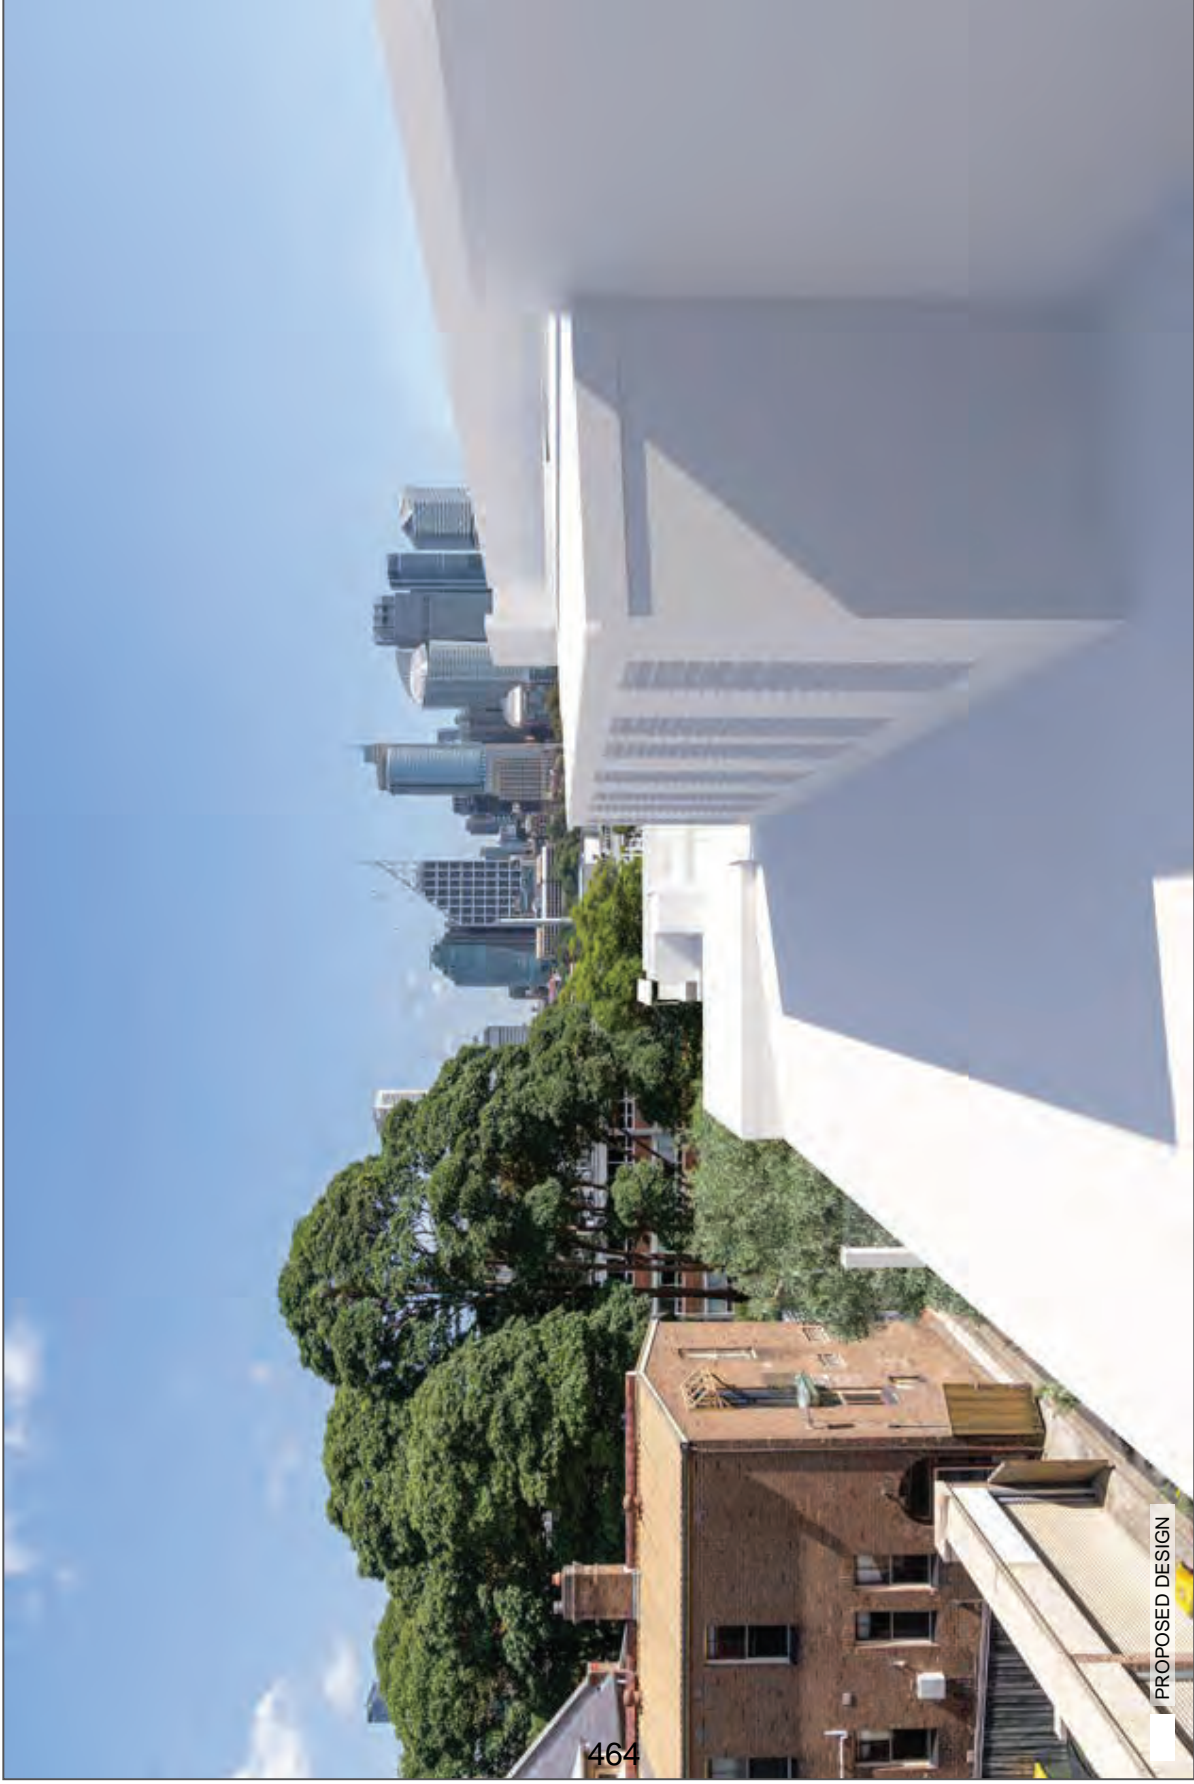
## 25.5 VIEWPOINT POSITION 21 - Hotel Challis, 21-23 Challis Avenue, Room 412

PHOTOMONTAGE OF PROPOSED BUILDING DESIGN

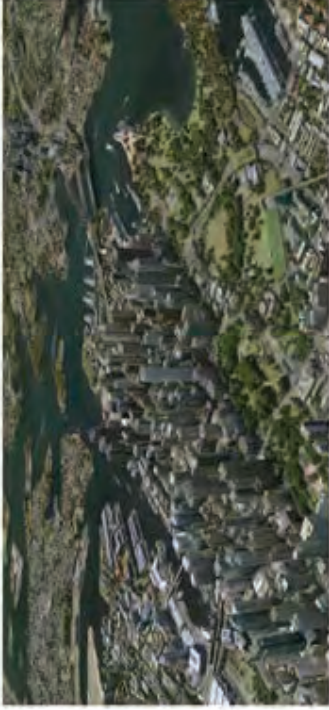
Figure 1: Sydney 2019 3D Model example

- **FBX Tiles** – 3D mesh tiles in FBX format split into their Level of Details. Please refer to the associated metadata.xml and Tile\_Index.kml folder for global offsets and tile extents respectively.

Please note there are different directories for different Level of details meaning L19 is typically the highest level of resolution and geometry and every Level down the geometry gets simplified as well as the texture resolution.
