Report on  
Geotechnical Desktop Investigation

Proposed Commercial Building  
232-240 Elizabeth Street, Surry Hills

Prepared for  
Stasia Holdings Pty. Limited

Project 218198.00  
November 2022

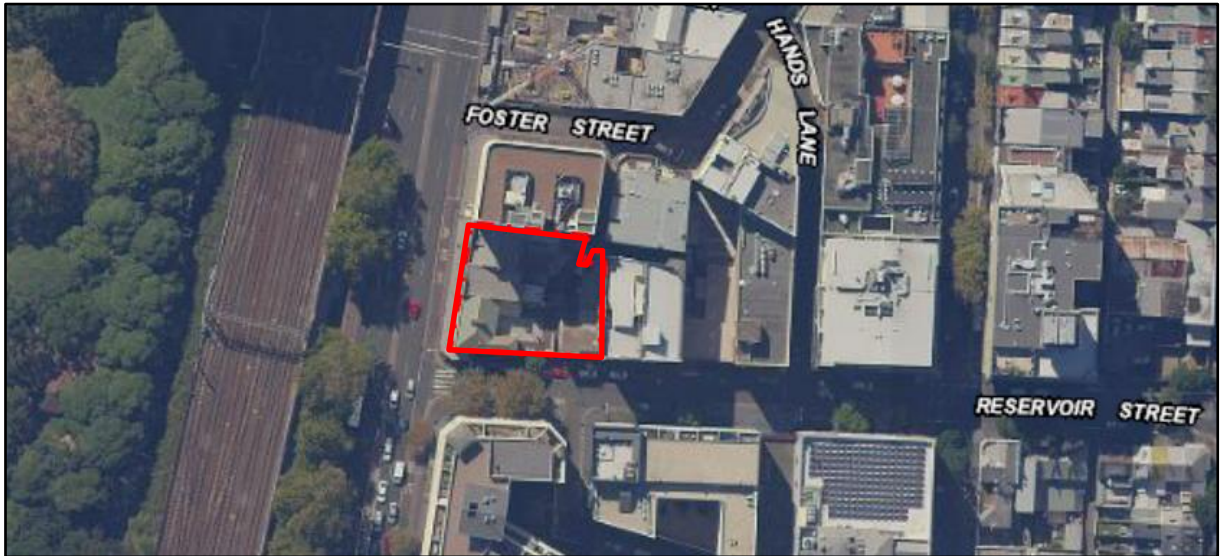
The roughly square site comprises three Lots and a strata plan encompassing 232 to 240 Elizabeth Street, Surry Hills (see Figure 1). The approximately 900 m<sup>2</sup> site has Elizabeth and Reservoir Streets on its western and southern sides and is bound to the north by a nine storey brick building and on the east by a six storey brick building. Foster Lane provides access to the northeast corner of the site. The site gently slopes to the southwest with a surface elevation on Elizabeth Street at about RL 10.9 m and RL 11.6 m at the southern end of Foster Lane.

**Figure 1: Aerial photograph of the site (outlined in red).**
