# **Attachment C4**

## **Visual Impact Assessment**

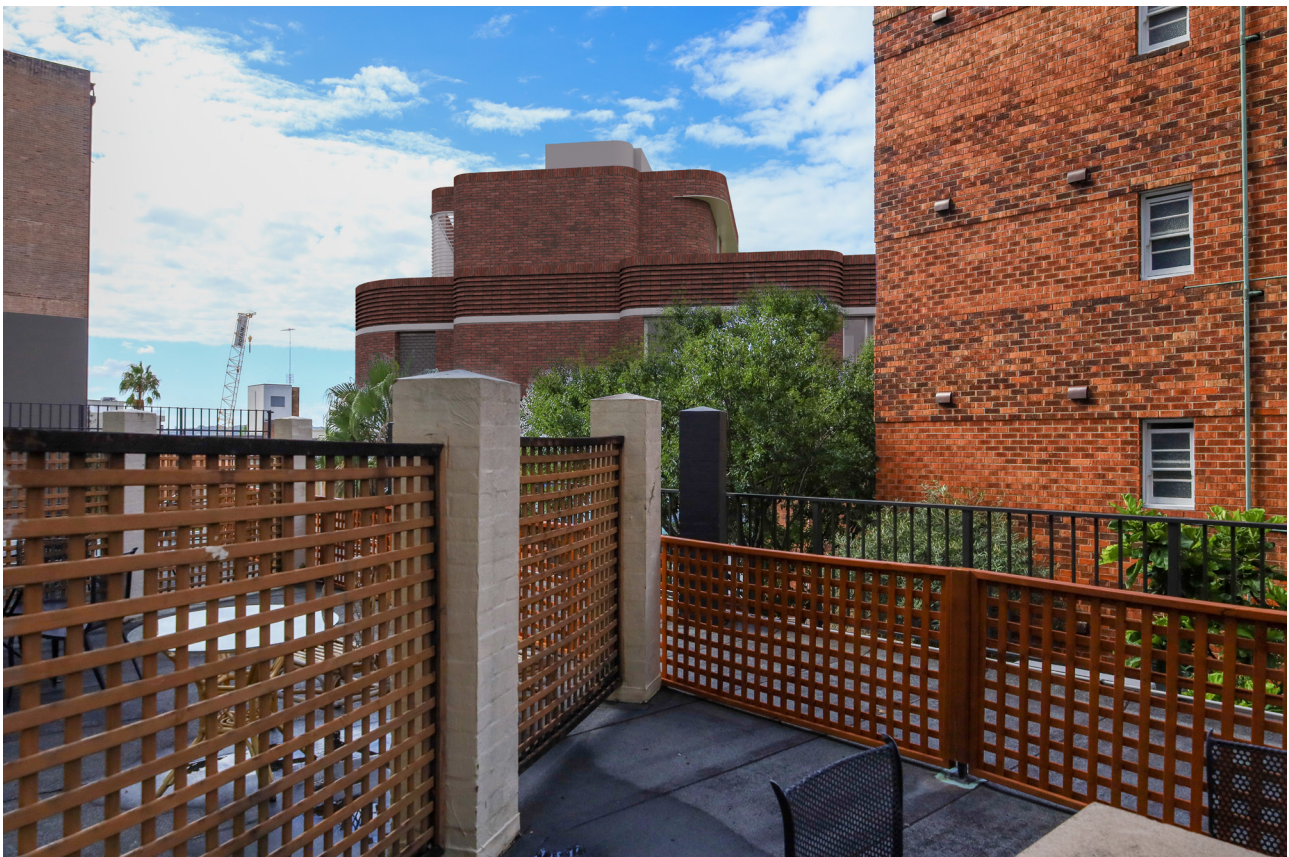
**Viewpoint No.06: Existing virtual view. Macleay Hotel, No.28, Macleay Street – Level 1, Unit 105.**  
 From apartment main living room on level 1.  
 RL +38.59. Distance to site boundary: 17.8m. Distance to centre of subject site: 29.6m

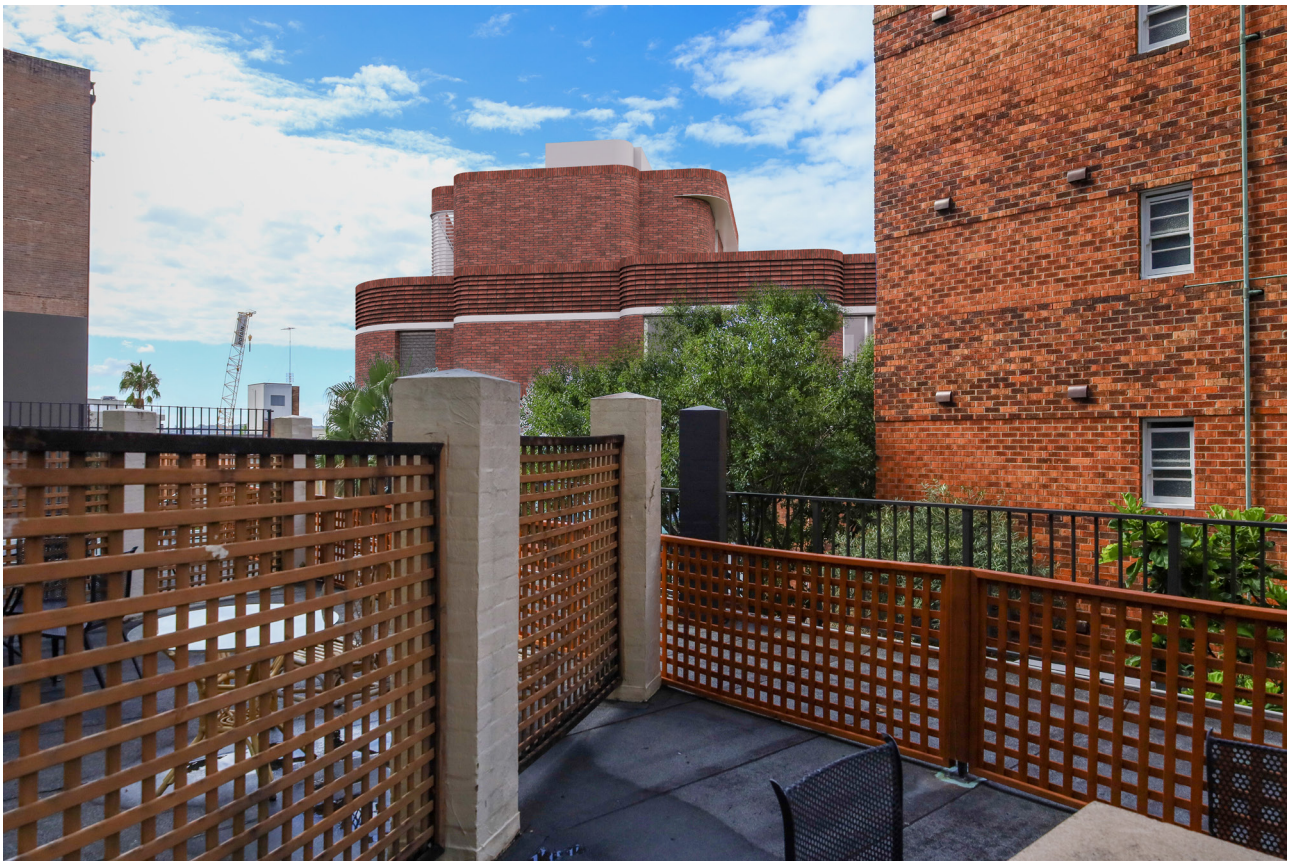
**Viewpoint No.06: Photomontage of new proposed landscaping onto Approved Development photo.**

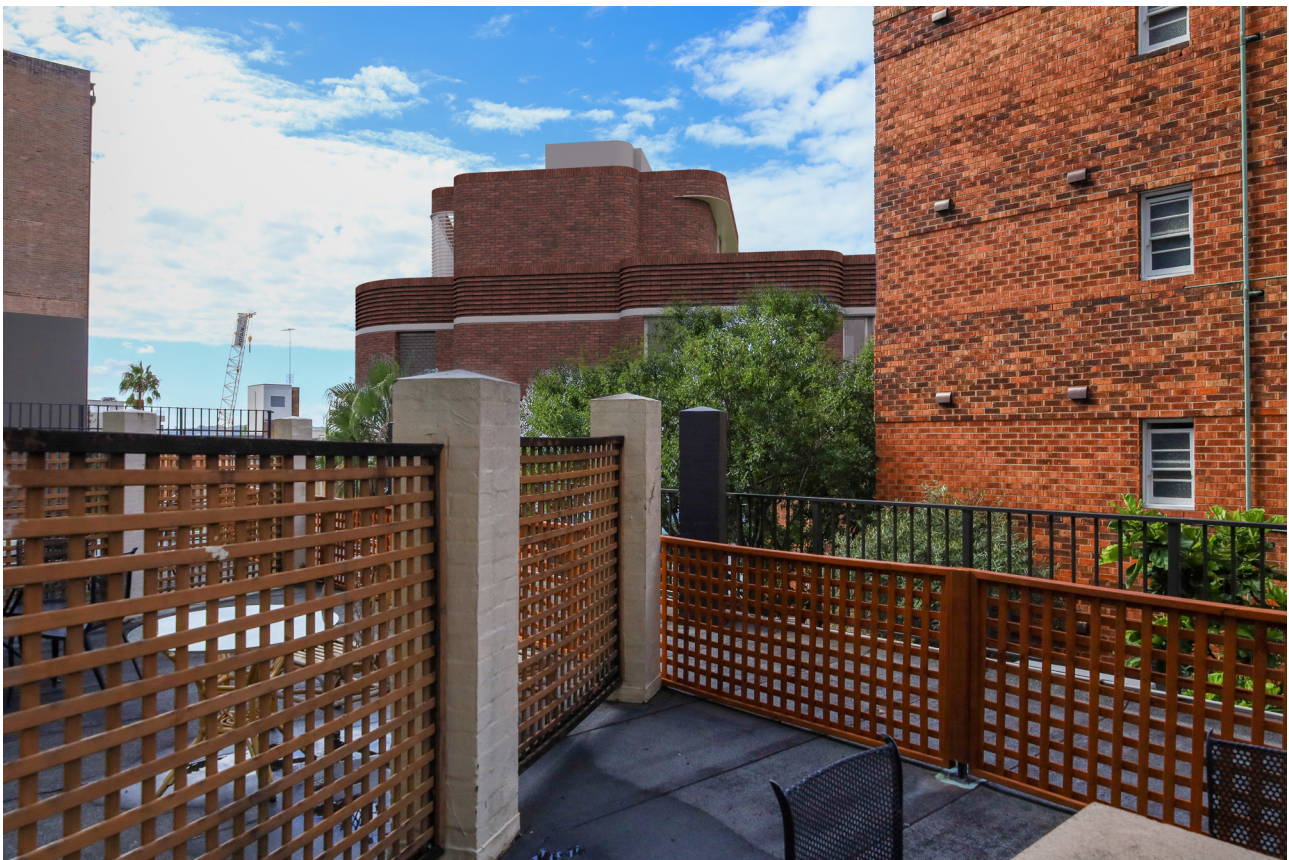
**Viewpoint No.06: Extent of visual impact of proposed landscaping - indicated in cyan overlay with red outline.**

Visual impact – portion of landscaping additions to new building visible in view – 68% of soft landscaping

Visual impact ratio of view loss to sky view loss in visible portion. 0%: 0%

Existing Visual Quality Scale no: 2 /15      Visual Impact Assessment Scale - additional view loss: 0 /15

The view loss, from the new proposed landscaping, would be considered negligible under the assessment guidelines of the Tenacity Consulting v Warringah Council [2004] NSWLEC 140 case. The additional landscaping, similarly affects sky view only and is not detrimental to the overall view.

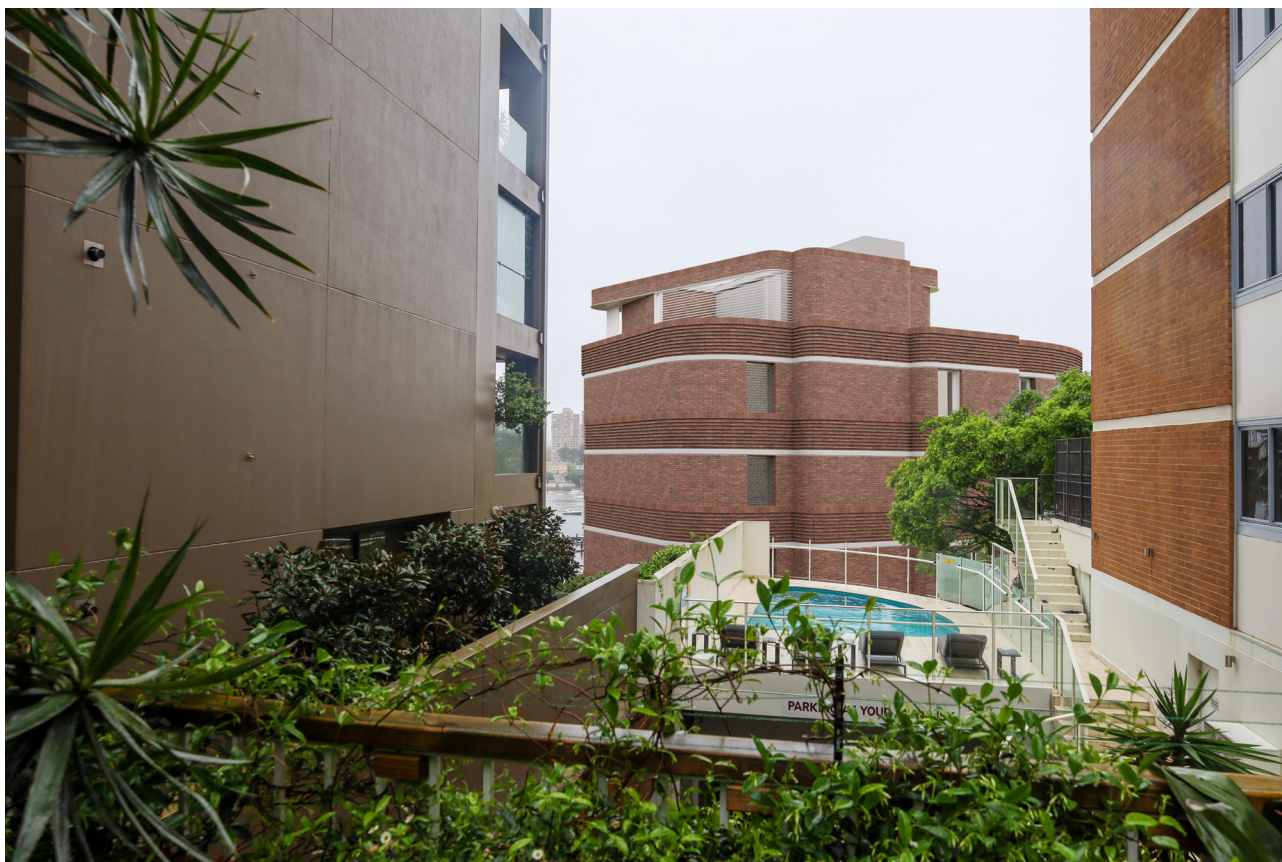
**Viewpoint No.07: Approved Development photo. Macleay Hotel, No.28, Macleay Street – Level 1, Unit 111.**  
 From living room balcony.  
 RL +38.59  
 Distance to site boundary: 13.8m. Distance to centre of subject site: 25.6m

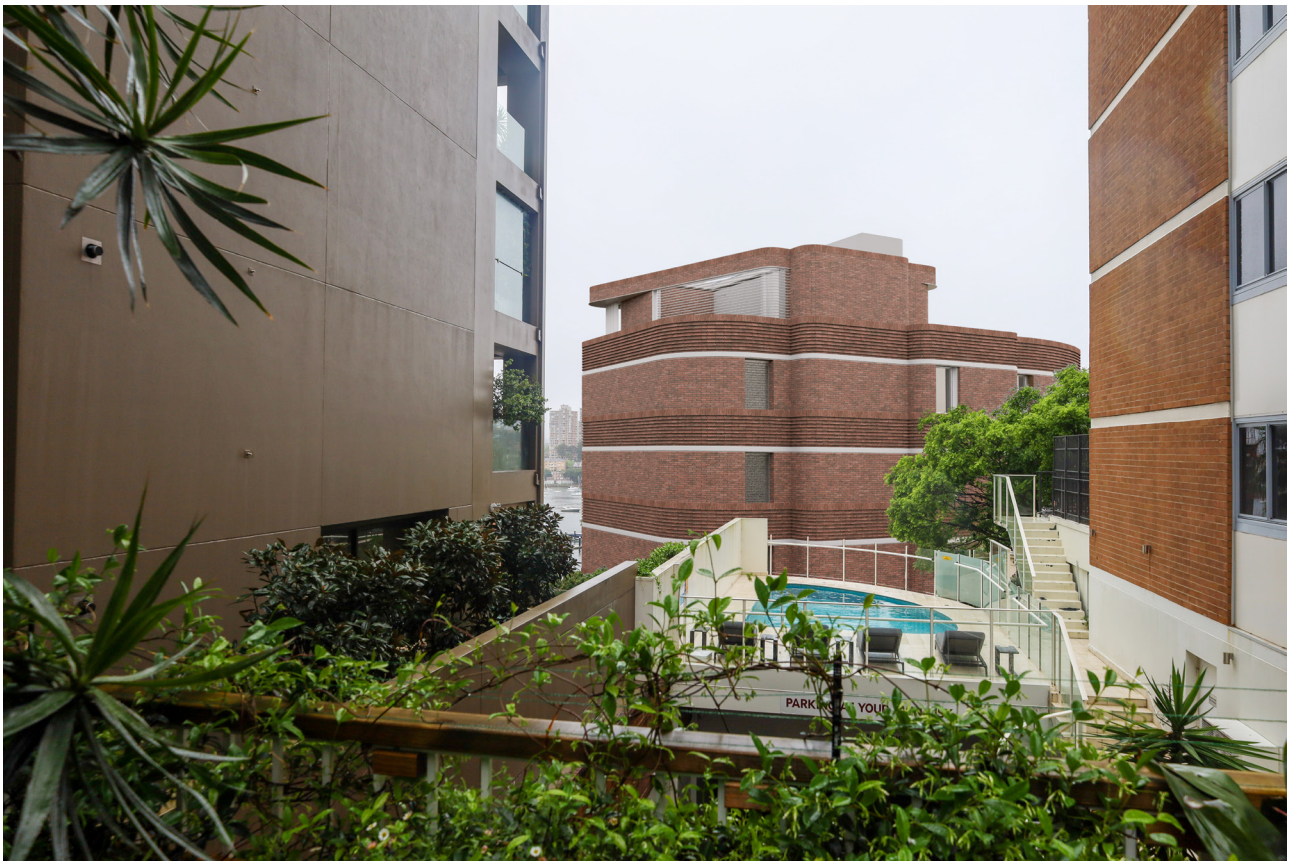
**Viewpoint No.07: Photomontage of new proposed landscaping onto Approved Development photo.**

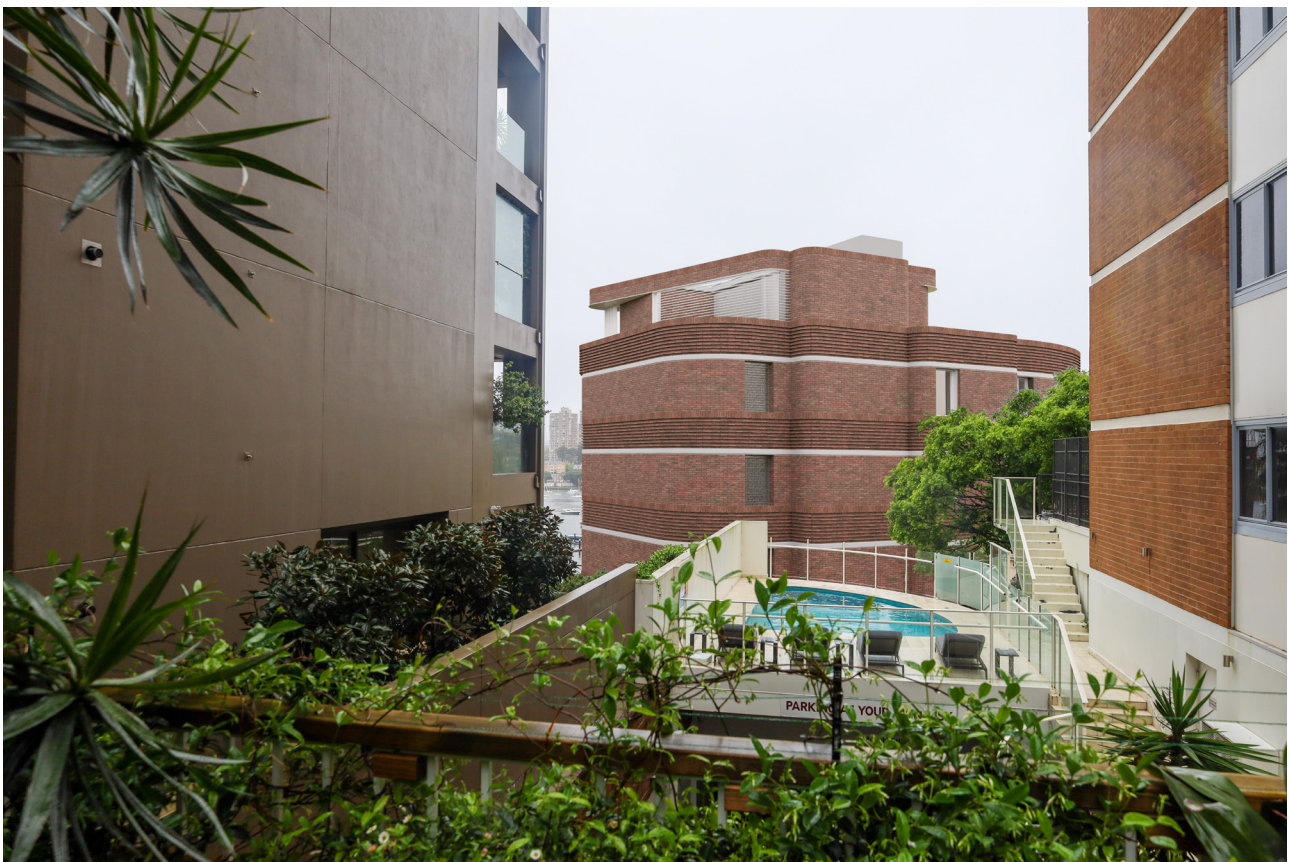
**Viewpoint No.07: Extent of visual impact of proposed landscaping - indicated in cyan overlay with red outline.**

Visual impact – portion of landscaping additions to new building visible in view – 100% of soft landscaping

Visual impact ratio of view loss to sky view loss in visible portion. 0%: 0%

Existing Visual Quality Scale no: 3 /15      Visual Impact Assessment Scale - additional view loss: 0 /15

The view loss, as a result of the new proposed landscaping, would be considered negligible under the assessment guidelines of the Tenacity Consulting v Warringah Council [2004] NSWLEC 140 case. The additional landscaping, similarly affects sky view only and is not detrimental to the overall view.

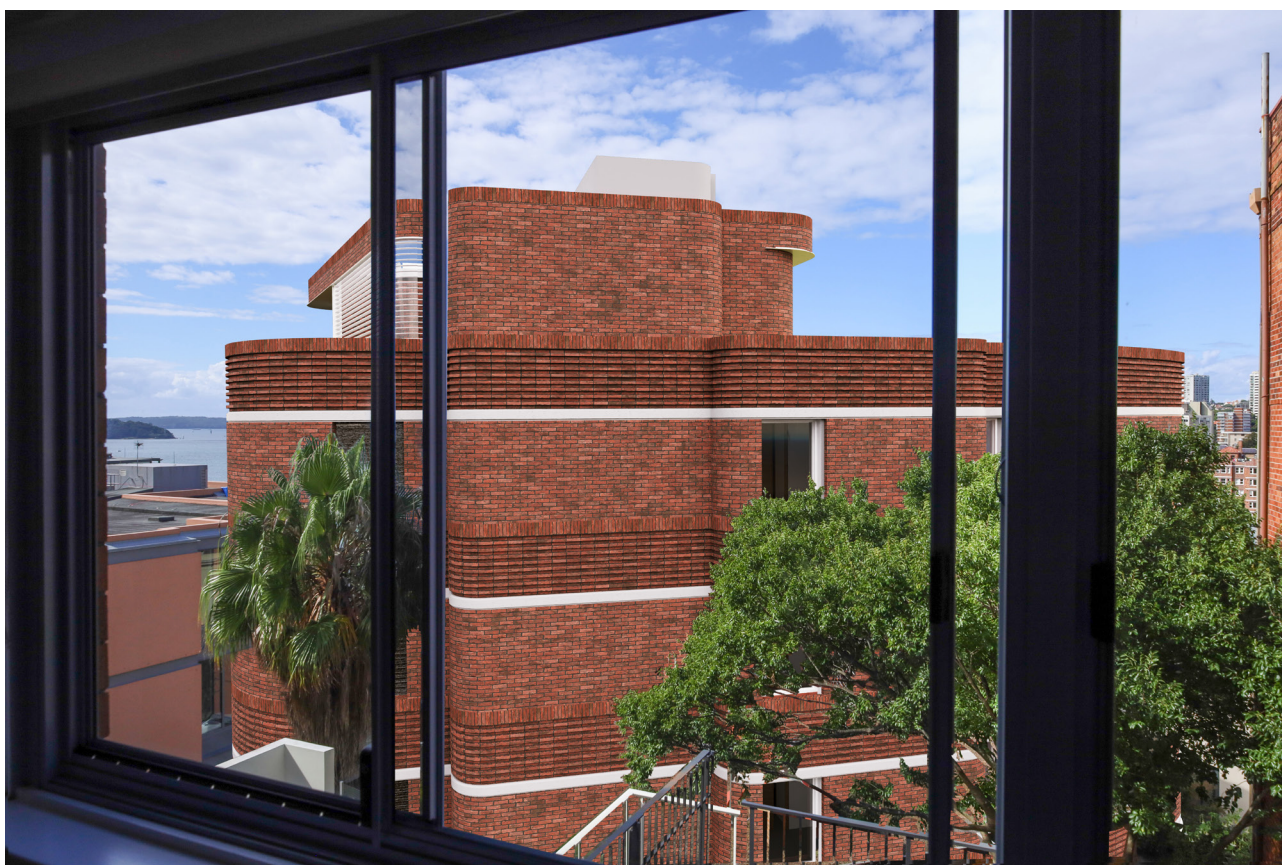
**Viewpoint No.08: Existing virtual view. Macleay Hotel, No.28, Macleay Street – Level 2, Unit 203.**

From main apartment bedroom

RL +41.01 Distance to site boundary: 13.8m. Distance to centre of subject site: 25.6m

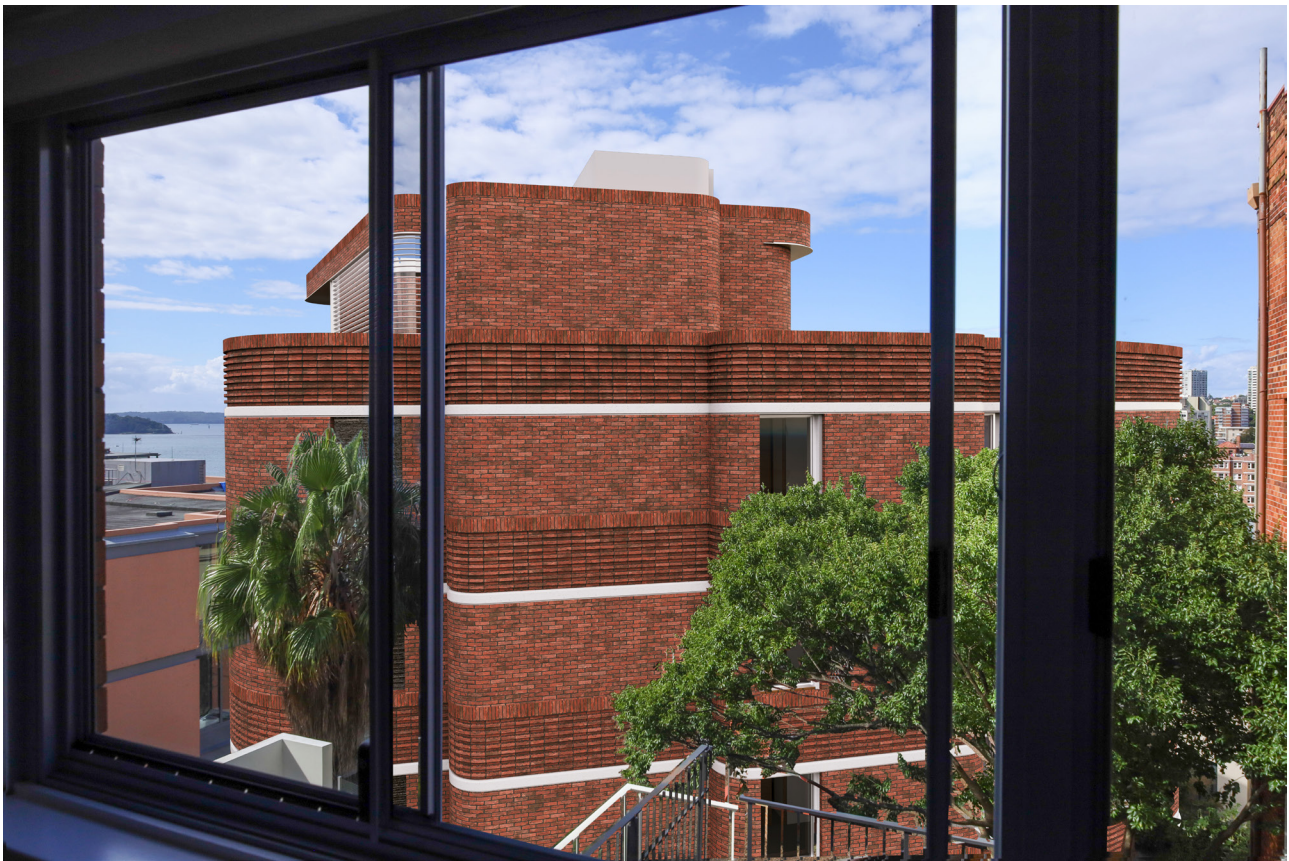
**Viewpoint No.08: Photomontage of new proposed landscaping onto Approved Development photo.**

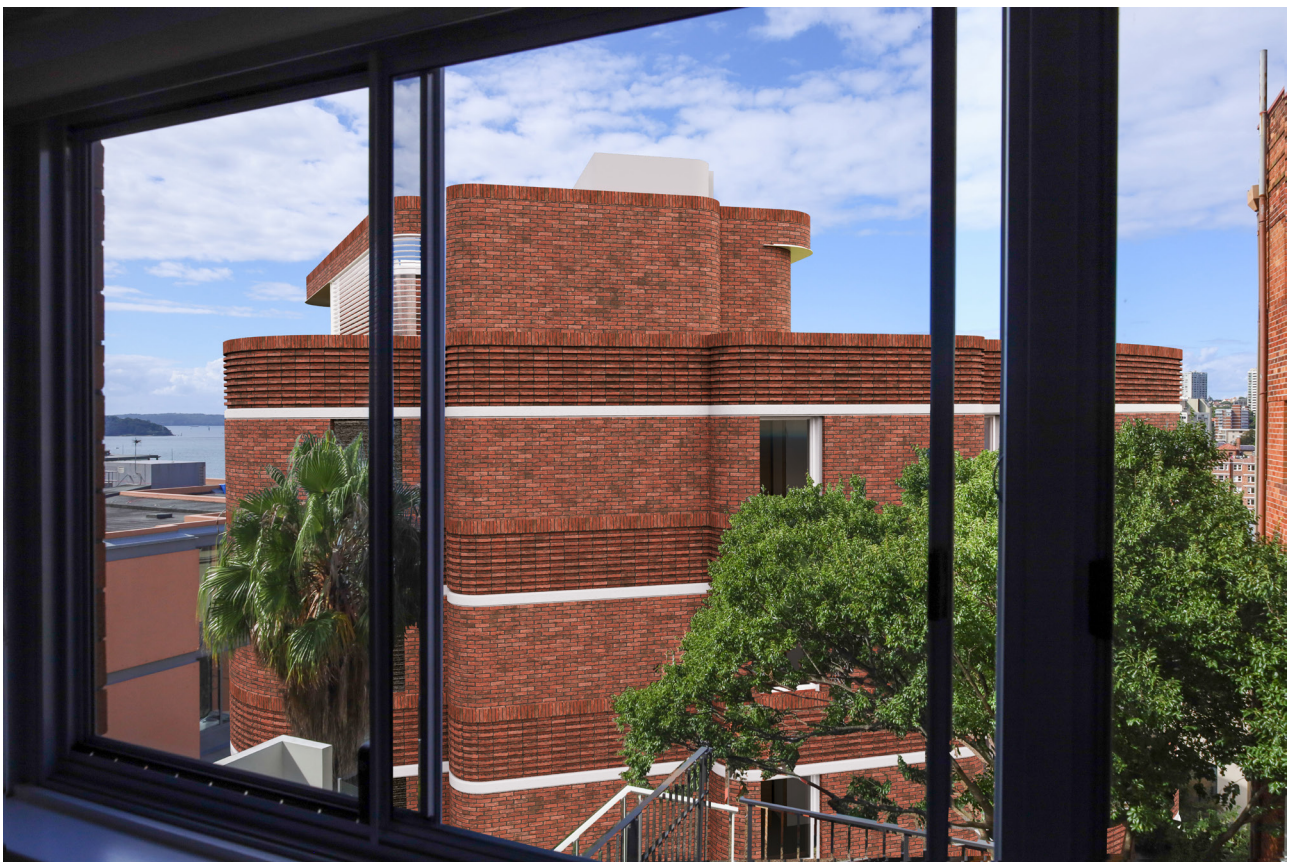
**Viewpoint No.08: Extent of visual impact of proposed landscaping - indicated in cyan overlay with red outline.**

Visual impact – portion of landscaping additions to new building visible in view – 84% of soft landscaping

Visual impact ratio of view loss to sky view loss in visible portion. 0%: 100%

Existing Visual Quality Scale no: 7 /15      Visual Impact Assessment Scale - additional view loss: 1 /15

This is a static, private viewpoint from a main bedroom of apartment no.203, on level 2 of No.28, Macleay Street. This view is obtained across a property side boundary and is curtailed to the south by the upper level and plant room of the apartment building at No.5, Onslow Avenue.

The view loss, as a result of the new proposed landscaping, would be considered negligible under the assessment guidelines of the Tenacity Consulting v Warringah Council [2004] NSWLEC 140 case. Sky view only is impacted by a small area of glazing, forming part of the addition. The additional landscaping, similarly affects sky view only and is not detrimental to the overall view.

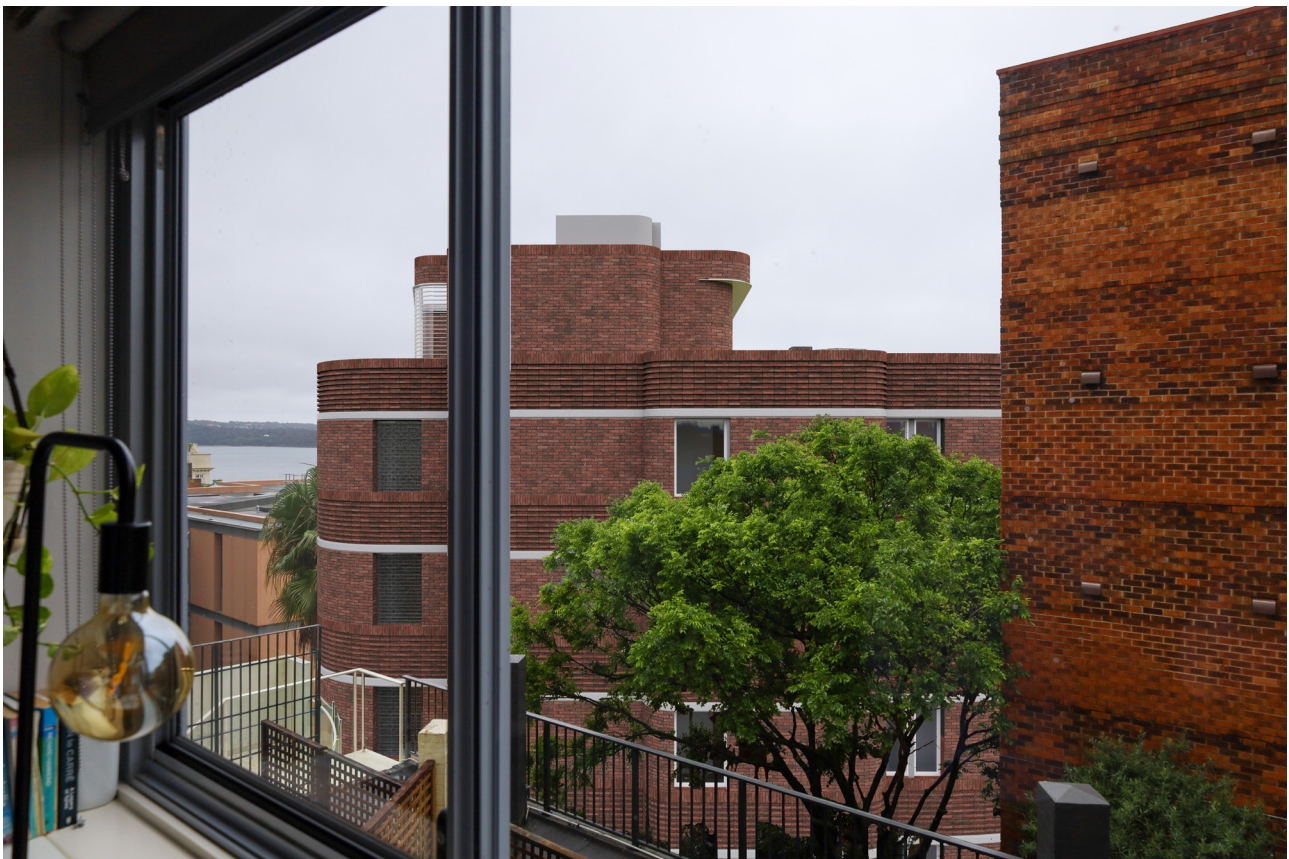
**Viewpoint No.09: Approved Development photo. Macleay Hotel, No.28, Macleay Street – Level 2 Unit 204.**  
 From main apartment bedroom, east facing.  
 RL +41.01  
 Distance to site boundary: 8.8m. Distance to centre of subject site: 22.6m

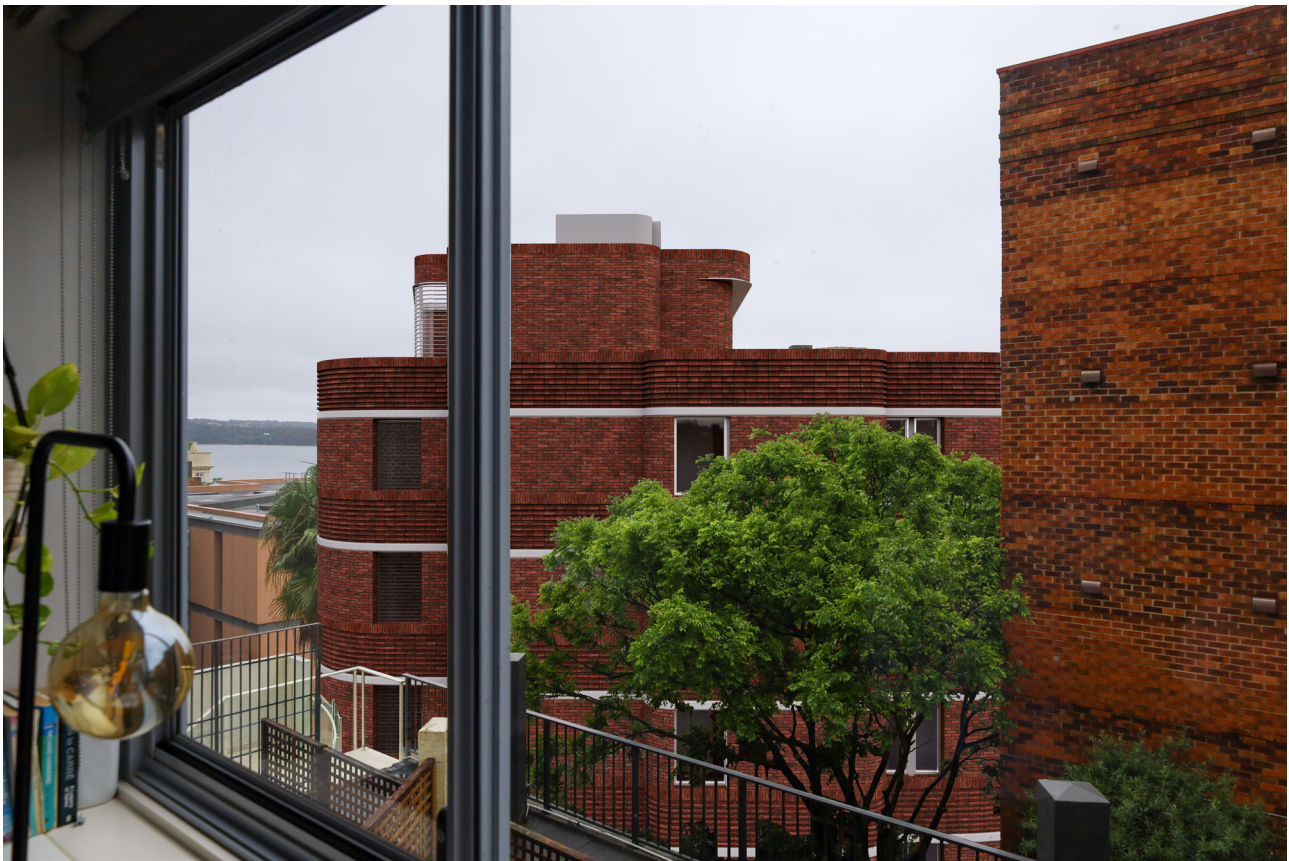
**Viewpoint No.09: Photomontage of new proposed landscaping onto Approved Development photo.**

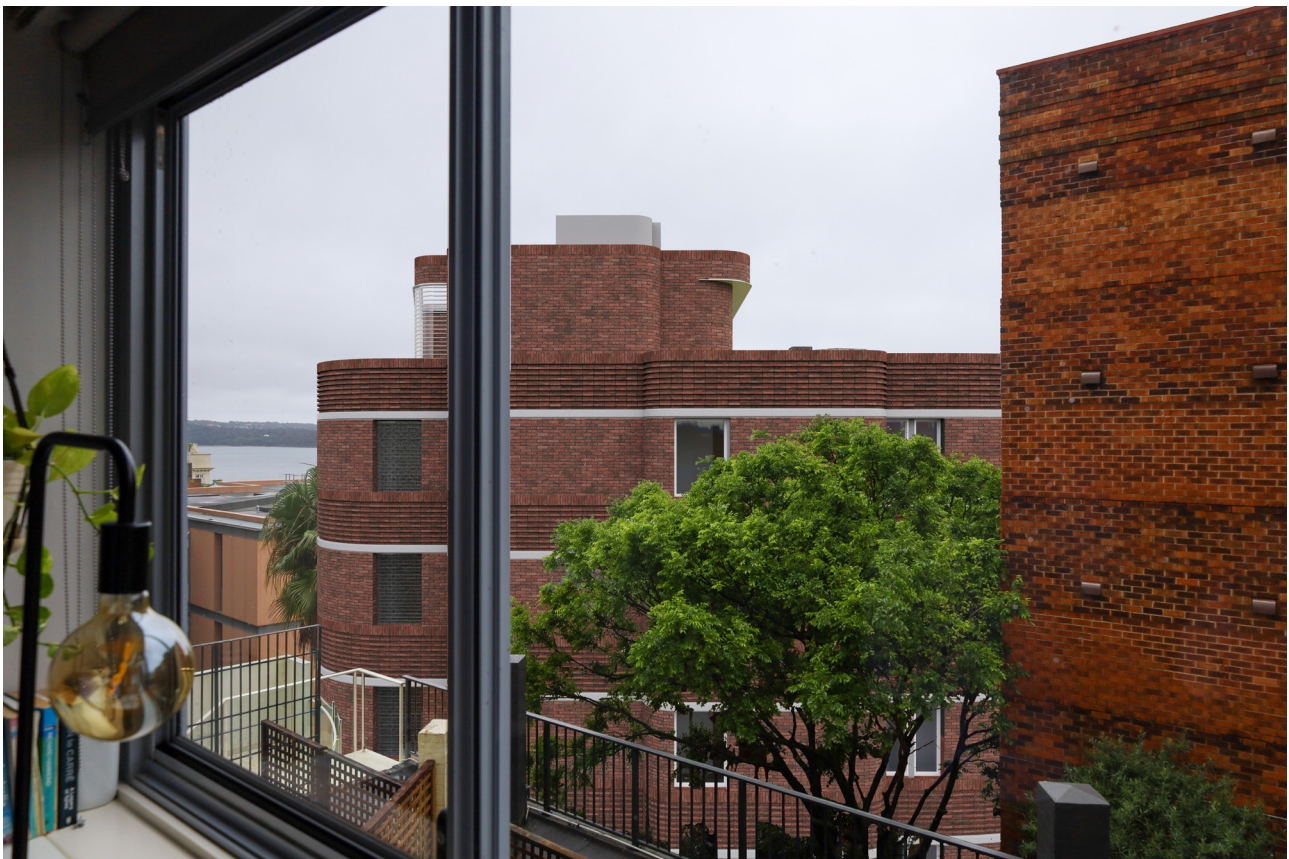
**Viewpoint No.09: Extent of visual impact of proposed landscaping - indicated in cyan overlay with red outline.**

Visual impact – portion of landscaping additions to new building visible in view – 96% of soft landscaping

Visual impact ratio of view loss to sky view loss in visible portion. 0%: 100%

Existing Visual Quality Scale no: 7 /15      Visual Impact Assessment Scale - additional view loss: 0 /15

The view loss, as a result of the new proposal, would be considered negligible under the assessment guidelines of the Tenacity Consulting v Warringah Council [2004] NSWLEC 140 case. Only loss of sky view is experienced from this location. The additional landscaping, similarly affects sky view only and is not detrimental to the overall view.

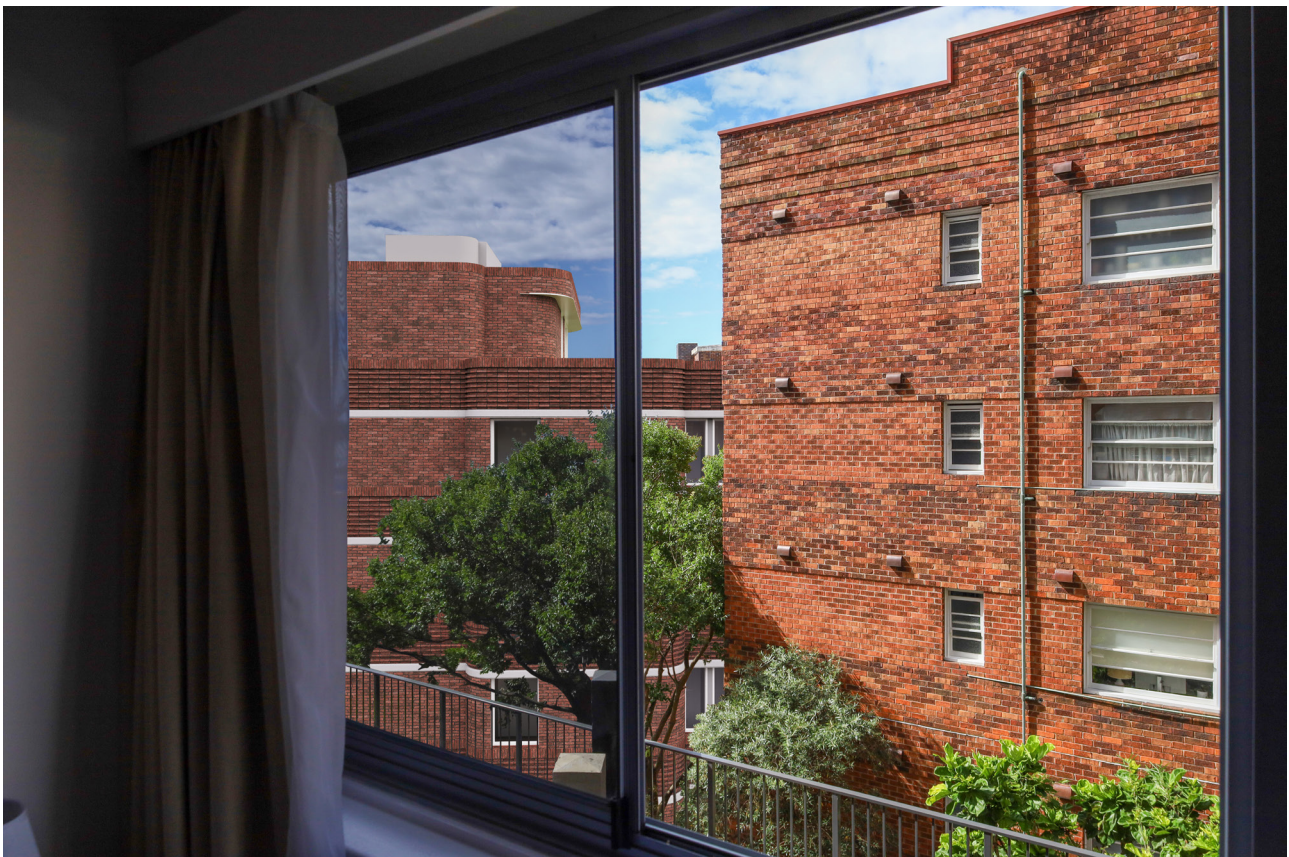
**Viewpoint No.10: Existing virtual view. Macleay Hotel, No.28, Macleay Street – Level 2 Unit 205**  
 From main apartment bedroom  
 RL +37.45. Distance to site boundary: 13.8m. Distance to centre of subject site: 25.6m

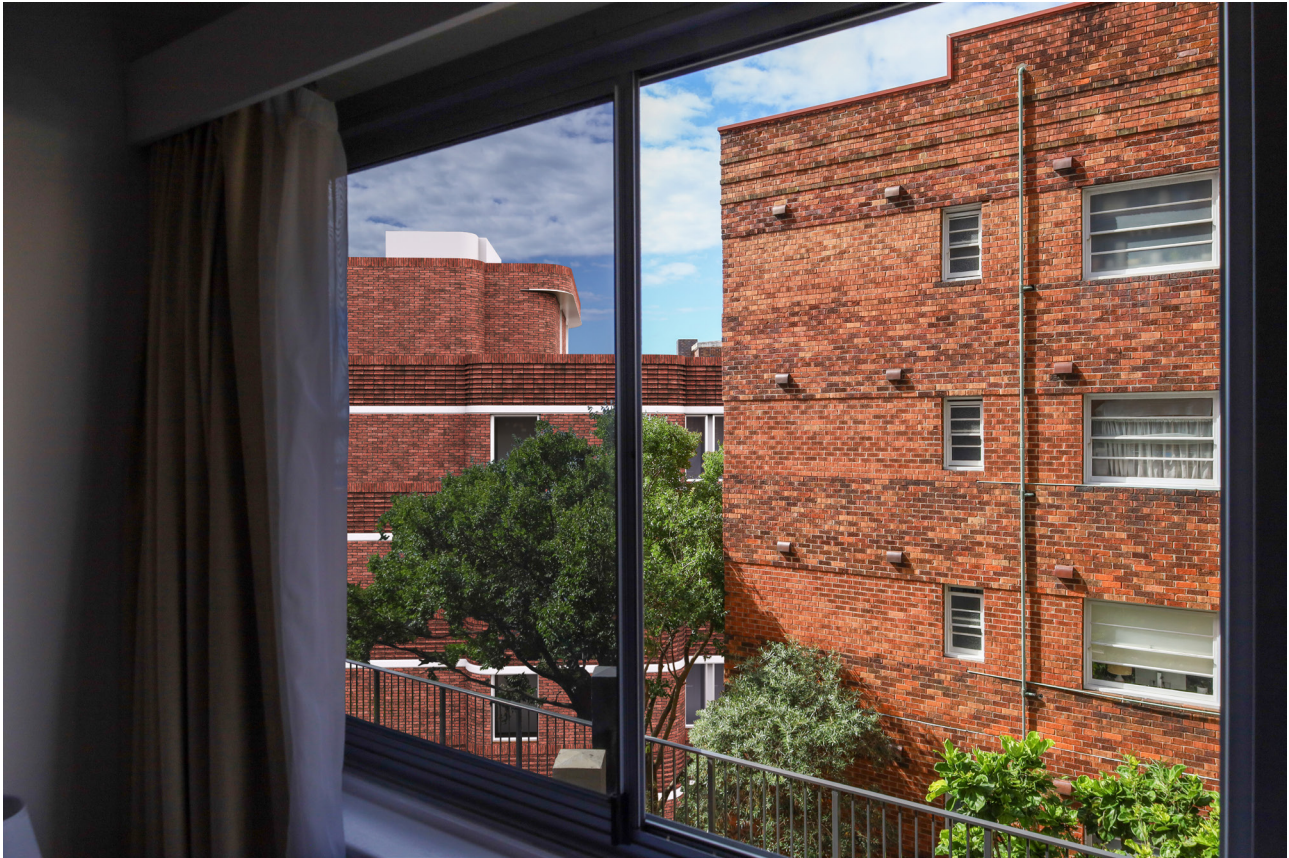
**Viewpoint No.10: Photomontage of new proposed landscaping onto Approved Development photo.**

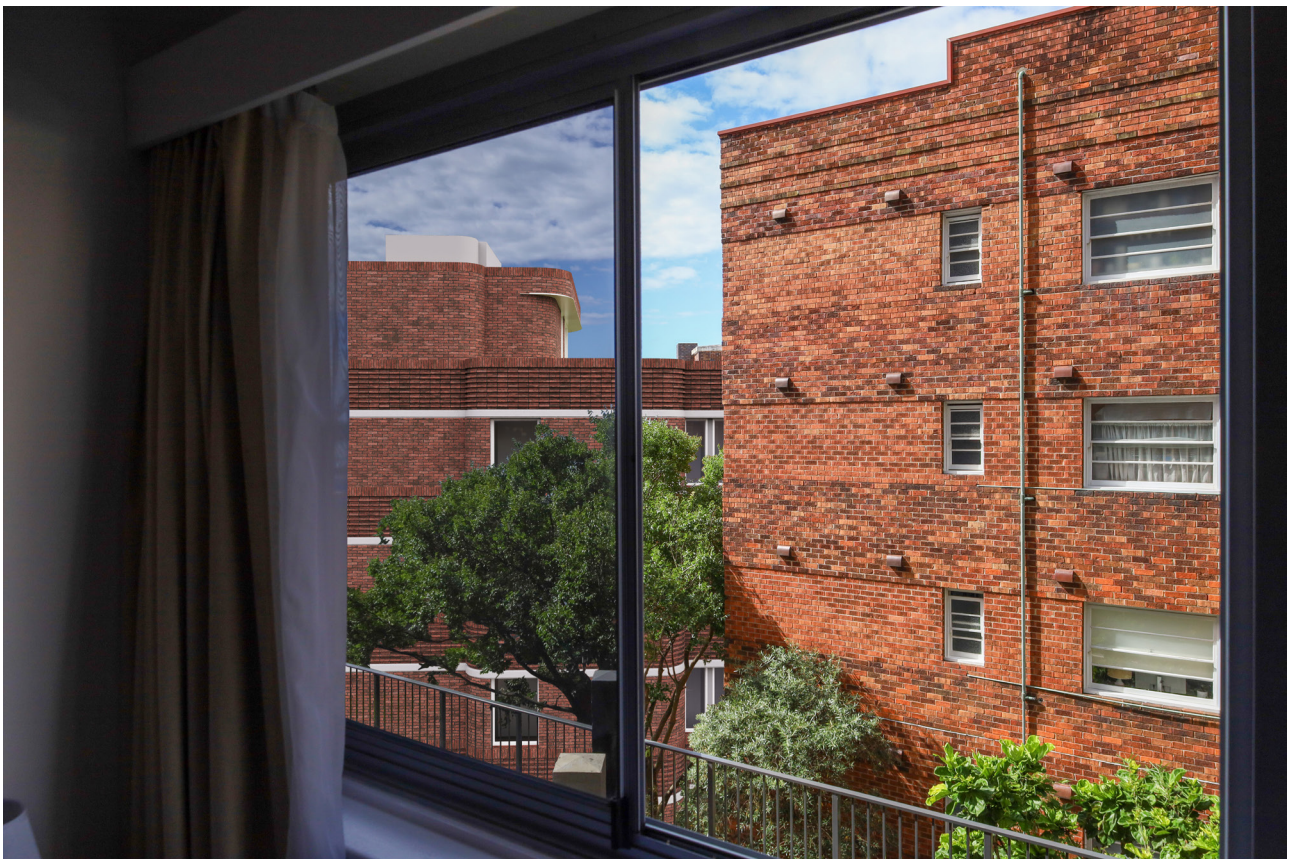
**Viewpoint No.10: Extent of visual impact of proposed landscaping - indicated in cyan overlay with red outline.**

Visual impact – portion of landscaping additions to new building visible in view – 68% of soft landscaping

Visual impact ratio of view loss to sky view loss in visible portion. 0%: 100%

Existing Visual Quality Scale no: 3 /15      Visual Impact Assessment Scale - additional view loss: 1 /15

The view loss, as a result of the new proposed landscaping, would be considered negligible under the assessment guidelines of the Tenacity Consulting v Warringah Council [2004] NSWLEC 140 case. Only loss of sky view is experienced from this location. The additional landscaping, similarly affects sky view only and is not detrimental to the overall view.

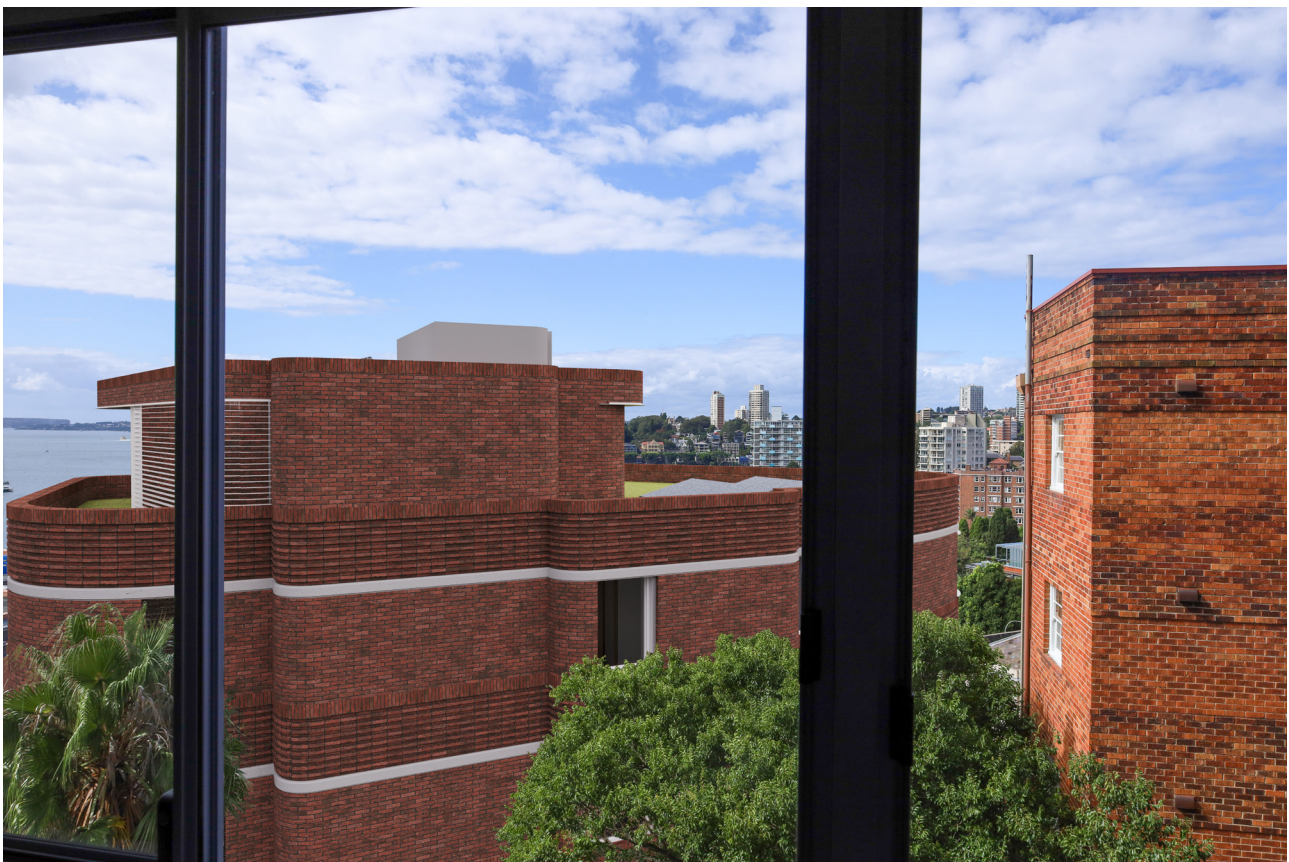
**Viewpoint No.11: Approved Development photo. Macleay Hotel, No.28, Macleay Street – Level 3 Room 303.**  
 From apartment main living / bedroom in studio apartment.  
 RL +43.84 Distance to site boundary: 13.8m. Distance to centre of subject site: 25.6m

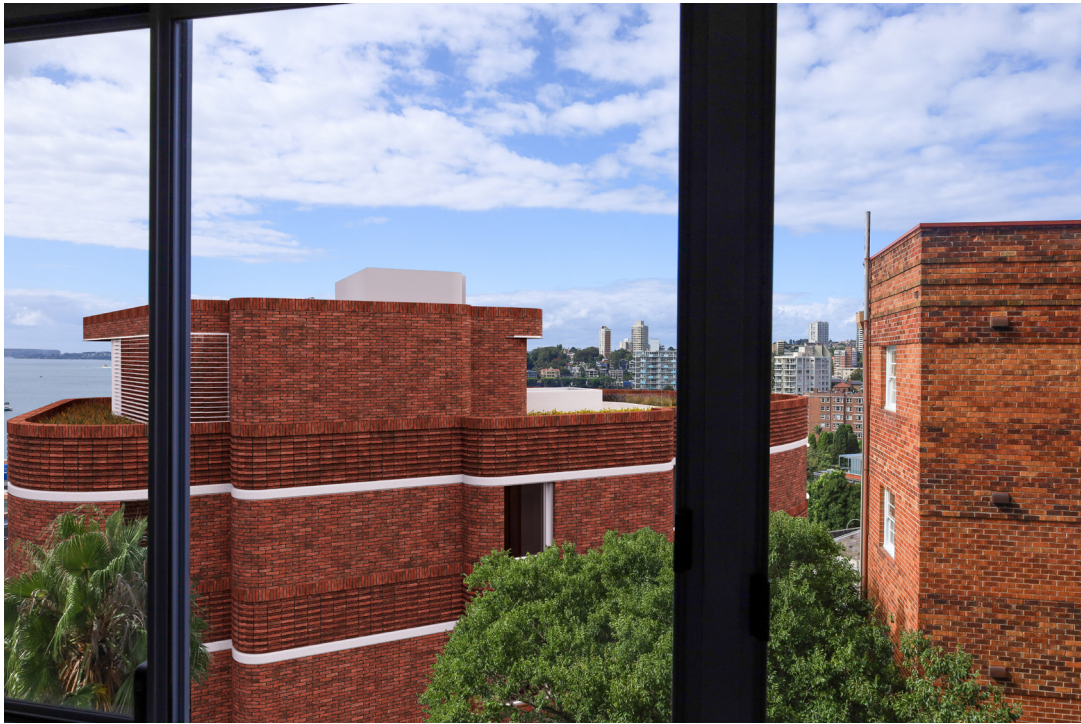
**Viewpoint No.11: Photomontage of new proposed landscaping onto Approved Development photo.**

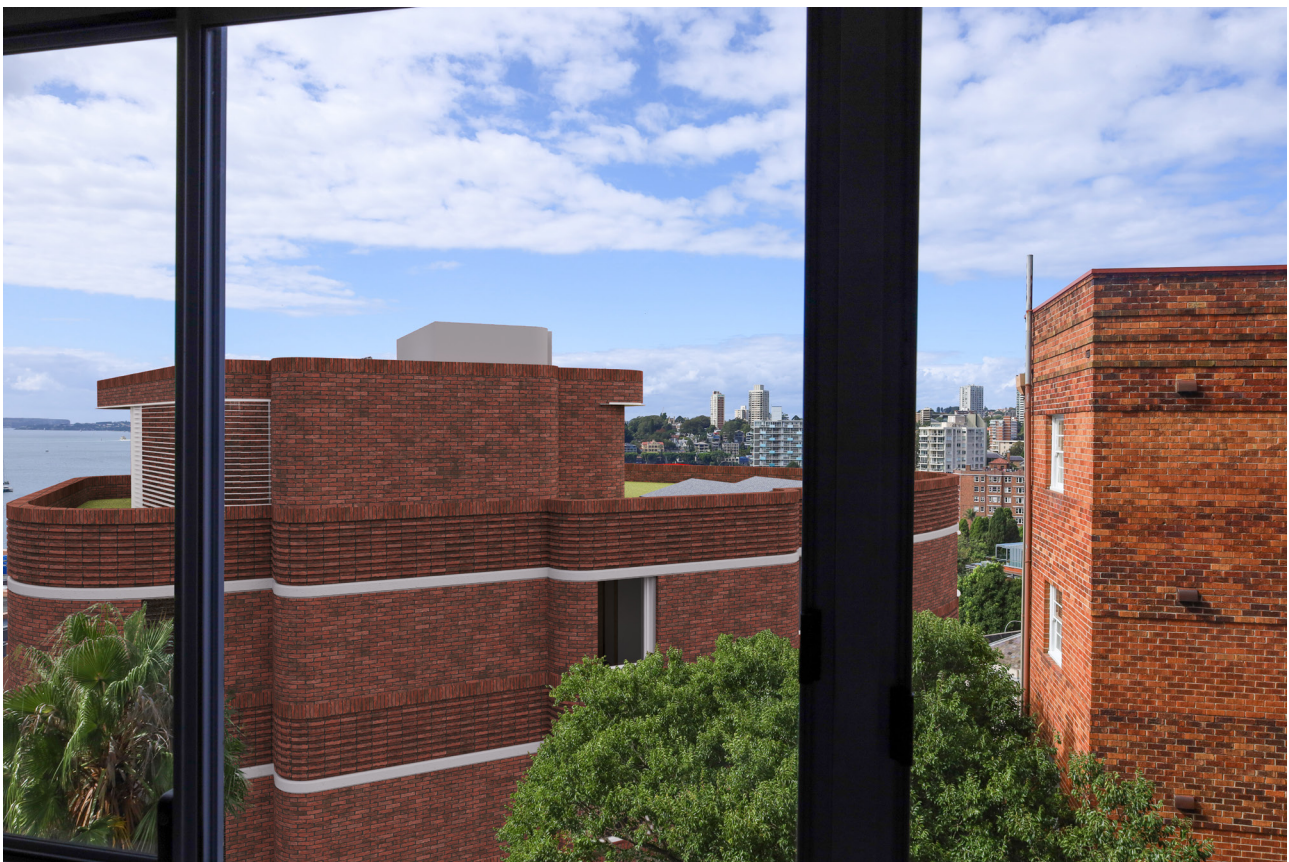
**Viewpoint No.11: Extent of visual impact of proposed landscaping - indicated in cyan overlay with red outline.**

Visual impact – portion of landscaping additions to new building visible in view – 72% of soft landscaping

Visual impact ratio of view loss to sky view loss in visible portion. 100%: 0%

Existing Visual Quality Scale no: 7 /15      Visual Impact Assessment Scale - additional view loss: 0 /15

The view loss from the additional landscaping is negligible from this viewpoint., impacting upon a very small area of the far-distance background component of the view.
