Goodman Limited

BURROWS INDUSTRIAL ESTATE
GEOTECHNICAL INVESTIGATION

PSM2808-005R REV1 MAY 2019

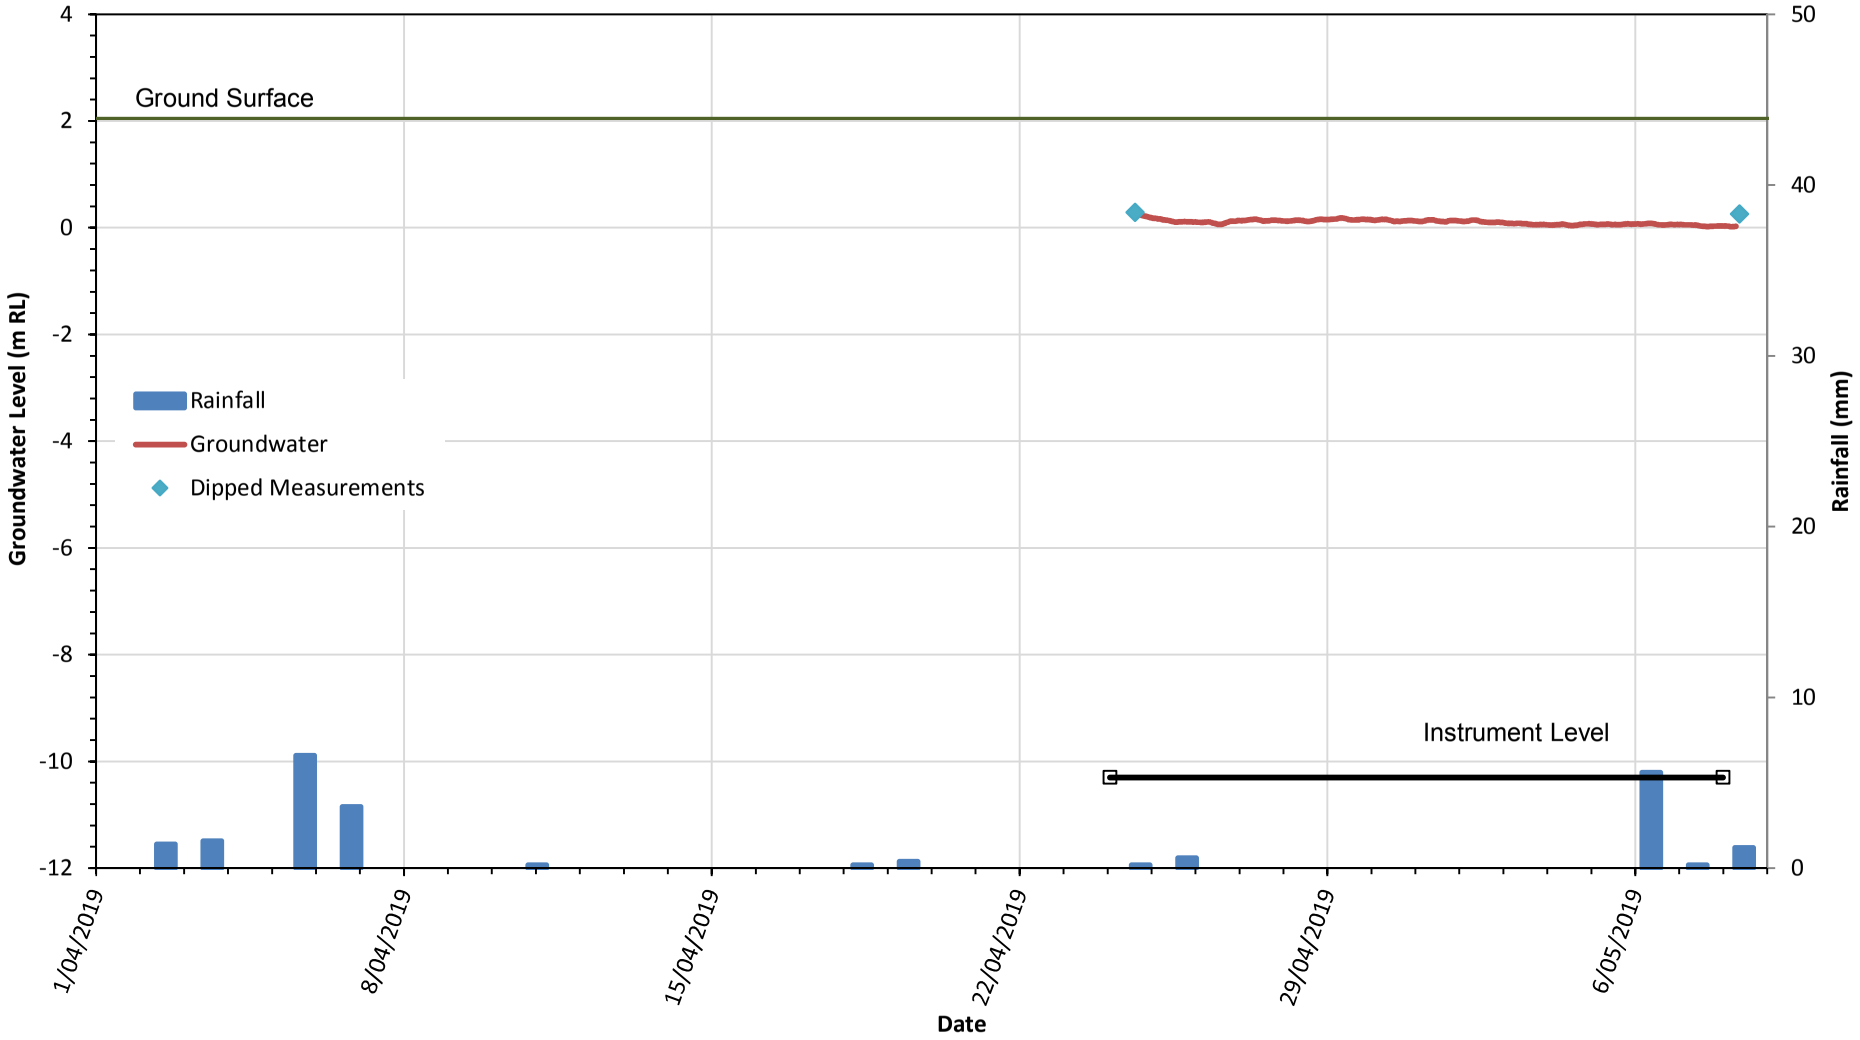
Goodman Limited
Burrows Road Estate
St Peters, NSW
GROUNDWATER MONITORING
BH01

1. Instrument depth (m RL): -10.3
2. Rainfall data source: BoM Sydney Aeroport (station number: 66037)
3. Measured water level on 24/04/2019 at -1.76 (m BGL)
4. Data logger installed on 24/04/2019 ☐

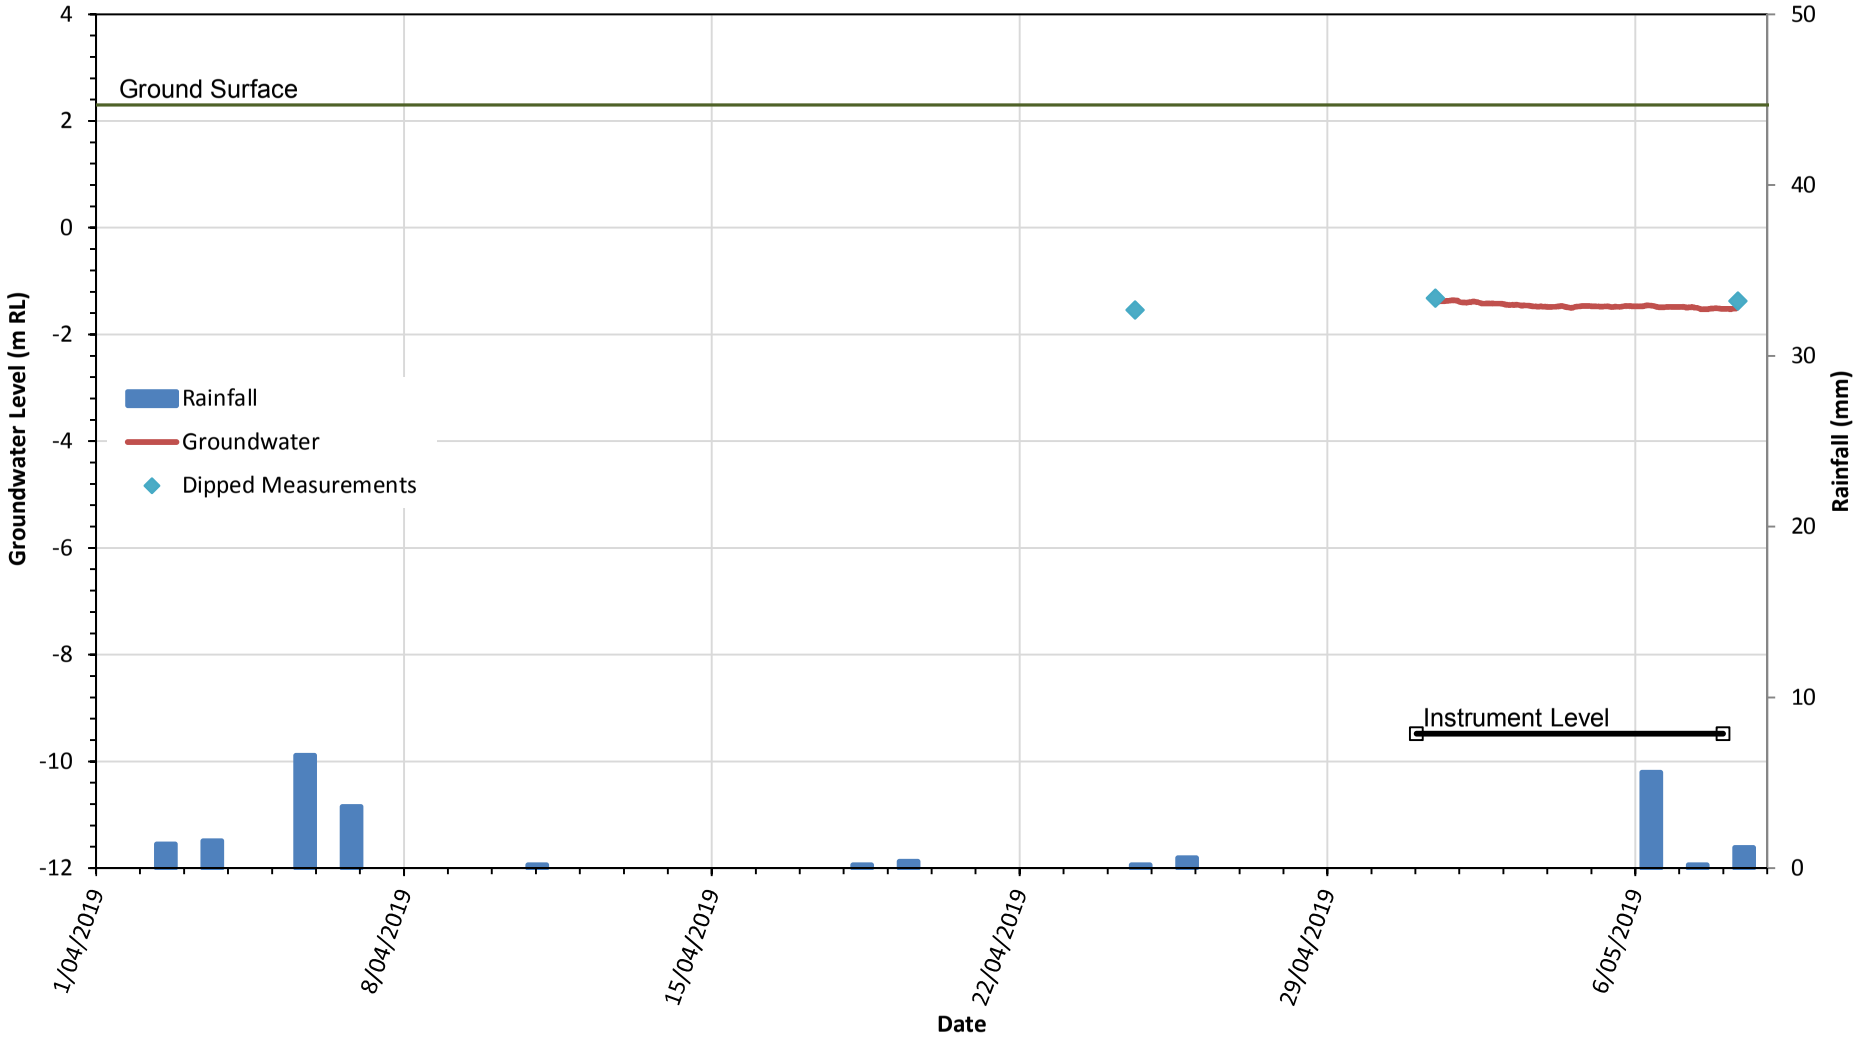
Goodman Limited
Burrows Road Estate
St Peters, NSW
GROUNDWATER MONITORING
BH02

1. Instrument depth (m BGL): -9.48
2. Rainfall data source: BoM Sydney Aeroport (station number: 66037)
3. Measured water level on 24/04/2019 at -3.84 (m BGL)
4. Data logger installed on 1/05/2019

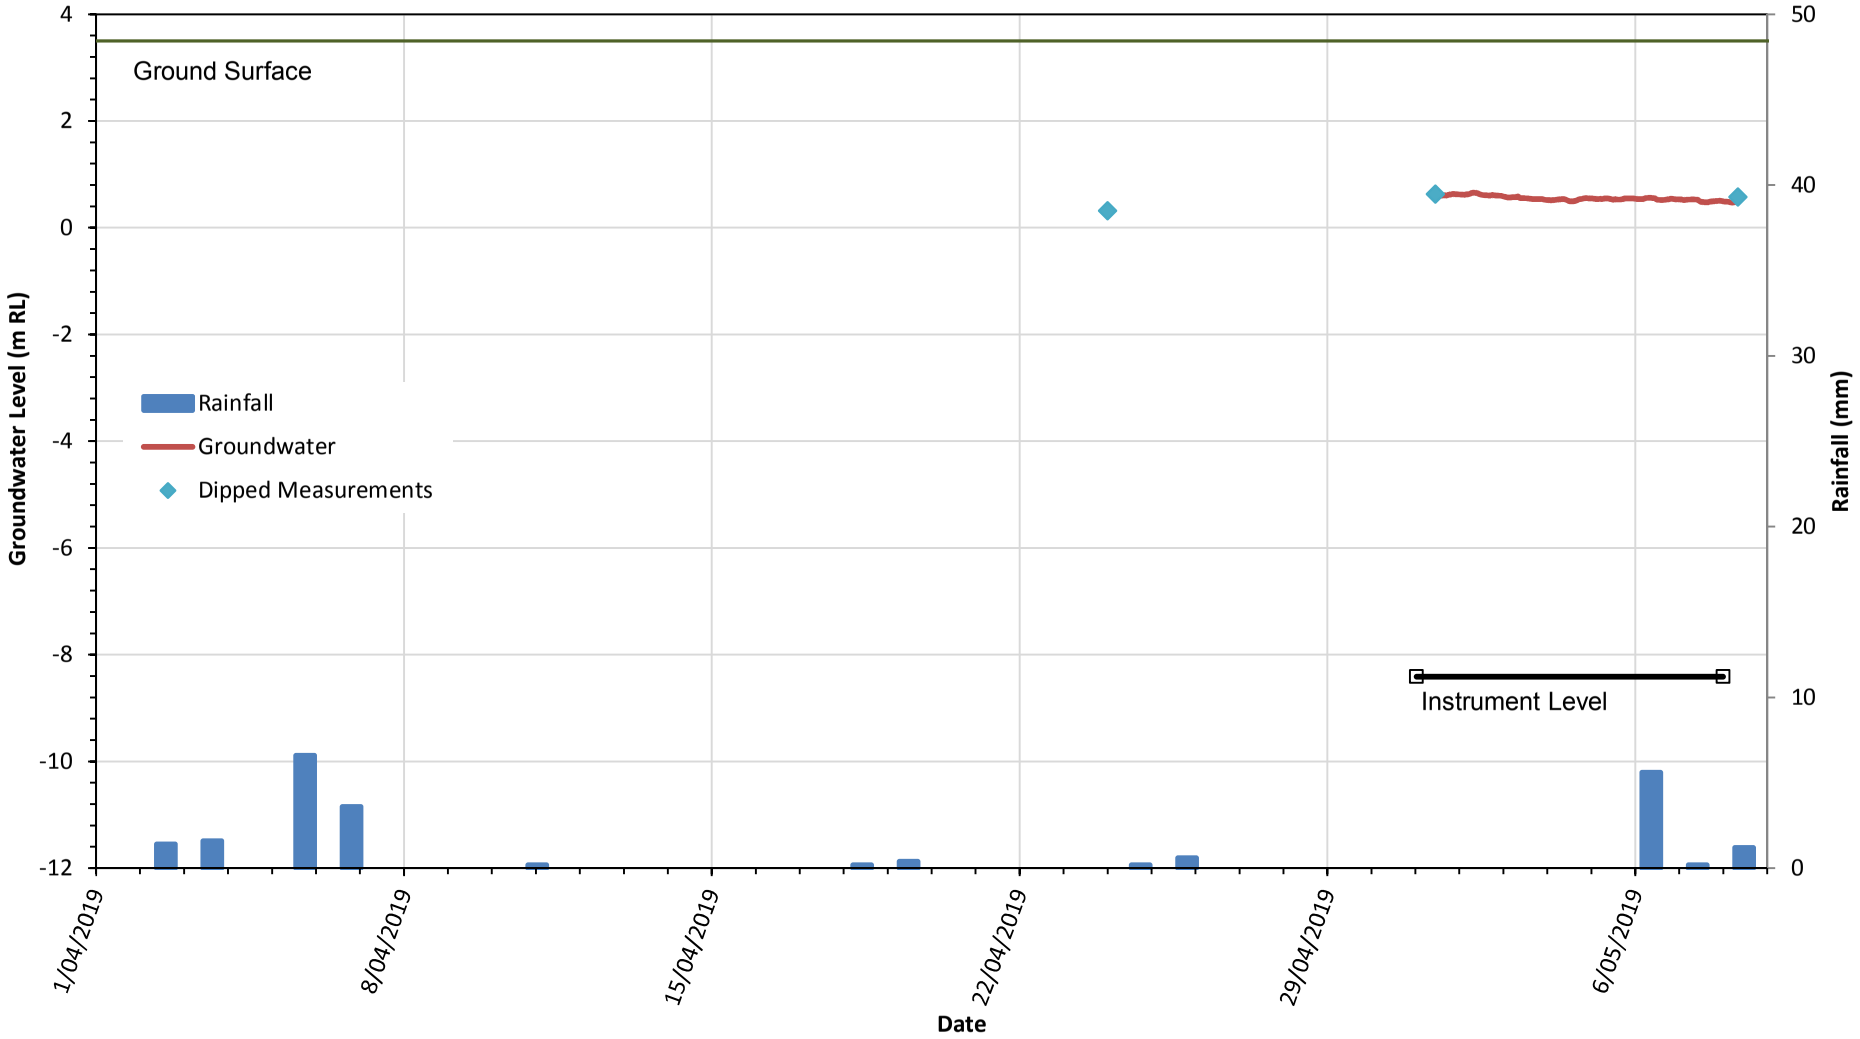
1. Instrument depth (m BGL): -8.41
2. Rainfall data source: BoM Sydney Aeroport (station number: 66037)
3. Measured water level on 24/04/2019 at -3.18 (m BGL)
4. Data logger installed on 1/05/2019

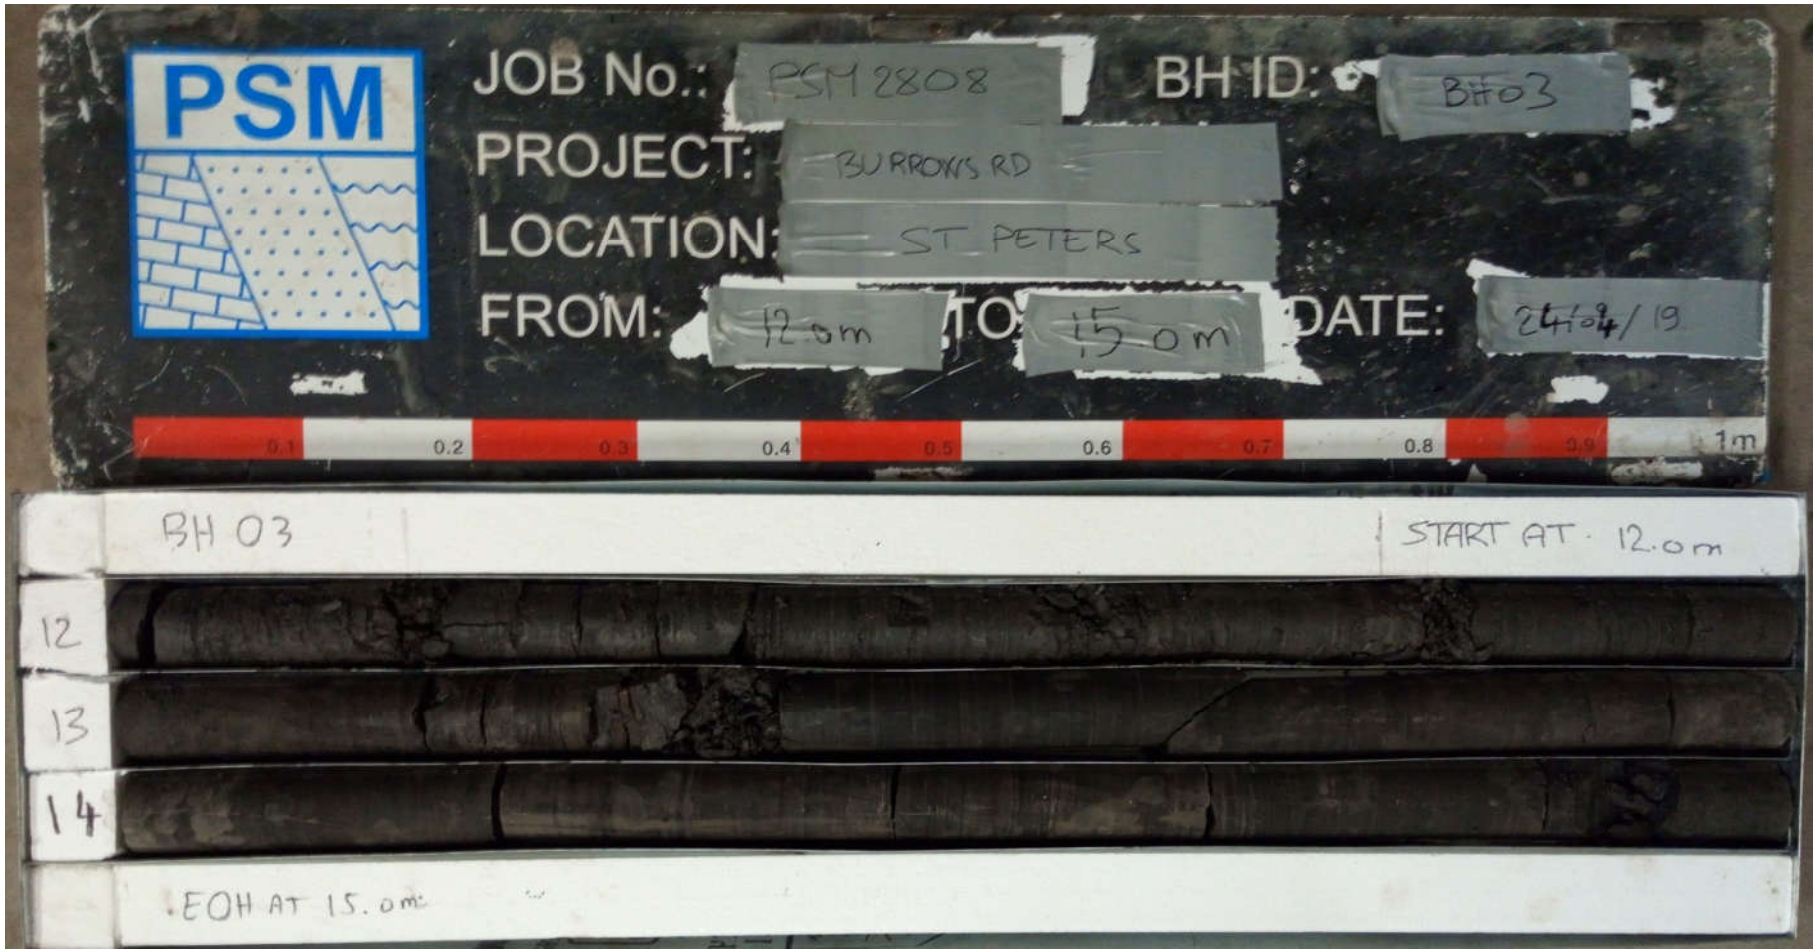
Goodman Limited	
1 - 3 Burrows Road, St Peters	
Geotechnical Investigation	
BOREHOLES CORE PHOTO	
BH03 From 12.0 m to 15.0 m	
PSM2808-005R	Appendix C

We observed hydrocarbon within BH03 during drilling. Environmental assessment may be required to remove groundwater and material in this area.
