**THE SUGAR FACTORY – REPORT
ON INCLUDED BRANCHES**

Inspection of Included Bark on Twenty-two
Hill's Weeping Fig *Ficus microcarpa* var. *hillii*
In Hyde Park North & South, Sydney CBD

9 August 2103

Ref: cos020

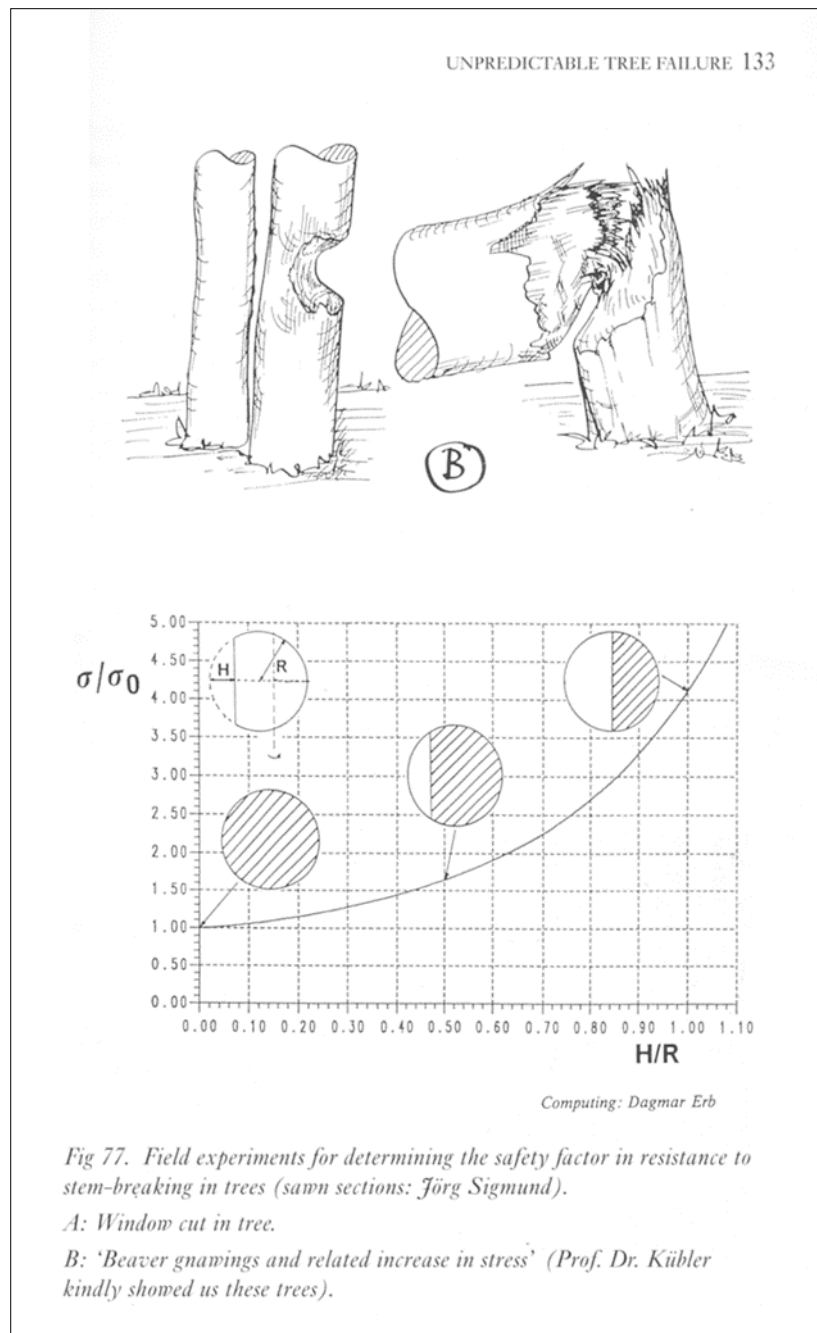
whereby the beavers have an uncanny ability to gnaw out a notch to more or less the precise point that will lead to the failure of the stem under normal, day-to-day conditions. In computing the forces that act upon the stem, it was found that the safety factor of the stem had been reduced to 1 (from approximately 4.5) once the notch occupied 50% of the stem diameter (figure B. left). At this point the failure load equals the day-to-day working load, and so the component breaks.

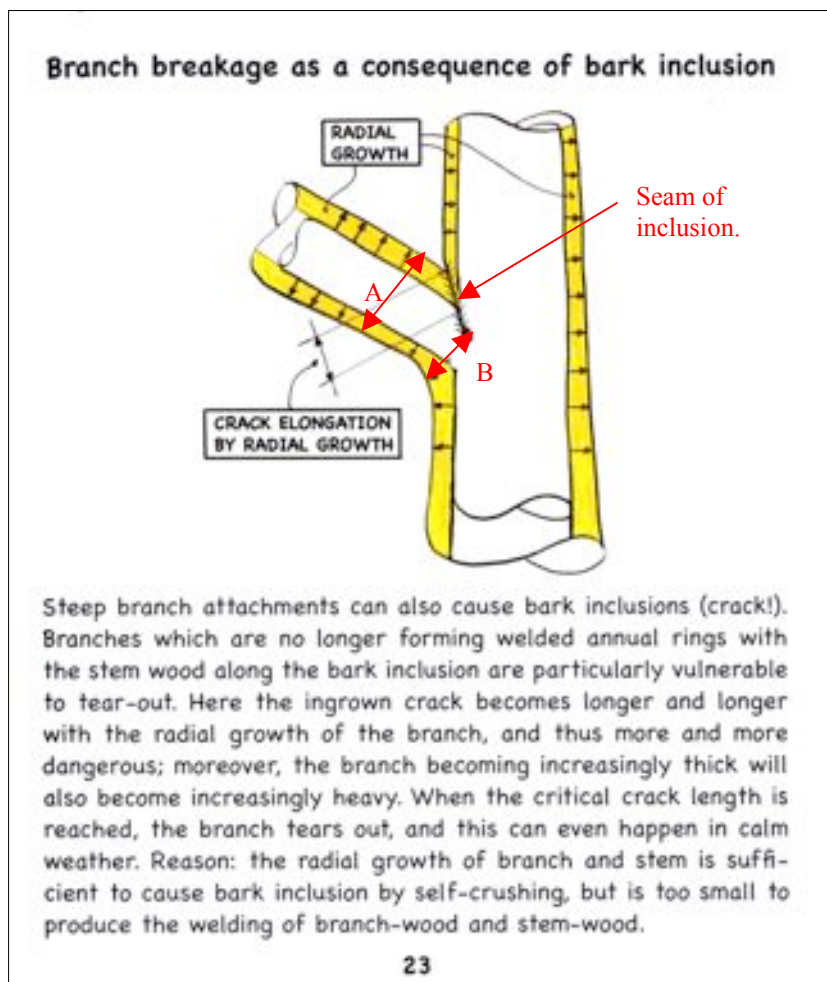
Included bark can cause a constriction similar to a notch. The ‘critical crack length’ of the inclusion is described in Figure C, below, from Mattheck 2007. In that figure, the red arrows, the letters A and B, and the words “seam of inclusion” have been added by this author.

The parameter developed for and adopted by Newcastle City Council is this: if the distance B is 60% or less of the distance A, the branch or stem will be deemed to be at risk of failure due to weak attachment. Once distance B is 60% of distance A, the constriction or ‘notch’ extends to 40% of the branch diameter. Compare this to Photograph B, two pages previous.

The configuration is first visually assessed with the distances A and B measured by tape, and then evaluated. If doubt exists over the shape of the branch within the union, the location of the seam of inclusion can be verified by taking a few readings with a resistograph.
