**One Investment Management Pty Ltd AFT
The Recap IV Management No. 4 Trust**

Preliminary Site Investigation

4 – 6 Bligh Street, Sydney NSW

25 July 2017

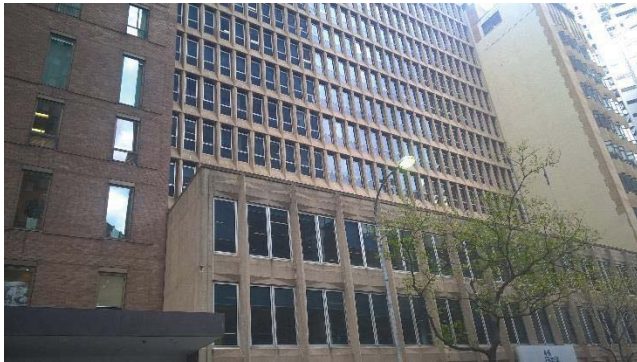
- The site is currently occupied by multi-storey building (Photograph 1) which consists of 19 floors of commercial space over ground floor commercial and retail units with one level of basement car-parking and one level of building plant room. The height of the current plant room is equivalent to approximately 2 basement levels (i.e. 6m). A design map identified in the plant room was dated 1964, which was confirmed by the Client to be the year of which the building was built.

Photograph 1:
Current site conditions at 4-6 Bligh Street, Sydney NSW.

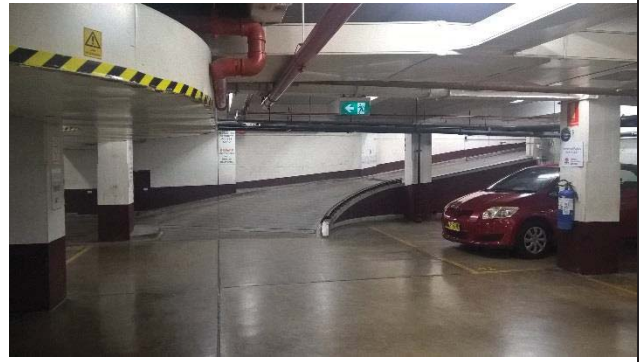
- The site is accessible via Bligh Street, with a lobby located on ground floor. Basement access is provided by a ramp located within the south western corner of the site (Photograph 2).

Photograph 2:
Basement car park level with access from the south western corner of the site off Bligh Street.
