# Existing Building Services Condition Report

**230655 PARK ROYAL HOTEL  
REDEVELOPMENT**

**Client:**  
UOL

**Date:**  
24/03/2025

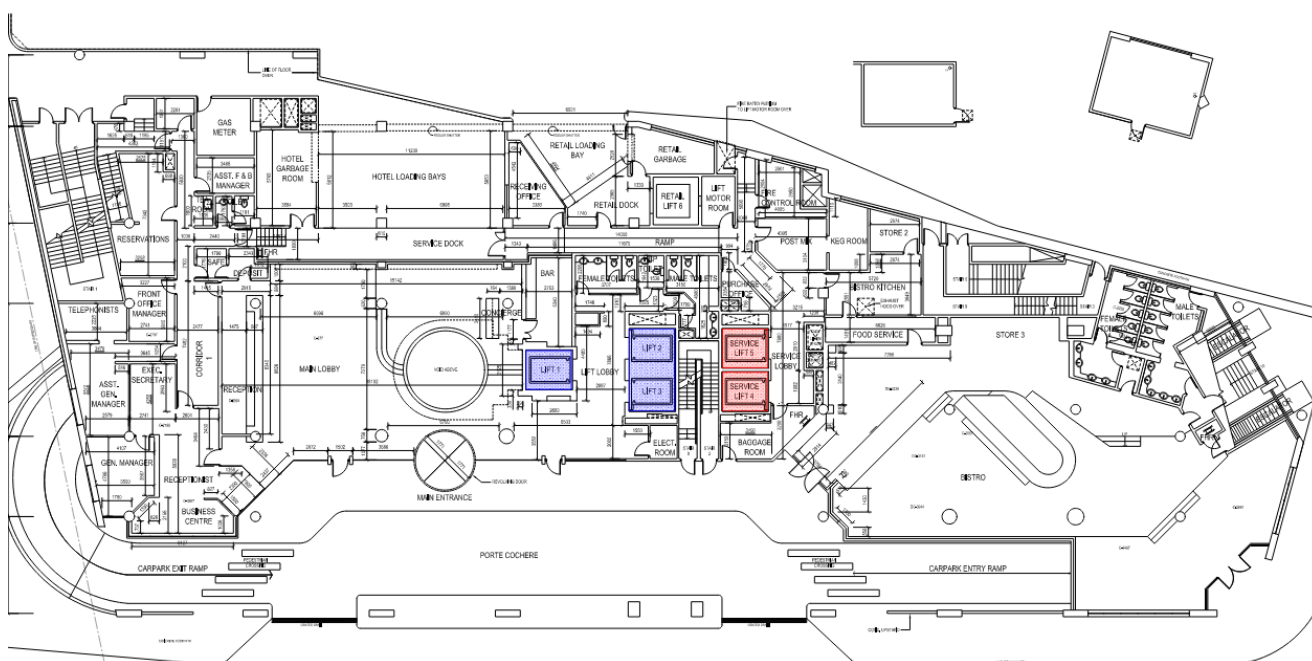
Ground Level

The existing vertical transportation services currently installed consist of three (3) guest passenger lifts for front of house serving ground to level 10 inclusive and two (2) dedicated service lifts for back of house serving basement level, carpark level and ground to level 10 inclusive centrally located in core arrangement below:
