CONSERVATION MANAGEMENT PLAN

Former First Church of Christ Scientist
262-270 Liverpool Street, Darlinghurst

UPDATED VERSION BASED ON CONSERVATION MANAGEMENT PLAN BY GRAHAM BROOKS
AND ASSOCIATES, MARCH 2013

NOVEMBER 2018

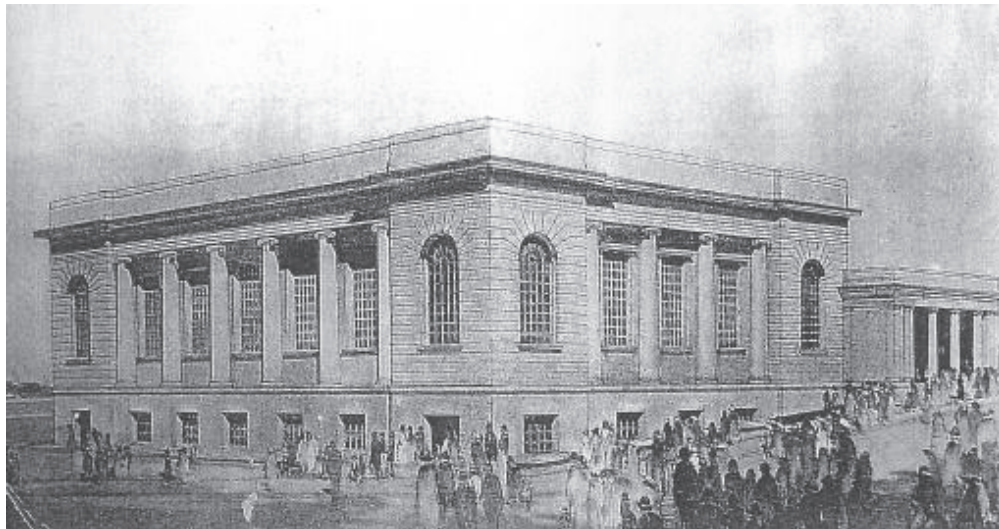
Figure 10: Perspective view of the First Church of Christ Science, 1926 (Source: Conservation Plan 2000)

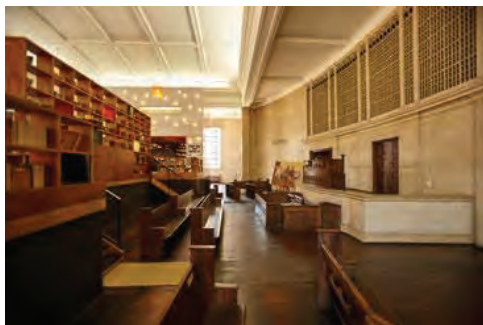
Figure 28: The auditorium space, showing the residence addition at left and the retained pews and joinery around the organ at right (Source: Cornerstone, 2018, 20181023_Shot_01_073.CR2)

The design for the building's conversion to a private residence was prepared by Bates Smart Architects and construction was completed in 2012. These primarily included a two-storey addition to the auditorium space, which comprises a kitchen, laundry, six bedrooms, living space and bathrooms, constructed on a new timber-framed floor over the original sloping floor of the auditorium. Architecturally, the addition was conceived as a 'pod' sitting within the existing space. The project was awarded the Australian Institute of Architects National Award for Interior Architecture in 2012.

These works necessitated the removal of many of the church pews from this space; however some have been retained at the eastern end of the auditorium, around the organ, and others are stored in the former Sunday School below.

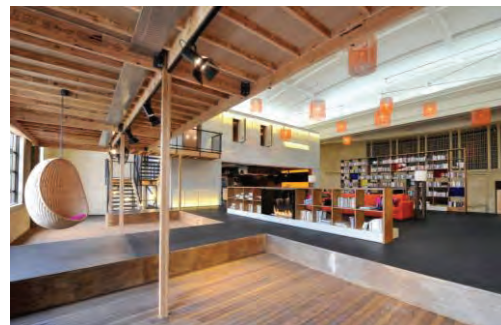
Figure 29: View of the main auditorium space, showing the 2012 additions (Source: <https://architectureau.com/articles/2012-national-architecture-awards-interior-1/>, photograph by Marcus Clinton)

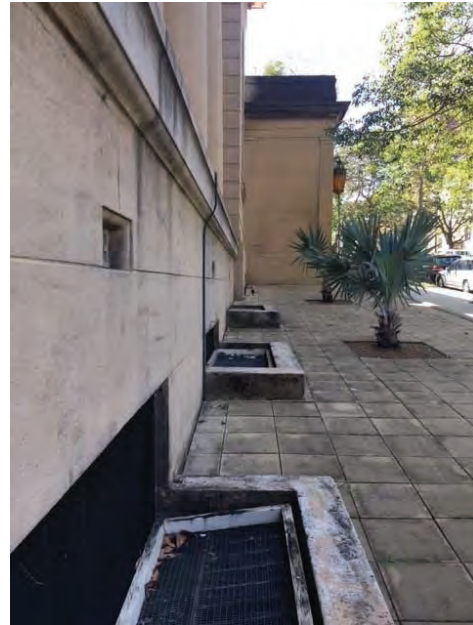
Figure 39: Light wells on the southern façade of the building (Source: NBR SARCHITECTURE 2018)

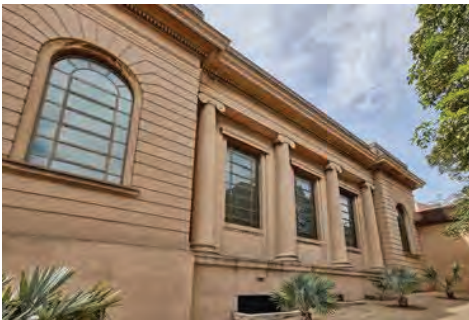
Figure 40: The south façade of the auditorium, fronting Liverpool Street (Source: Cornerstone 20181023_Shot_03_053.CR2)

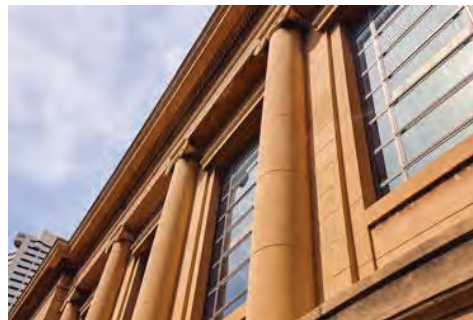
Figure 43: Ionic columns and windows on the south façade (Source: Cornerstone, 20181023_Shot_03_070.CR2)

The building is a combination of concrete frame, masonry walling and steel framed and trussed roof structure. The principal external finish is unpainted tinted cement render in three tones suggesting light brown sandstone to the plinth, golden sandstone to the walls and a grey stone to the parapets. The portico columns are similarly accented in an off white tone with the main doors set in architraves of lighter tone to the walling. The present window frames are of bronze anodised aluminium which replaced the original steel framed multi paned windows in the 1960s.

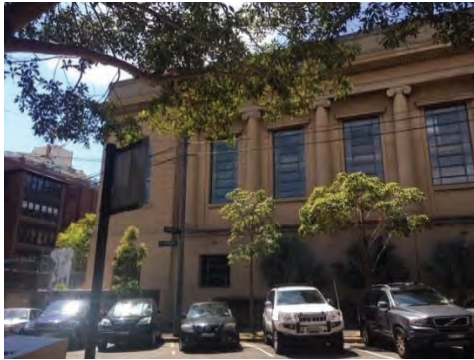
Figure 44: The western façade of the building, viewed from Forbes Street (Source: NBR SARCHITECTURE 2018)

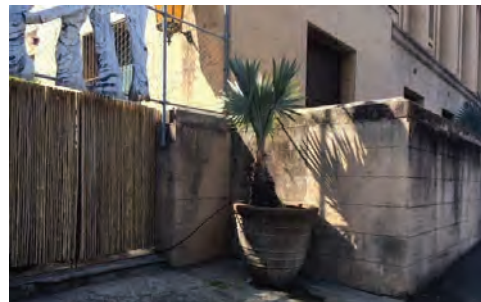
Figure 47: Stone retaining wall on the north-west corner of the building (Source: NBR SARCHITECTURE 2018)

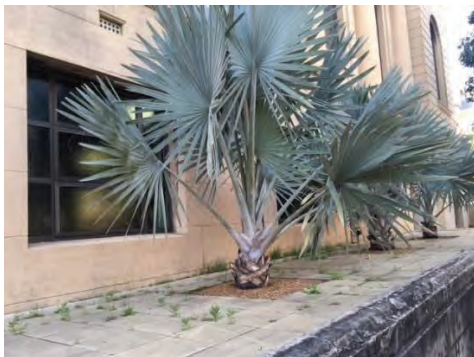
Figure 48: Pavers and planting behind the stone retaining wall on the western side of the building, above pavement level (Source: NBR SARCHITECTURE 2018)

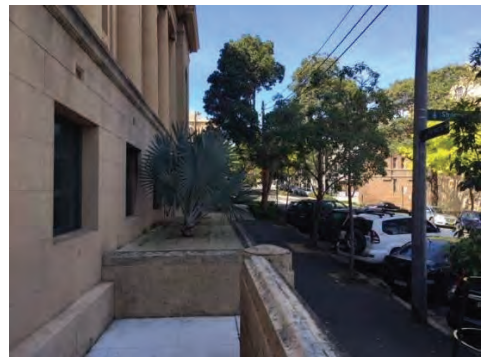
Figure 49: View of the western façade of the building, facing south down Forbes Street (Source: NBR SARCHITECTURE 2018)

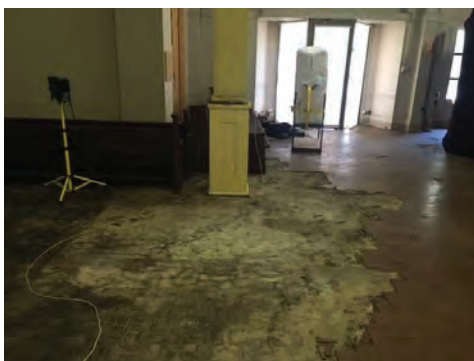
Figure 58: Parquet flooring, showing damaged section, on the lower ground floor (Source: NBR SARCHITECTURE 2018)

Considering the age of the building, previous alterations and additions in the interior are also relatively minor. The timber parquetry in the former Sunday School space is generally in poor condition, with large missing sections. With this exception, the layout of various spaces and the internal fabric of the building is substantially intact, including wall and floor finishes, plaster ceilings, built in furniture and hardware.

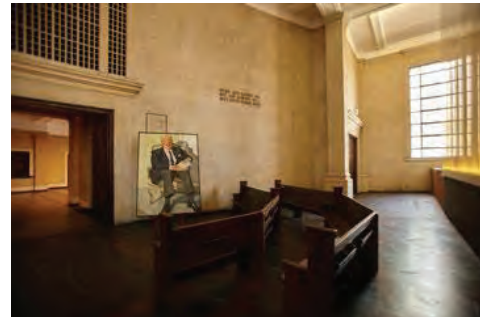
Figure 69: View of the auditorium showing pews retained around the organ, facing south-east (Source: Cornerstone, 20181023_Shot_01_063.CR2)

Although Hill, Norman & Beard made some repairs in 1928-29, it became necessary for the organ to be rebuilt by Whitehouse Bros in 1935.

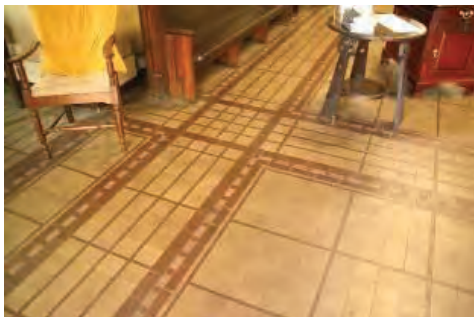
Figure 79: Office to the east of the entry foyer (Source: 2013 CMP, p. 39)

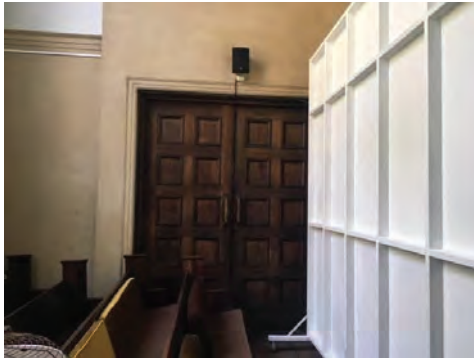
Figure 80: Southern door to the auditorium, viewed from the entry hall (Source: NBR SARCHITECTURE 2018)

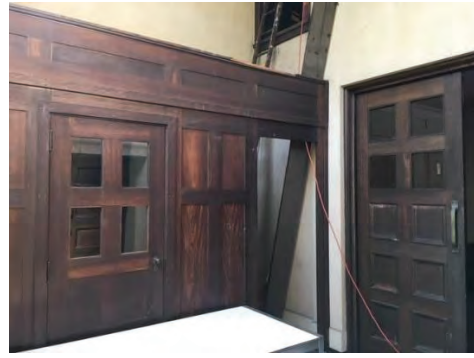
Figure 81: Timber screen and doors in the northern entry (Source: NBR SARCHITECTURE 2018)

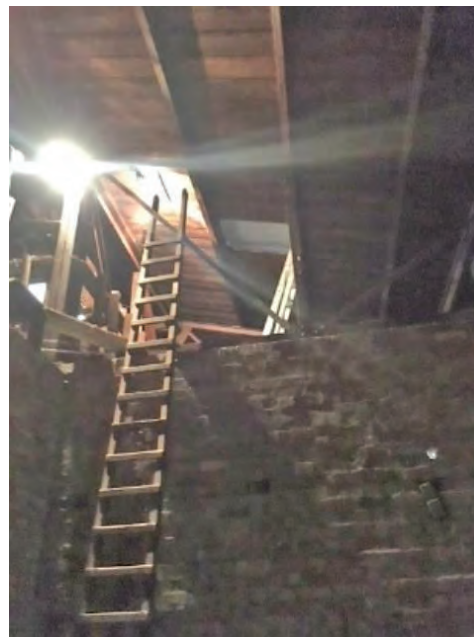
Figure 85: Roof space above the northern entry (Source: NBR SARCHITECTURE 2018)

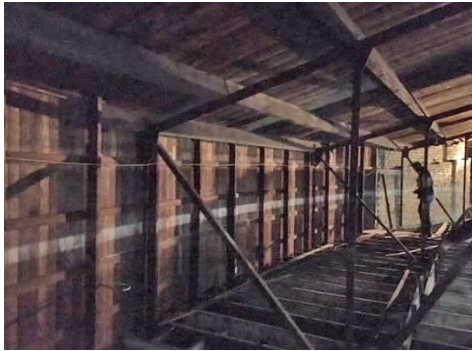
Figure 86: Perimeter roof space on the southern side of the building (Source: NBR SARCHITECTURE 2018)

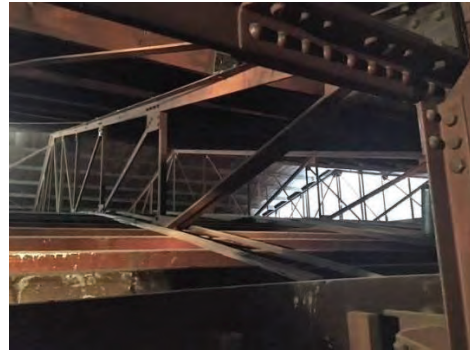
Figure 87: Roof space above the auditorium, showing its curved structure and steel trusses (Source: NBR SARCHITECTURE 2018)

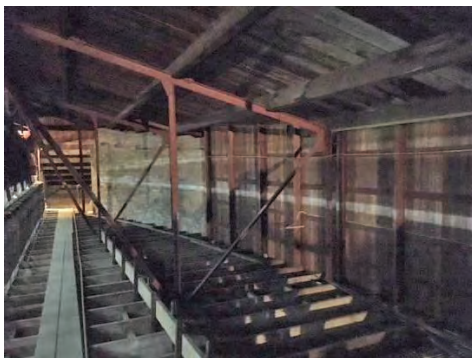
Figure 88: Roof space above the organ, to the west of the organ chamber (Source: NBR SARCHITECTURE 2018)

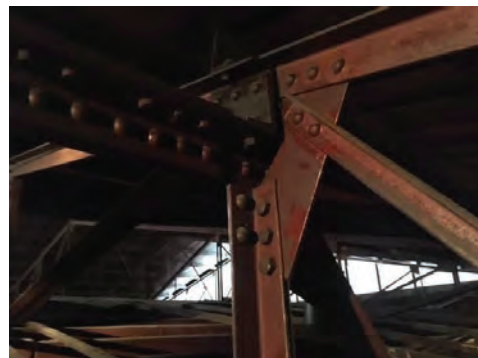
Figure 89: Steel roof trusses (Source: NBR SARCHITECTURE 2018)

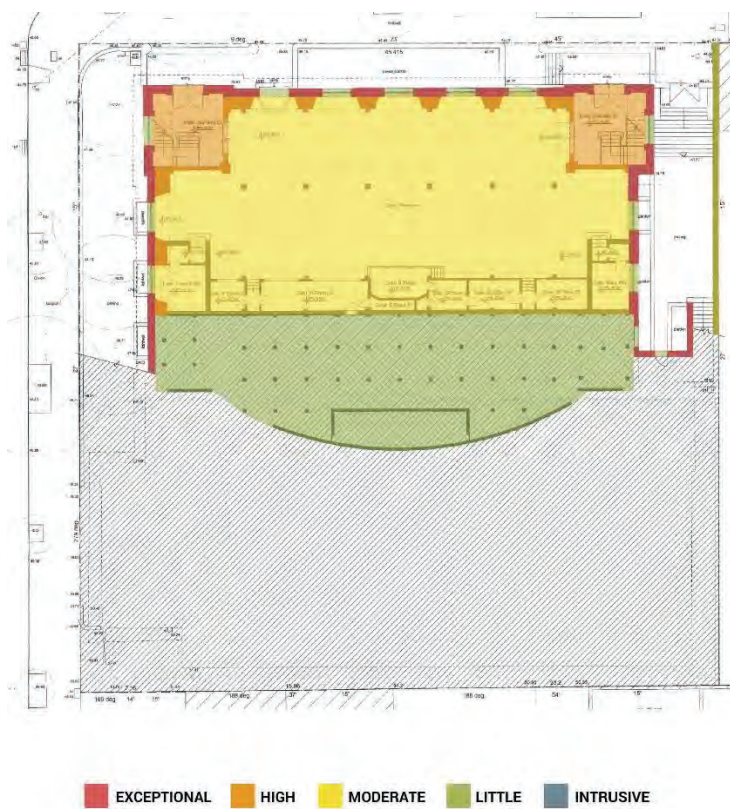
Figure 106: Lower ground floor – Significance Gradings Diagram

Significance of screens, furniture, bathroom and kitchen fitouts and joinery items, including original and later timber joinery associated with the building's previous use as a church, is not indicated in the drawings below. The table above should be referred to for the significance of these items.

Gradings are indicated by different colours, as outlined in the accompanying keys. For this reason, these diagrams should be printed in colour if a hardcopy of this document is being used.

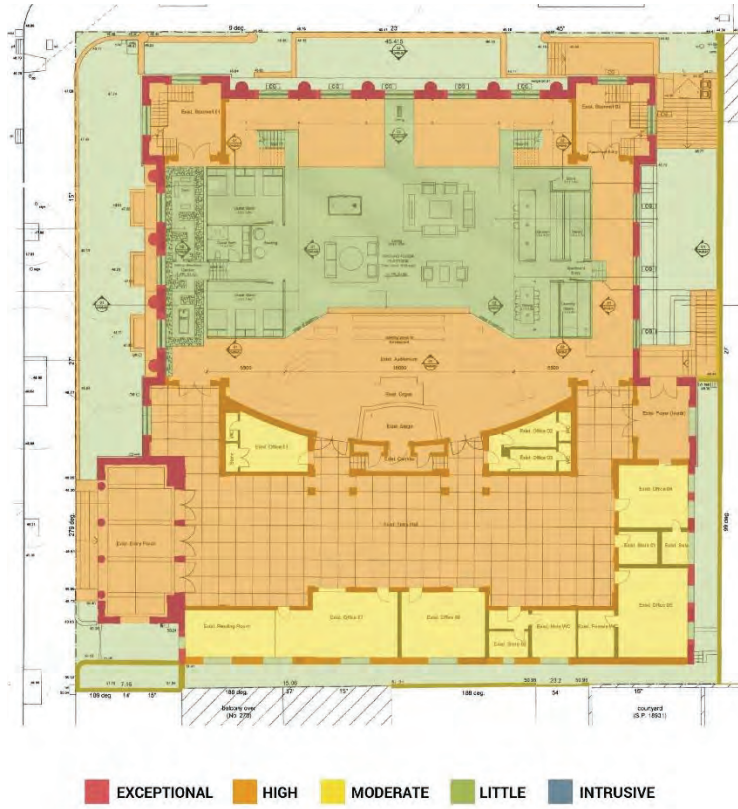
Figure 107: Ground Floor
(main auditorium level) –
Significance Gradings
Diagram
