**Inspection Report -  
371 Pitt Street, Sydney**

**Council investigation officer Inspection and Recommendation Report  
Clause 17(2) of Schedule 5, of the Environmental Planning and Assessment Act  
1979 (the Act)**

**File:** CSM 2113484                      **Officer:** Hieu Van Luu                      **Date:** 17 July 2019

**Premises:** 371 Pitt Street, Sydney

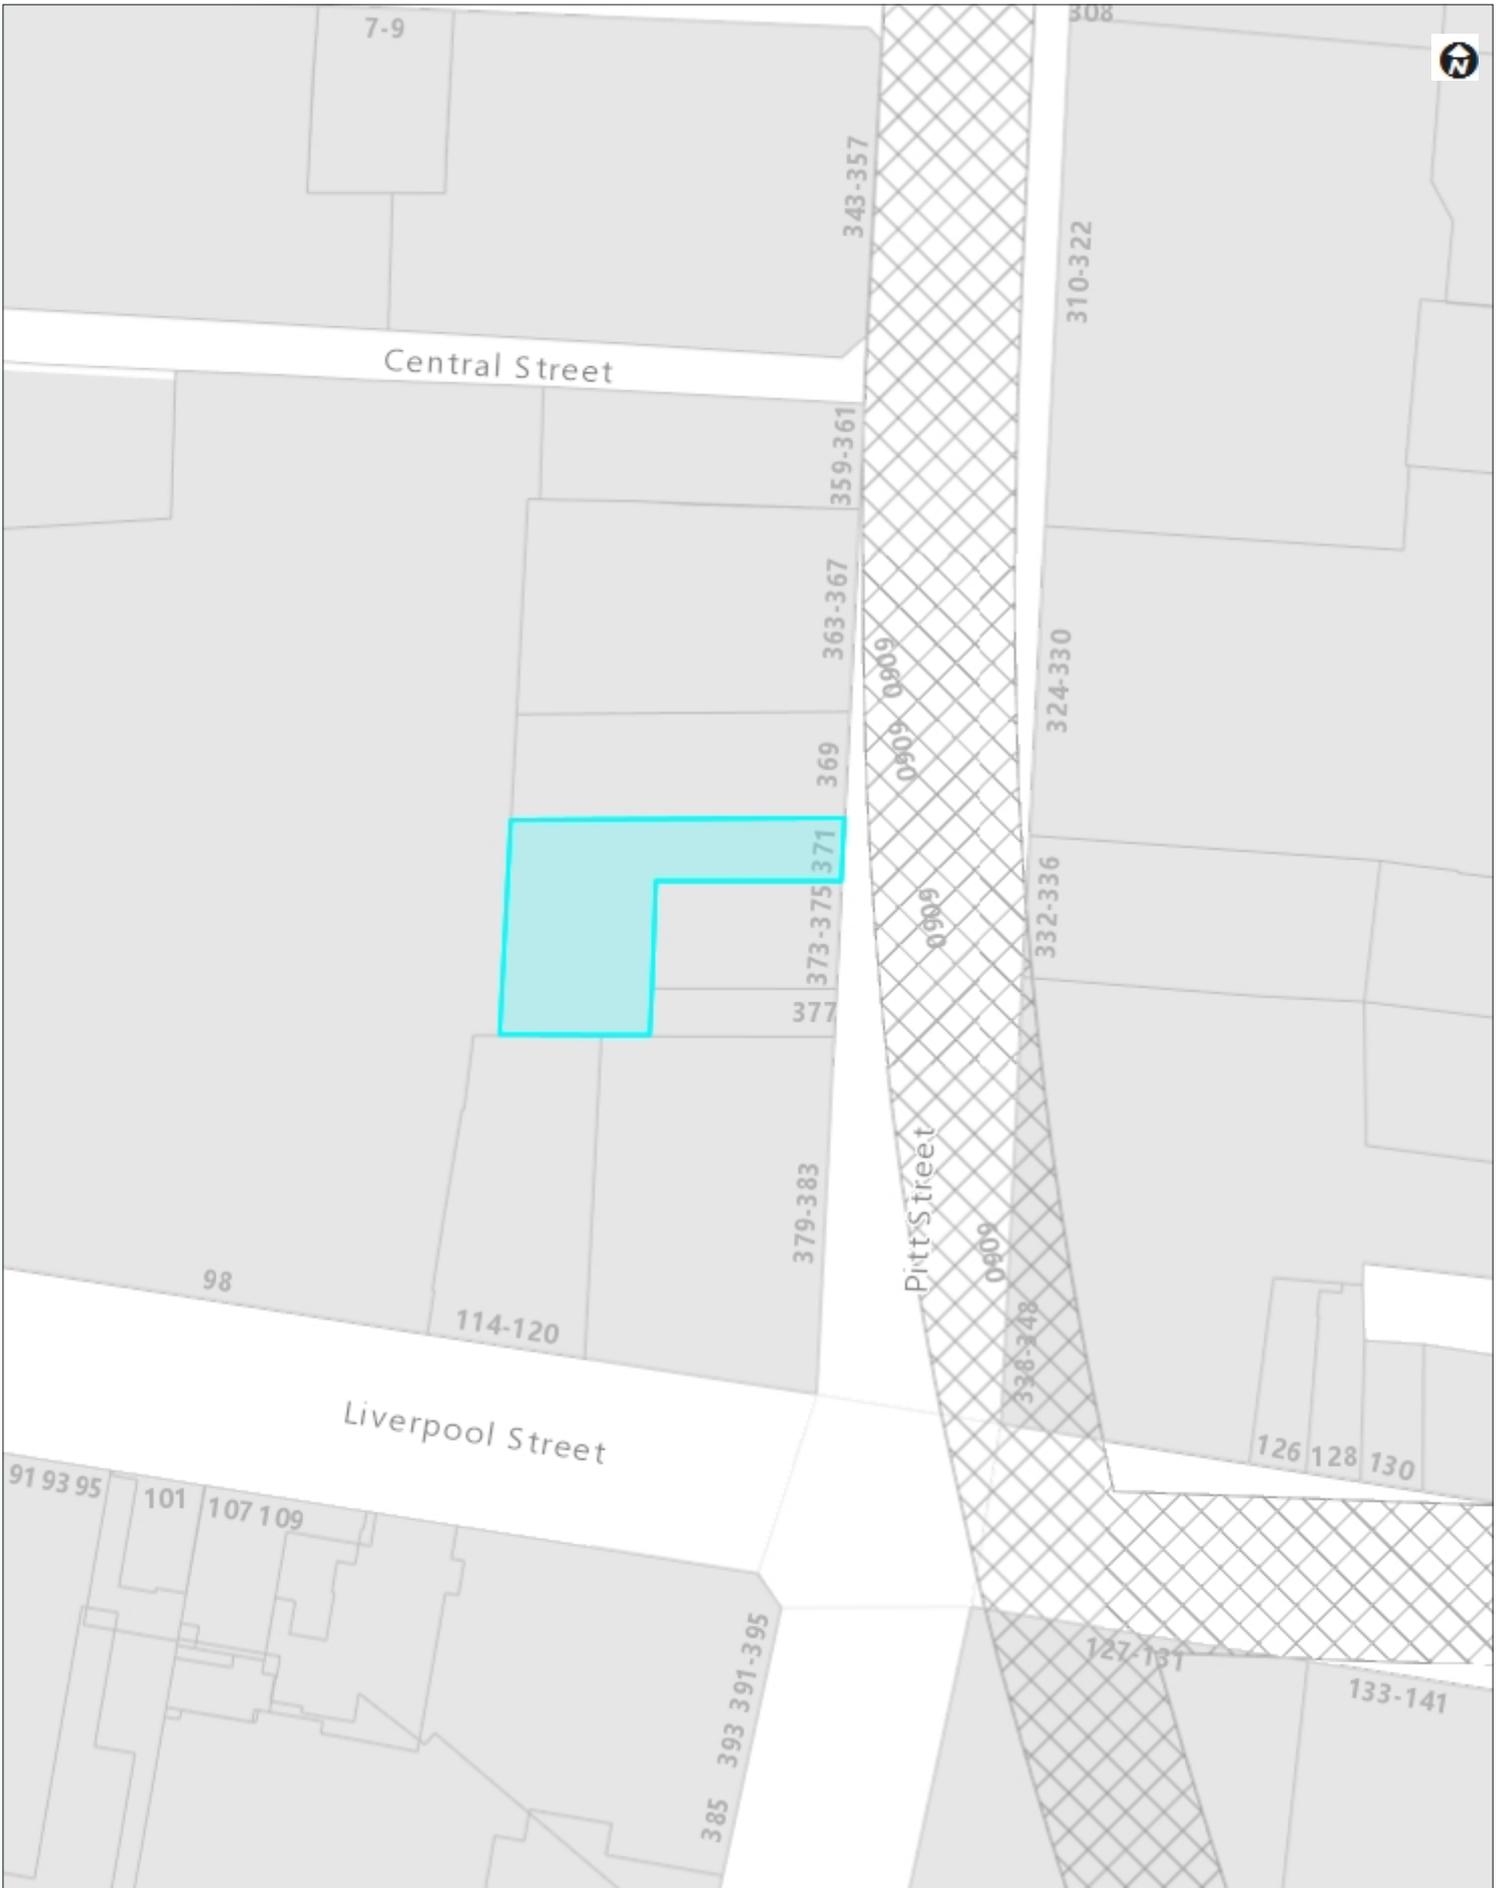
The premises is located to the west of Pitt Street, mid-point between the intersection of Central Street and Liverpool Street. An un-named lane runs parallel to the northern boundary and provides vehicular access to the site and other properties.

The site is 'L'-shaped, a primary frontage to Pitt Street. There are two buildings contained within the site. The front building is a three storey commercial restaurant known as "88 Pocha". The rear building (371A Pitt Street) has four storey and is not directly accessed from Pitt Street. Ground and first floors of this building is operating as a separate restaurant known as 'Madang'. Second floor has commercial use and third floor is currently vacant.
