**Heritage Committee Report for D/2020/1071
and D/2020/1072**

HERITAGE COMMITTEE REPORT

Date: 12 March 2021
Development Application: D/2020/1071 and D/2020/1072
Site: 58-76, 82-106, and 110-122 Oxford Street, Darlinghurst
Applicant: TOGA Projects Services
Committee Members:
Scott Robertson, Robertson & Hindmarsh
Hari Gohil, Shreeji Consultant
Otto Cserhalmi, OCP Architects

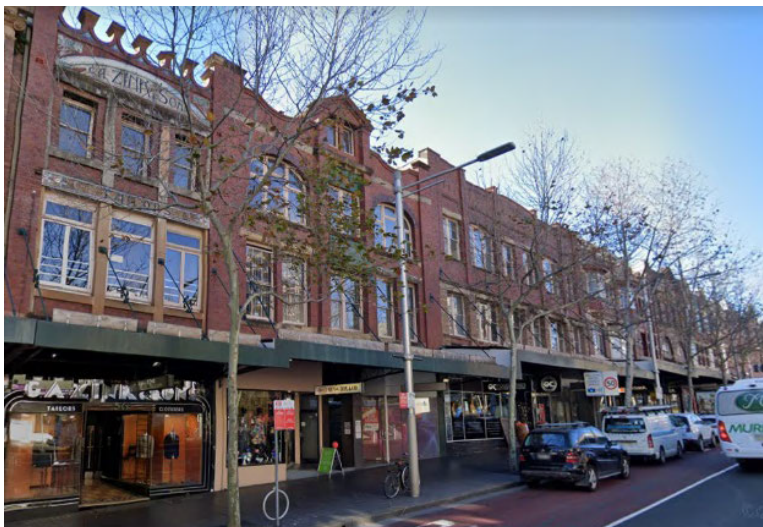
Figure 1 - Exterior view of group 1 buildings at 56-76 Oxford Street showing buildings at the western end of the group. Source: Google Streetview.

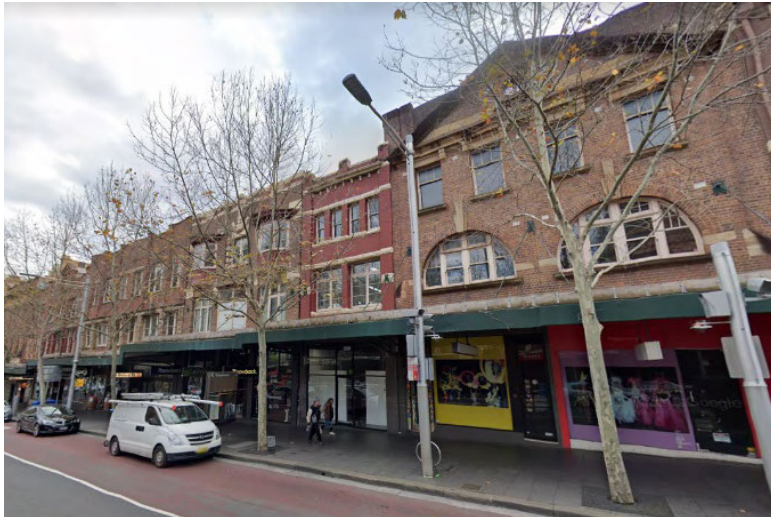
Figure 2 - Exterior view of group 1 buildings at 56-76 Oxford Street showing the buildings at the eastern end of the group. Source: Google Streetview.

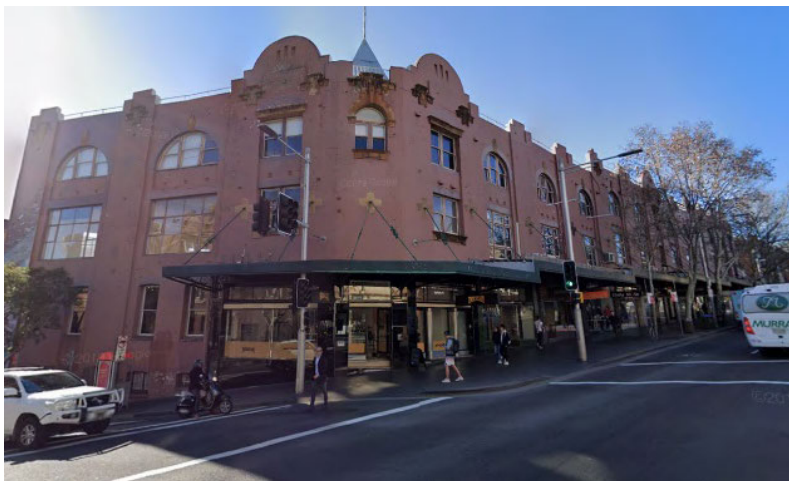
Figure 3 - Exterior view of group 2 building at 82-106 Oxford Street showing the Oxford and Crown Street facades. Source: Google Streetview

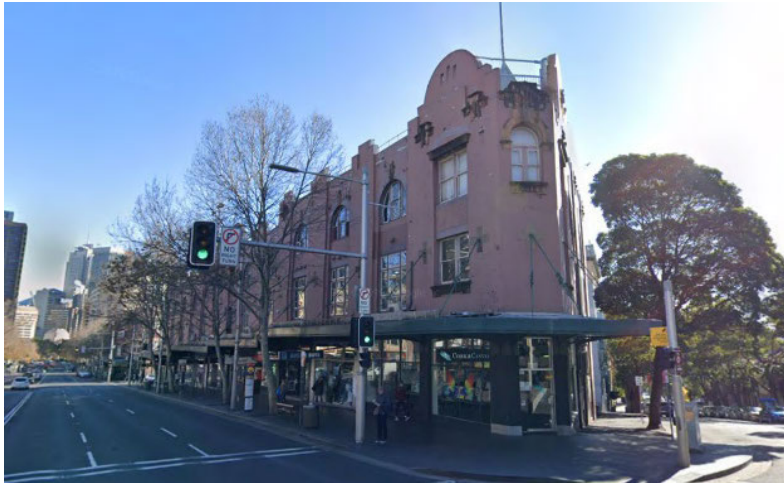
Figure 4 - Exterior view of group 2 building at 82-106 Oxford Street showing the building façade at the corner of Oxford and Palmer Street. Source: Google Streetview

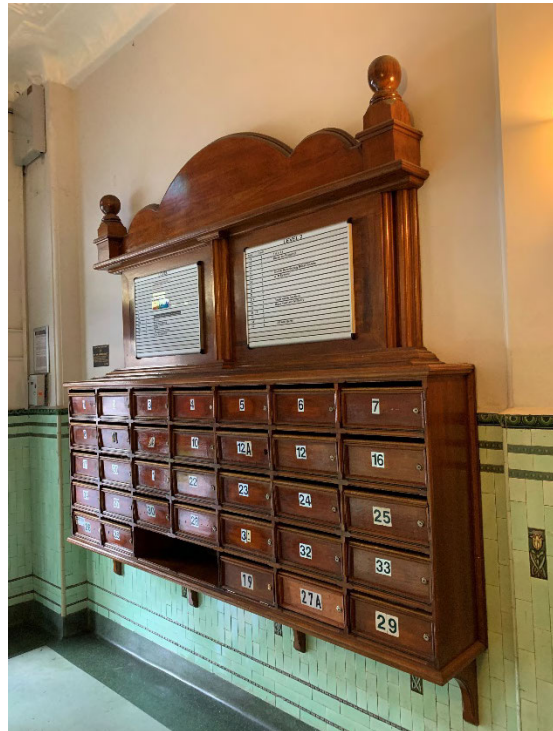
Figure 6 – View early tiles and timber letterboxes within entrance foyer of 94 Oxford Street.

The entrance foyer dates from the date of construction of the building and still retains all its interior finishes (terrazzo floor finish – probably dating from the Inter-war refurbishment), original Art Nouveau-pattern wall tiles forming a wainscot – dating from the construction of the building), and original decorative plaster ceilings. The length of the foyer is punctuated by engaged piers which contain (Monel?) metal fluted half-column supports to glass wall sconce light fittings (dating from the Inter-war refurbishment). At the Foley Street (north) end of the foyer the original lift and concrete stairs with timber newel posts and balustrade still remain.

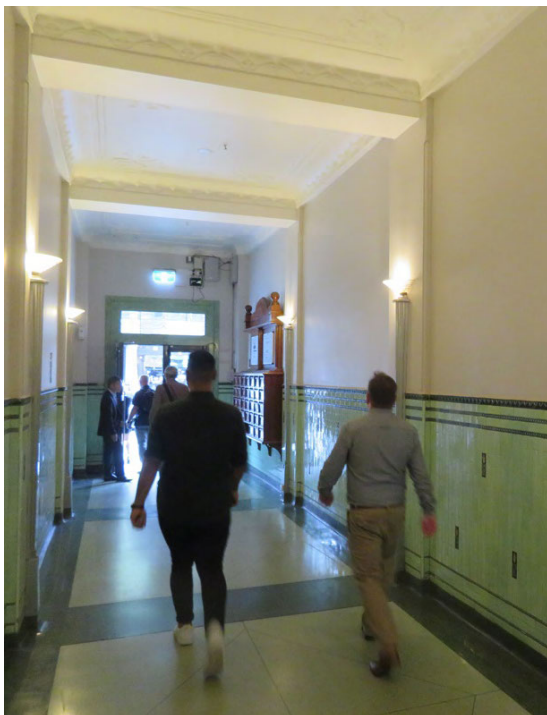
Figure 7 – View of entrance foyer at 94 Oxford Street showing tiled dado terrazzo floors pressed metal ceilings and Inter War lighting.

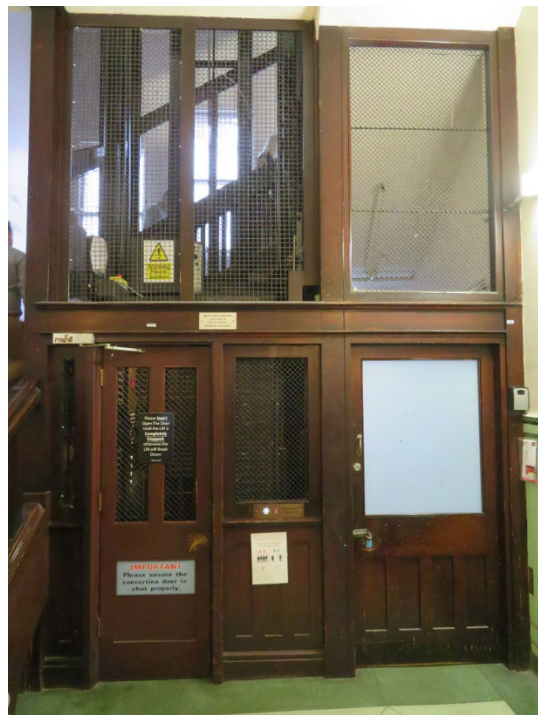
Figure 8 – View of lift and staircase at 94 Oxford Street.

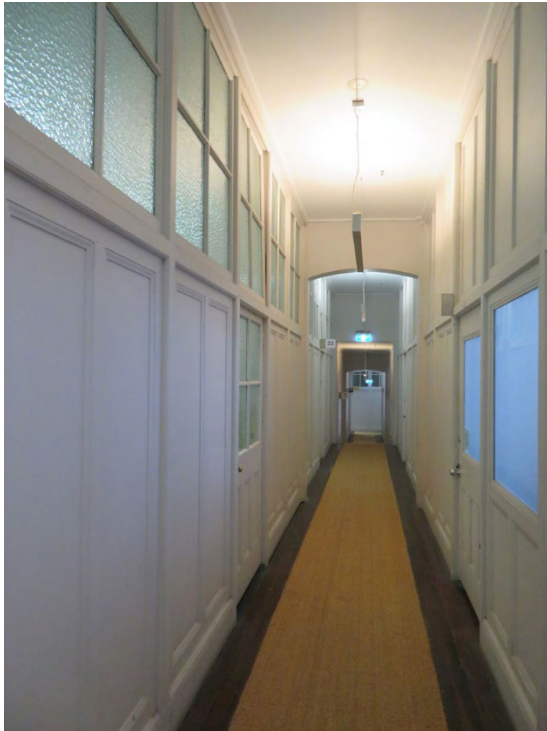
Figure 9 – View of typical corridor in upper floor of building.

The commercial office floors (first & second floors) are remarkably intact with their Kauri timber floor boards, pressed metal and decorative plaster ceilings, masonry dividing walls and Edwardian period timber partitions defining the corridor. The toilets also contain the original toilet cubicle walls and timber cubicle doors but the fixtures have been replaced with modern fixtures and the floor re-tiled in sympathetic modern tiling. The staircase rises up to the trafficable roof level and the stair can be fire-isolated by sliding fire doors which are either original or an early addition to the building.

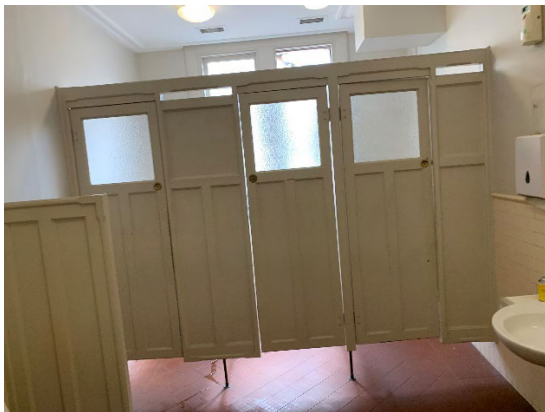
Figure 11 – Early bathroom partitions on second floor of 94 Oxford Street.

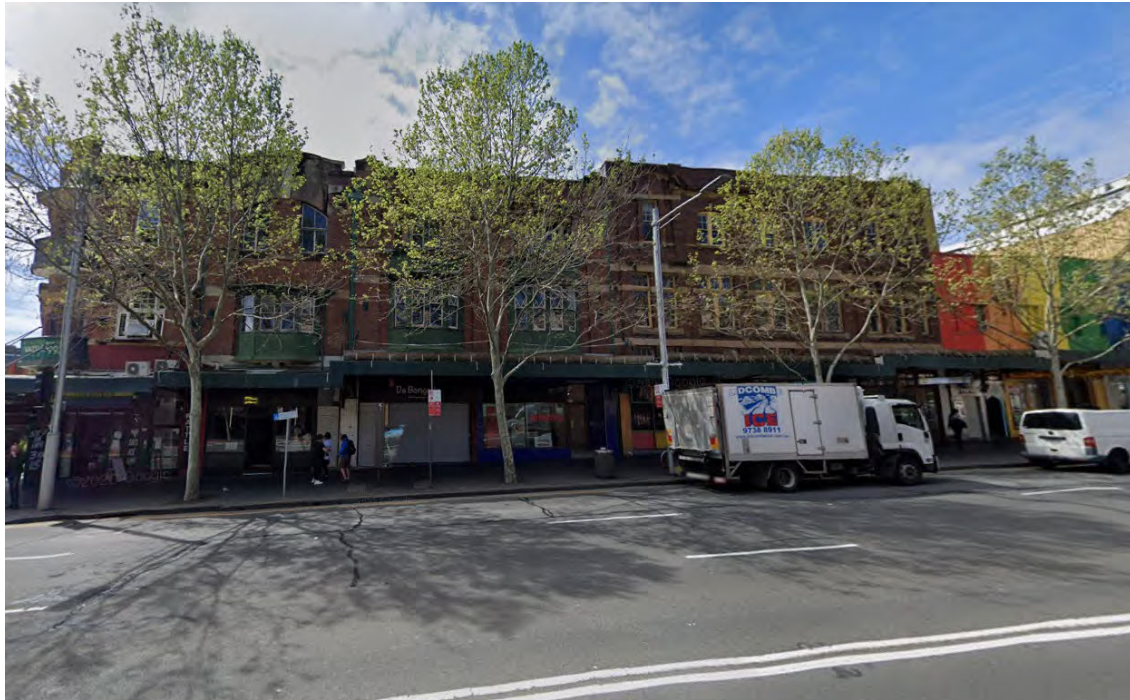
Figure 13 – View of Group 3 buildings (Source: Google Streetview).

Group 3 (110-122 Oxford Street) consists of three separate three-storey buildings with a fourth level at basement level opening onto Foley Street. All have retained early suspended footpath awnings that are original, although cut back by the City of Sydney in the 1960s and 2005.

Their Oxford Street facades are varied in detail but consistent in scale, materials and form. The facades are substantially intact, symmetrically composed and constructed out of face brick with sandstone dressings. These sections of the facades demonstrate several characteristics of the Federation Free Style, including decorative use of classical elements such as columns and pediments and different sizes and shapes of windows.
