For Asset Management And Sydney Water Corporation

DEVIATION OF THE TANK STREAM SEWER

33-35 Pitt Street, Sydney

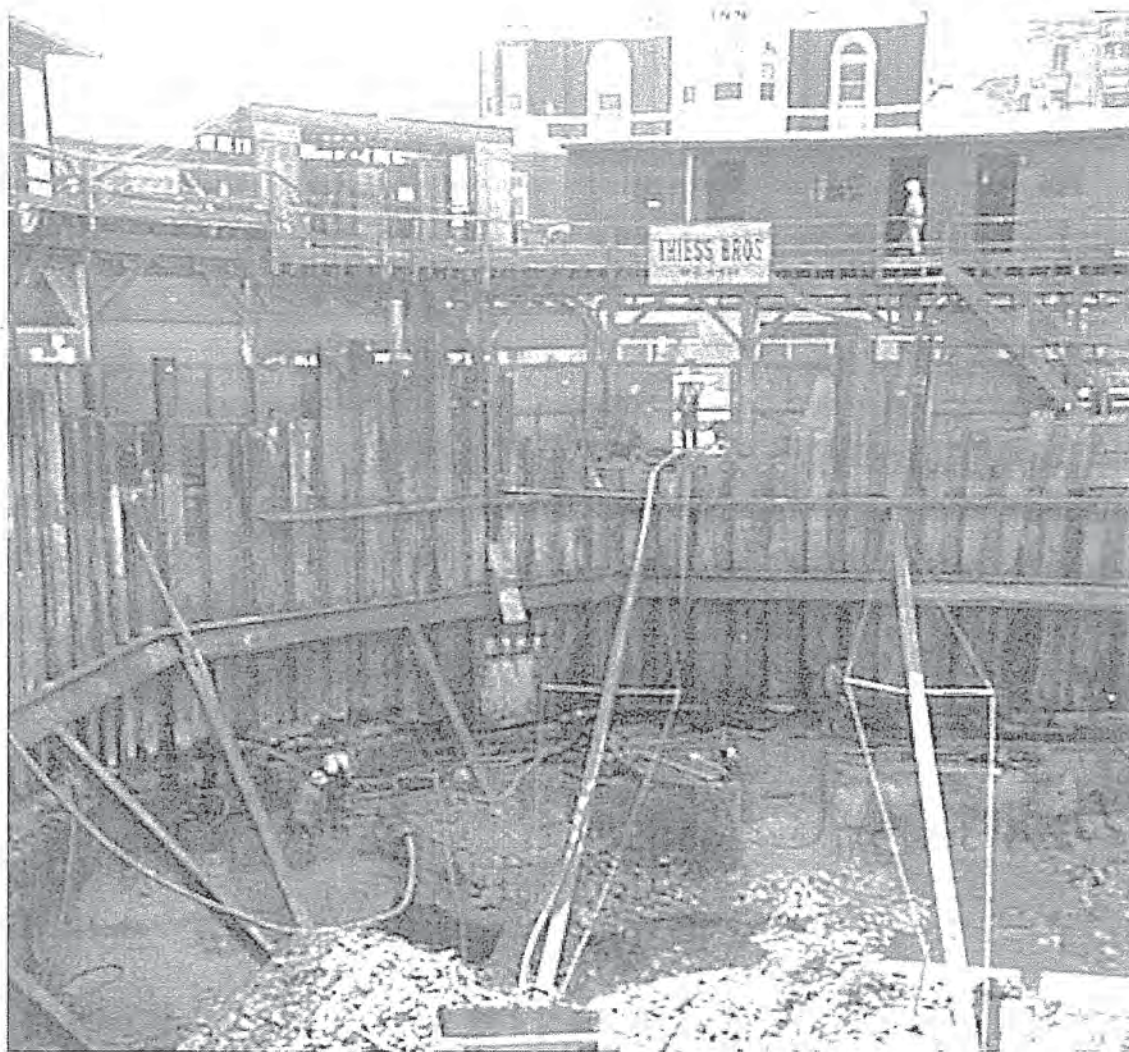
Figure 3.15: 1965 image showing the excavation and shoring for the below-ground levels of the Gold Fields House development. This view is looking east to Pitt Street, note the bystander on street level (beneath the Theiss sign). The tank stream is in Pitt Street behind the shoring. (Source: City of Sydney Council Archives)

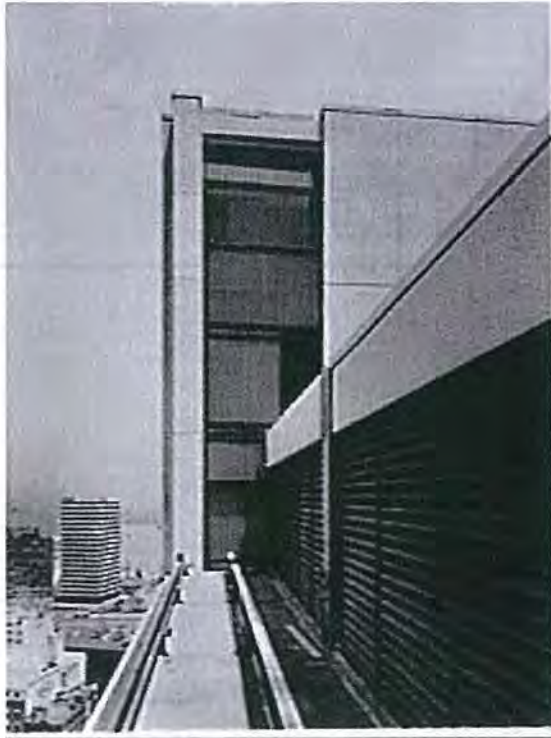
Figure 6.10 The modernist city, the air conditioning louvers on Gold Fields House demonstrating the new, sleek skyscraper design. (Source: City of Sydney Archives)

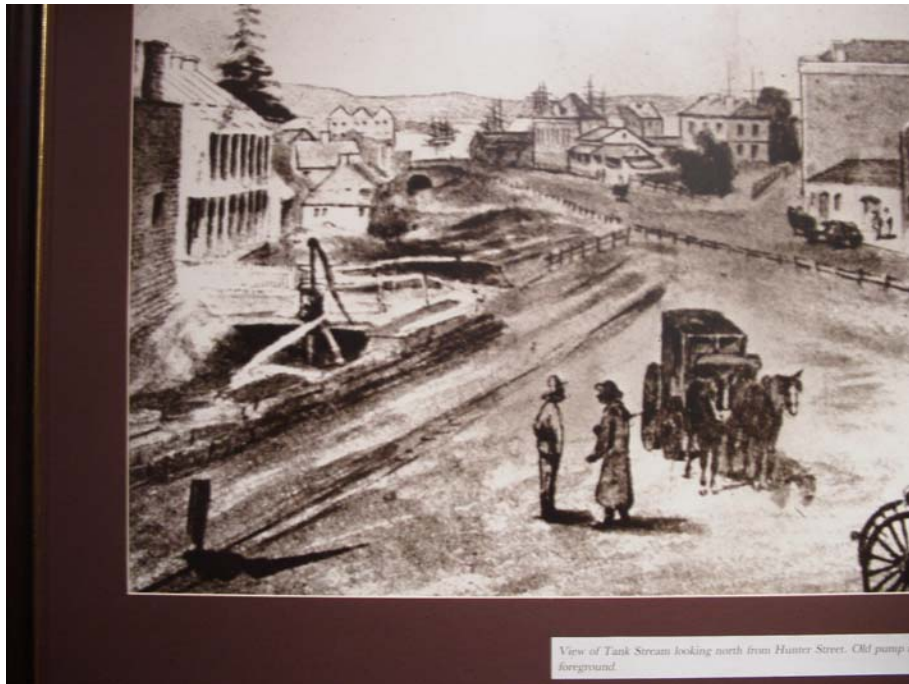
FIGURE 2-3 Unknown Artist – Detail of Illustration showing probable square water tank and pump

Governor Phillip was forced in 1791 to enclose the Tank Stream in a fence to keep stock out. This was as much to prevent trampling and muddying of the water as for hygiene. Ditches were cut alongside the stream, presumably to intercept dirty water that would otherwise pollute the water supply. These measures were *ad hoc* and ultimately ineffective. Tanks to store and hold water were cut into the bedrock near the present location of Australia Square in 1790. There were either three or four tanks, with sources not being definitive. An undated and unsourced drawing, probably c. 1850, is the only known illustration of one of the tanks (Figure 2-3). It shows a rectangular, possibly square, depression to the west of the junction of Pitt and Hunter Street. A large water pump stands on an indistinctly drawn assembly within the boundaries of the tank. The tanks are believed to have been about 5m deep and held 20,000 litres (GML 1996: 9).

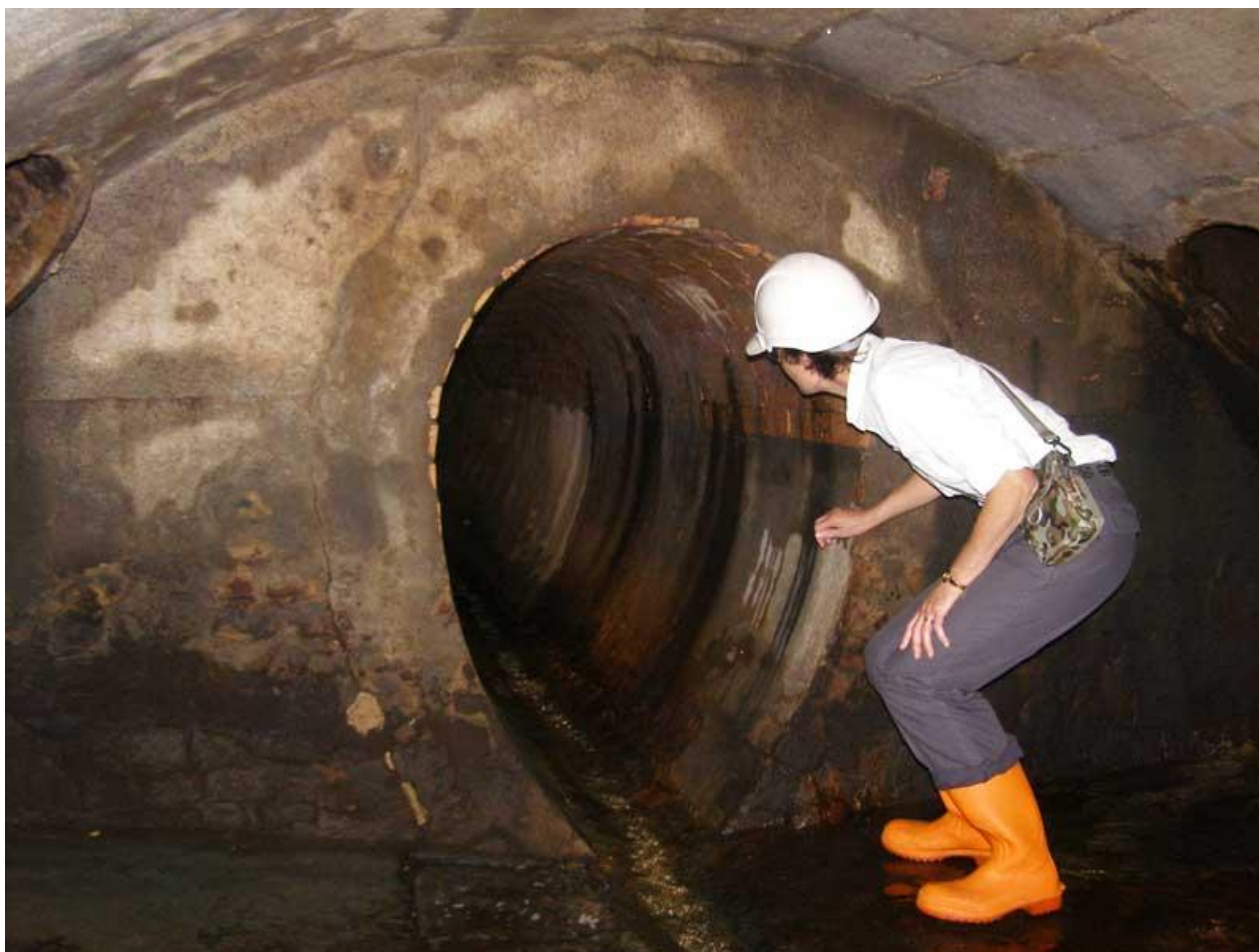
Figure 2.5: Section of brick oviform drain joining arched stone section of Tank Stream. Google

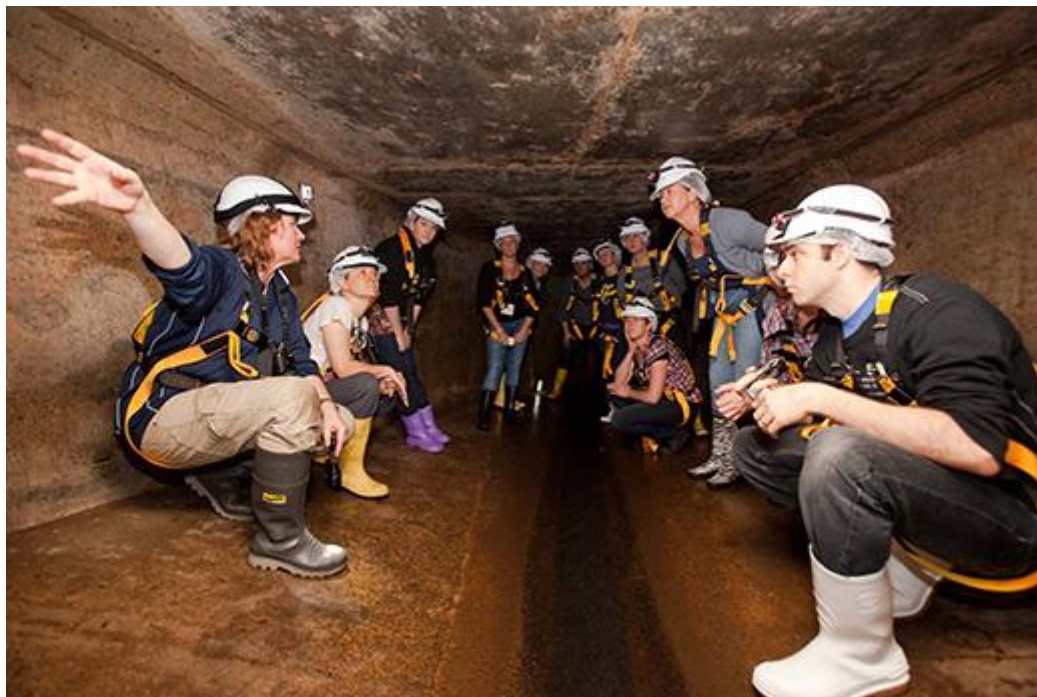
Figure 2.6: Section of Tank Stream with stone floor and flat roof. Google

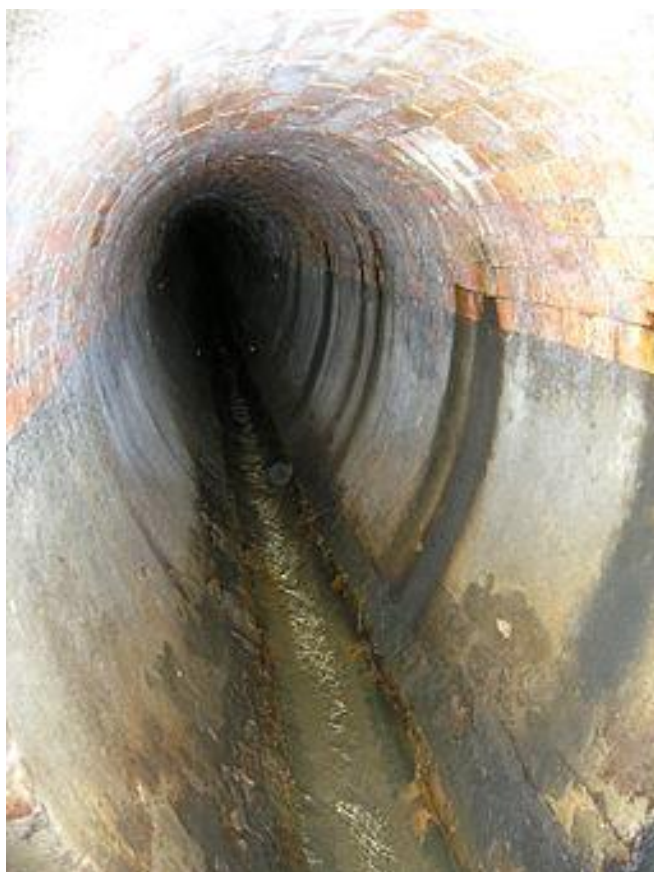
Figure 2.7: Brick oviform section of drain with rendered base and exposed brick upper part. Google

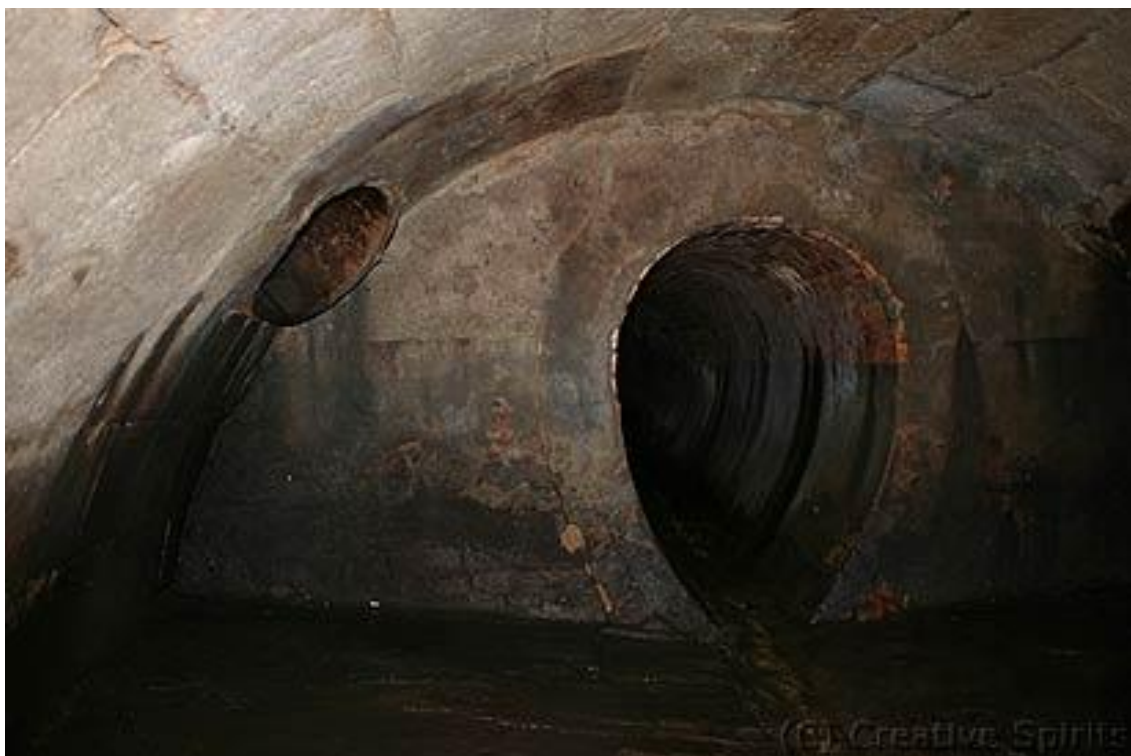
Figure 2.8: Section of brick oviform drain from arched stone section of Tank Stream. Google

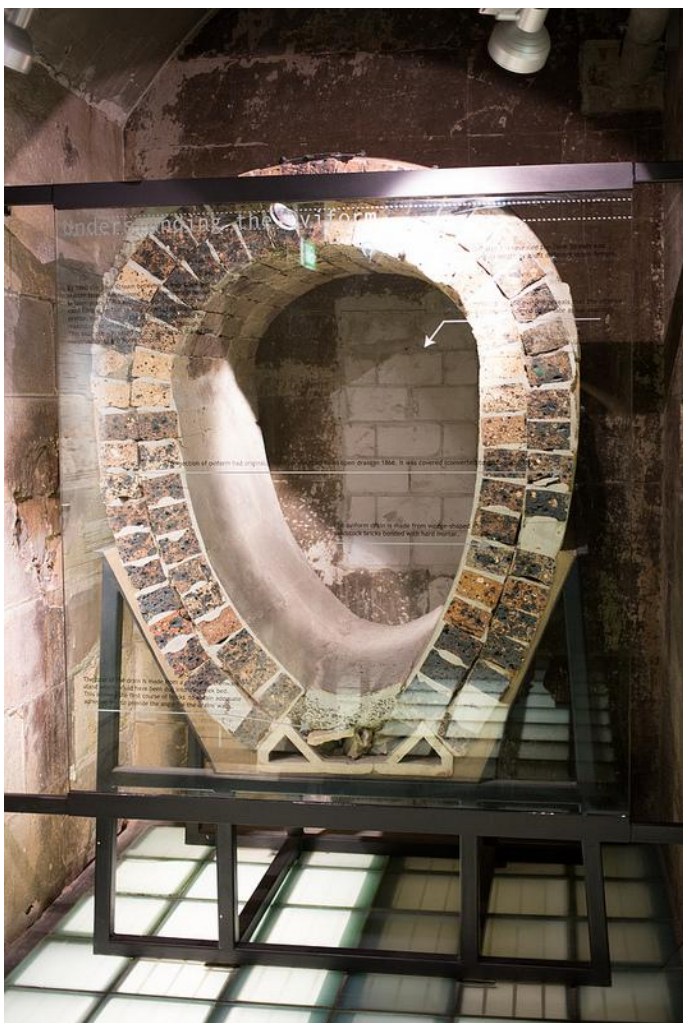
Figure 2.9: Section of oviform Tank Stream with teracotta base. This should be similar to the section in Pitt Street, adjacent to 33-35 Pitt Street. GPO Sydney
