**RUSHCUTTERS BAY CATCHMENT FLOOD  
STUDY (DRAFT REPORT)**

## RUSHCUTTERS BAY FLOOD STUDY

### FINAL DRAFT REPORT

JUNE 2013

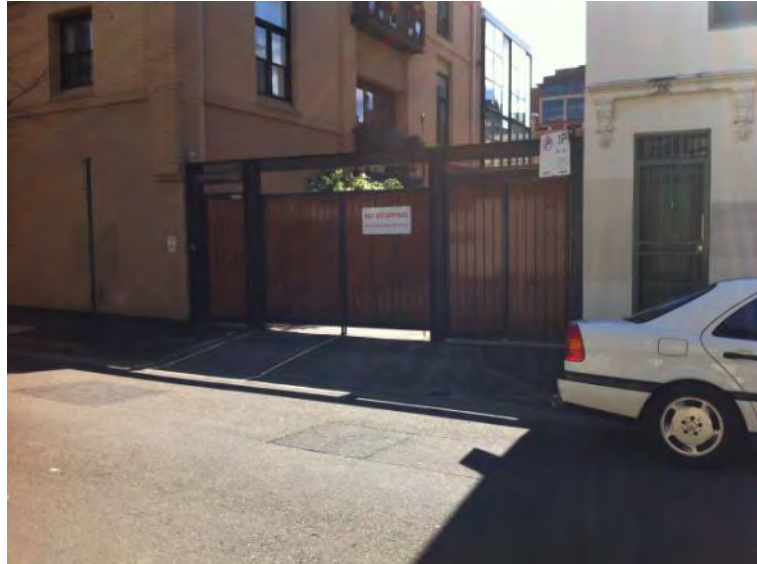
**Photo 1:** Flow path from Taylor Street to Sturt Street

the past with reported depths of greater than 1 m. The lowest available flow-path from Taylor Street to Sturt Street is through a property along Taylor Street. Photo 1 shows the existing fence with a gap underneath, however it is not known whether the same fence was in place in historic events. Given the difference in peak flood depths between Taylor Street and Sturt Street low points, it is quite likely that the flow-path through Taylor Street was historically more blocked (by fences/gates for example) than under current conditions, which would have increased flood levels within Taylor Street.

Properties within Sims, Taylor and Sturt Streets have experienced substantial road flooding in

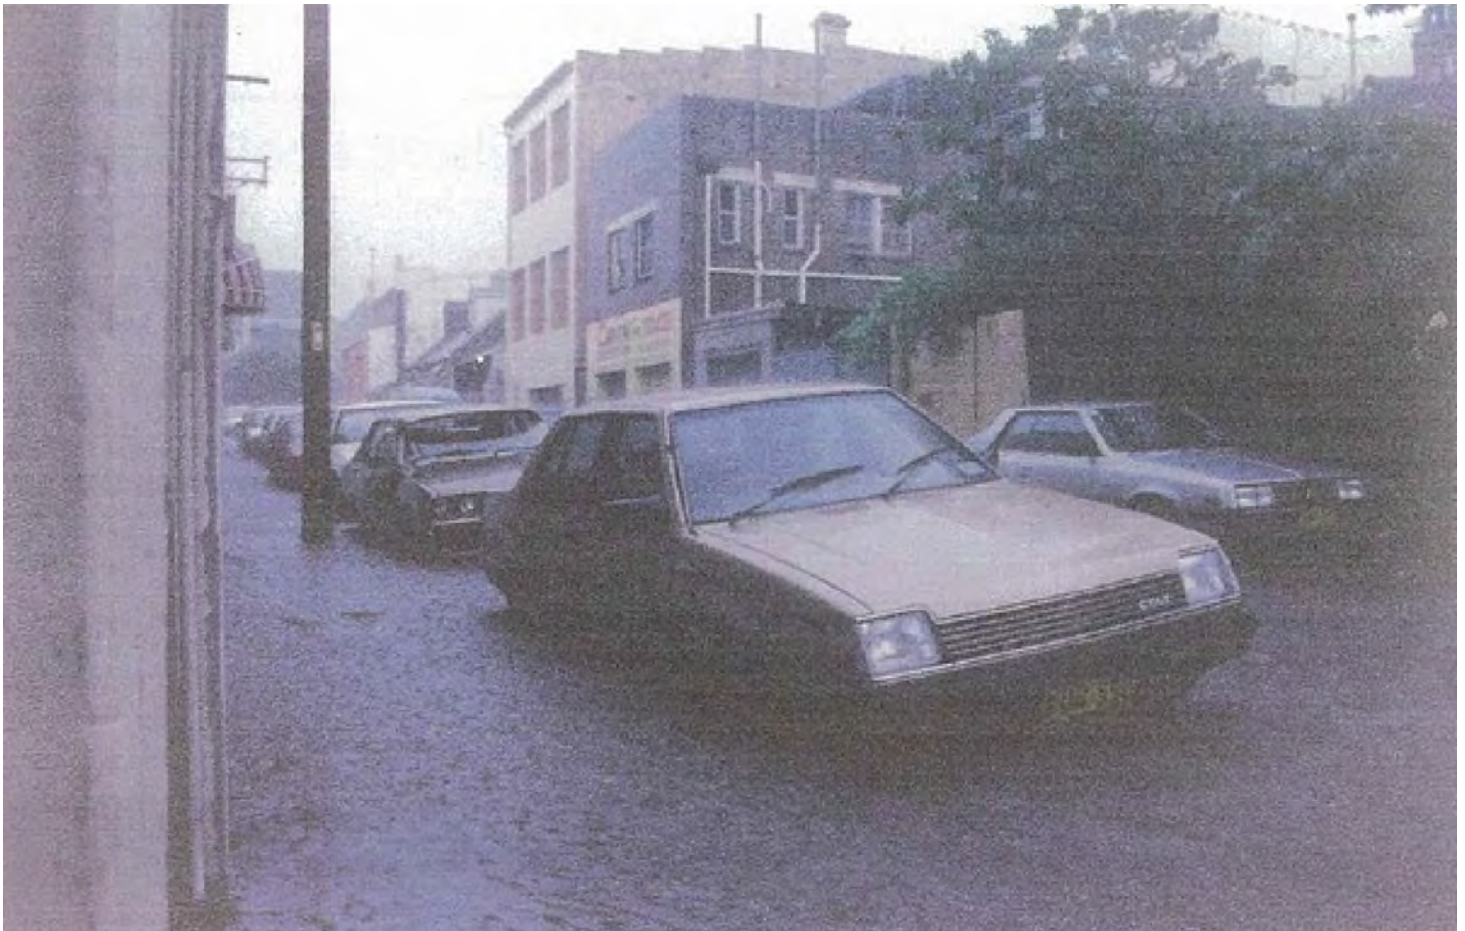
Flooding in Victoria Street, Paddington on January 6, 1989. This location is immediately outside the study area, though indicates the downstream flooding within the same catchment.
