## **Report on Dewatering Management Plan**

### **Proposed Mixed Use Development**

**41-49 Mountain Street, Ultimo NSW**

**Project 231957.02**

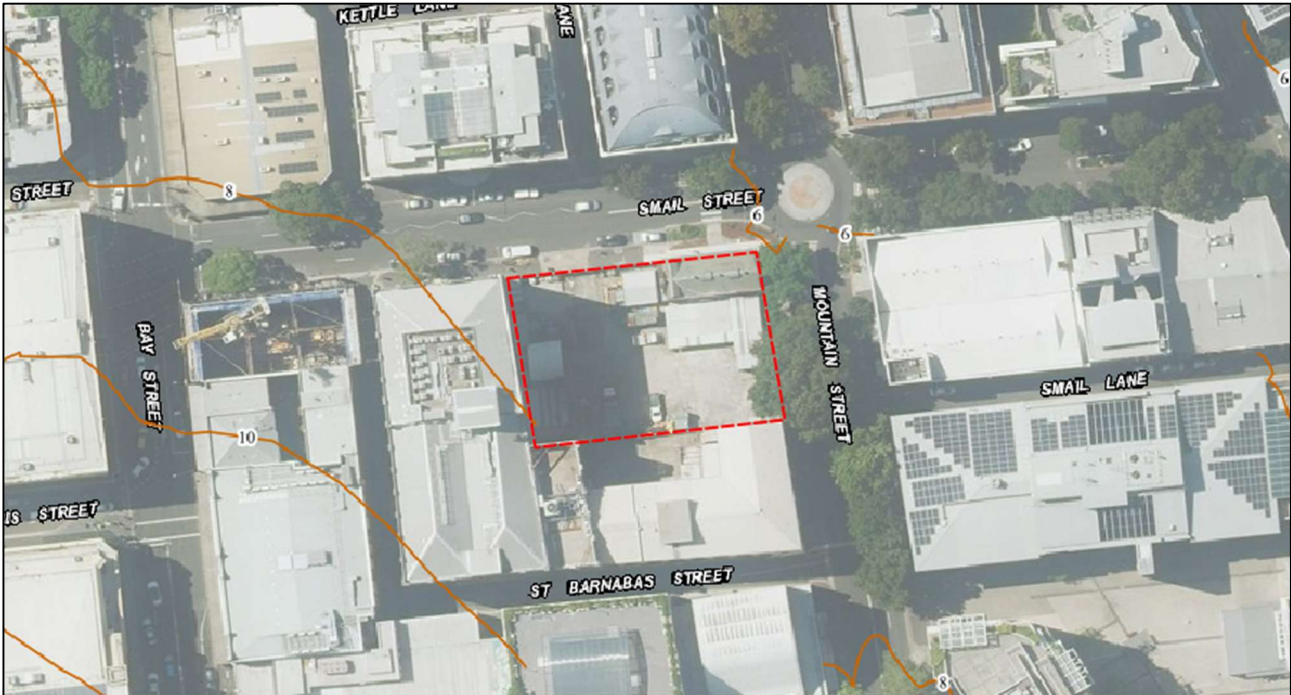
**Figure 1: Site location (highlighted with red boundary) with topographic contours**

RL 6 m AHD at the northeast boundary. The site boundary and topographic contour levels obtained from NSW government mapping service are shown in Figure 1.

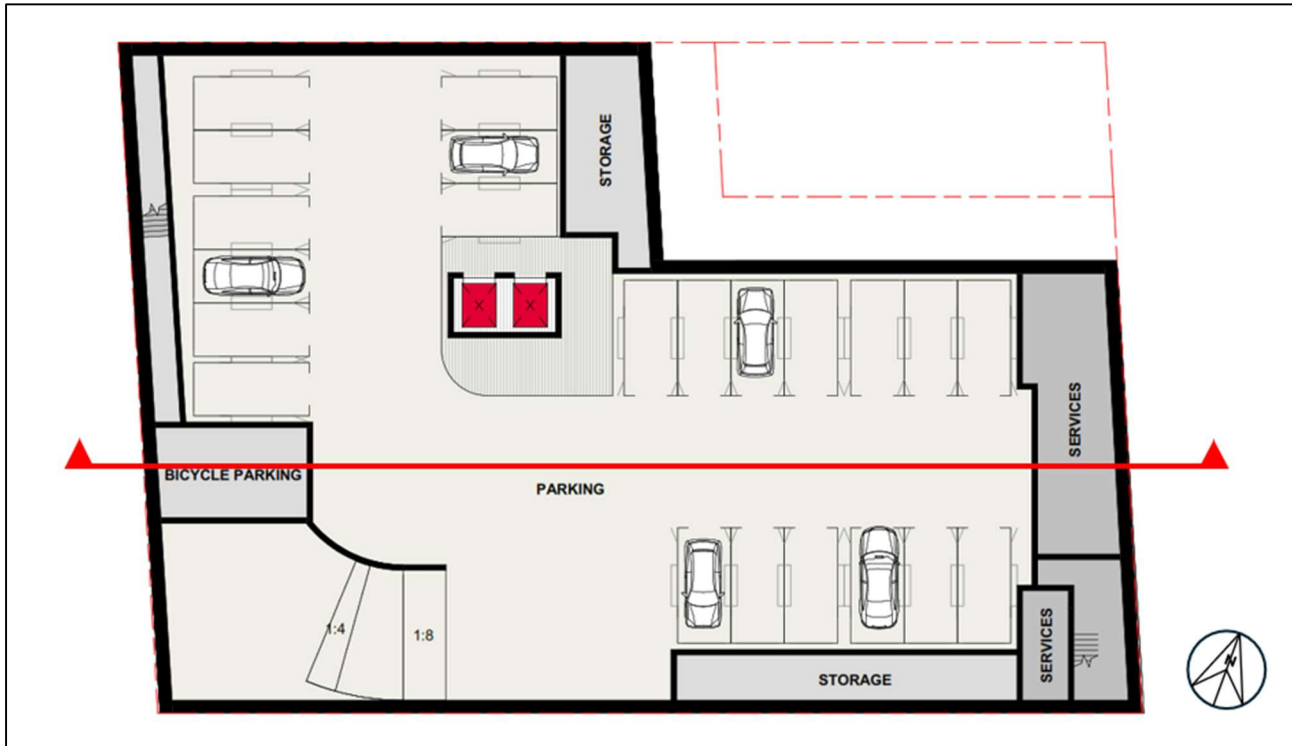
**Figure 2: Model geometry and cross-section for 2D modelling**

A cross section aligned in the west to east direction intercepting the basement footprint was selected to run the 2D analysis. The cross sections are presented in Figure 2.

The aquifer surrounding the proposed development was simulated as a two-layer numerical model to represent the subsurface conditions beneath the site and to allow simulation of the vertical flow components. The model boundaries were extended 100 m beyond the proposed excavation boundaries.

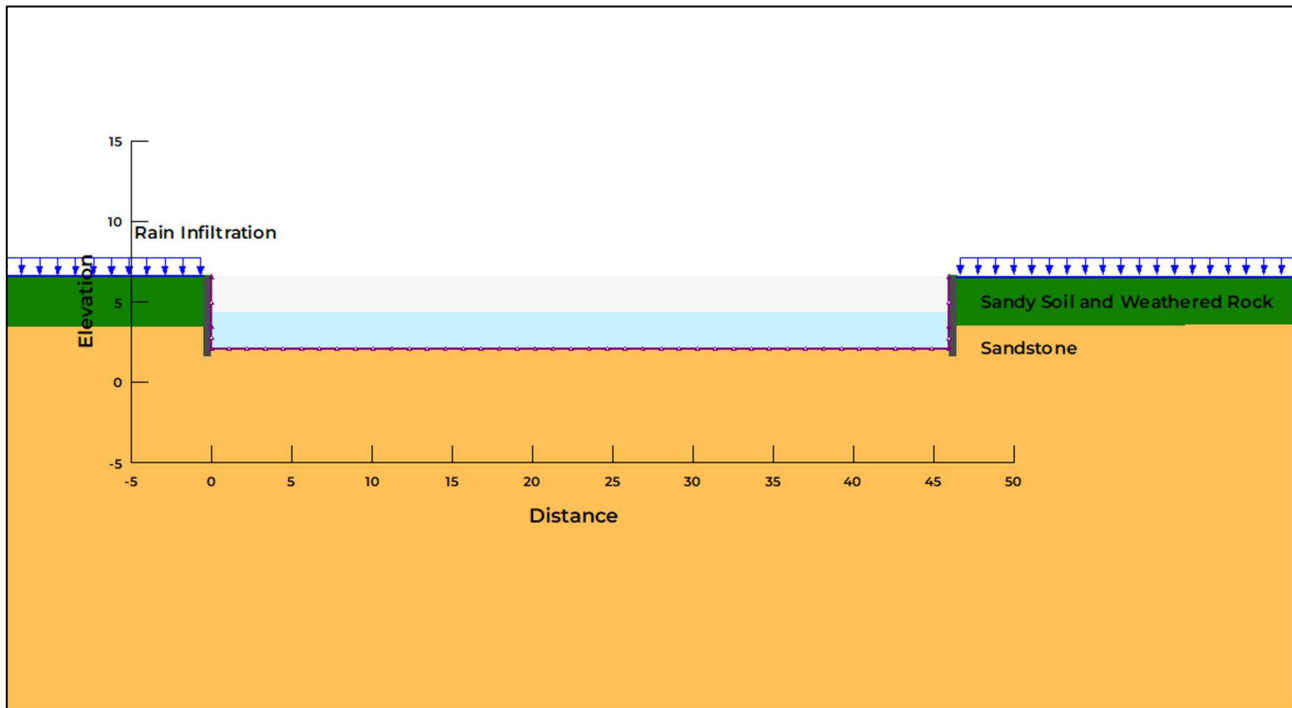
**Figure 3: Model set-up (Baseline Case)**

The lowest proposed finished floor level (FFL) of the basements is RL 2.6 m AHD. Douglas has assumed the bulk excavation level will be 0.5 m below FFL, at RL 2.1 m AHD.

It has been assumed that the construction dewatering will be required for one year for the proposed basement. The Baseline Case model set-up is presented in Figure 3.

To simulate the temporary dewatering required during construction, transient flow conditions were modelled in the analysis. For the purpose of the analysis, excavation was undertaken in a single stage (i.e., instantaneously) and the subsequent temporary dewatering period was assumed to be up to one year, subdivided into multiple time intervals.

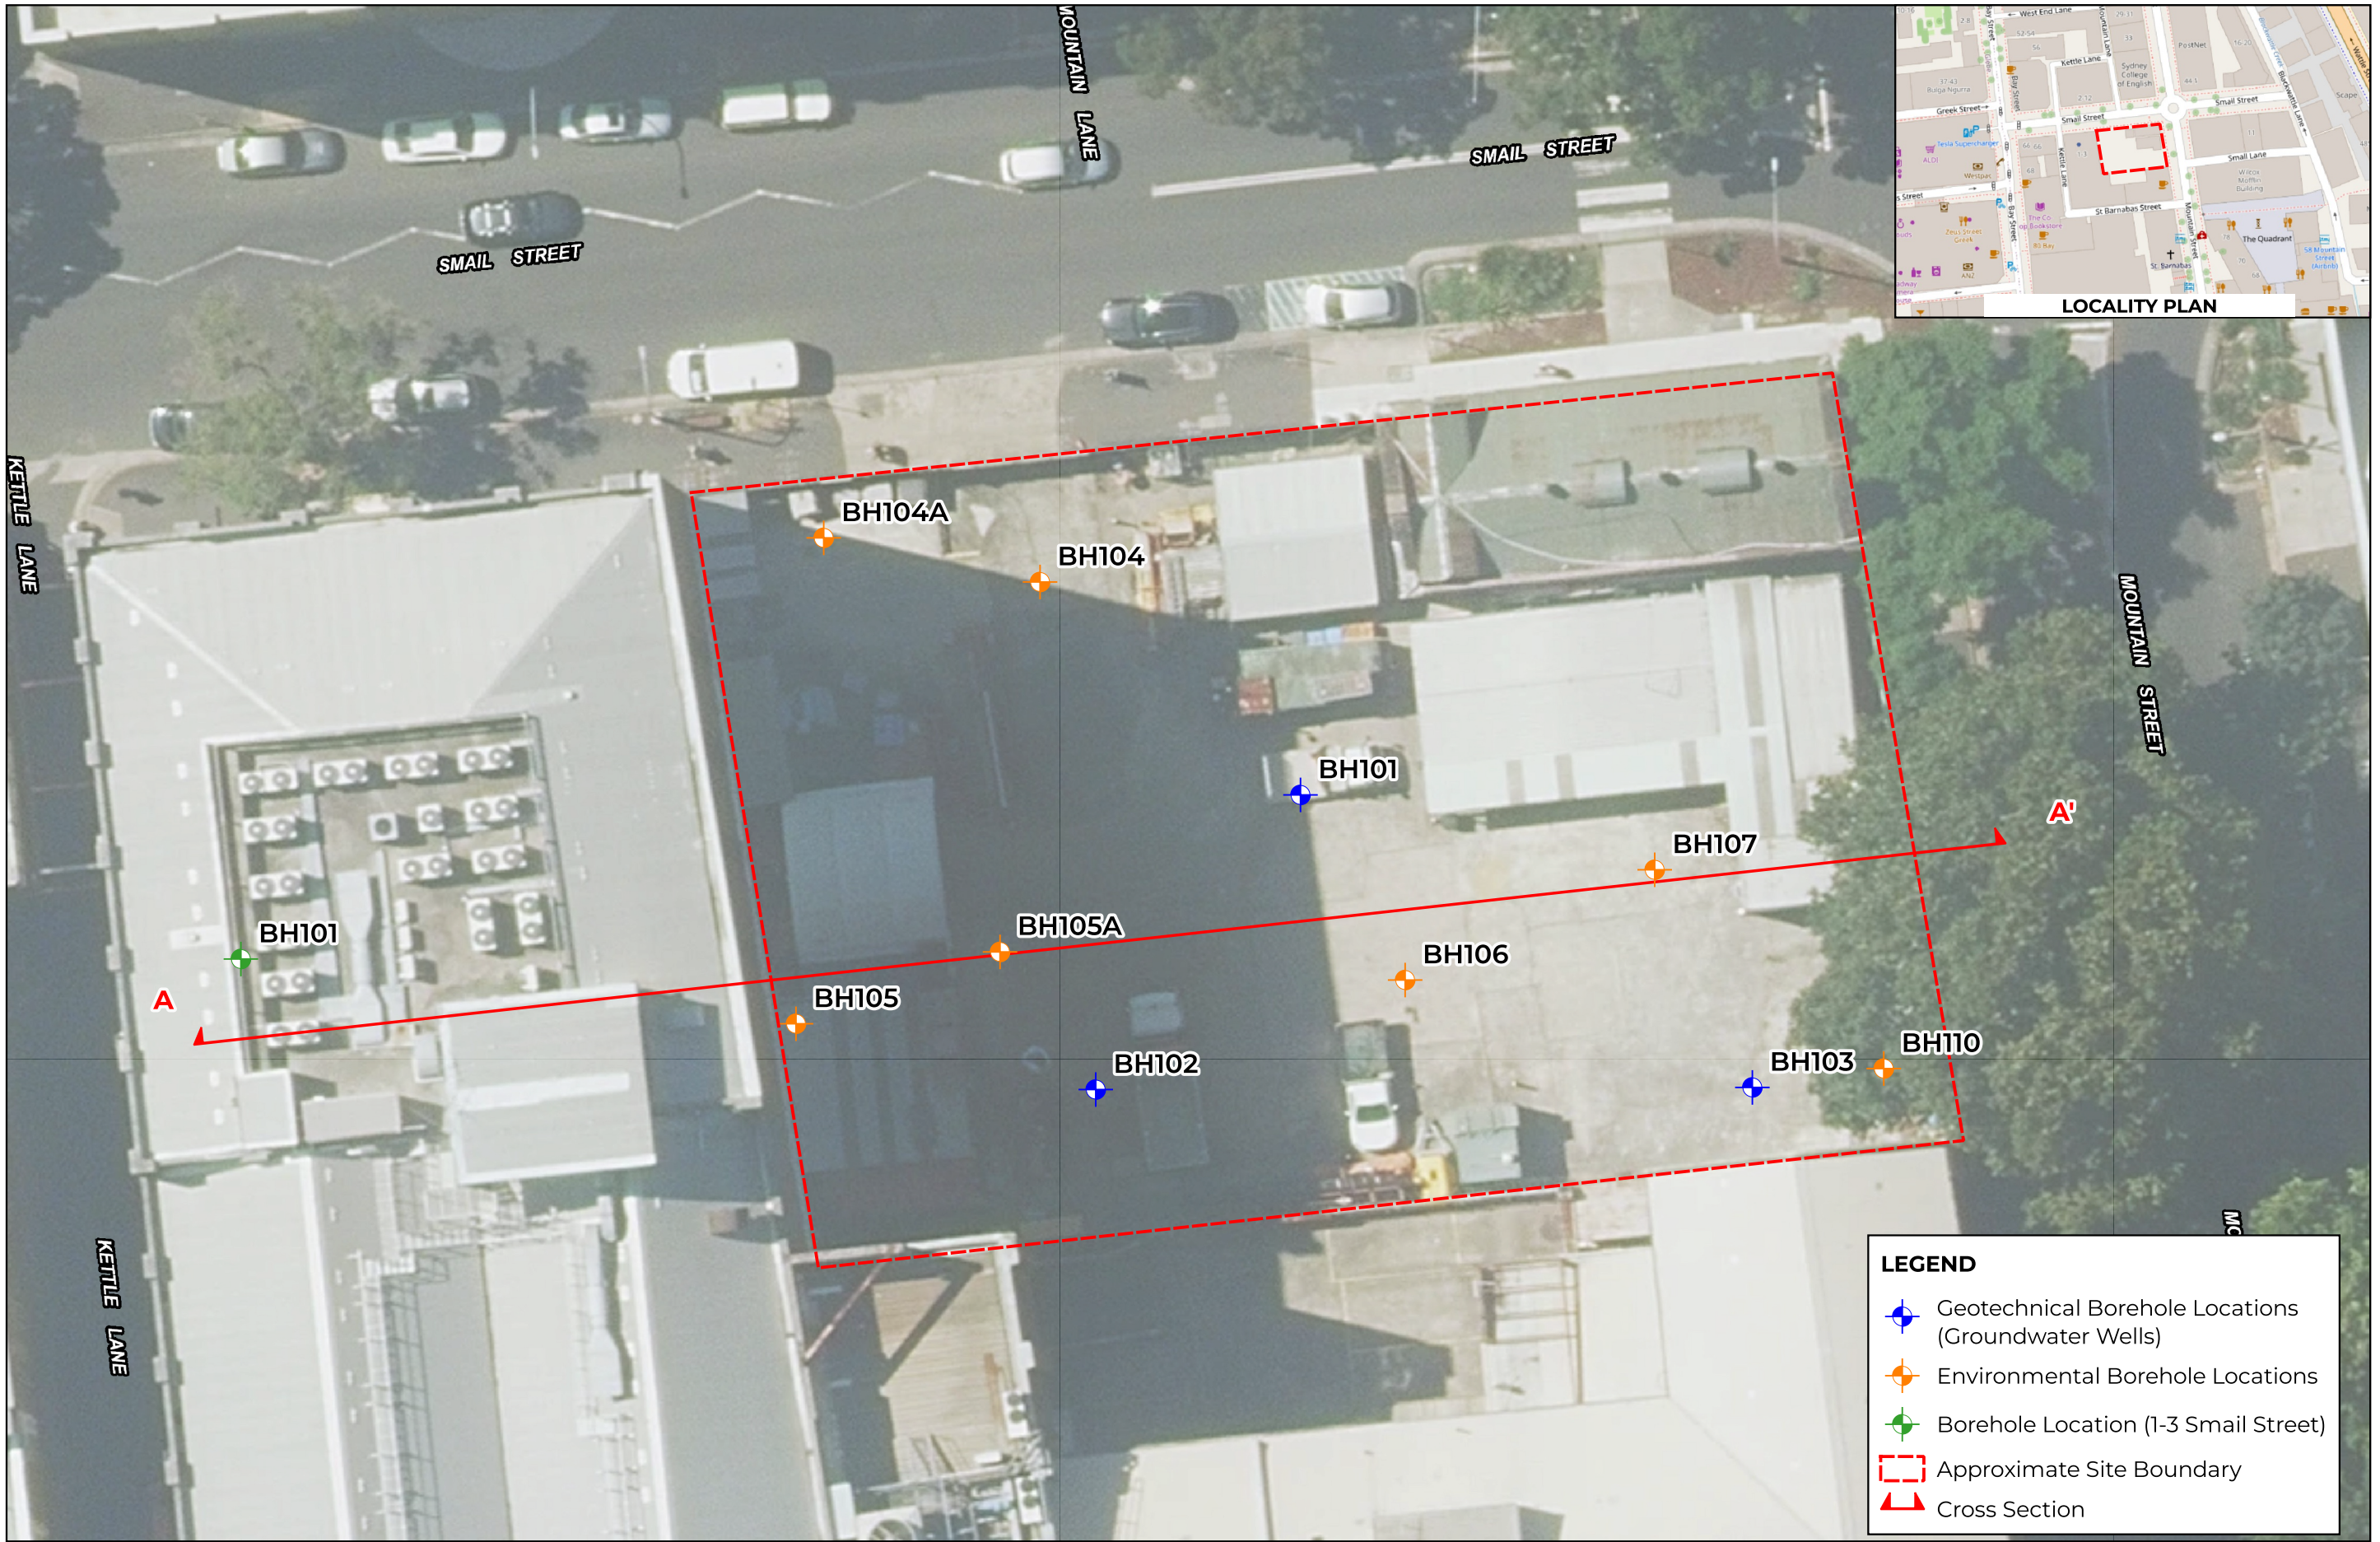
- Geotechnical Borehole Locations (Groundwater Wells)
- Environmental Borehole Locations
- Borehole Location (1-3 Smail Street)
- Approximate Site Boundary
- Cross Section

The geotechnical investigation identified that the site consists of sandy alluvial and residual soils underlain by low to medium strength Hawkesbury Sandstone. Interpreted geotechnical cross-sections are provided in Appendix B. Relatively shallow groundwater levels (between 2.5 m and 4 m below ground surface) have been observed in all boreholes.

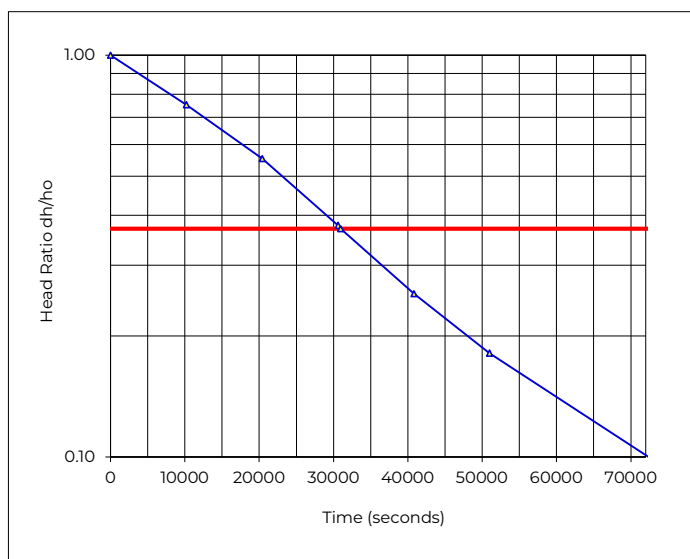
To = 516.0 mins  
30960 secs

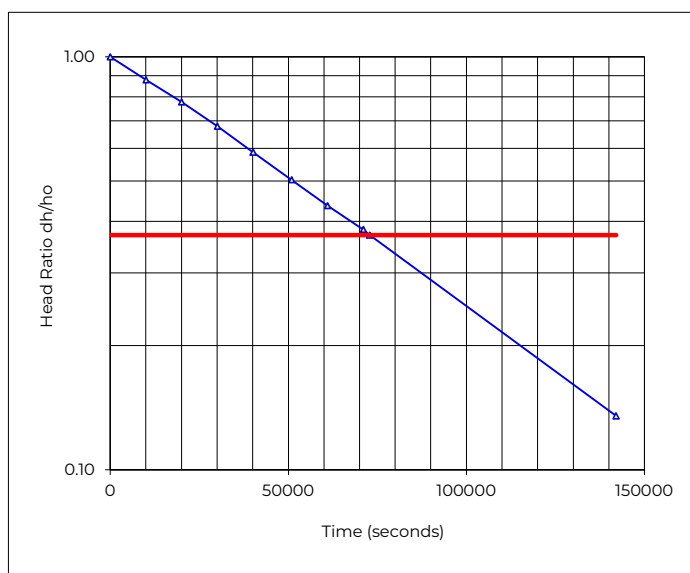
To = 1214.0 mins  
72840 secs
