Draft Heritage Inventory Sheet

Item name: Weatherboard Cottage**Location:** 46 Chisholm Street Darlinghurst 2010

Item name: Weatherboard Cottage

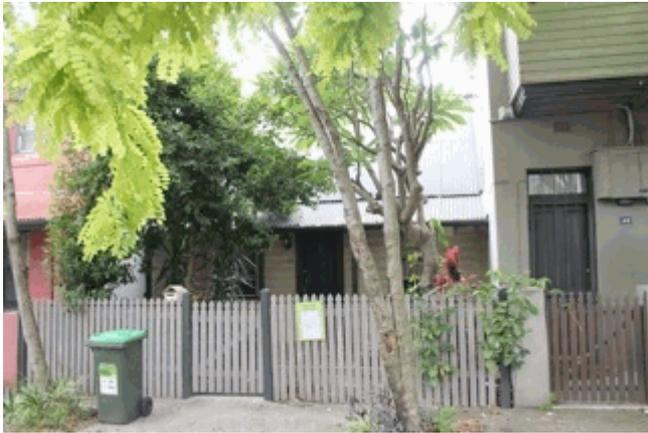
Caption: 46 Chisholm Street Front Elevation

Physical description: 46 Chisholm Street is a single storey, late Victorian cottage in the Georgian vernacular style set on a wide lot to the east side of the street. The house retains its original form and detail but has been modernised internally.

The house is in timber weatherboards (O) with a gabled, corrugated metal roof in short sheets (L). The original timber shingles (O) are extant under the later cladding. There is a verandah to the front with a skillion, corrugated metal roof supported on timber posts on metal stirrups (rebuilt). The verandah has no soffit lining. The cottage has a symmetrical front elevation with two pane, double hung, timber sashes (L) each side of a four panel, timber door and fanlight (Door L). Part of the original, timber internal lining is evident to the northern side of the front elevation where original boards have fallen away. There is a narrow skillion wing to the rear in chamfered timber weatherboards with a corrugated metal roof (L).

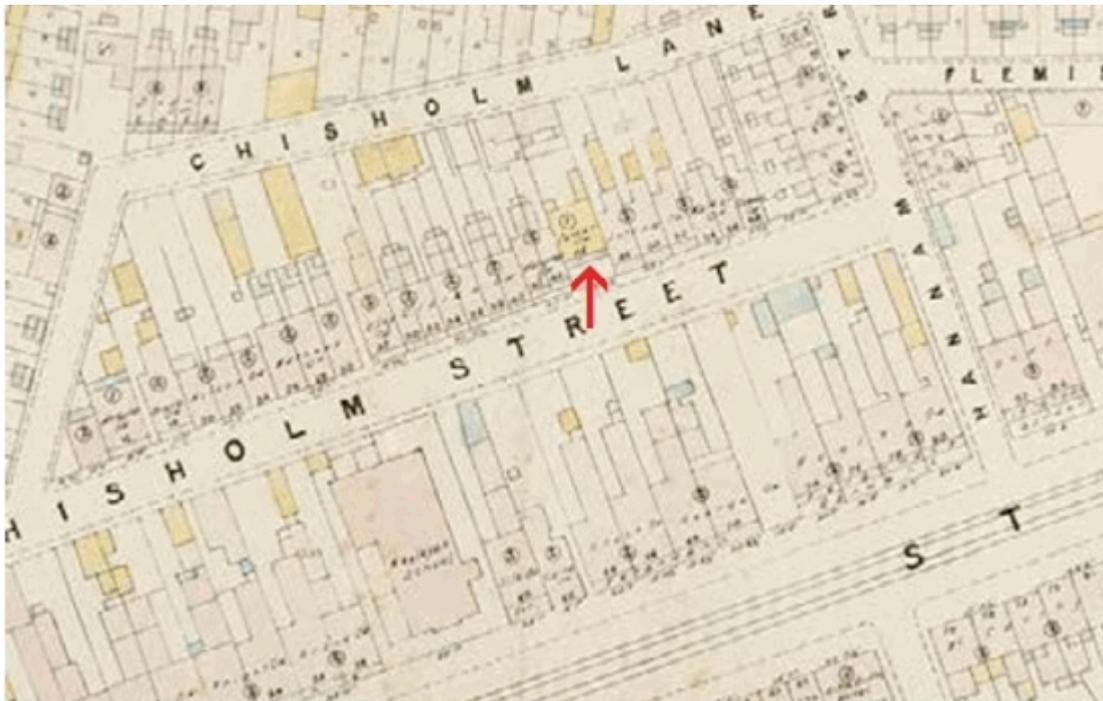
Caption: Detail of Rygate and West's plan of Sydney c. 1888 Sheet 30

Criteria f): The single storey, weatherboard cottage type is uncommon in the area that largely comprised two storey, masonry terraces. In the plan of 1888 (Figure 2.1) only five, one storey timber cottage are shown in the area and the subject cottage is now the only weatherboard house in the former Chisholm Estate subdivision and dates from the earliest building period for the area.
