# Assessment of View Sharing

**10 Onslow Avenue  
Elizabeth Bay**

**Proposal:  
Alterations & Additions  
Residential Flat Building**

**DA-A ISS.**

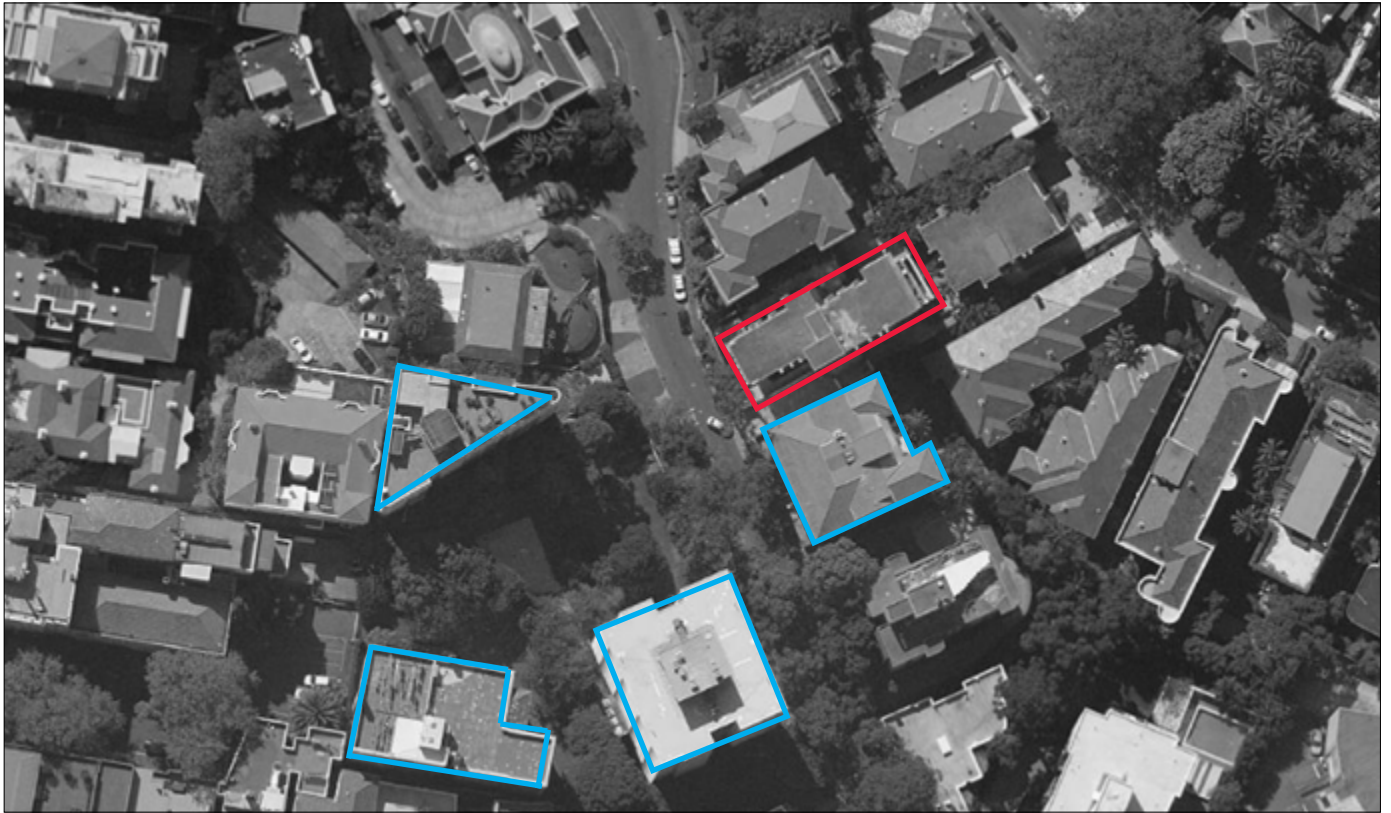
The development site (in red with arrow) and all sites assessed in this report as part of the view sharing analysis (in blue)

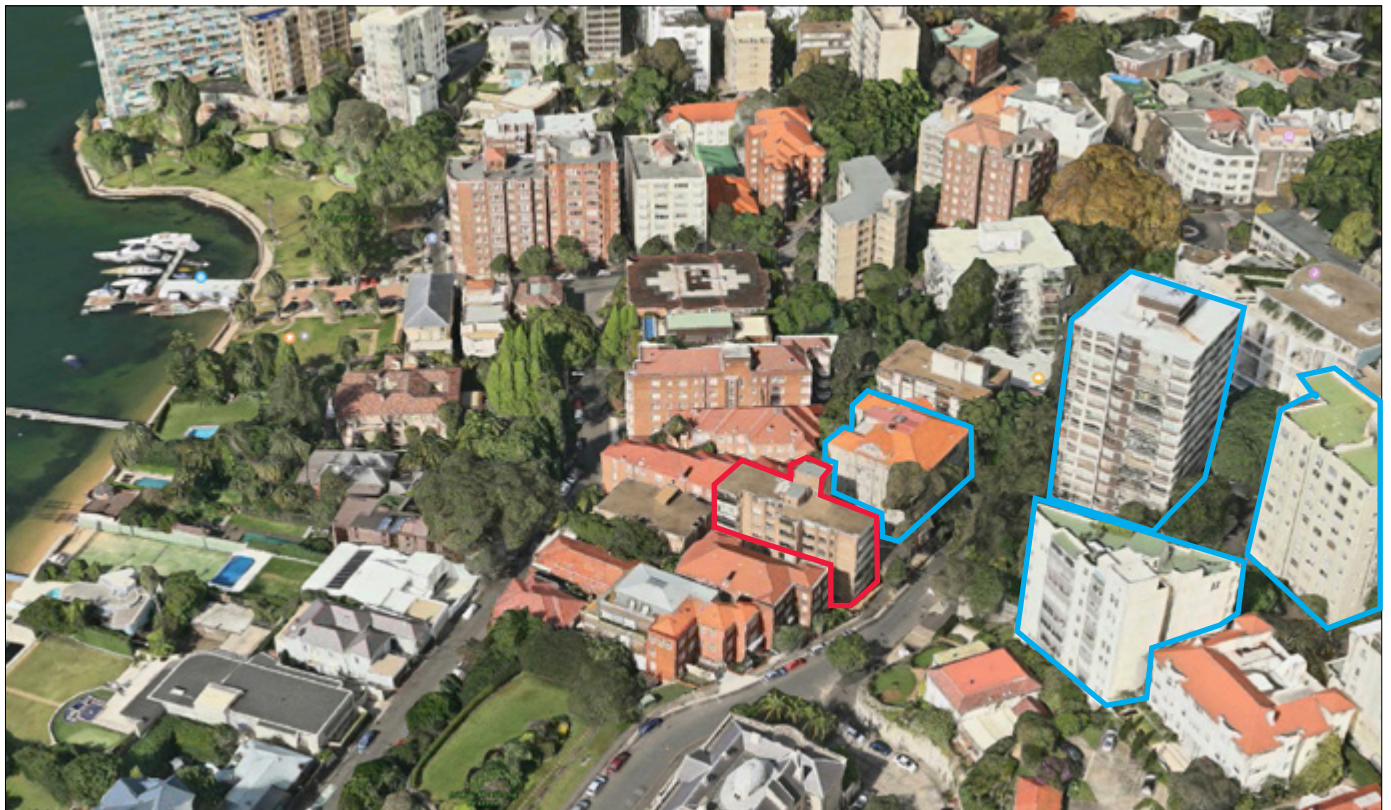
3D Map of the Locality (Digital Enhancement) - Source: APPLE Maps | Subject Development Site in RED and Analysed Properties in BLUE

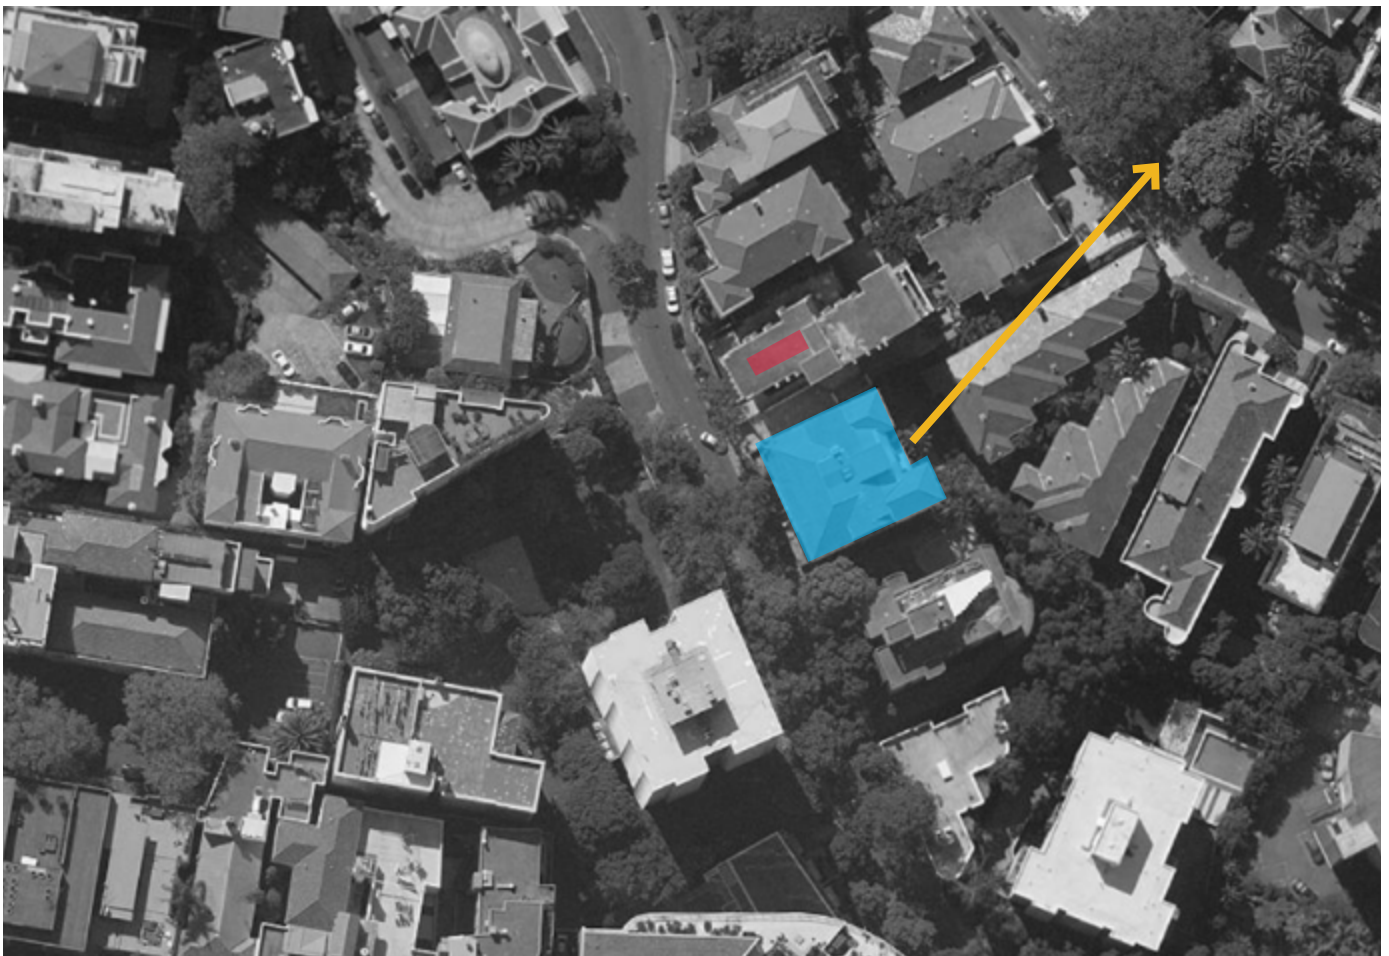
The analysed subject site (in Blue) which may be affected by the proposed development site (in Red) and key view corridors (in yellow)

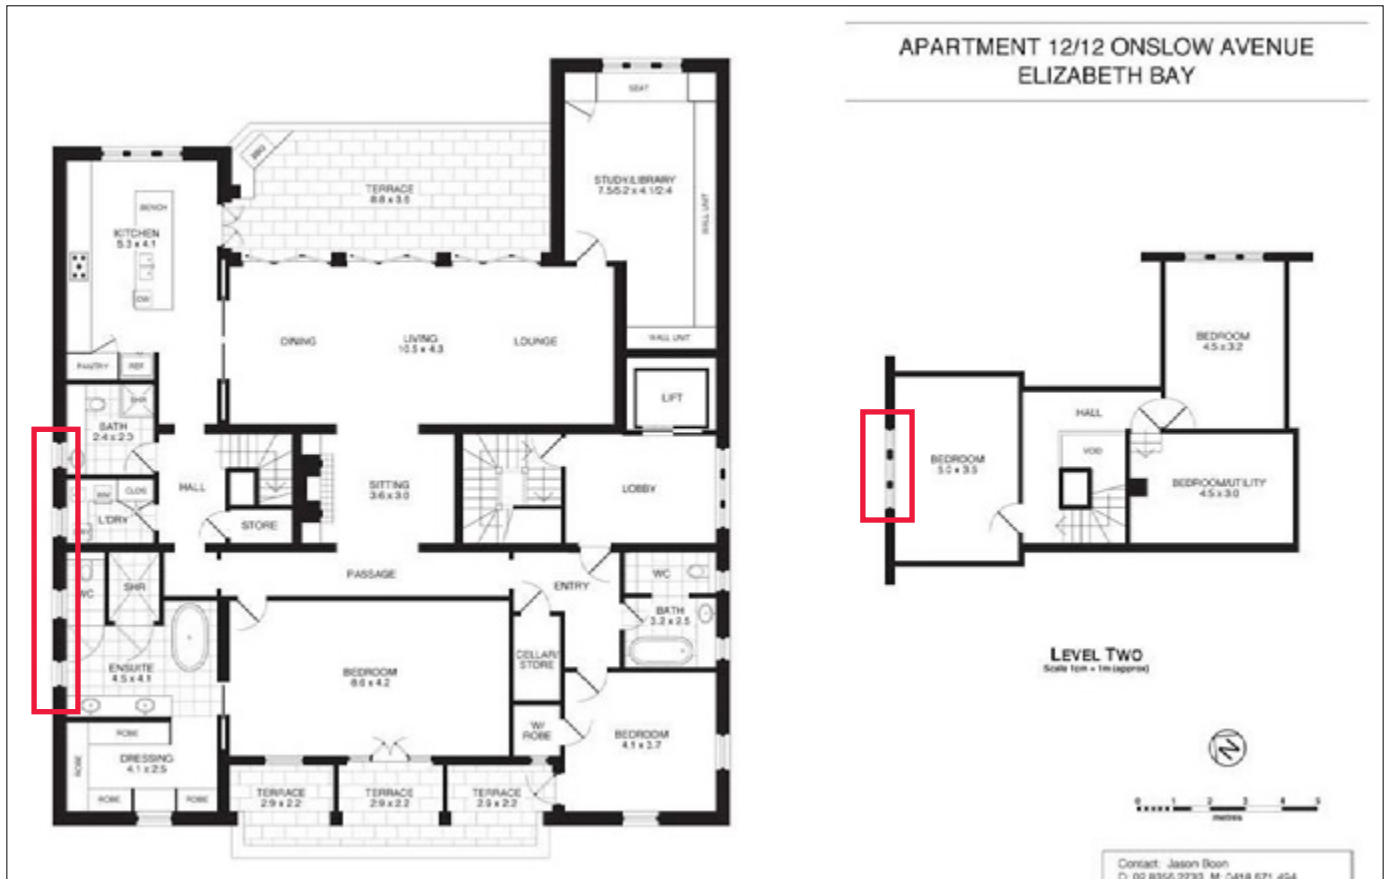
Floor plan of the unit. Relevant facade areas from the unit from which there are potentially significant views are highlighted in RED.

It is noted that the windows which face North and which abut the subject development site (No. 10 Onslow Ave) are all secondary windows and openings to laundry rooms and bathrooms. As such, they are not affected by the proposed development.

It is also noted that the primary view is not enjoyed from this direction (North) but rather from the rear boundary (East) of No. 12 Onslow Avenue.

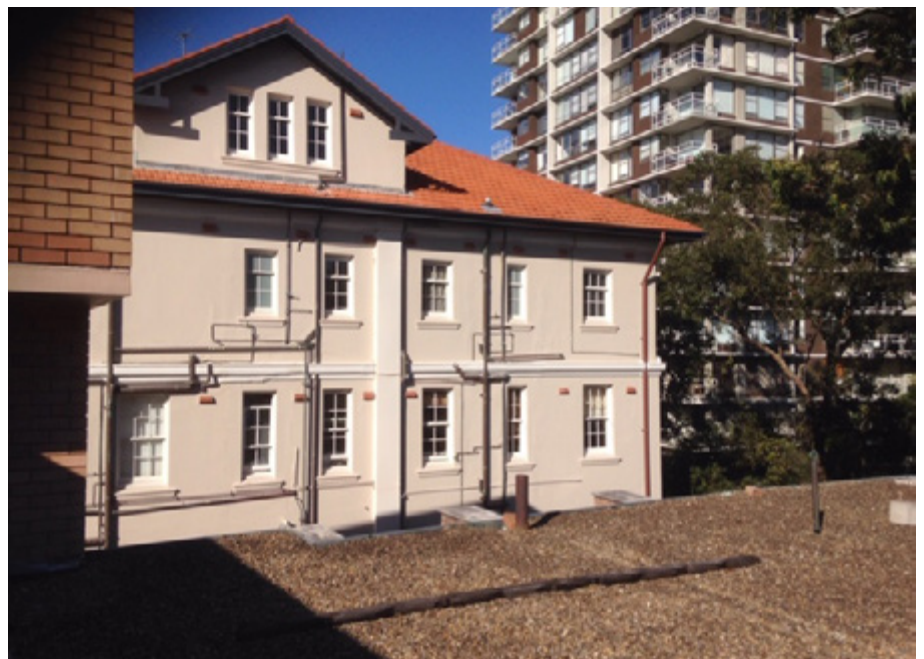
The image to the right taken from No. 10 Onslow Avenue roof indicates the location of existing windows which are identified in the floor plan as secondary windows to bathroom areas and laundries. As such, some windows are also opaque glass panels and will therefore not be affected by the proposed development.

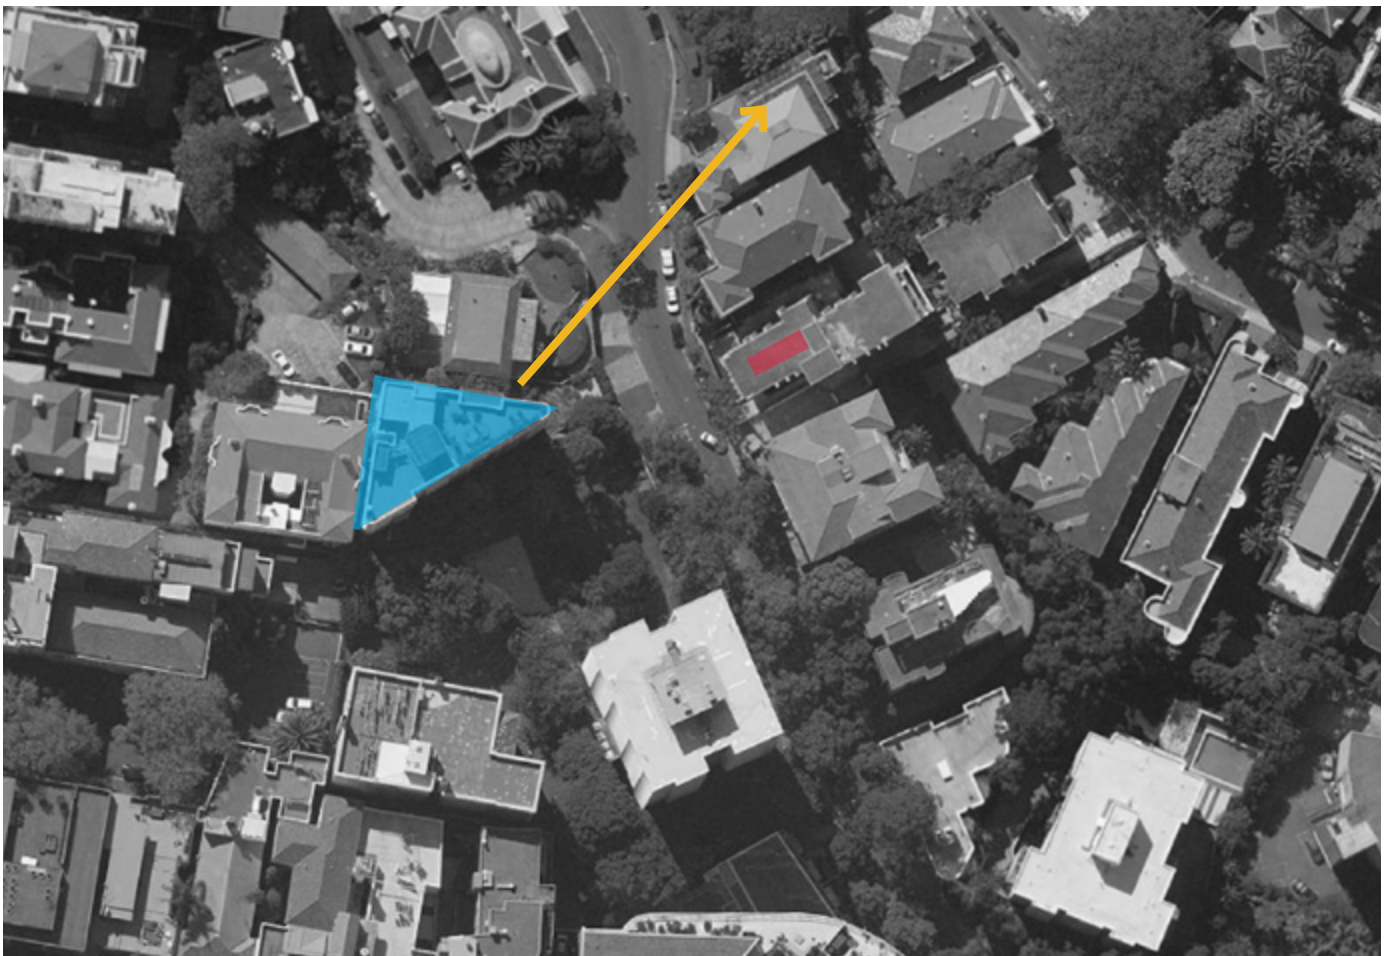
The analysed subject site (in Blue) which may be affected by the proposed development site (in Red) and key view corridors (in yellow)

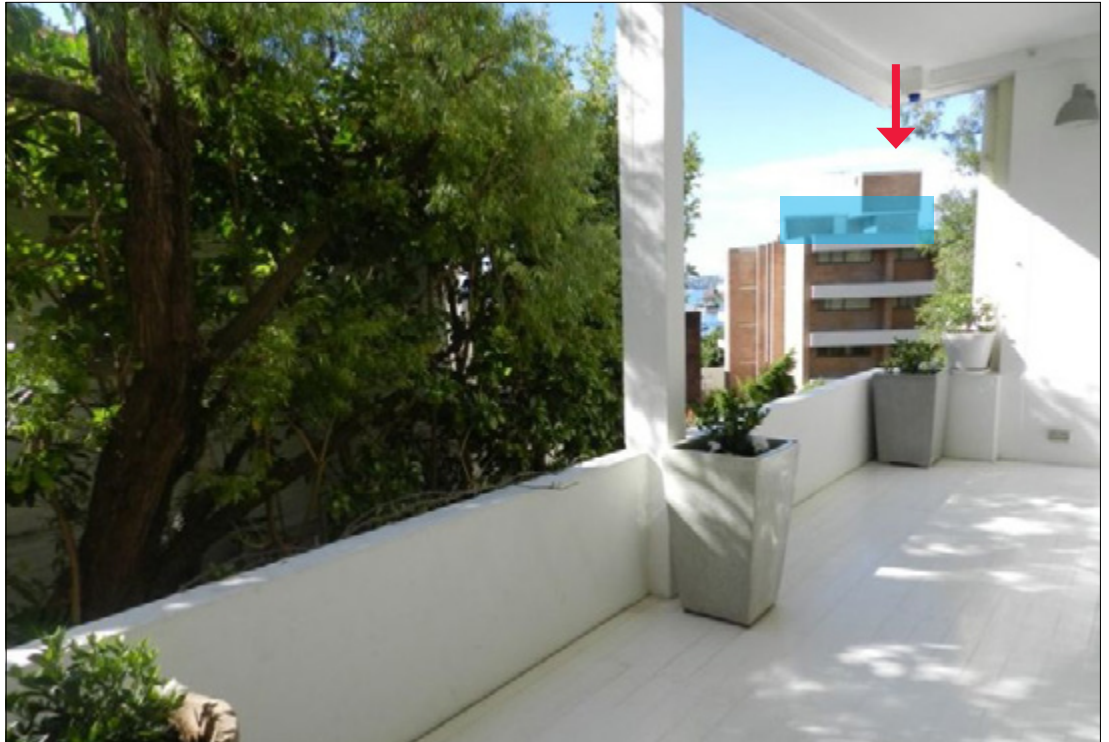
The terrace view of No. 2/13 Onslow Avenue. It is noted that the view is obstructed by foliage and that the proposed development is not visible as the orientation is to the East side of the neighbour.

This image also demonstrates that the view enjoyed by the neighbouring property is not visible from the terrace, but enjoyed from existing windows inside the living area. (See Image 02 Below)

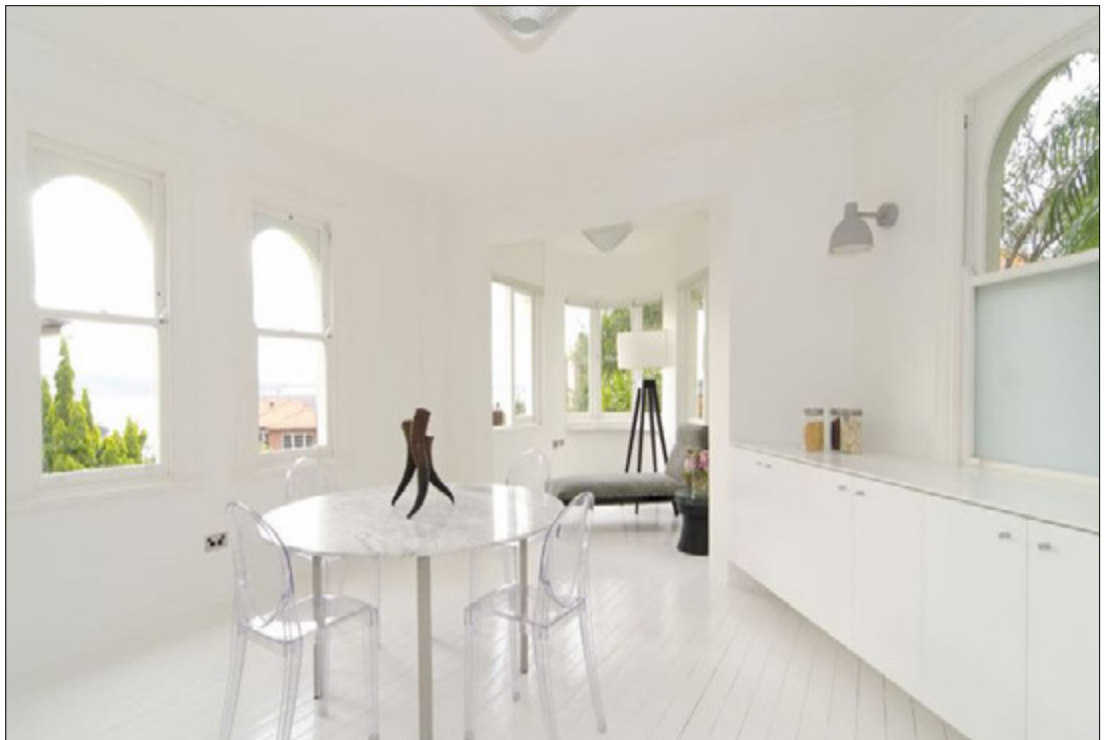
#### IMAGE 02

A marketing image depicting the view from the living room views towards Elizabeth Bay, partially obstructed by trees. The view is not in any way obstructed by the proposed development. The view is clearly enjoyed by multiple windows at the property and a majority of these windows will not be affected by the proposed development.

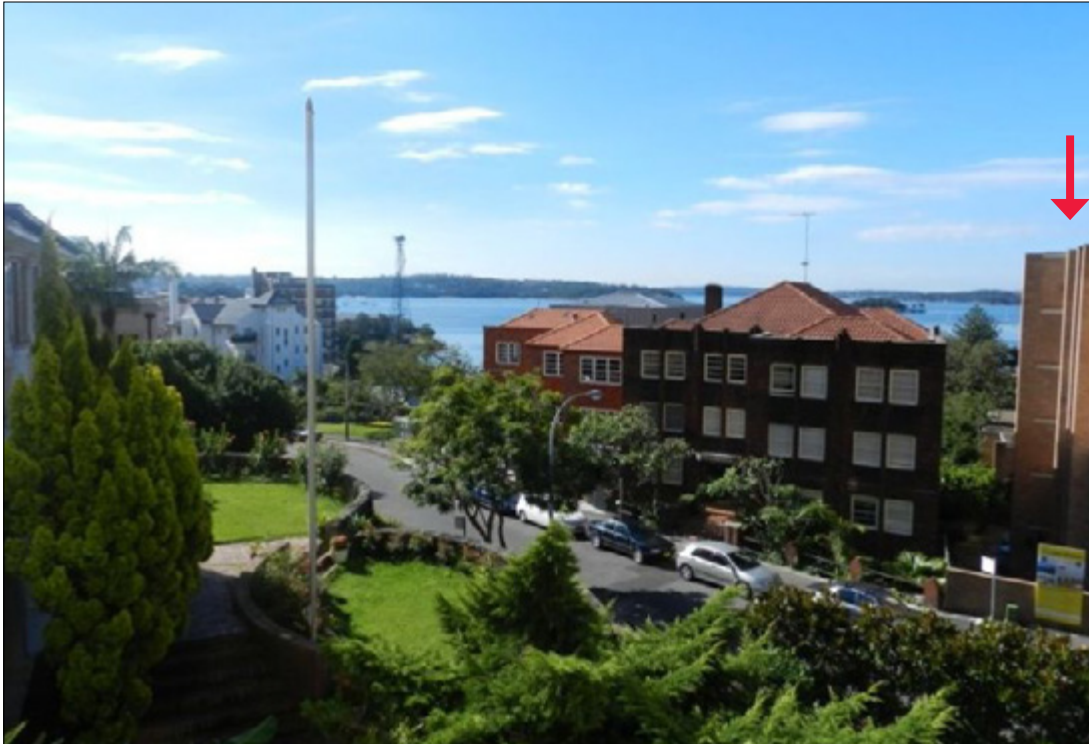
IMAGE 03

Alternative view of the water and locality as viewed from the balcony of Unit 2/13 Onslow Avenue.

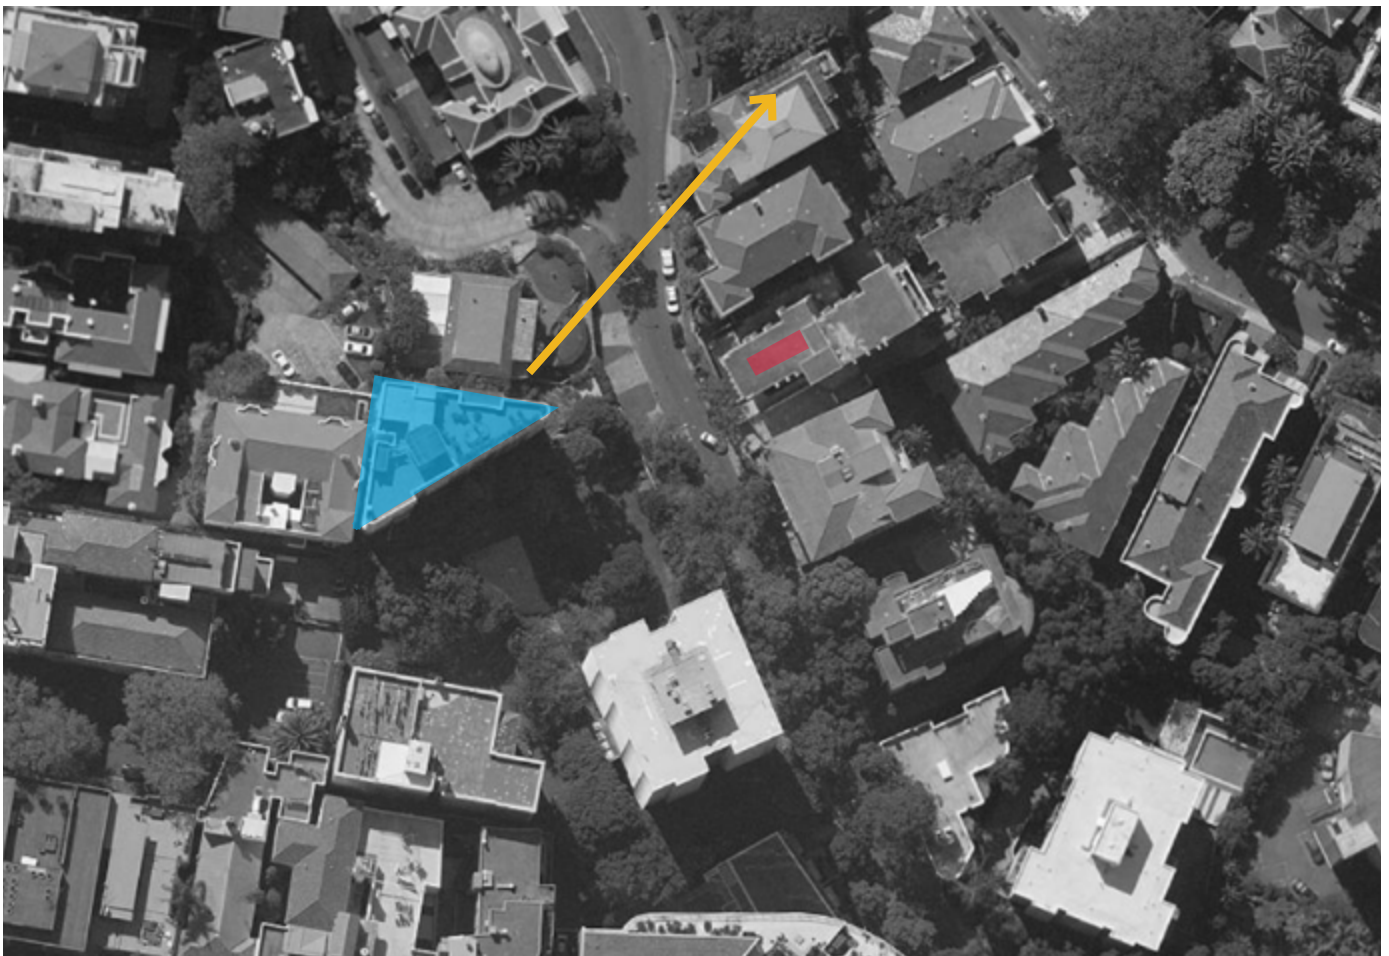
The analysed subject site (in Blue) which may be affected by the proposed development site (in Red) and key view corridors (in yellow)

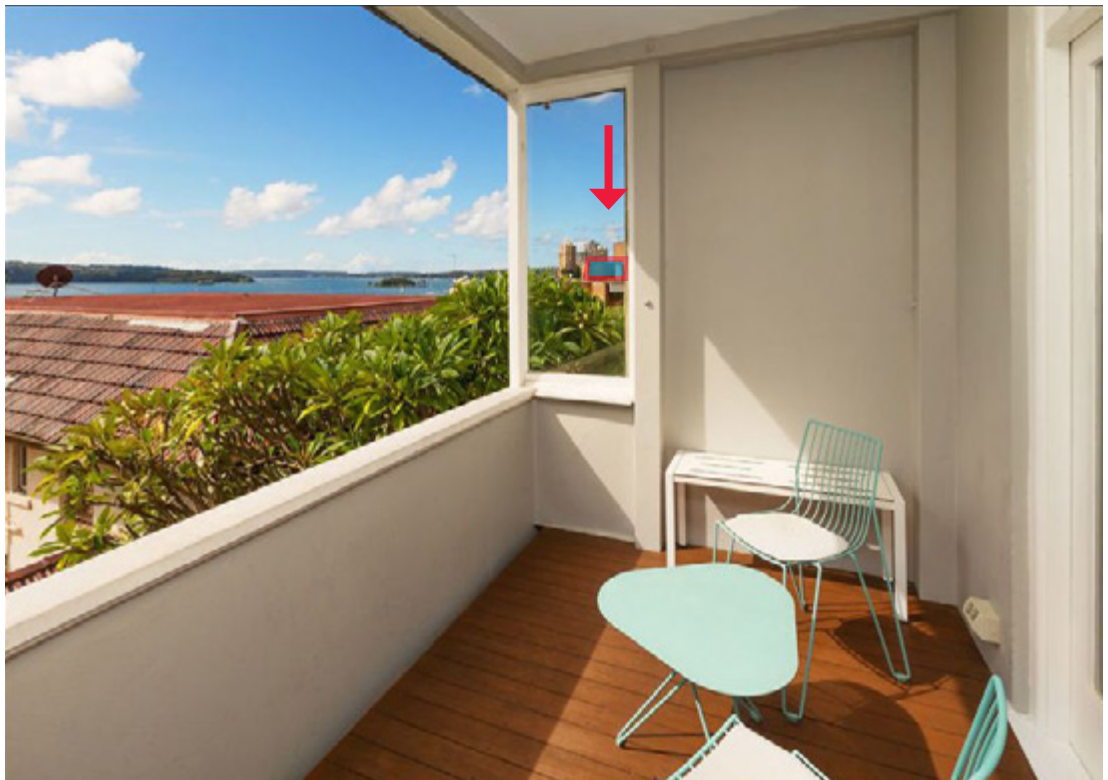
A marketing image taken (it is believed) from the living room windows of 3/13 Onslow Avenue. It is noted that the views towards Elizabeth Bay are primarily obstructed by the neighbouring building at No 12 Onslow Avenue as well as by trees.

The subject development site is just visible on the periphery of the terrace, obscured by the unit's own wall.

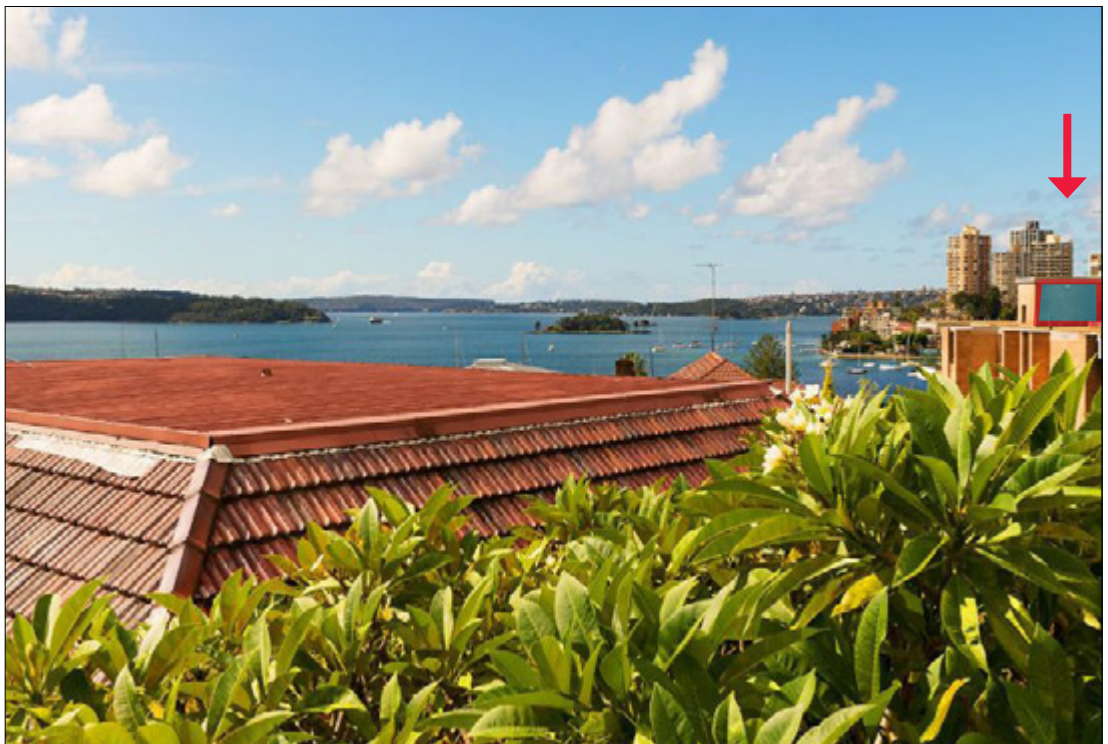
A marketing image taken from living room of Unit 3 of 13 Onslow Avenue shows the view through to the proposed development. Note that the views are partially obstructed by trees and that the proposed development site will only affect the periphery of this view.

The subject development site is just visible on the periphery of the terrace and does not impact the enjoyment of the ocean view or the landscape and district views.

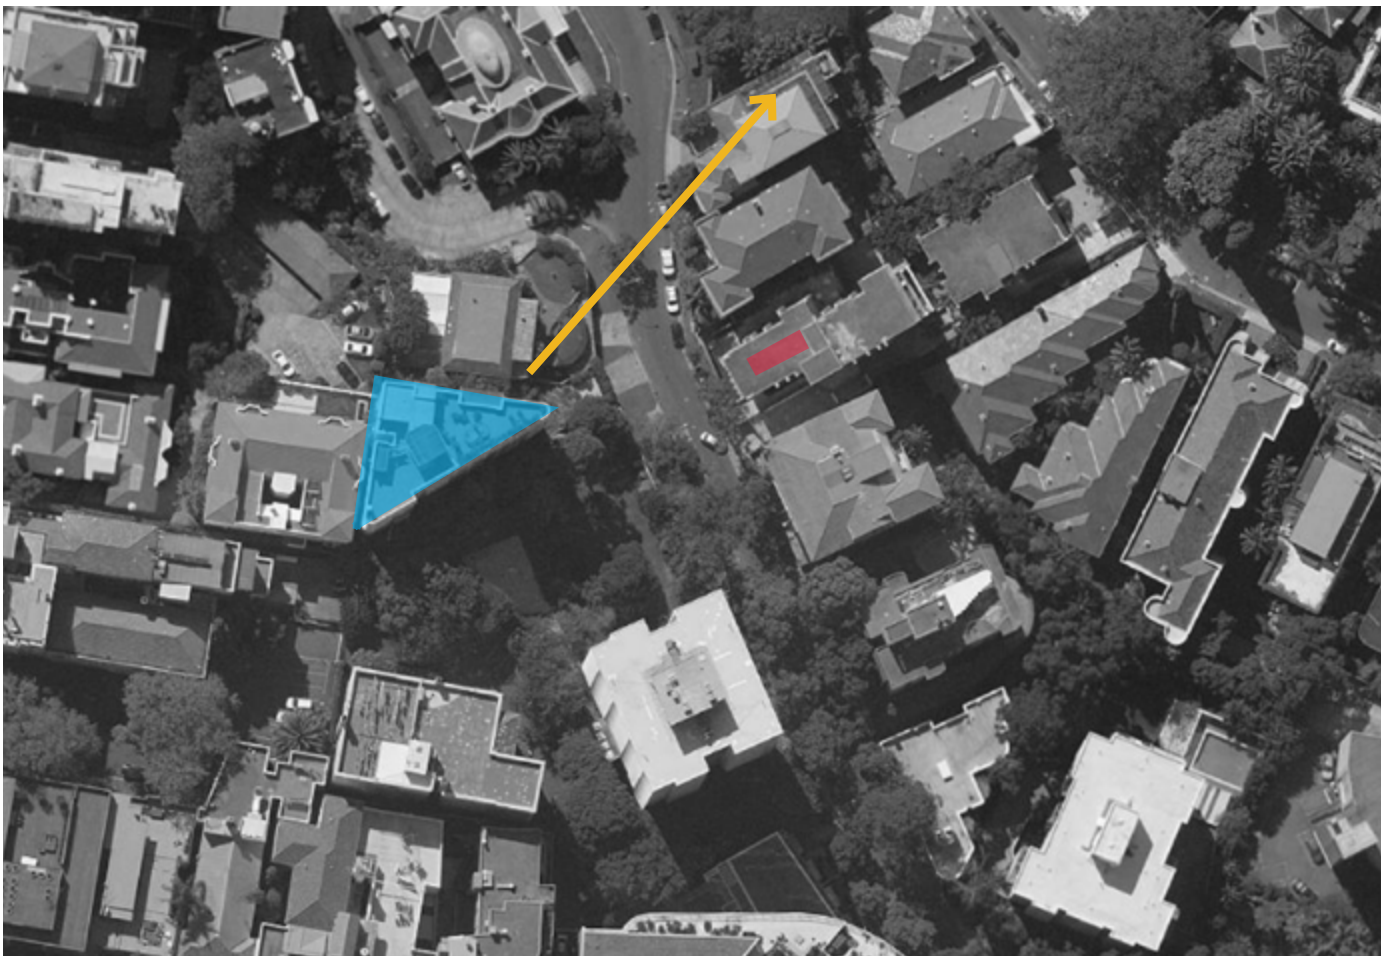
The analysed subject site (in Blue) which may be affected by the proposed development site (in Red) and key view corridors (in yellow)

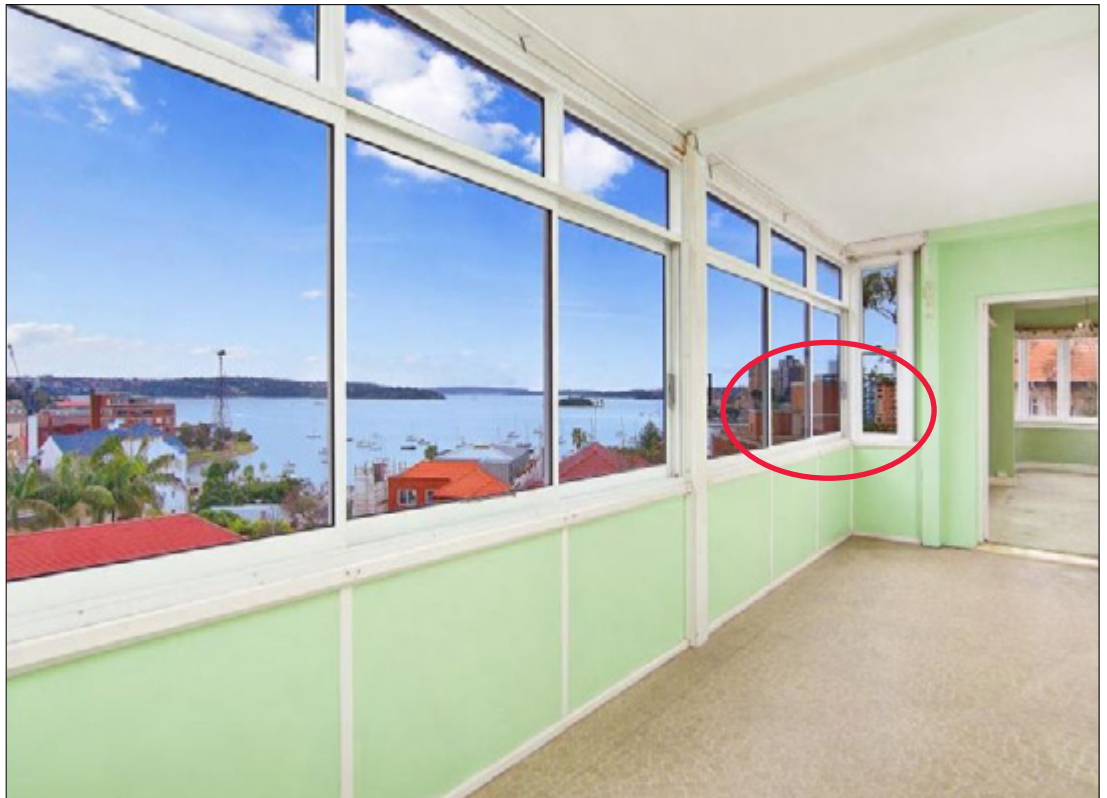
As shown here, the proposal is not anticipated to have an impact upon the neighbour's enjoyment of the view.

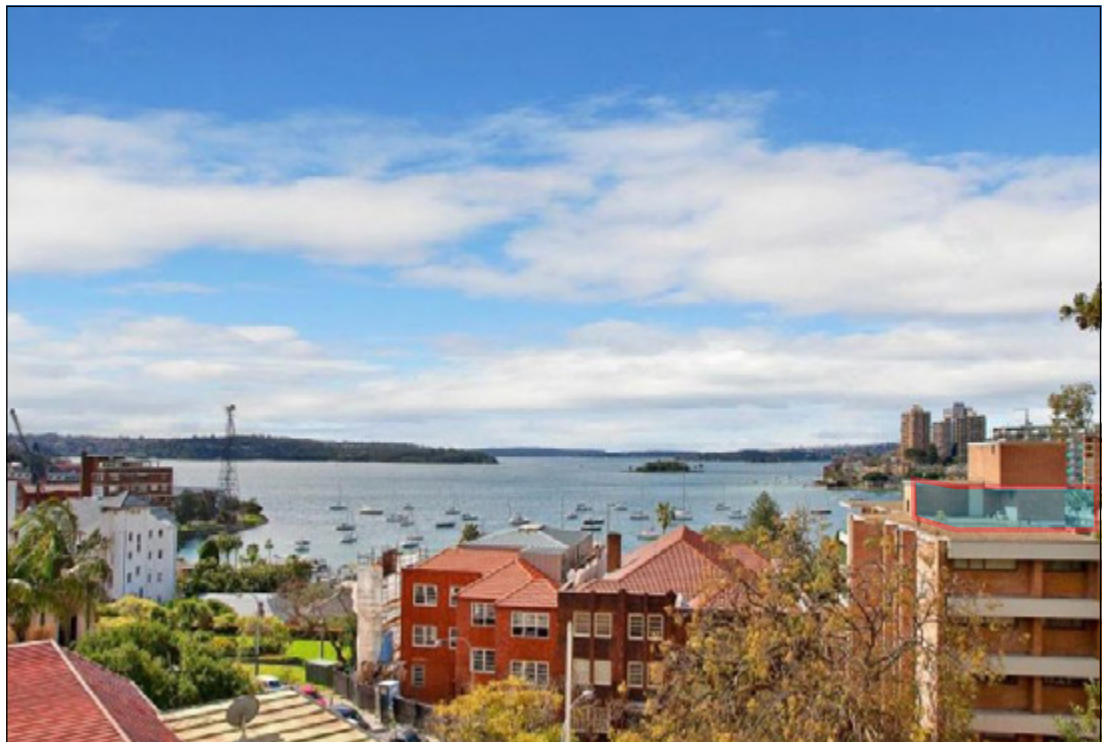
View taken from the Living Room Windows of Unit 6, No. 13 Onslow Avenue. As seen here, the proposed development area is highlighted by a light blue box in a red outline. It is clearly indicated that the proposal is located on the periphery of the view and will not have a significant adverse impact upon the view enjoyed by the neighbouring property.

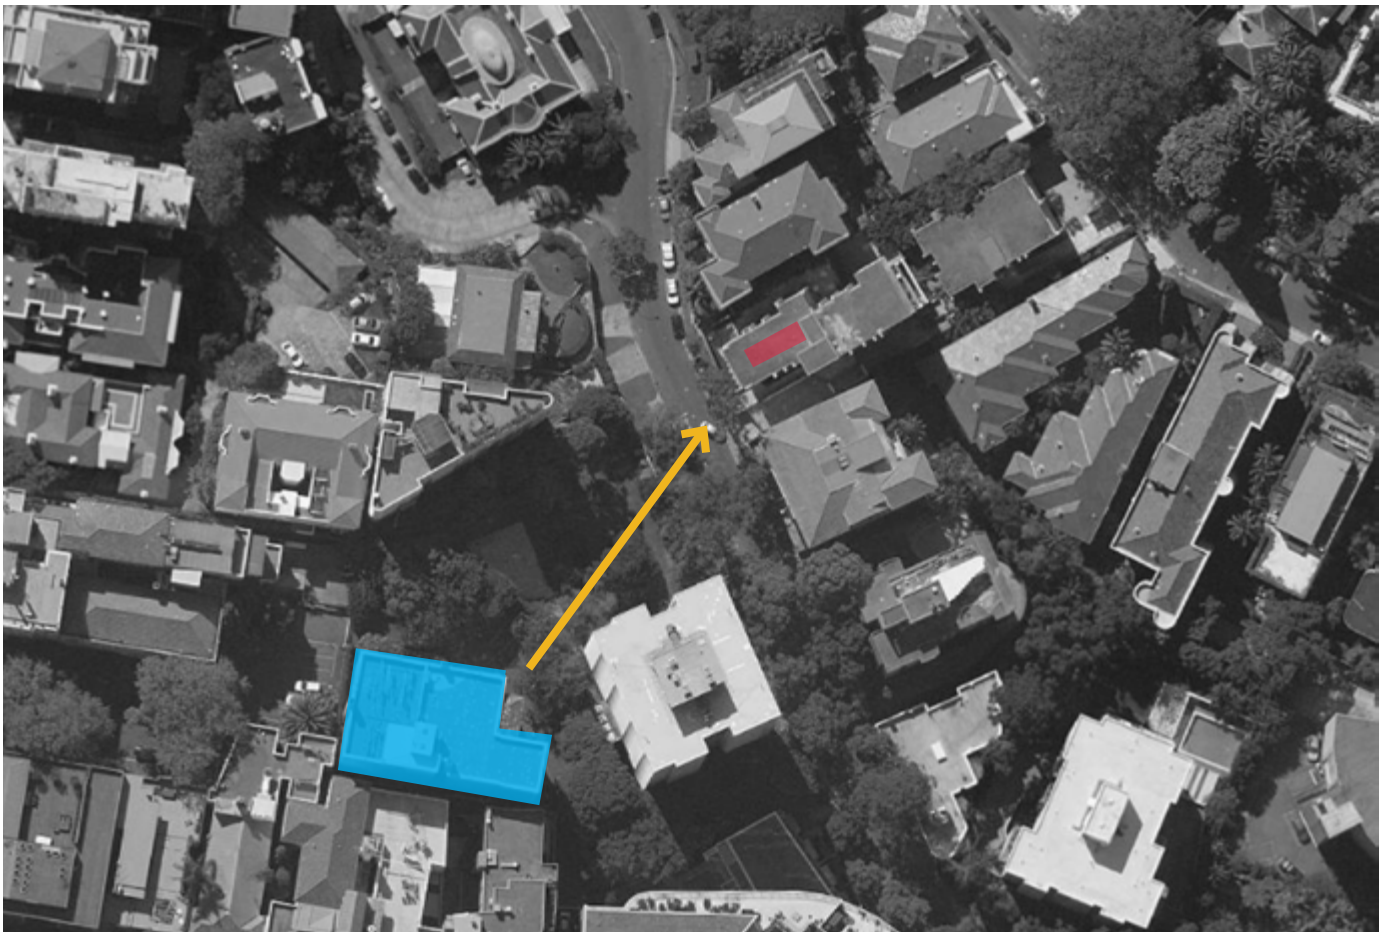
The analysed subject site (in Blue) which may be affected by the proposed development site (in Red) and key view corridors (in yellow)

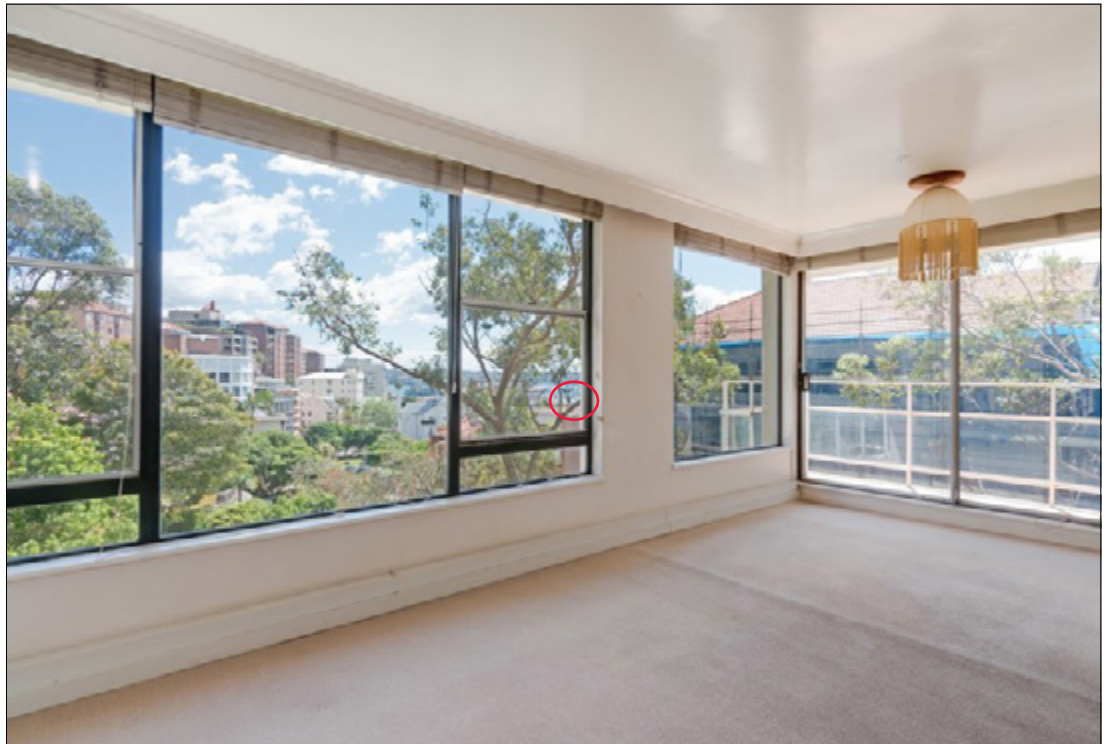
Marketing Image of the living room view of Unit 4D No.15-19 Onslow Avenue. It is noted that from a seated position, Elizabeth Bay is partially visible.

Existing Trees and curtilage prevent much of the water view from being seen, but a clear district view of Elizabeth Bay is enjoyed and unencumbered by the proposed development.

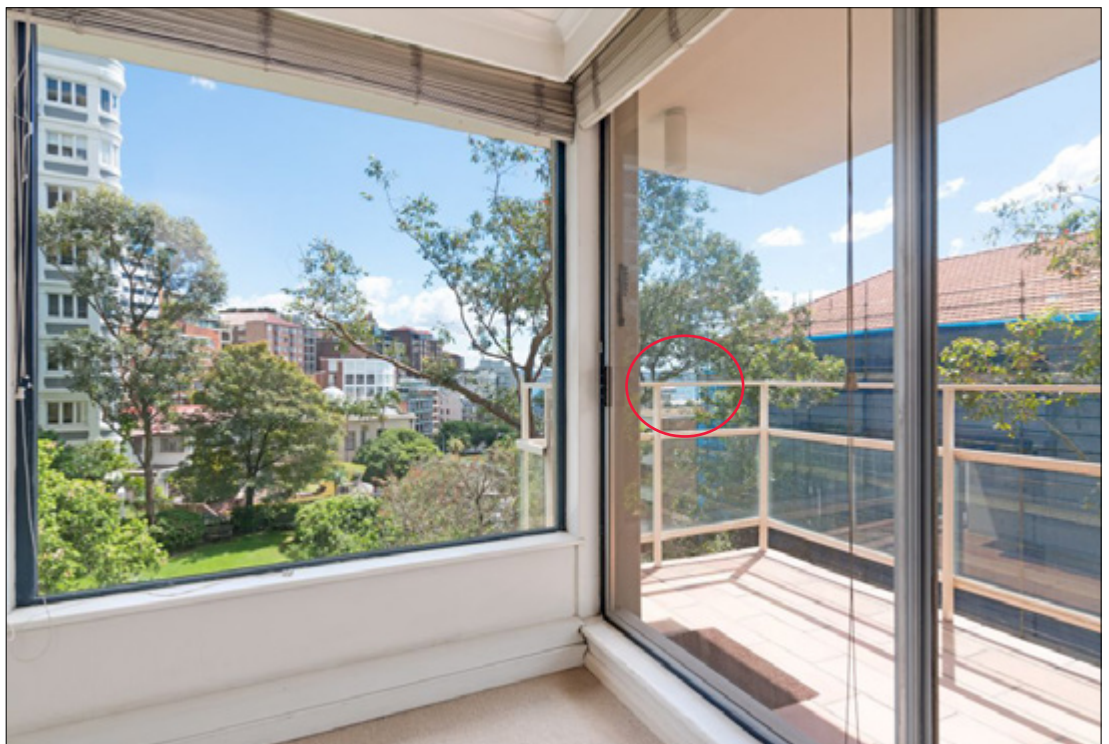
A marketing image depicting the view from the main living room terrace toward Elizabeth. The view is not in any way obscured by the proposed development as the orientation is to the East of the neighbour.

Existing Trees and curtilage prevent much of the water view from being seen, but a clear district view of Elizabeth Bay is enjoyed and unencumbered by the proposed development.

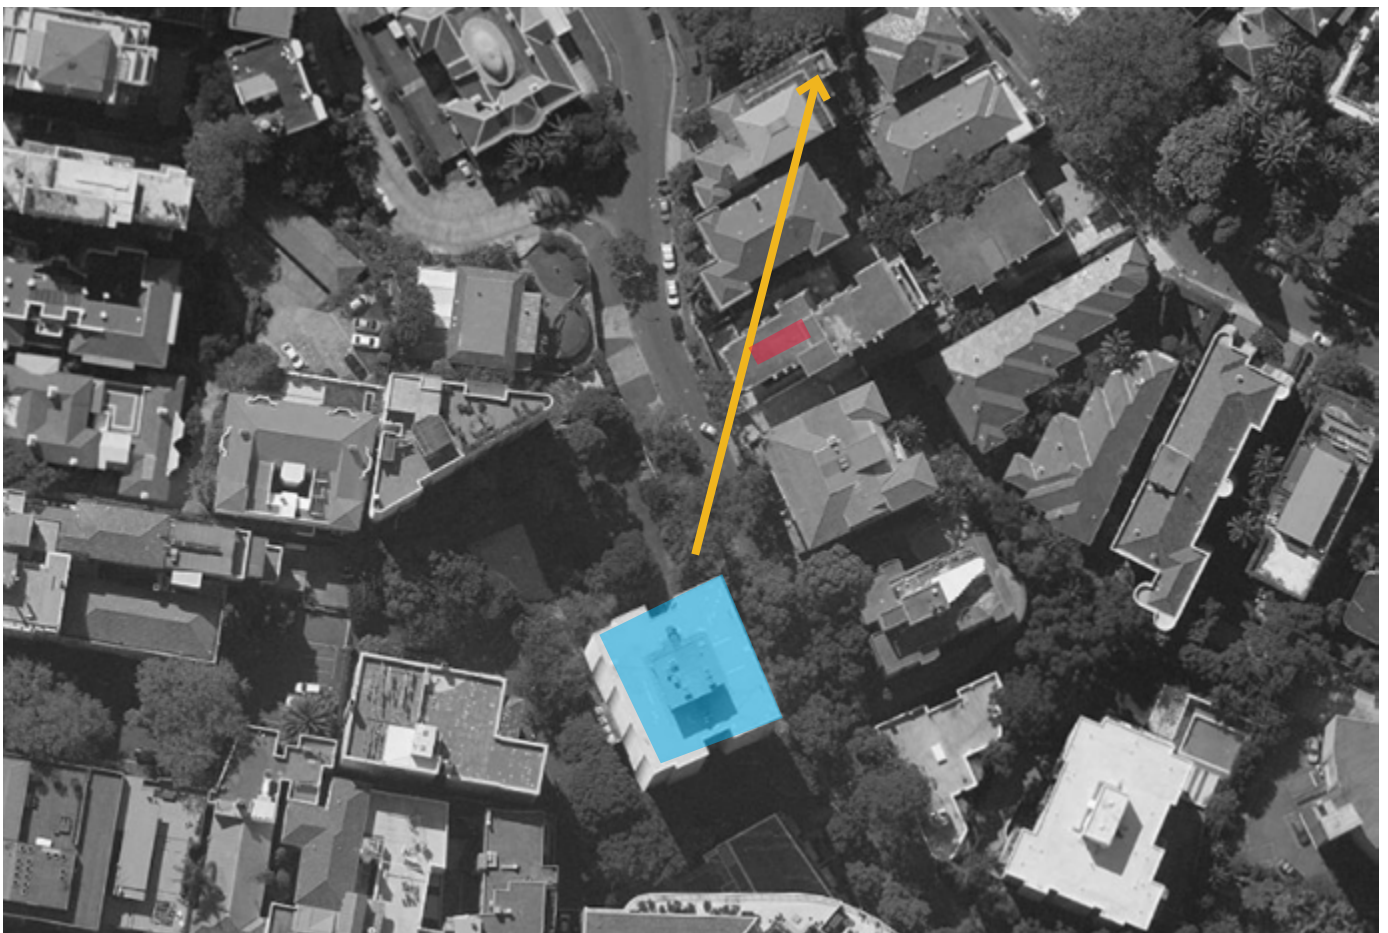
The analysed subject site (in Blue) which may be affected by the proposed development site (in Red) and key view corridors (in yellow)

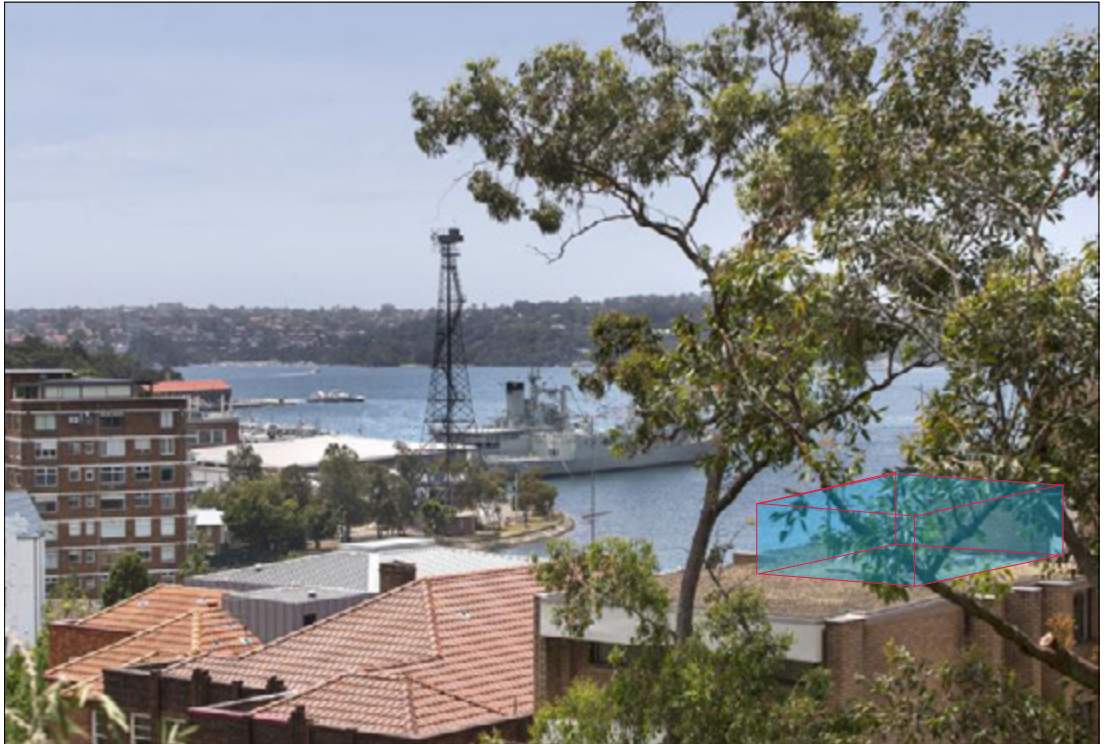
The terrace view of Unit 5C No. 15-19 Onslow Avenue. It is noted that from a seated or standing position, Elizabeth Bay is visible.

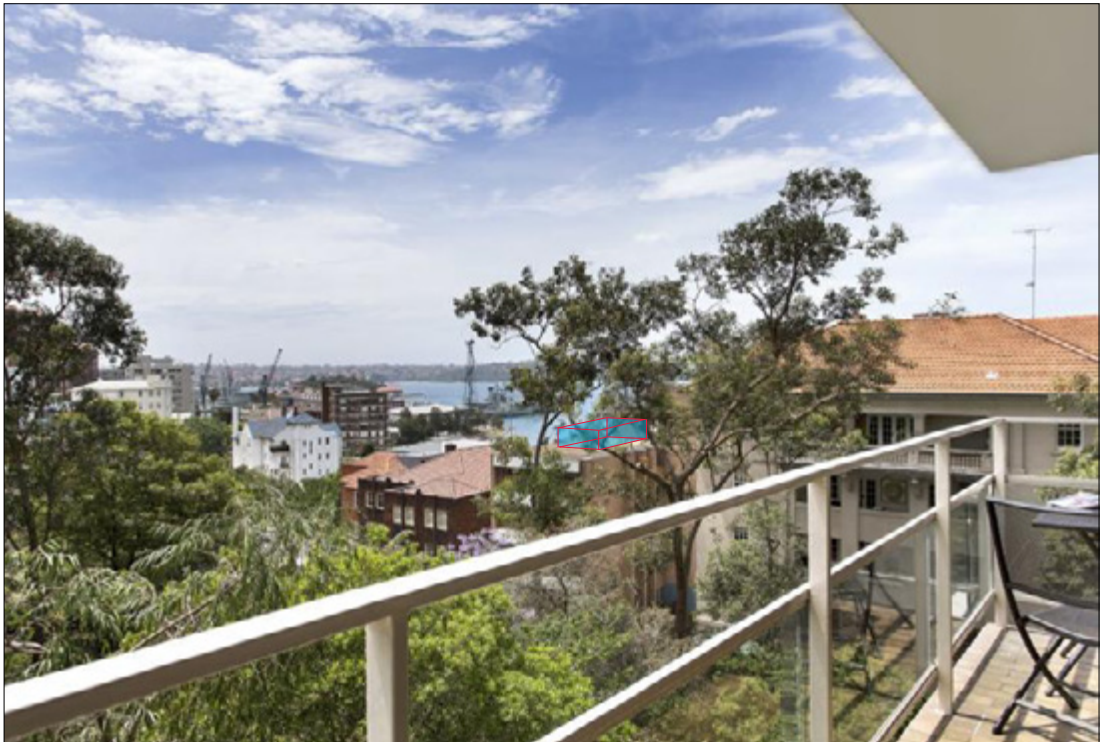
A marketing image depicting the view from the main terrace toward Elizabeth Bay.
