# Assessment of View Sharing

**10 Onslow Avenue  
Elizabeth Bay**

**Proposal:  
Alterations & Additions  
Residential Flat Building**

**DA-A ISS.**

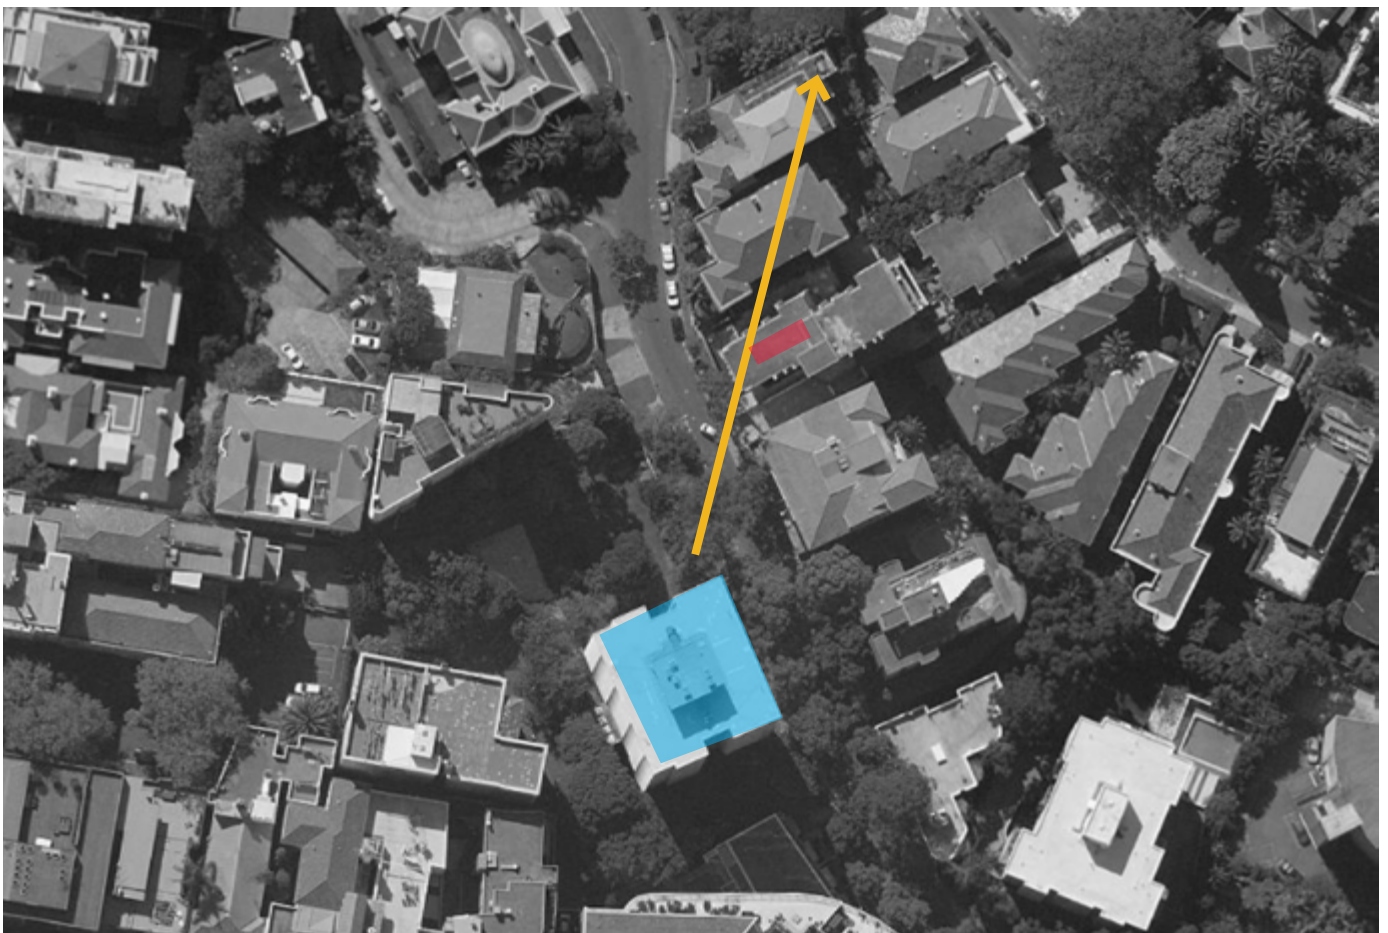
The analysed subject site (in Blue) which may be affected by the proposed development site (in Red) and key view corridors (in yellow)

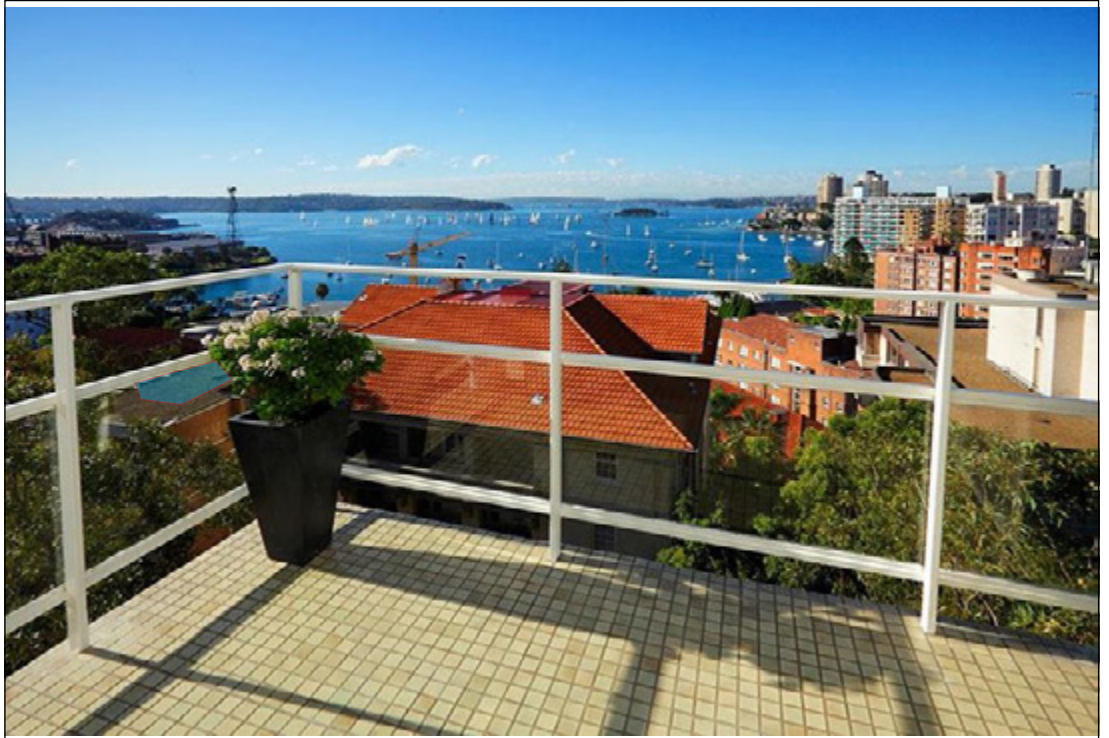
The terrace view of Unit 8D No. 15-19 Onslow Avenue. It is noted that from a seated or standing position, Elizabeth Bay, Keltie Bay and Clark Island are visible, and the proposed building is not intrusively visible.

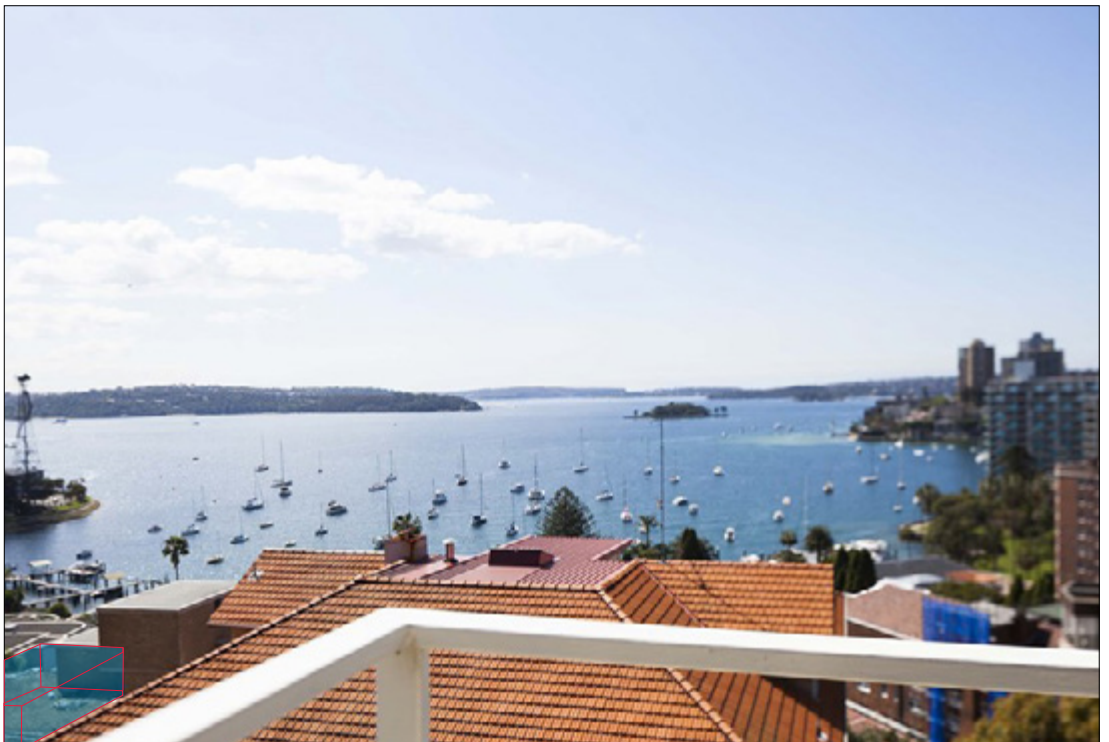
A marketing image depicting the view terrace toward Elizabeth Bay, Keltie Bay and Clark Island. The view is not in any way obscured by the proposed development.

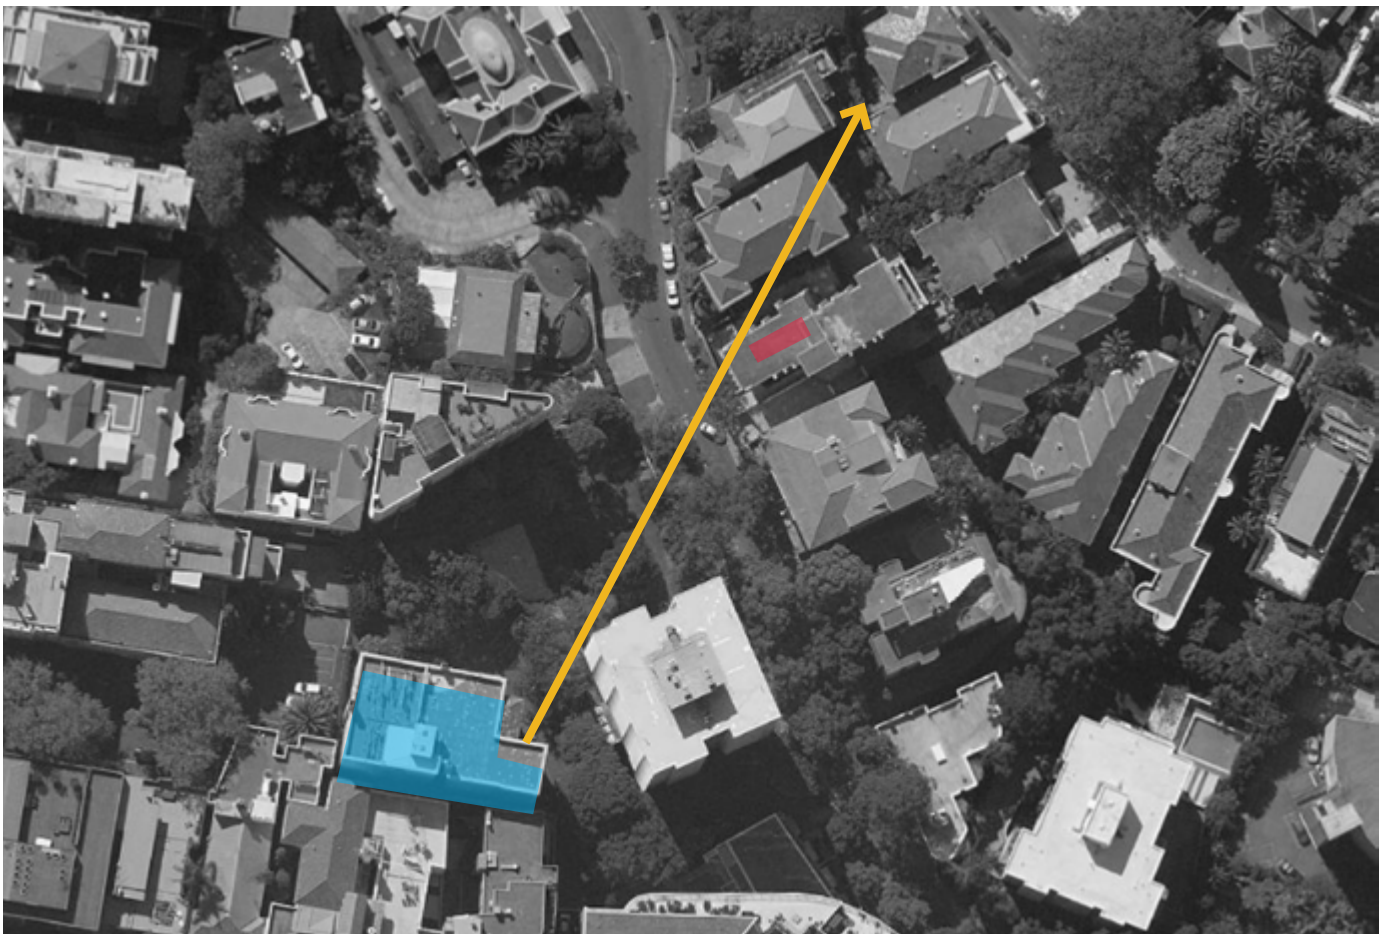
The analysed subject site (in Blue) which may be affected by the proposed development site (in Red) and key view corridors (in yellow)

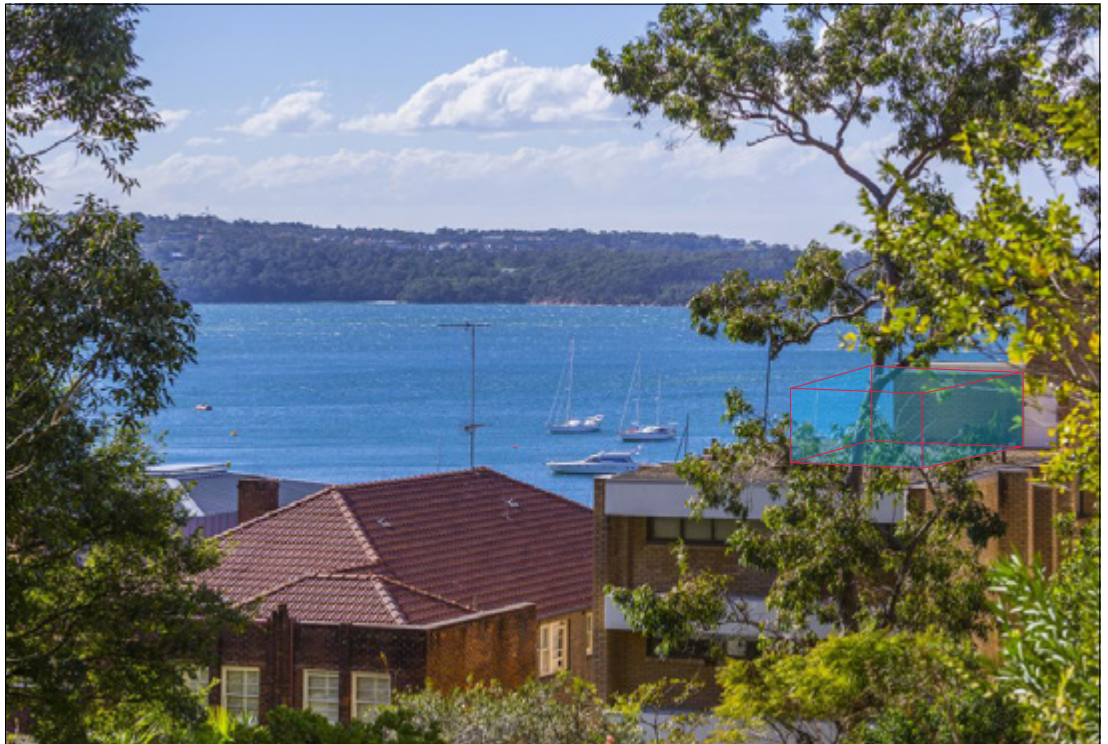
The potential development bulk and footprint are highlighted in a blue box with a red outline. It is noted that there will be a minor impact to the area of visible water, but the partially obscured portion is not significant in consideration of the view as a whole.

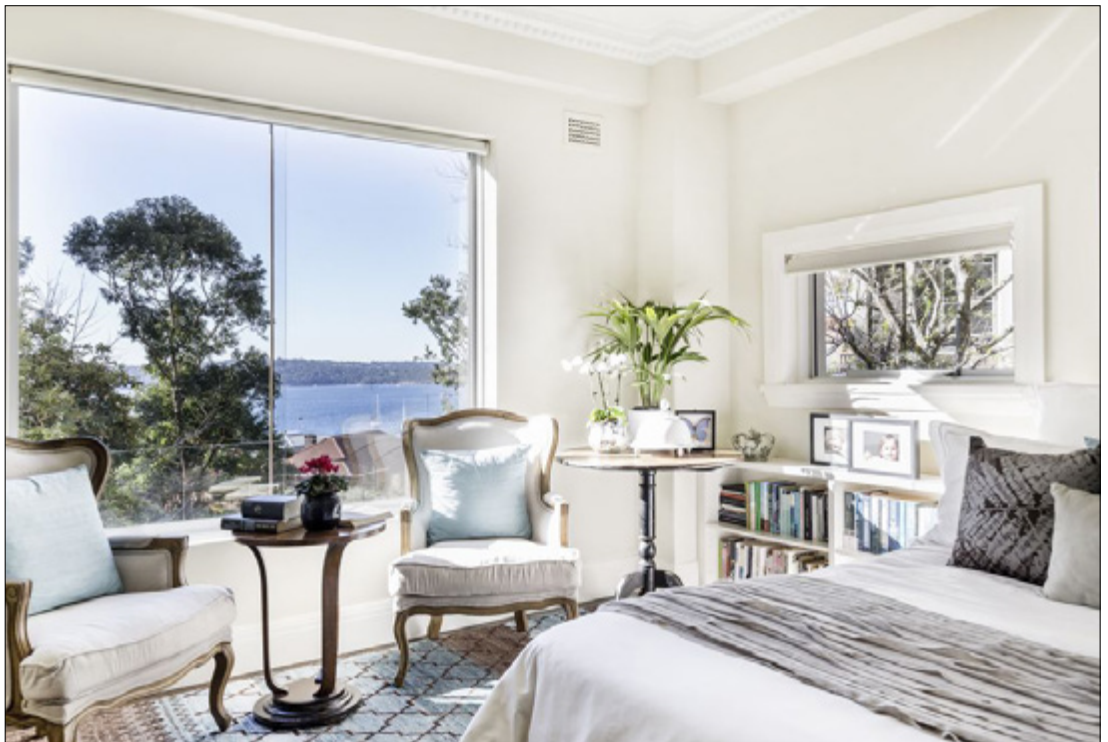
A view of Bedroom 1. It is noted that the primary sitting and standing views from this room to the main window will not be affected by the development at No. 10 Onslow Avenue.

It is noted that existing trees obscure any significant views from the secondary slot window.

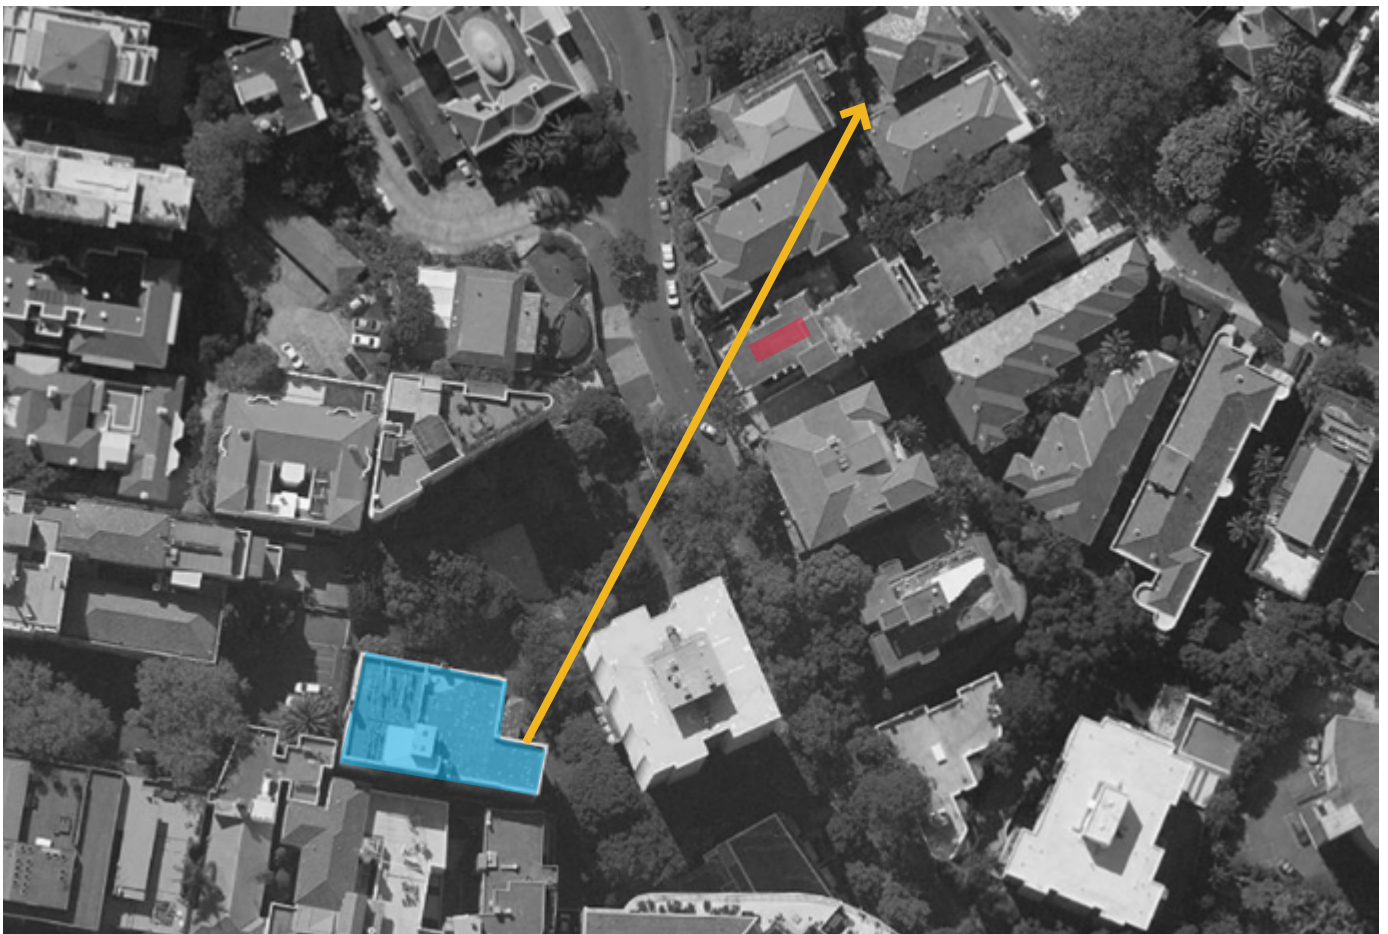
The analysed subject site (in Blue) which may be affected by the proposed development site (in Red) and key view corridors (in yellow)

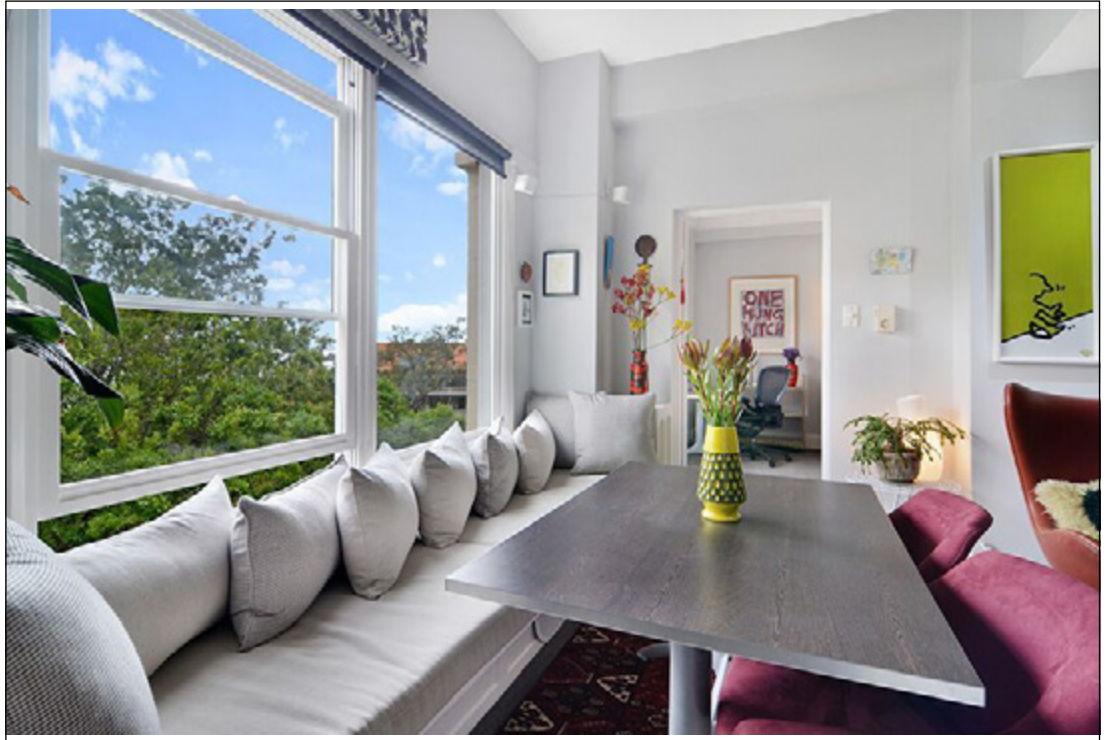
Marketing image depicting the view from the living room towards

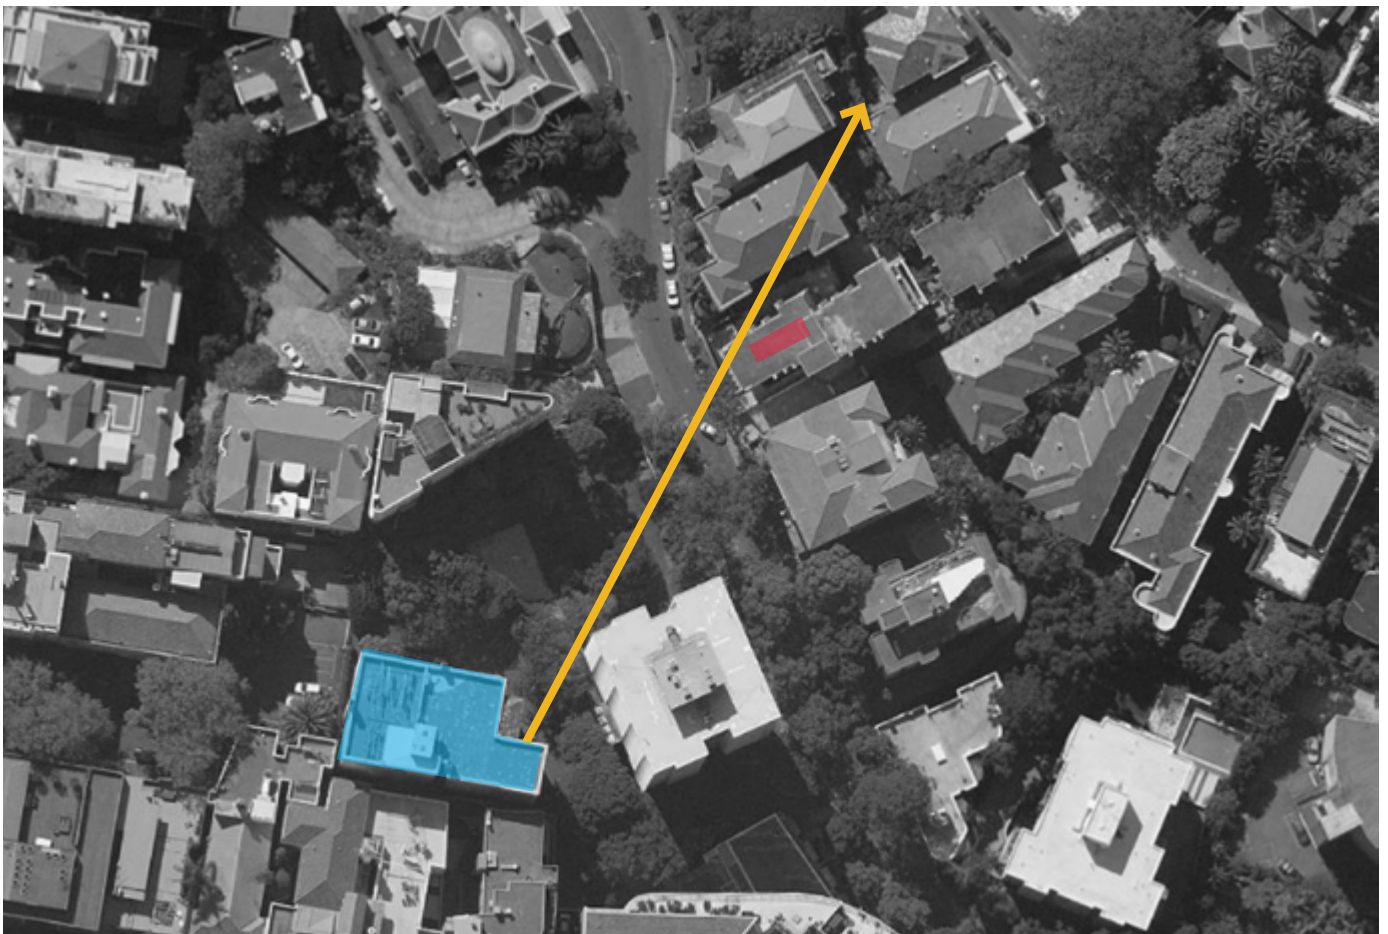
The analysed subject site (in Blue) which may be affected by the proposed development site (in Red) and key view corridors (in yellow)

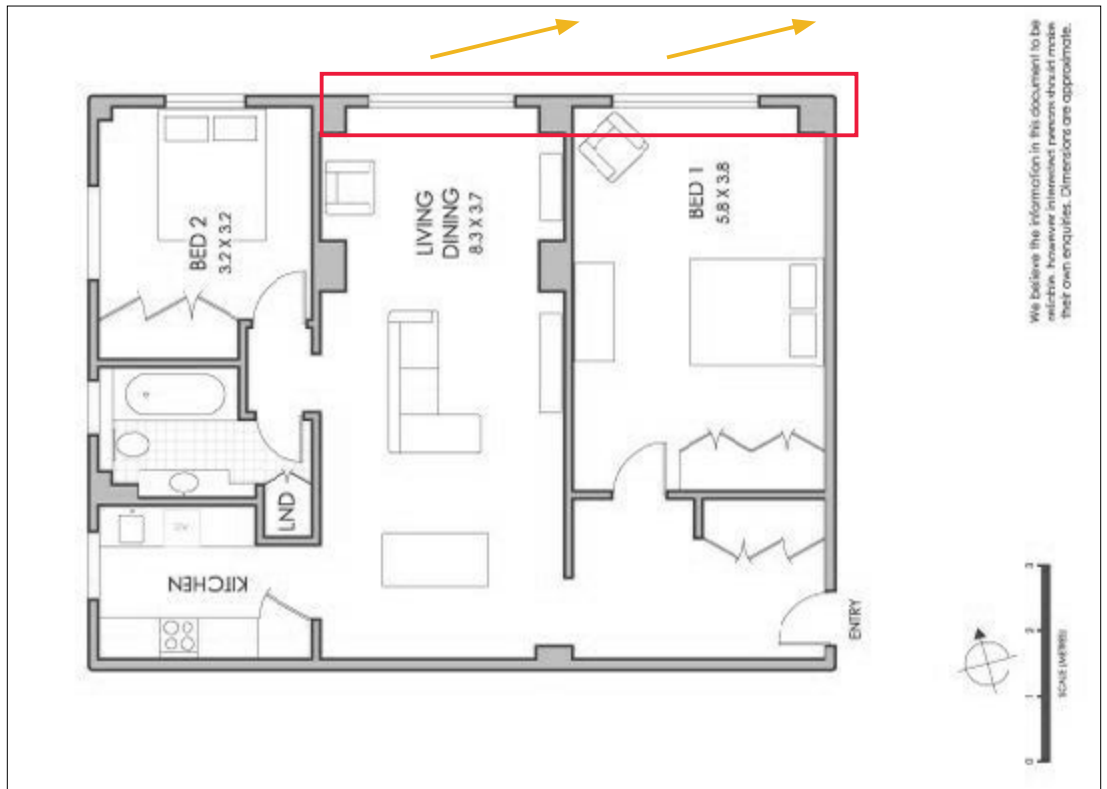
Floor plan of the Unit 15, 6A Greenknown Ave, Elizabeth Bay. The windows from which the principal view and the approximate direction of the view are highlighted.

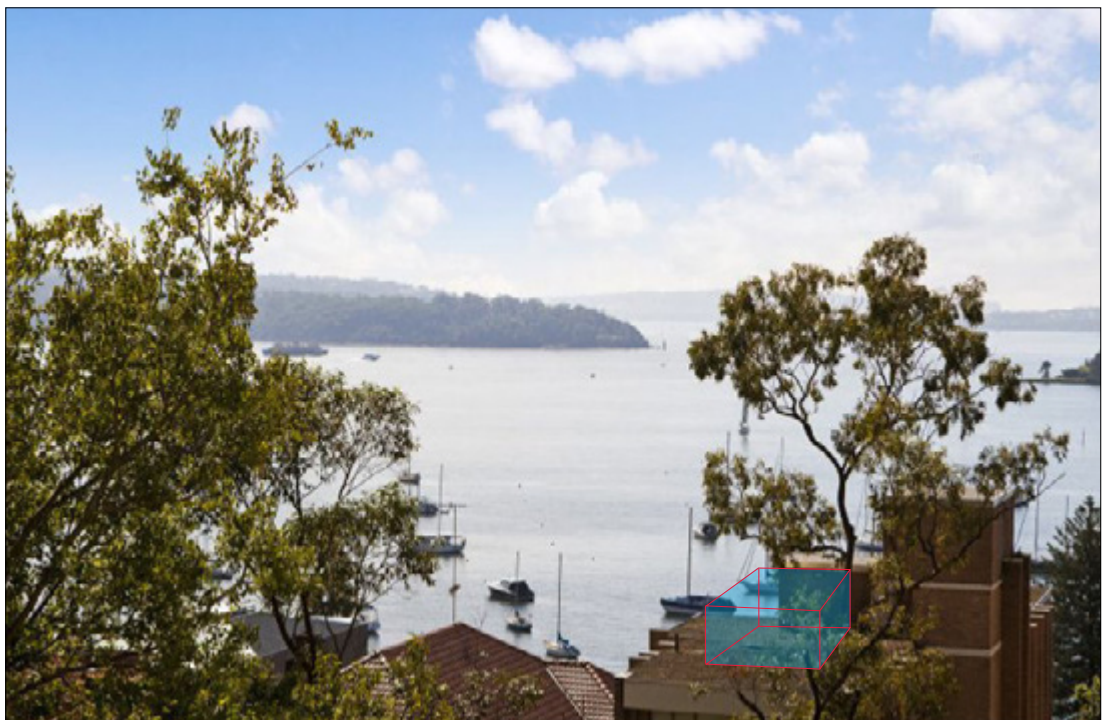
Image (Marketing) taken from the principal living room of the Unit. Note that the proposed development at U11/10 Onslow Ave will have negligible impact on the enjoyment of the view, as it is confined to the periphery and the roof additions are contained within the existing building footprint.

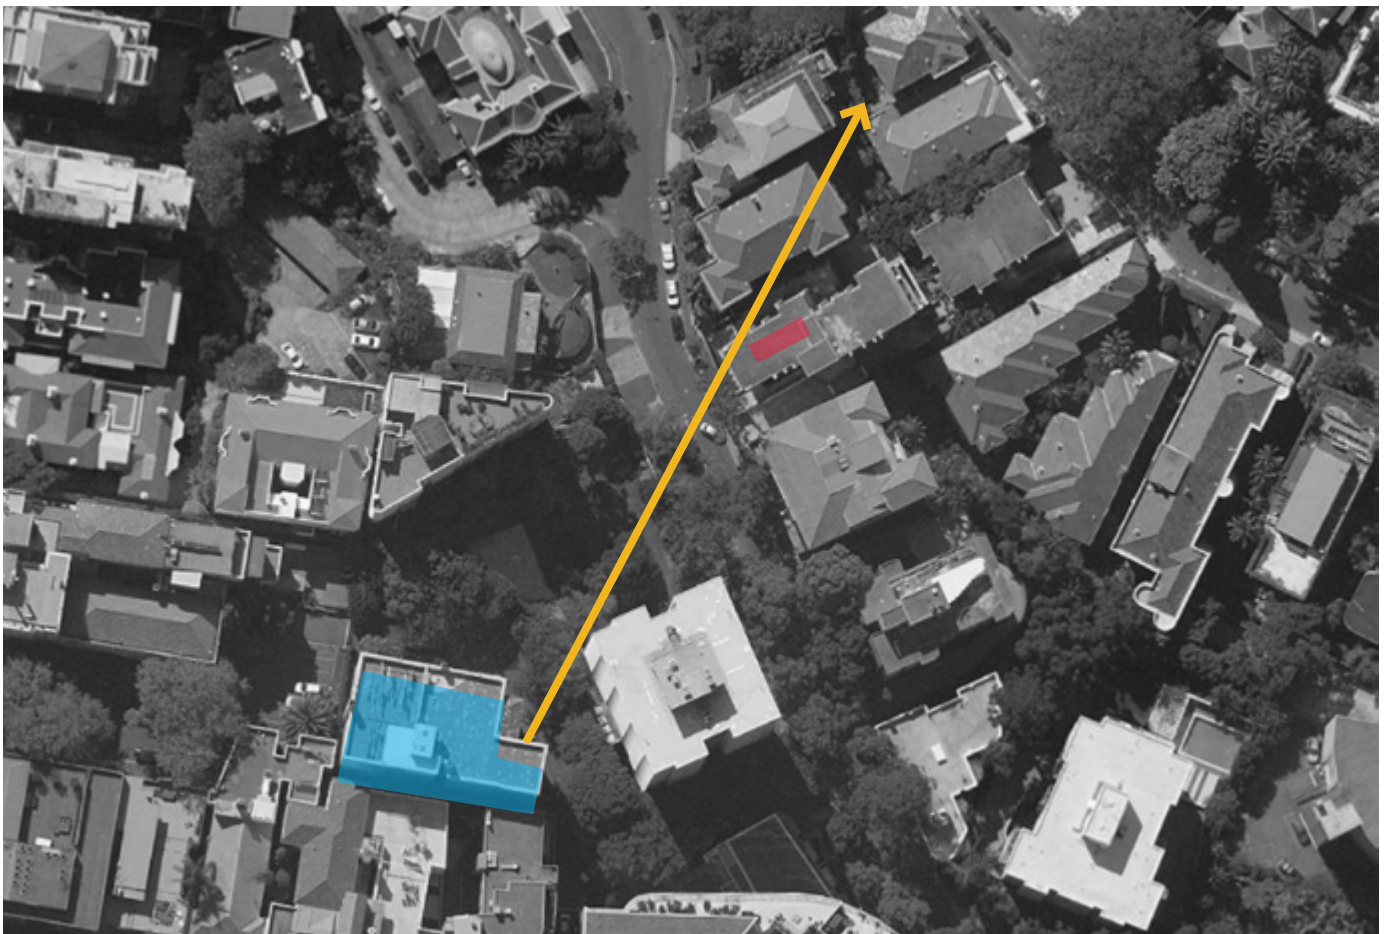
The analysed subject site (in Blue) which may be affected by the proposed development site (in Red) and key view corridors (in yellow)

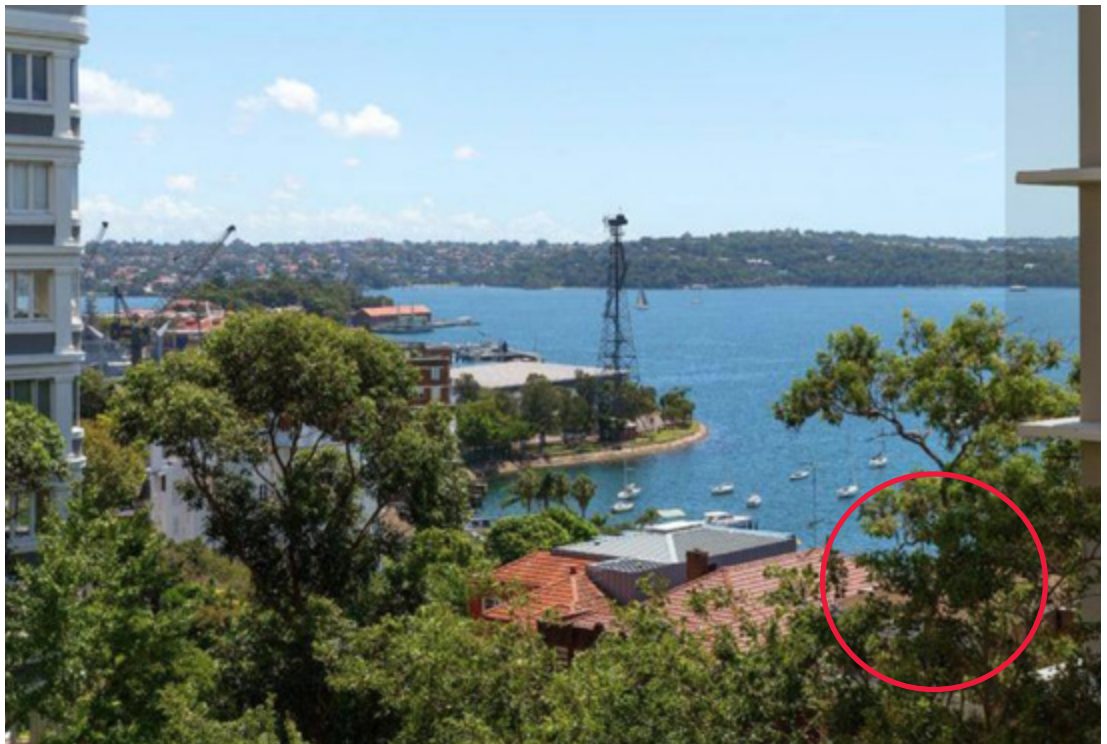
A view from the Dining Room window of the subject property at No. 17/6A Greenknown Avenue. The Subject development site at No. 10 Onslow Avenue is significantly lower and is obscured entirely by existing street trees. The proposal is not expected to have any impacts upon the view currently enjoyed.
