**Preliminary Geotechnical Assessment
187 Thomas Street, Haymarket**

Your ref 187 Thomas St
Our ref 270416-02
File ref 270416-RPT-001

187 Thomas Street Planning Proposal - Reference Scheme Option 5E - Geotechnical Desktop Assessment

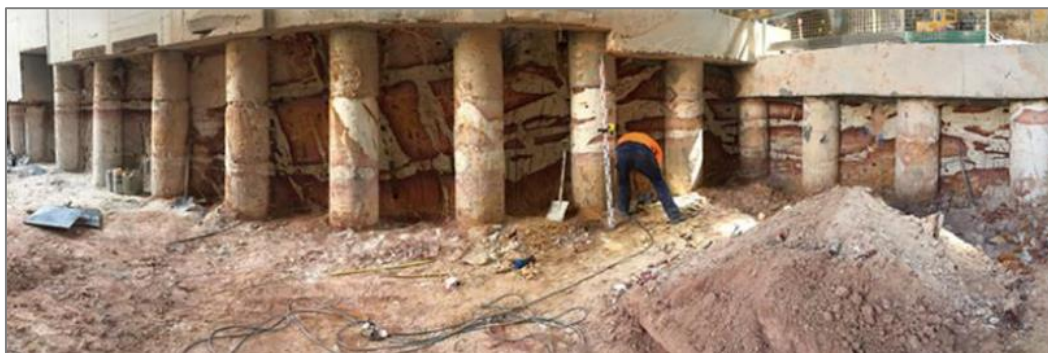
The GPO Fault Zone is characterised by multiple ‘crushed’ zones of Sandstone bedrock, and closely spaced jointing and faulting with normal and reverse fault offset. It has been encountered in many sites within the Sydney CBD. An image of a supported vertical excavation through the fault zone is shown in Figure 5 below.

Figure 5: View from the first stage of excavation for a basement within the GPO Fault Zone ([6]).
