**Preliminary Geotechnical Assessment  
187 Thomas Street, Haymarket**

Your ref 187 Thomas St  
Our ref 270416-02  
File ref 270416-RPT-001

## **187 Thomas Street Planning Proposal - Reference Scheme Option 5E - Geotechnical Desktop Assessment**

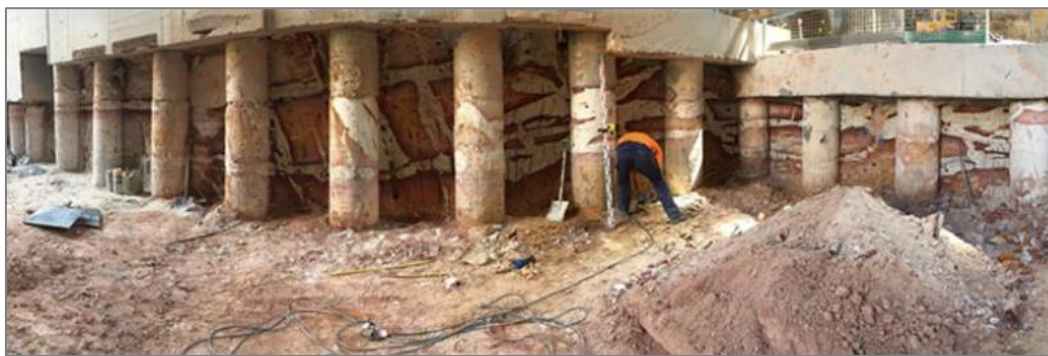
The GPO Fault Zone is characterised by multiple ‘crushed’ zones of Sandstone bedrock, and closely spaced jointing and faulting with normal and reverse fault offset. It has been encountered in many sites within the Sydney CBD. An image of a supported vertical excavation through the fault zone is shown in Figure 5 below.

Figure 5: View from the first stage of excavation for a basement within the GPO Fault Zone ([6]).

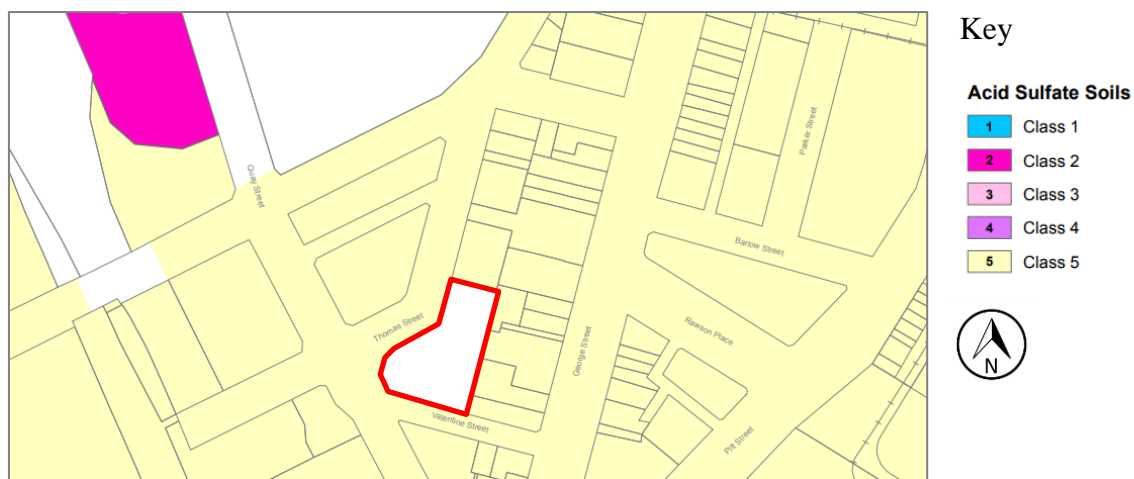
A Phase 1 (Preliminary Site Investigation) Assessment has not been undertaken at this stage of works. A review of the Sydney Local Environmental Plan Acid Sulfate Soil (ASS) Risk Map (Ref [4]) for the Sydney Region indicates that the risk of ASS on the site is Class 5. An ASS Assessment would be required where works within 500m of adjacent Class 1, 2, 3 or 4 land that is below 5mAHD, and where the water table is likely to be lowered below 1mAHD on the adjacent Class 1, 2, 3 or 4 lands. A Class 2 site is located within 500m of the site, as shown in Figure 7 below.

Figure 7: Extract from Sydney Local Environmental Plan ASS Map - Sheet ASS\_015, with the project highlighted in red.
