# **Attachment A6**

**Conservation Management Plan – Part 2**

## 4. COMPARATIVE ANALYSIS

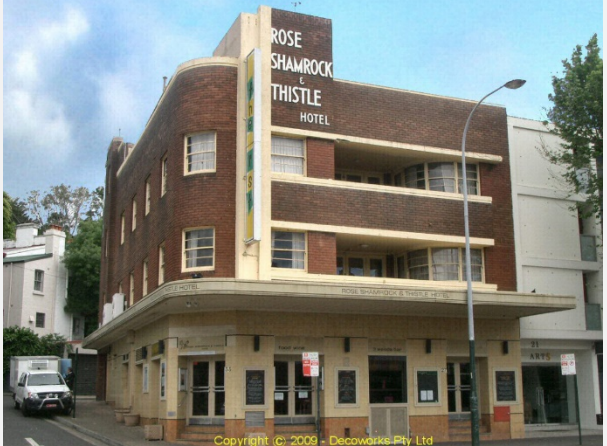
Property	Heritage Listing and Significance	Description	Photograph
<p><b>Rose Shamrock and Thistle Hotel</b></p> <p>27-33 Oxford Street, Paddington, Sydney NSW</p>	<p>Not listed.</p>	<p>The Rose, Shamrock and Thistle Hotel is an Inter War Functionalist style hotel, built in 1939. The hotel was designed by Prevost and Ancher. It comprises three storeys and a basement level. The primary façade is constructed of brick, below the cantilever awning, tiles have been used and above the awning bare face bricks have been used.</p> <p>The ground floor contains public bar and saloon areas while the first floor contains accommodation spaces and facilities<sup>7</sup>.</p> <p>The interiors of the hotel have been substantially altered. There is nothing remaining of the original bar finishes.</p>

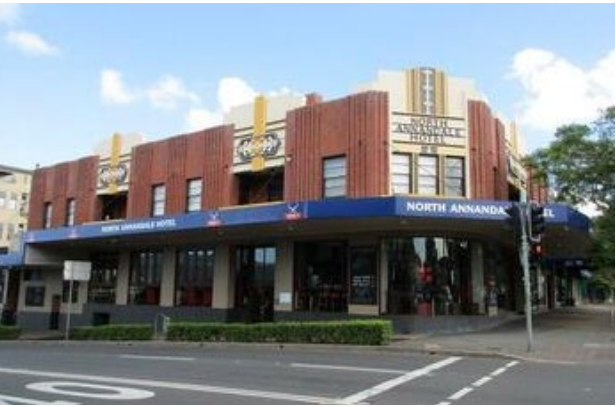
<p>Source: <a href="http://artdeco.blogspot.com">artdeco.blogspot.com</a></p>
<p><b>North Annandale Hotel</b></p> <p>105 Johnston Street, Annandale NSW 2038.</p>	<p>Not listed.</p>	<p>The North Annandale Hotel is defined by red brickwork and large masses of cream cement work. The brickwork is broken up by columns of articulated brickwork providing a series of vertical lines. The application of concentrated panels of modern ornament enriches the cement work.</p> <p>The doors are glass with names of departments and a series of horizontal lines sand-etched and coloured cold and silver. Double bar push-bars protect the doors and the unusually wide centre lights are also protected by bars. Copper glazing gives individually to the fan</p>

Property	Heritage Listing and Significance	Description	Photograph
		<p>light treatment and here again the horizontal motif is emphasized<sup>8</sup>.</p> <p>The interiors of the North Annandale have also been heavily stripped and altered. This includes the removal of the original bar finishes.</p>	
<p><b>Union Hotel</b></p> <p>271 Pacific Highway, North Sydney, NSW 2060</p>	<p><b>North Sydney LEP, 2013 (I0960)</b></p> <p><i>The Union Hotel extensively rebuilt in 1938 is an early example of the International style, streamlined with stylised decoration and extensive use of vertical and horizontal lines. Designed by Prevost and Ancher it is aesthetically and historically significant as a relatively intact Interwar period hotel in North Sydney retaining many features of the period. The building has local social significance as a physical reminder of a site which has continuously housed a hotel since the 1870s, which continued to contribute to and serve the public<sup>9</sup>.</i></p>	<p>The Union Hotel is a two storey simple geometric brick hotel on the corner of Pacific Highway and West Street, with sculptured parapet which conceals a terracotta tiled hipped roof. Curved corner with vertical and horizontal elements to the facades that demonstrate the international style. The building's design displays contrasting vertical and horizontal elements which associate the building with the international style. Coursed render to the ground floor with timber framed French doors with a cantilevered metal awning with a pressed metal soffit. Brick façade above with a band of two pane double hung sash windows set between a continuous render sill and head. There is a modern extension to rear.</p> <p>Internal materials include original tiles to dado, remnants of original plaster ceiling detailing, original timber stair and leadlight to south east elevation. Bars located in original configuration. Sandstone fireplaces.</p>

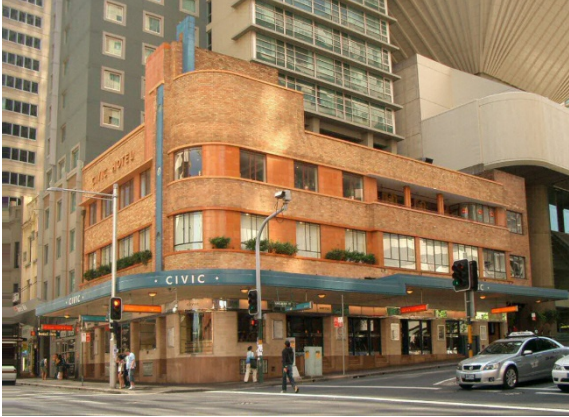
Property	Heritage Listing and Significance	Description	Photograph
<p><b>The Civic Hotel</b></p> <p>388 Pitt Street, Sydney NSW</p>	<p><b>Sydney LEP, 2012 (Item 1945)</b></p> <p><i>The Civic Hotel considered to be the last purpose built hotel in the CBD, has social significance as it ends a tradition which extends back to the earliest decades of the colony. The building is an important corner element located on a prominent corner site within easy reach of the major entertainment and former prominent district. The building has aesthetic significance for the strong contributor it makes to the streetscape. Although poorly maintained the building is largely intact externally and internally and has high aesthetic significance as the finest of five hotels constructed in the Inter War Functionalist style in the city during a short period between 1938 and 1842' the others area the Australian (Broadway), the Hollywood, The Kegroom Tavern, and the Sutherlands. At the time of building the Civic was claimed to be a landmark in architectural treatment and finish as well as containing structural features of interest. The building has scientific significance for structural features such as the cantilevered section in Goulburn Street.<sup>10</sup></i></p>	<p>The Civic Hotel was designed by Prevost and Ancher in the Inter War Functionalist Style. It was constructed in 1940-41.</p> <p>The hotel has three-storeys with a deeply recessed balcony on the second floor on the southern façade. The façade is exposed brick above the awning and granite and travertine cladding on the ground floor. Rendered string courses on the two upper floors enclose steel framed casement windows bordered by orange terracotta tiles.</p> <p>An extended parapet (face brick) is located on the corner with a vertical brick and terracotta tile tower element on the western façade. This breaks the strong horizontal lines of the façade.</p> <p>Some alterations to the interiors have been made over the years, however some original fabric has been retained on the upper floors.</p>

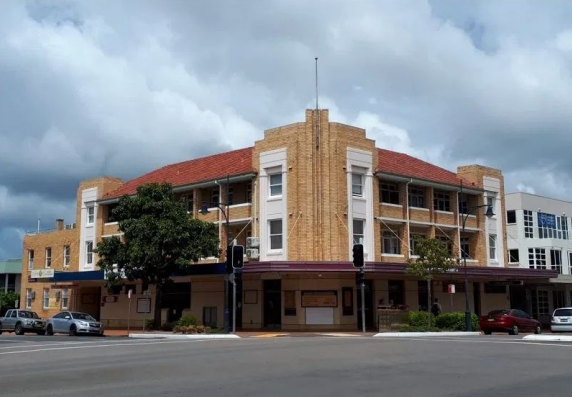
<p>Source: Heritage NSW online database, Item 167.</p>

Property	Heritage Listing and Significance	Description	Photograph
<p><b>Fotheringham's Hotel</b></p> <p>4 Pulteney Street, Taree NSW 2430</p>	<p><b>Greater Taree LEP, 2010 (I167)</b></p> <p><i>Fotheringham's Hotel is listed for its historical significance as an existing building representative of extensive redevelopment of the local commercial centre during the 1920s.</i></p> <p><i>Additionally, it is a prominent townscape element occupying a corner position at Pulteney Street intersection. It forms an important composition with the AMP building and "beehive" building.</i></p> <p><i>It is a site of formal and informal social gatherings and has the propensity for research as an example of grand hotel design from the 1930s<sup>11</sup>.</i></p>	<p>The Fotheringham's Hotel was designed by Prevost and Ancher constructed in 1938-39. It is an excellent example of Art Deco Hotel largely intact internally and externally. Occupies important corner site opposite Beehive Store &amp; AMP Building. The "Gateway" location marks start of the main commercial strip.</p>

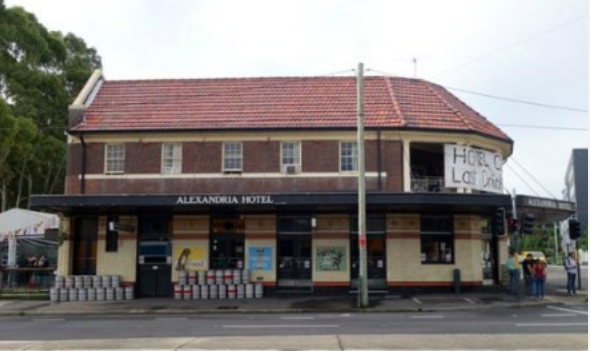
<p>Source: Heritage NSW online database, item 2223.</p>

Property	Heritage Listing and Significance	Description	Photograph
<p><b>The Alexandria Hotel</b></p> <p>36 Henderson Road, Eveleigh, Sydney NSW</p>	<p><b>City of Sydney LEP 2012 (item I2223)</b></p> <p><i>The Alexandria Hotel is a fine and representative example of an Inter War suburban hotel. Dating from 1935, the hotel demonstrates the work of prominent hotel architects, Rudder &amp; Grout, for the Tooth &amp; Co brewery. With its uncommon level of integrity including a surviving u-shaped bar, the building exemplifies the planning and design of suburban hotels constructed in NSW during the 1930s.</i></p> <p><i>Historically, the location of the hotel, if not its site, has been continuously associated with hotel use since the 1870s. The original lessee of the site, Catherine Goodfellow, has local historical significance as an early inhabitant of Alexandria who was responsible for development of property in this section of the suburb including the Alexandria Hotel. The building also provides evidence of the widening of Henderson Road, one of a number of road widening initiatives undertaken by Alexandria Council during the interwar period.</i></p> <p><i>The prominent corner site, intact 1930s hotel and continuity of hotel use in this location since the 1870s, make this building a local landmark of Alexandria and Eveleigh. The building contributes to the character of the locality and</i></p>	<p>The Alexandria Hotel is a two-storey brick building located on a prominent corner site. It has a hipped roof covered with terracotta tiles. The parapet element shown on the corner of the building in early photographs has been removed. Apart from this minor change, the building is an intact example of a suburban hotel from the Inter War period. It has no affinity to a particular architectural style from this period.</p> <p>The first-floor walls are constructed of face brickwork, with multi-paned double-hung sash windows regularly spaced along both facades. Windowsills and heads are emphasised by continuous coursing executed in cement render. The corner features a recessed first floor balcony with metal balustrade and classical columns. The walls step in slightly on either side of the open balcony. The original awning soffit lining has been replaced with new metal decking.</p> <p>The ground floor is divided into four main rooms. The entrance vestibule off Garden Street separates the two bar rooms along Henderson Road from the dining room and kitchen along Garden Street. The Public Bar room is located on the corner with an adjoining Saloon, separated by a partition wall with multi-paned timber windows. The Saloon was originally divided into three separate rooms for a Ladies Parlour, Bottle Shop and Saloon. The green wall tiles mark the portion that was once a separate room. The central u-shaped bar counter of the public bar continues in a ring through the adjacent saloon. The ground floor rooms have retained original ceramic wall tiles, window and door joinery, timber picture rails, fireplace, plaster cornices</p>

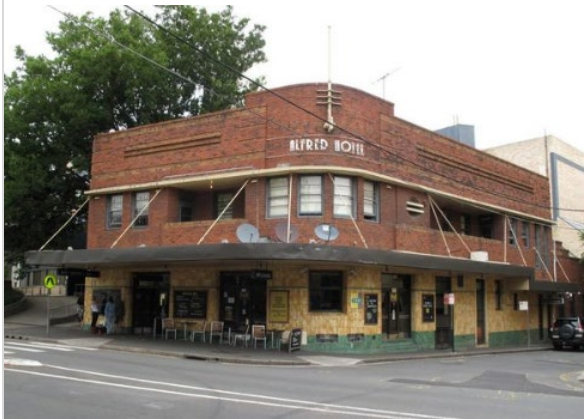
<p><i>Source: Heritage NSW online database.</i></p>

<p><b>The Alfred Hotel</b> 51-55 Missenden Road Camperdown, Sydney NSW</p>	<p><b>City of Sydney LEP, 2012 (item I70)</b></p> <p><i>The Alfred Hotel is of local historic, social and aesthetic significance. It is a fine and externally intact example of an Inter War Functionalist style hotel designed by prominent architects Copeman, Lemont &amp; Keesing. It is a prominent visual element in the historical precinct of Camperdown due its position on the corner of the street block and its stream-line modern style. It is important for its association with the earlier hotel of the same name, its role in the development of the locality and its role in</i></p>	<p>The site contains a two storey Inter War Functionalist style hotel with basement below street level at the Missenden Road end of the site. The building is a brick structure with reinforced concrete floors to the basement, ground floor and the first-floor balconies and bathrooms. The rest of the first-floor rooms have timber beams resting on steel joists. The main roof is framed in timber with light-weight metal sheet cladding and largely concealed by the parapet.</p> <p>The façade features face brickwork with the parapet having three recessed blond brick courses and a header course, projecting and recessed bricks to form simple modern motifs and expressing the curved corner as a recessed plane with the two elevations wrapping round. The curved parapet corner is</p>

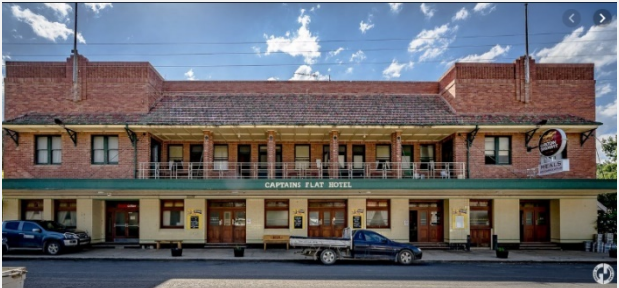
<p>Source: Tripadvisor.com.au</p>

<p><b>Captain Flat's Hotel</b> 49 Foxlow Street, Captains Flat, NSW</p>	<p><b>Palerang LEP, 2014 (item I255)</b> <i>Intact building exhibiting significant architectural details of the 1940s period with many of the original furnishings still in situ including the dining table. It makes an important contribution to the streetscape and is a building significant to the structure of the community. A good example of a hotel from the pre-war era. High degree of original intactness. Historic (a), aesthetic (c), social (d) and representative (g) heritage significance.</i><sup>14</sup></p>	<p>Captain's Flat Hotel is a two-storey red brick building with cream tiled wall on lower street façade and verandah above. The verandah is mostly enclosed with four brick pillars.</p> <p>The roof is partially parapeted, partly clad with terracotta tiles and partly corrugated asbestos. It has 20 bedrooms<sup>15</sup>.</p>

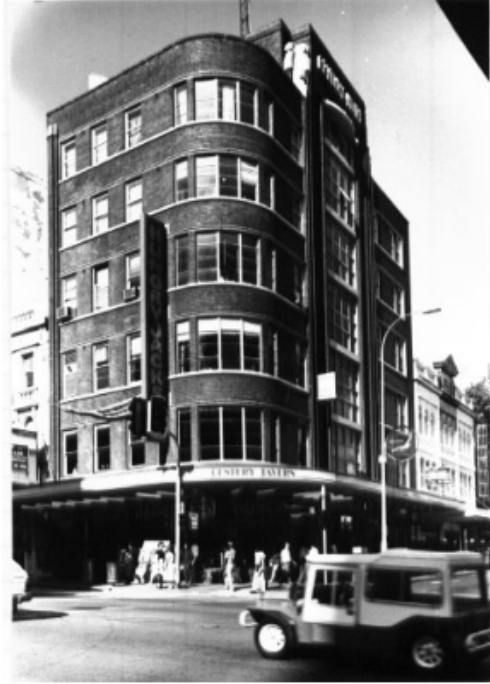
Property	Heritage Listing and Significance	Description	Photograph
<p><b>Century Hotel</b></p> <p>640-642 George Street, Sydney NSW</p>	<p><b>City of Sydney LEP, 2012 (item I1801)</b></p> <p>The Century Hotel, located on a prominent corner of George and Liverpool Streets, is a six-storey hotel of Inter war Art Deco Style. It is historically significant as part of a group of hotels like the Great Southern further along George Street, and the Broadway Hotel near Central Station. The Century Hotel has a powerful ability to reflect the attractive building opportunities offered for breweries in the brief period between the end of the depression and the beginning of the Second World War. It is an important building in the professional career of the architectural partnership of Rudder and Grout, most noted for their hotel designs. It is aesthetically significant as a rare and outstanding example of a highly intact original Art Deco Hotel with an exterior and some intact interiors of high-quality design with outstanding potential to be restored with minimum effort. It is particularly noted for its use of horizontal and vertical massing. It is socially significant as a surviving example of an Art Deco Hotel with a lengthy tradition of hotel trade on the site<sup>16</sup>.</p>	<p>The facade of streamlined modern style is faced in red bricks with dominant spandrel trims terminated by the central glazed bay to Liverpool Street, which has replaced the original curved glazing. Moulded bricks, terminating in terracotta scrolls, occur on each side of this curved window and rise up as a tower element in which the signage of the building was originally incorporated.</p> <p>The windows to the main facades are contained within the horizontal banding which stops short of the facade as a frame. Rainwater heads have been specially fabricated to match the stepped brick piers. Parts of the original gold and green tiles remain as remnants to the Liverpool Street facade. Elsewhere the tiles have been replaced. Internally the building contains a semi-circular stair which features full height glazing. The stair retains part of its original railing and timber panelling. The bar at the first floor is original and features plaster cornices, mirrors and reed glass and cocktail bar<sup>17</sup>.</p>

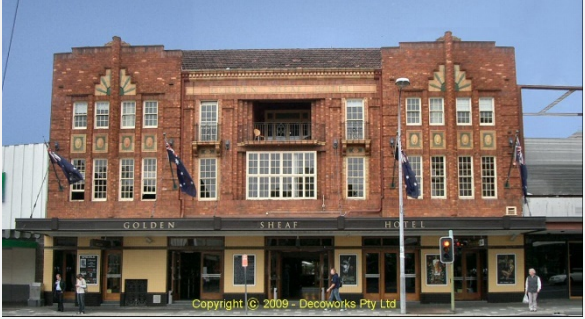
Property	Heritage Listing and Significance	Description	Photograph
<p><b>The Golden Sheaf Hotel</b></p> <p>429 New South Head Road, Double Bay</p>	<p><b>Woollahra LEP, 2014 (Item 208)</b></p> <p><i>No statement of significance available.</i></p>	<p>The Golden Sheaf Hotel was designed by Prevost and Ruwald, in a typical Inter War, art deco style. The hotel was constructed in 1936. The exposed brick façade with tiled ground floor and awning was typical of this era.</p> <p>The hotel has a small enclosed balcony on the third floor and multipaned, painted, timber windows. The original name of the hotel has been retained along the roof line in the centre.</p> <p>The detail above the windows and motifs are significant art deco features.</p>

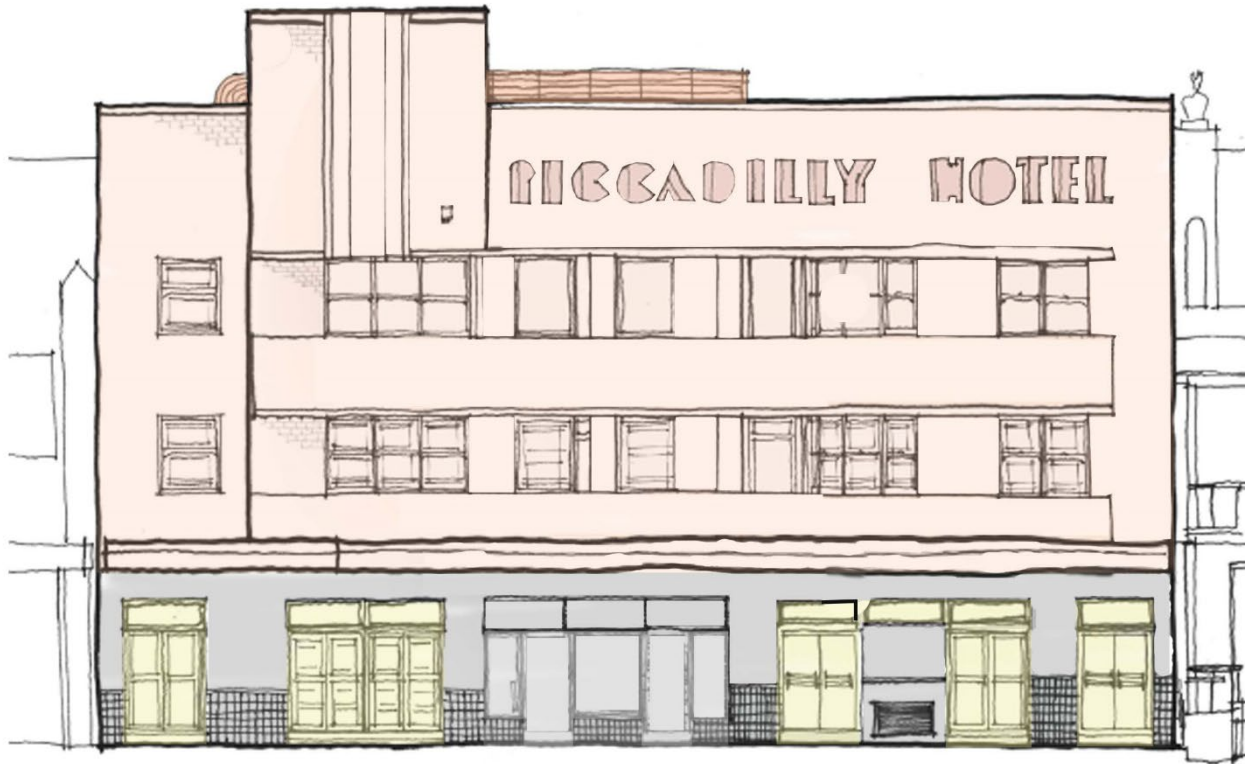
Figure 143 – Significance map for the Eastern Facade

The following maps have been prepared to illustrate significant fabric on the eastern façade and all floors of the subject site. These should also be read in conjunction with the schedule above (Table 11 and Table 12).

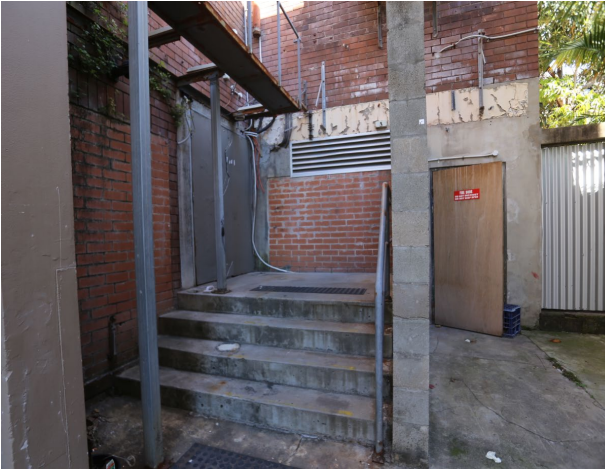
Figure 152 – Views of the western façade from Hourigan Lane.

Significant views to the subject site have been identified in this section. However, due to the built-up nature of the street and scale of the building, there is limited visibility towards the site. In addition, Victoria Street is lined with trees which obscure the subject site from view. The effect of this varies depending on the season. Further, no significant views toward the western façade have been identified given the Brougham Street terraces obscure views and much of the fabric to the western façade is later fabric of no significance. This is demonstrated in the photographs included below.

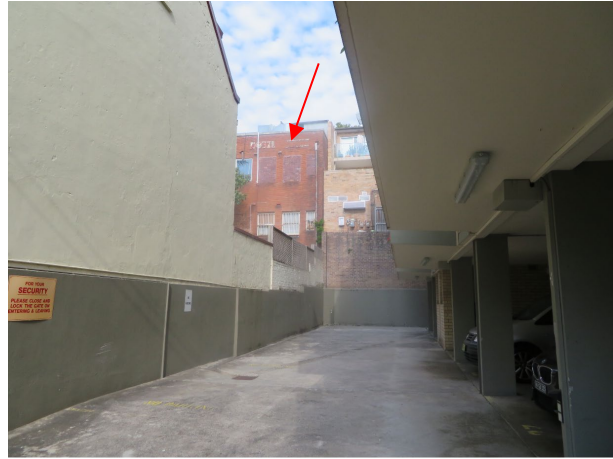
Figure 153 – Views from Brougham Street of the top corner of the western façade (indicated).

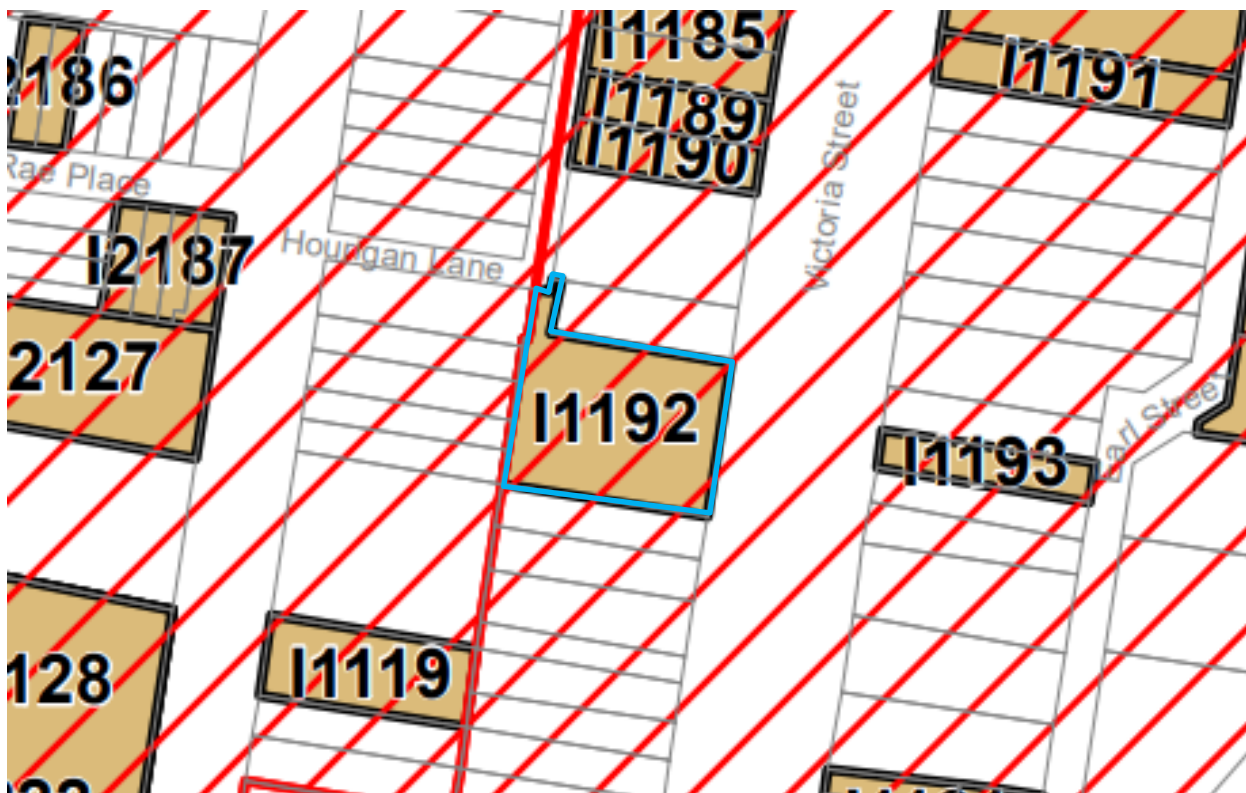
The subject site is item of Local heritage significance “Piccadilly Hotel including interior” (I1192) and is located within the “Potts Point Heritage Conservation Area” (C51) as shown below in the heritage map.

Figure 162 – Heritage Map. The subject site is outlined in blue.
