Attachment B26(d)

**Pedestrian Wind Environment Study Part 4
– Waterloo Estate (South) – Land and
Housing Corporation**

8 ASSESSMENT

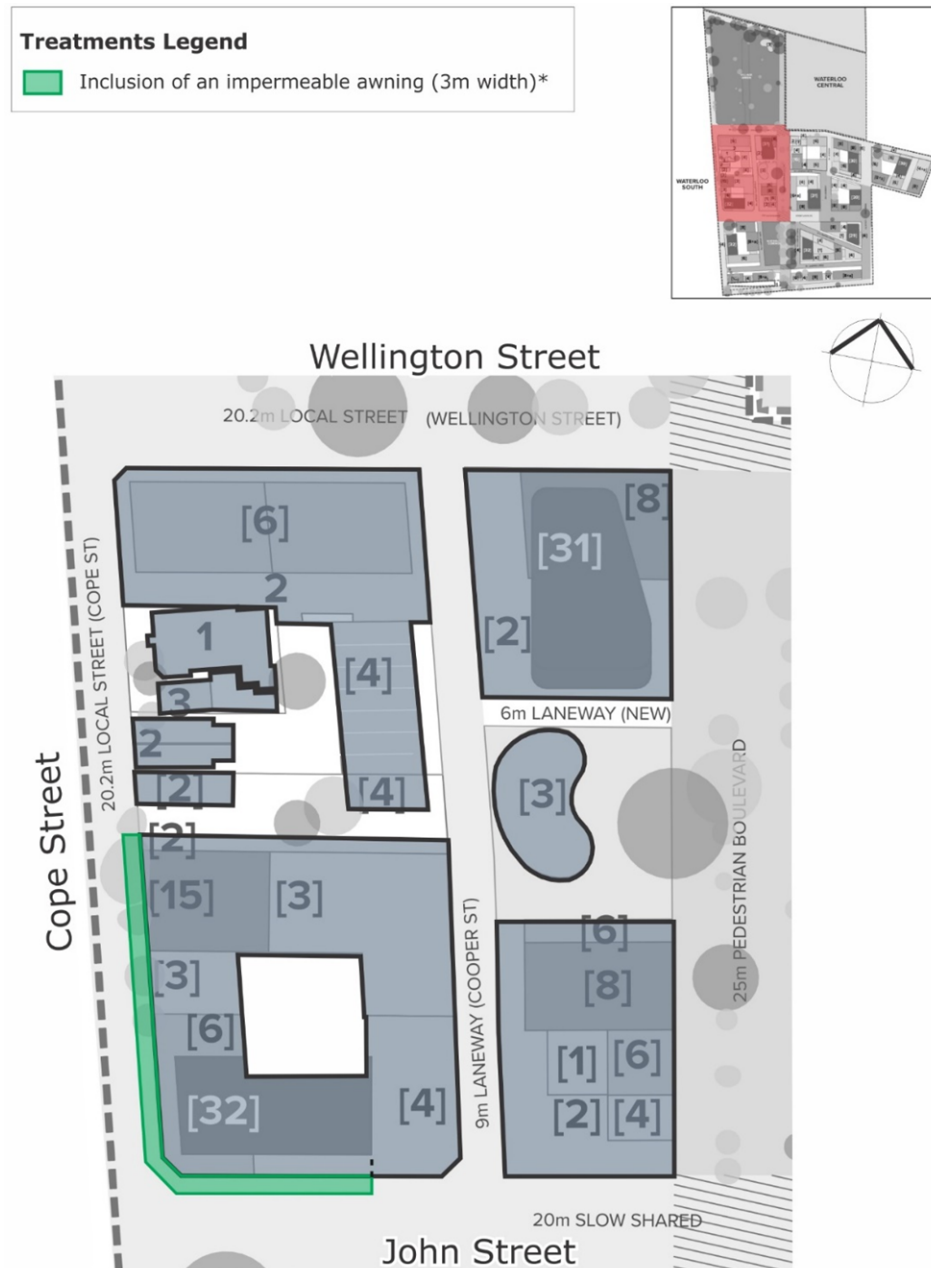
Figure 12a: Recommended Treatments – Lot L, M, PS, R and Q

- Inclusion of an impermeable awning (3m width)*
- Inclusion of a 2m high porous screen (5m length)*

- Recommended wrap around awning on western and southern aspects of Building Q1, as shown in Figure 12a.
- Recommended wrap around awning on western and southern aspects of Building U2, as shown in Figure 12b.
- Recommended wrap around awning on western and southern aspects of Building Y1, as shown in Figure 12b.
- Recommended chamfering of south-east building corner on Building Z5, as shown in Figure 12c.
- Recommended wrap around awning on eastern and southern aspects of Building Z5, as shown in Figure 12c.
- Recommended porous screen at north-west corner of Building U4, as shown in Figure 12b.
- Retention of trees as noted in tree retention plan (No.: 17018, Dwg.: 710.3, dated: 18.2.20).

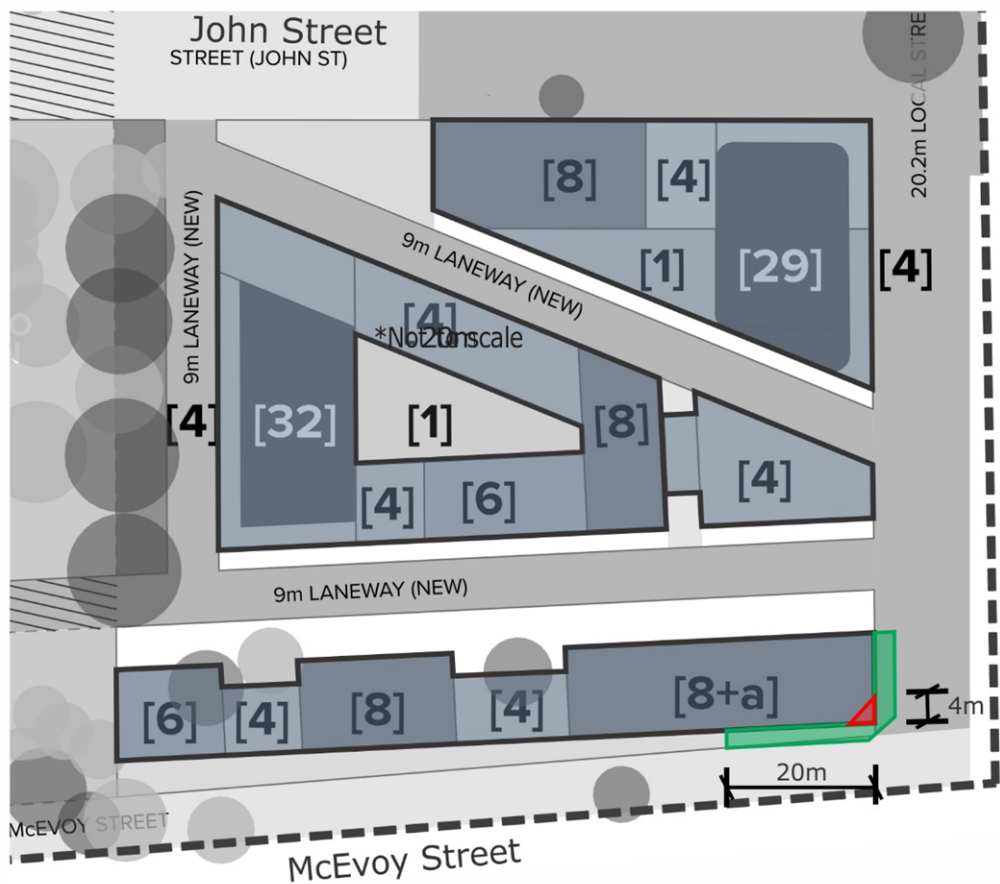
Figure 12c: Recommended Treatments – Lot W, X and Z

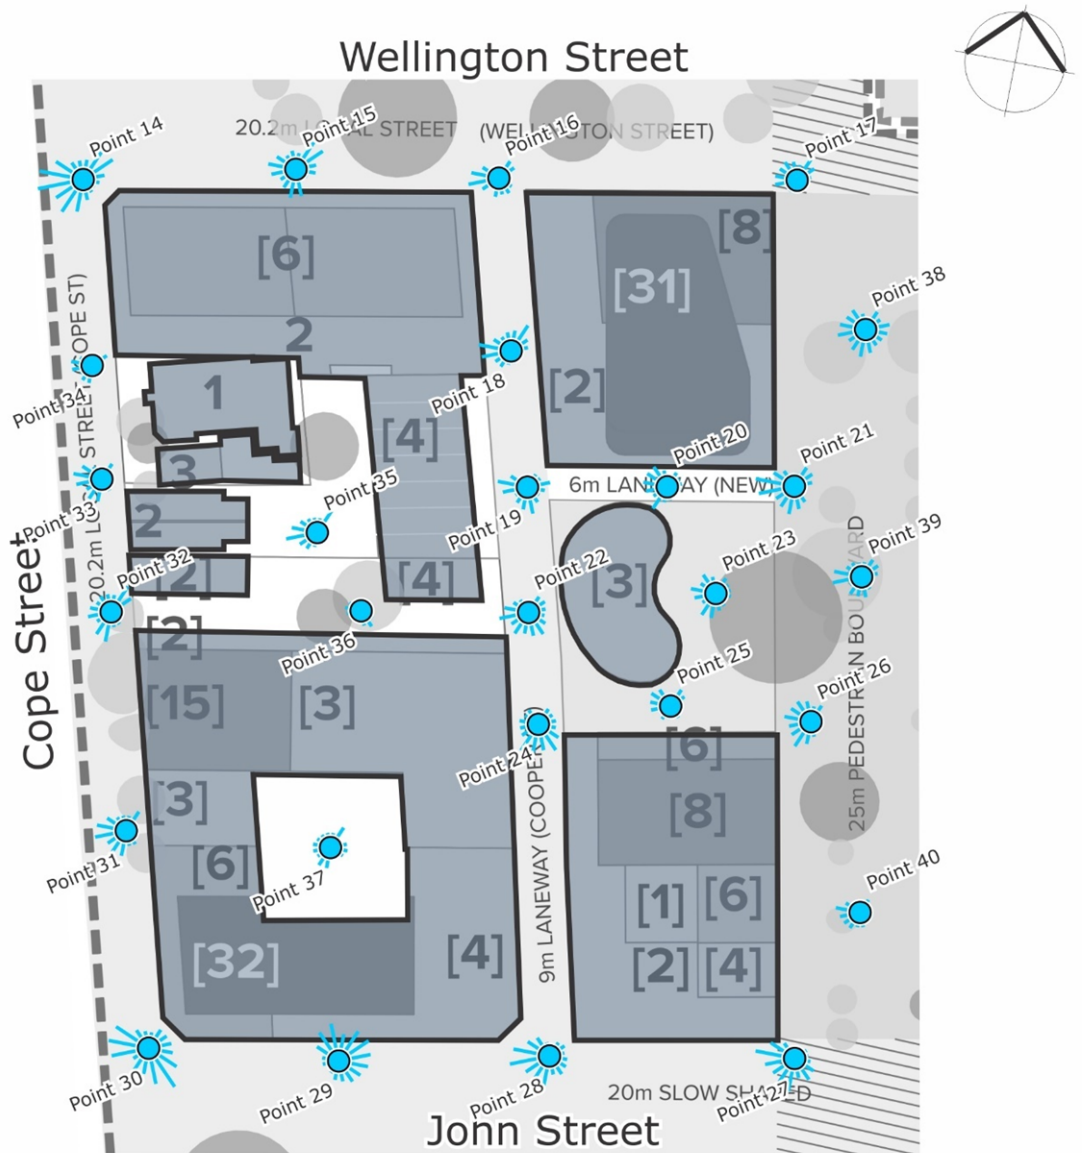
**Figure 13b: Wind Directionality Plots – Lot L, M, PS, R and Q
(with treatments applied)**

The results for study points locations can be seen in the form of directional wind speed plots presented in Figures 13a – 13g.

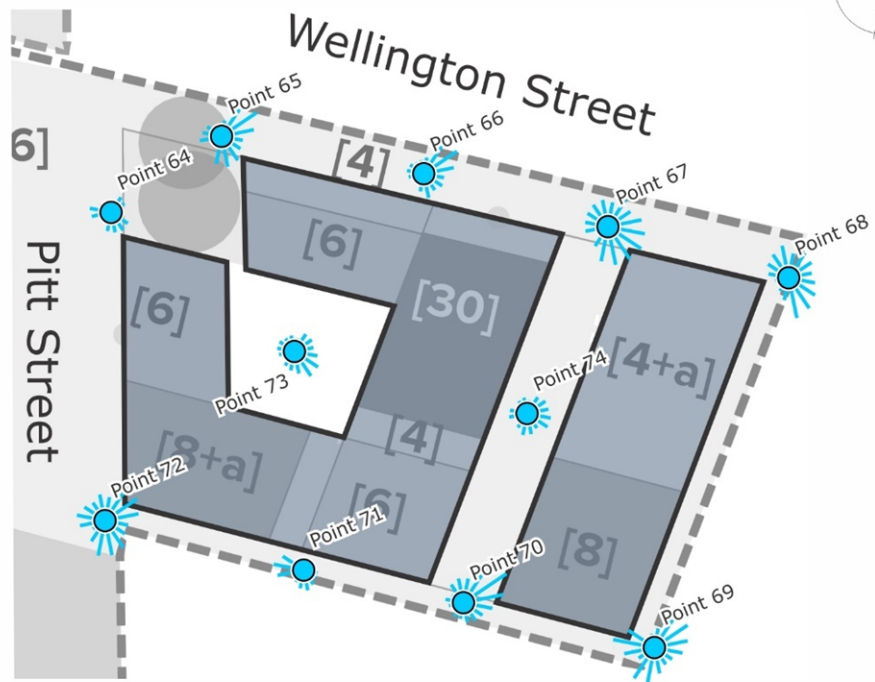
**Figure 13d: Wind Directionality Plots – Lot P
(with treatments applied)**
