# **Attachment A6**

**Site Survey - 15-25 Hunter and 105-107 Pitt  
Street, Sydney**

**PLAN SHOWING DETAIL & LEVELS**  
AT THE CORNER OF PITT STREET AND HUNTER STREET

JOB No.: 192625	LGA: SYDNEY
PLAN No.: 192625-1	DATUM: AHD
DATE: 19/11/2019	SCALE: 1:200@A1
DRAWN: RA	CONT. INTERVAL: 0.25m
CHK: WH	SHEET 1 OF 1

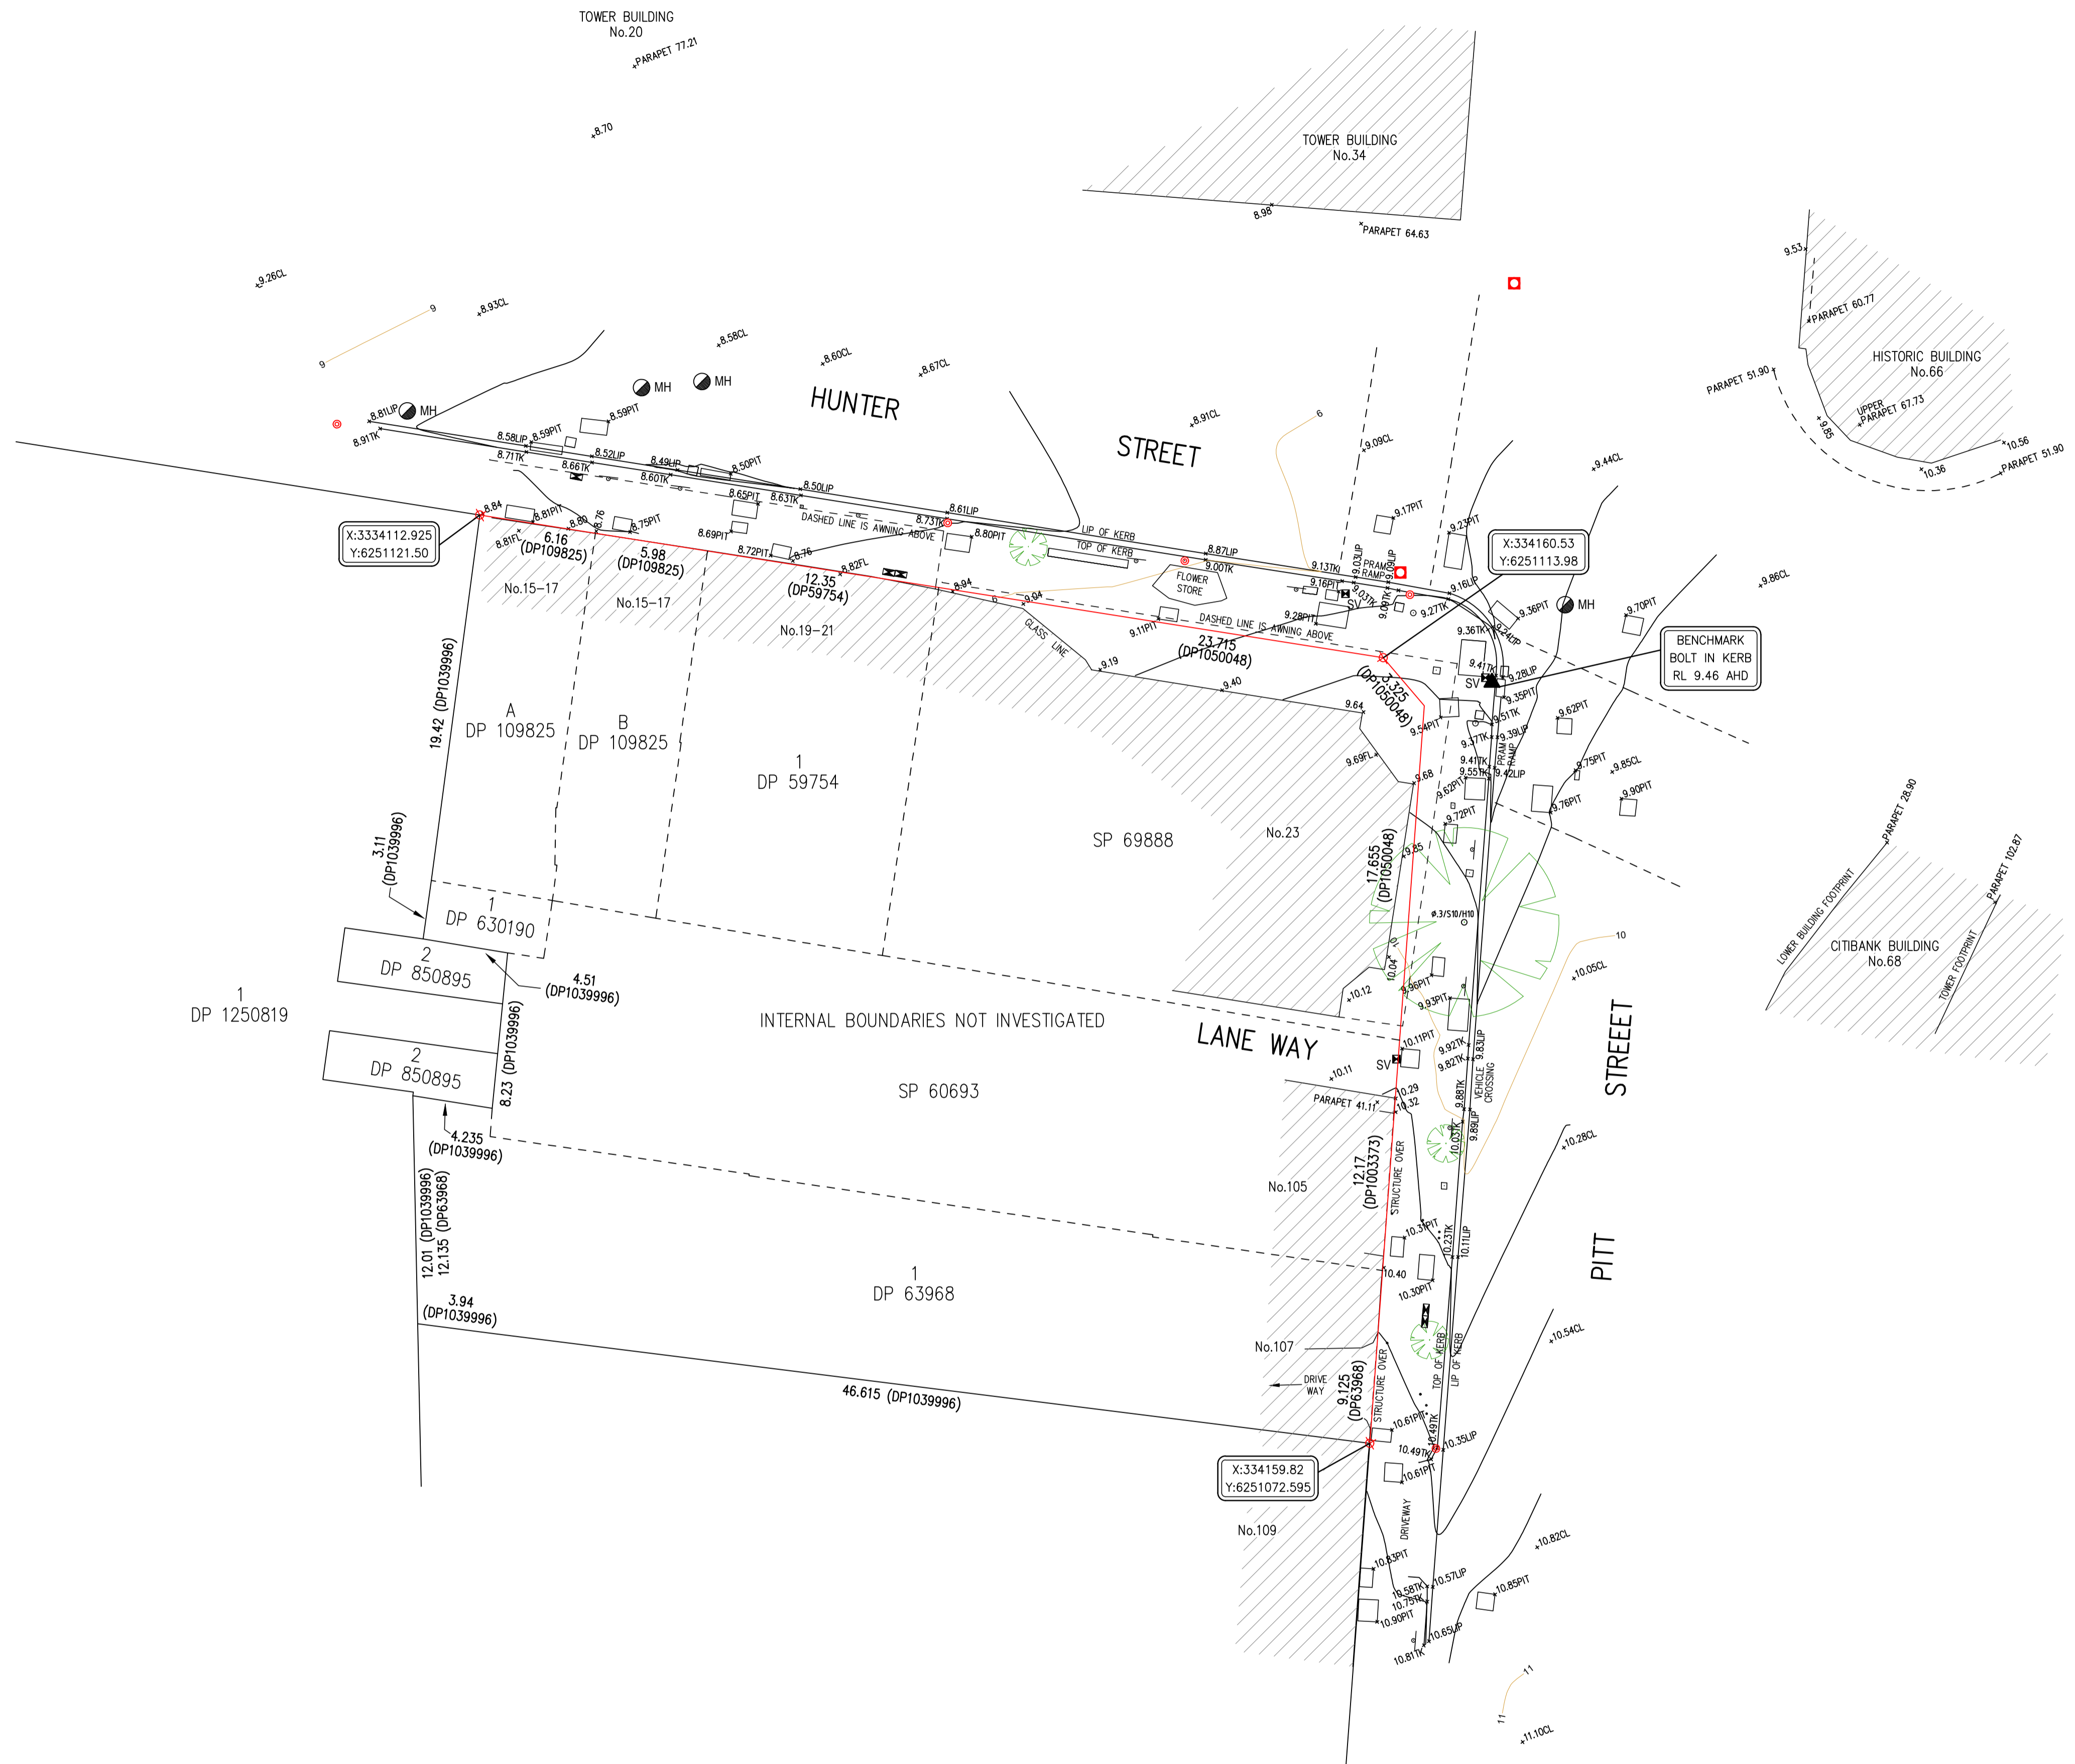
LEVELS ARE BASED ON AUSTRALIAN HEIGHT DATUM (AHD) USING PM 147079 WITH RL 8.903 (AHD).

CONTOURS SHOWN DEPICT THE TOPOGRAPHY. EXCEPT AT SPOT LEVELS SHOWN THEY DO NOT REPRESENT THE EXACT LEVEL AT ANY PARTICULAR POINT. THE SPOT LEVELS ARE TRUE FOR THEIR POSITION, AND ARE INTENDED TO BE USEFUL TO REPRESENT THE GENERAL TERRAIN. CARE SHOULD BE TAKEN IF EXTRAPOLATING.

ALL BOUNDARIES HAVE NOT BEEN LOCATED BY SURVEY. THE BOUNDARIES SHOWN IN BLACK ON THIS PLAN HAVE BEEN TAKEN FROM THE TITLE DEPOSITED PLAN AND ARE APPROXIMATE ONLY. BOUNDARIES EDGED IN RED HAVE BEEN DEFINED BY SURVEY ON 14/11/2019. FURTHER INVESTIGATION MUST BE COMPLETED PRIOR TO ANY FINAL DESIGN.
