Local Planning Panel

Address: 25-27 Dunning Avenue, Rosebery

D/2021/1491

Alterations and additions to heritage warehouse building to create a five storey commercial development

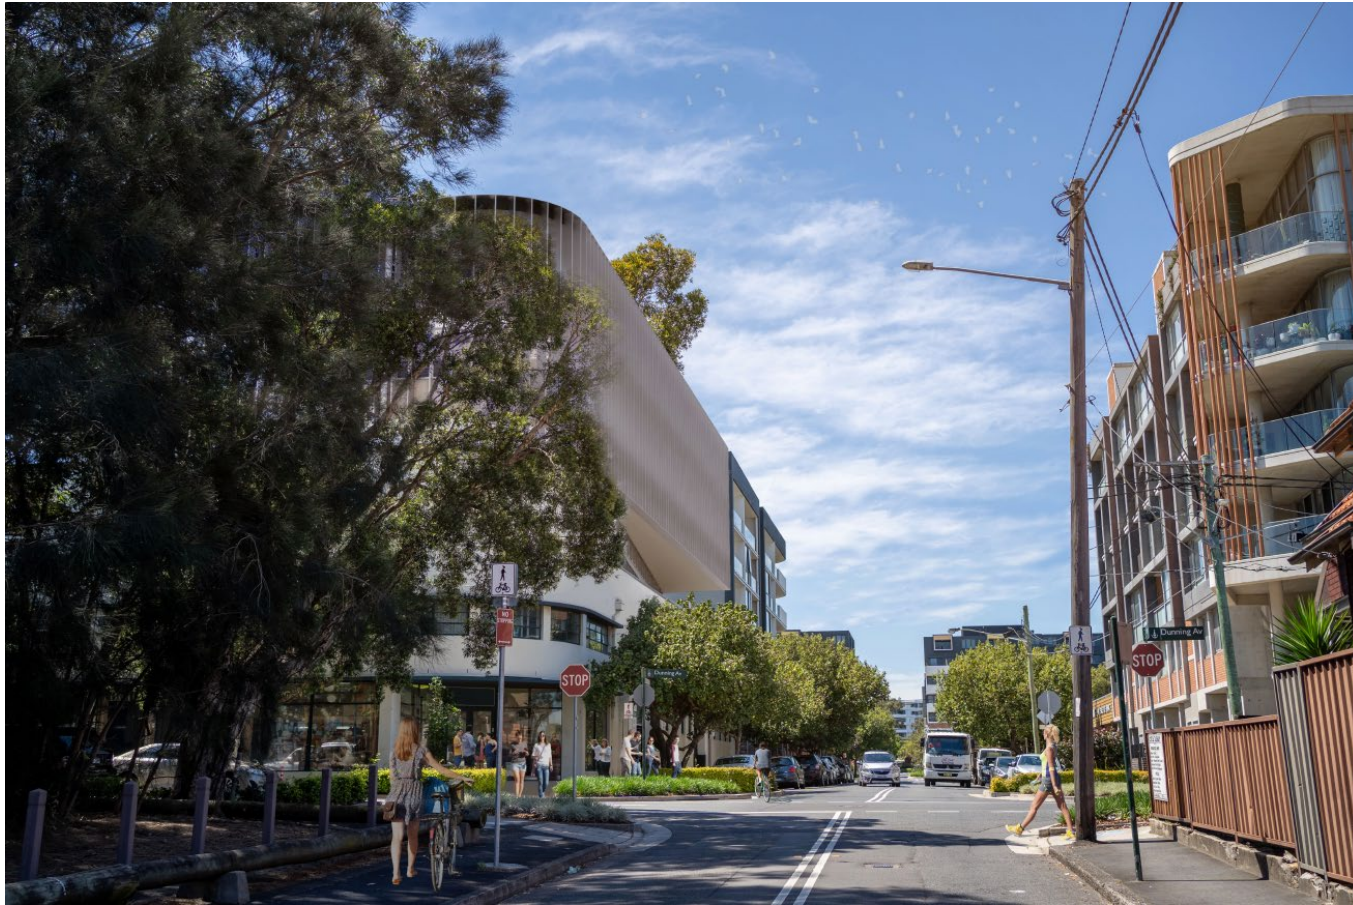
Photomontage – view east along Cressy Street

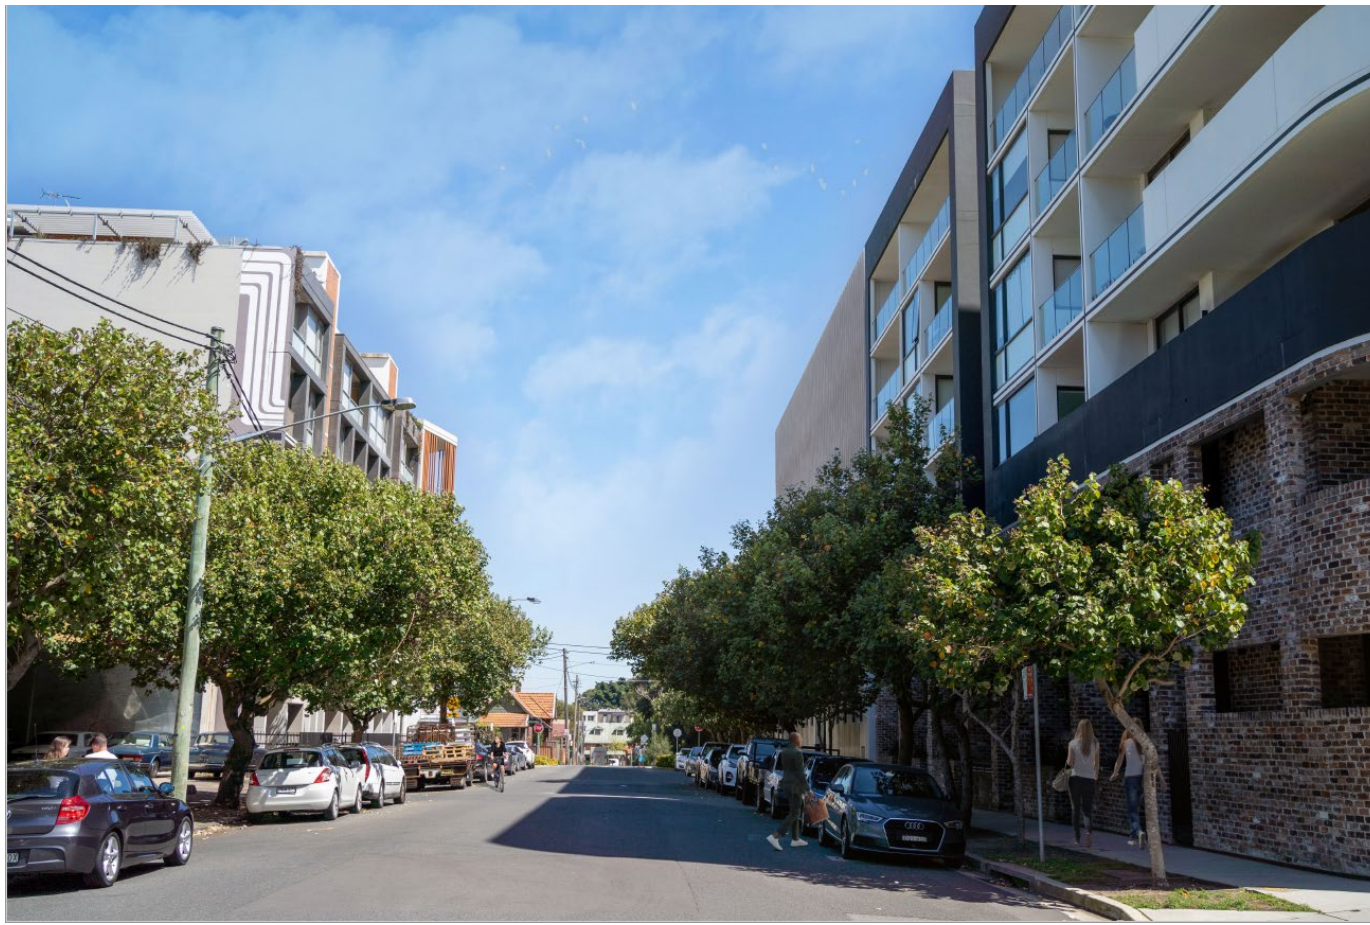
Photomontage – view west along Cressy Street

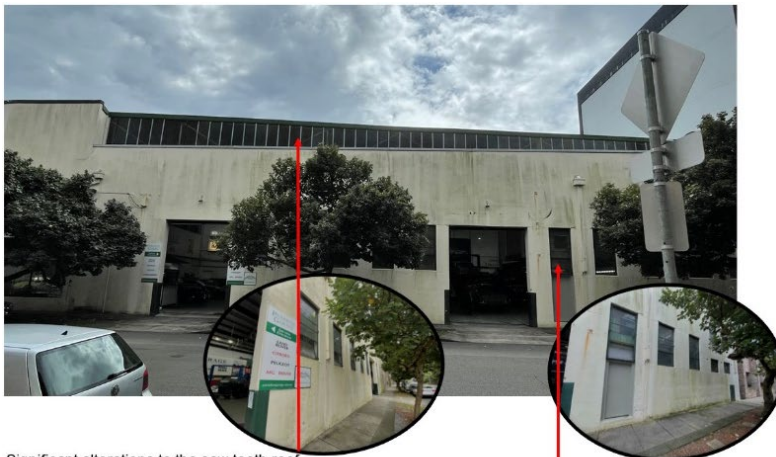
Significant alterations to the saw tooth roof glazing to be replaced by cantilevered terrace fronting cressy street.

New glazing treatments not part of the existing façade and not consistent with any existing elements.

Additional windows as shown are significantly different and alter the heritage façade and impacts the fabric negatively.

Windows are proposed to be altered in size and type.
