Attachment A8

Surveys

JBW SURVEYORS PTY LTD CLIENT: MERITON GROUP PROJECT: 118-130 EPSOM RD & 905 SOUTH DOWLING ST, ZETLAND

PLAN SHOWING SELECT FEATURES & LEVELS

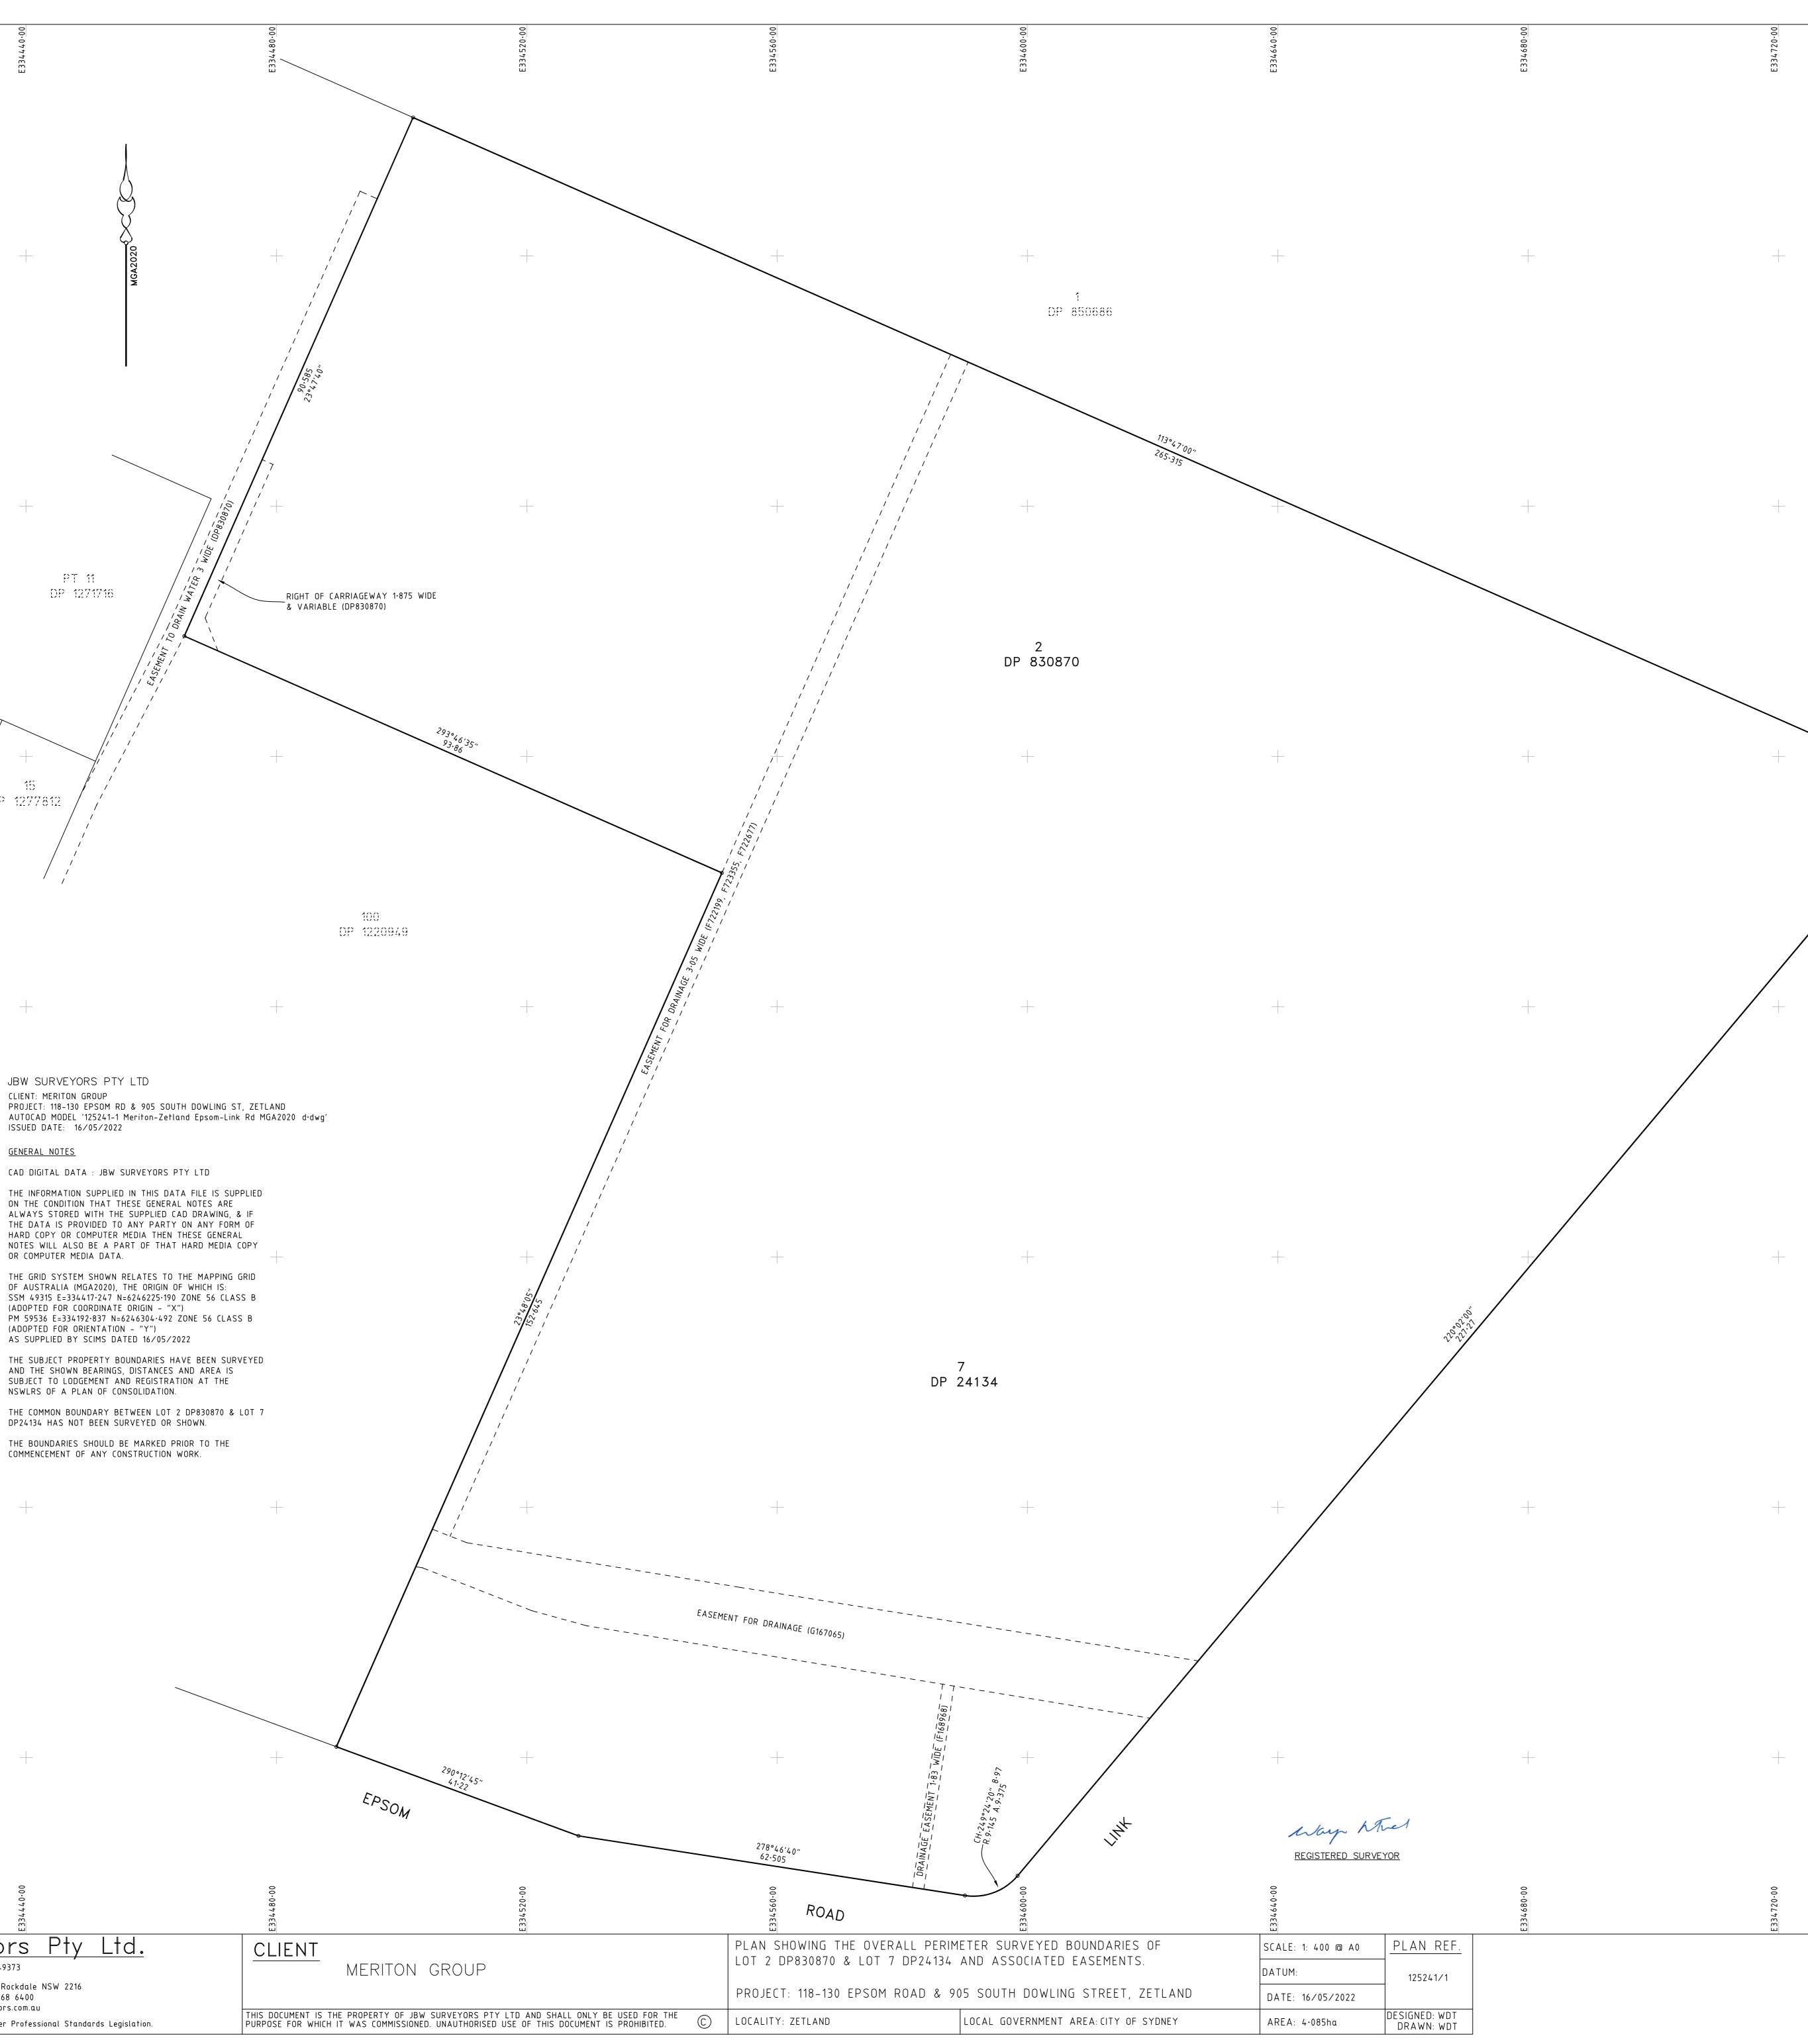
THE SUBJECT LAND - LOT 7 DP 24134 IS AFFECTED BY COVENANT (VIDE DEALING No. F722199)

(C) EASEMENT FOR DRAINAGE BURDENING PART OF THE SUBJECT LAND (VIDE DEALING No. G167065) (E) EASEMENT FOR DRAINAGE 3.05 WIDE BURDENING PART OF THE SUBJECT LAND (VIDE DEALING No. F722199) (M) EASEMENT FOR DRAINAGE BURDENING PART OF THE SUBJECT LAND (VIDE DEALING No. F168968)

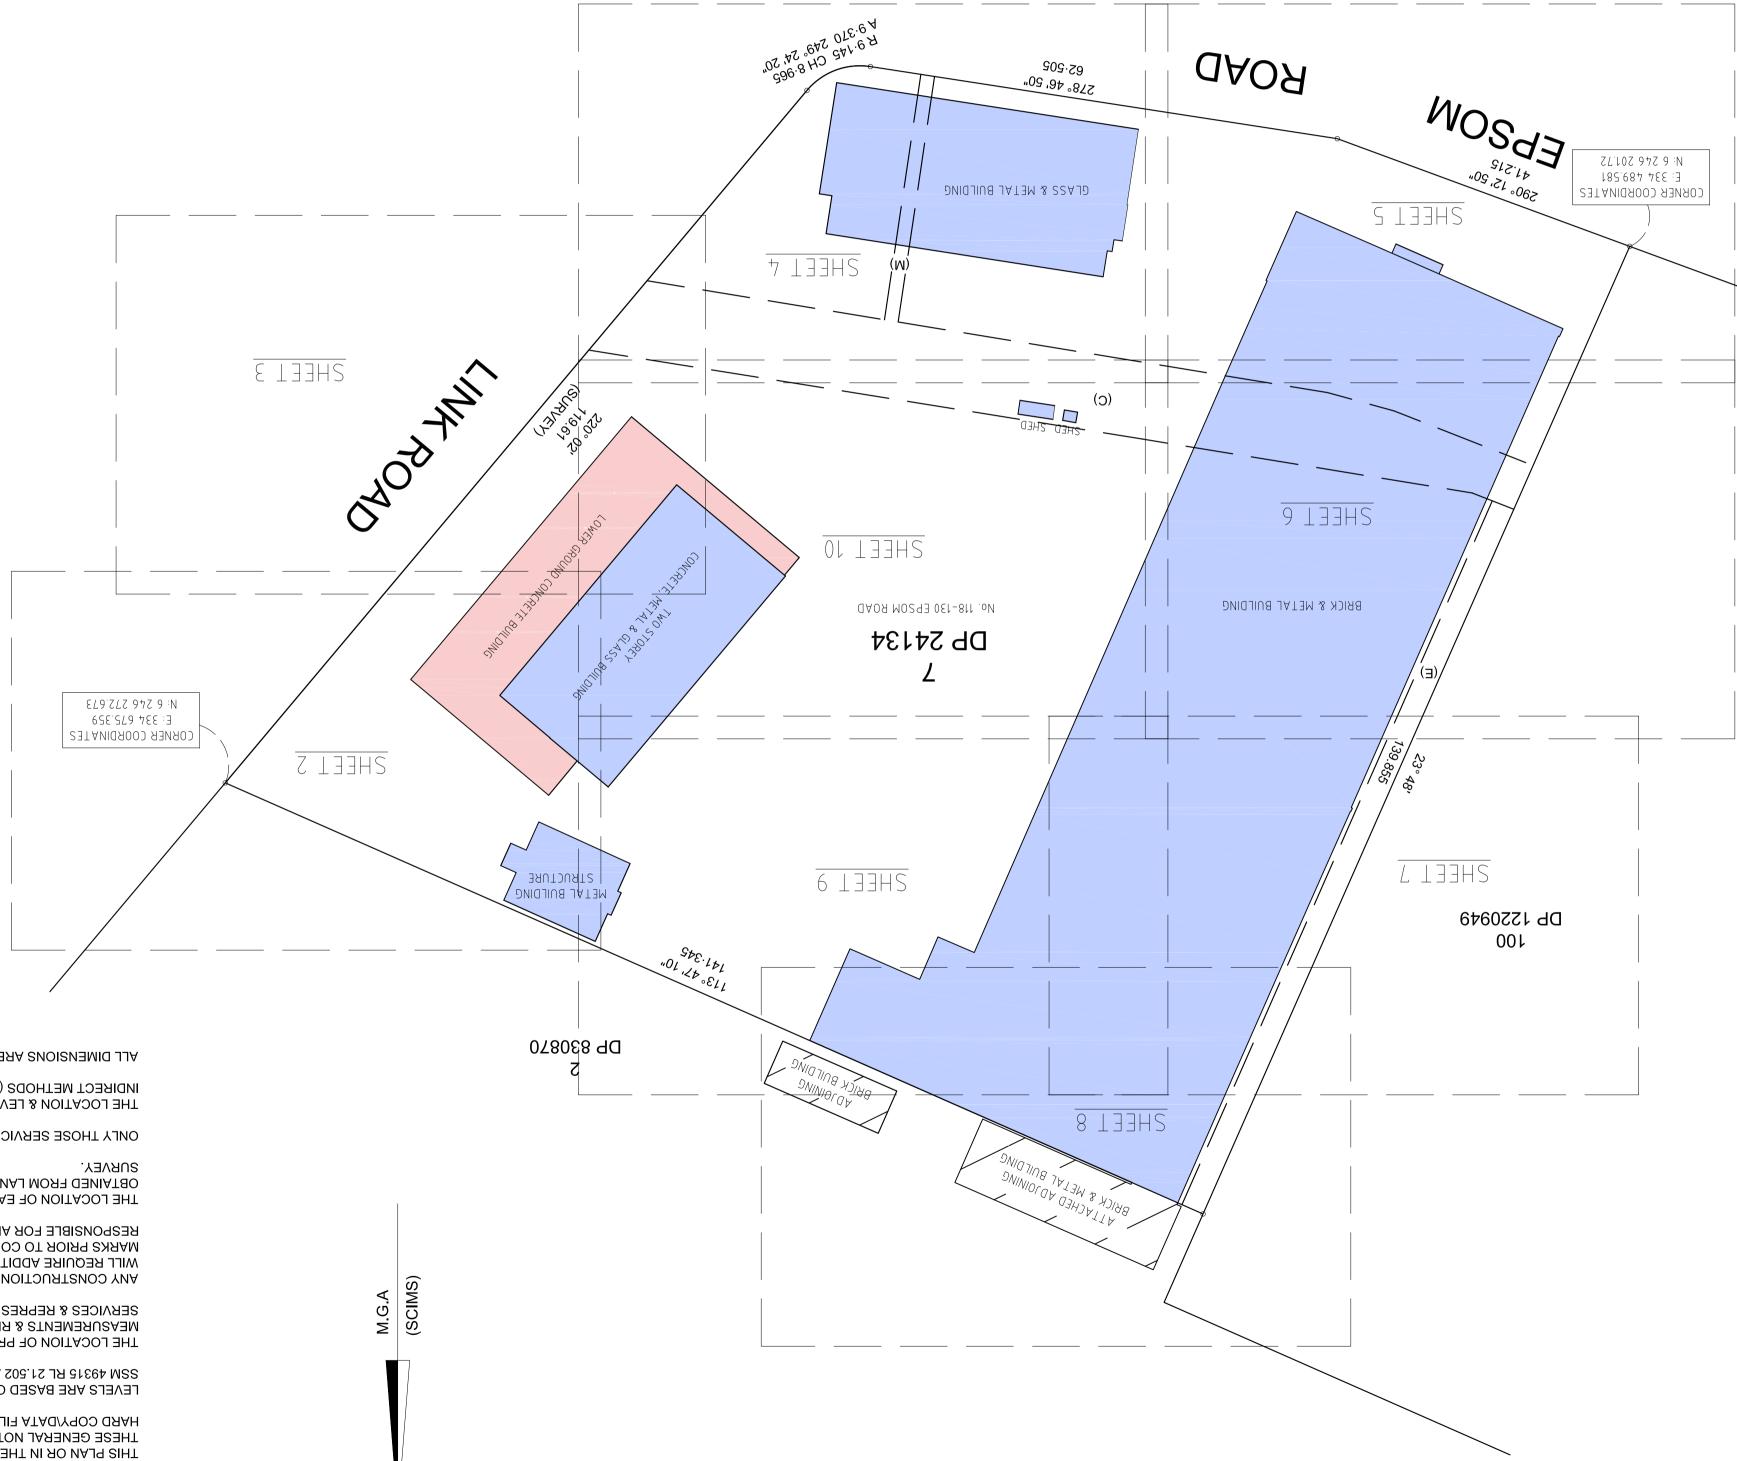
REING No.118-130 EPSOM ROAD, ZETLAND, 2015	СНЕСКЕD : DW	REF: 75183RL	SHEET No. 1 OF 10				<u> </u>	
COL 2 IN Db 54314		L.G.A. : LANE COVE	СОИТОЛЯ INTERVAL: 0.25m	COMPANIES			<u> </u>	
PLAN SHOWING GENERAL SITE CONDITIONS	צחצאבא : צר	ΓΟΟΥΓΙΤΥ : ΓΟΝGUEVILLE	OBIGIN OF LEVELS : SSM 49315	SUTTONS GROUP OF			<u> </u>	
DESCRIPTION:	DATE : 15-05-2020	SCALE : NOT TO SCALE	. G. H. A : MUTAD	- РСАИ РАЕРАКЕD FOR:	COMMENTS	REV	A <u></u> TAD	- ¹ 5

Erected on the subject land is a brick and metal industrial and office building attached to the building erected on the adjacent property, a metal building structure, a glass and metal building and a concrete, metal and glass building with carparking under. These building structures as surveyed generally stand within the subject property and the location relative to subject property boundaries is as shown on the accompanying plan. Encroachments are as noted below.

- 1. Reservations and conditions in the Crown Grant(s).
- 2. Drainage Easement burdening the subject land (vide Dealing No. F168968) designated (M) as shown on the accompanying plan.
- 3. Easement for Drainage burdening the subject land (vide Dealing No. F722199) designated (E) as shown.
- 4. Covenant (vide Dealing No. F722199).
- 5. Easement for Drainage burdening the subject land (vide Dealing No. G167065) designated (C) as shown.

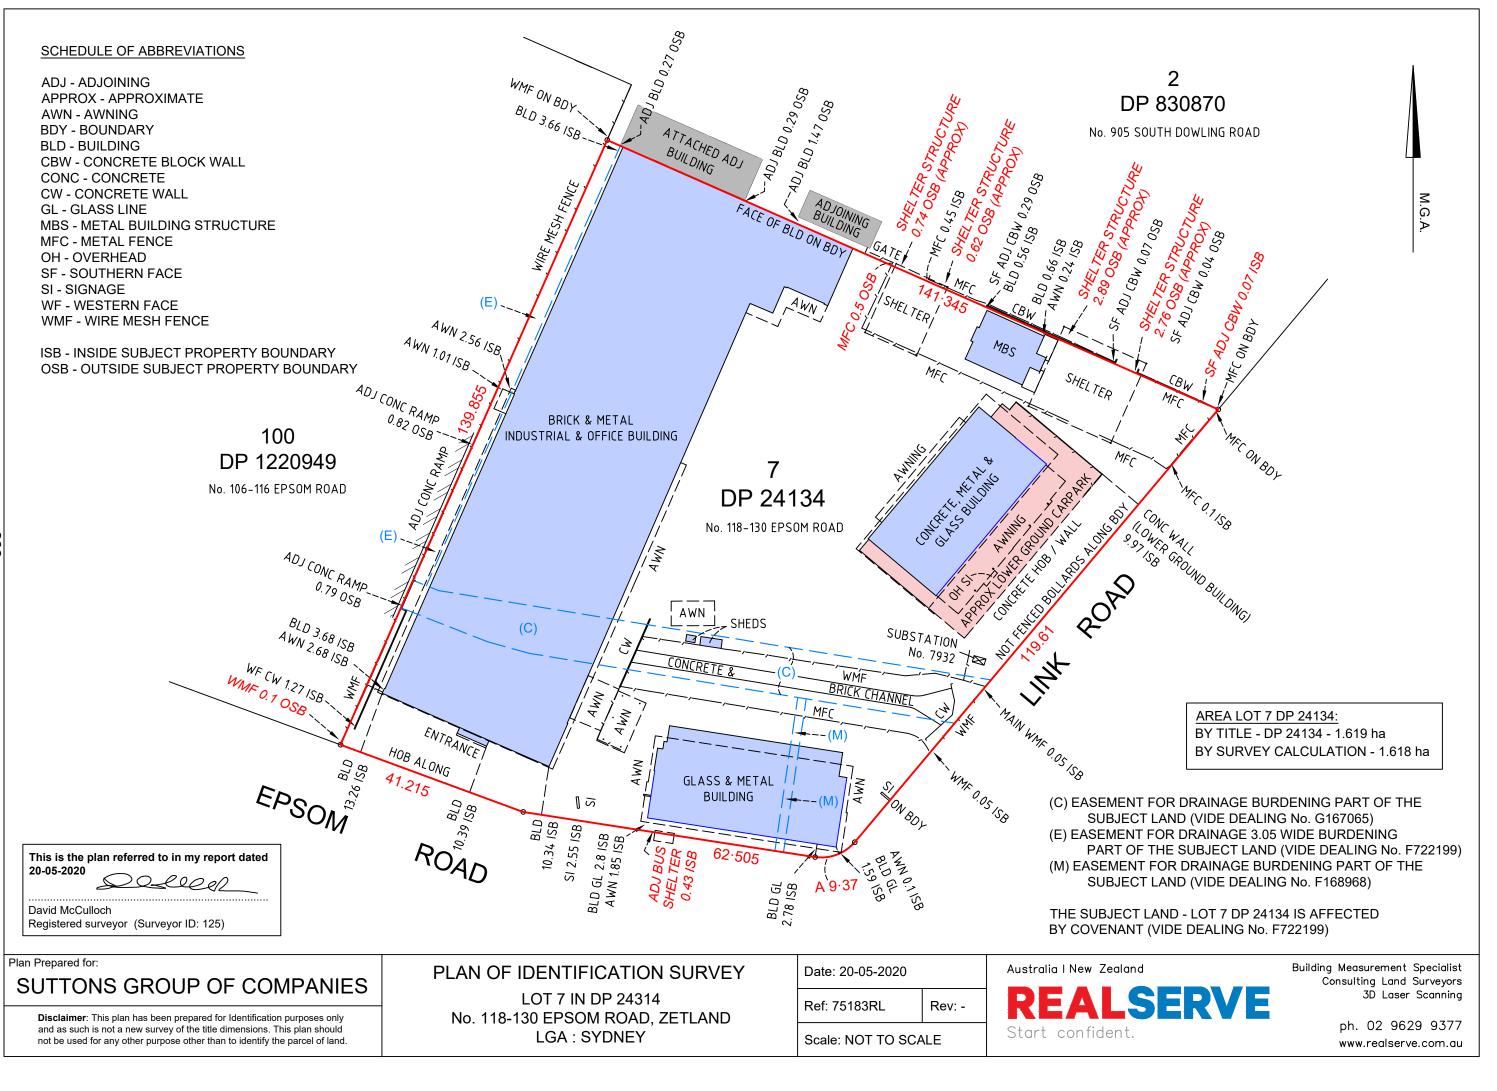
- The northern part of two shelter structures erected on the subject land stand and overhang over the adjoining land to the north (Lot 2 DP 830870) by up to 2.89 metres as shown.
- Part of the southern face of a concrete block wall erected on the adjoining land to the north (Lot 2 DP 830870) stands over the subject land by 0.07 metres as shown on the accompanying plan.
- The northern part of a bus shelter structure erected on Epsom Road to the south overhangs over the subject land by 0.43 metres as shown.

Apart from fencing irregularities shown on the accompanying plan there appears to be no further visible encroachments by or upon the subject property as surveyed & where accessible.

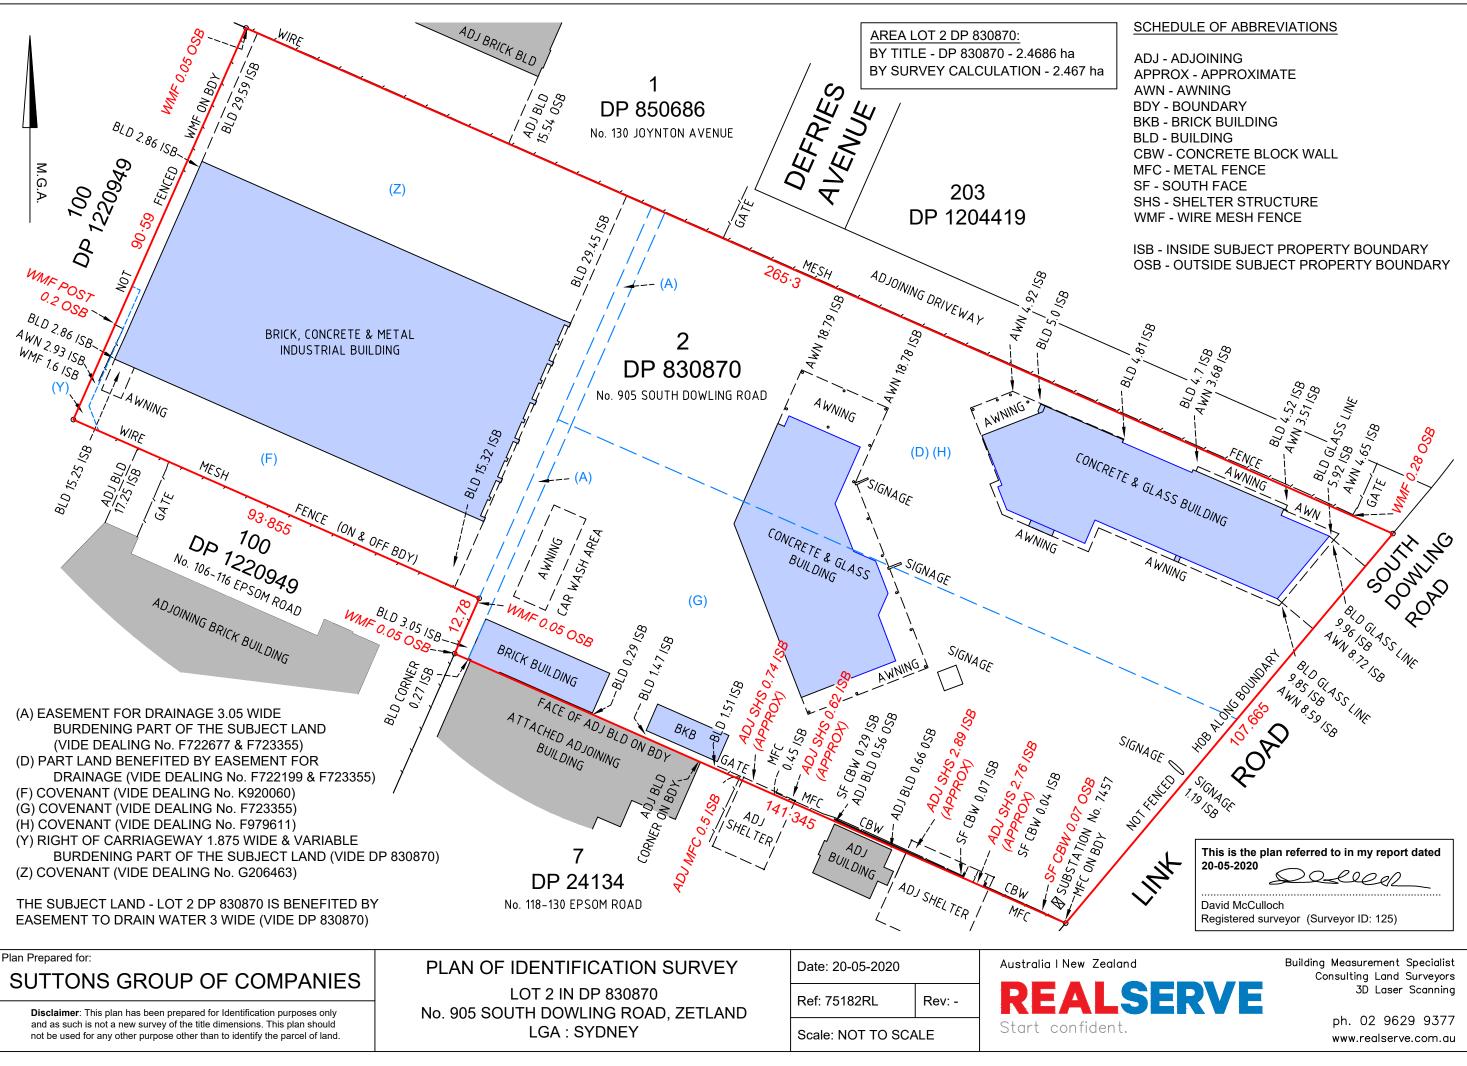
- Part of the southern face of a concrete block wall erected on the subject land stands over the adjoining land to the south by 0.07 metres as shown on the accompanying plan.
- The northern part of two shelter structures erected on the adjoining land to the south (Lot 7 DP 24134) stand and overhang over the subject land by up to 2.89 metres as shown.

Apart from fencing irregularities shown on the accompanying plan there appears to be no further visible encroachments by or upon the subject property as surveyed & where accessible.

- 1. Reservations and conditions in the Crown Grant(s).
- 2. Covenant (vide Dealing No. F723355) designated (G) as shown on the accompanying plan.
- 3. Covenant (vide Dealing No. F979611) designated (H) as shown.
- 4. Covenant (vide Dealing No. G206463) designated (Z) as shown.
- 5. Covenant (vide Dealing No. K920060) designated (F) as shown.
- 6. Easement for Drainage 3.05 metres wide benefiting part of the subject land (vide Dealing No. F722199 & F723355) designated (D) as shown.
- Easement for Drainage 3.05 metres wide burdening part of the subject land (vide Dealing No. F722677 & F723355) designated (A) as shown and, Right of Carriageway 1.875 metres wide and variable width (vide DP 830870) designated (Y) as shown.
- 8. Easement to Drain Water 3 metres wide benefiting the subject land (vide DP 830870).
