Report on
Geotechnical Desktop Investigation

Proposed Commercial Building
232-240 Elizabeth Street, Surry Hills

Prepared for
Stasia Holdings Pty. Limited

Project 218198.00
November 2022

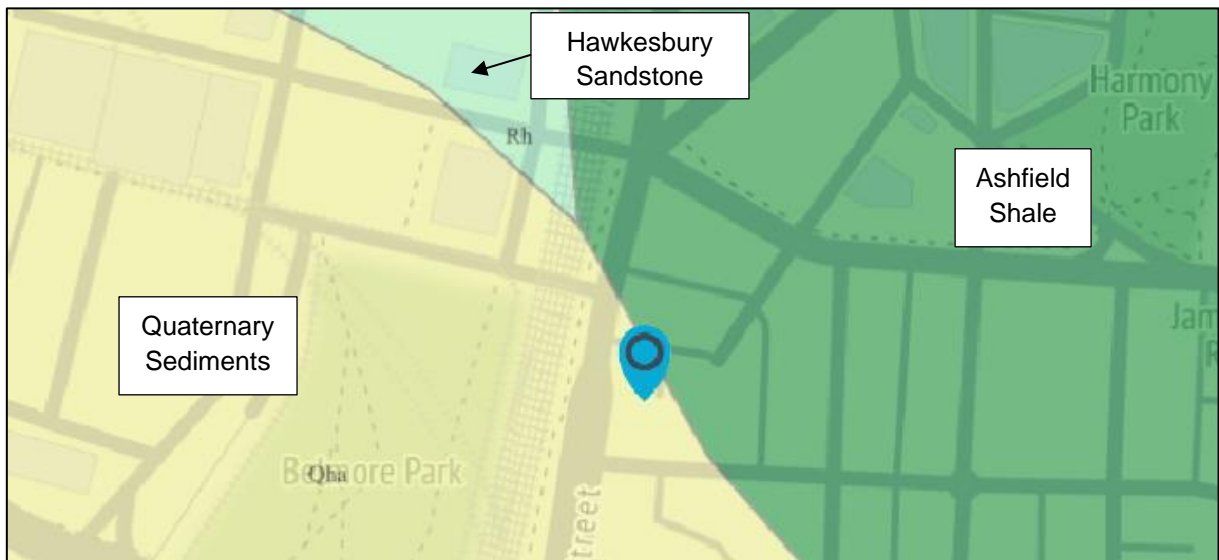
Figure 2: Excerpt of Sydney 1:100 000 Geological Series Sheet with Site (Blue Marker).

Reference to the Sydney 1:100 000 Geological Series Sheet (see Figure 2) indicates that the site is underlain by Quaternary aged alluvial and estuarine sediments which typically comprise silty to peaty quartz sand, silt, and clay with ferruginous and humic cementation in places and common shell layers.

The site is located close to the boundary between the Hawkesbury Sandstone and Ashfield Shale units, both of Triassic Age but the overlying sediments mask the boundary. The Mittagong Formation, which typically contains interbedded shale, laminite and medium-grained quartz sandstone, is a transitional unit between the Ashfield Shale and the Hawkesbury Sandstone. The Hawkesbury Sandstone comprises flat or gently dipping medium and coarse grained, quartzose sandstone with minor shale and siltstone interbeds, while the Ashfield Shale comprises shale, laminite and carbonaceous shale.

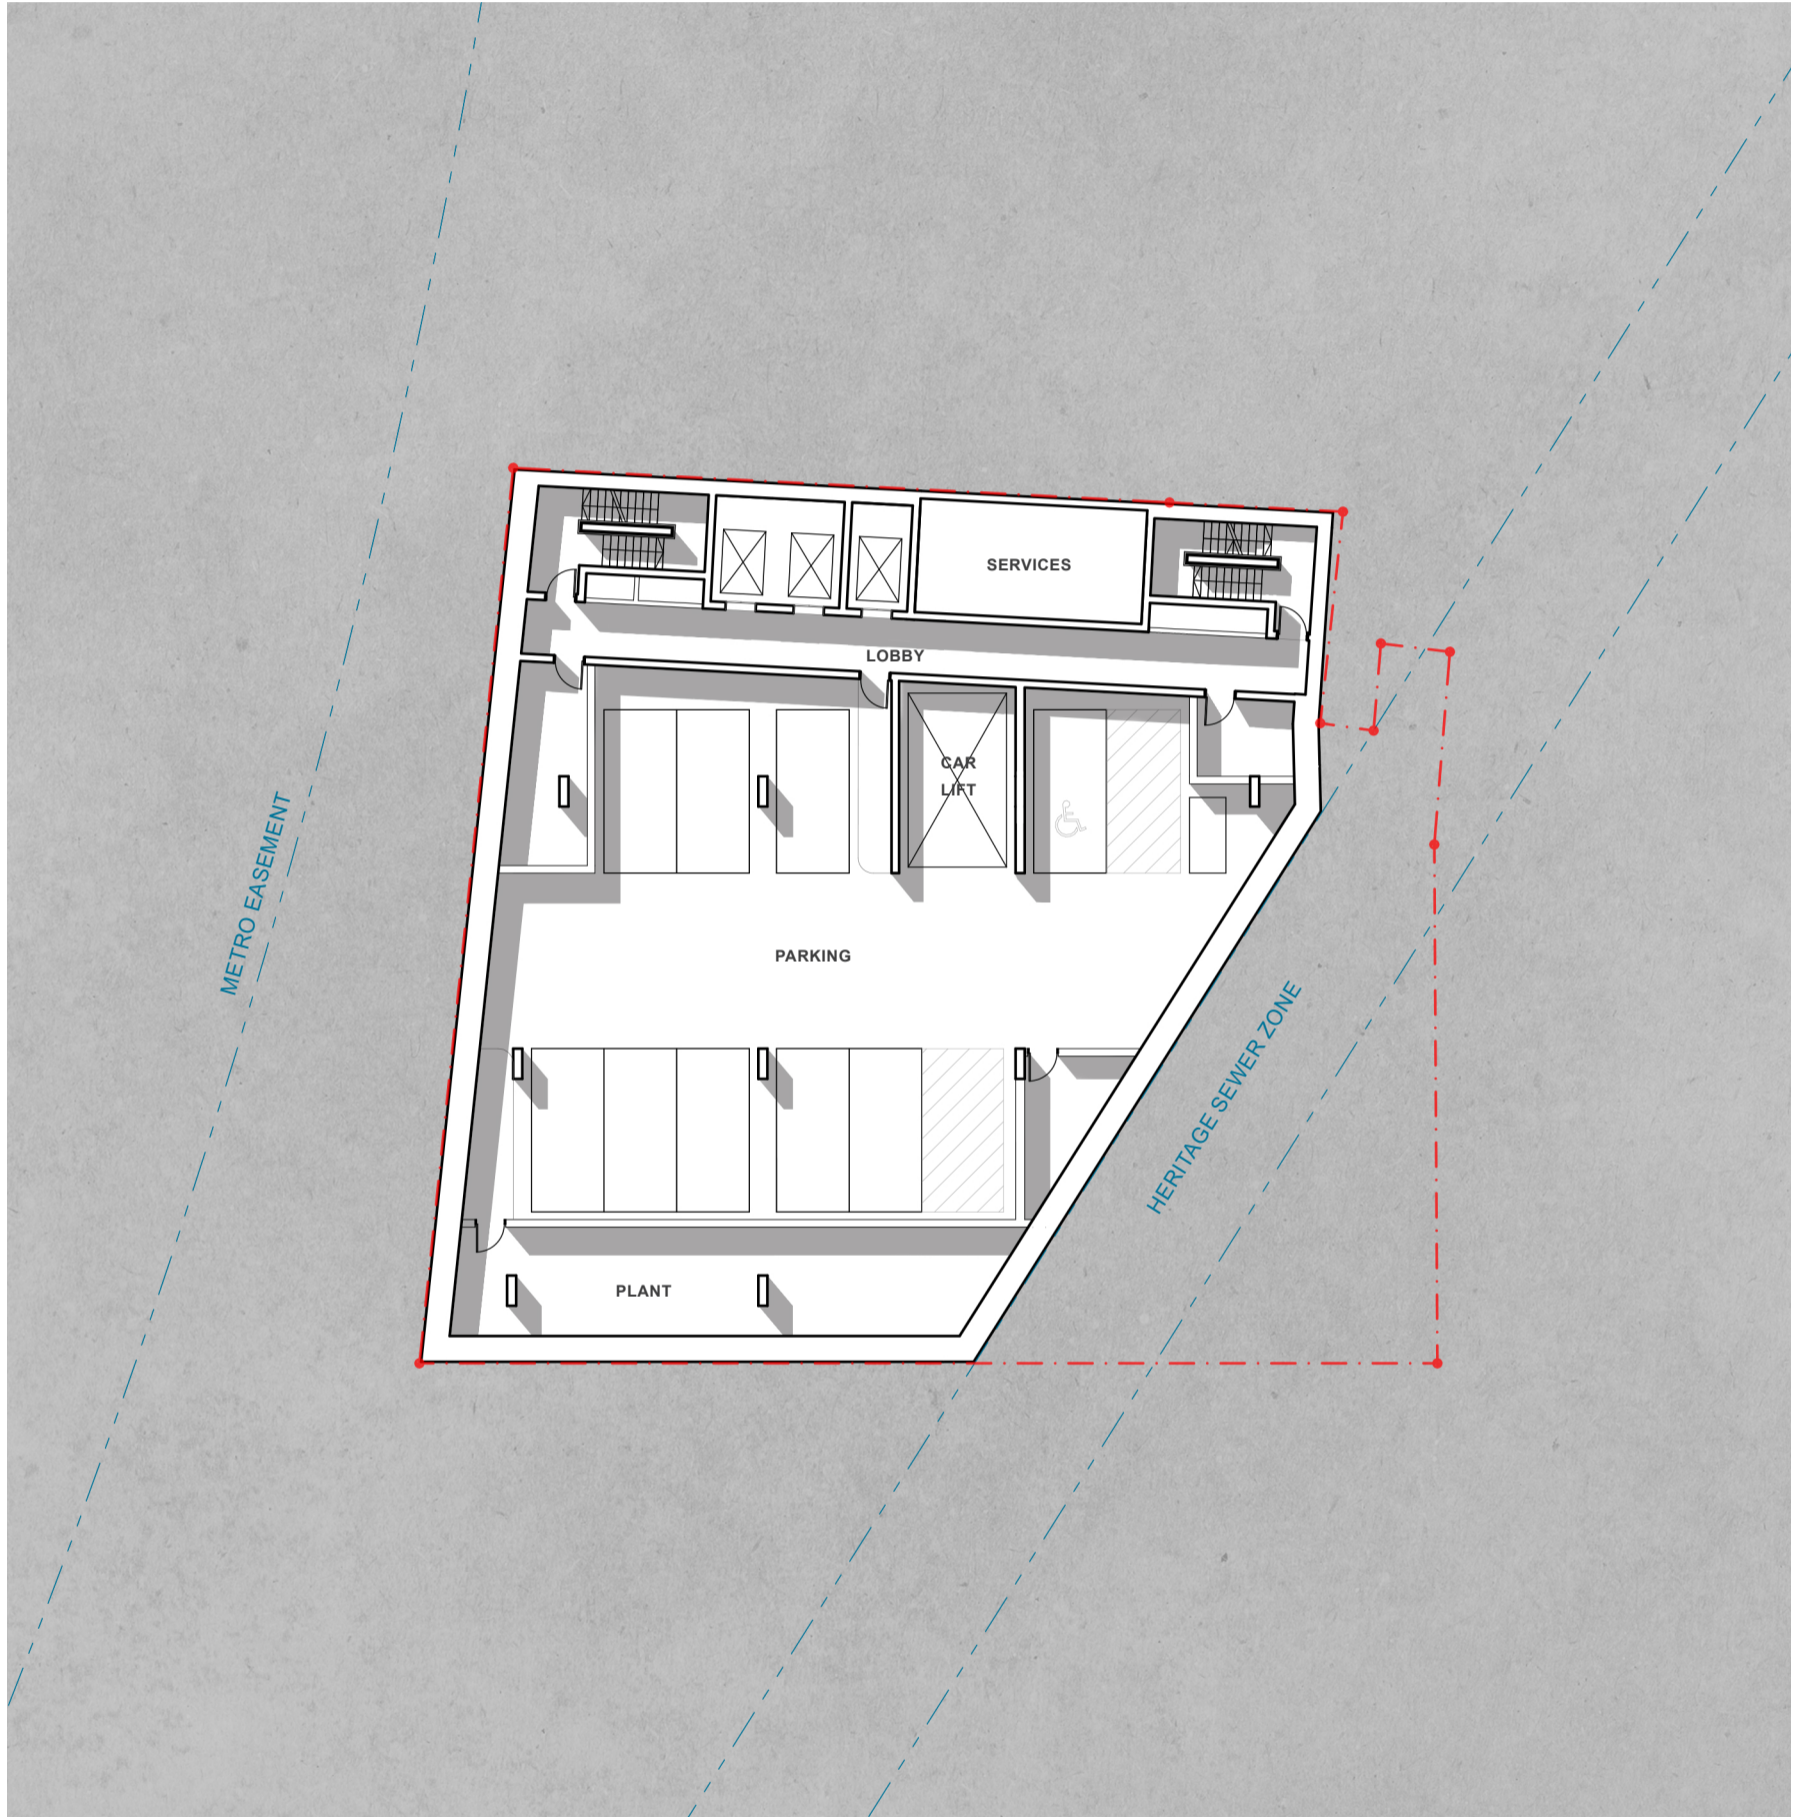
BASEMENT 2-3 PLAN

CAR PARKS PER LVL 9
MOTORCYCLE PARKS PER LVL 1

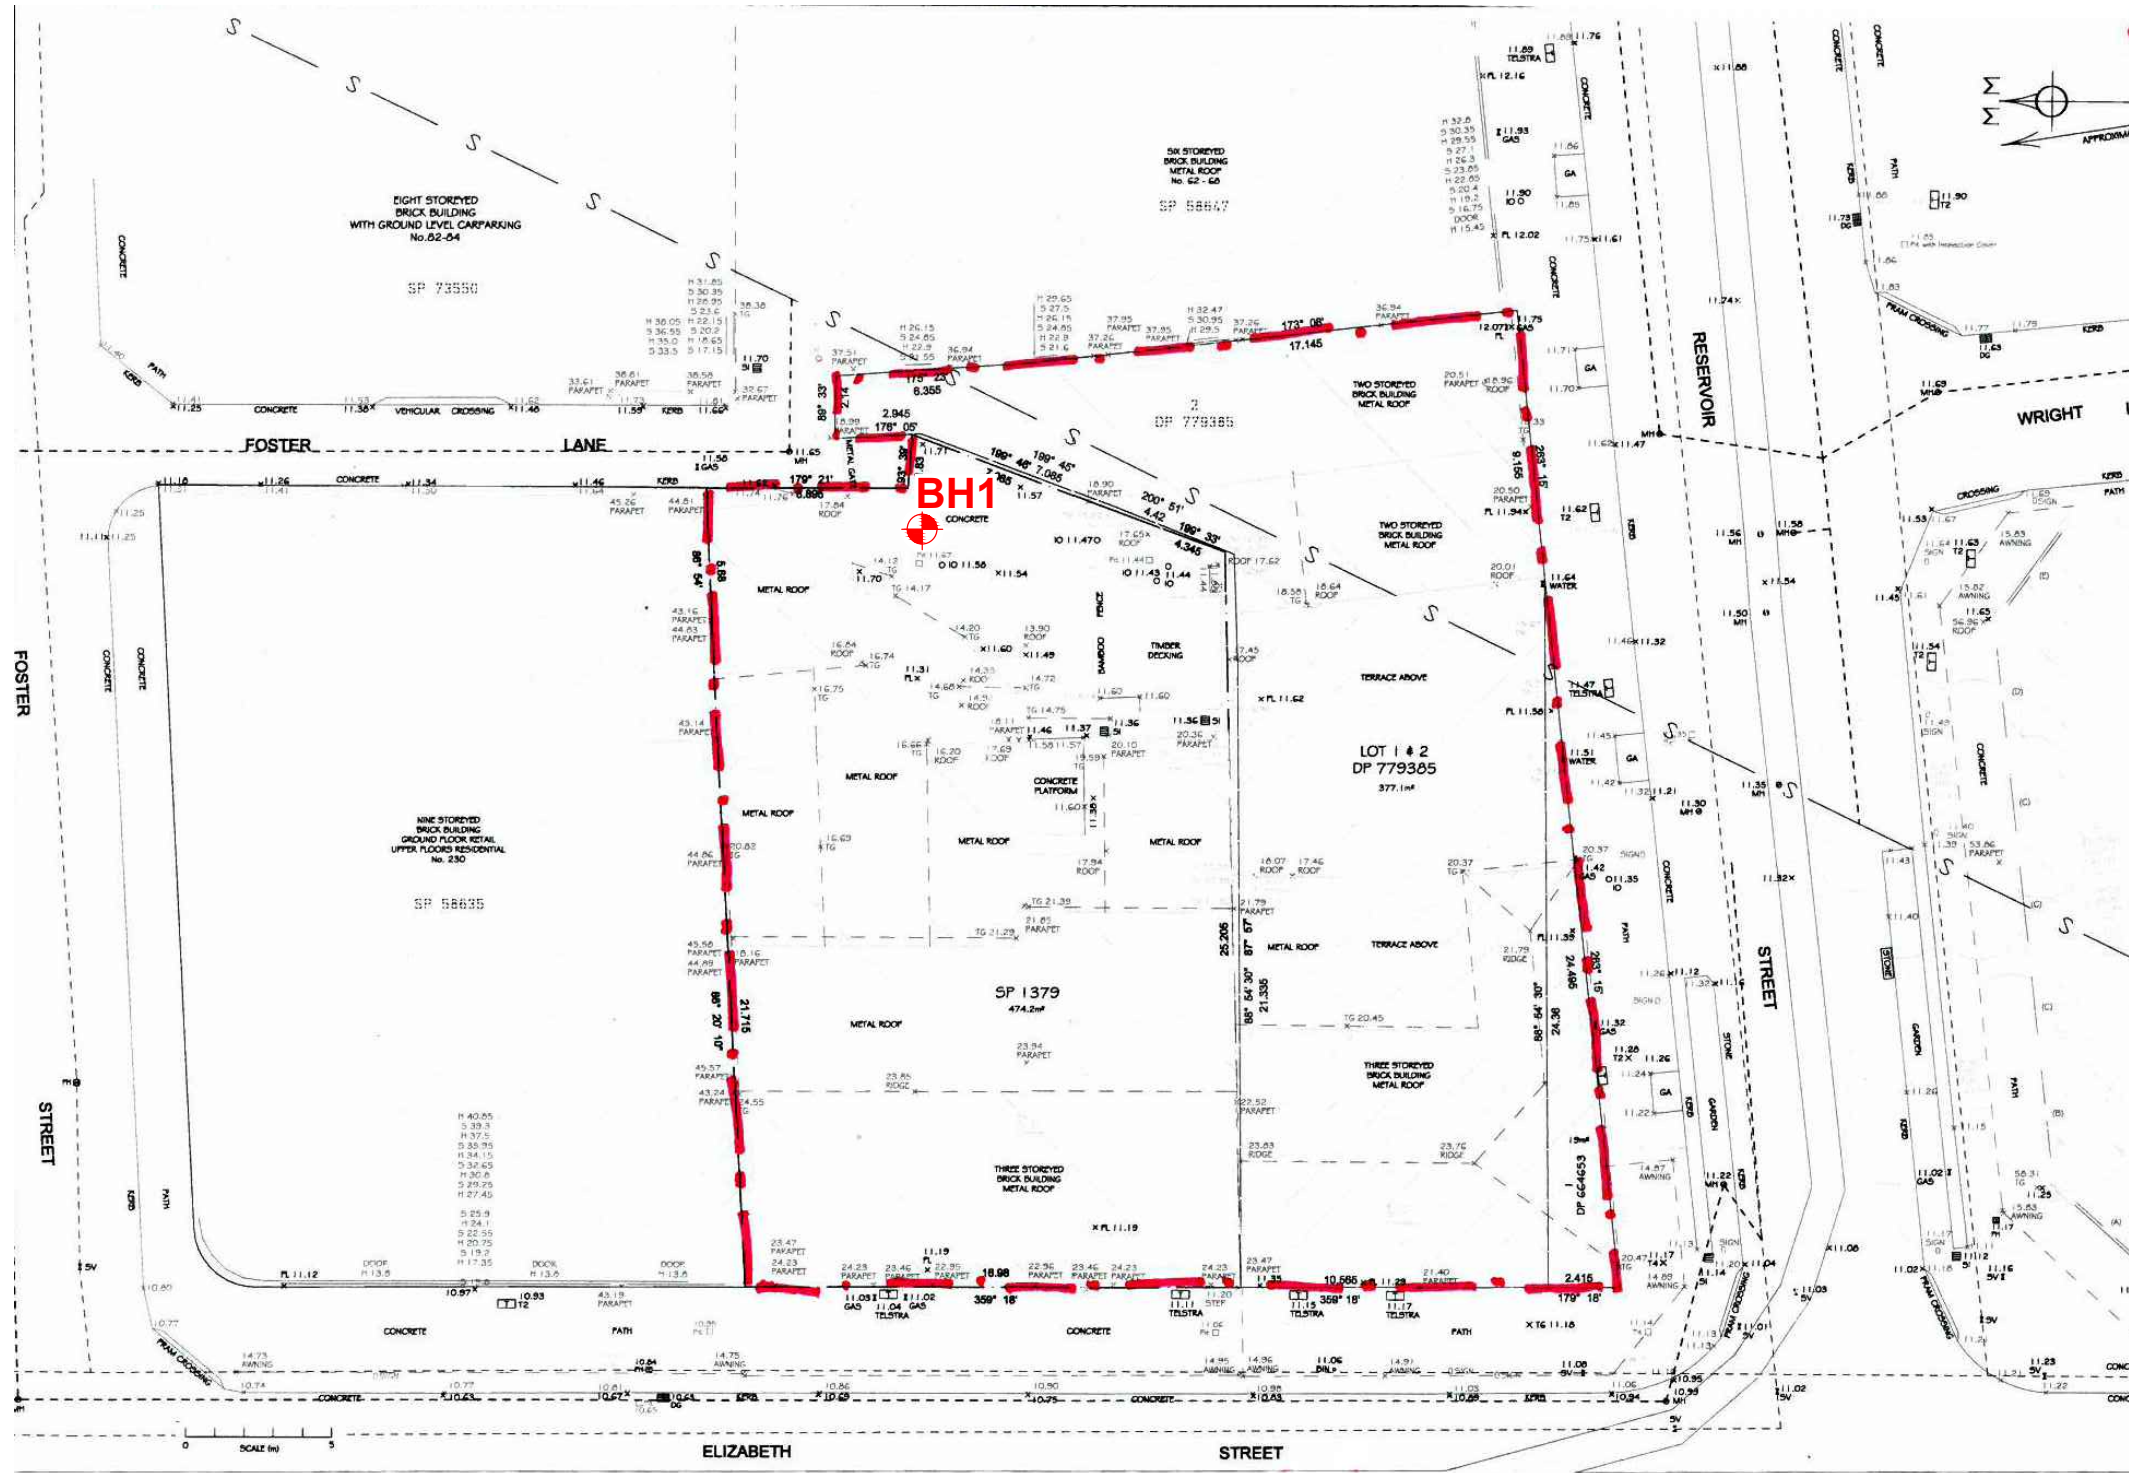
Locality Plan

NOTE: 1. Base drawing from Eric Scerri & Associates Pty Ltd (Dwg 2332/14, dated 18.6.2015)
 2. Test locations are approximate only and are shown with reference to existing site features.

DP carried out a previous investigation at the site in 2015 (DP Report 85134.00.R.001.Rev0). The 2015 investigation comprised a site walkover by a senior engineering geologist and the drilling of one (1) borehole (see for borehole location and borehole log).
