Report on
Geotechnical Desktop Investigation

Proposed Commercial Building
232-240 Elizabeth Street, Surry Hills

Prepared for
Stasia Holdings Pty. Limited

Project 218198.00
November 2022

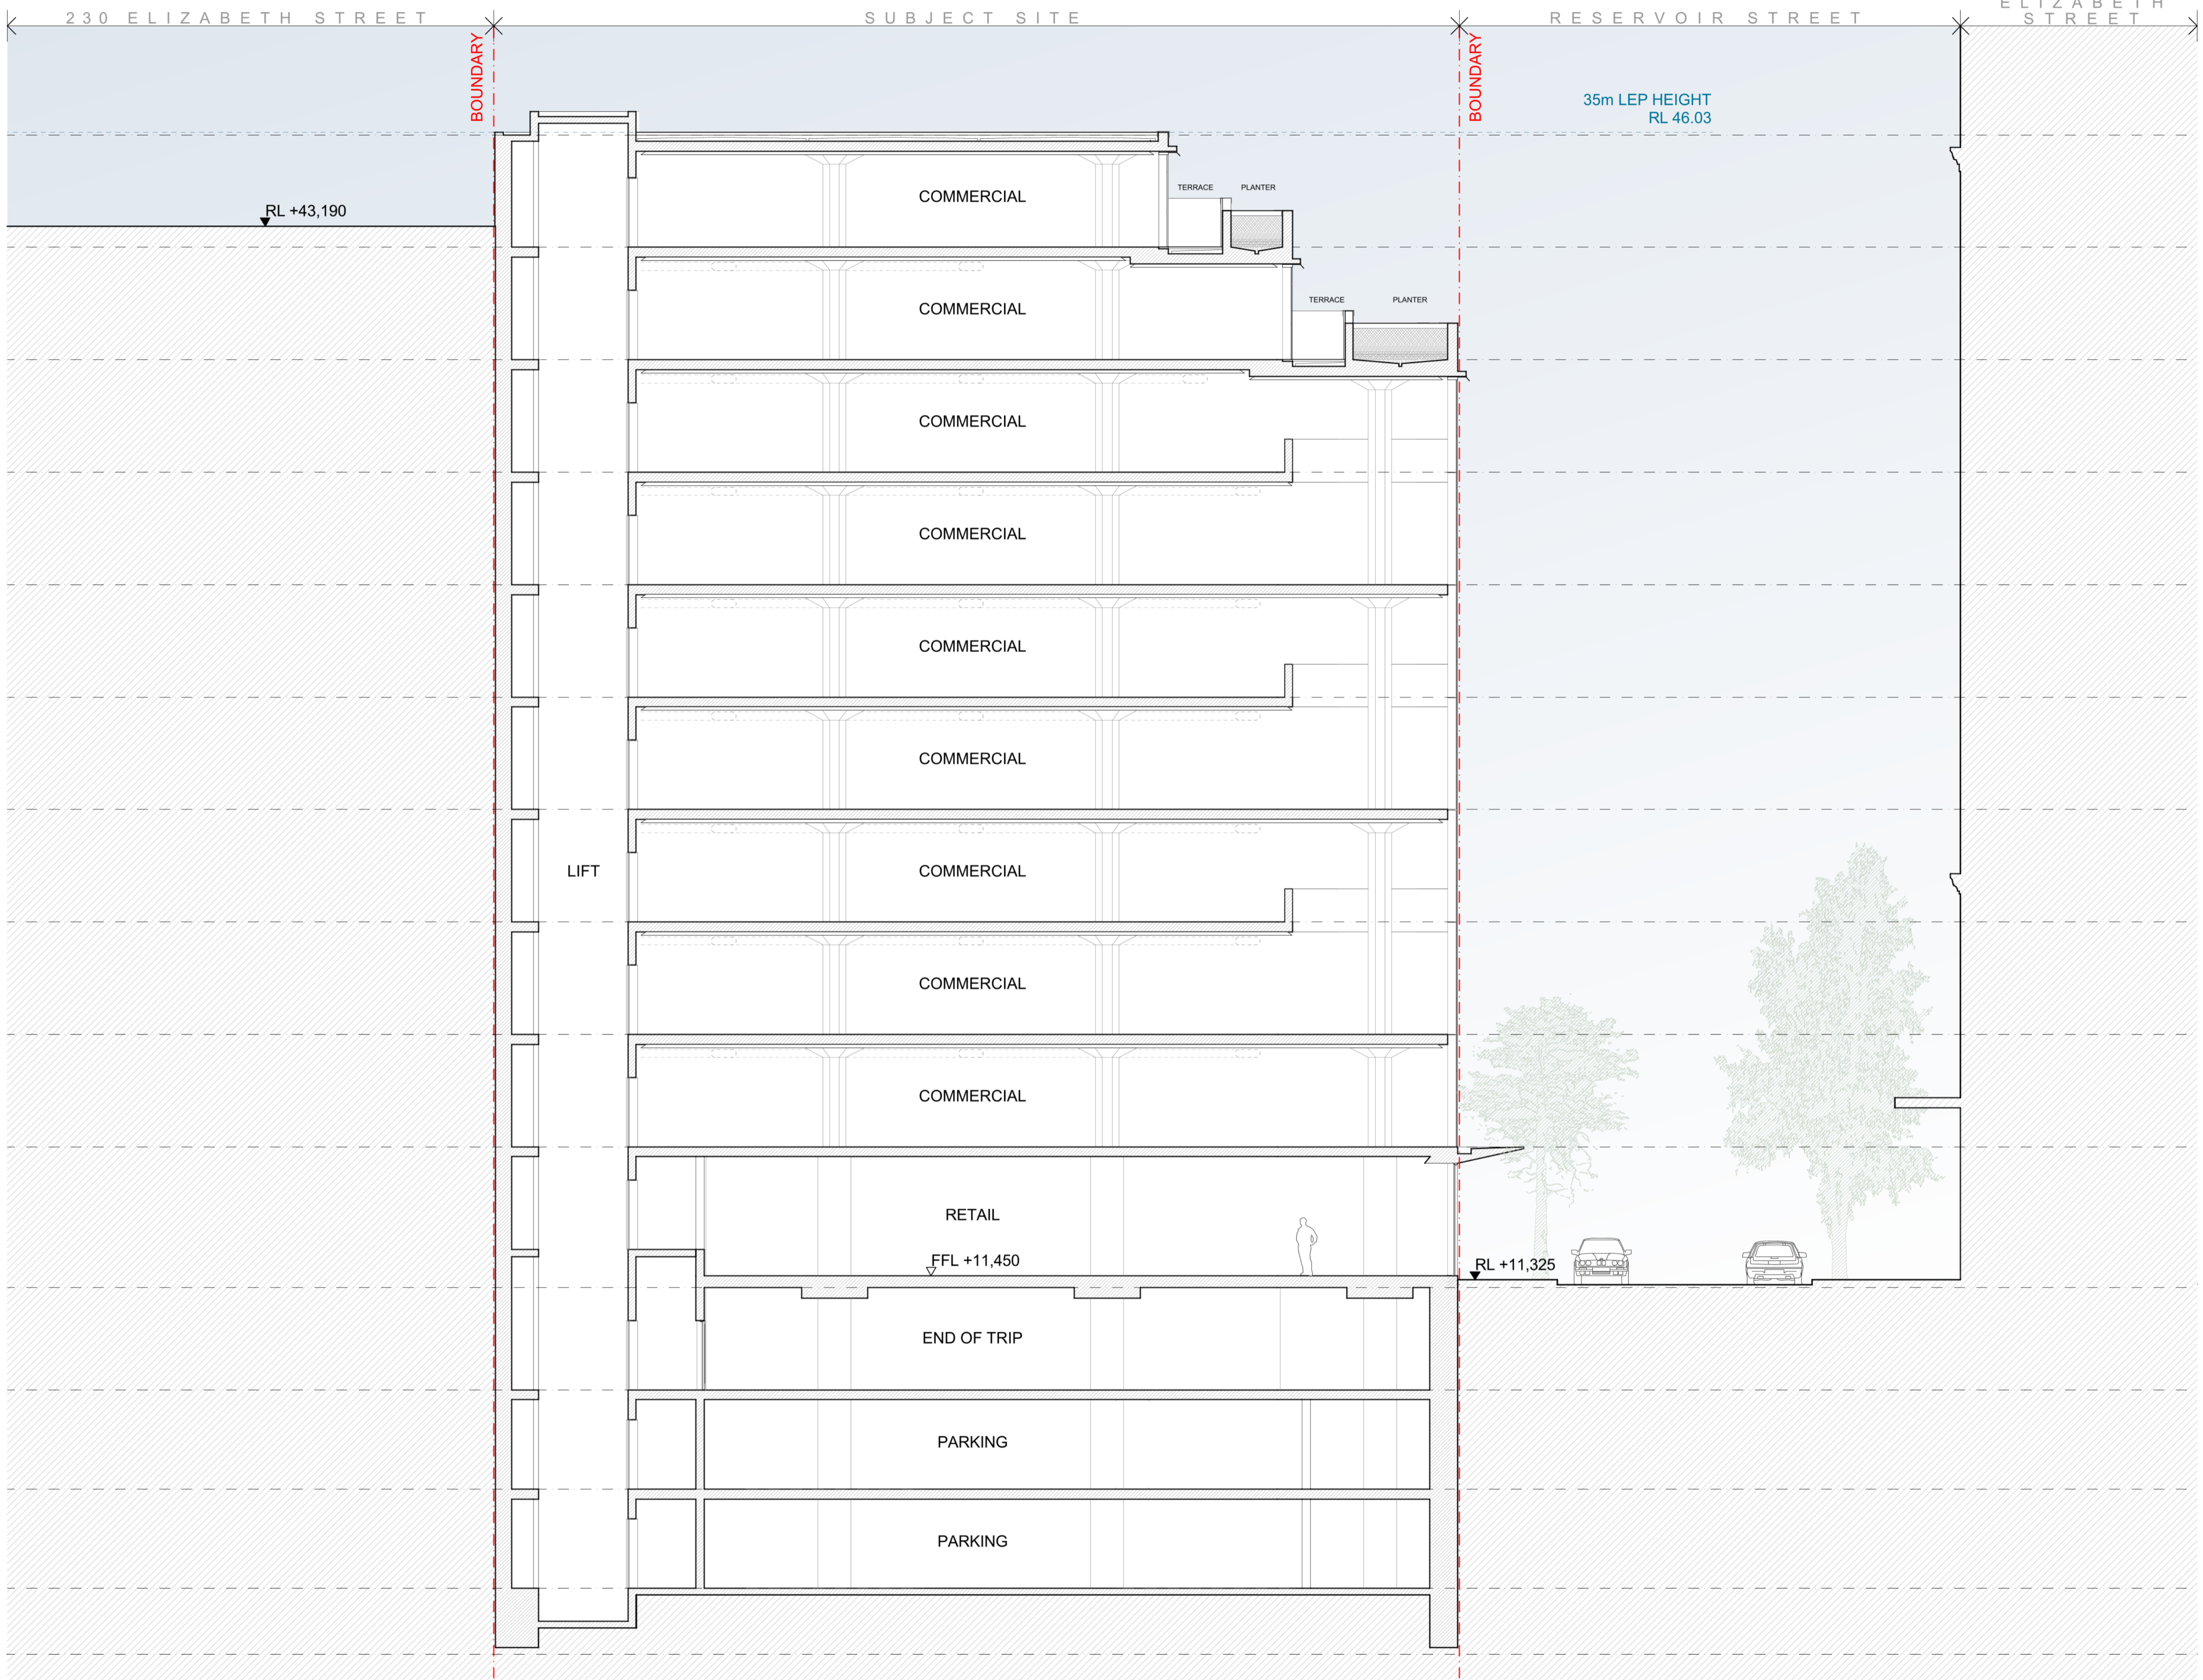
SECTION A
1:100

PRELIMINARY NOT FOR CONSTRUCTION - DESIGN INTENT ONLY	
Drawing: SECTION A	Job Number: 5968
Drawing Number: PP 1101	Issue: P6 - WIP

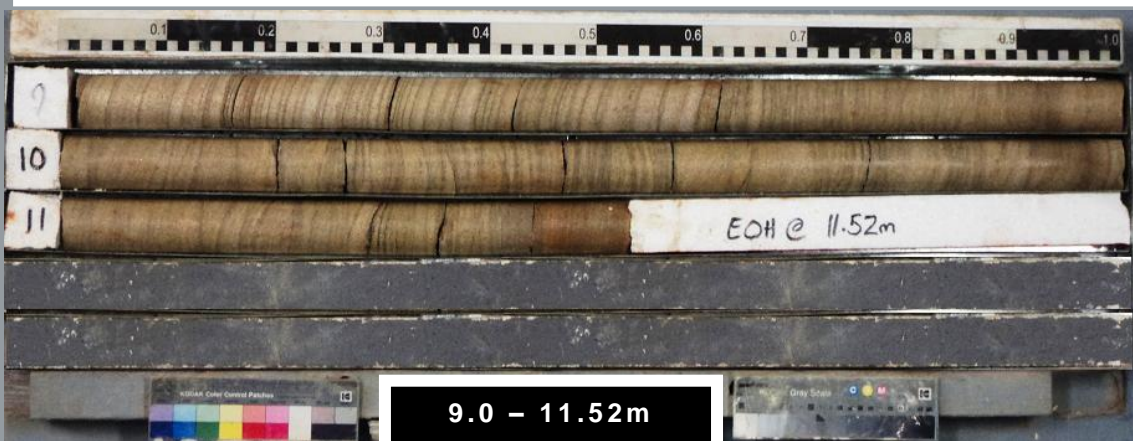
DOUGLAS PARTNERS PTY LTD
PROPOSED RESIDENTIAL DEVELOPMENT – SURRY HILL
BORE 1 PROJECT 85134 OCT 2015

6.35	SANDSTONE - high and medium to high strength, moderately weathered then fresh, slightly fractured and unbroken, brown then pale grey, medium to coarse grained sandstone																								PL(A) = 1.4
	7																									PL(A) = 2.1
	8																						C	100	97	PL(A) = 2.5
	9																									PL(A) = 2.3
	10																									
	11																						C	100	100	PL(A) = 1.8
	12

WATER OBSERVATIONS: No free groundwater observed whilst augering

- Concrete and pavers - concrete slab over pavers to about 200 mm.
- Filling – clayey filling with some sand and sandstone fragments to about 0.75 m.
- Silty Clay - grey mottled brown, medium to high plasticity, stiff to very stiff silty clay with a trace of ironstone gravel (inferred residual soil) to a depth of about 5.3 m. Ironstone gravel bands were noted below 2.5 m.
