Attachment B

**Victoria Walks Road Safety Audit Tool for
Pedestrians who are Vision Impaired**

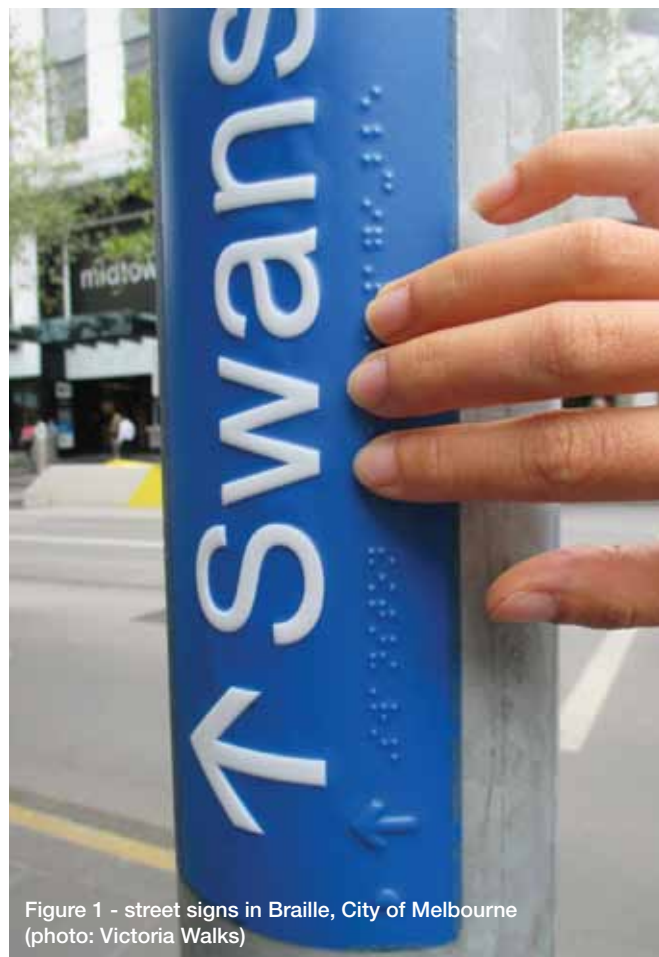
Figure 1 - street signs in Braille, City of Melbourne (photo: Victoria Walks)

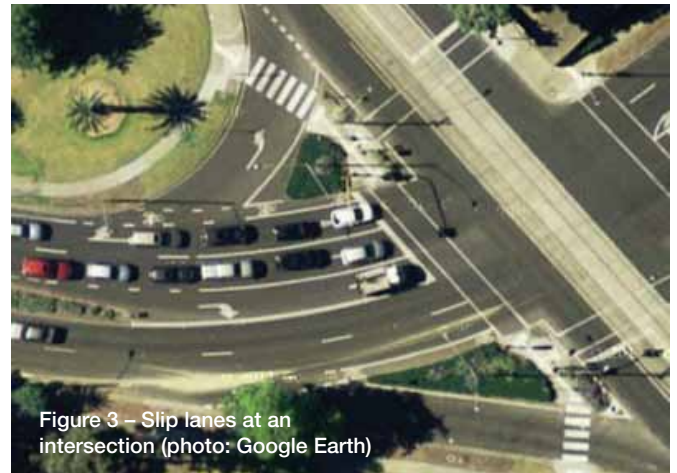
Figure 3 – Slip lanes at an intersection (photo: Google Earth)

Slip lanes are similarly problematic. They add additional crossings, at best an inconvenience to pedestrians, and at worst a hazard. The Australian Road Rules require drivers to give way to pedestrians at a slip lane, but this rule appears to be poorly understood. *“An uncontrolled slip lane can block, or seriously endanger, vision-impaired pedestrians negotiating the road system”* (Maplesden 2012). A signalised crossing of the slip lane is likely to improve safety, but may add to the time required to cross

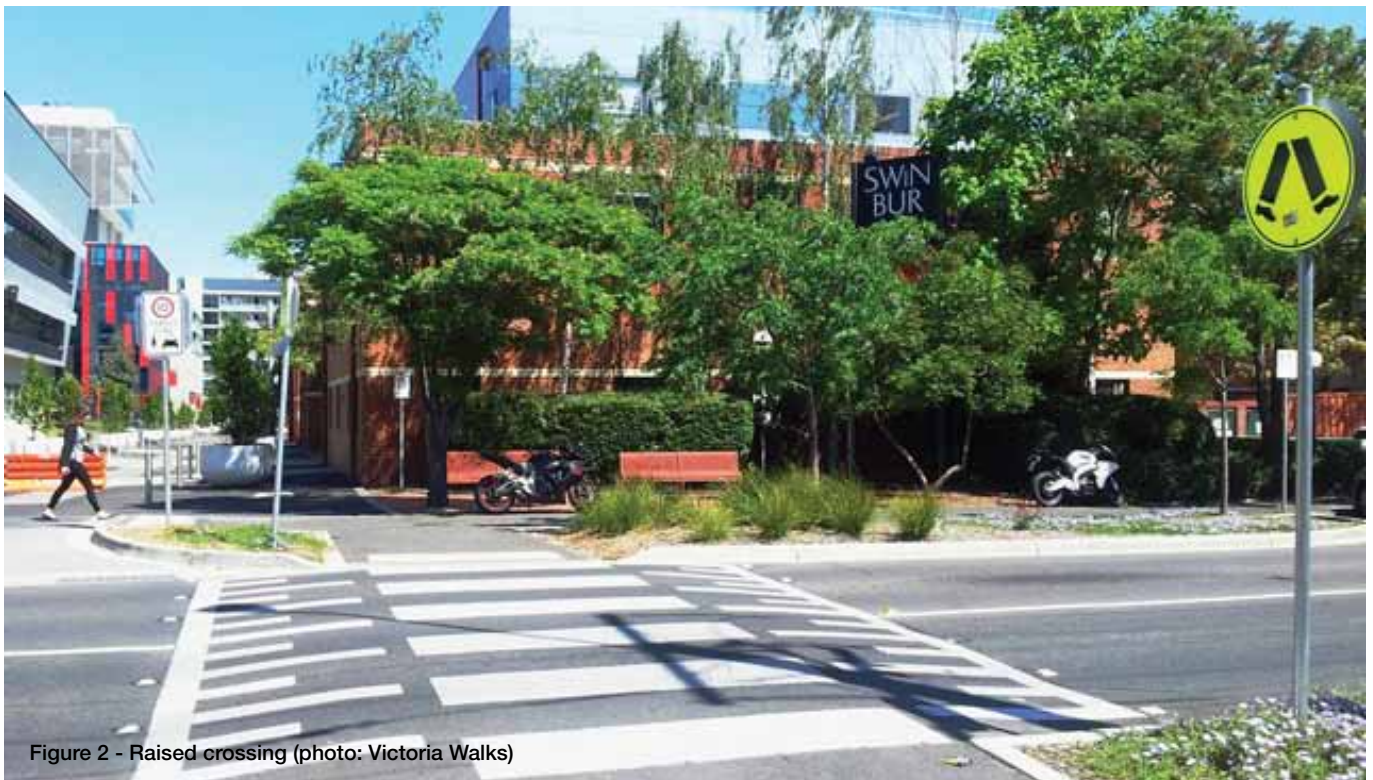
Figure 2 - Raised crossing (photo: Victoria Walks)

and therefore reduce convenience for both drivers and pedestrians. A raised crossing may provide a reasonable balance between safety and convenience for pedestrians. In areas with lots of pedestrians such as town centres, consideration should be given to removing the slip lane altogether.

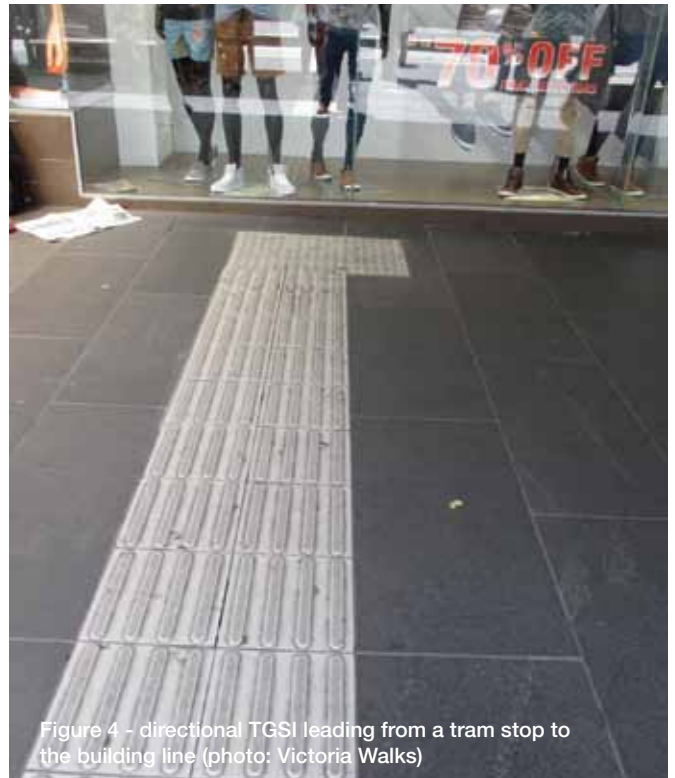
Figure 4 - directional TGSI leading from a tram stop to the building line (photo: Victoria Walks)

DTGSI should commence at the building line and be wide enough for pedestrians not to miss them between strides. In wide open spaces such as public transport interchanges and rail platforms environmental features associated with paths do not exist and the use of DTGSI may need to be considered to assist people who are blind or vision impaired to navigate the area.

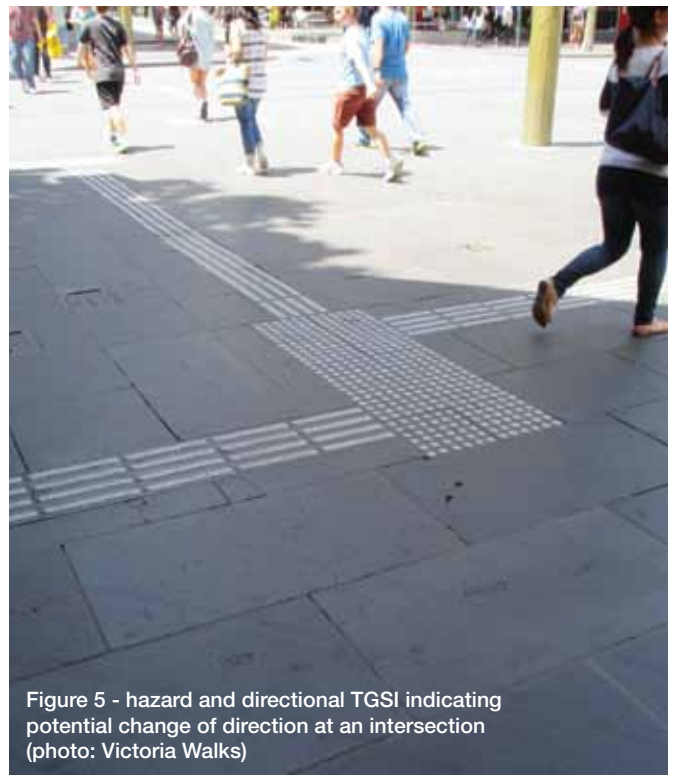
Figure 5 - hazard and directional TGSI indicating potential change of direction at an intersection (photo: Victoria Walks)

1. Raised dots are hazard or warning indicators (WTGSI) which indicate a nearby hazard. A grid of hazard bumps indicates the ground surface will be changing – a ramp, stairs or train platform edge may be imminent.
2. Parallel raised lines are directional TGSI (DTGSI), which indicate the direction of travel.

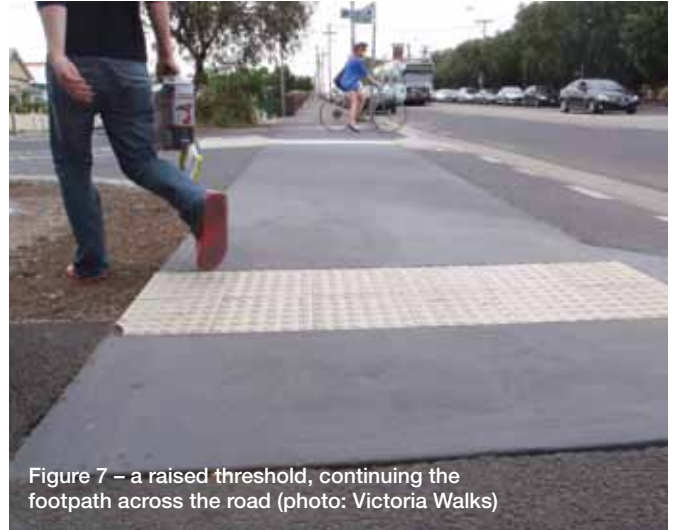
Figure 7 – a raised threshold, continuing the footpath across the road (photo: Victoria Walks)

Raised thresholds are informal crossing points where the pavement is raised to provide a level continuation of the footpath, usually with colours or materials that differentiate the crossing from the road. While not formal pedestrian crossings, raised thresholds can slow traffic and emphasise pedestrian priority to turning vehicles. WTGSI must be installed at a raised crossing or raised threshold, as there is no change in level to alert pedestrians that they are now crossing a road.

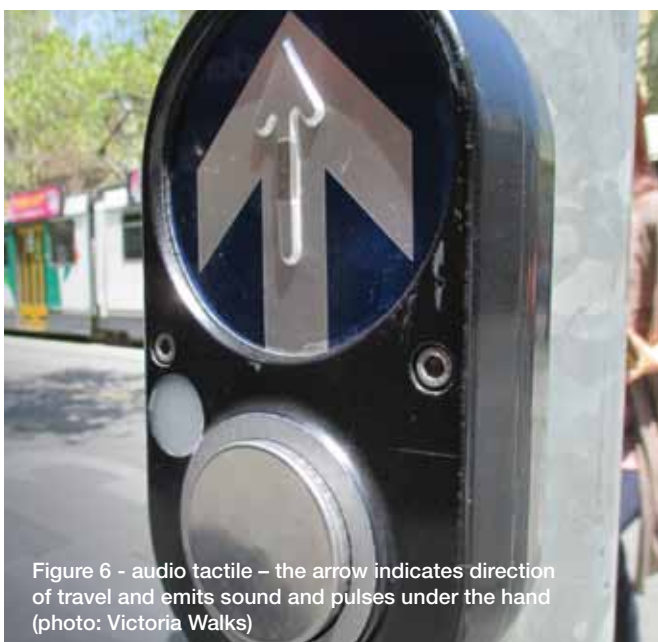
Figure 6 - audio tactile – the arrow indicates direction of travel and emits sound and pulses under the hand (photo: Victoria Walks)

Signalised crossings with audio tactiles are the safest type of crossing to use because they provide audio, visual and tactile indications of when it is safe to cross (Vision Australia 2014b). Audio tactiles are mechanical or electronic devices connected to the pedestrian 'call button' box on crossing poles that pulse (which can be detected by someone's hand) and emit a ticking or beeping sound. Audio tactiles are designed to synchronise with the slow clicking phase (when the red man is illuminated) and fast clicking phase (when the green man is illuminated) of traffic signals. A ticking audio tactile device should be louder than ambient noise. Push buttons for pedestrian activated signals and audio tactiles should be located within easy reach of the kerb ramp.

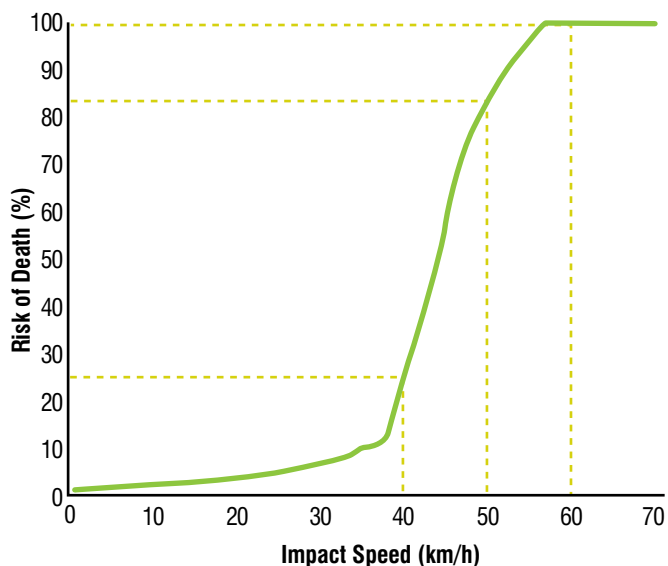
Figure 8 – Risk of pedestrian death as a function of vehicle impact speed (Oxley 2010)

Traffic volume and speed are significant factors in pedestrian exposure to crash risk (Oxley 2010). It is well established that pedestrians have a rapidly increasing likelihood of death at collision speeds beyond 30km/h. Consideration should be given to 30 or 40 km/h speed limits in areas where there are likely to be significant numbers of pedestrians or vulnerable pedestrians such as seniors, children and vision impaired. Detailed guidance on setting speed limits is provided in VicRoads' [Speed Zoning Guidelines](#).

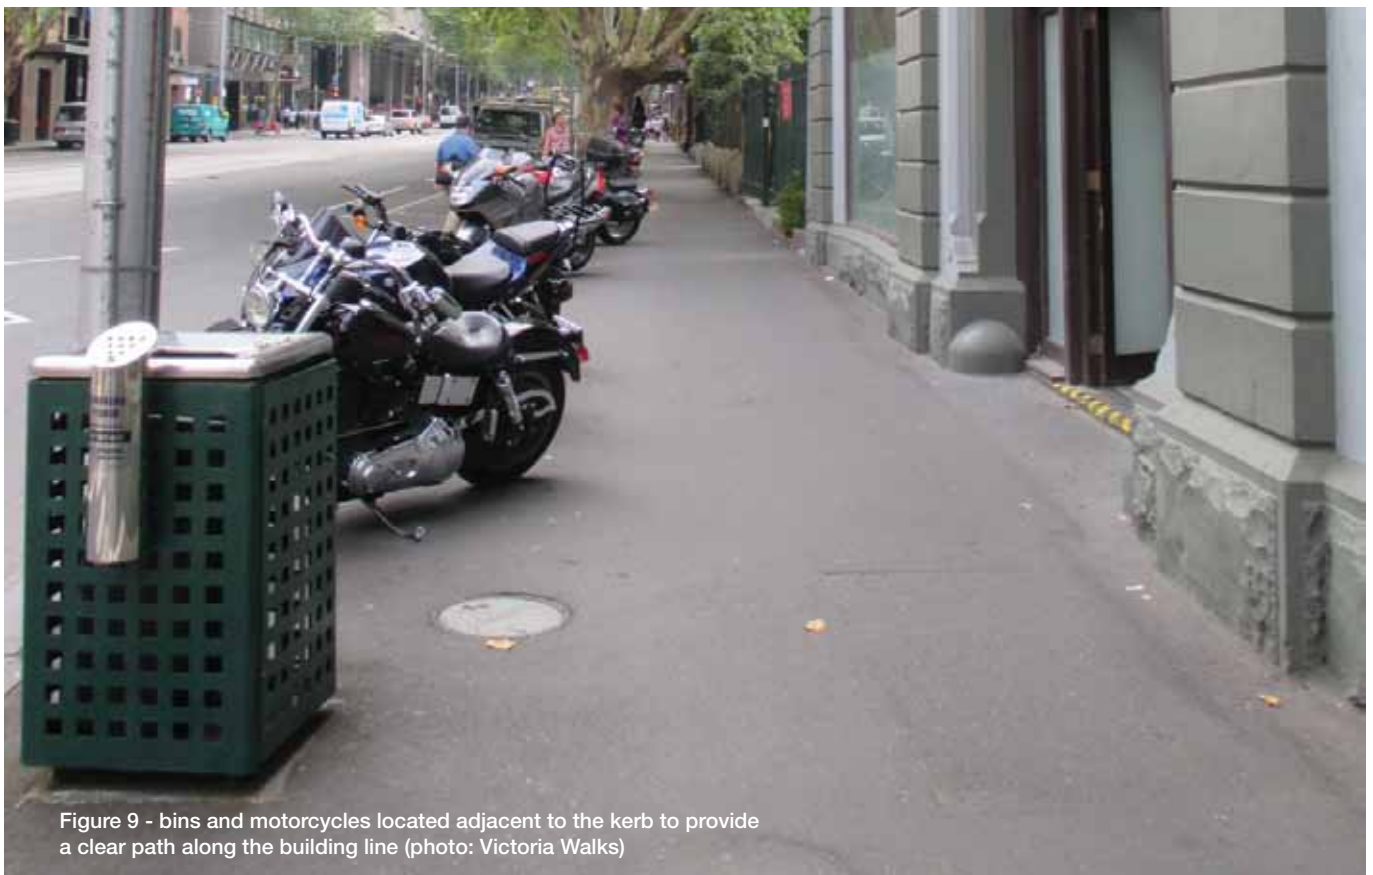
Figure 9 - bins and motorcycles located adjacent to the kerb to provide a clear path along the building line (photo: Victoria Walks)

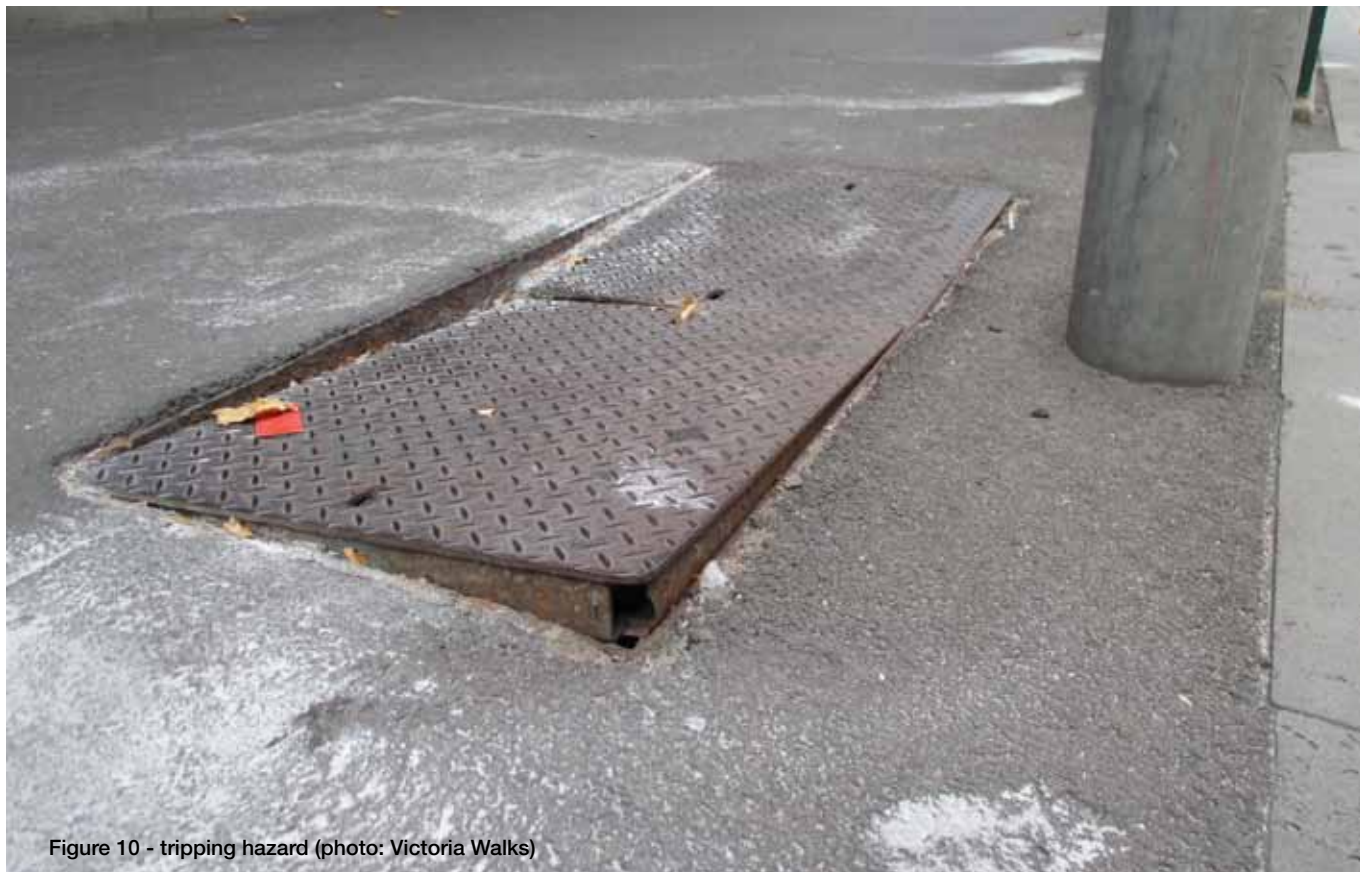
Figure 10 - tripping hazard (photo: Victoria Walks)

It is particularly important to ensure footpaths are free of tripping hazards. Poor or uneven surfaces on paths and roads are a hazard for all pedestrians, but especially for the elderly and vision impaired. Falls may account for up to 75% of pedestrian injuries in public spaces (International Transport Forum 2011). Walking surfaces should be a consistent level and where changes in level are necessary, gentle slopes, as opposed to steps, are preferred. Management of utilities such as service pit covers and trenches should not create uneven surfaces.

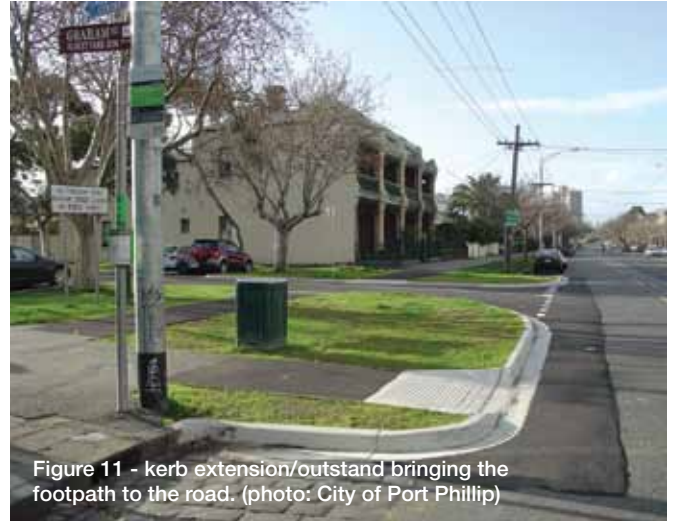
Figure 11 - kerb extension/outstand bringing the footpath to the road. (photo: City of Port Phillip)

At uncontrolled crossings, kerb extensions or outstands and pedestrian refuges can potentially assist by narrowing the road crossing, slowing vehicle speeds and making pedestrians more prominent to drivers. Pedestrian refuges also reduce the complexity of crossing, as the pedestrian does not have to judge both directions of approaching traffic simultaneously. However neither treatment provides pedestrians with vision impairment with assurances of when it is safe to cross.

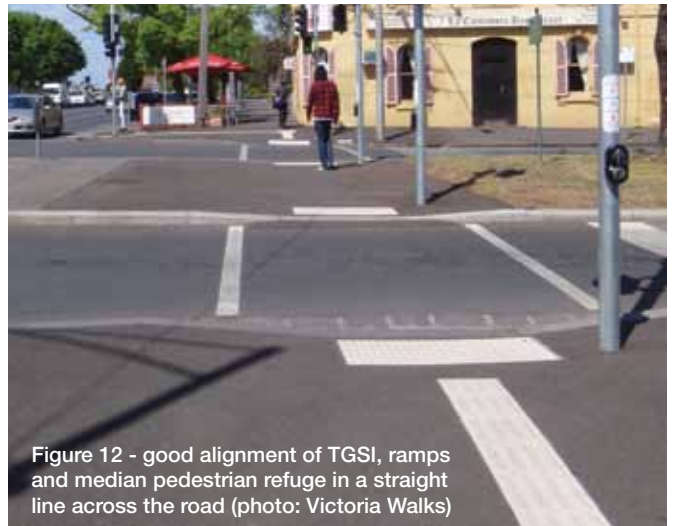
Figure 12 - good alignment of TGSIs, ramps and median pedestrian refuge in a straight line across the road (photo: Victoria Walks)

When crossing a road, people who have impaired vision often use the kerb ramp to align themselves and then walk in a straight line to the other side. It is important that kerb ramps on either side of the road are directly aligned with each other and with any pedestrian refuge islands (Government of South Australia 2008).

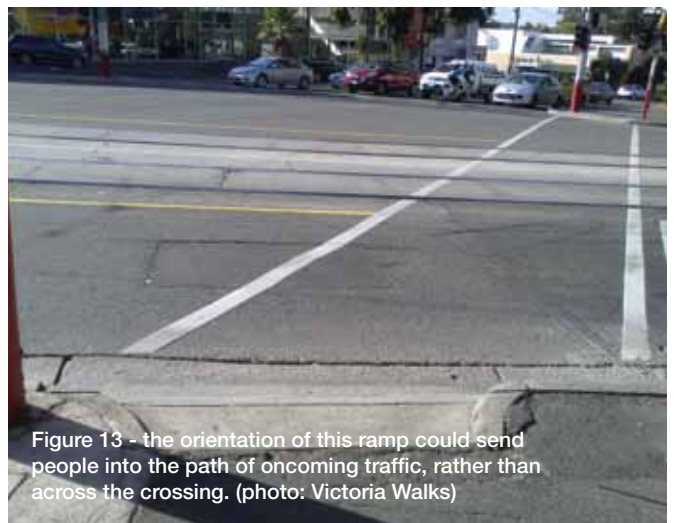
Figure 13 - the orientation of this ramp could send people into the path of oncoming traffic, rather than across the crossing. (photo: Victoria Walks)

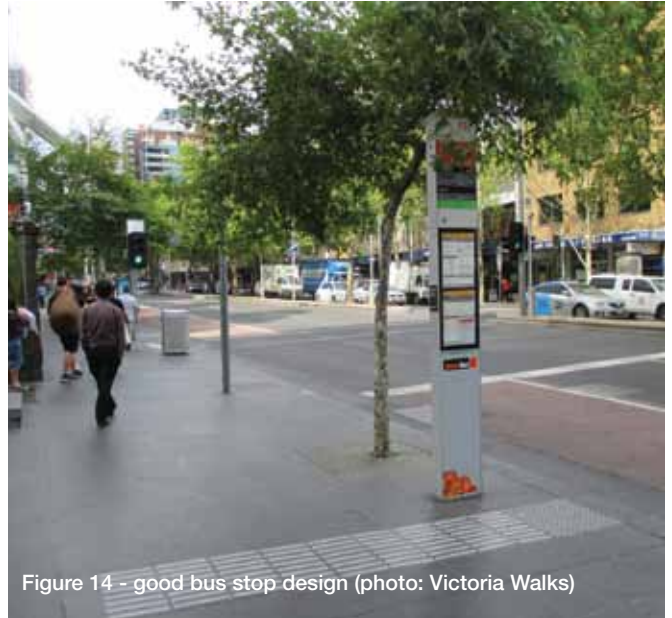
Figure 14 - good bus stop design (photo: Victoria Walks)

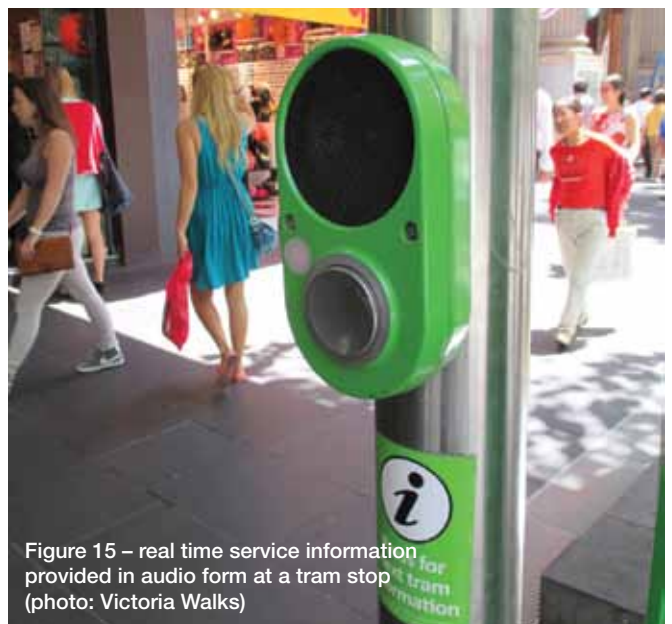
Figure 15 - real time service information provided in audio form at a tram stop (photo: Victoria Walks)
