Local Planning Panel

Address: St Vincent's College, 1 Challis Avenue

Application: D/2023/878

Alterations and additions to school including:

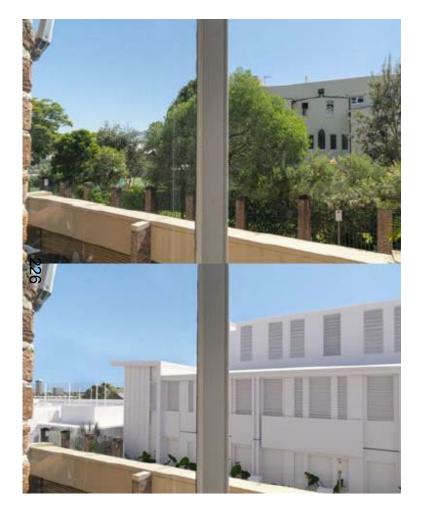
- most affected Unit 2
- view impacted standing views from bedroom, glimpse of Harbour Bridge
- existing view improved following recent vegetation removal
- view loss for Unit 2 considered moderate to severe
- view loss assessed as minor for all other units in 6-8 Rockwall Crescent

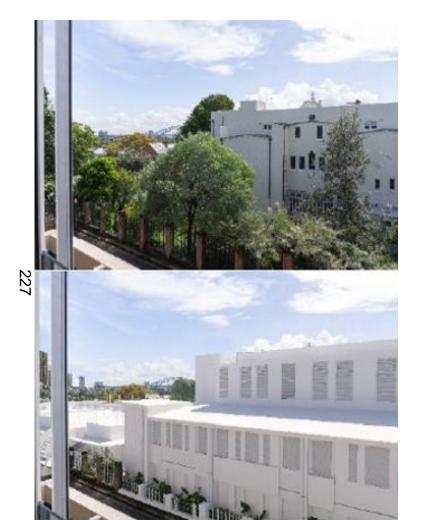
10-16 Rockwall Crescent

- view impacts to all units considered negligible to minor
- example of minor view loss impact for Unit 2, 10 Rockwall Crescent
- existing for Unit 1 & Unit 2, 10, Unit 2, 12 & Unit 2, 14 and 16 Rockwall Crescent views improved following recent vegetation removal

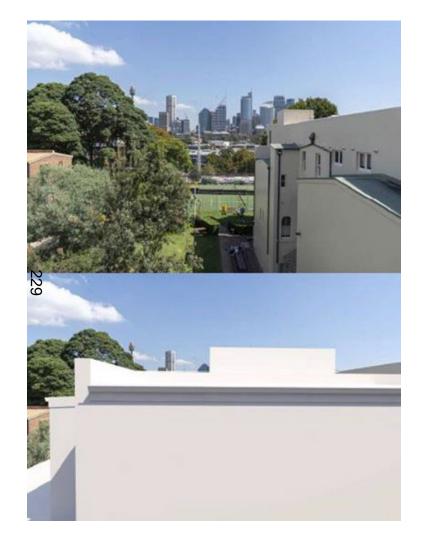
Hotel Challis - Room 408 on level 3

- view impacted high-value linear views of the City CBD skyline and Sydney Tower
- devastating view loss

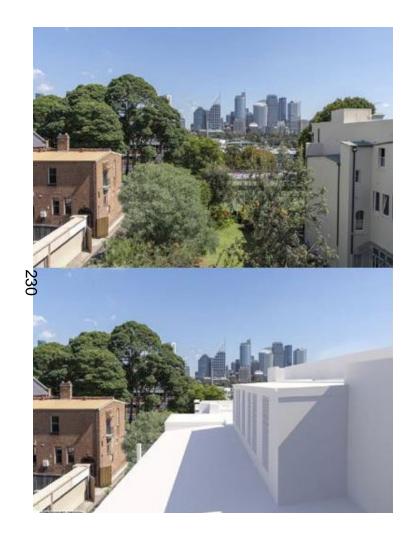
Hotel Challis - Room 412 on level 3

- view impacted high-value linear views of the City CBD skyline and Sydney Tower
- moderate to severe view loss
