Report on
Geotechnical Desktop Investigation

Proposed Commercial Building
232-240 Elizabeth Street, Surry Hills

Prepared for
Stasia Holdings Pty. Limited

Project 218198.00
November 2022

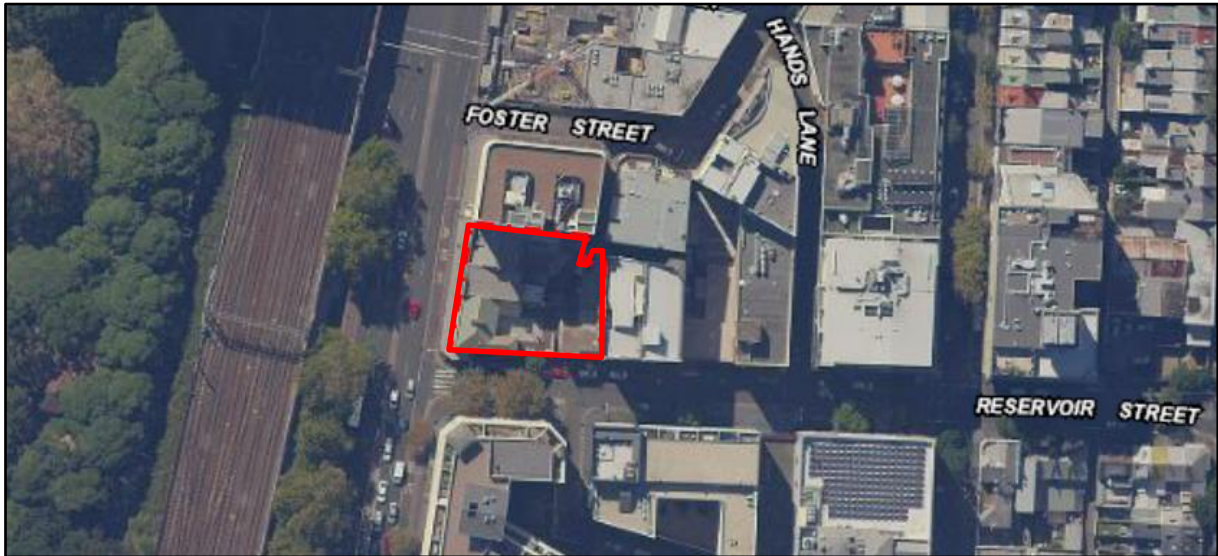
Figure 1: Aerial photograph of the site (outlined in red).

The roughly square site comprises three Lots and a strata plan encompassing 232 to 240 Elizabeth Street, Surry Hills (see Figure 1). The approximately 900 m² site has Elizabeth and Reservoir Streets on its western and southern sides and is bound to the north by a nine storey brick building and on the east by a six storey brick building. Foster Lane provides access to the northeast corner of the site. The site gently slopes to the southwest with a surface elevation on Elizabeth Street at about RL 10.9 m and RL 11.6 m at the southern end of Foster Lane.

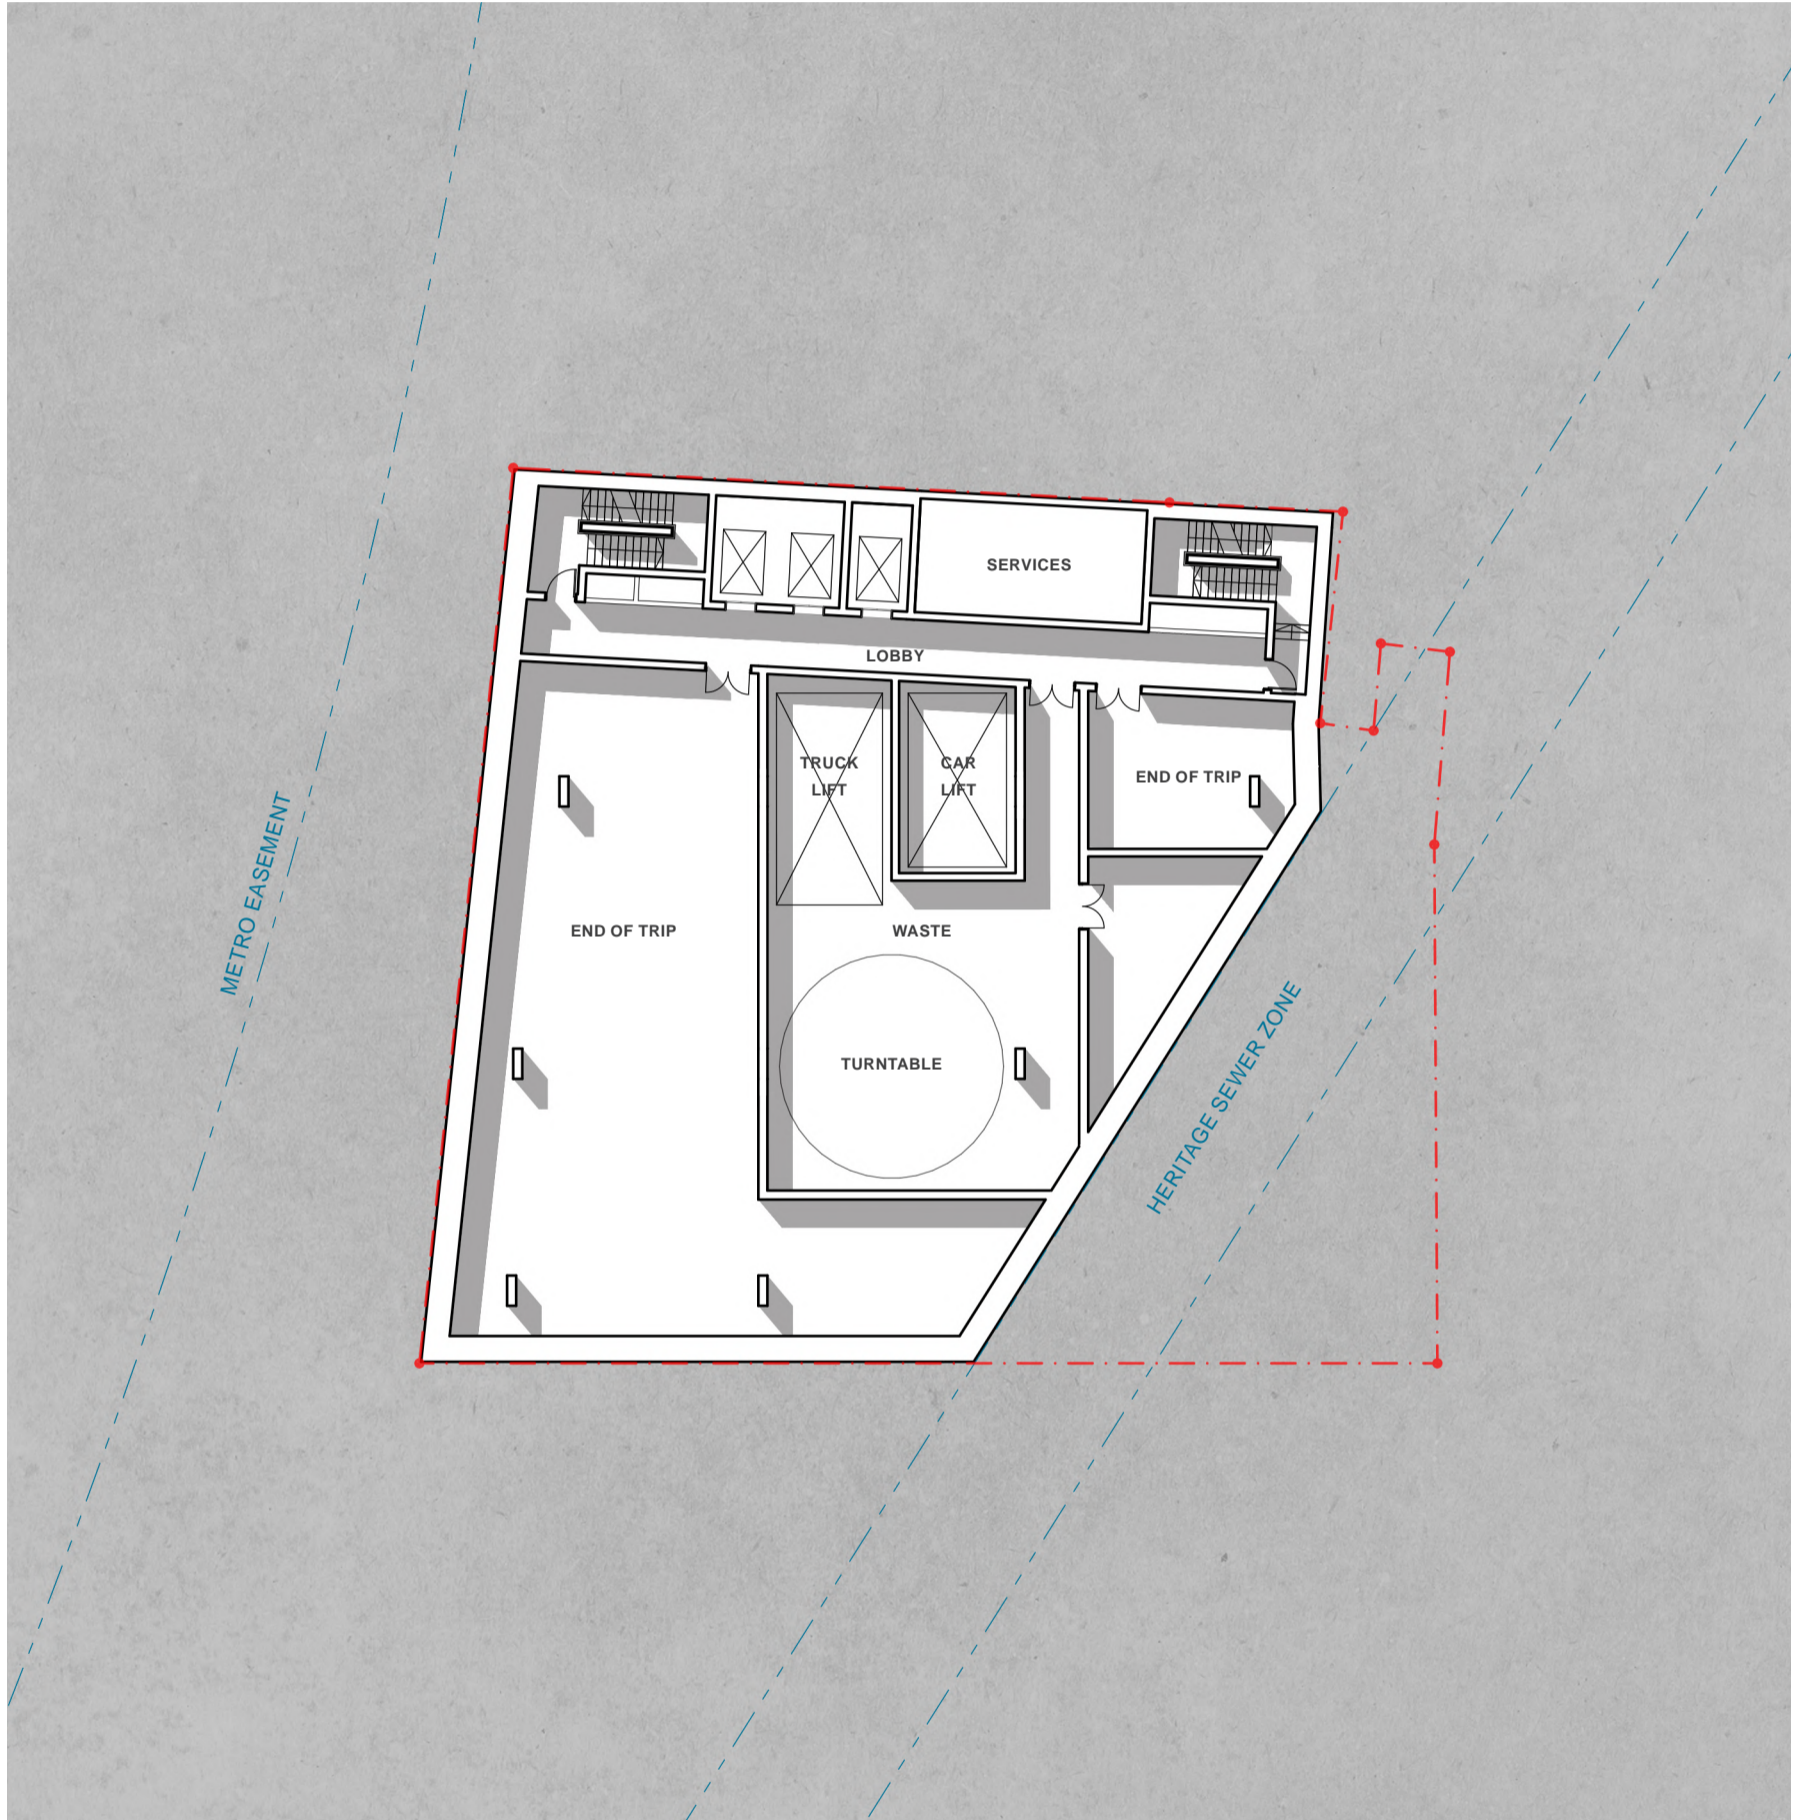
BASEMENT 1 PLAN

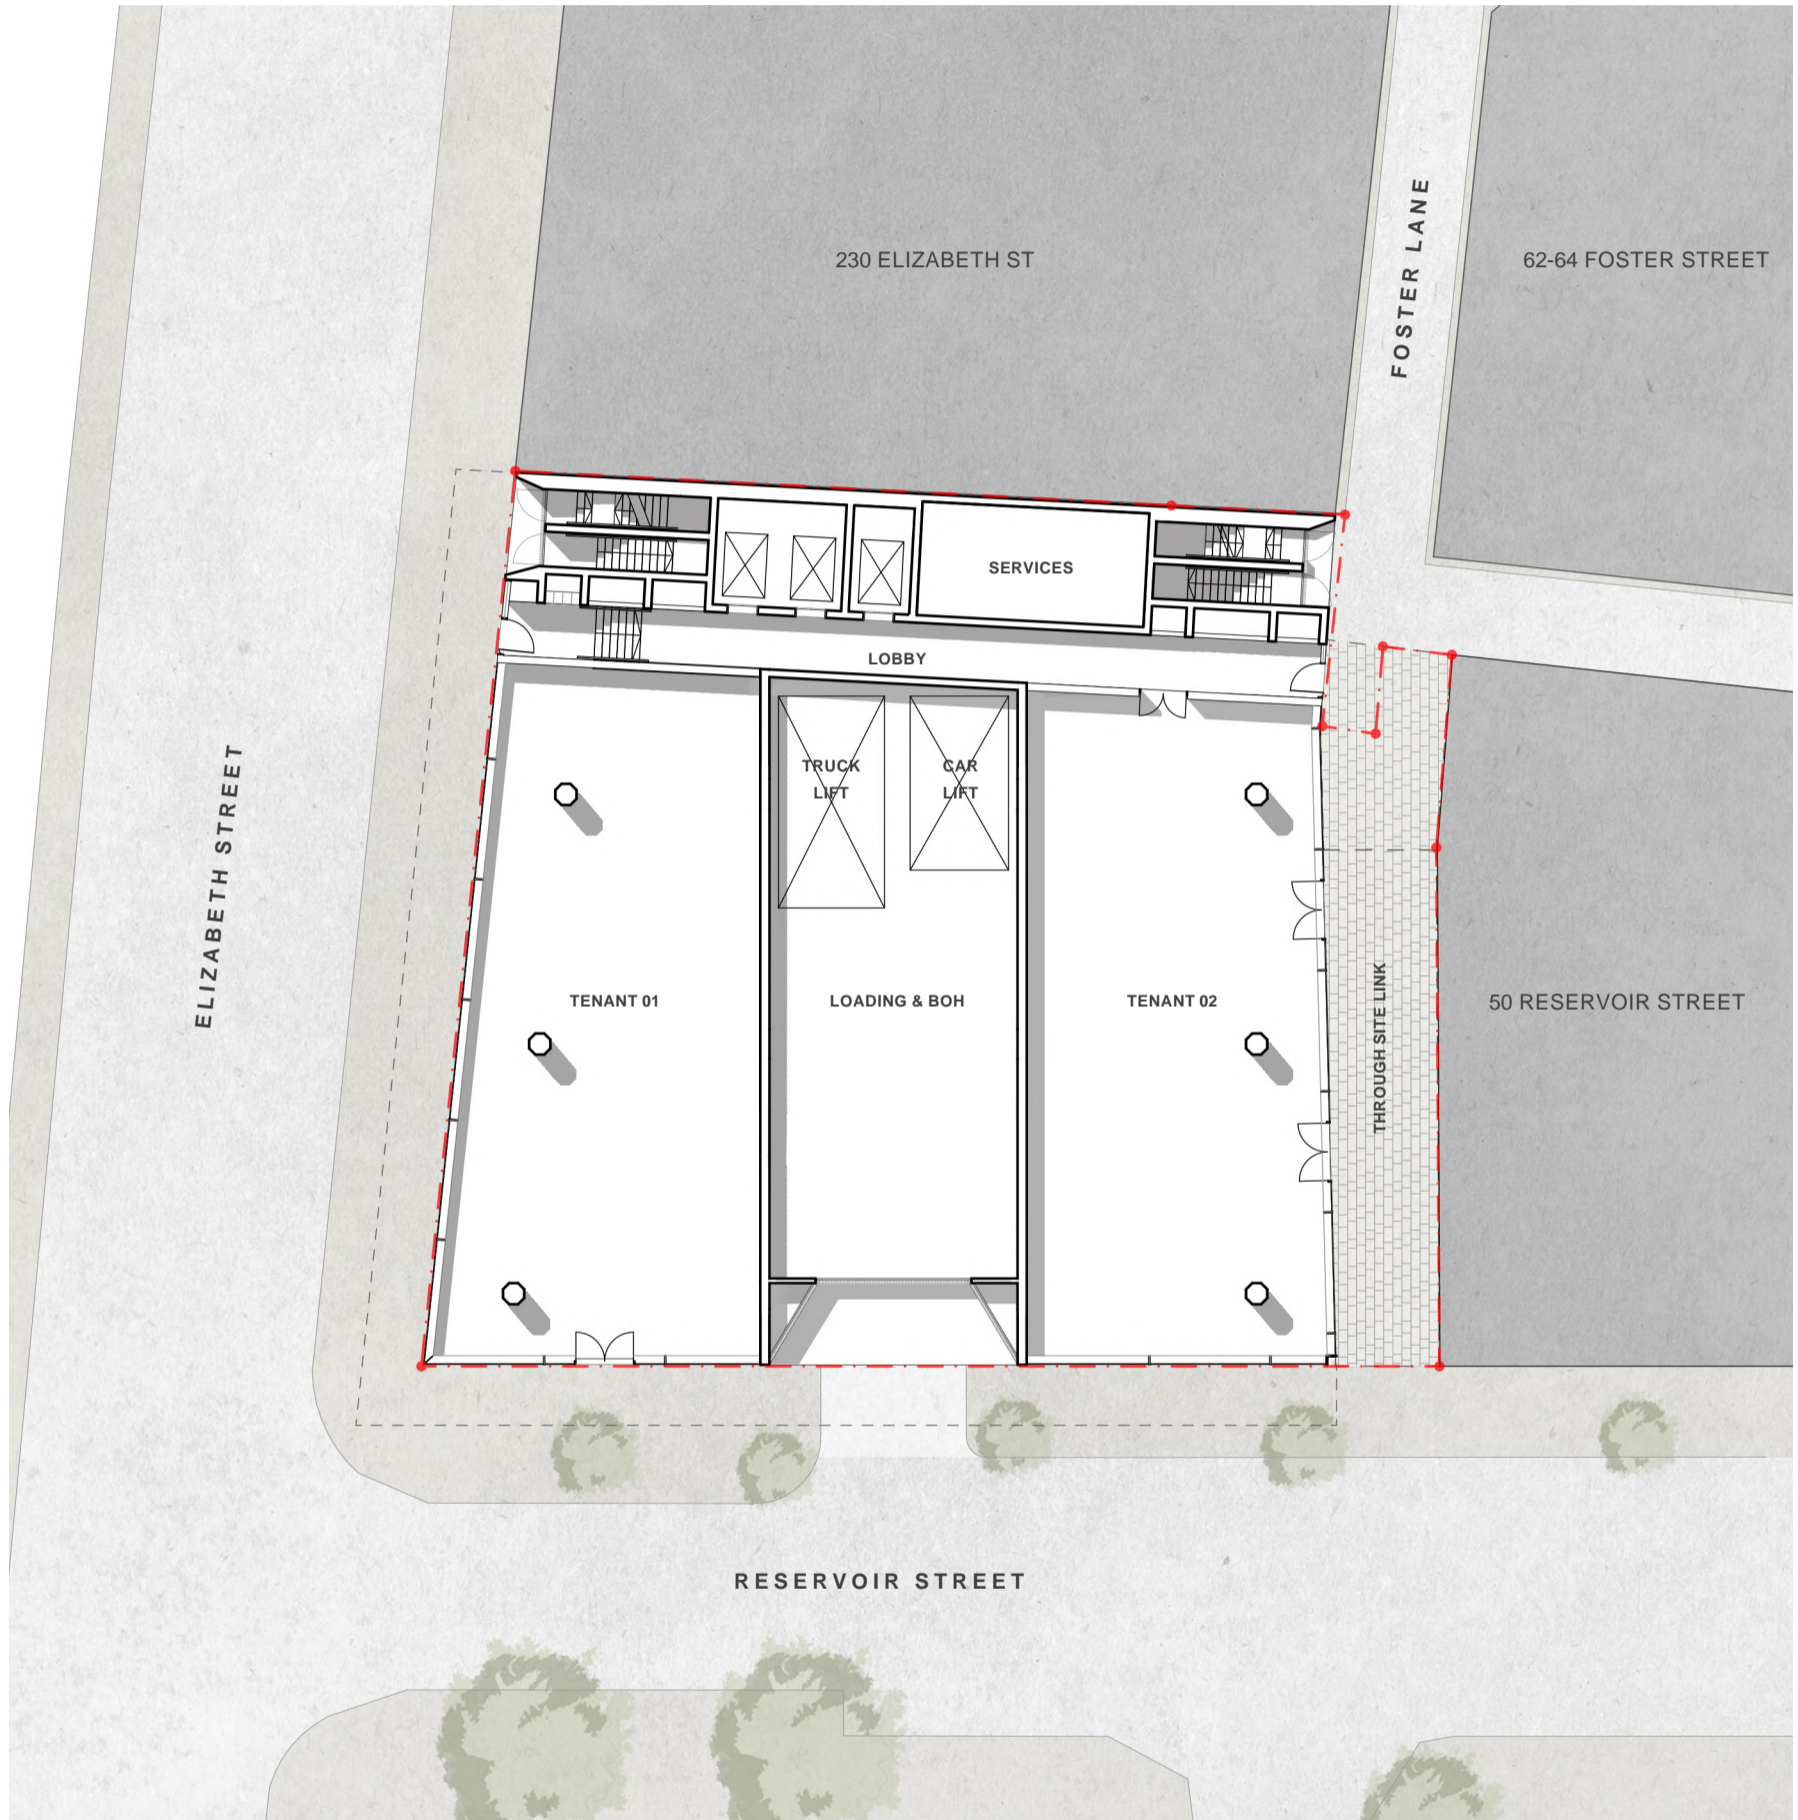
GROUND FLOOR PLAN

COMMERCIAL GFA 79 m²
RETAIL GFA 452 m²

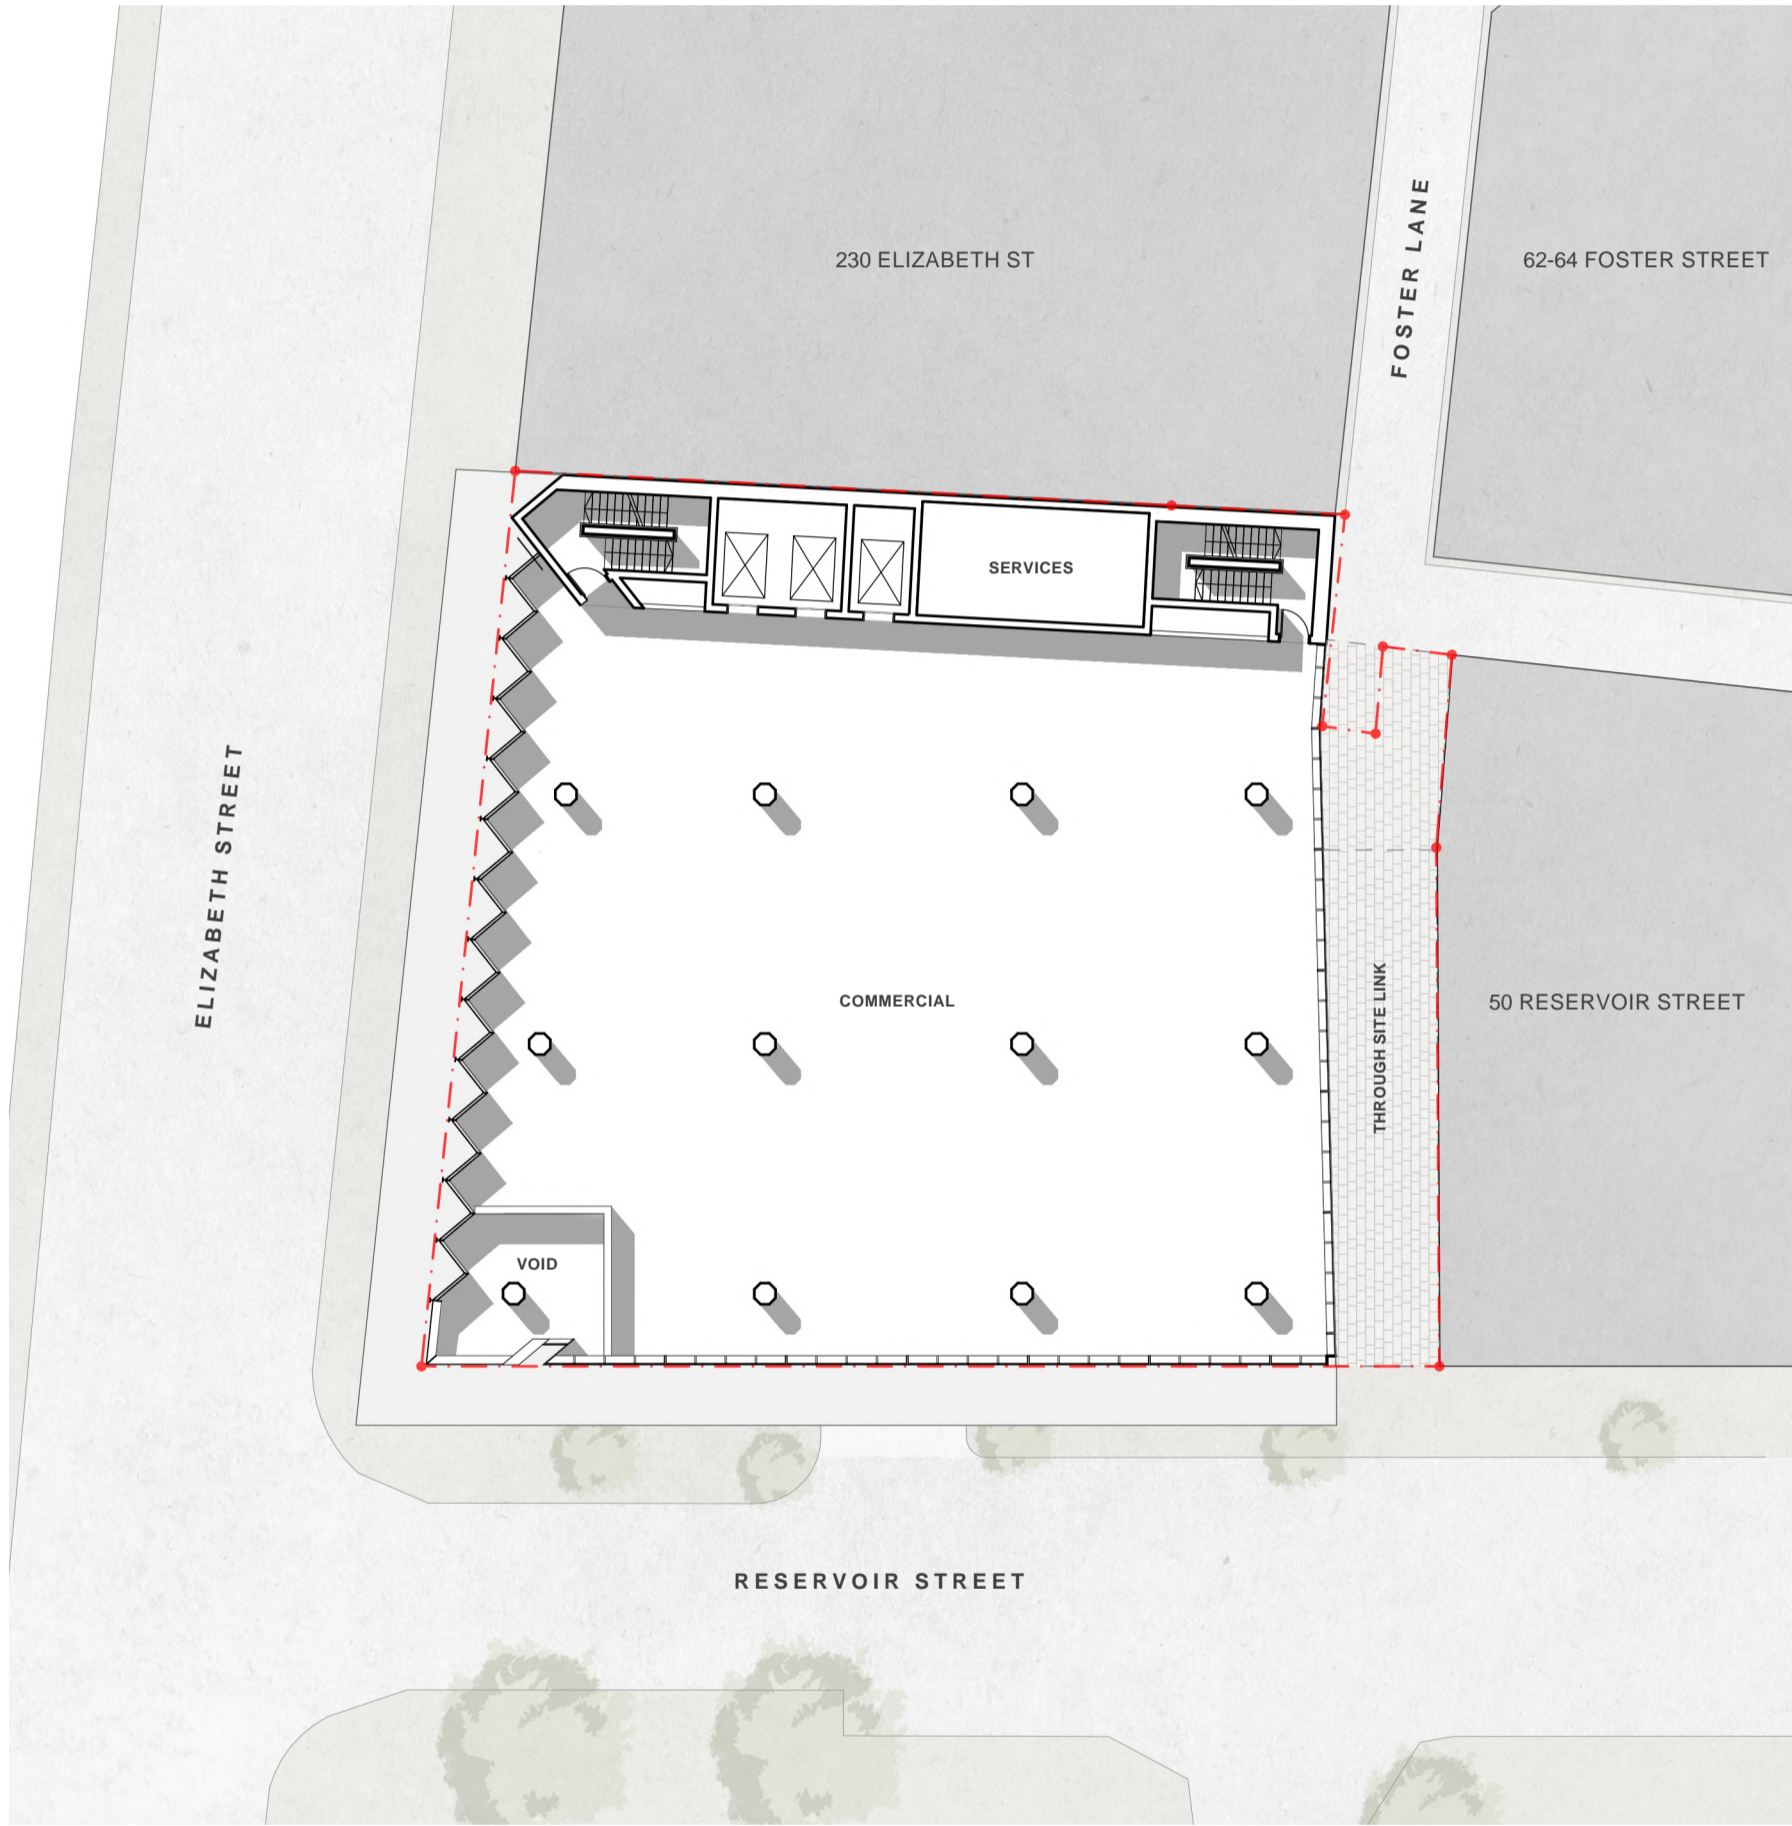
TYPICAL FLOOR PLAN L3, L5, L7
COMMERCIAL GFA 681 m²

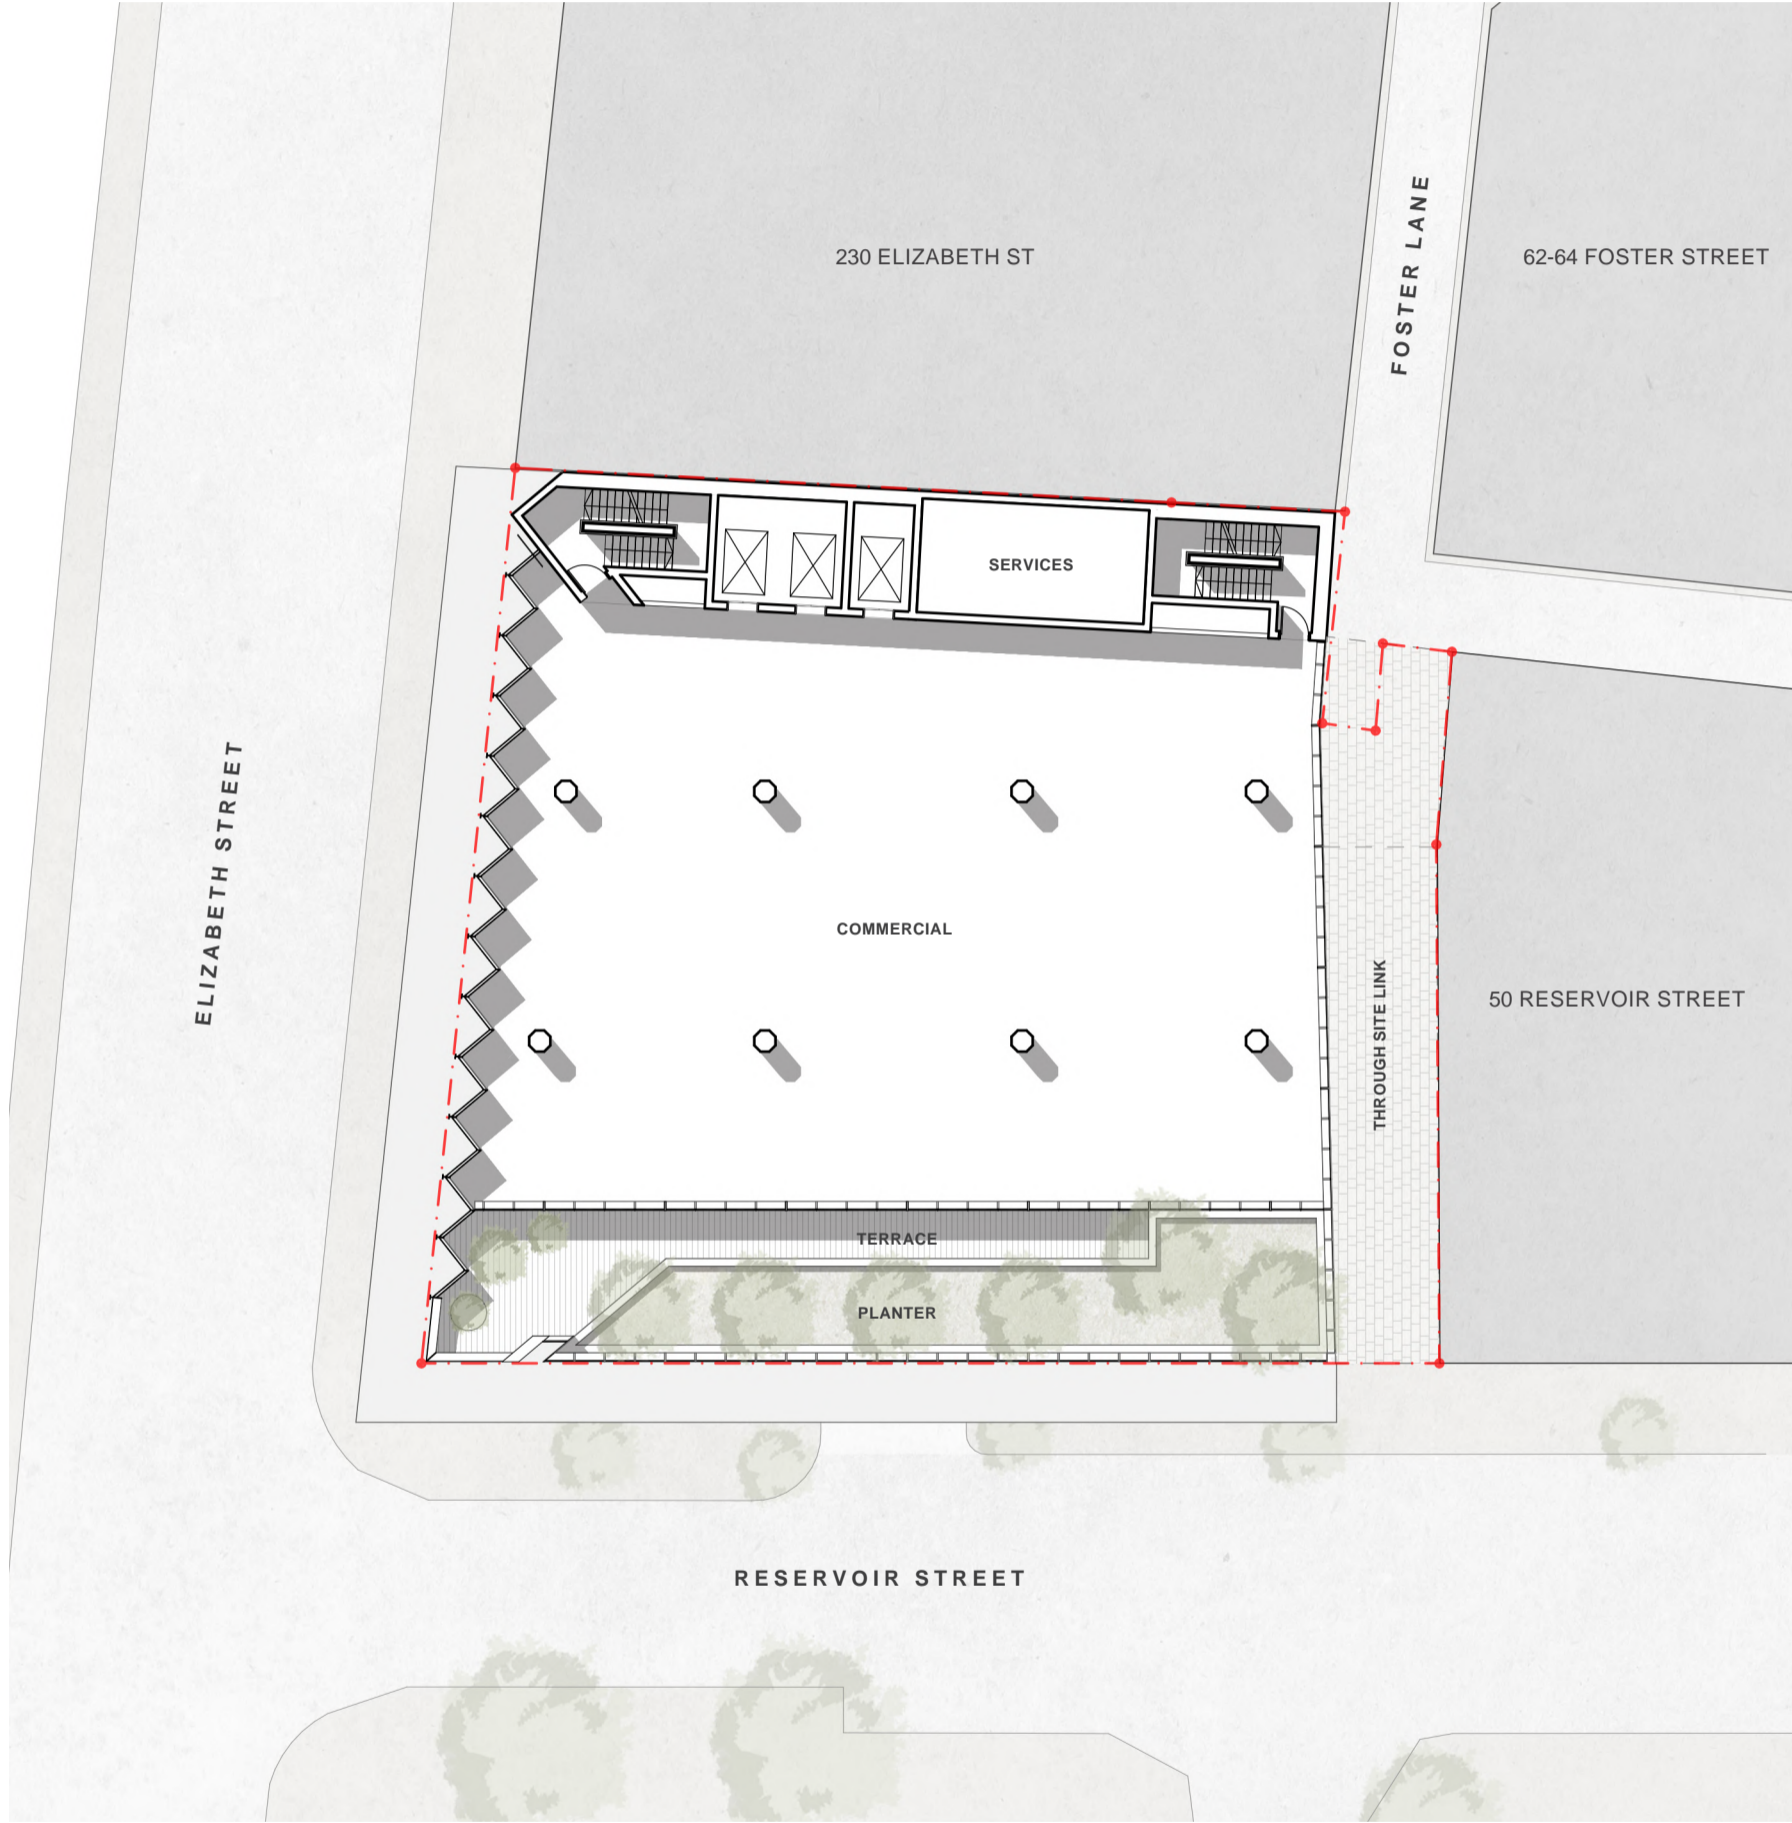
FLOOR PLAN - L8

COMMERCIAL GFA	561 m ²
TERRACE	61 m ²
PLANTER	78 m ²

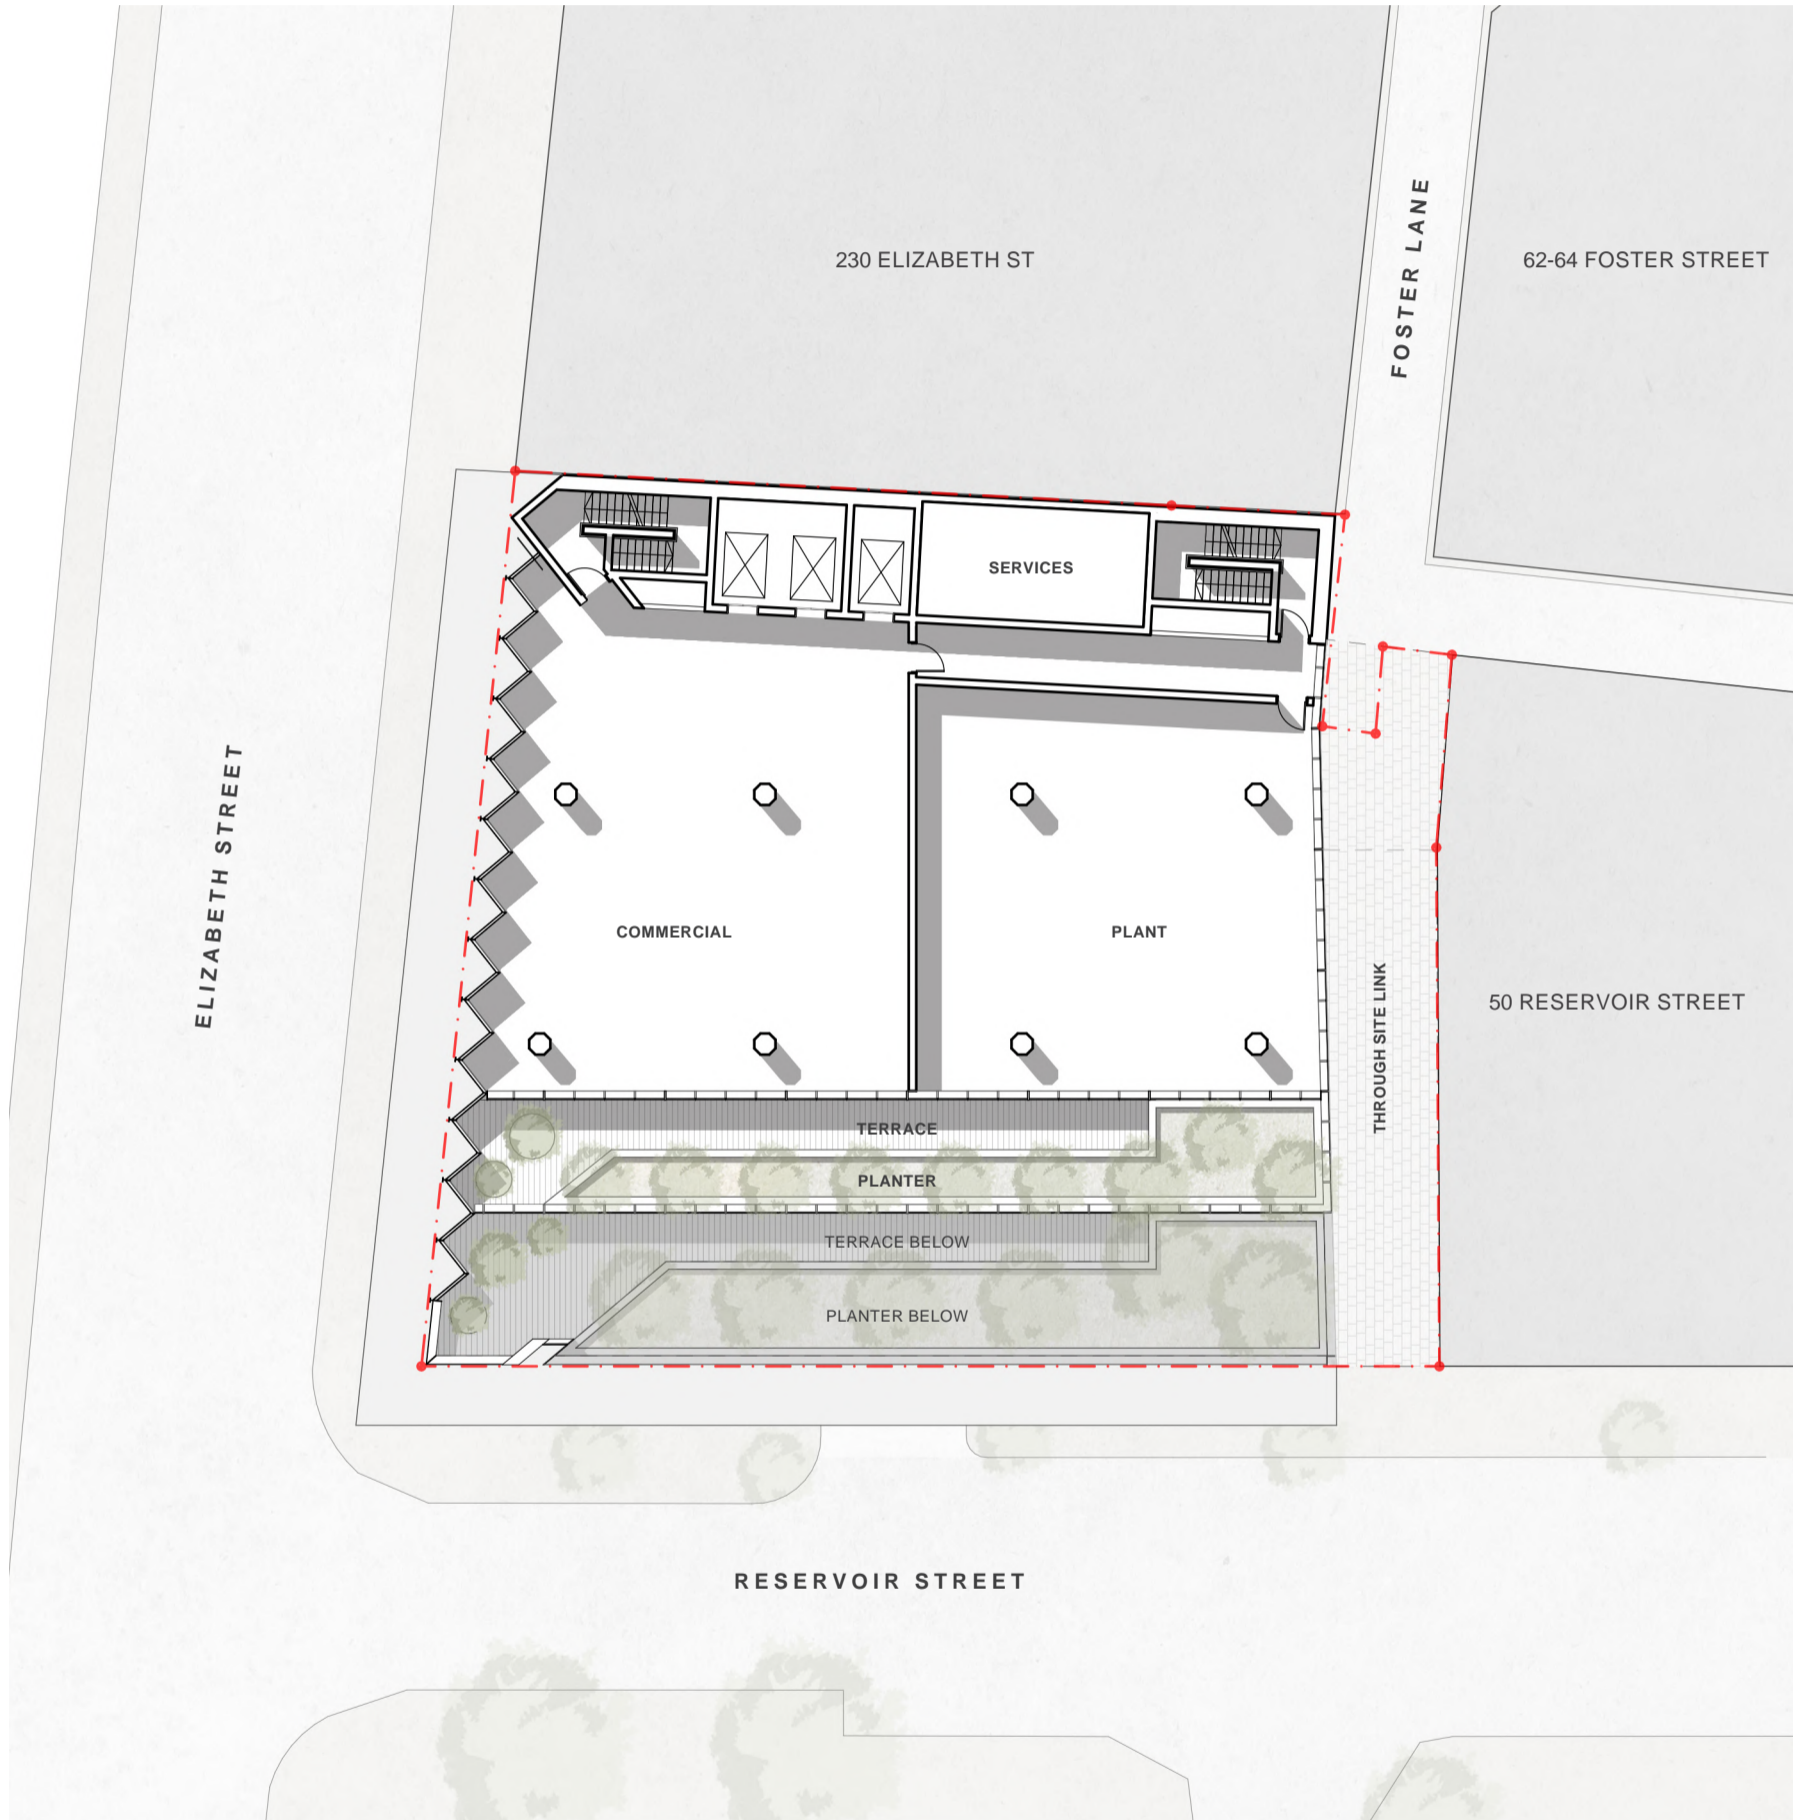
FLOOR PLAN - L9

COMMERCIAL GFA	380 m ²
TERRACE	44 m ²
PLANTER	58 m ²
PLANT	66 m ²

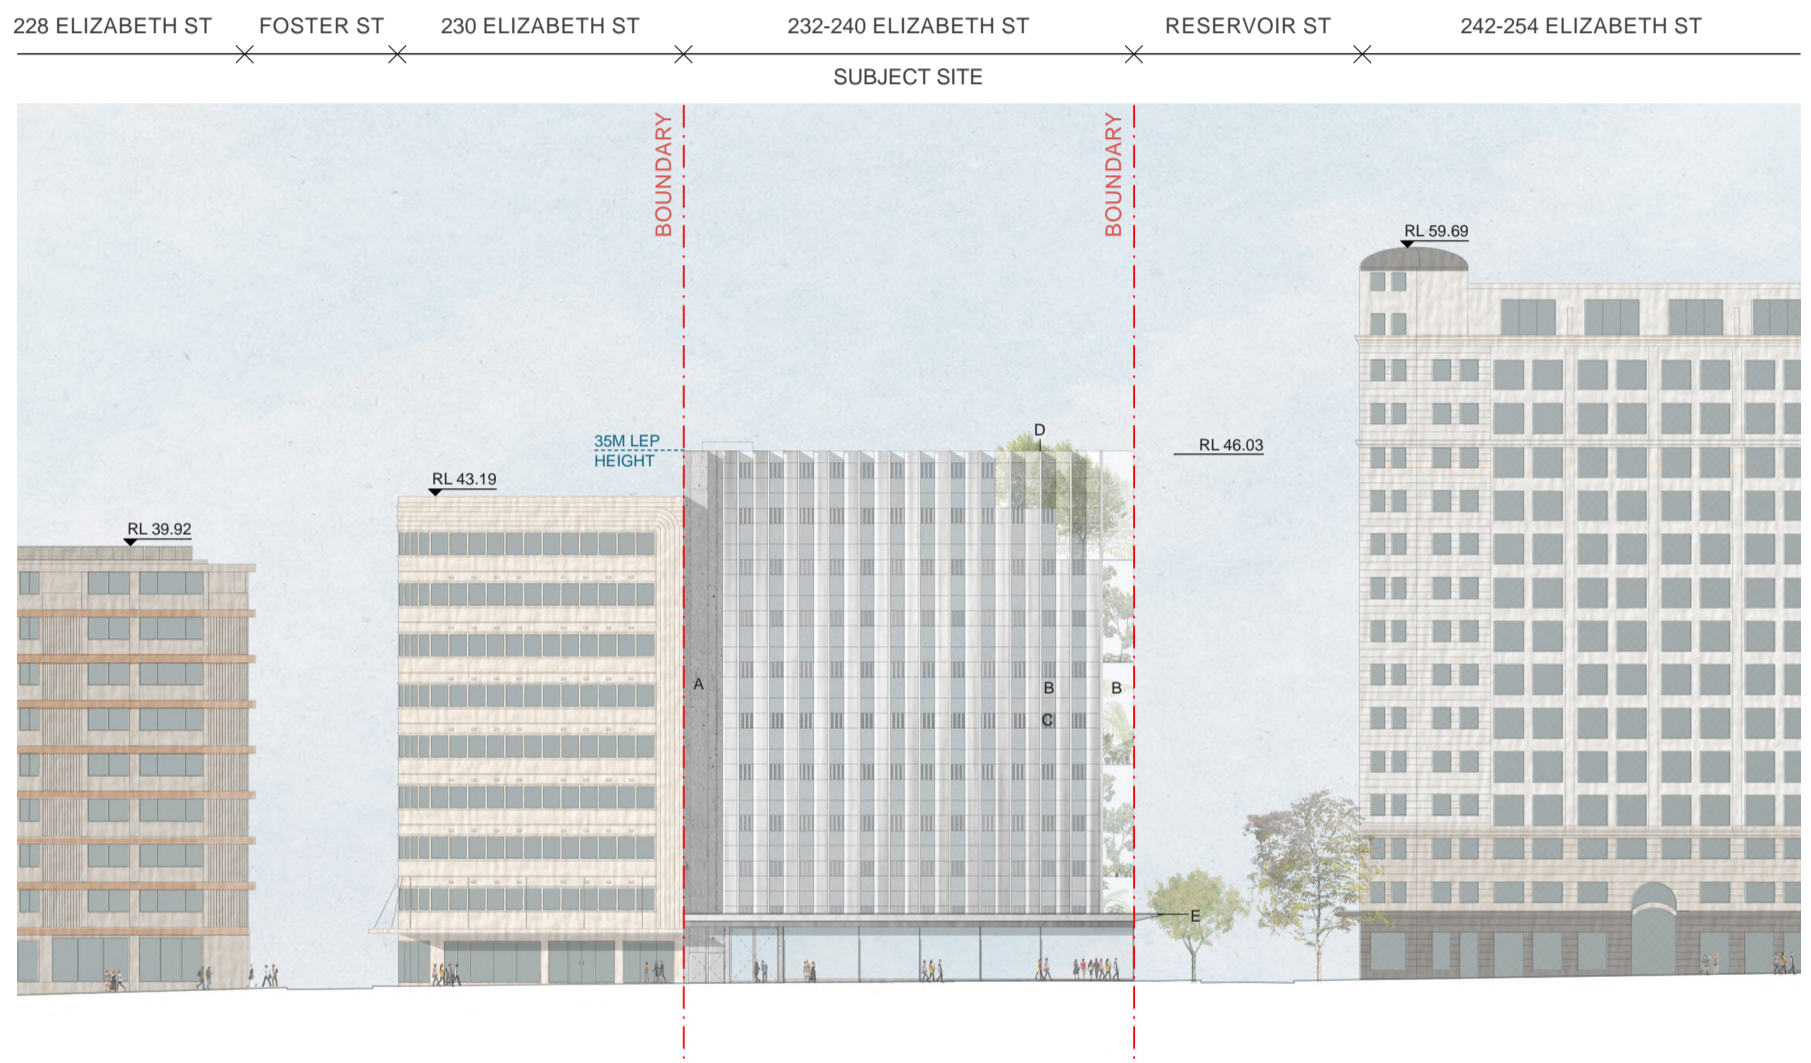
WEST ELEVATION - ELIZABETH STREET

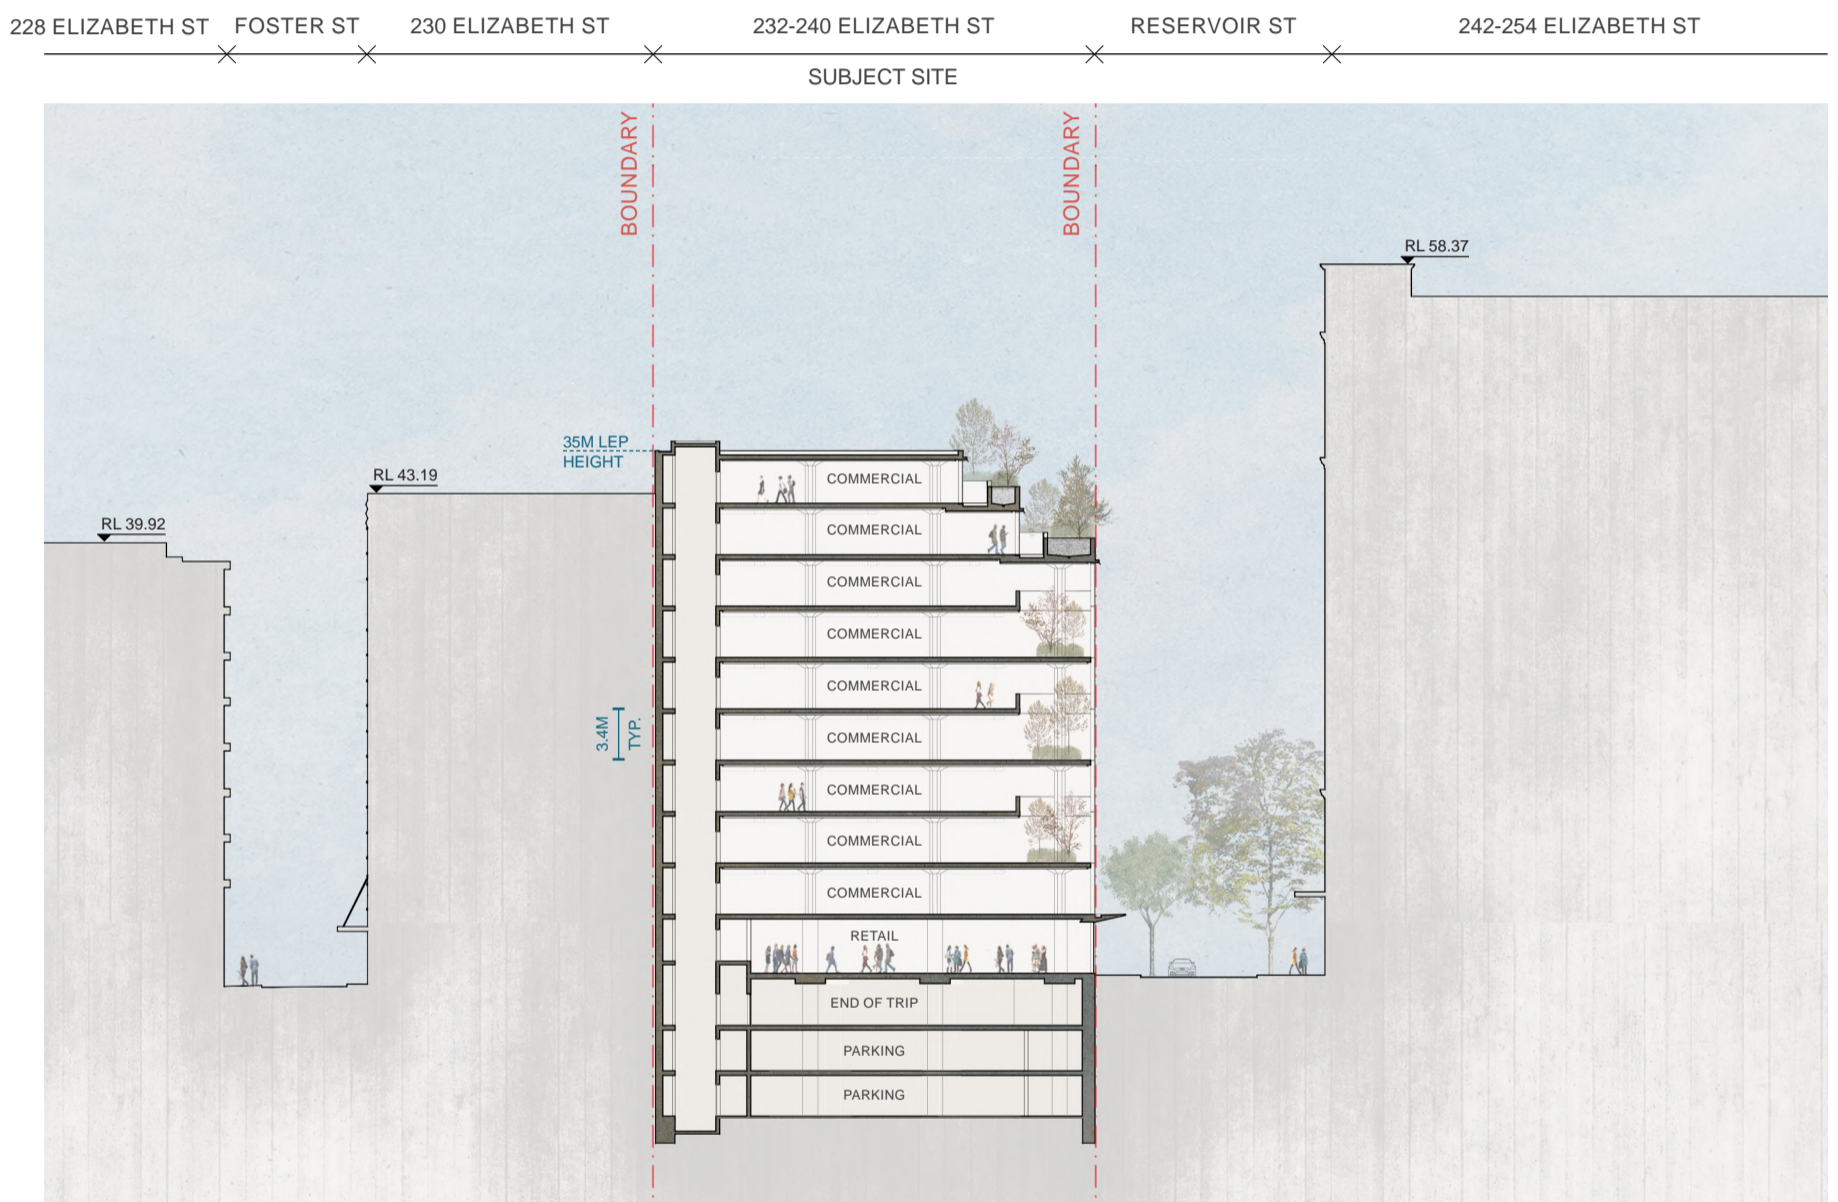
SECTION AA
