**Conservation Management Plan**

**Haymarket Library**

**744-744B George Street, Haymarket  
NSW 2000**

7 DECEMBER 2018  
SH1373  
PREPARED FOR CITY OF SYDNEY COUNCIL

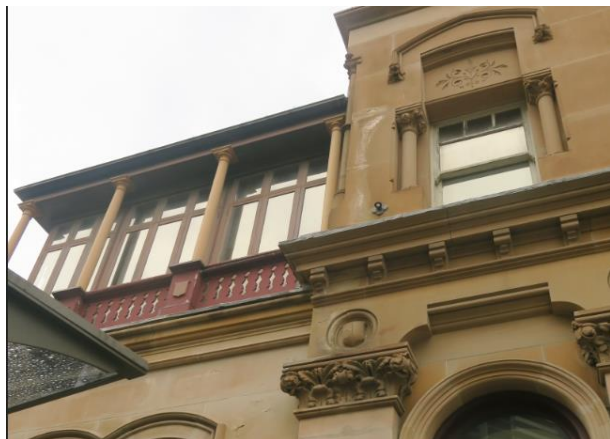
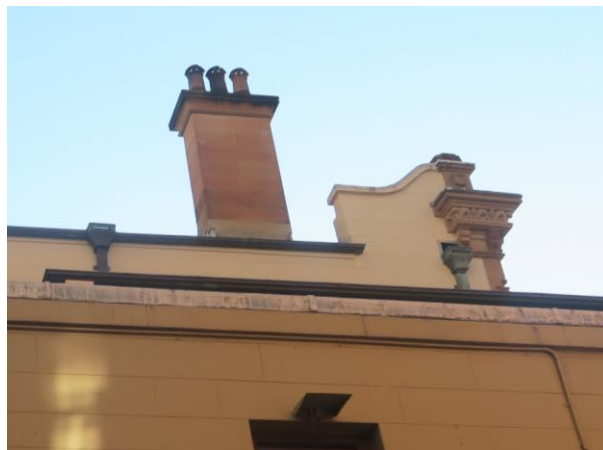
Figure 5 – View of the reconstructed original timber framed balcony with later infill setback from balustrade (left image). The eastern façade of the principal building form is only exposed at level 2. This façade is rendered brick with Ashlar course scribing. 3 copper downpipes are visible to this elevation. The northernmost downpipe is substantially tarnished (right image).

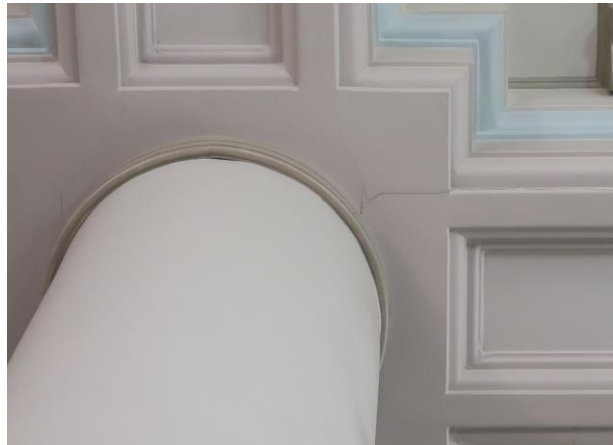
- The later addition bluestone base course to the northern façade appears to be failing.
- Possible evidence of damp to southern wall of principal building form (visible from timber frame structure) requires further investigation.
- Some internal timber window sills are loose and require refixing
- Minor cracking to coffered ceilings

Figure 27 – Failing bluestone basecourse (left image) Cracking to coffered ceiling at Ground Floor (right image).

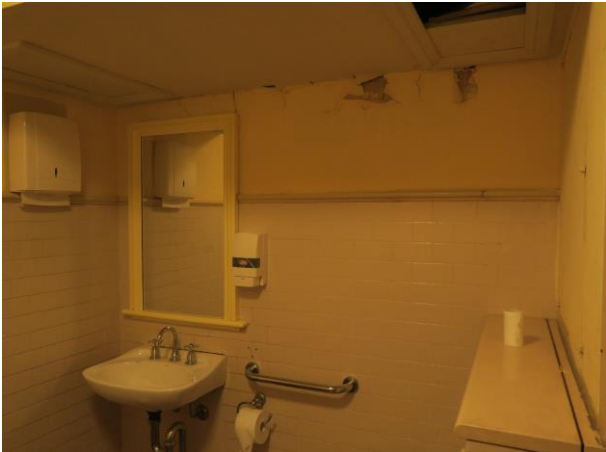
Figure 28 –Evidence of damp to west face of bathroom at Level 1 (left image)

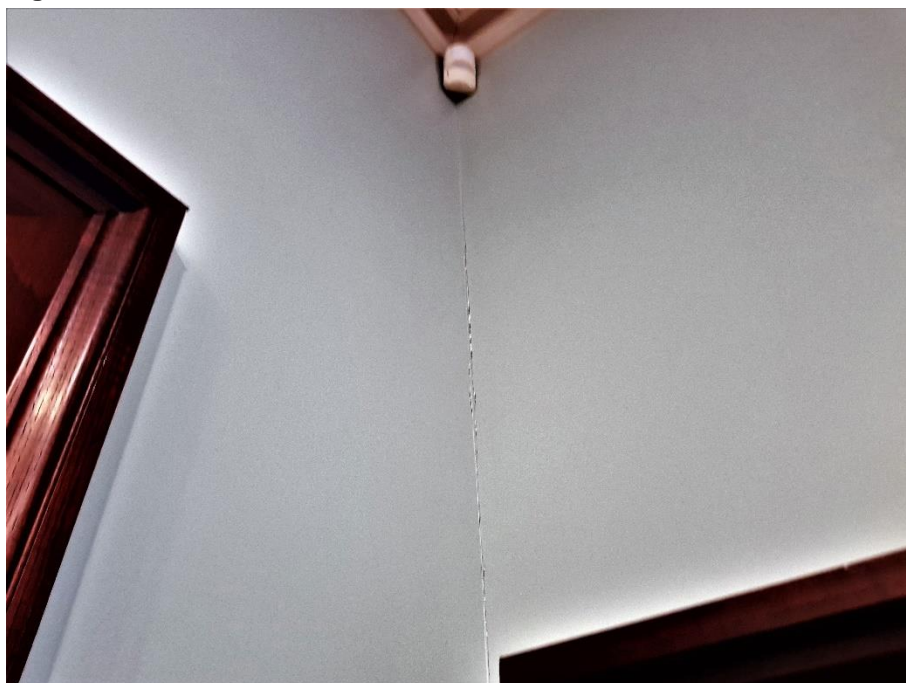
**Figure 8: Crack in Corner**

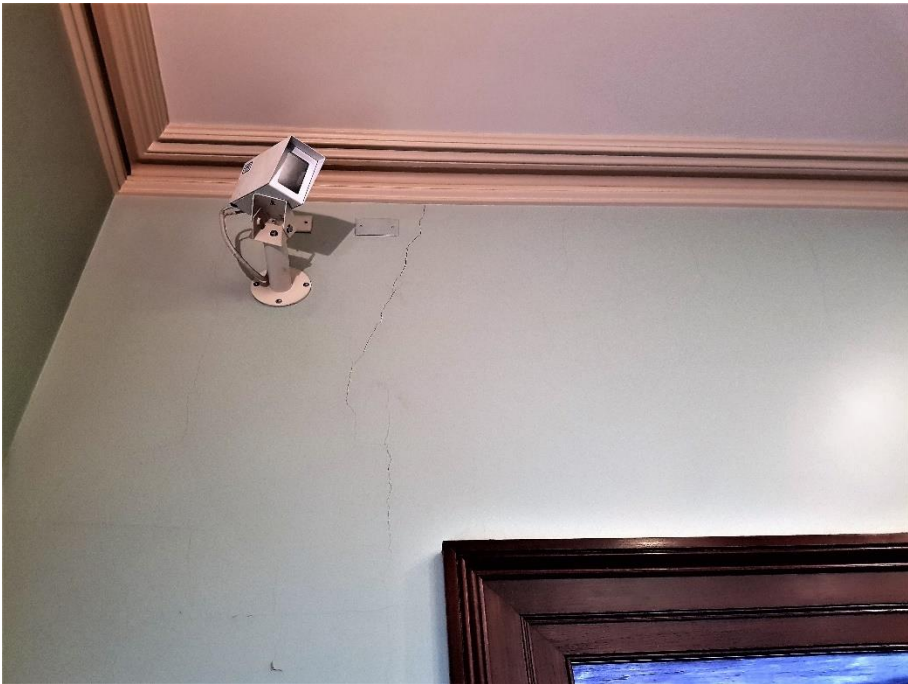
**Figure 9: 2mm Cracking Over Door, Crazed Cracking**

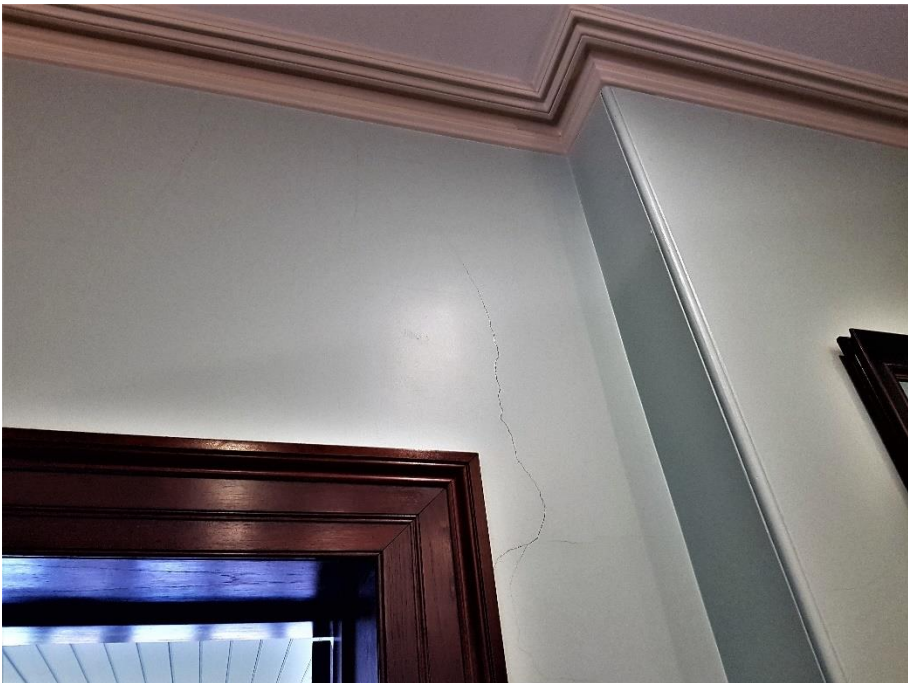
**Figure 10: 2mm Cracking Over Door, Crazed Cracked**

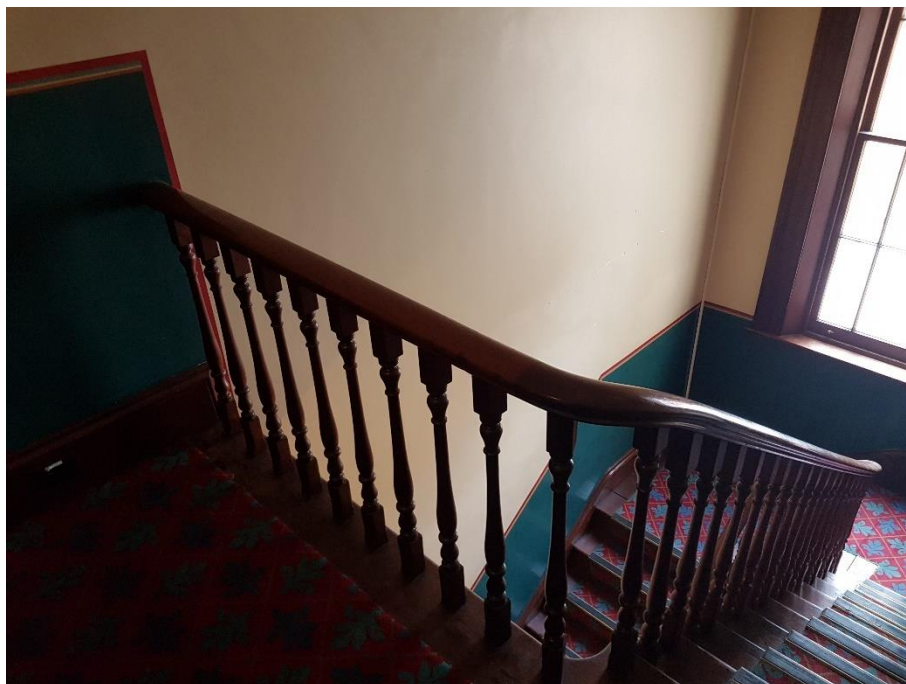
**Figure 11: Low Balustrade to Landing 800mm High**

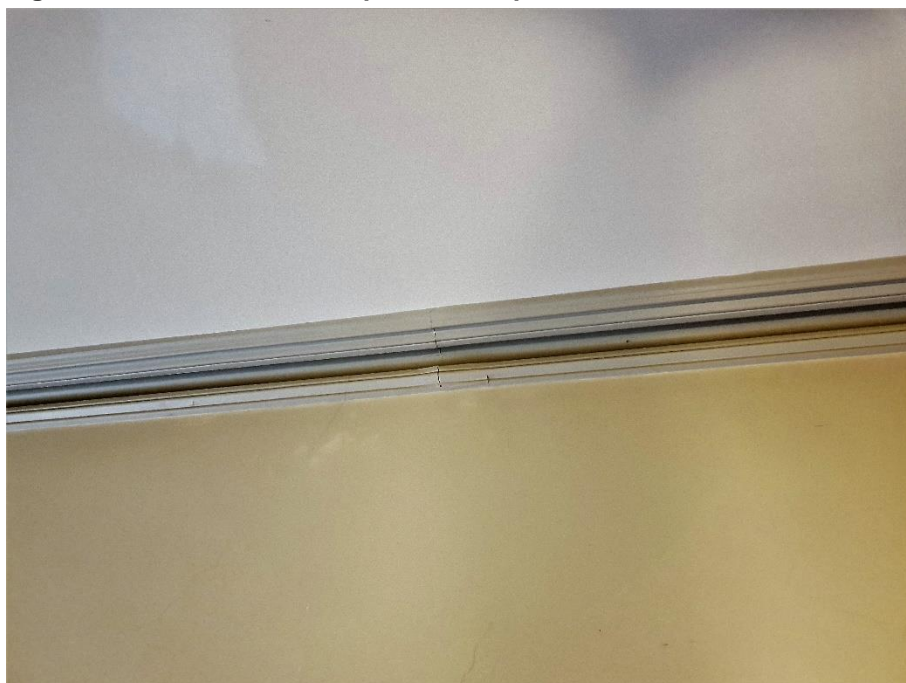
**Figure 12: Cornice Crack Repaired Multiple Times**

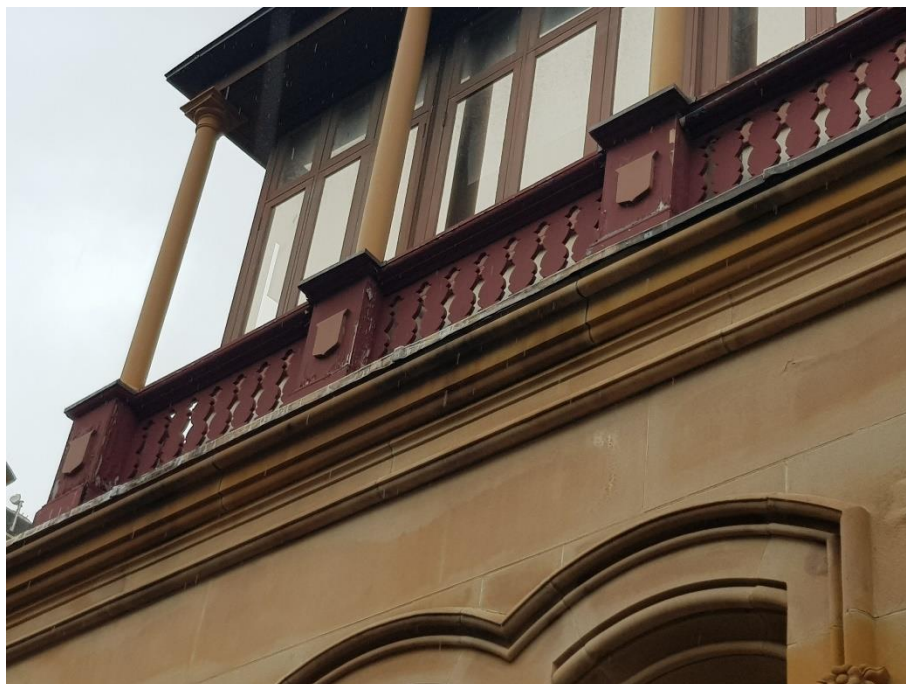
**Figure 13: Timber Paint Peeling**

13	Figure 13	North Façade	Timber paint peeling	Repaint timber
14	Figure 14	North Façade	Sandstone weathering	N/A
15	N/A	Level 2	Creaky floors, no bounce when walking on	N/A

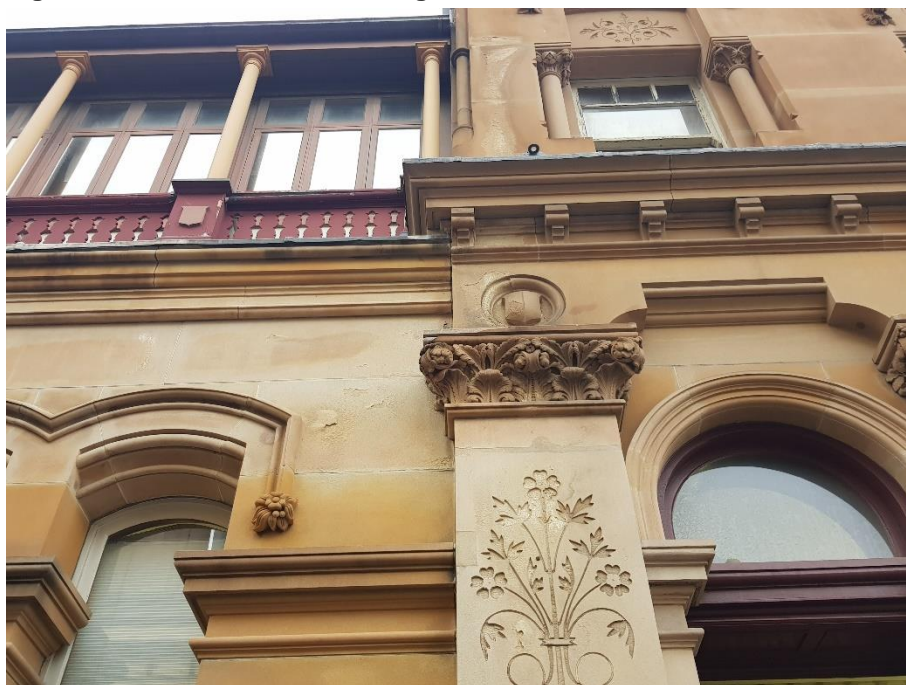
**Figure 14: Sandstone Weathering**
